KEEYASK TRANSMISSION PROJECT WATERCOURSE CROSSINGS POST-CONSTRUCTION MONITORING REPORT – 2021

June 2021

Manitoba Hydro

North/South Consultants Inc.
Aquatic Environment Specialists

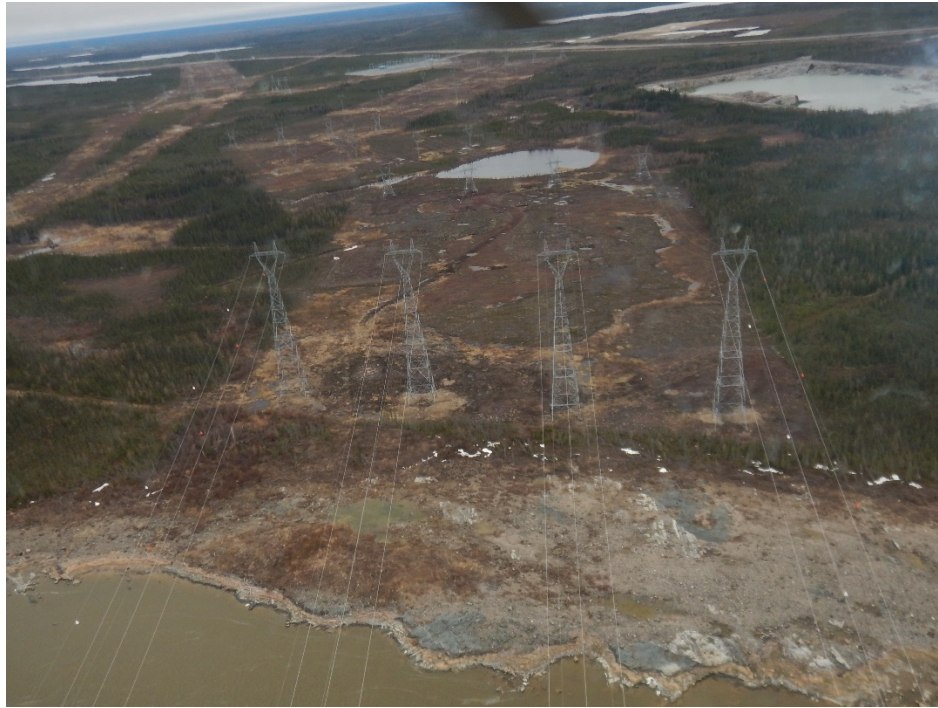
Photo 1. Sites KE1-Aqua-100a, KE2-Aqua-100b, KE3-Aqua-100c and KE4-Aqua-100d showing completed towers on south shoreline, no mitigation compliance issues.

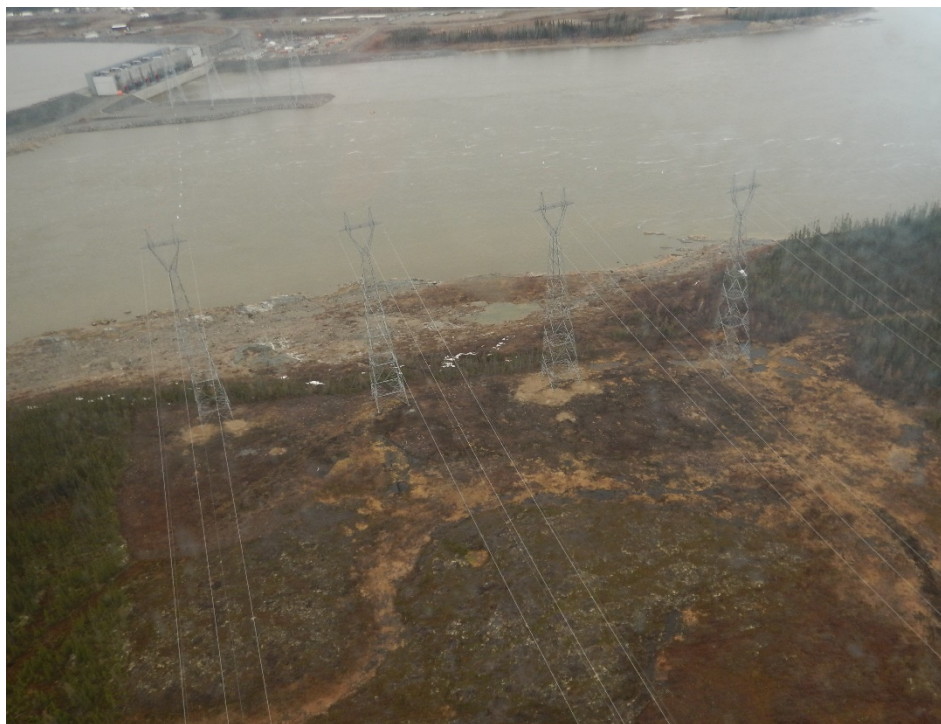
Photo 2. Sites KE1-Aqua-100a, KE2-Aqua-100b, KE3-Aqua-100c and KE4-Aqua-100d showing completed towers on south shoreline looking towards the Keeyask GS, no mitigation compliance issues.

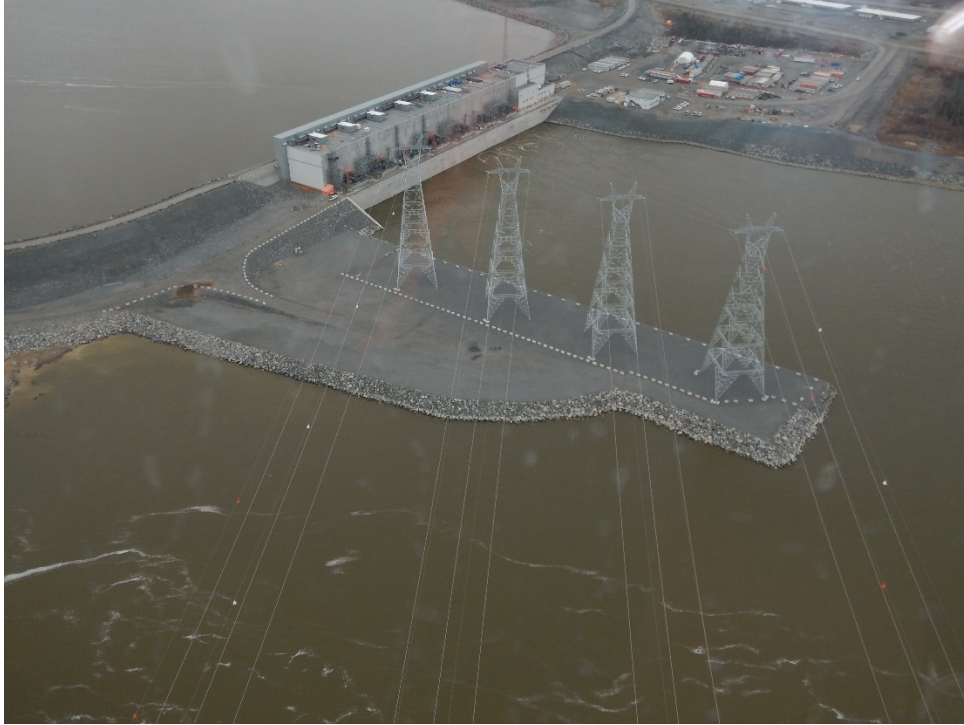
Photo 3. Sites KE1-Aqua-100a, KE2-Aqua-100b, KE3-Aqua-100c and KE4-Aqua-100d showing completed towers on the north shoreline at the Keeyask GS, no mitigation compliance issues.
