Keeyask Transmission Project **Environmental Effects Monitoring Plan** Technical Reports

KEEYASK TRANSMISSION PROJECT WATERCOURSE CROSSINGS

POST-CONSTRUCTION MONITORING REPORT – 2016

June 2017

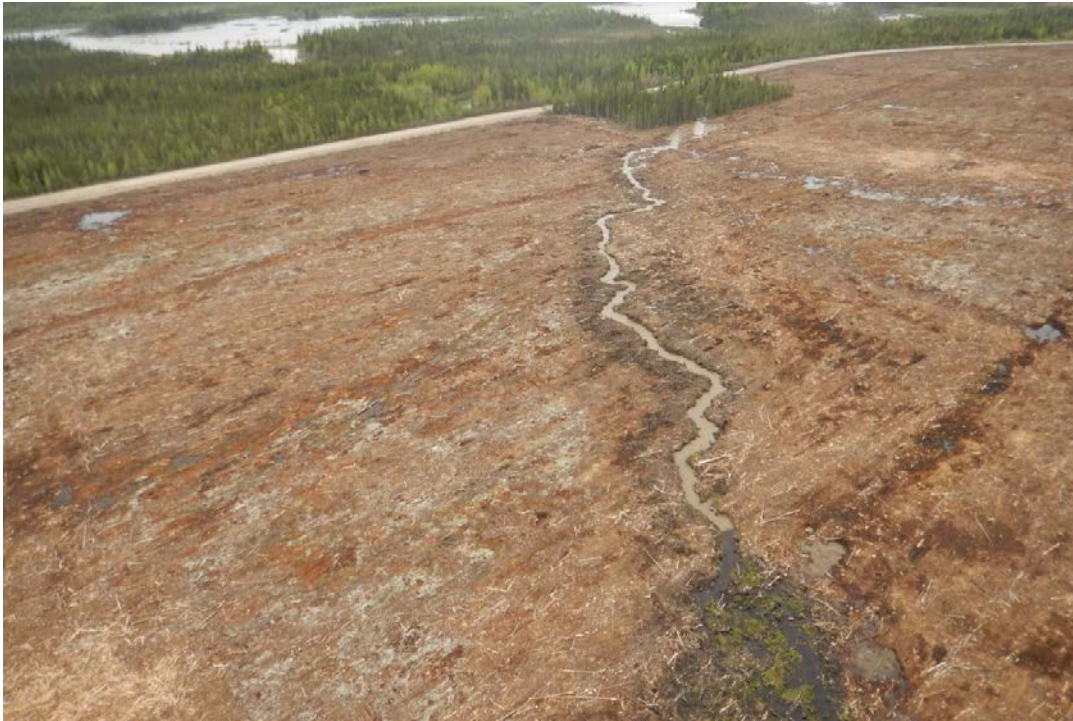
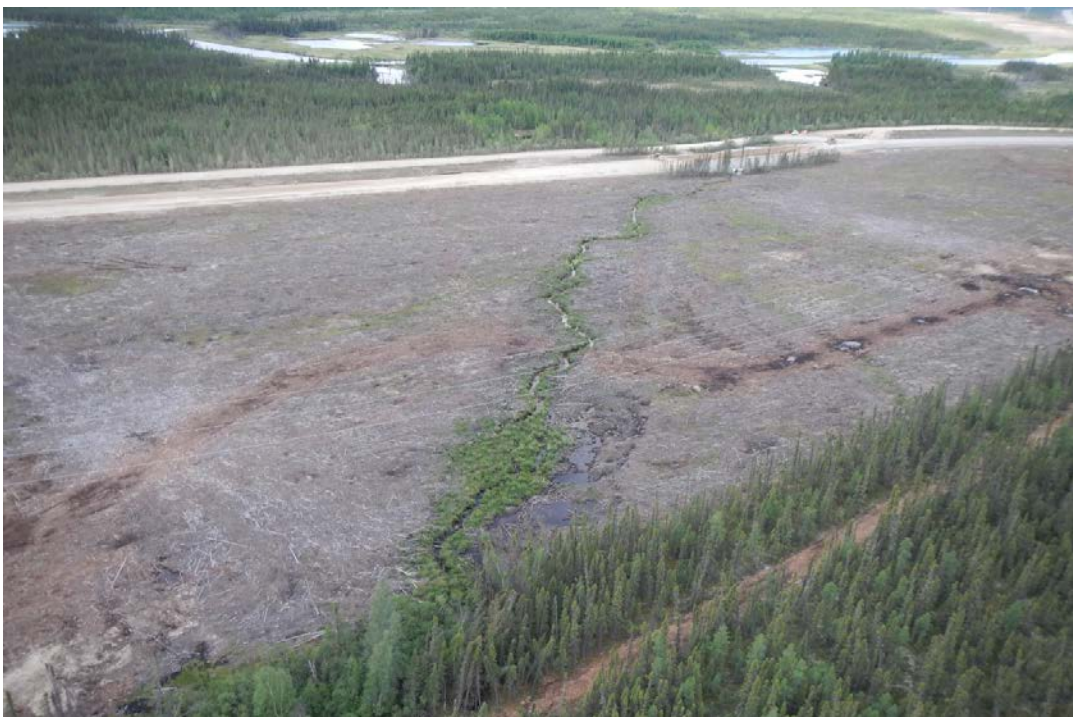
In 2015 a riparian buffer was not established during clearing at KGOT-Aqua-128, 129 and 130 resulting in erosion and sedimentation of the stream. Erosion control measures and a follow-up visit in 2016 was recommended. Other than the natural re-vegetation of the stream, no other erosion control measures were applied. Small shrubs and forbes were observed growing along the banks of the stream and no sedimentation was observed during the post spring runoff conditions at the time of the survey. It is expected the vegetation will continue to grow and stabilize the banks and riparian zone. No further remediation is recommended.

Photo 1. KGOT-Aqua-128 to 130 (tributary of the Butnau River). Un-mitigated stream crossing cleared June 15, 2015 (top) and state as of June 21, 2016 (bottom).

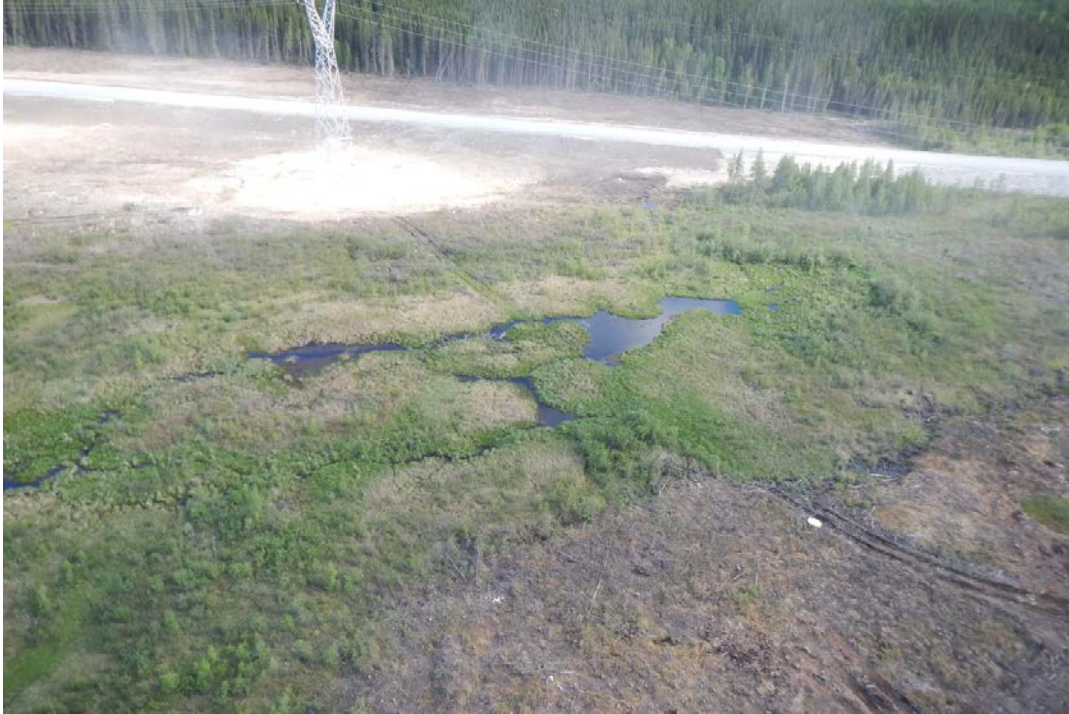
Thirty-two sites at ten watercourse crossings were evaluated along the GOT line. Non-compliance was limited to a single stream crossing (KGOT-Aqua-100, 101 and 102) where it appears the watercourse was crossed with a vehicle or vehicles unnecessarily. A road was present adjacent to the RoW from which the watercourse could be accessed from either side. However, due to the marginal importance of the stream to fish and fish habitat and absence of stream bank damage no remediation or follow-up is recommended.

Photo 2. KGOT-Aqua-100 to 102 (unnamed tributary). Evidence of a stream crossing despite the presence of the road adjacent to the RoW, June 21, 2016.
