KEYYASK TRANSMISSION PROJECT WATERCOURSE CROSSINGS
POST-CONSTRUCTION MONITORING REPORT – 2017

December 2017

Manitoba Hydro

North/South Consultants Inc.
Aquatic Environment Specialists

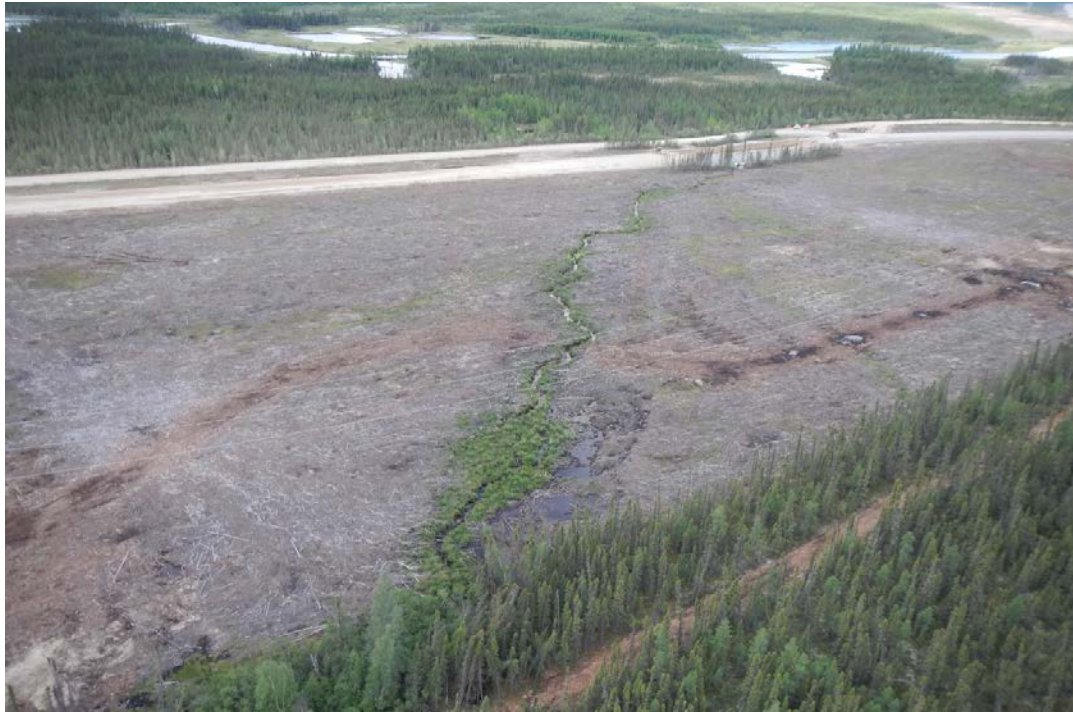
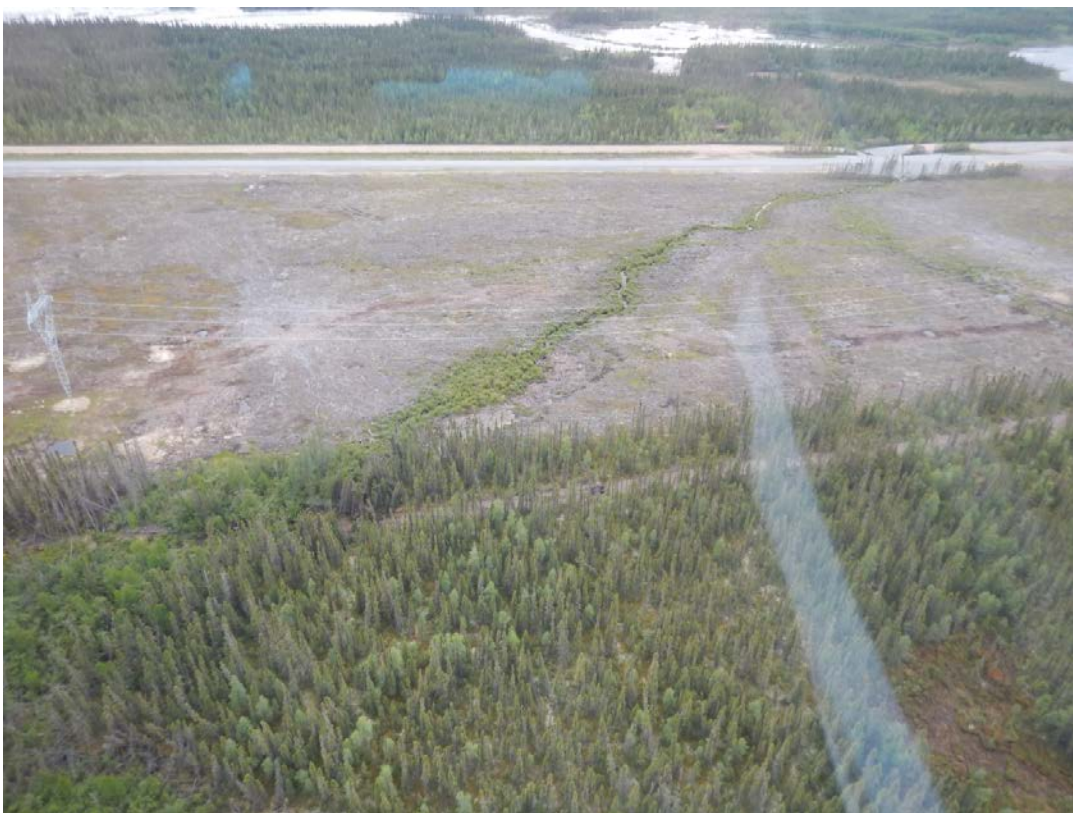
In 2015 a riparian buffer was not established during clearing at KR1-Aqua-128, KR3-Aqua-129, and KR2-Aqua-130 resulting in erosion and sedimentation of the stream. No mitigation measures have been implemented since 2015 but re-vegetation is occurring naturally. Small shrubs and forbes were observed growing along the banks of the stream and no sedimentation was observed during the survey in 2017. It is expected the vegetation will continue to grow and stabilize the banks and riparian zone. No further remediation is recommended.

Photo 1. KR1-Aqua-128, KR3-Aqua-129, and KR2-Aqua-130 (tributary of the Butnau River). Un-mitigated stream crossing June 21, 2016 (top) and state as of June 26, 2017 (bottom).

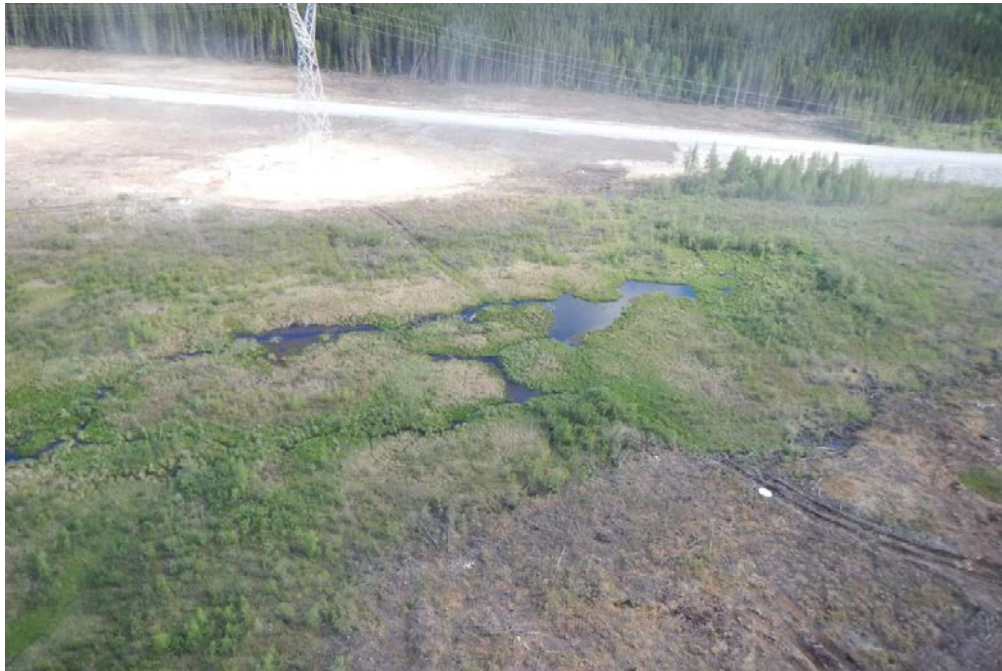
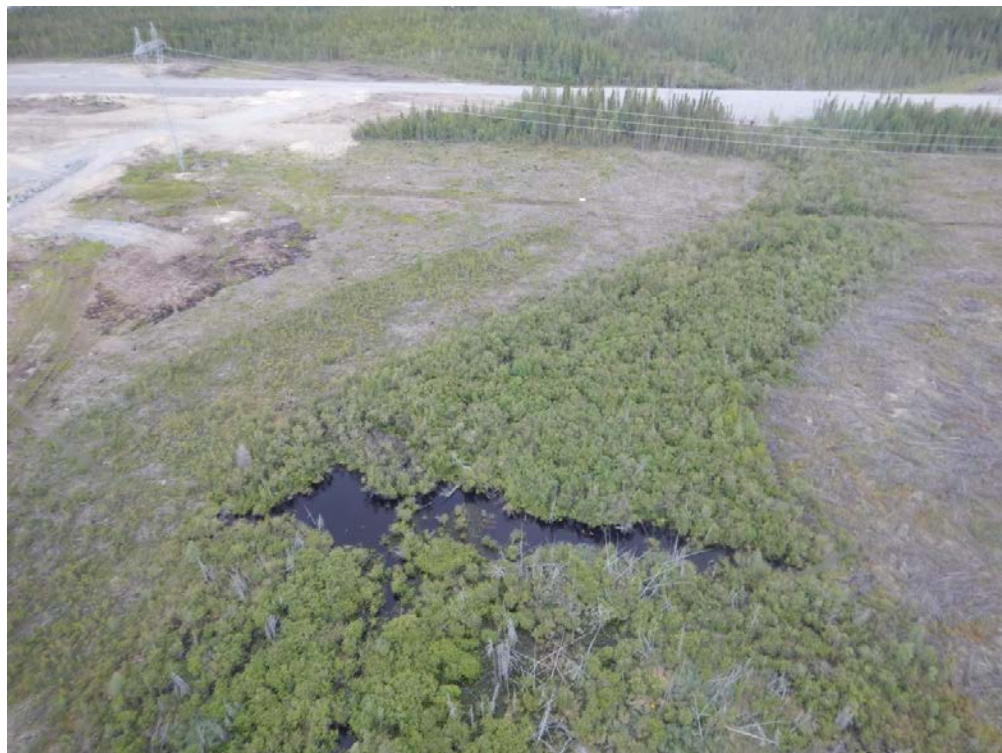
Photo 2. KR1-Aqua-100, KR3-Aqua-101, and KR2-Aqua-102 (unnamed tributary). Evidence of a stream crossing through the RoW in June 2016 (top). No evidence of tracks in June 2017 with shrub re-growth present throughout the crossing.
