KEYYASK TRANSMISSION PROJECT WATERCOURSE CROSSINGS
POST-CONSTRUCTION MONITORING REPORT – 2018

March 2019

Manitoba Hydro

North/South Consultants Inc.
Aquatic Environment Specialists

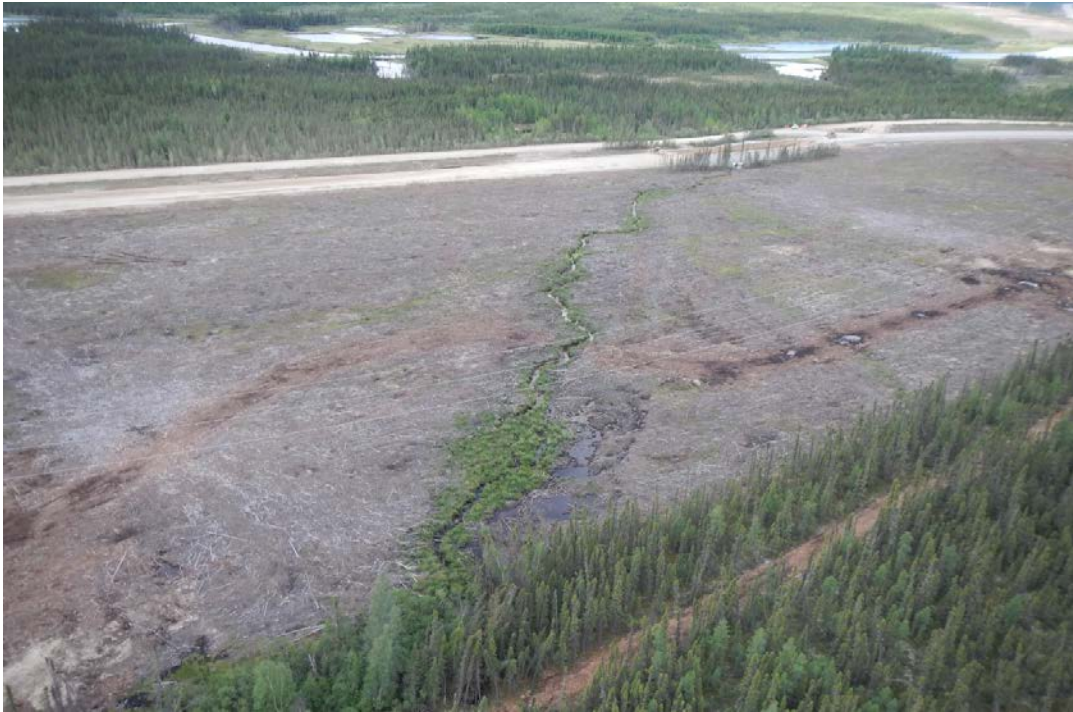
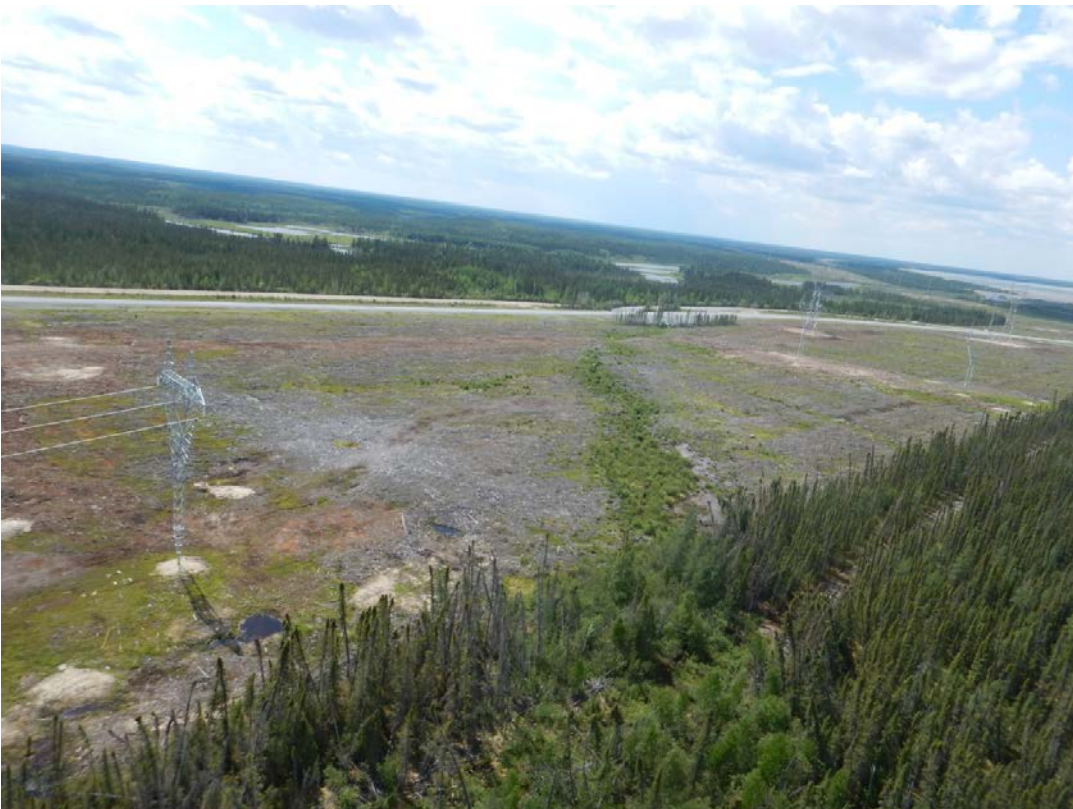
In 2015 a riparian buffer was not established during clearing at KR1-Aqua-128, KR3-Aqua-129, and KR2-Aqua-130 resulting in erosion and sedimentation of the stream. No mitigation measures have been implemented since 2015 but re-vegetation is occurring naturally (Photos 1-2). Small

Photo 1. KR1-Aqua-128, KR3-Aqua-129, and KR2-Aqua-130 (trib. of the Butnau River). Un-mitigated stream crossing June 21, 2016 (top) and state on June 25, 2018 (bottom).

shrubs and forbes were observed growing along the banks of the stream and no sedimentation was observed during the ground survey in 2018 (Photo 3). It is expected the vegetation will continue to grow and stabilize the banks and riparian zone. No further remediation is recommended (Appendix 1).

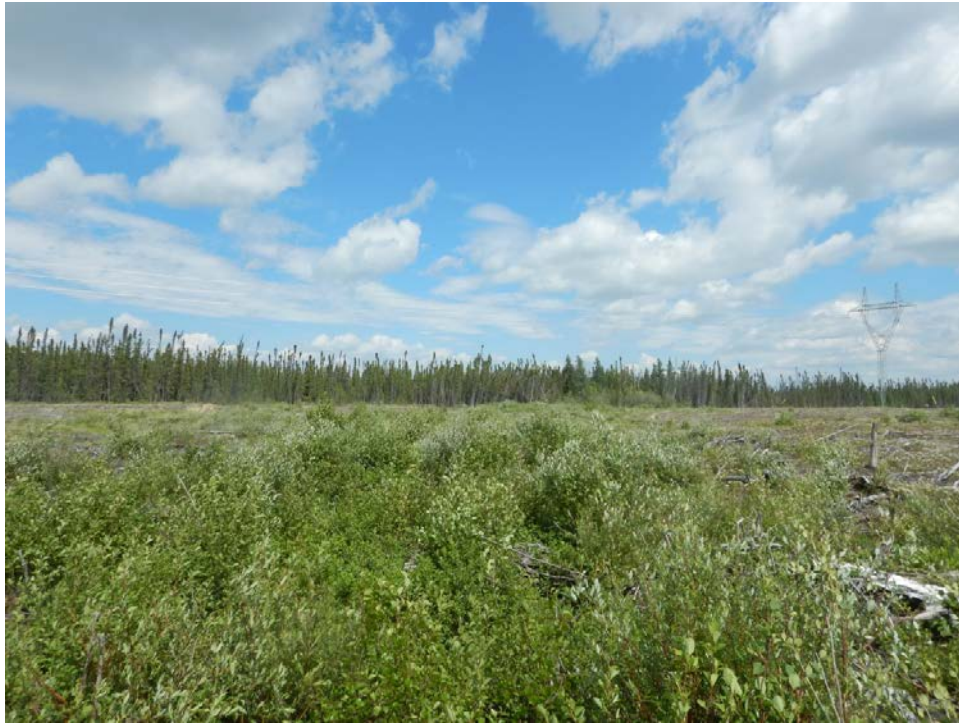
Photo 2. Site visit photo from KR1-Aqua-128, KR3-Aqua-129, and KR2-Aqua-130 (trib. of the Butnau River) showing regrowth, June 25, 2018.

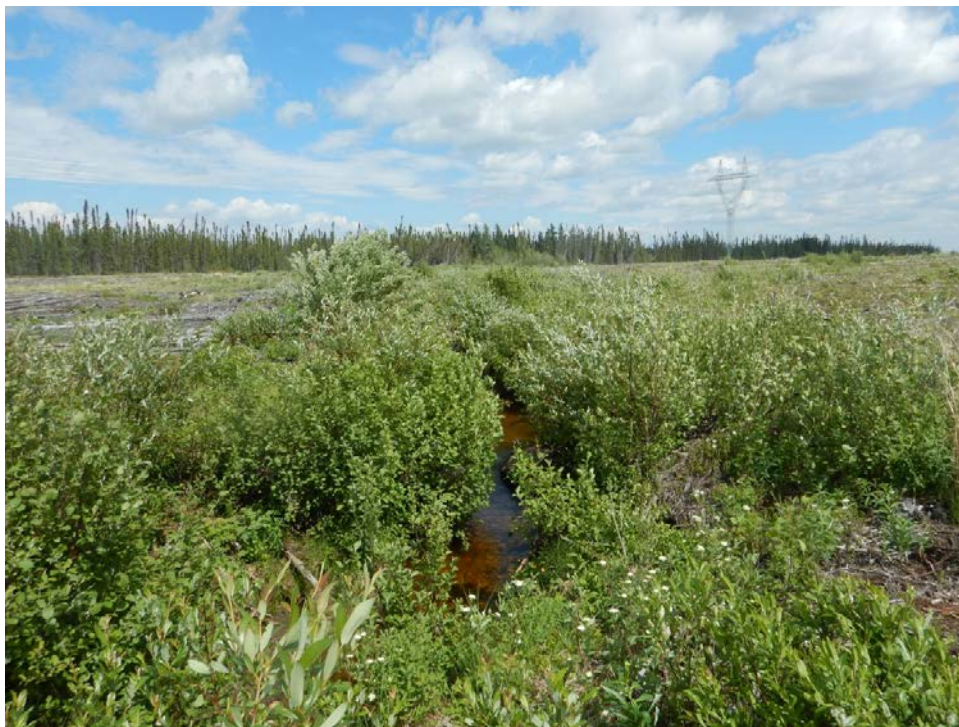
Photo 3. Site visit photos from KR1-Aqua-128, KR3-Aqua-129, and KR2-Aqua-130 (trib. of the Butnau River) showing regrowth and watercourse, June 25, 2018.
