KEEYASK TRANSMISSION PROJECT

ENVIRONMENTAL EFFECTS MONITORING PLAN

ECOSYSTEM DIVERSITY MONITORING IN 2018

By
ECOSTEM Ltd.
January 2019

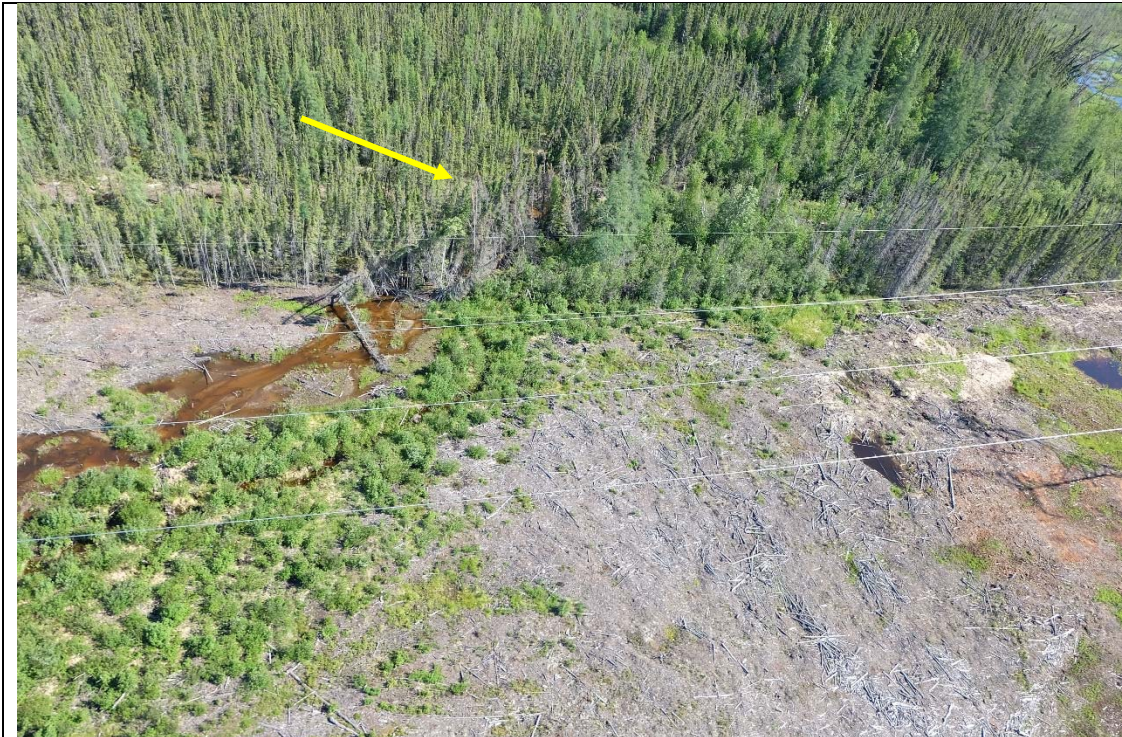
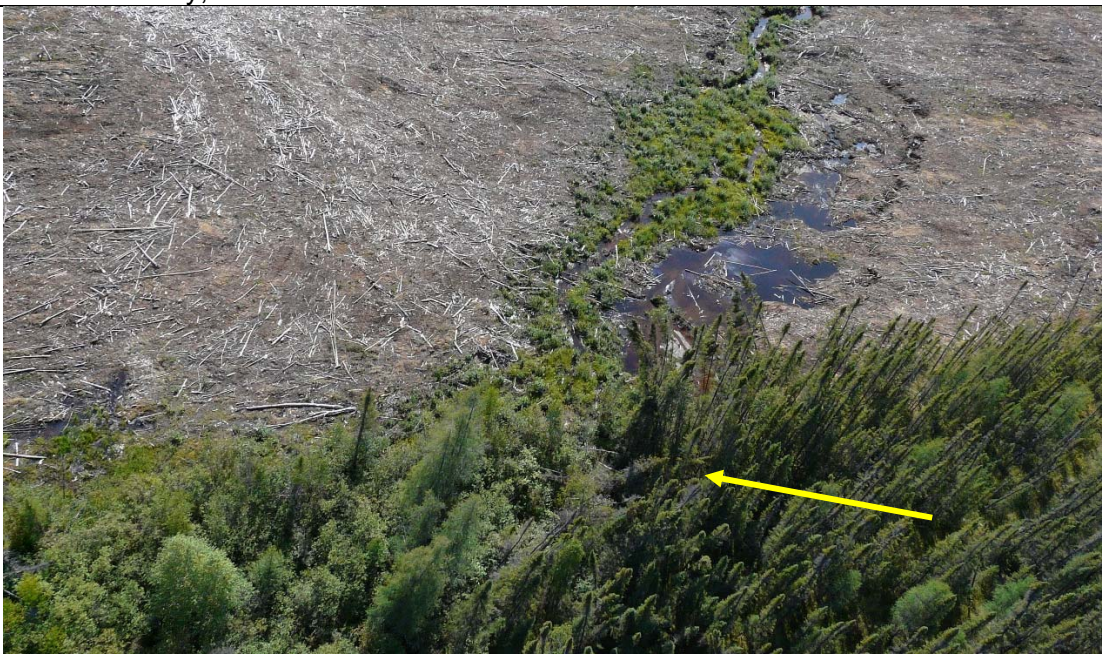
The largest effect by far was the one observed in patch PH1874 during aerial surveys. In this patch, collapsing and dying trees extended for approximately 70 m along a pre-existing runnel. Also, runoff from the ROW was flowing into the patch along this runnel and depositing sediment. Examination of aerial photos of the area taken in 2015 showed that the majority of the tree collapse and mortality that was near the ROW edge occurred after clearing. It is uncertain how much of the total observed tree collapse was due to Project effects. At minimum, some of the effects at the ROW edge were definitely Project-related while the rest was likely accelerated by indirect Project effects.

PH1874 in July, 2018

PH1874 in August, 2015

Photo 3-1: Erosion and sediment deposition with tree mortality in priority habitat patch PH1874.

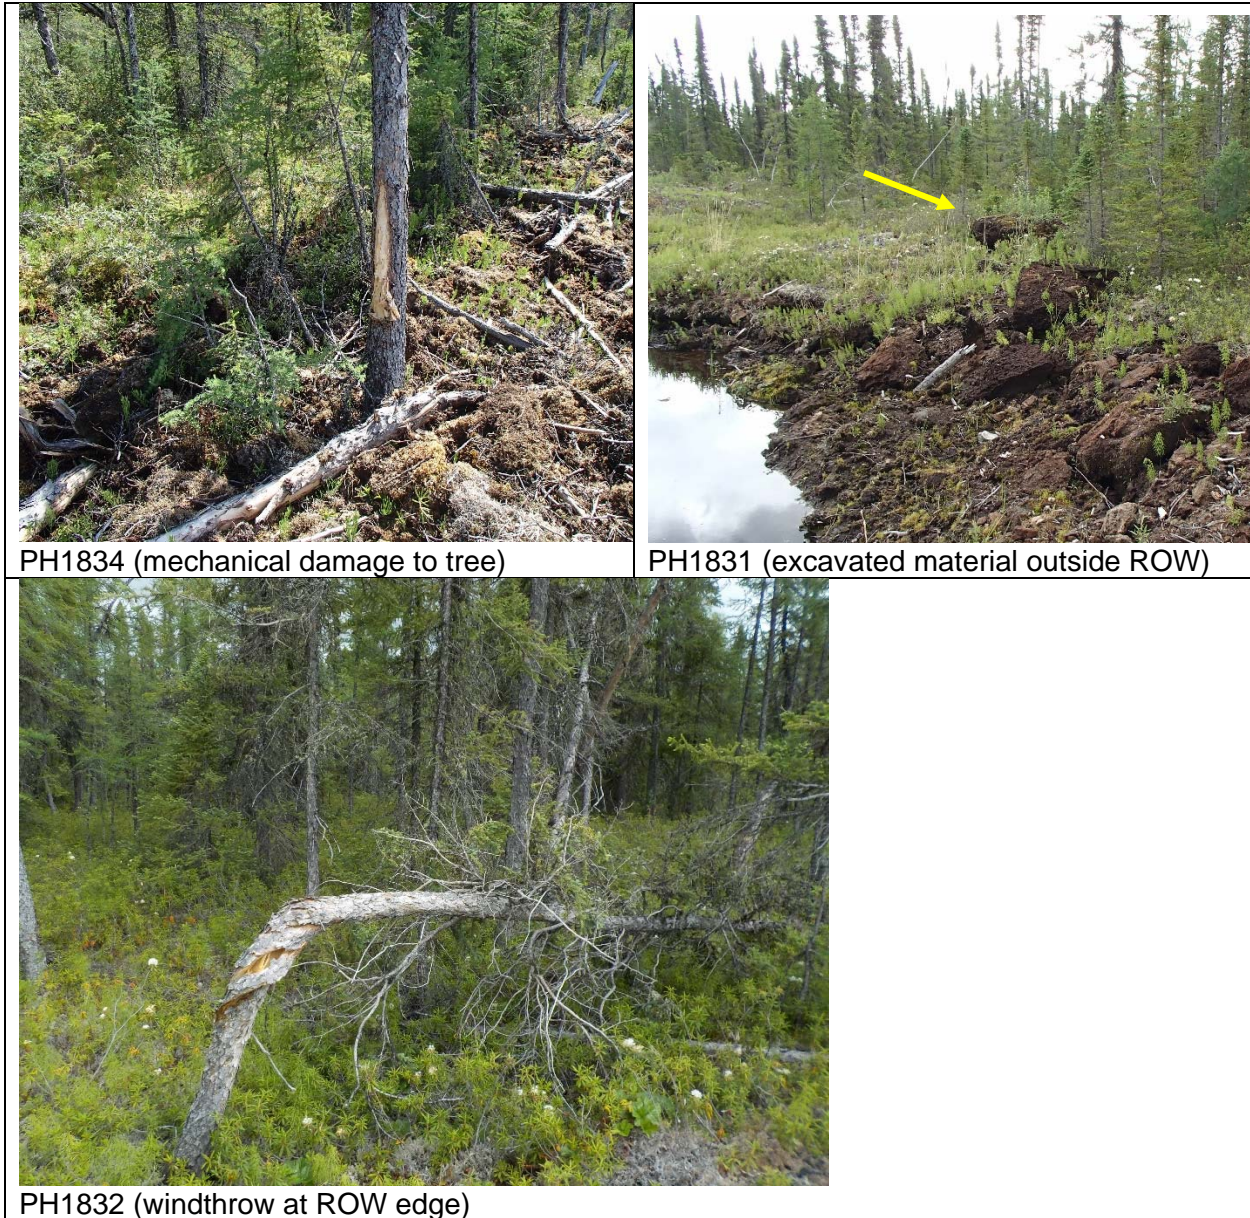
The five definite Project effects were on trees or understorey vegetation (Table 3-1). At one patch (PH1834) the bark and trunk of a tree adjacent to the clearing was damaged. In patches PH1839, PH1831 and PH1833, excavation was present, or excavated material was deposited over understorey vegetation near the ROW edge. At PH1874, erosion in the ROW was carrying sediment down a runnel that extended into the patch, and this sediment was covering vegetation in the understorey. The tree collapse in this patch was also very likely caused, or at least accelerated by the Project.

Photo 3-2: Examples of mechanical damage observed in priority habitat patches in 2018.

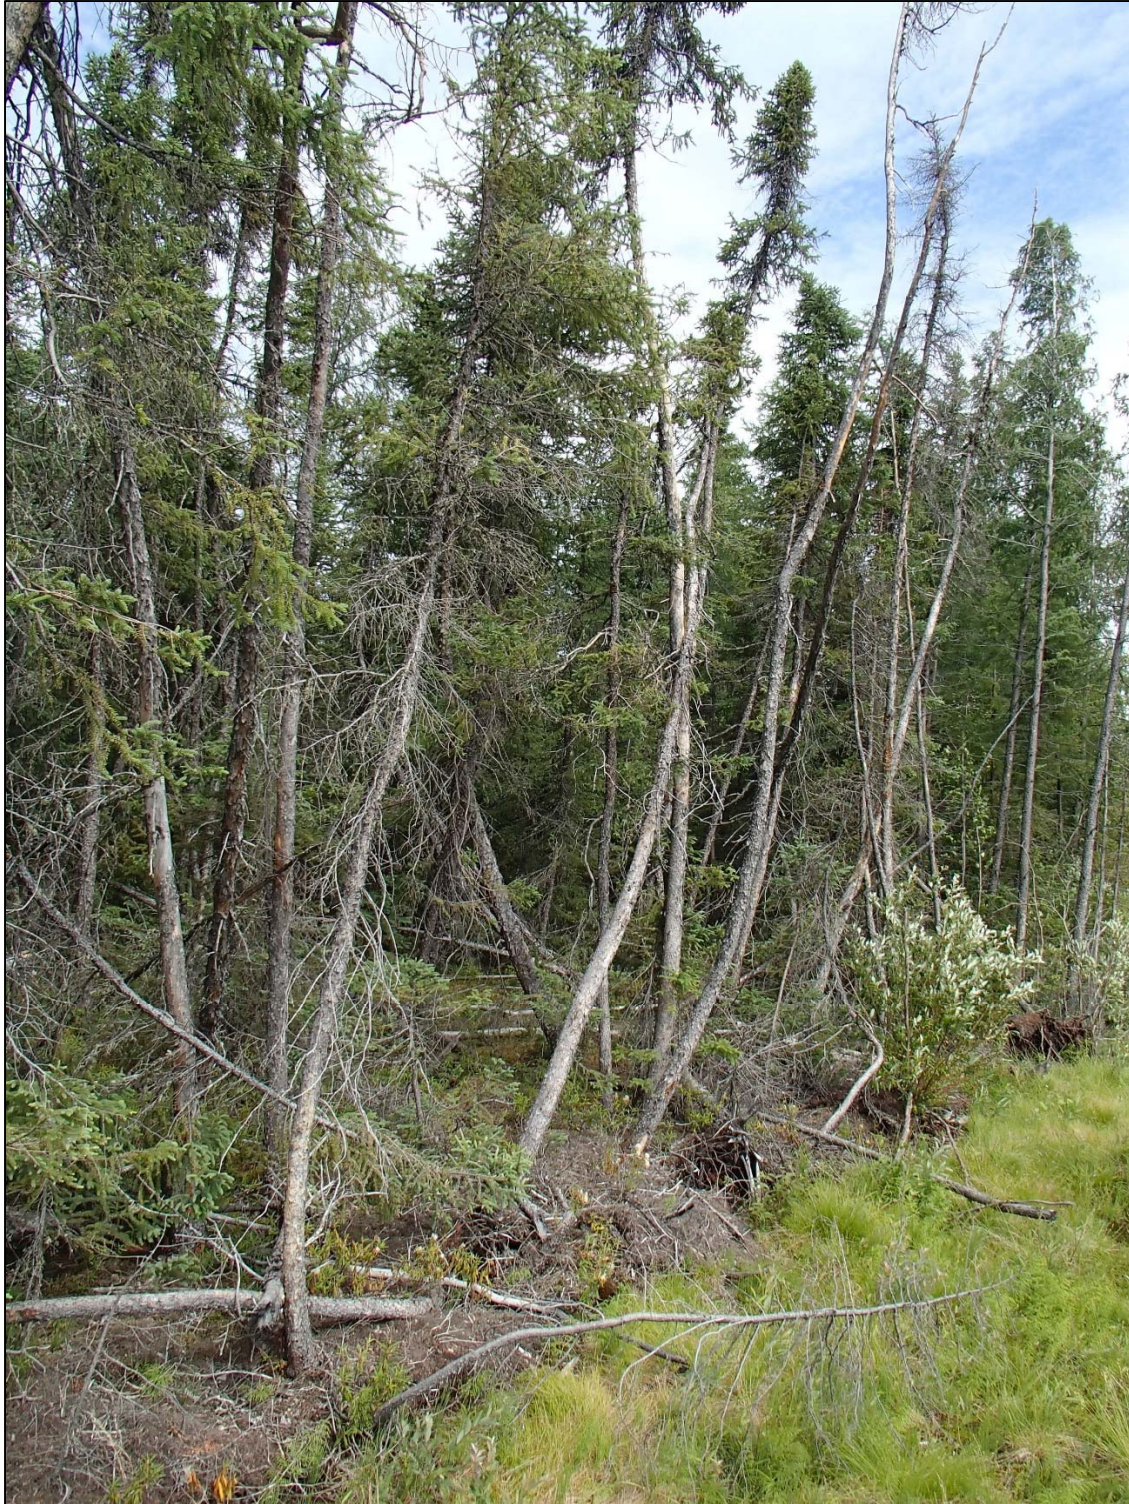
At two patches (PH1829, PH1840), several black spruce (*Picea mariana*) trees at the edge were beginning to collapse into the ROW. At each location, tree roots were likely severed by peat scalping in the adjacent ROW (Table 3-1). Another likely indirect Project effect was at patch PH1832, where one black spruce tree at the cleared edge had fallen down, apparently due to windthrow.

| Patch ID | Observed Change Type | Observed Change in Priority Habitat Patch ¹ | Direct Effect | Indirect Effect- Primary ² | Extent | Likelihood that Change is Due to Project |
|---|--|---|---|---|---|--|
| PH1829 | Tree collapse | Collapsing trees at uncleared edge. | Tree roots severed by peat scalping in the ROW | Support for tree partially removed > Drier moisture regime | 3 | Likely |

Photo 3-3: Leaning trees adjacent to ROW in priority habitat patch PH1829.

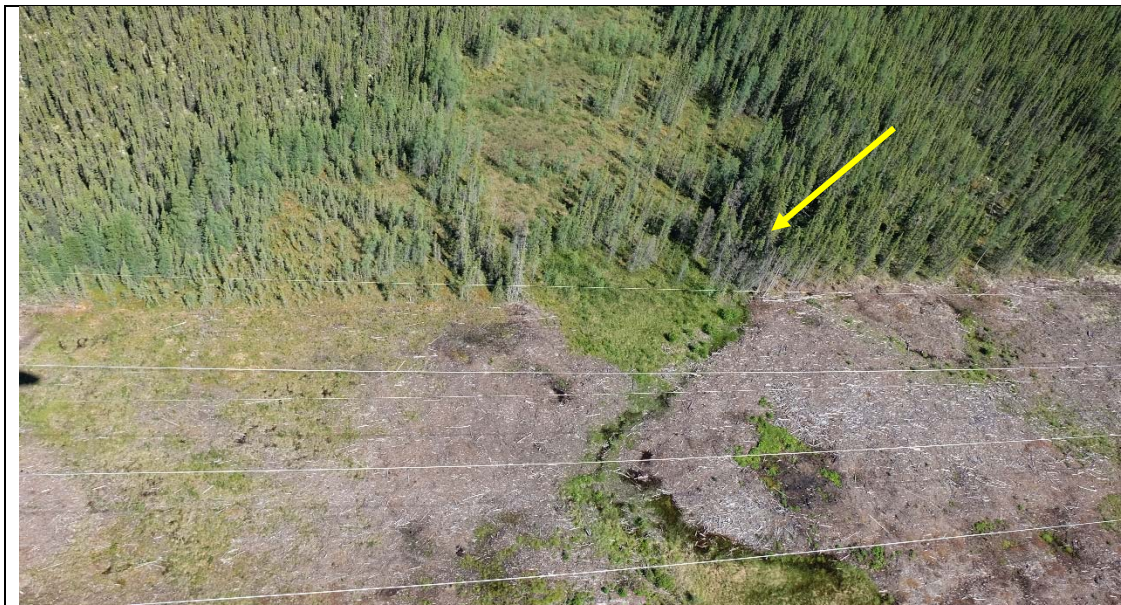
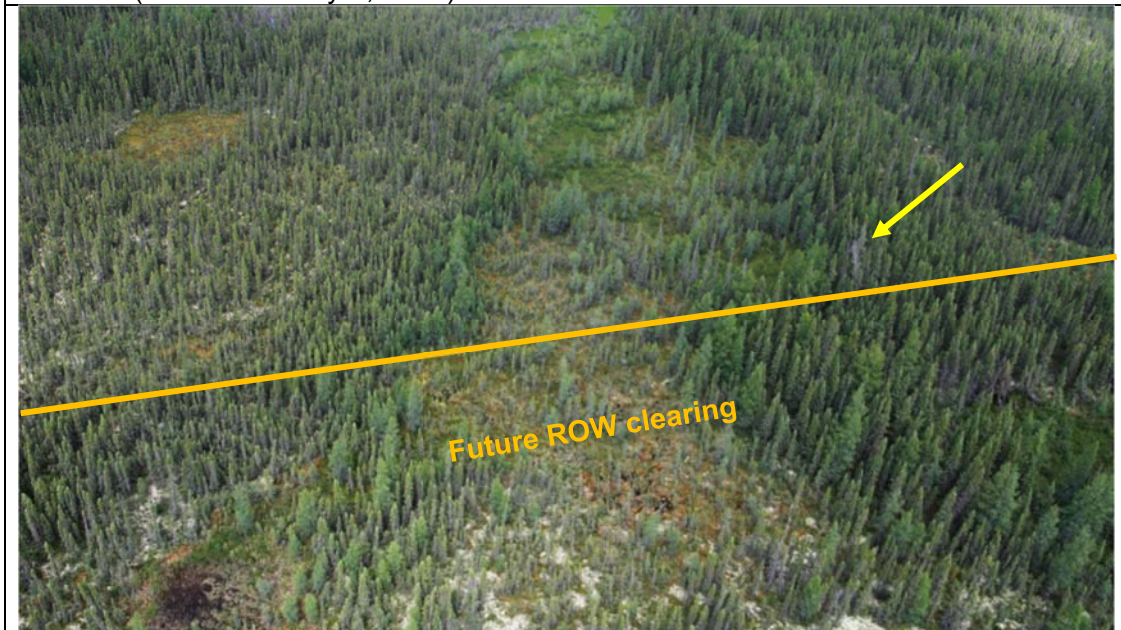
Natural processes were determined to be the cause for one of the 15 observed effects. At the edge of patch PH1840 (adjacent to a pre-existing deep, wet peatland), tree mortality and collapse extended into the patch for approximately 10 m from the cleared ROW edge (Photo 3-4). While some of the tree collapse closest to the ROW and further away from the wet peatland was likely due to the Project (see below), photography of this particular location from 2009 showed that the tree mortality and collapse was occurring adjacent to the wet peatland before the Project. That habitat change appeared to be caused by permafrost melt, and was therefore not attributed to the Project.

| Patch ID | Observed Change Type | Observed Change in Priority Habitat Patch ¹ | Direct Effect | Indirect Effect- Primary ² | Extent | Likelihood that Change is Due to Project |
|---|--|---|---|---|---|--|
| | Tree collapse and mortality | Dying and other collapsing black spruce around the runnel. Not attributed to Project as a 2009 photo found that some collapsing trees and mortality was already underway. | None | - | 3 | None |

PH1840 (aerial view July 6, 2018)

PH1840 (aerial view July 18, 2009)

Photo 3-4: Tree collapse and mortality observed beside ROW clearing in 2018 that was present prior to the Project.

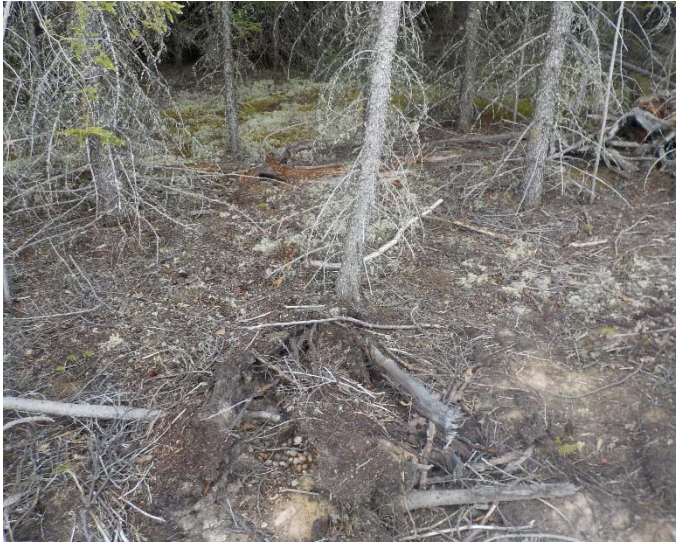
| Patch ID | Observed Change Type | Observed Change in Priority Habitat Patch ¹ | Direct Effect | Indirect Effect- Primary ² | Extent | Likelihood that Change is Due to Project |
|---|--|---|---|---|---|--|
| PH1837 | Vegetation mortality | Localized dead and dying moss and lichen extending 2 m into forest from ROW edge. | None | Increased light and wind at edge > Drier soil moisture regime > Drying out of moss and lichen | 4 | Likely |

PH1837 (dead and dying moss and lichen adjacent to edge of ROW)

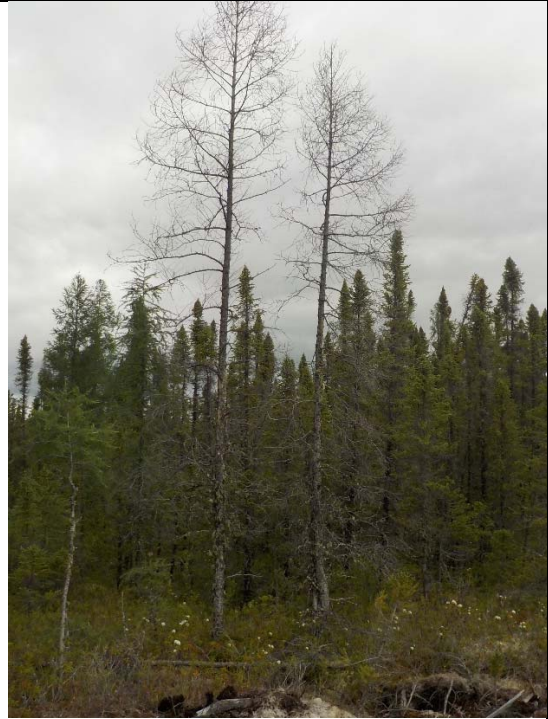
The three effects possibly due to the Project were on tamarack (*Larix laricina*) trees at patches PH1828, PH1840 and PH1839. At each patch, dead or dying tamarack trees were observed within 20 metres of the cleared ROW. This was the only tree species with dead stems in the patch, and the black spruce appeared to be healthy. Tamarack further from the clearing and at other areas along the ROW edge appeared healthy. The mortality was possibly caused by a combination of root damage and change in the soil moisture regime resulting from the ROW clearing and peat scalping (Photo 3-5).

PH1839 (dead tamarack)

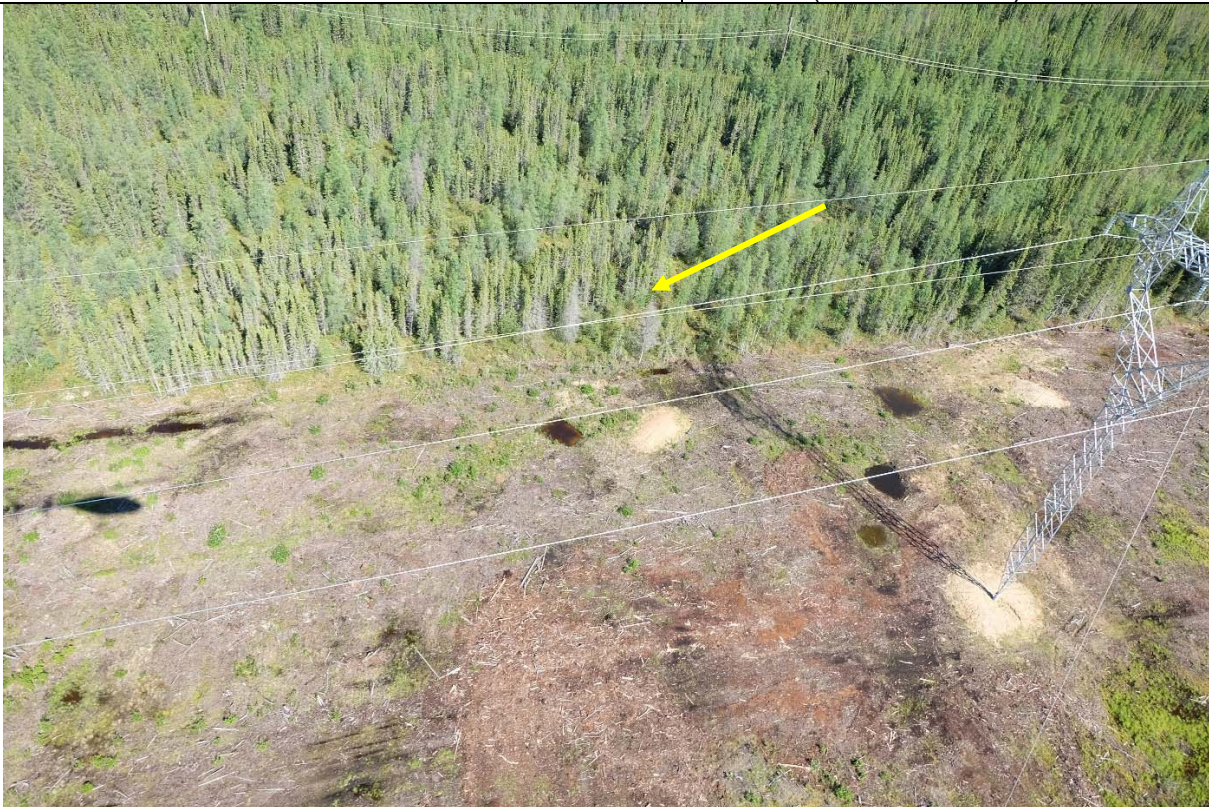
| Patch ID | Observed Change Type | Observed Change in Priority Habitat Patch ¹ | Direct Effect | Indirect Effect- Primary ² | Extent | Likelihood that Change is Due to Project |
|---|---|--|---|--|---|--|
| PH1828 | Tree mortality | Dead or dying tamarack trees within 20 m of the cleared ROW edge at two locations. | None | Possible change to water table, moisture regime or other edge effects (e.g., increased light and wind at edge) | 3 | Possible |

PH1828 (dead tamarack concentrated at edge of ROW)
