May 2020

Manitoba Hydro

EXECUTIVE SUMMARY

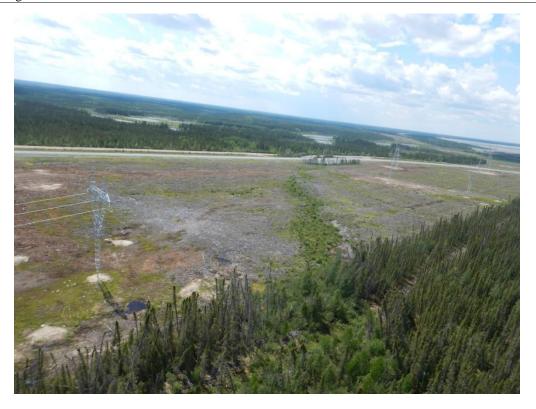
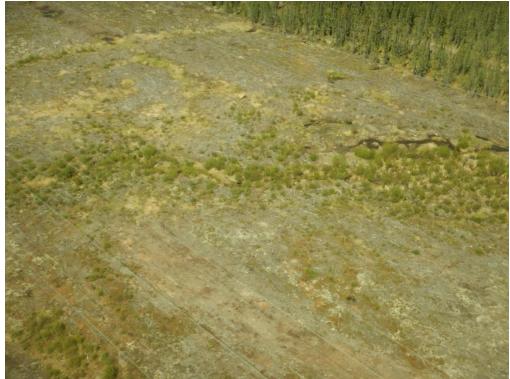
In 2015 a riparian buffer was not established during clearing at KR1-Aqua-128, KR3-Aqua-129, and KR2-Aqua-130 resulting in erosion and sedimentation of the stream. No mitigation measures have been implemented since 2015 but re-vegetation is occurring naturally, albeit slowly (Photo 1). Small shrubs and forbes were observed growing along the banks of the stream and no sedimentation was observed during the aerial survey in 2019 (Photo 1). It is expected the vegetation will continue to grow and stabilize the banks and riparian zone. No further remediation is recommended (Appendix 1).

Photo 1. KR1-Aqua-128, KR3-Aqua-129, and KR2-Aqua-130 (trib. of the Butnau River). Un-mitigated stream crossing on June 25, 2018 (top) and June 17, 2019 (bottom).
