Marketing & Customer Service

Natural Gas System Asset Condition Assessment

Date Prepared: November 2, 2016

File Number: 2016-04073

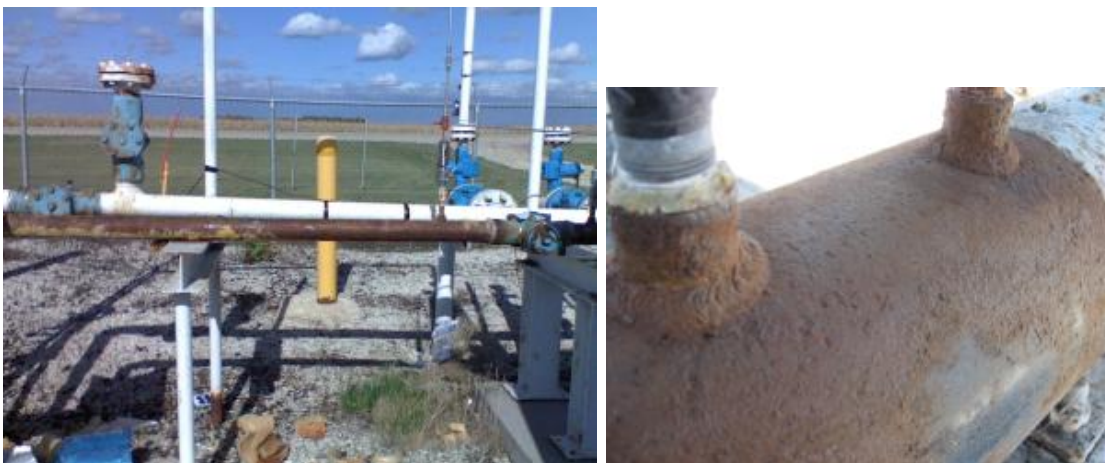
Metal loss corrosion has the potential to affect all stations, especially the ones with insulation that was designed to minimize the noise from regulation equipment or designed to keep heat within the pipe after a line heater. This insulation which is wrapped around a pipe can allow water to penetrate to an unpainted or poorly painted surface of the steel pipe and gradually cause corrosion. Figure 11 below shows corrosion that has occurred at stations.

Figure 11: Corrosion under insulation at Ste. Agathe (GS-180) and Fort Whyte (GS-020)

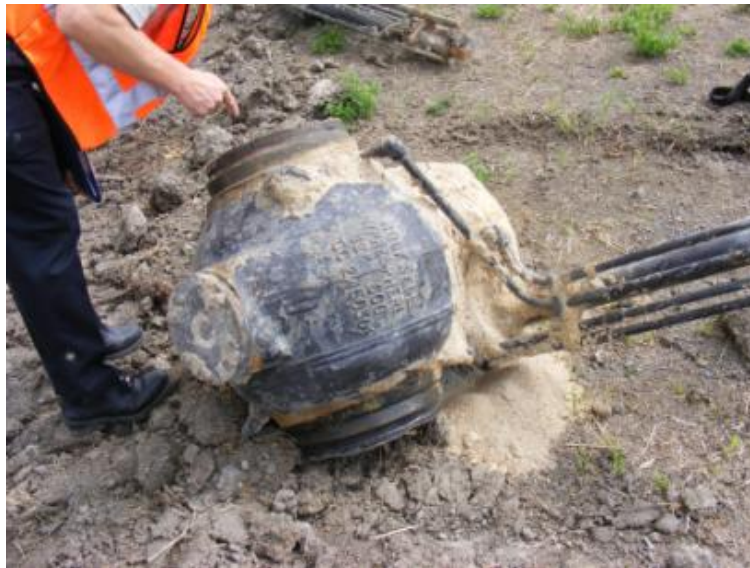
Environmental contamination occurs to below grade valves as water, salt and ice make their way into the actuators and either corrode or break the actuators. This occurs mostly because many of our underground valves were not rated for underground service and eventually fail. Even those that are rated for underground use will fail eventually, as steel exposed to excess water, and road salt corrodes the metal quickly. Figure 12 show a vintage valve removed from service due to seizing.

Figure 12: Vintage valve removed from service due to seizing.

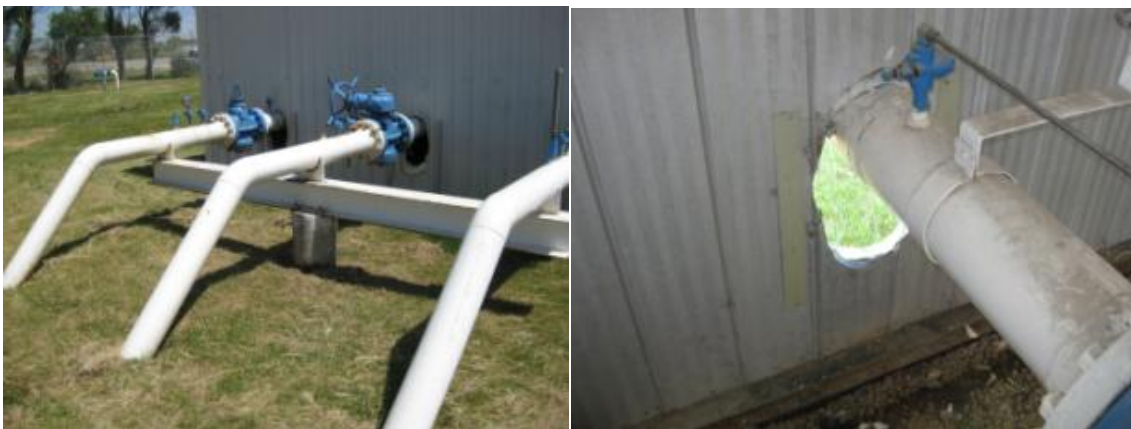
Pipe movement due to heaving or settling is one of several modes of degradation. Gas pipes are typically set at depths that will be subject to freezing in the winter months. Soil settlement due to compacting backfill, settlement or expansion of vertisolic soils can also put stress on the pipe and cause pipe movement. Settling or shifting pipe can put stress on piping connections such as flanges and if left unabated could progress to the point of causing a pipe or weld failure. Figure 13 below shows heaving that has occurred at Transcona gate station due to freezing or water logged soils.

Figure 13: Heaving of piping and pipe supports causing damage to station building and stressing of pipe at Transcona Gate (GS-003)

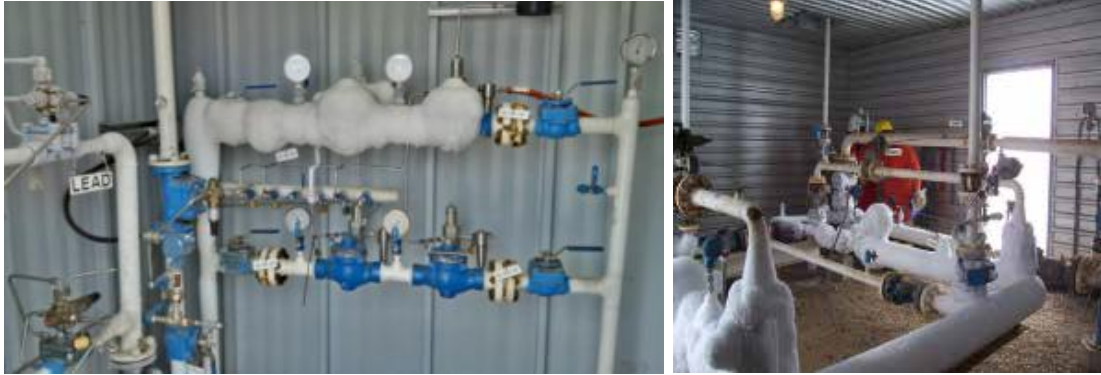
pressure drop. The Joule-Thompson cooling effect may also be observed on above ground piping by external icing as shown in Figure 14.

Figure 14: External icing on station piping due to the Joule-Thompson effect

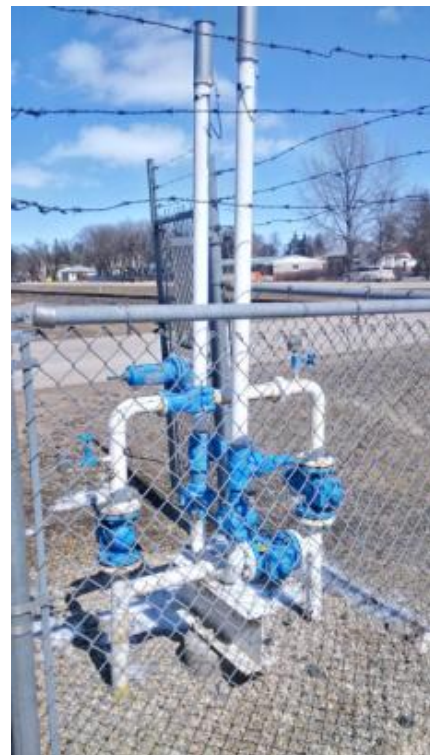
Figure 15: 630 Regulator Station in Gimli with Obsolete 630 Fisher Regulator

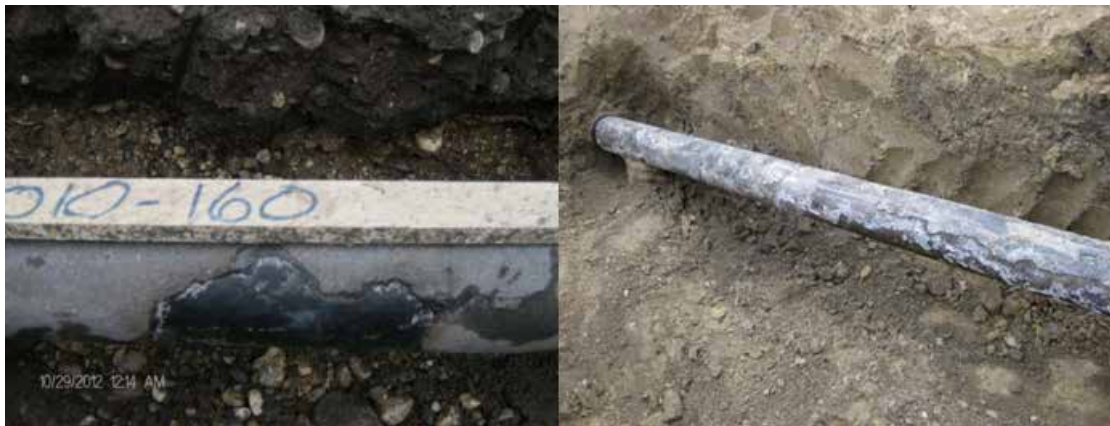
Figure 7: Deteriorated coal tar enamel coating on Shilo (left) and Dominion City (right) transmission pipelines.

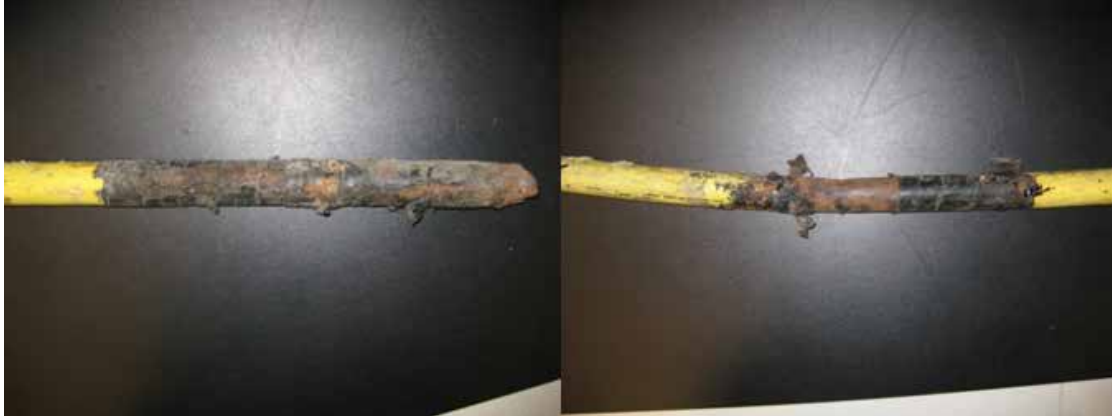
Figure 8: Corrosion leaks on service lines below polyethylene tape joint coating

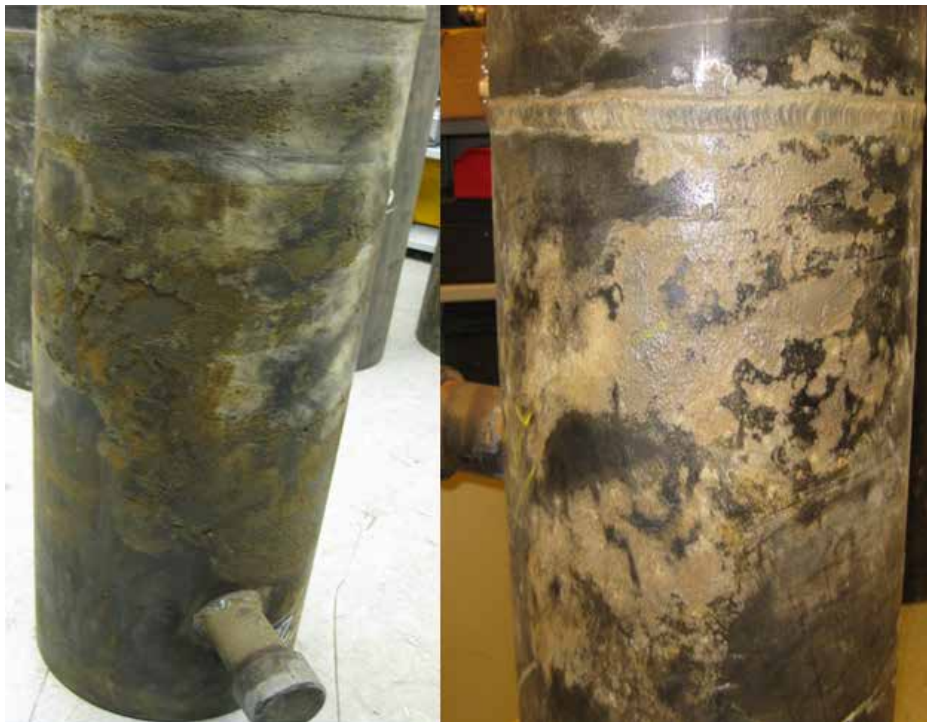
Figure 9: Cylinder of severely corroded pipe from below polyethylene tape joint coating

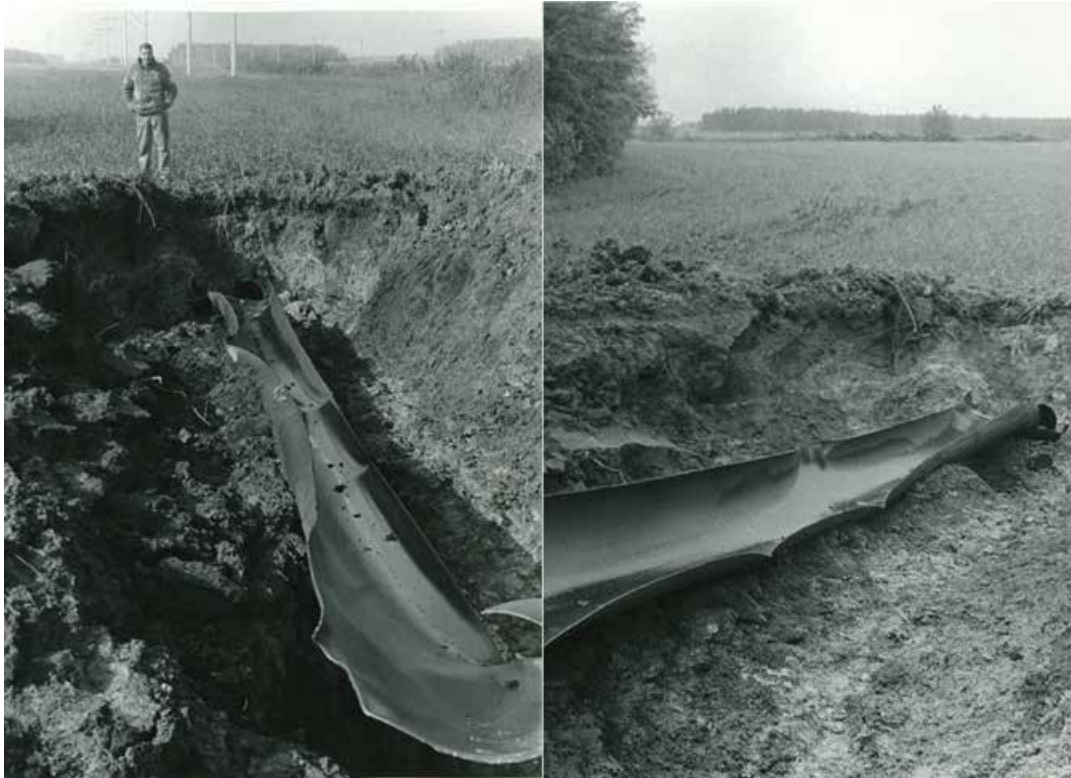
Figure 12: Rupture incident of La Salle NPS 12 transmission pipeline south of McGillivray Boulevard during pneumatic pressure test in 1964. Rupture occurred at 7080 kPa (1027 psi) corresponding to 57% SMYS.

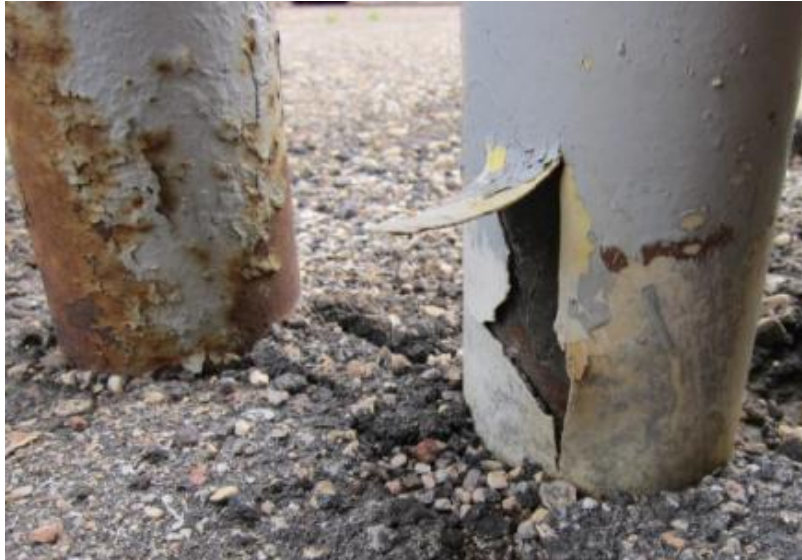
Some risers are field wrapped with a polyethylene tape. Wrapping deficiencies are a contributing degradation mechanism related to risers. Unwrapped steel service risers or incorrectly wrapped risers can lead to corrosion leaving the strength of the riser compromised. Badly corroded risers can be replaced by cutting out the corroded section and welding an extension of pipe.

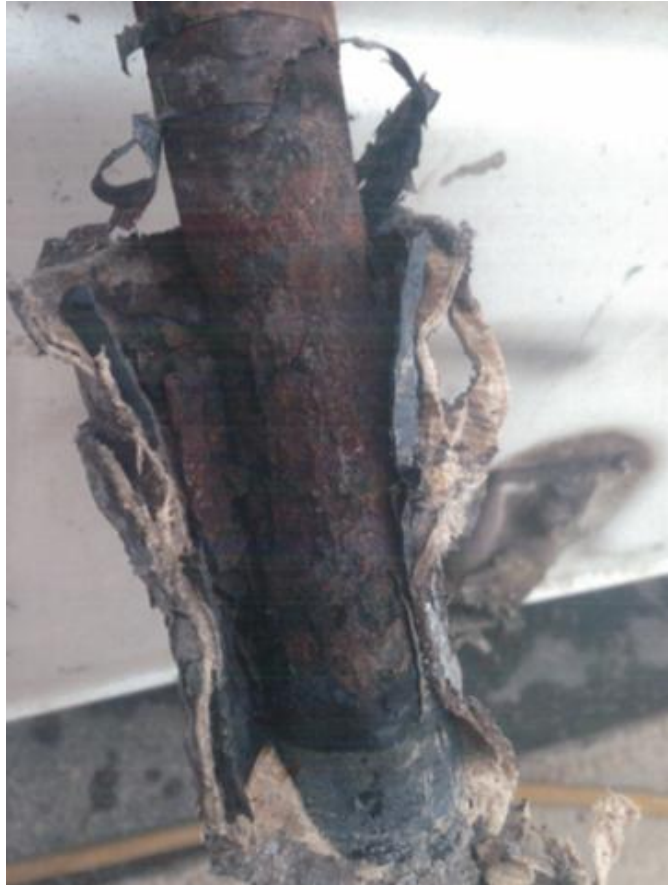
The location of the riser is also a contributing factor to riser degradation. In particular, when installed in high traffic areas prone to salt spray and snow clearing. In Winnipeg, services with a front service orientation on regional streets such as those found on Selkirk Avenue, Logan Avenue and Corydon Avenue are all subject to corrosive elements from street clearing and general traffic. Service risers in backlanes along streets such as Portage Avenue have also been subjected to salt spray and snow pack that has negatively impacted the riser condition.

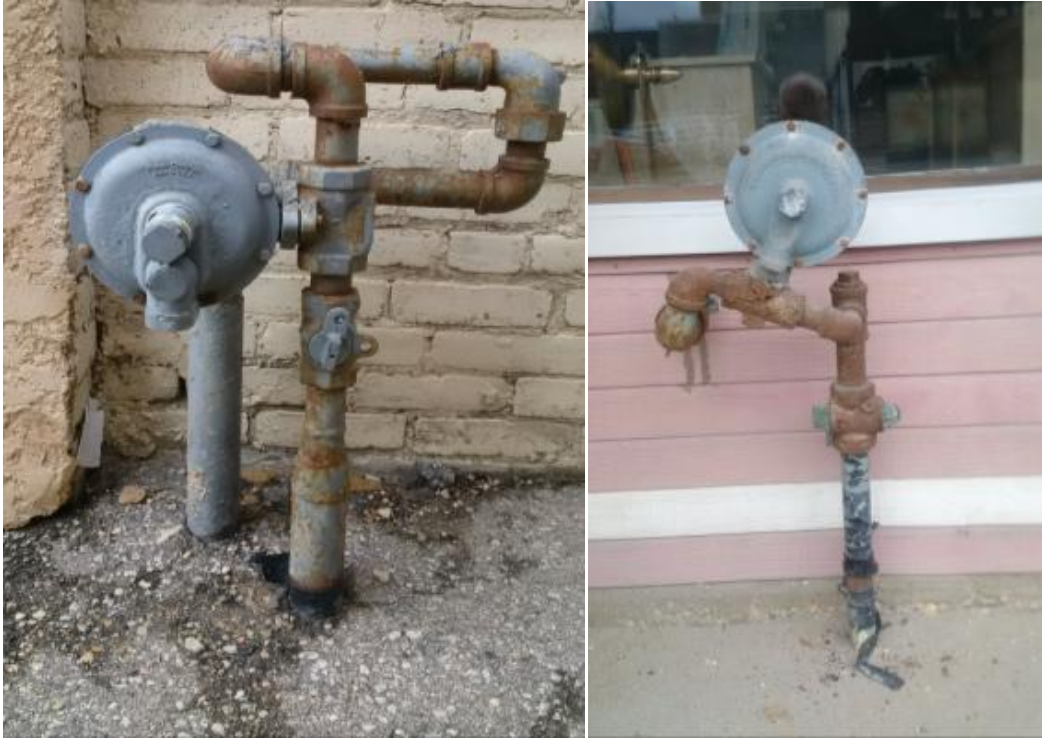
Where risers are wrapped with polyethylene tape, improper wrapping can also be a contributing factor to riser corrosion. Wrapping should be done in an overlap manner so that moisture can flow down over the sheathed wrapping. If wrapping is done in the wrong direction, it can actually provide a conduit for moisture accumulation and eventual corrosion. Risers are also subject to the soil movement. Although this is not a degradation mechanism, soil movement has the potential to accelerate corrosion based degradation failures.

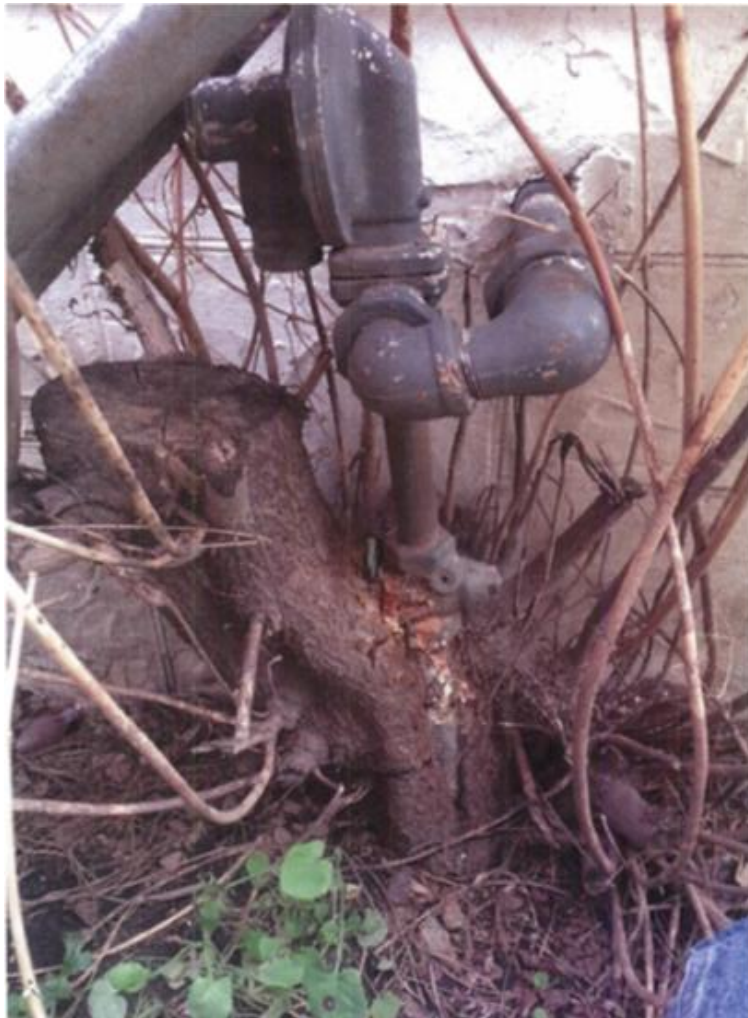
Risers which have sunk and no longer provide adequate ground clearance for service valves (150 mm or less above grade) require upgrade. Access is required to provide emergency shut offs. Sunken risers are subject to strain which can lead to leaks. In the event that these components are buried, they also become subject to degradation by corrosion. Remediation is typically conducted

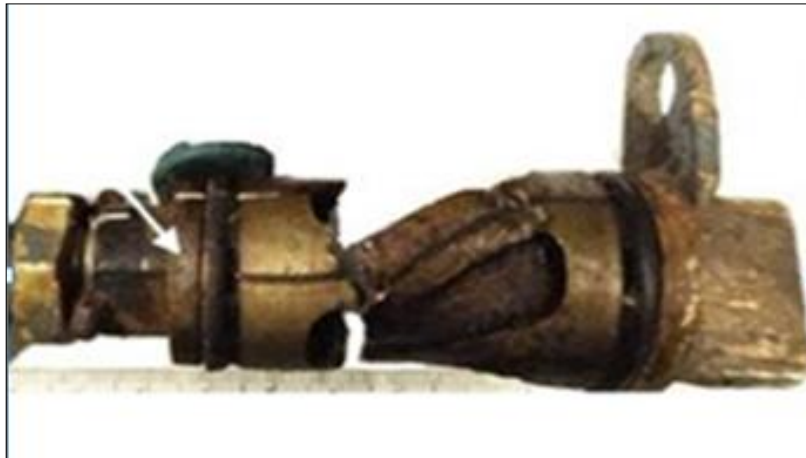
Extreme strain on a service riser can lead to a service valve snapping off. The male threads that enter the service valve provide a weak point on a strained service. Snapped services led to a riser rehabilitation program to ensure risers provided adequate clearance and eliminated strain on a service riser. Manitoba Hydro has experienced snapped service risers at the service valve on $\frac{3}{4}$ ", $1\frac{1}{4}$ ", 2" and 4" services.

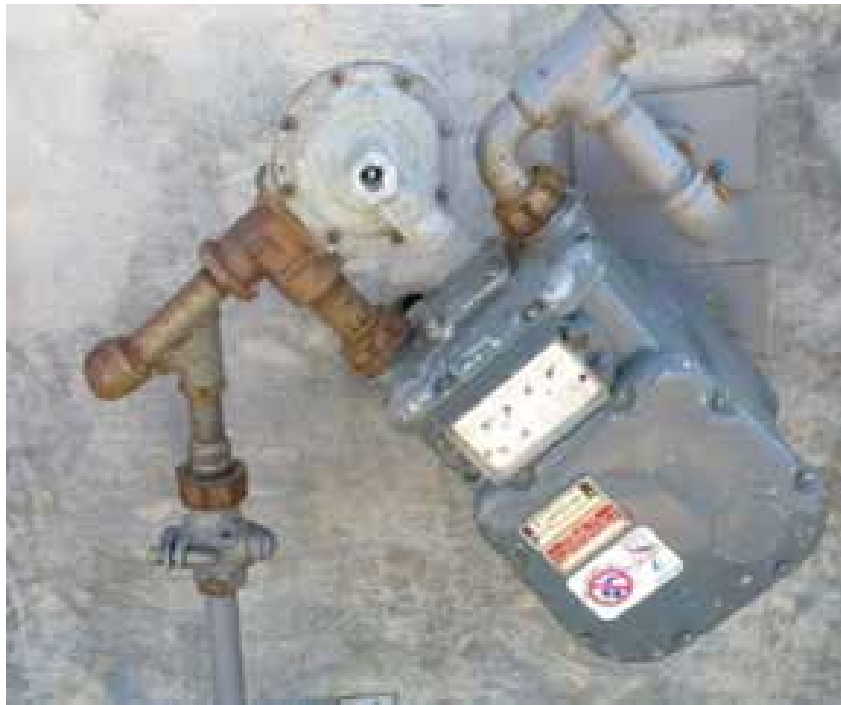
Movement on the joint fittings can lead to minor fitting leaks which may need to be repaired. Excessive riser movement beyond the capability of the swing joints to handle also leads to stress on the riser and meter set piping and fittings. Manitoba Hydro's design standard has evolved to more effectively deal with minor leaks. Fittings such as street elbows and dresser elbows have been removed from new standards due to frequent leaks. Also, the standard piping configuration has changed to place the regulator closer to the meter stop, thereby reducing the pressure of gas flowing through more fittings at lower pressure. The change has resulted in fewer fitting leaks found through the annual leak surveys.

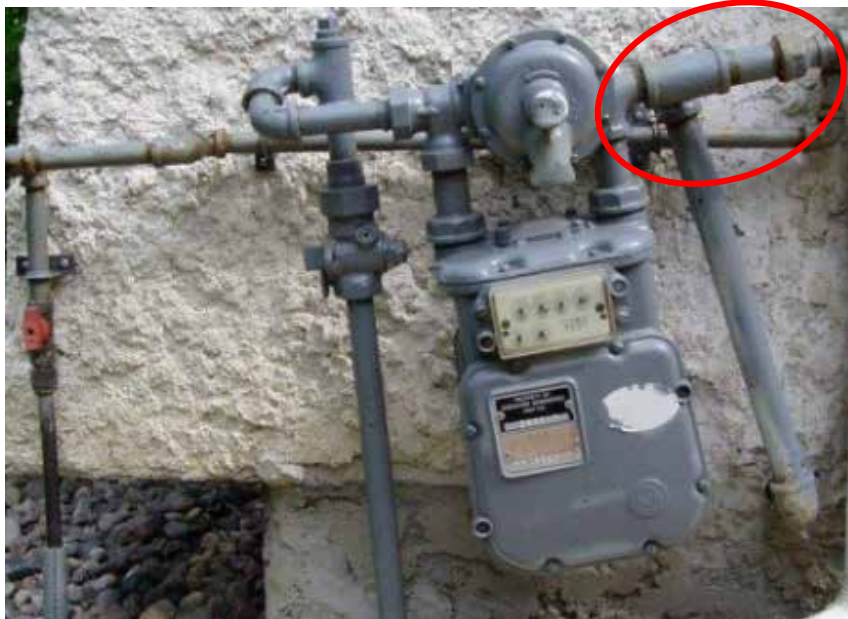
The wall pipe which extends from outside to the inside of a service address is also subject to degradation. Wall pipes on older services often entered the service address below the ground and into a basement. The services are known as below grade entries and an example is shown in Figure 17 below.
