File: *BPIII\_CON\_FA590*

Date: *September 8, 2021*

## **Reference: Field Survey Summary – Rare Plant Survey - BPIII**

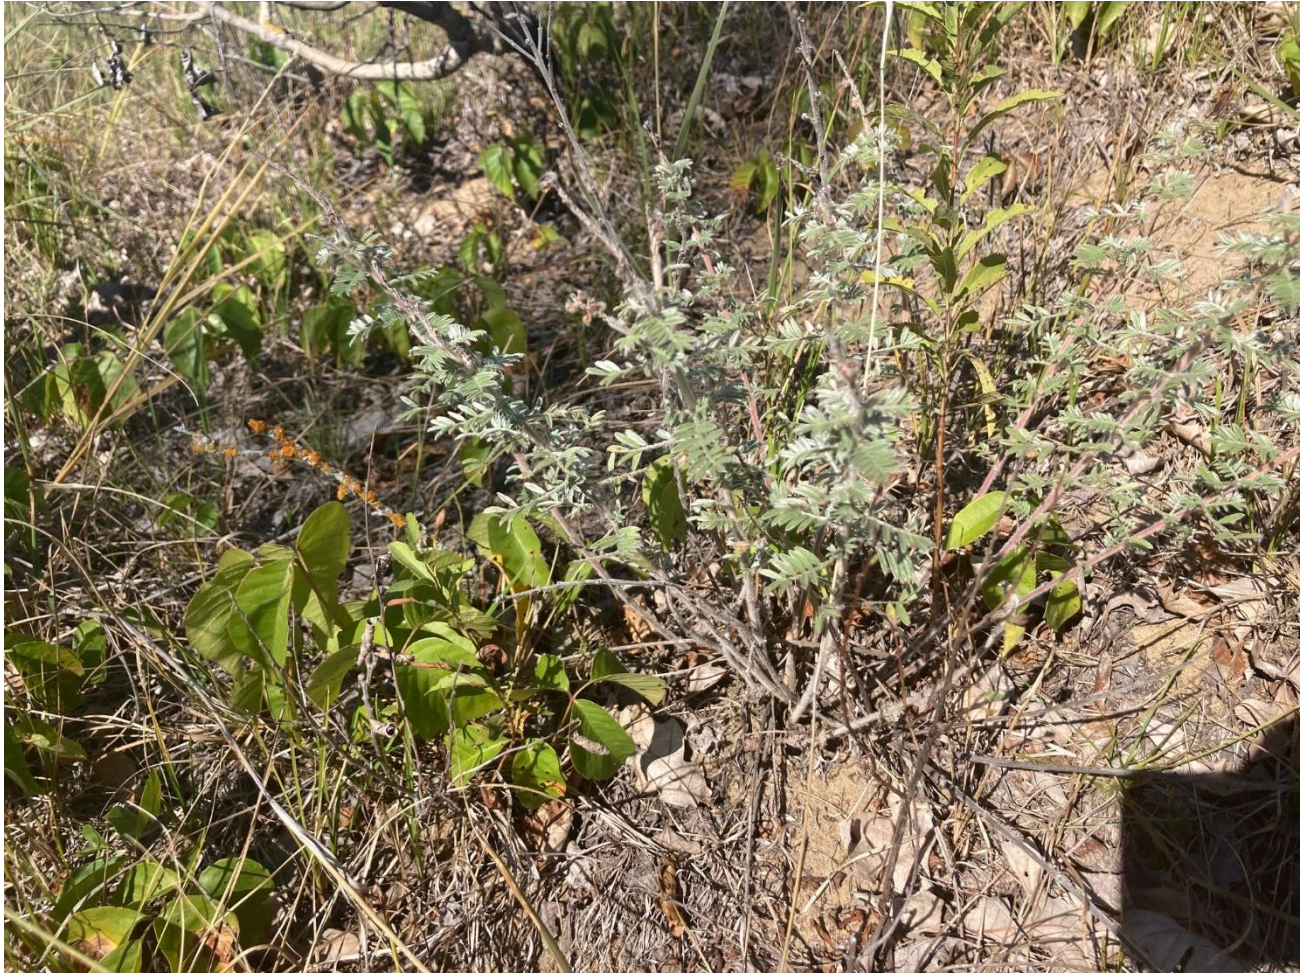
Hairy prairie clover plant on the Bipole III right of way at monitoring site S1-PRA-900.

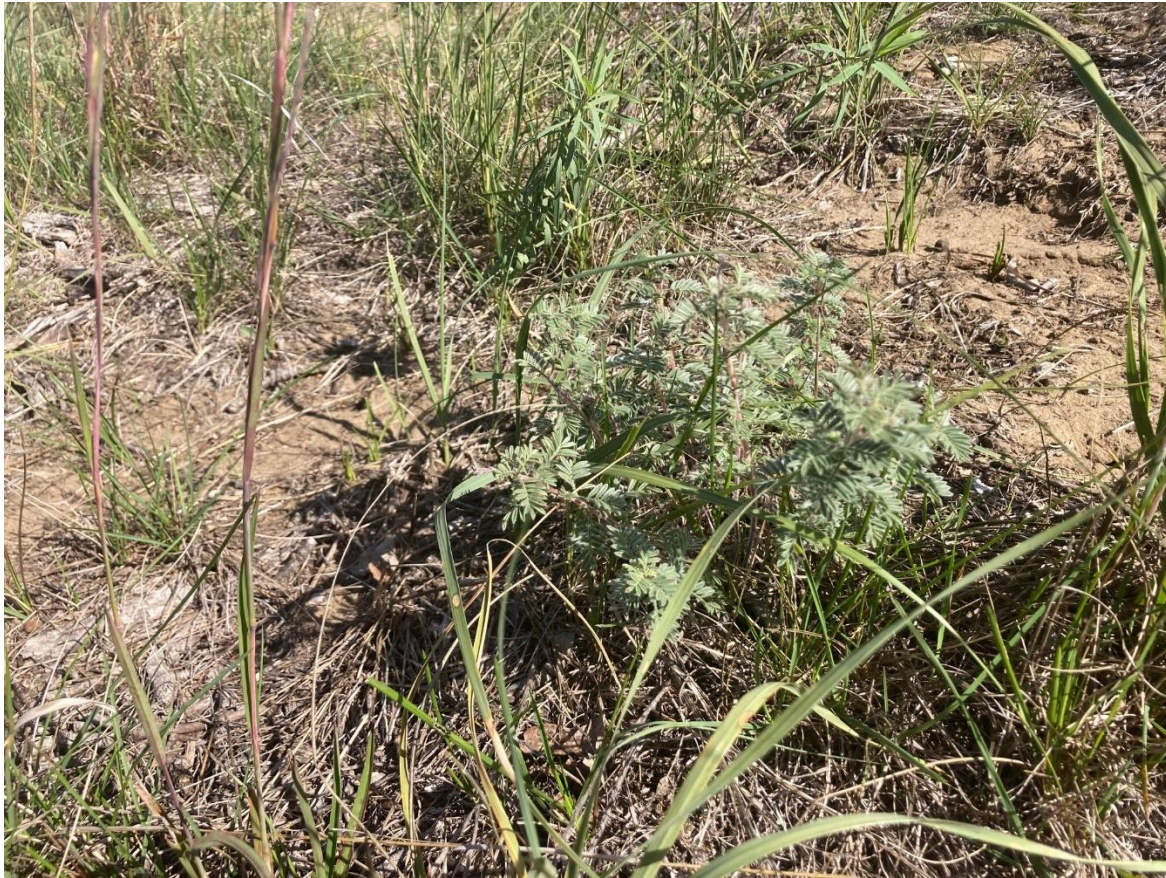
Hairy prairie clover plant on the Bipole III right of way at monitoring site S1-PRA-900.

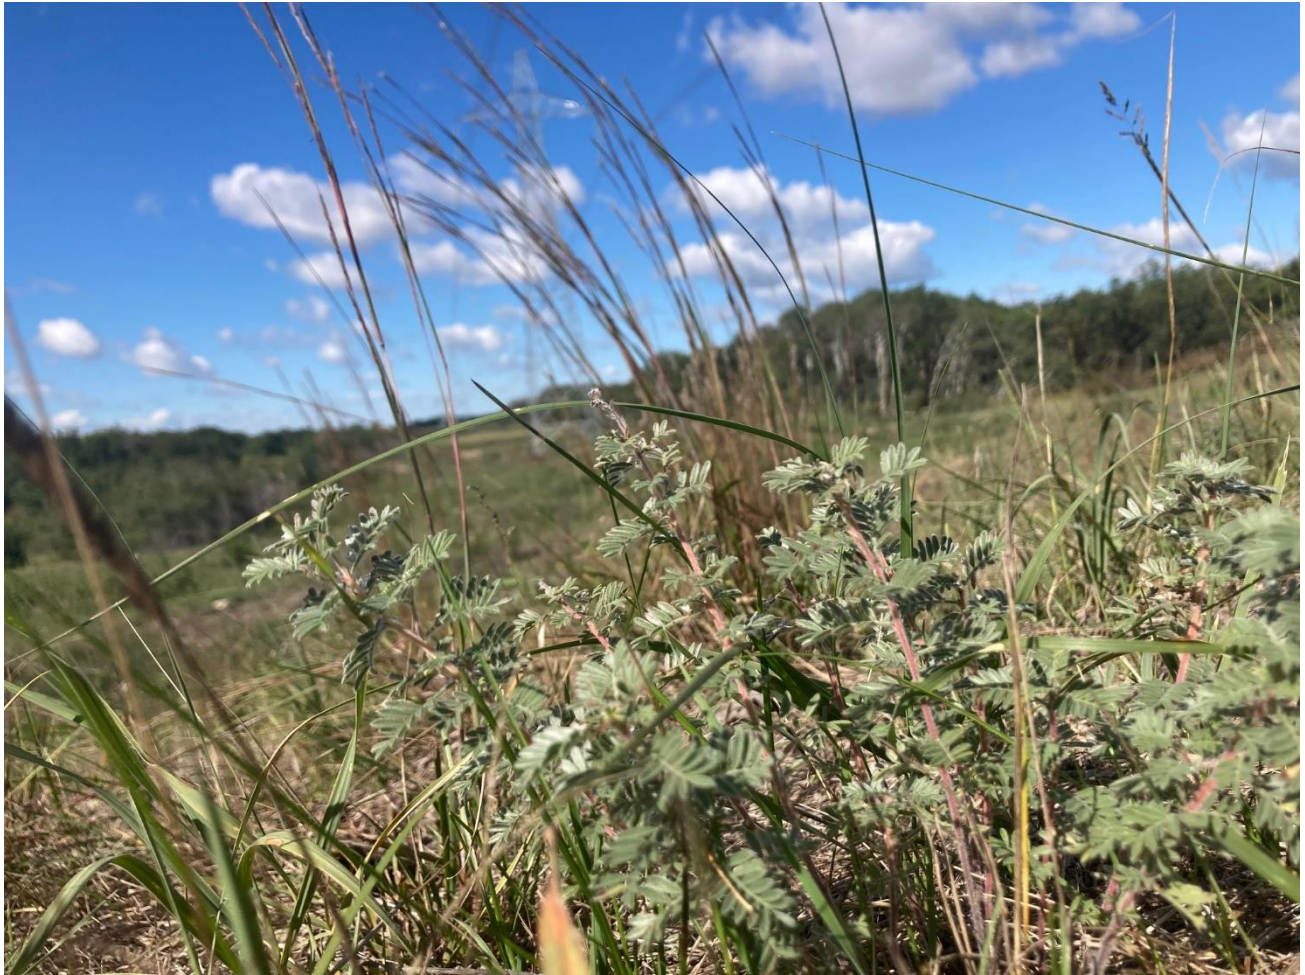
Hairy prairie clover plant on the Bipole III right of way at monitoring site S1-PRA-900.

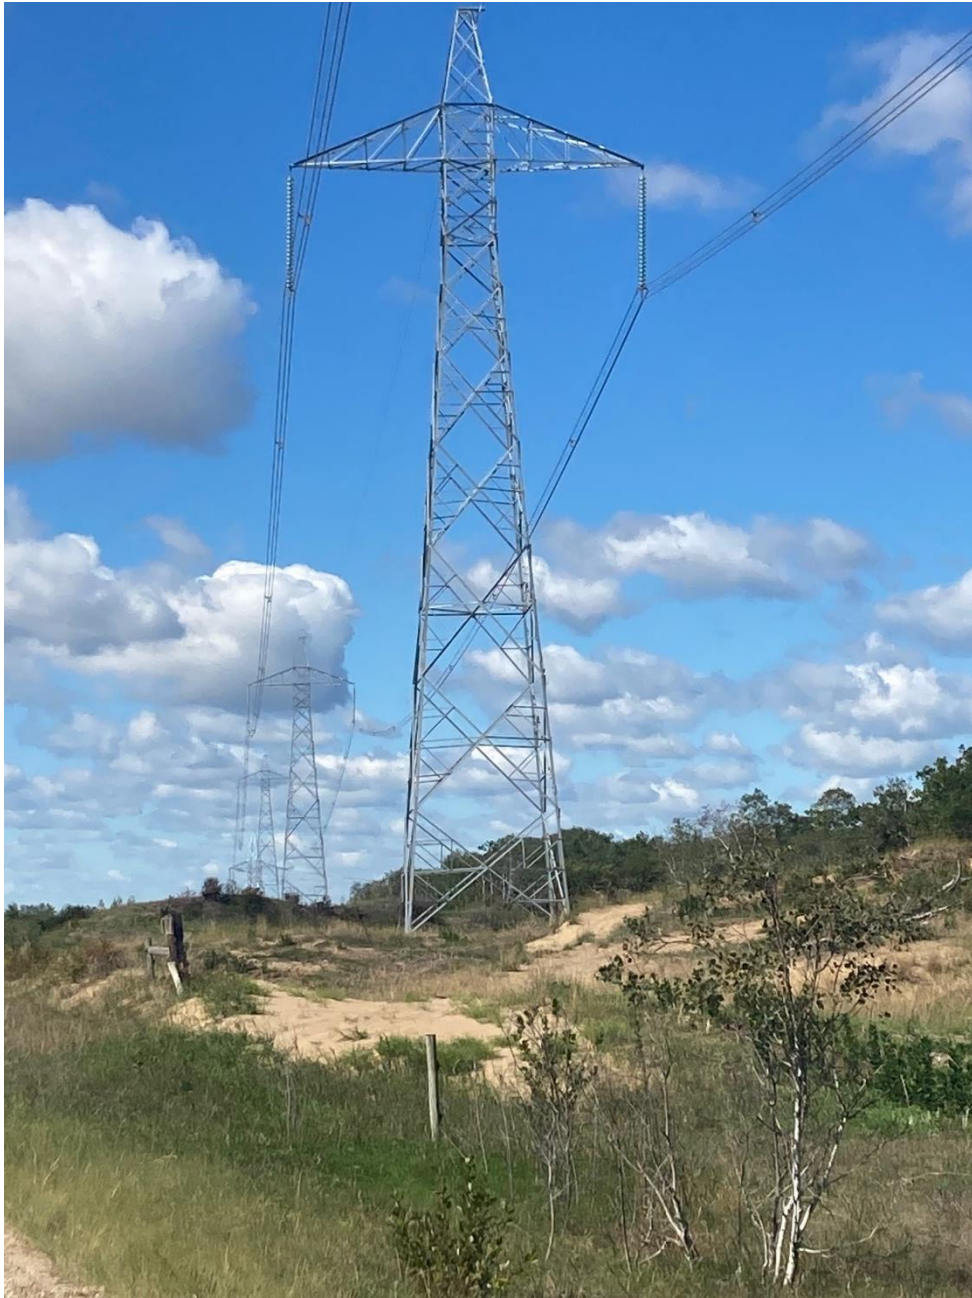
Photo of the Bipole III right of way at monitoring site S1-PRA-900.
