Keeyask Transmission Project Environmental Effects Monitoring Plan Technical Reports

# KEEYASK TRANSMISSION PROJECT

#### **ECOSYSTEM DIVERSITY MONITORING IN 2016**

ECOSTEM Ltd. 2017. Keeyask Transmission Project: Environmental Effects Monitoring – Ecosystem Diversity Monitoring in 2016. A report prepared for Manitoba Hydro by ECOSTEM Ltd., June 2017.

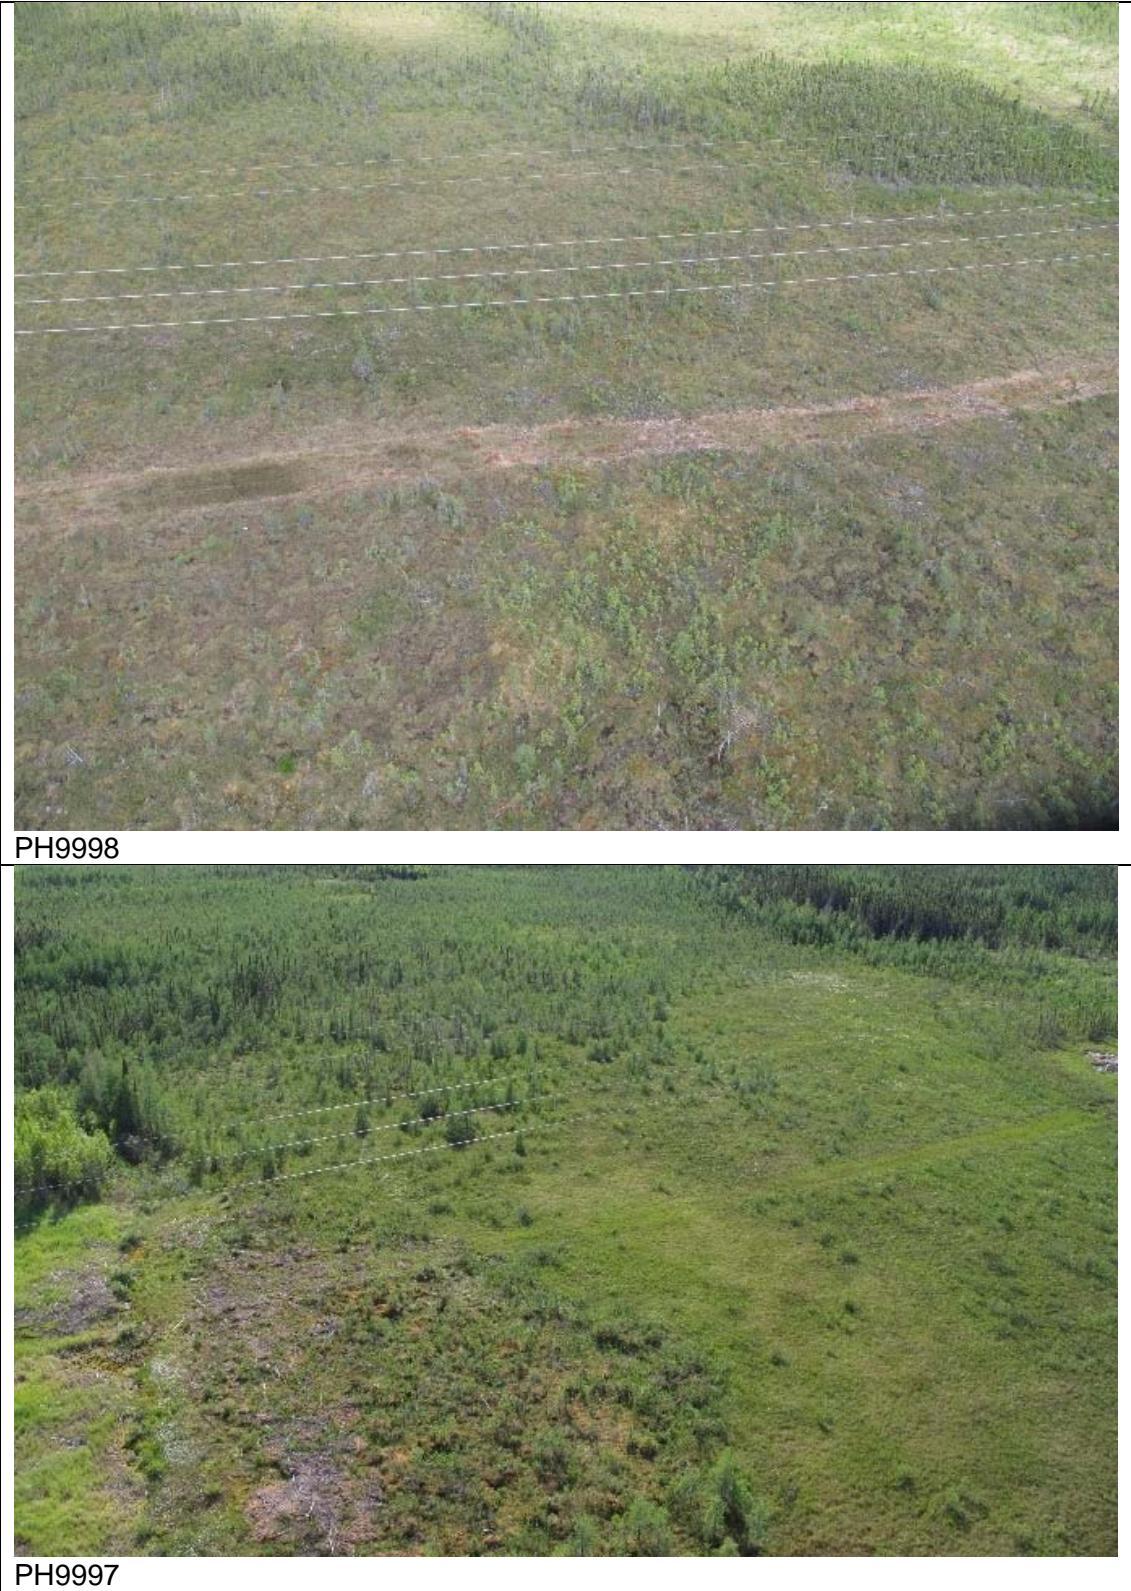
In four of the ten patches with some ROW clearing, the clearing was limited to either a narrow track or clearing of larger trees without disturbing the substrate and low vegetation (Photo 3-1). These situations occurred in wetlands with low vegetation or very sparse tree cover.

Photo 3-1: Two priority habitat patches adjacent to a ROW segment having minimal clearing.

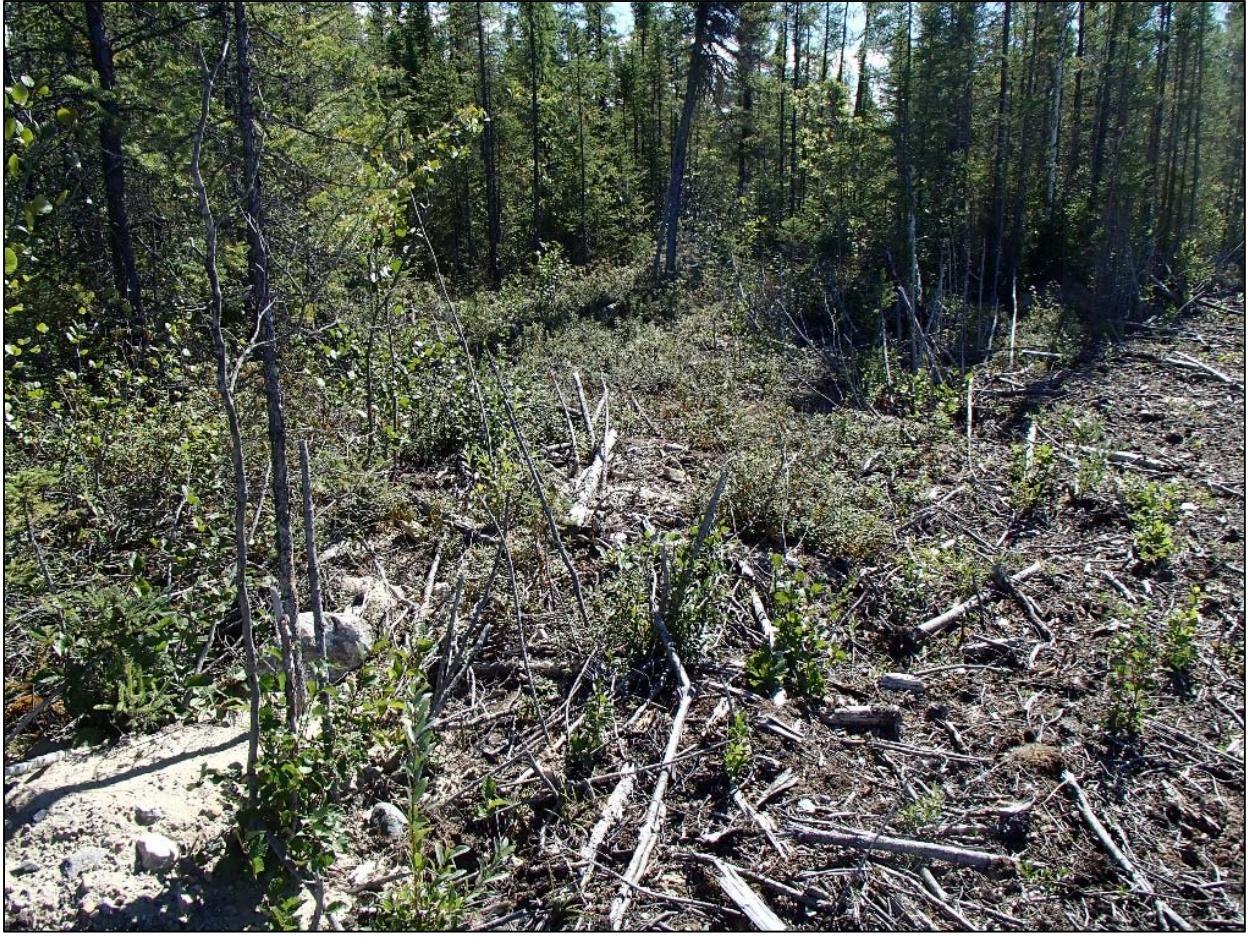
One priority habitat patch (PH0938) had clearing beyond the edge of the ROW. This was an approximately 20 m<sup>2</sup> patch with cleared trees, accompanied by mechanical damage to the surrounding trees and to the substrate (Photo 3-2).

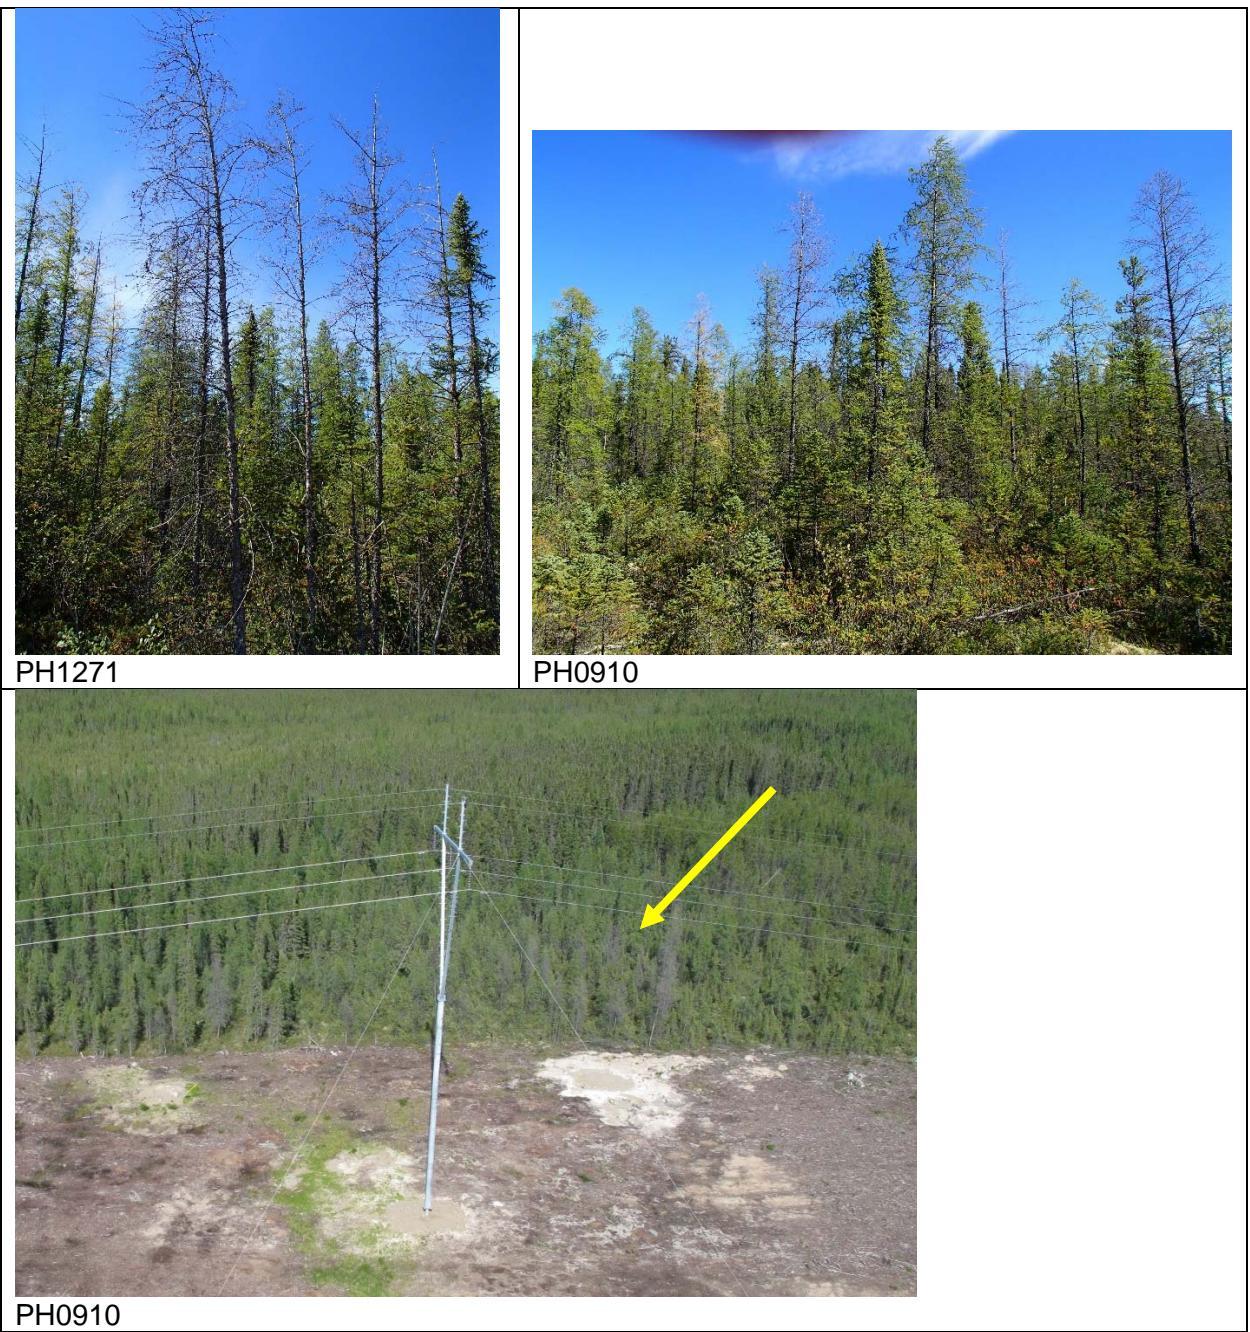
Three other priority habitat patches (PH1271, PH0910 and PH0001) had tree mortality in the undisturbed forest adjacent to the ROW (Photo 3-3). At these patches, all of the dead trees were tamaracks (*Larix laricina*). The mortality was limited to areas adjacent to the ROW, extending from a few metres, up to 20 metres into the undisturbed forest. Tamarack trees further from the ROW appeared healthy.

Photo 3-3: Tamarack mortality in two priority habitat patches adjacent to the ROW.

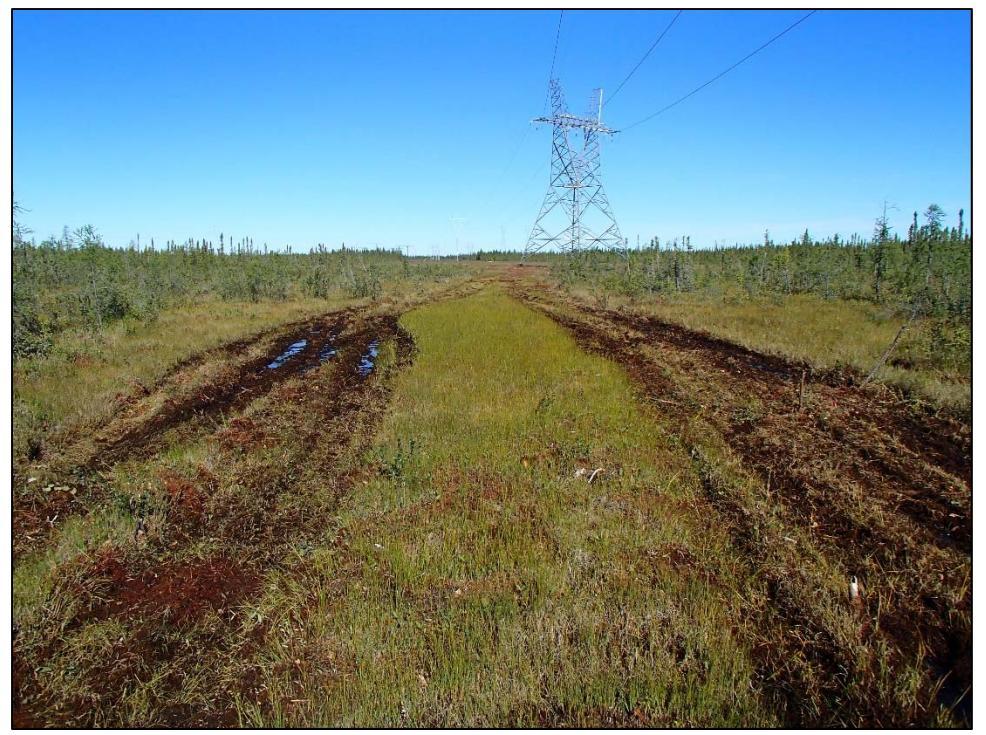
Deeper rutting from two sets of vehicle tracks was present within the ROW adjacent to patch PH9998 (Photo 3-4). At other locations within the ROW with shallow organic substrates, deeper excavations were also present. While these usually appeared to be places where material for transmission tower foundation construction was excavated, these excavations or disturbances were at least 80 m from towers at locations near priority habitat patches PH9998 and PH0001 (Photo 3-5).

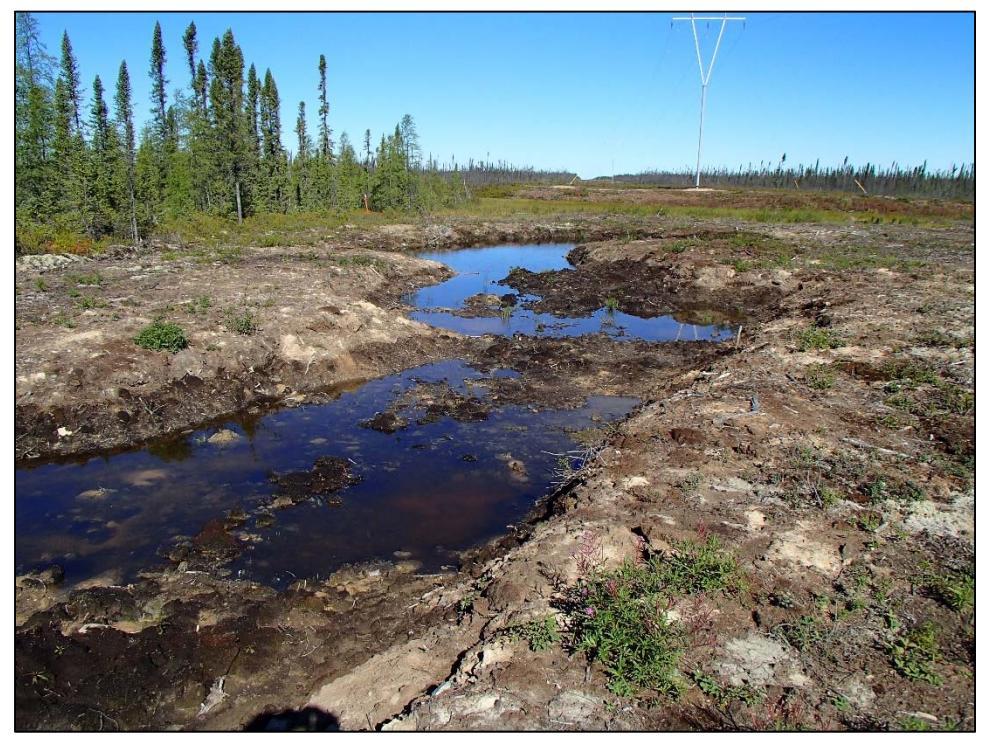
#### Photo 3-5: Excavation in ROW near priority habitat patch PH0001.

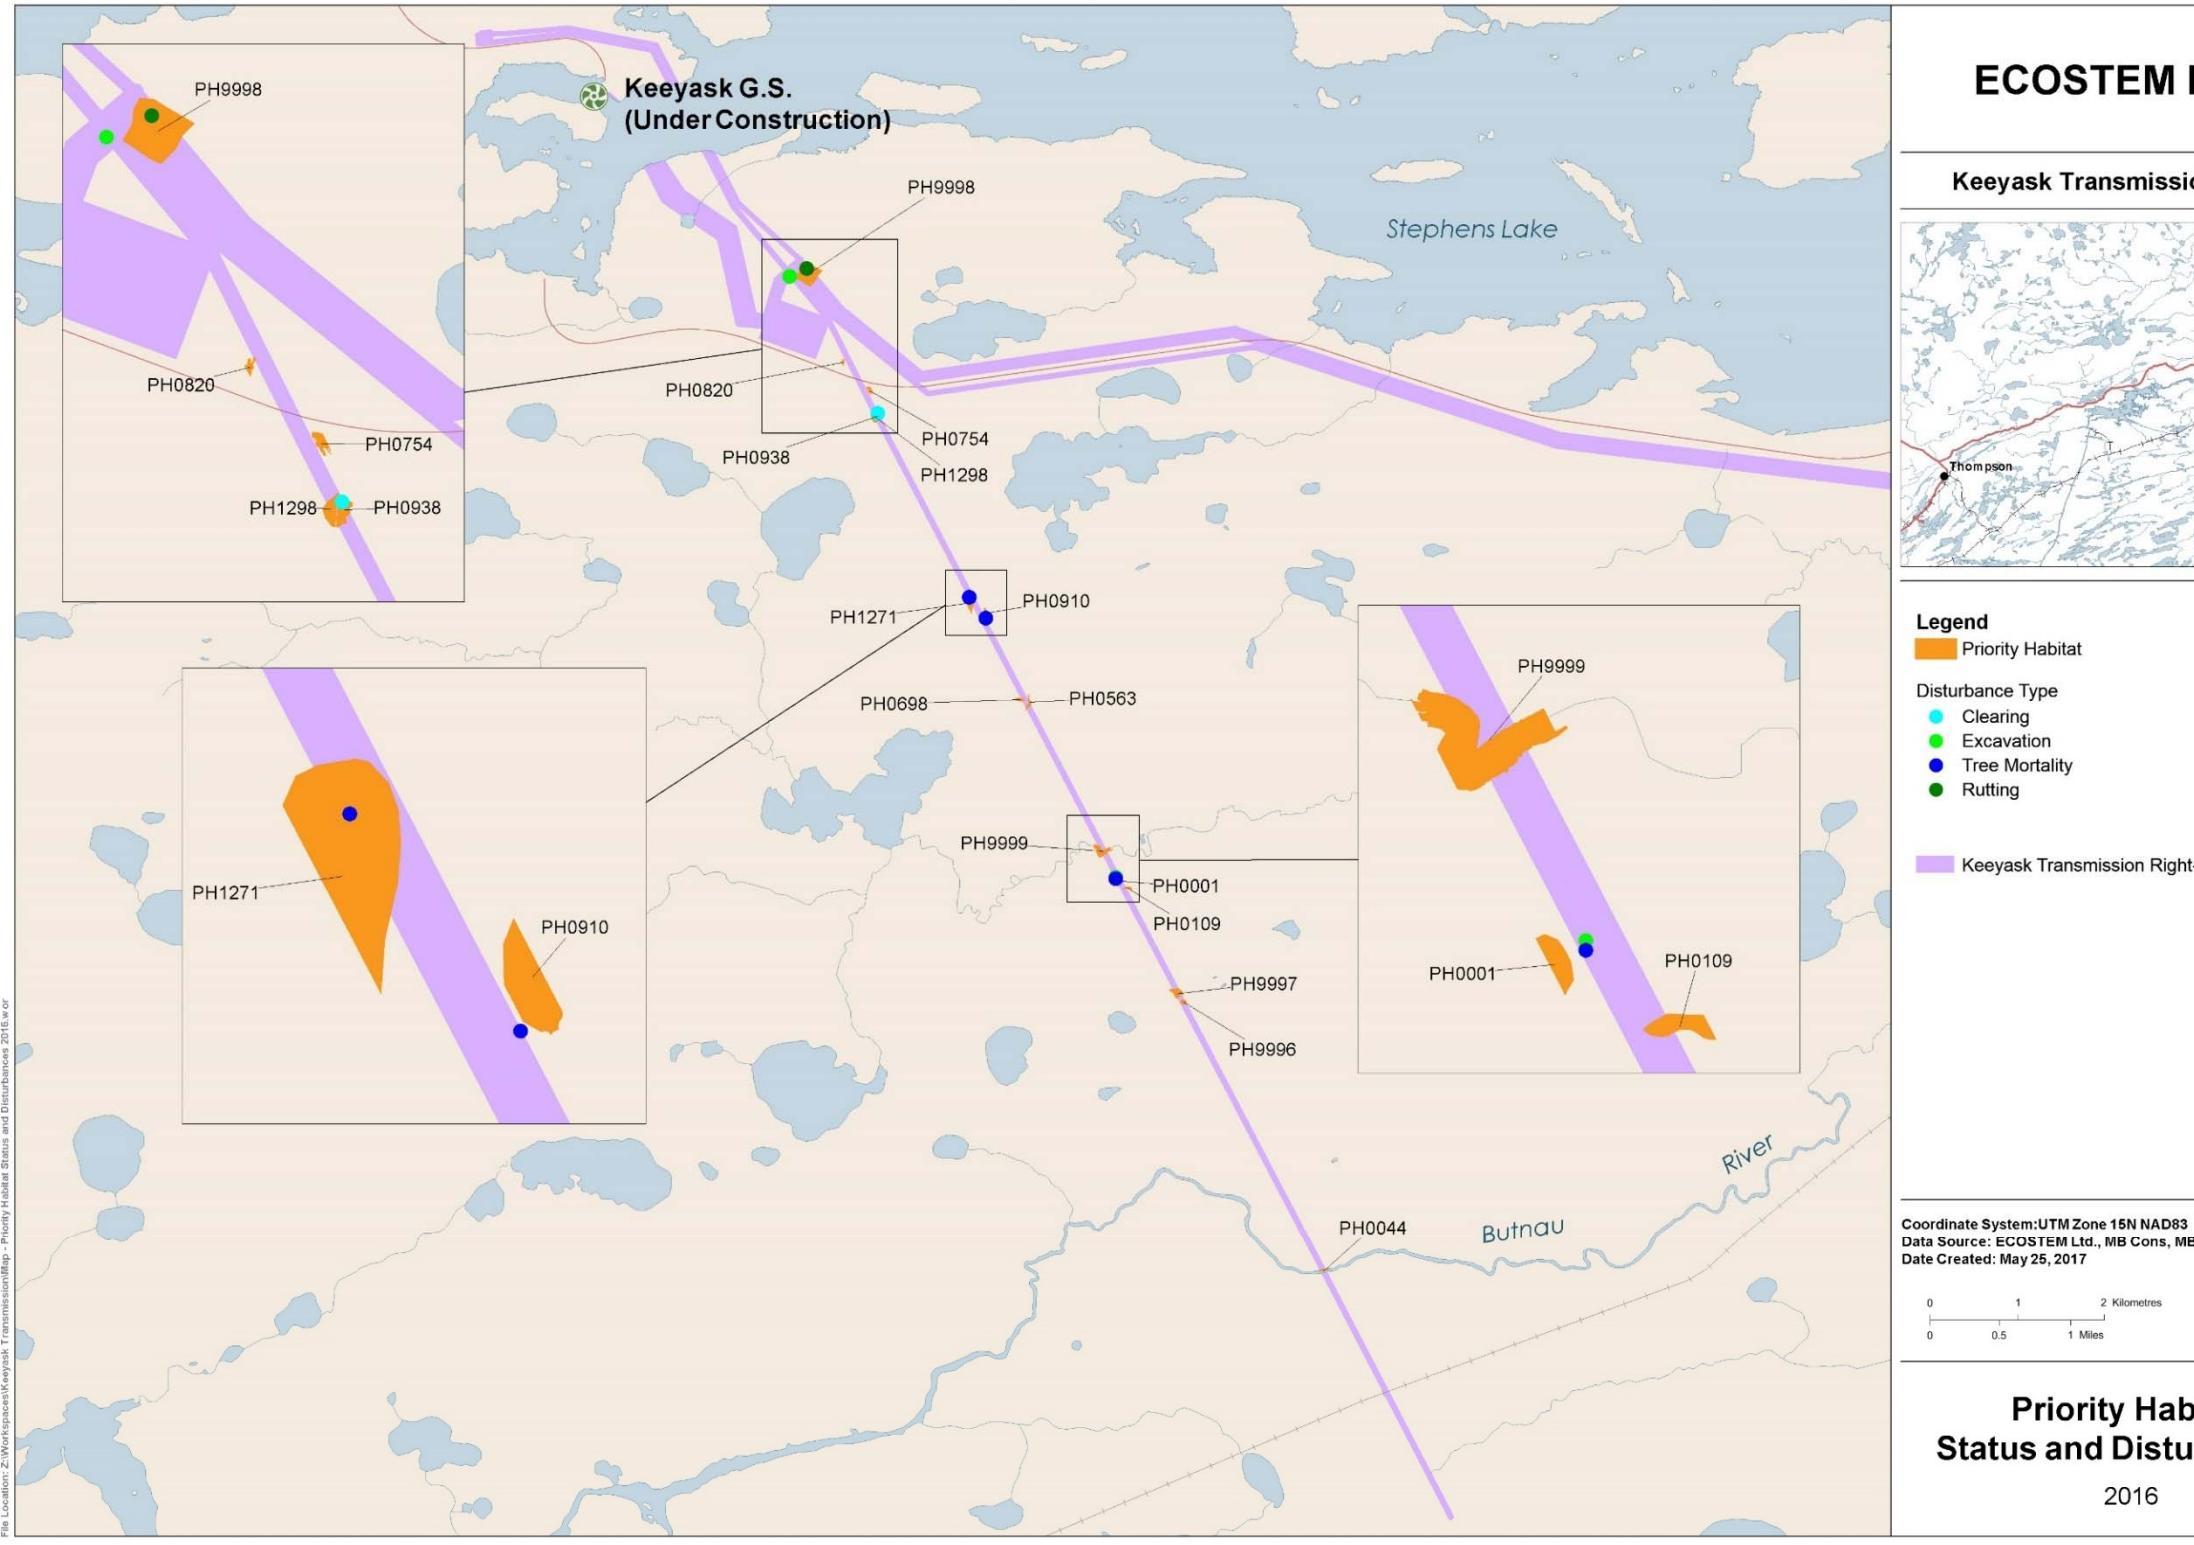
Map 3-1: The status of priority habitat patches, and locations where disturbances occurred outside of the cleared Construction Power ROW

Relative to their pre-Project boundaries, impacts on the 15 priority habitat patches were generally limited (Table 3-1). Ten patches had some clearing for the ROW, as expected. Relative to their pre-Project boundaries, the remaining five had no clearing either because they were buffered from the cleared ROW by undisturbed vegetation, or because clearing within the ROW was unnecessary since the native vegetation was already short. Map 3-1 shows the status of the priority habitat patches, including any impacts at each patch.
