Site 120

Unnamed Tributary of Wintering Lake

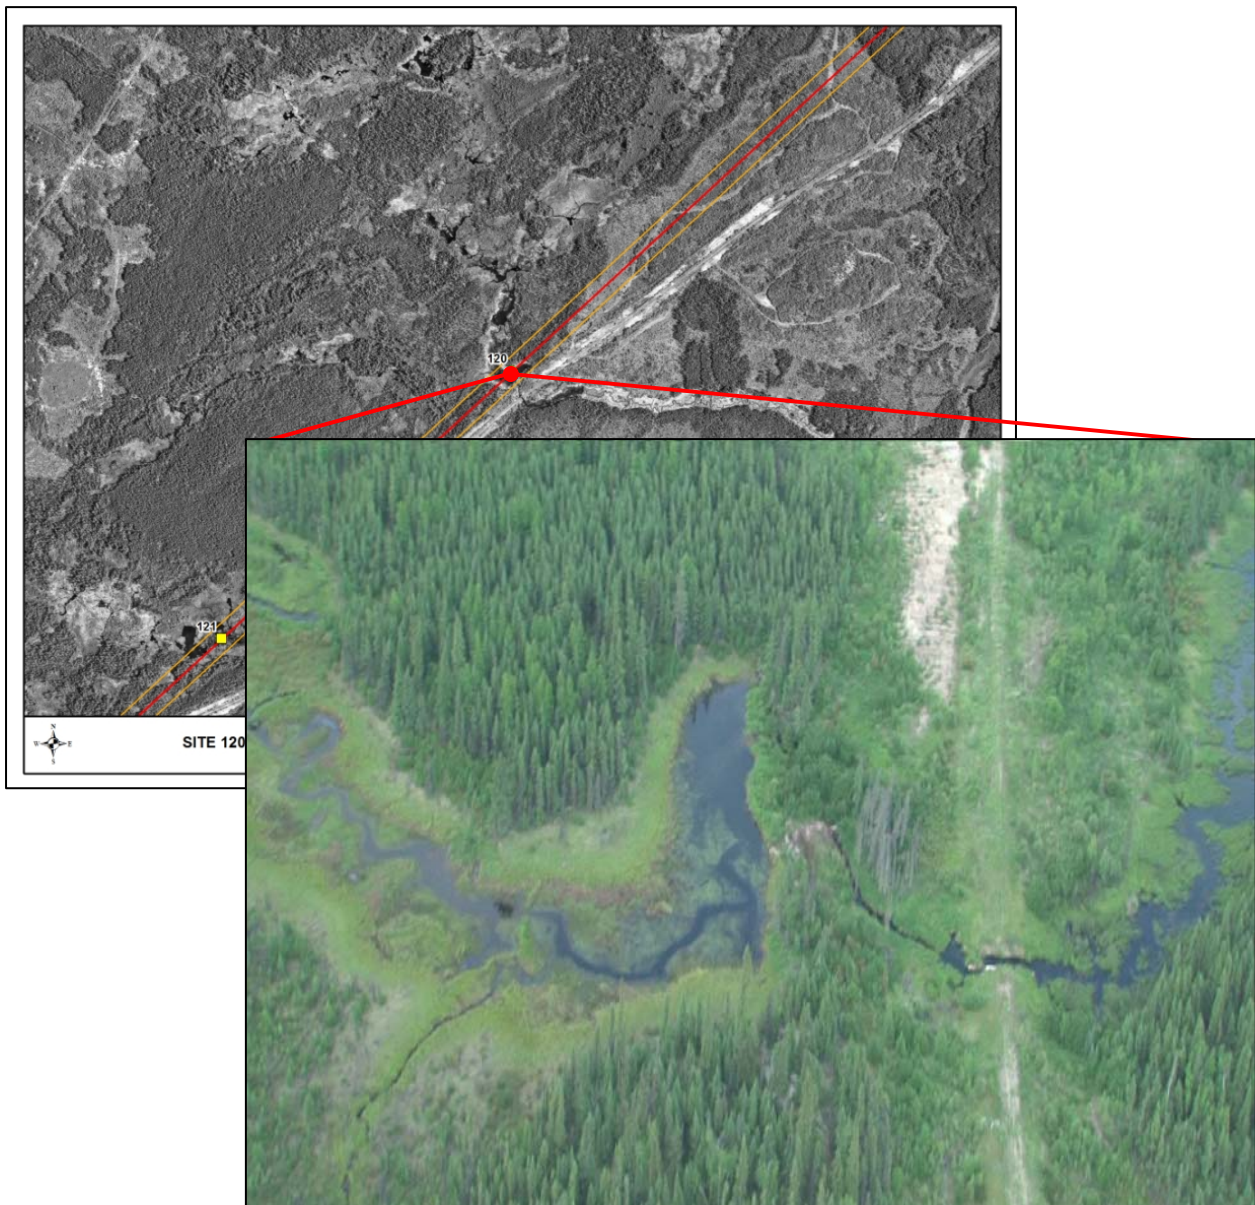
The RoW at site 120 crosses this unnamed tributary of Wintering Lake in the headwaters of this small stream and habitat is typical of small boreal streams with wetland habitat, ponded areas and a saturated floodplain. Forage fish are expected at this site and due to the lack of overwintering habitat and distance from Wintering Lake large bodied fish are not expected at this site

The floodplain region is sensitive to damage during construction.

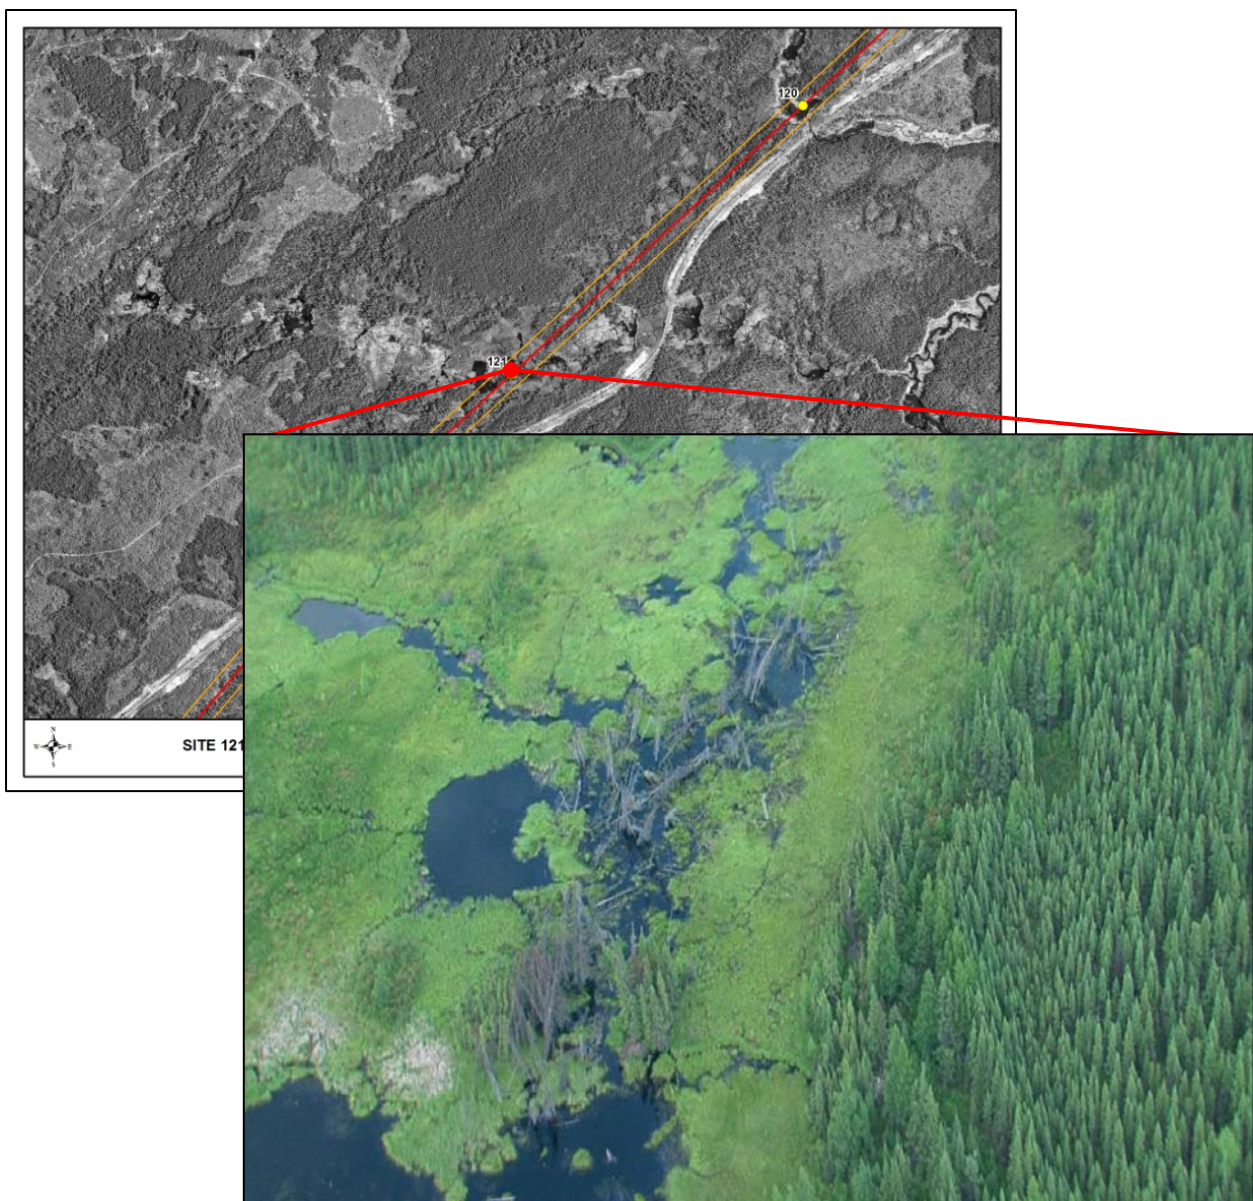
Site 121

The RoW at site 121 crosses this unnamed tributary of Wintering Lake in the headwaters a considerable distance from Wintering Lake. Habitat is typical of small boreal streams with wetland areas consisting of ponded water and poor channel formation. Due to lack of overwintering habitat and distance from wintering lake, forage fish only are expected at this site.

The floodplain region is sensitive to damage during construction.

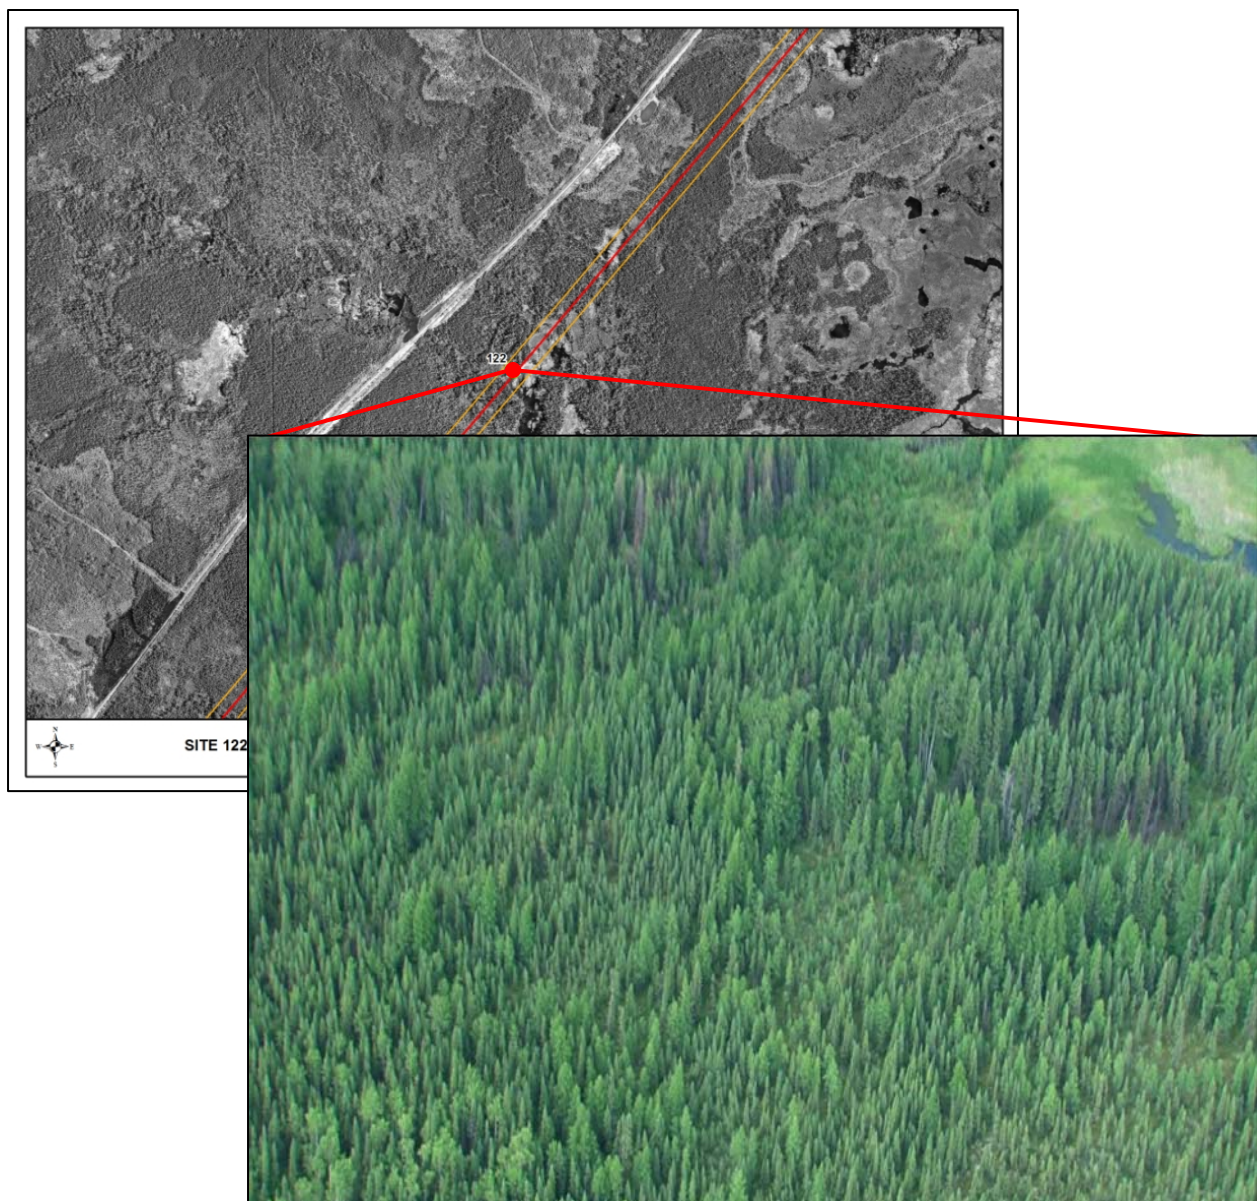
Site 122

The RoW at site 122 crosses this unnamed tributary of Wintering Lake in the headwaters of this small boreal stream. Forage fish may be found at this site.

The floodplain region is sensitive to damage during construction.

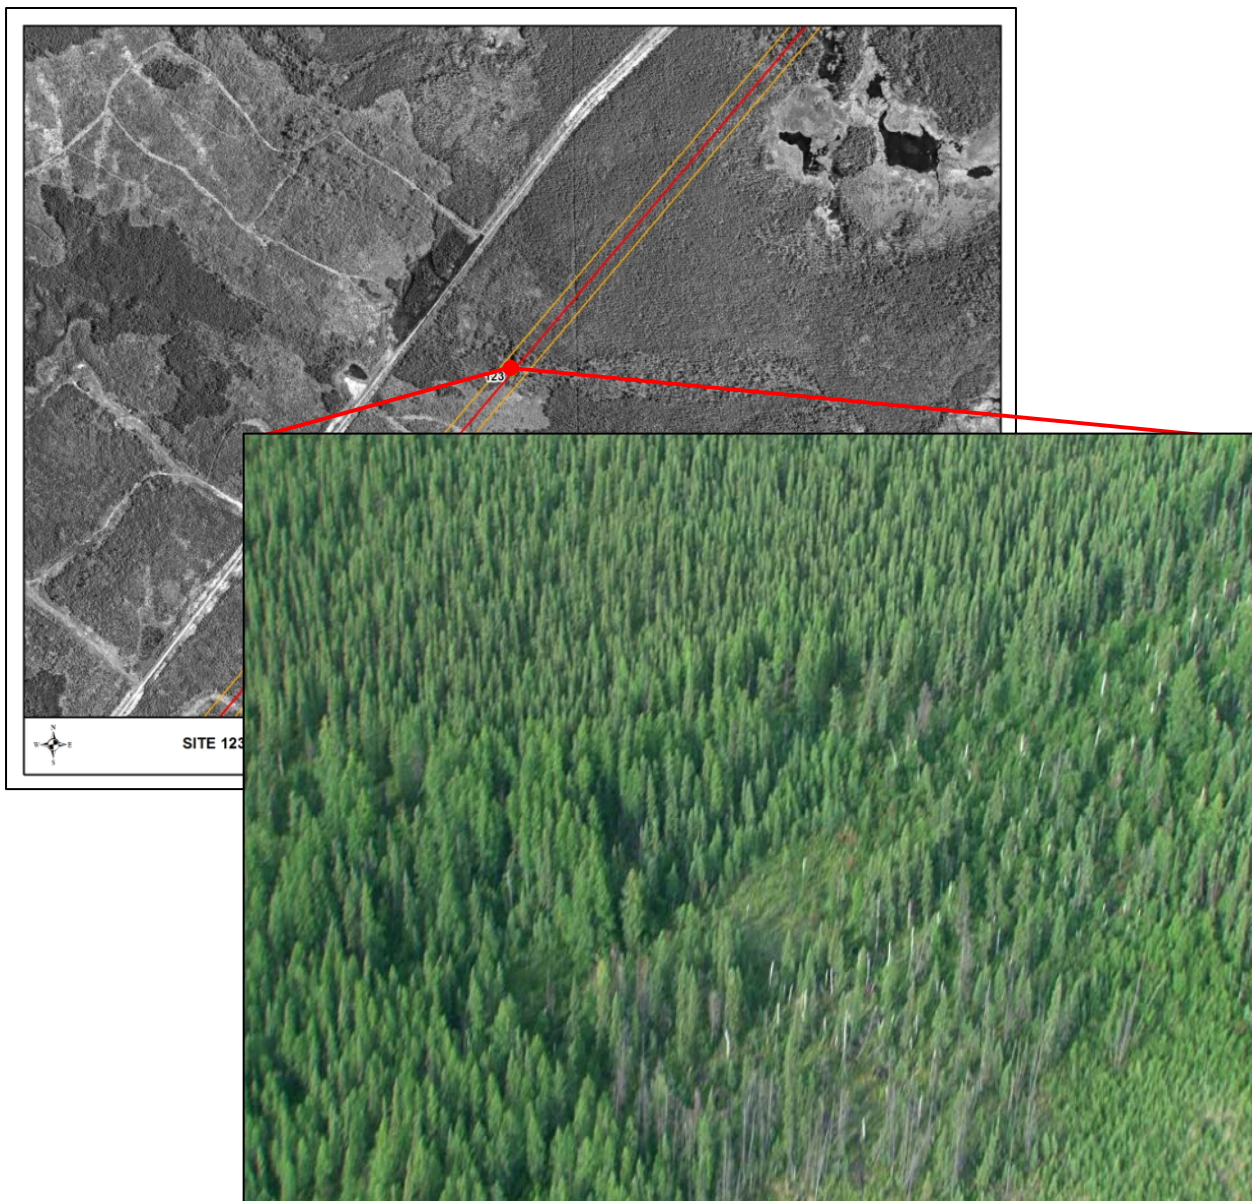
Site 123

The RoW at site 123 crosses this unnamed tributary of Wintering Lake in the extreme headwaters reach. A channel or water are not visible at this site and therefore considered no fish habitat

Stable banks and no fish habitat result in a low sensitivity rating

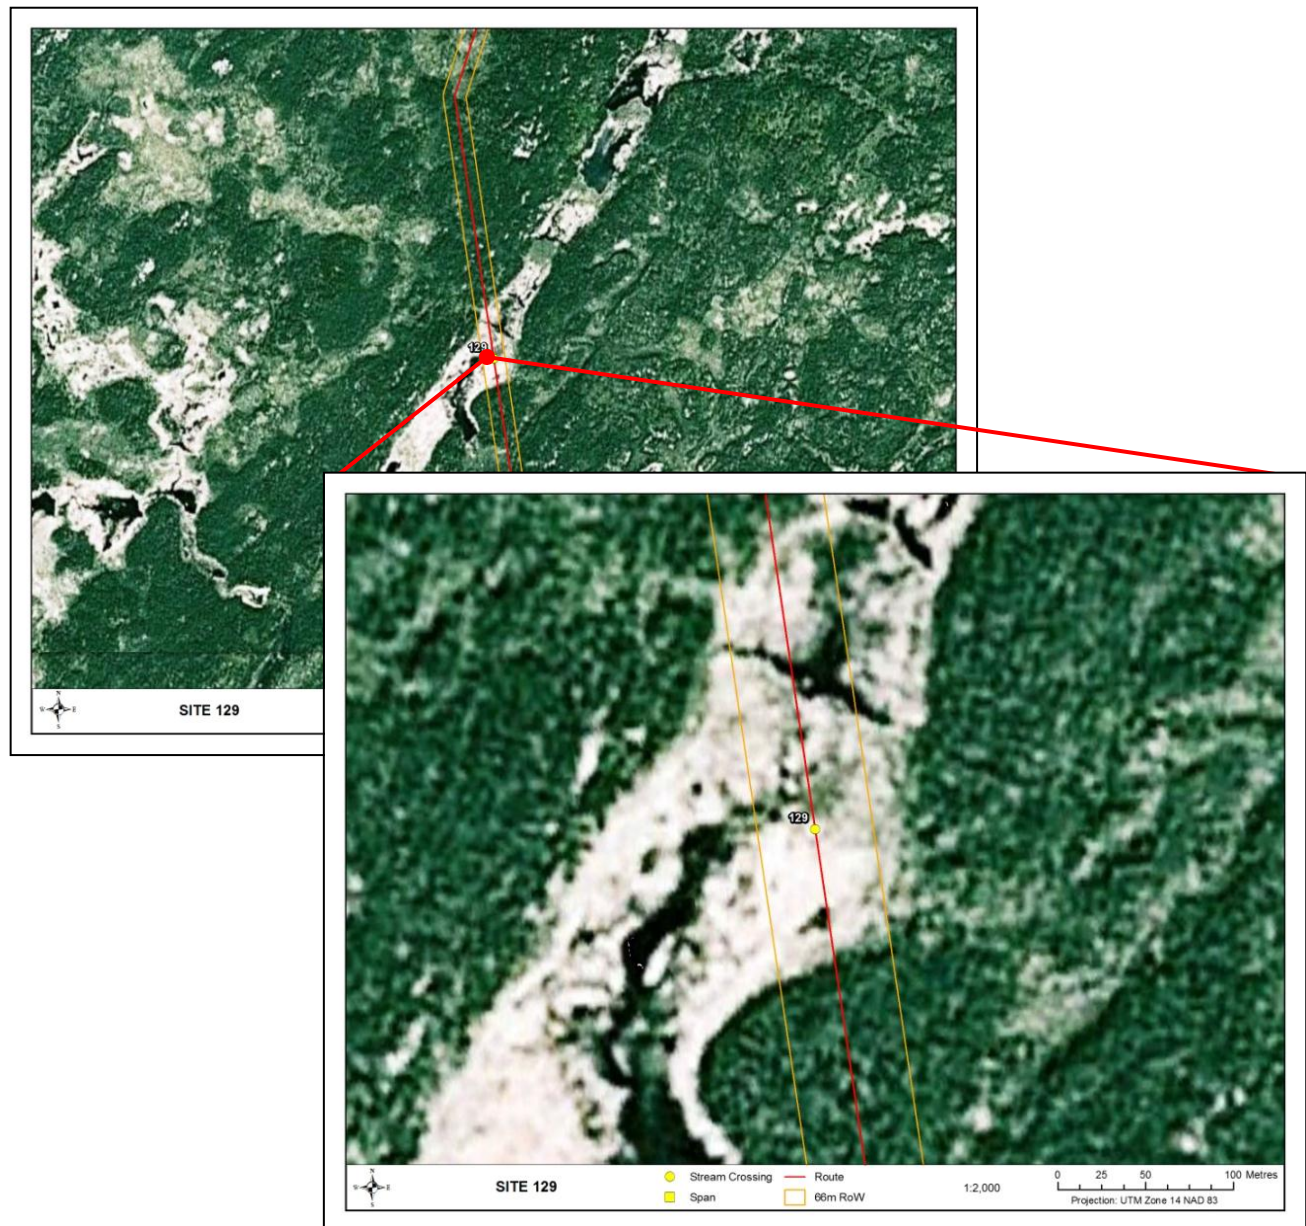
This unnamed tributary of Tooth Lake is found within forest and wetland habitat. It likely provides marginal habitat for forage fish. It is surrounded by a soft grass floodplain.

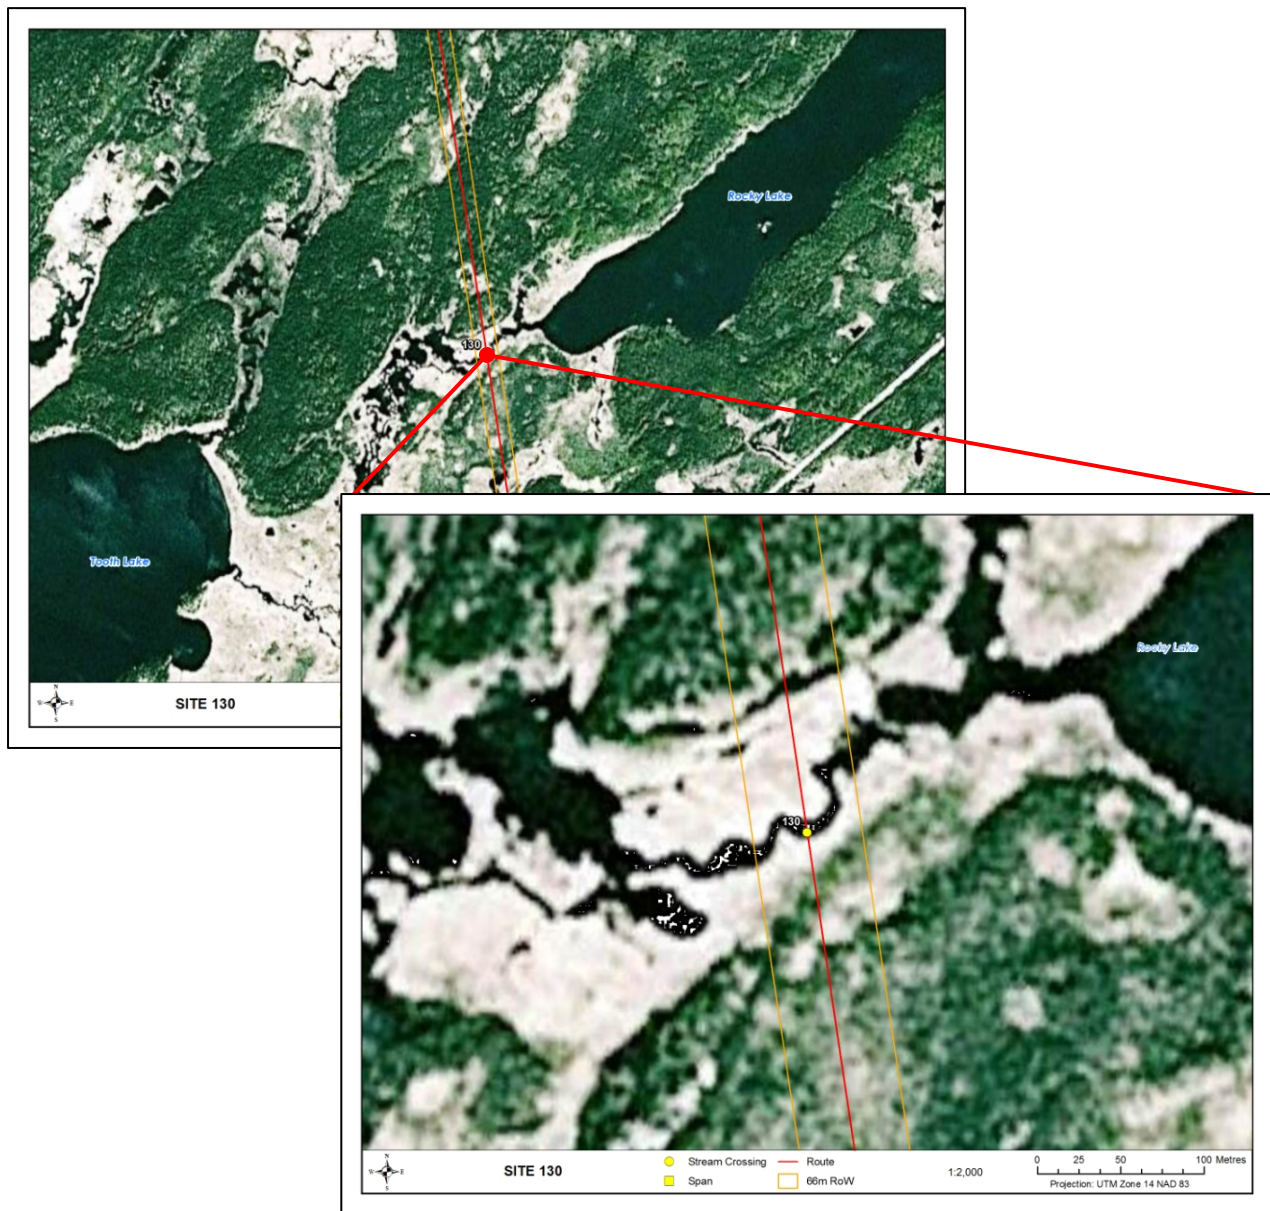
This unnamed tributary of Rocky Lake is found within forest and wetland habitat. It connects Rocky and Tooth Lake, and likely provides important habitat for indicator and forage fish. It is surrounded by a soft grass floodplain.

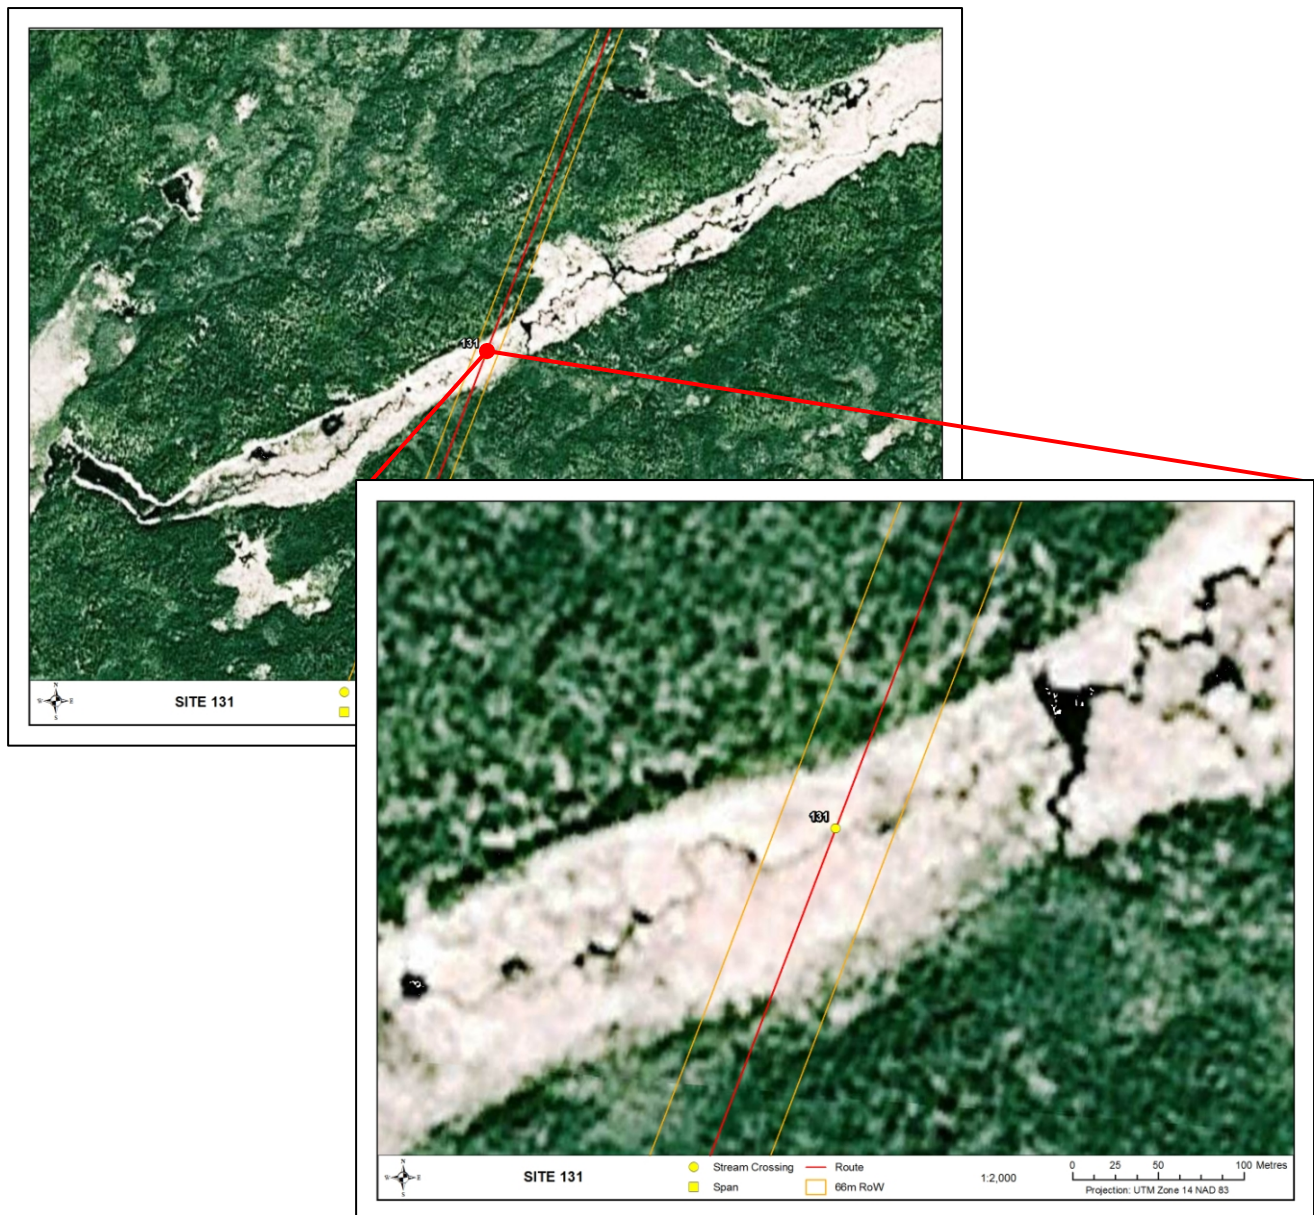
This unnamed tributary of Monty Lake is found within forest habitat. It likely provides marginal habitat for forage fish. Indicator fish species may be found in the area, but the channel's small size likely limits their usage of it. It is surrounded by a soft grass floodplain.

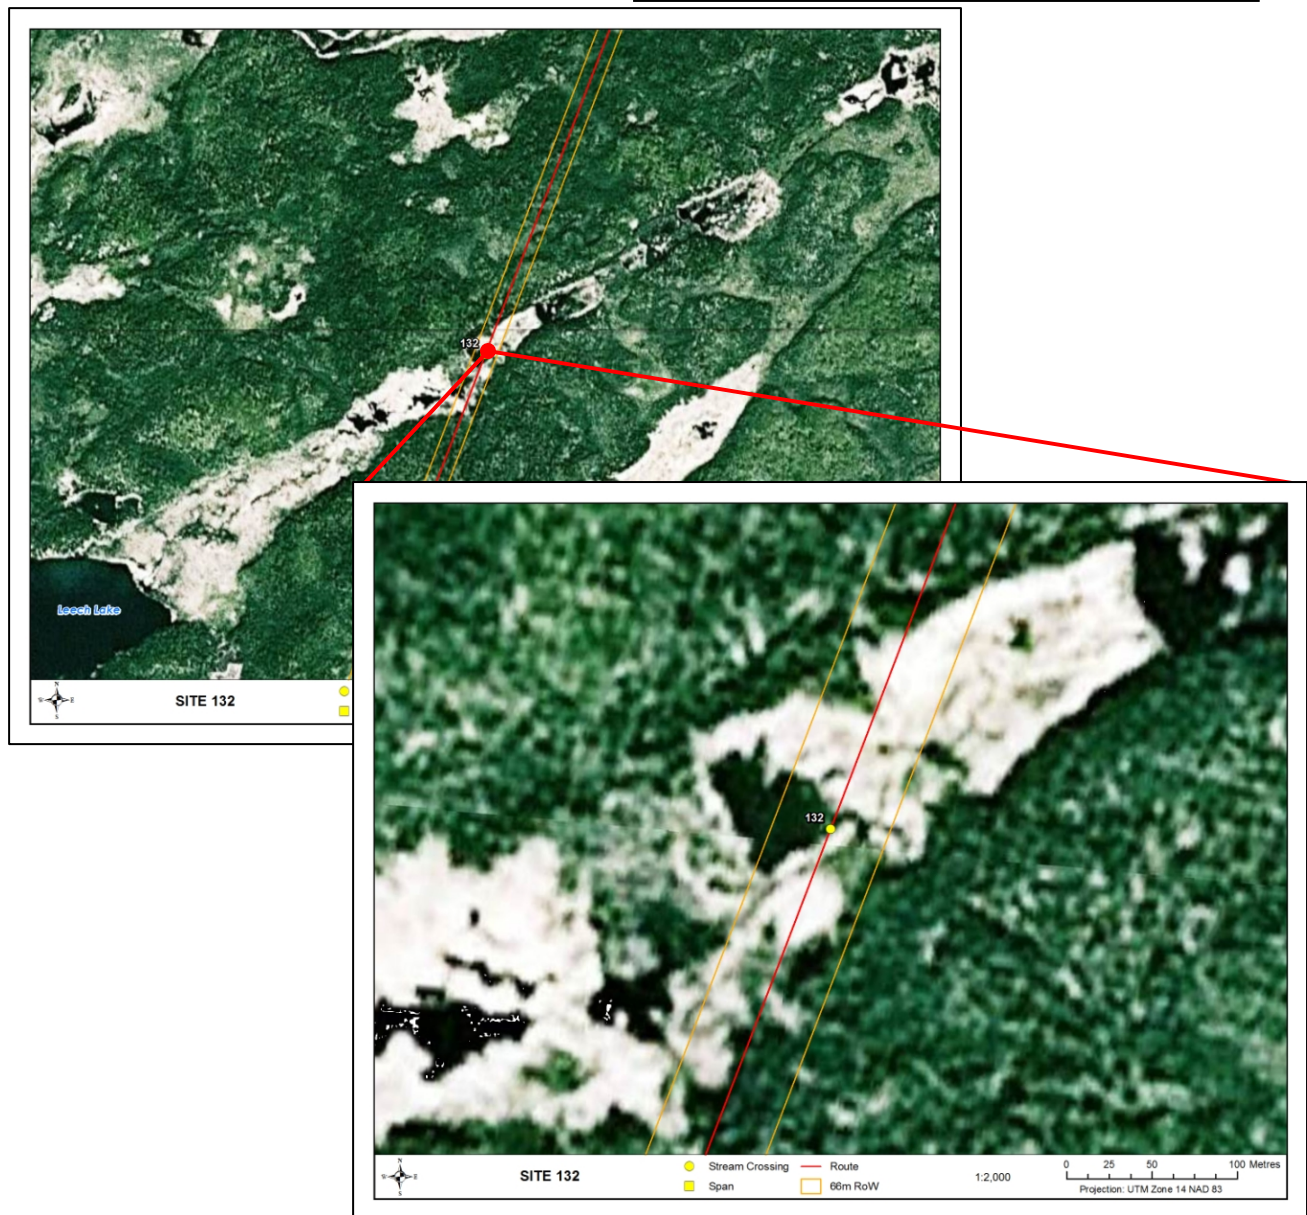
This unnamed tributary of Leech Lake is found within forest habitat. It likely provides marginal habitat for forage fish. The channel is not well-defined, and there is a pooled area within the RoW. It is surrounded by a soft grass floodplain.

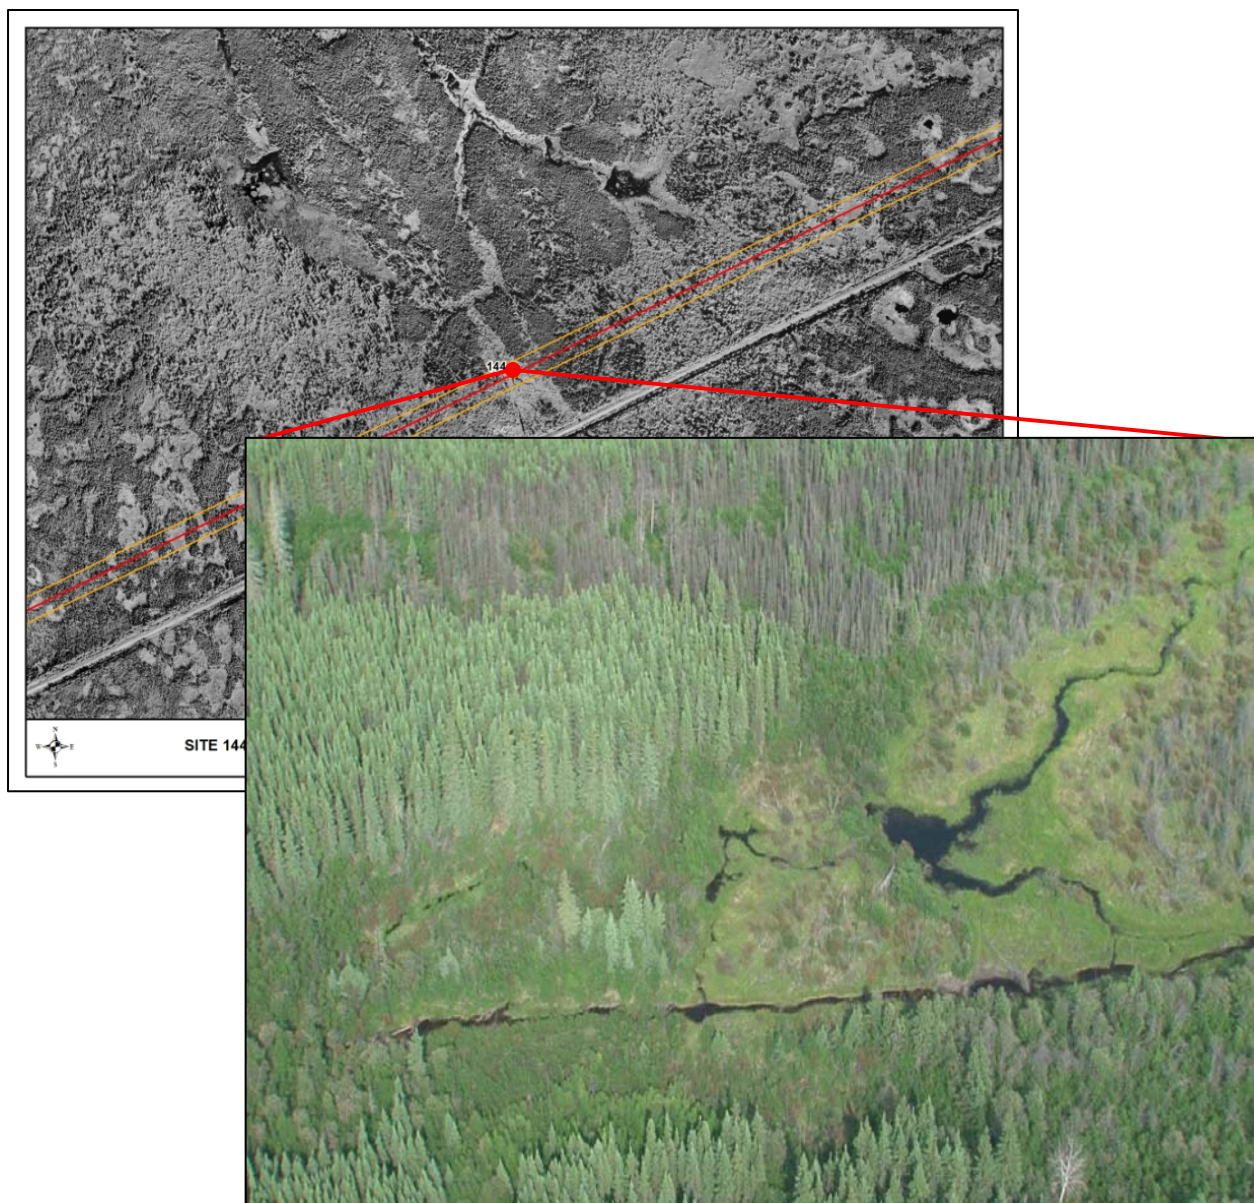
The RoW at site 144 crosses this unnamed tributary of Mitishto River. The tributary is an intermittent stream with low habitat diversity and low overwintering potential. Forage fish may be found at this site, but large bodied species are not expected.

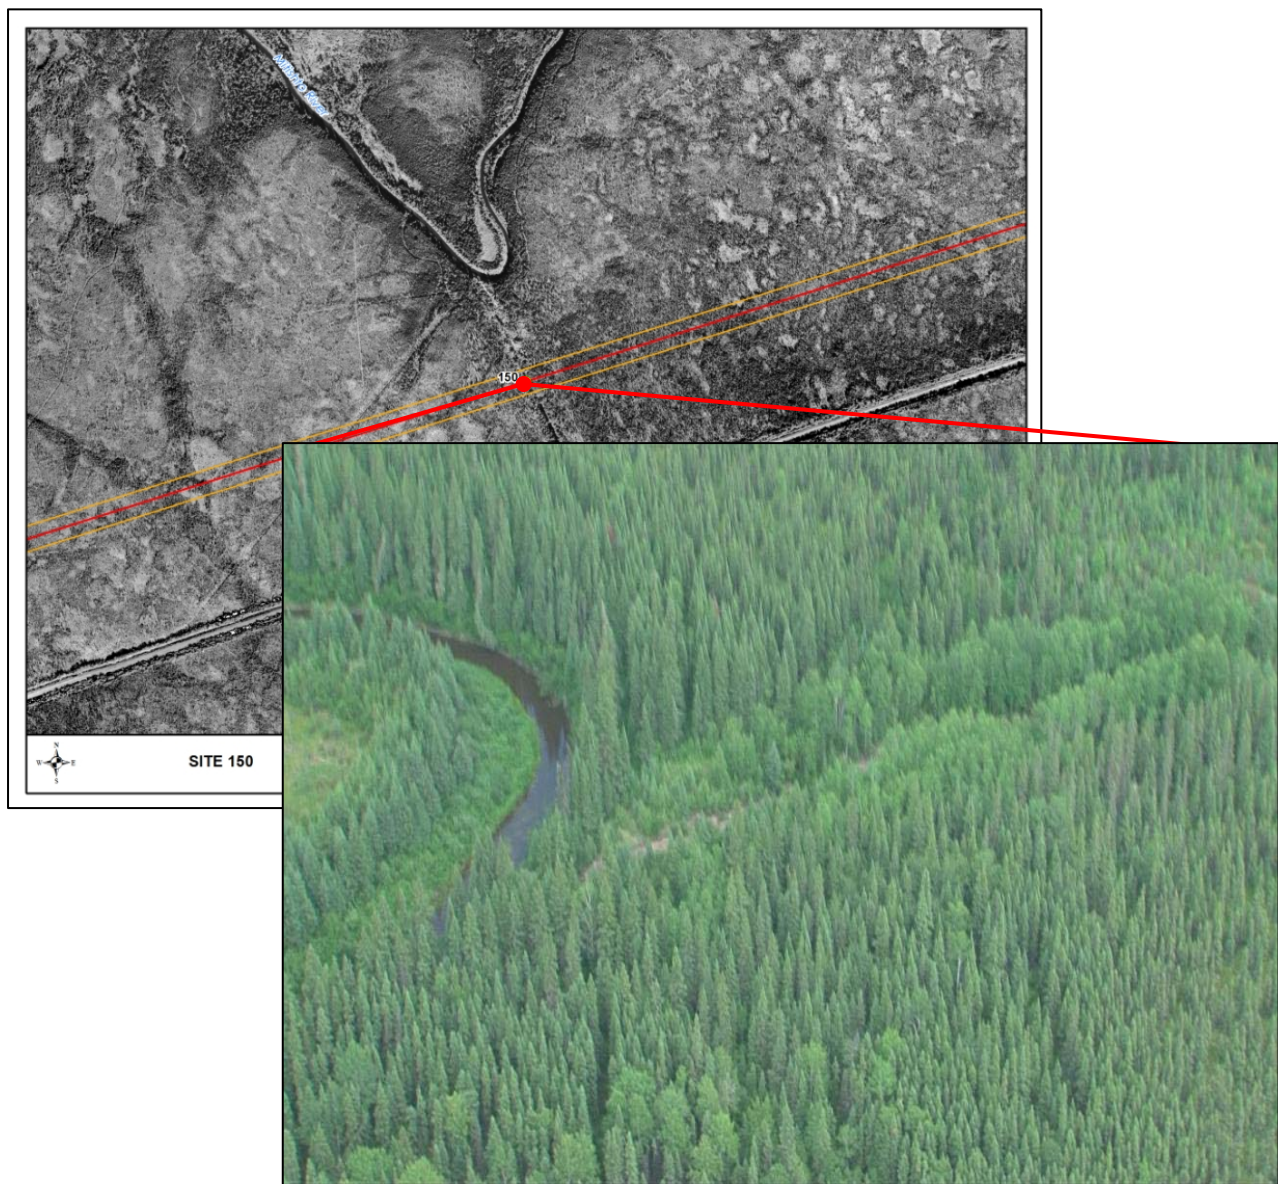
This unnamed tributary of the Mitishto River likely provides habitat for forage fish species, with low overwintering potential. It is channelized as a diversion channel of the CN Railway Line. The assessment was conducted 287m upstream of the site, however conditions appear similar at both sites.

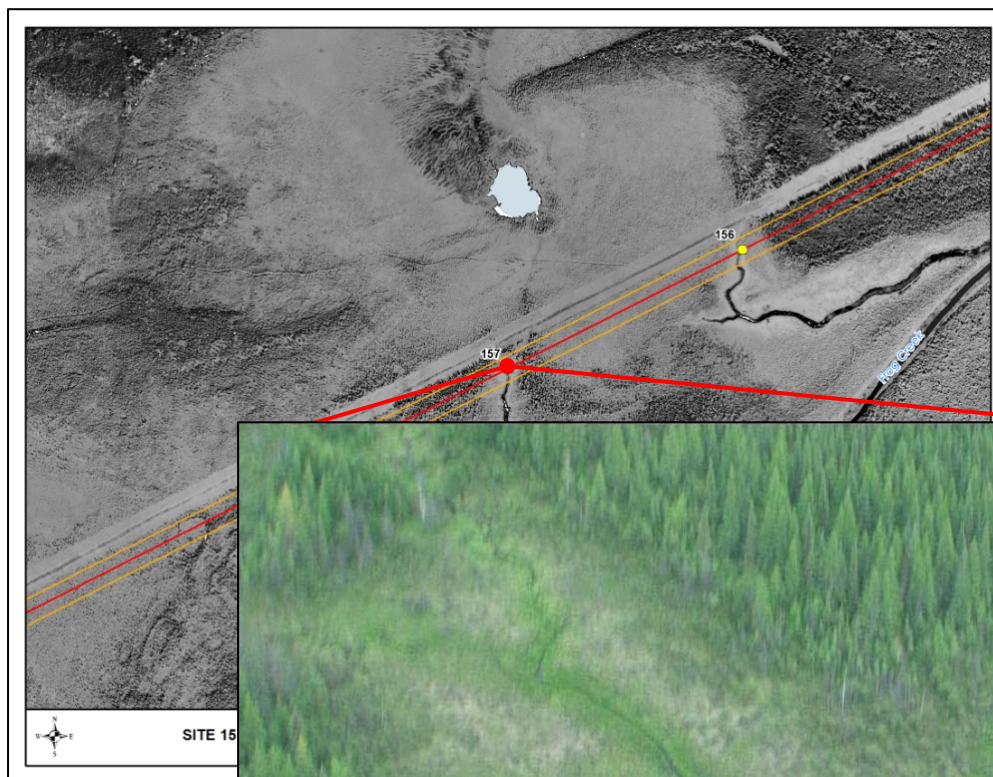
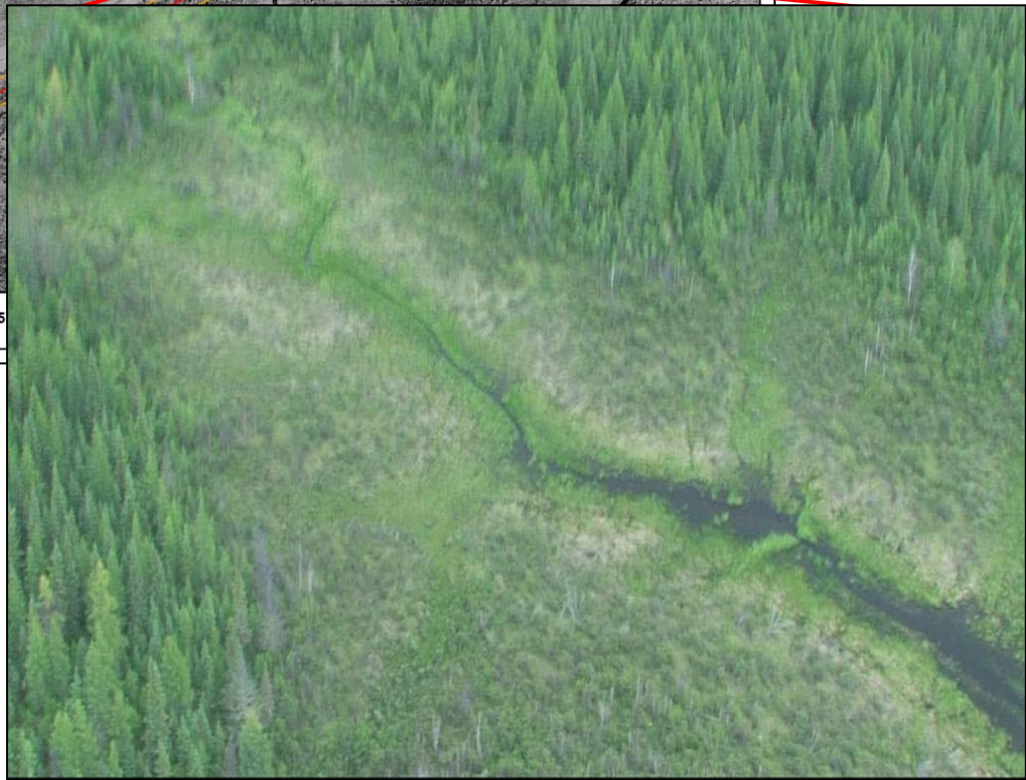
This unnamed tributary of Frog Creek likely provides habitat for forage fish and those species found in boreal wetland habitats (e.g., brook stickleback).

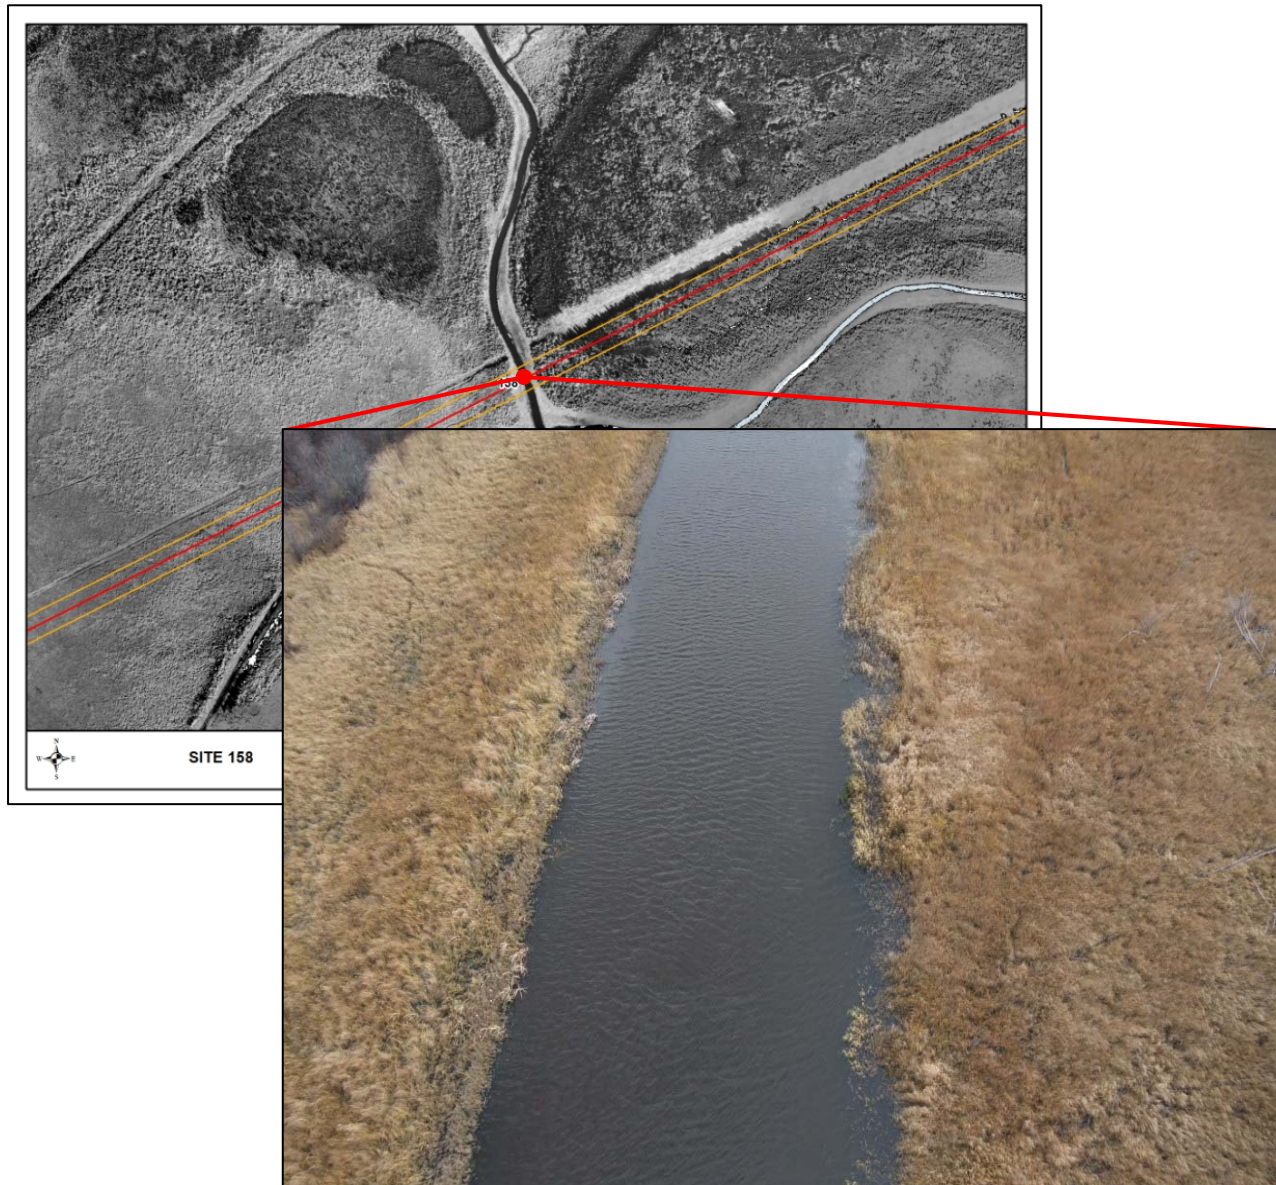
Frog Creek connects Cormorant Lake with North Moose Lake and provides complex habitat for indicator fish species. It is surrounded by a soft grass floodplain. The site assessment was conducted 51m downstream of the actual site, however conditions appear similar at both locations.
