Site 181

Unnamed pond

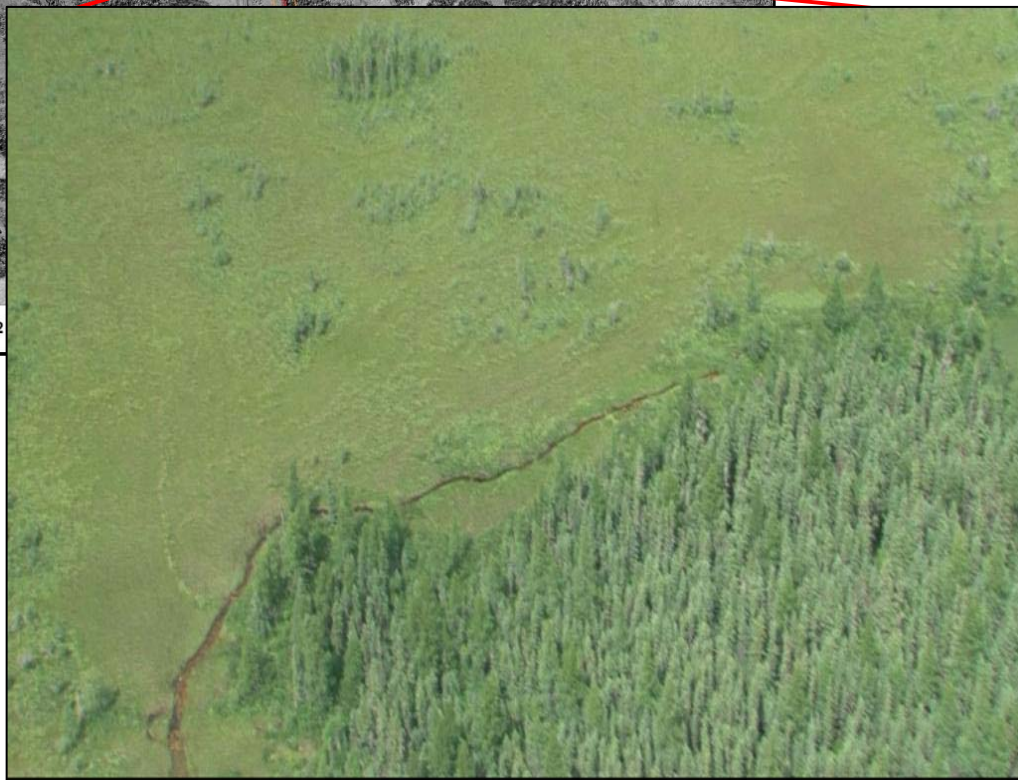
Site 182

Iskwayanikakespeetik Creek likely provides complex habitat for forage fish species, with low overwintering potential. The channel is surrounded by a soft grass/shrub floodplain. Sites 182, 183, and 184 all cross Iskwayanikakespeetik Creek.

Surrounding soft floodplain results in a moderate sensitivity rating, despite marginal fish habitat.

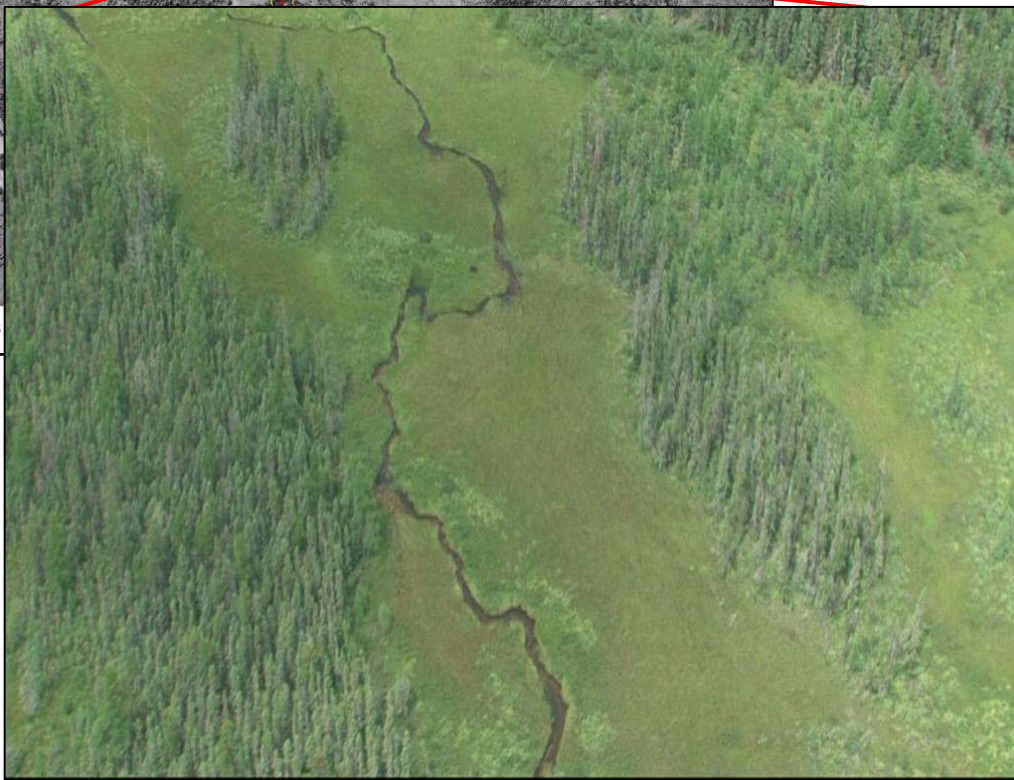
Site 183

Iskwayanikakespeetik Creek likely provides complex habitat for forage fish species, with low overwintering potential. The channel is surrounded by a soft grass/shrub floodplain. The RoW crosses the floodplain for 157m downstream of the site, and crosses the channel two times within this distance. Sites 182, 183, and 184 all cross Iskwayanikakespeetik Creek.

Surrounding soft floodplain results in a moderate sensitivity rating, despite marginal fish habitat.

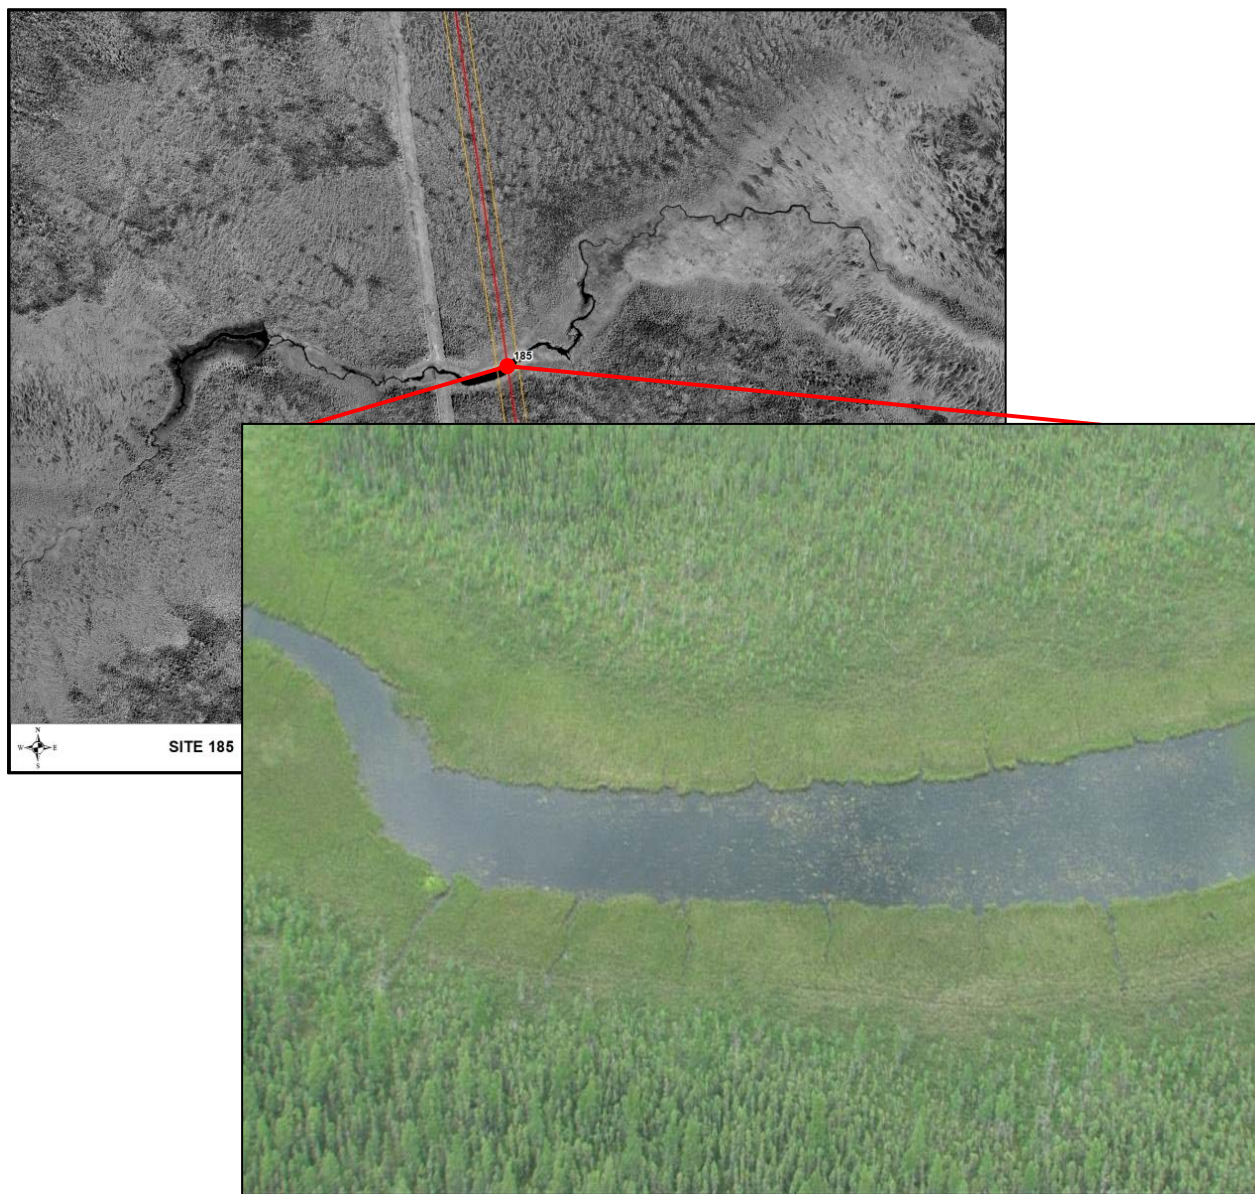
Site 185

Stream/Lake: Stream
Pattern: IM
Confinement: UN
Stage: Moderate
Flow Regime: Intermittent
Morphology: LC
U/S Drainage: 4.8 km²
Distance to Receiving Water: Cedar Lake 14 km
