**BIPOLE III TERRESTRIAL ECOSYSTEMS AND VEGETATION
ENVIRONMENTAL MONITORING
ANNUAL TECHNICAL REPORT – YEAR VI**

**Prepared for:
Manitoba Hydro**

**Prepared by:
Szwaluk Environmental Consulting Ltd.

November 2019

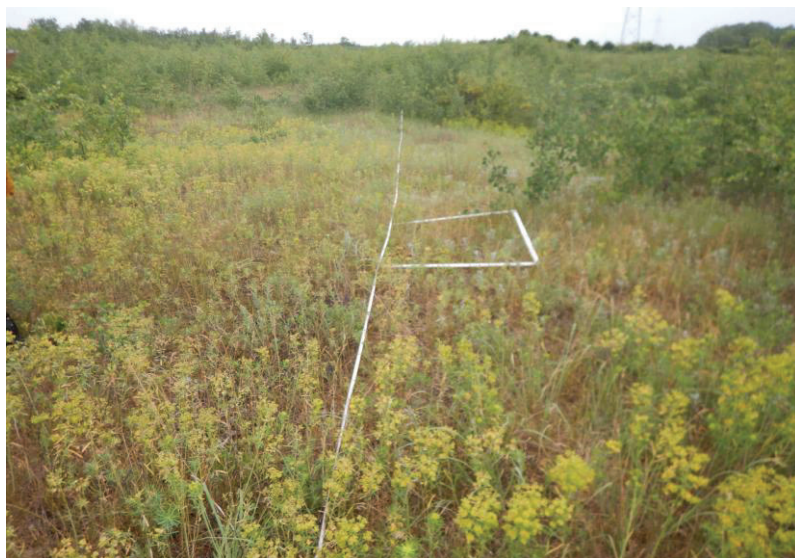
A single grassland prairie (PRA) site was surveyed for continued monitoring in 2019 (Map 4-1, Appendix II) (Field Activity ID BPIII_CON_FA487). This PRA site, located in the southern portion of the Bipole III RoW Section S1, was visited on July 9. No off-site survey was established as this patch was originally too small to allow a paired survey adjacent to the RoW, within the same habitat. This site is a dry sandy prairie, with trembling aspen (*Populus tremuloides*) and bur oak (*Quercus macrocarpa*) adjacent to the RoW and currently present as regenerating saplings within the RoW (Photograph 4-1a).

Photograph 4-1a. Regeneration on the RoW at S1-PRA-900.

In 2019, vegetation ground cover continues to show disturbance from previous construction activities at prairie monitoring site (S1-PRA-900) and surrounding area. Machinery used to establish anchor points has resulted in loss of vegetation cover around the tower footprint. The area is extremely sandy, and the ground vegetation is easily disturbed. Bare ground was observed around the tower footing area, where invasive species were again noted this year. ATV tracks elsewhere on the property (both on RoW and off site) have produced bare ground (i.e., sand) with very little vegetation regenerating.

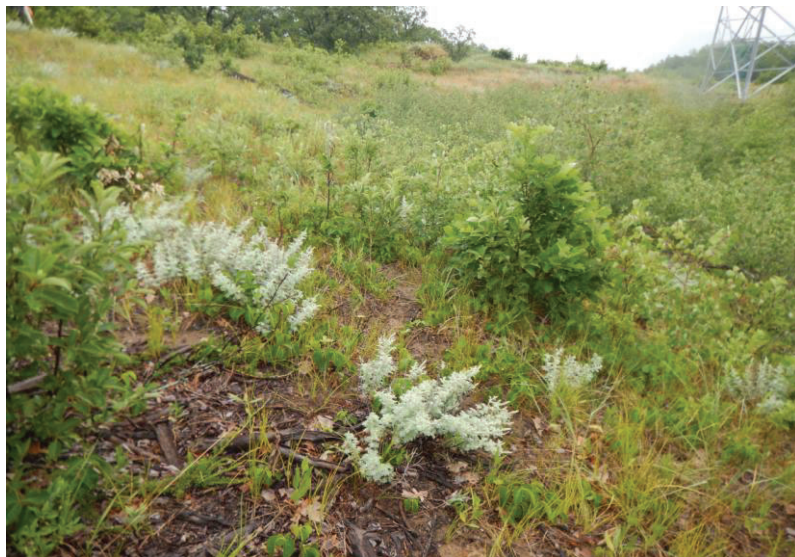
Noxious and invasive species observed in S1-PRA-900 are discussed in Section 4.5.1. One species of conservation concern, prairie spike-moss (*Selaginella densa*, S3), has not been relocated in this area since 2015, prior to clearing. Photograph 4-1b shows hairy prairie-clover observed on the RoW.

Photograph 4-1b. Hairy prairie-clover on the RoW.

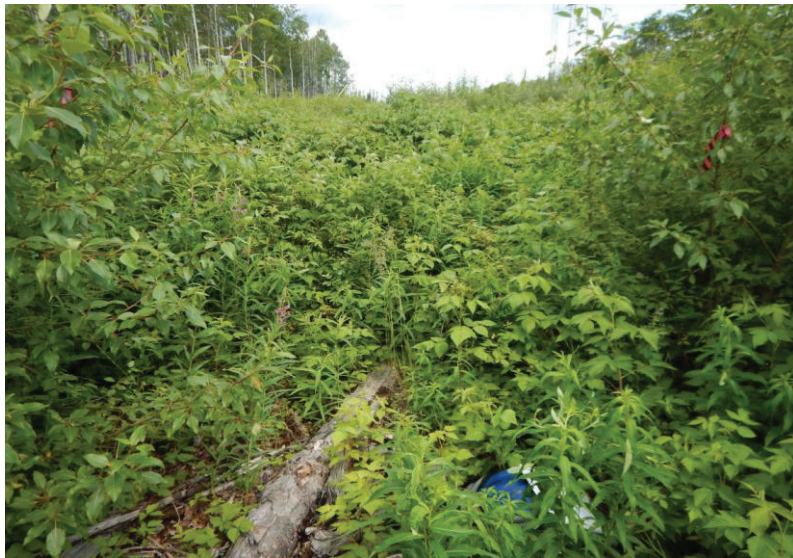
Terrestrial vegetation on the RoW continues to show recovery of vegetation after clearing and construction activities, with increasing cover and changing structure (Photograph 4-2a). Recommended mitigation was effective for terrestrial vegetation which minimized the disturbance from project activities. In the absence of mitigation, site disturbance likely would have increased.

Photograph 4-2a. Regeneration along the RoW at N2-TER-200.

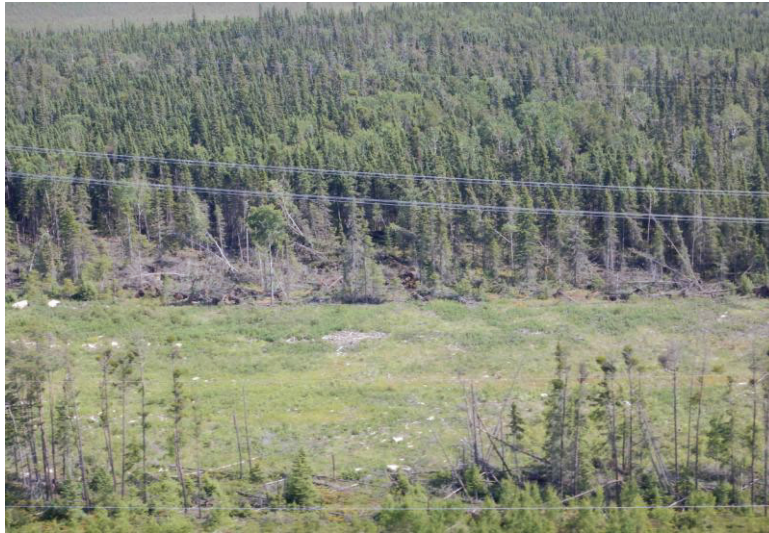
Windthrow or blowdown (uprooted trees) was commonly observed north of The Pas, along the Wuskwatim transmission line (Photograph 4-2b). Both forest edges of the Bipole RoW (east and west) showed areas of windthrow. Along portions of the RoW, the

narrow buffer between the two RoW's no longer exists. Windthrow in this area of the project has been previously observed.

Photograph 4-2b. Windthrow observed along the RoW boundary.

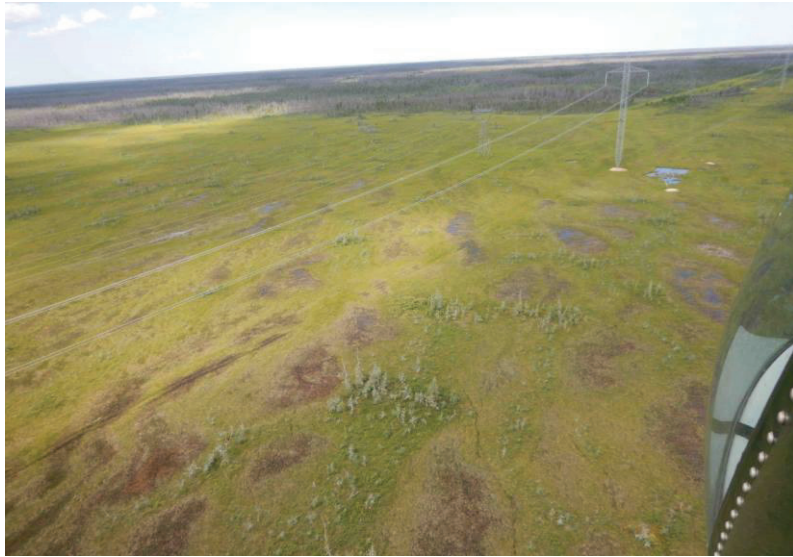
equipment paths on the RoW. Photograph 4-3a shows the equipment path in the centre of the RoW, seen at plot N4_WET_300. Recommended mitigation was effective for the patterned fen wetlands which minimized the disturbance from clearing and construction activities. In the absence of mitigation, surface disturbance (i.e., rutting, exposed soils) likely would have increased.

Photograph 4-3a. Previous equipment path used during construction activities.

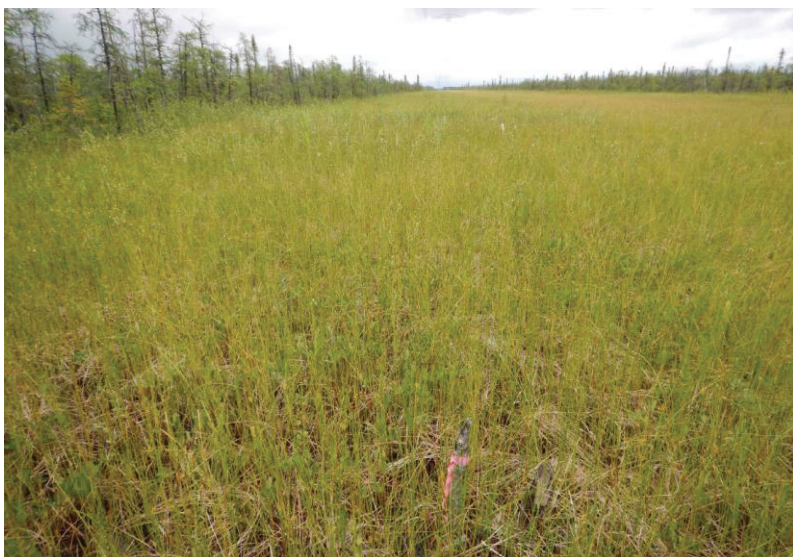
Photograph 4-3b. Wetland regeneration at N3-WET-300.

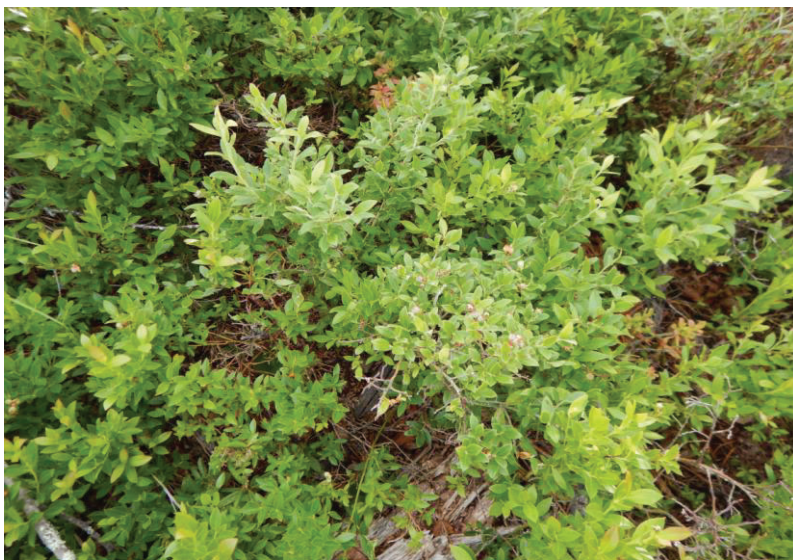
Total blueberry cover for sites supporting blueberries (both low sweet blueberry and velvetleaf blueberry) on the RoW (2019) averaged 13.3%, an increase since initial RoW pre-clearing surveys in 2014 (12.1%). Photograph 4-4b shows blueberry plants in the Cowan Blueberry Resource Area.

Photograph 4-4b. Blueberry plants in the Cowan Resource Area.

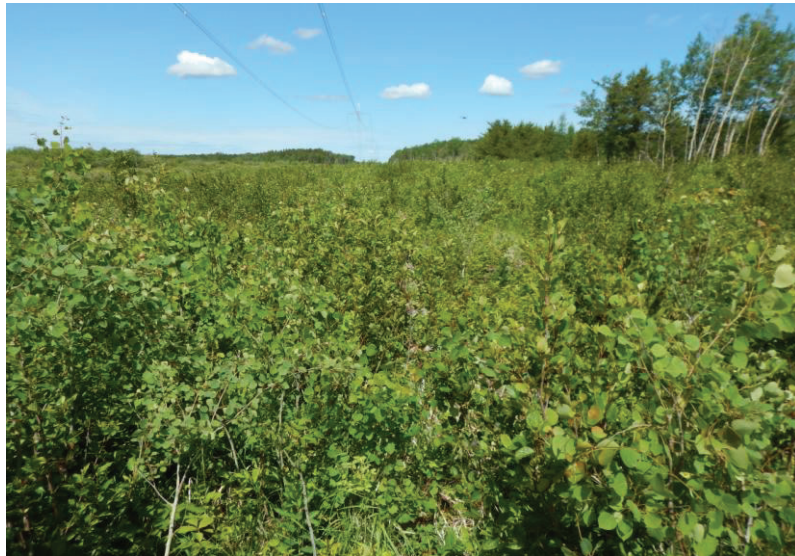
In other parts of the RoW, tall shrub cover (>1m height) is dominating with species of trembling aspen and green alder. Also observed as tall shrubs on the RoW were Bebb's willow, pin cherry, Saskatoon, balsam poplar (*Populus balsamifera*) and jack pine. Photograph 4-4c shows the regeneration of tall shrub vegetation on the RoW, at plot C1-ATK_600. Elsewhere, open areas continue to support dominantly native grasses and forbs (e.g., C1-ATK-800).

Photograph 4-4c. Regeneration of tall shrub vegetation in the Resource Area.

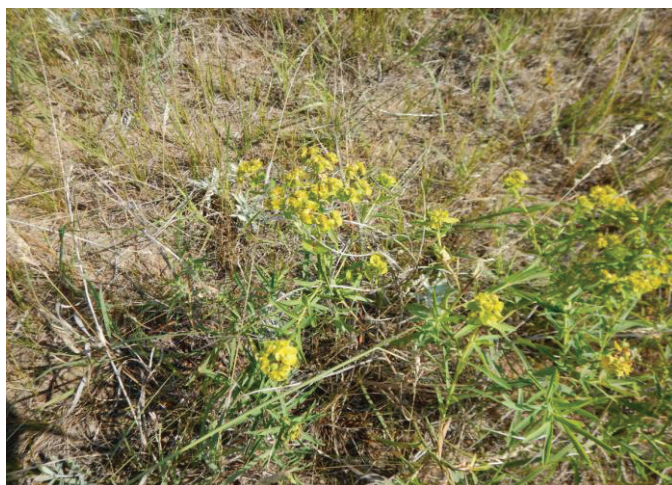
Species observed during surveys in Sections S1 and S2 with the highest threat (Tier II regulated under The Noxious Weeds Act) included leafy spurge (*Euphorbia virgata*), bladder campion (*Silene vulgaris*) and ox-eye daisy (*Leucanthemum vulgare*). Leafy spurge was observed at several locations during surveys, including one location where it was observed driving between monitoring sites, near Towers 6211 to 6212 (Photograph 4-5a). All observations of leafy spurge were in Section S1. Bladder campion and ox-eye daisy were less frequently observed.

Photograph 4-5a. Leafy spurge observed on the RoW.

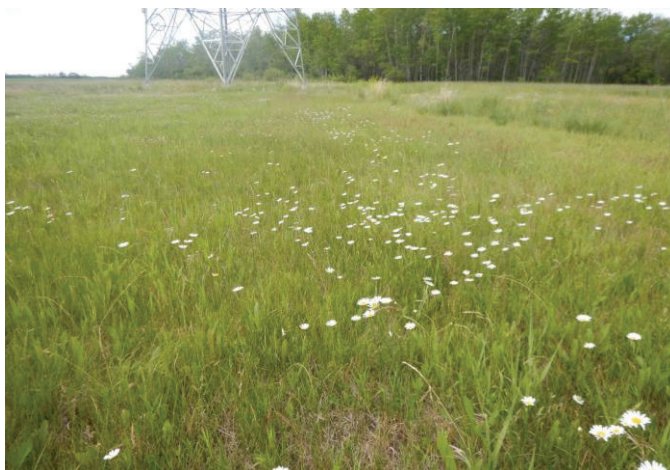
In Sections C1, C2, and N4, invasive species were commonly observed in monitoring plots and occasionally in noticeable patches during aerial inspections. While present on the RoW last year, ox-eye daisy has increased in abundance and distribution along the RoW. This species was observed spreading in areas of intersecting roadway ditches (e.g., C1-INV-300), adjacent fields (e.g., tower 4212) and also further into the RoW. The infestation recorded around Tower 4212 was one of the largest seen this season and estimated to cover an area of approximately 10,000m², overlapping the RoW and adjacent fields (Photograph 4-5b). Species management should occur in this area. New areas of species establishment included intersecting highway ditches, tower footings, and the equipment path. This species has the ability to spread rapidly in favorable habitats. Corner tower 3290 and the RoW immediately east of the tower was infested with invasive species including alfalfa (*Medicago sativa*), smooth brome (*Bromus inermis*), and white and yellow sweet clovers (*Melilotus* spp.).

Photograph 4-5b. Ox-eye daisy observed along the RoW at Tower 4212.

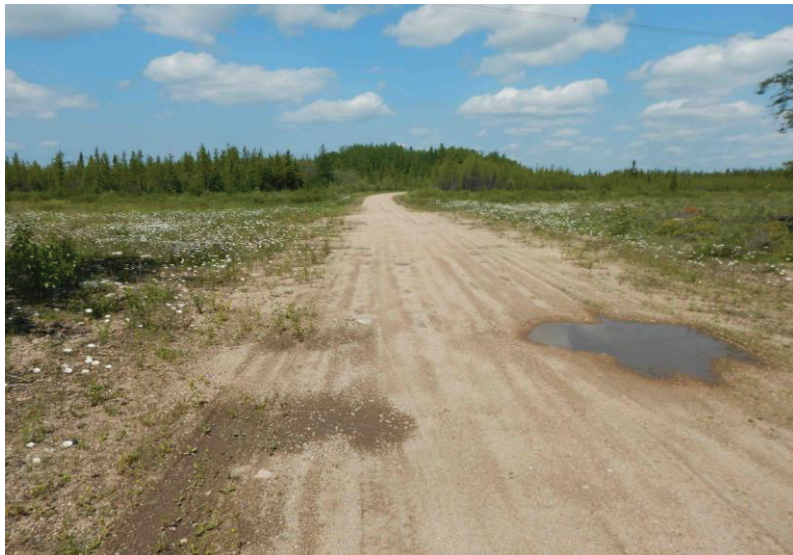
The largest weed infestation observed in 2019 occurred in the area of plot N3-INV-400, with ox-eye daisy. This infestation occurred from Towers 2114 and 2120, and abundance ranged from sporadic to several large patches along this stretch of RoW (Photograph 4-5c). Ox-eye daisy was abundant along the Wekusko gravel road and spreading off-RoW, into adjacent forest cover near the monitoring plot. The previous off-site camp/staging area at this location was also infested with this plant (Photograph 4-5d). Species management should occur in this area. At monitoring site N3-INV-600, successful weed management was observed from the previous season at this site. However, several sporadically occurring individuals and small patches of ox-eye daisy and scentless false mayweed were observed again this season. It is recommended that only spot treatment management occur from Towers 2024 to 2025 for these individuals, to control species spread.

Photograph 4-5c. Ox-eye daisy infestation on RoW, at Wekusko Road (Tower 2118).

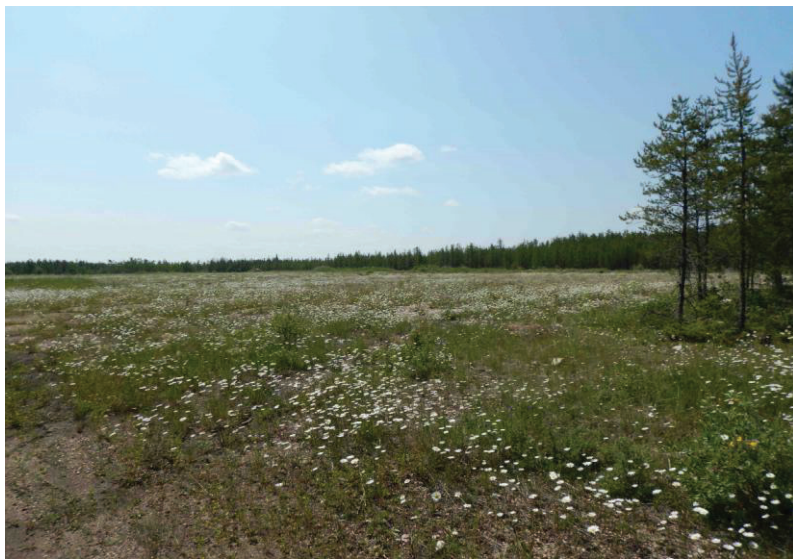
Photograph 4-5d. Ox-eye daisy infestation at previous construction camp and staging area.

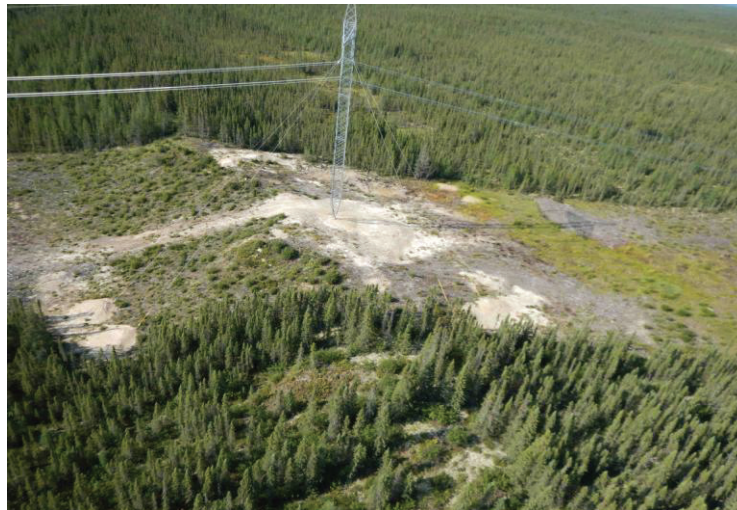
Several sites were re-assessed for slope erosion, at or near foundation sites along the RoW. Tower sites 70 and 81 are located on sloping terrain with exposed sandy soils. Tower 70 was sparsely vegetated around the tower footing. The site has a moderate (10-15%) slope to the east and a strong (20%) slope to the west, with exposed soil on the sloping equipment path (Photograph 4-7a). At Tower site 81, the equipment path was located on a strong (20%) slope to the east, and has resulted in exposed soil (Photograph 4-7b). No infestation of species was observed in these areas at this time.

Photograph 4-7a. Exposed soil on sloping terrain at Tower 70.

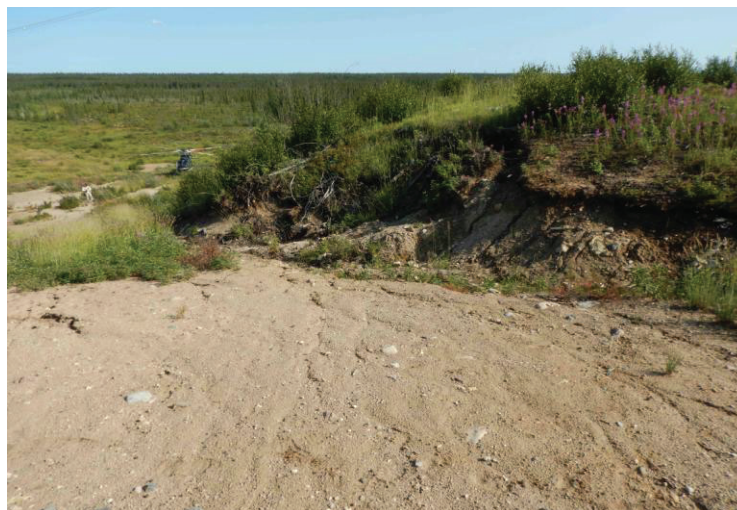
Photograph 4-7b. Soil erosion observed at Tower 81.

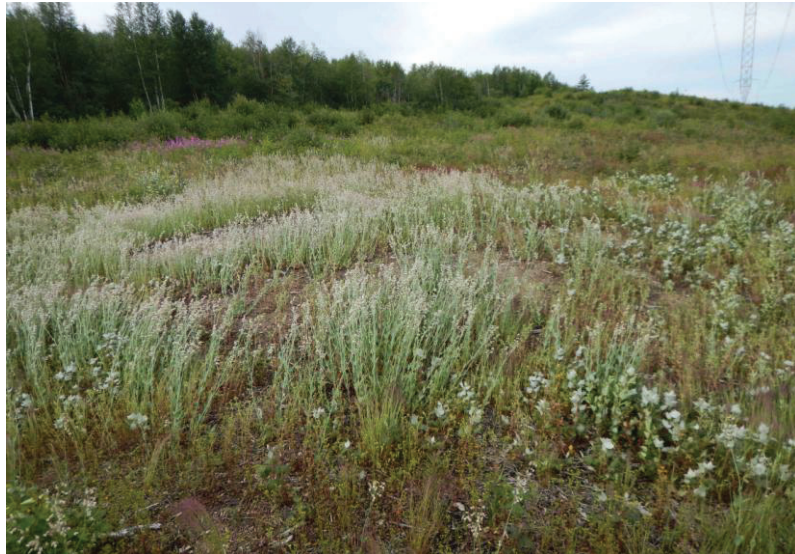
Erosion control blankets were inspected at Towers 466, 516 and 517. Tower 466 is stable with vegetation colonizing the strong slope (16-30%). Species included wild red raspberry (*Rubus idaeus*), green alder (*Alnus viridis*), Bebb's willow (*Salix bebbiana*), pin cherry (*Prunus virginiana*), fireweed (*Chamerion angustifolium*), marsh reed grass (*Calamagrostis canadensis*), and hay sedge (*Carex foenea*). A patch of bladder campion (*Silene vulgaris* - Tier II noxious weed) occurs east of the tower at the base of the slope, and wild barley (*Hordeum jubatum* - Tier III noxious weed) was observed on the equipment path (Photograph 4-7c).

Photograph 4-7c. Bladder campion observed near Tower 466.

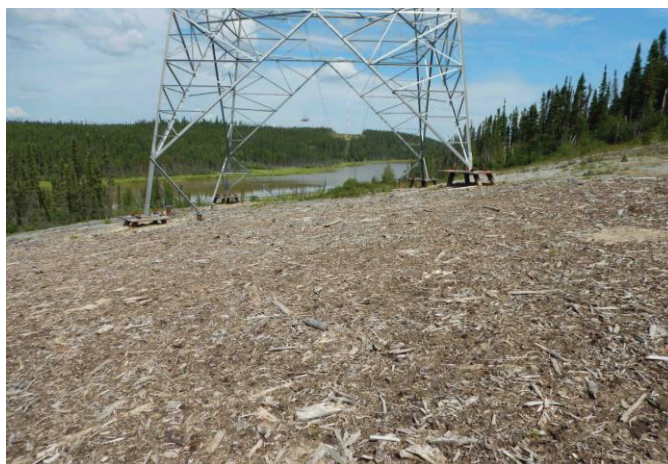
Natural regeneration is occurring slowly at both tower sites 516 and 517. Fibre blankets remain in areas of Tower site 516, but other areas of exposed sandy soil exist on the moderate slope (10-15%) with the potential for erosion. Tower 517 occurs on a strong slope but erosion was not observed at this site. Wood mulch from previous clearing activities has helped to protect the ground surface from erosion (Photograph 4-7d). At Tower site 1249, rill erosion was observed where sediment has been transported down slope in parallel channels.

Photograph 4-7d. Sparse regeneration at Tower 517, near the Odie River.

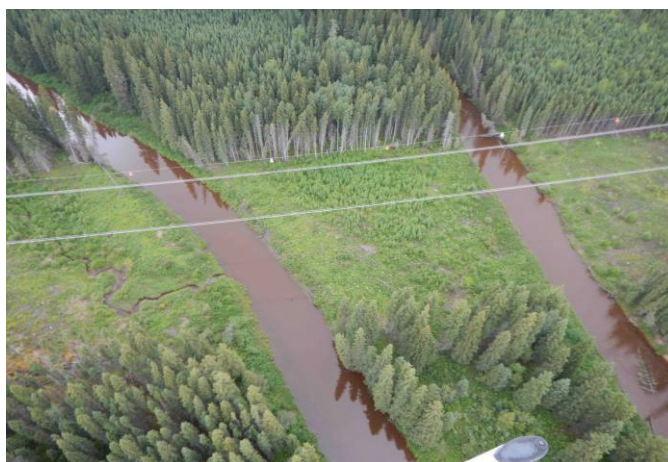
Continued environmental monitoring occurred at two water crossings where erosion control was previously established. At the Hunting River (Section N1), no measureable disturbance or erosion were visible, other than evidence of the equipment path. Banks were vegetated with Bebb's willow (*Salix bebbiana*) as a tall shrub, and various forbs and graminoids occupied the lower stratum. Other species included common horsetail (*Equisetum arvense* – a Pteridophyte), common mint (*Mentha arvensis*), Macoun's buttercup (*Ranunculus macounii*), water-parsnip (*Sium suave*), fowl bluegrass (*Poa palustris*), marsh reed grass (*Calamagrostis canadensis*) and water sedge (*Carex aquatilis*). Species cover was observed to be greater on the west bank compared to the east side. At the Mitishto River (Section N3), only an aerial evaluation could be conducted safely again this season as a result of tall shrubs growing on the RoW and high forest cover adjacent to the RoW, with conductors strung. Banks were vegetated with herbaceous plants and shrub cover and no disturbances were observed at this location (Photograph 4-7e).

Photograph 4-7e. Aerial view of Mitishto River crossing.

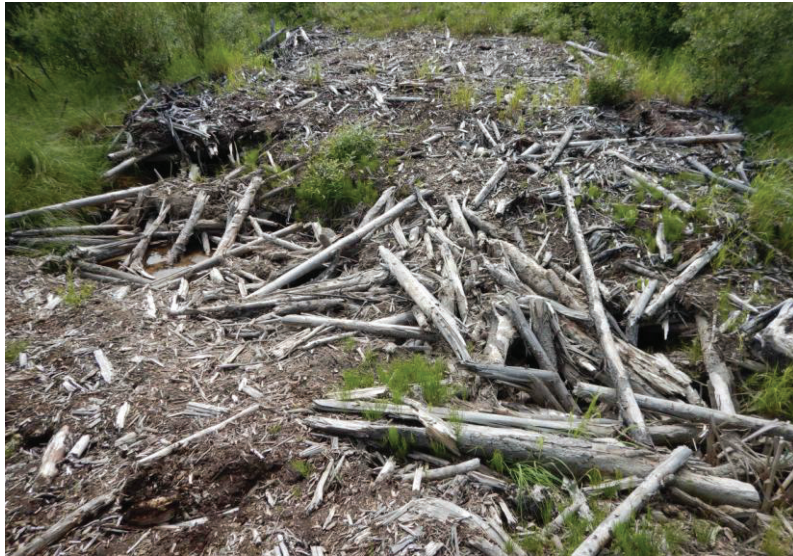
Other crossings assessed for stream bank erosion, near sampling plots, included the Missewaitay (Section N1), Halfway (Section N2) and a small unnamed tributary of Lake Winnipegosis in Section N4; no rehabilitation was required at any of the sites. This season, five additional water crossing sites (AQUA) were visited, identified for follow-up monitoring by Manitoba Hydro. Tree debris at crossings was visible, obscuring the waterways as seen in Photograph 4-7f, showing the crossing at N1-AQUA-169.

Photograph 4-7f. Woody debris remaining at stream crossing N1-AQUA-169.

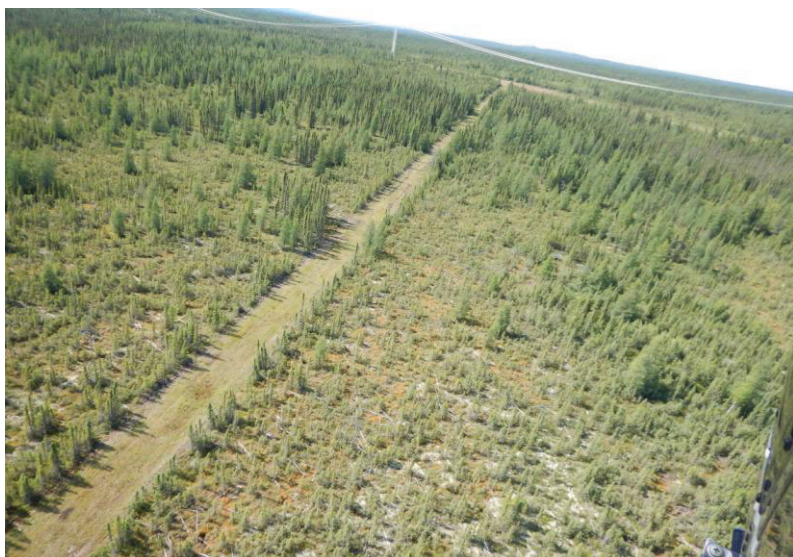
Several access trails in the northern sections were inspected for disturbance, exposed soils and invasive species, from previous construction activities. Only minor rutting was occasionally observed and the amount of exposed soil was low. Trails were vegetated and plant species infestations were not observed. Photograph 4-7g shows an access trail near Tower 214.

Photograph 4-7g. Access trail near Tower 214 with low disturbance.
