**BIPOLE III TERRESTRIAL ECOSYSTEMS AND VEGETATION PRE-
CONSTRUCTION AND ENVIRONMENTAL MONITORING
ANNUAL TECHNICAL REPORT – YEAR III**

Manitoba Hydro

Szwaluk Environmental Consulting Ltd.

October 2016

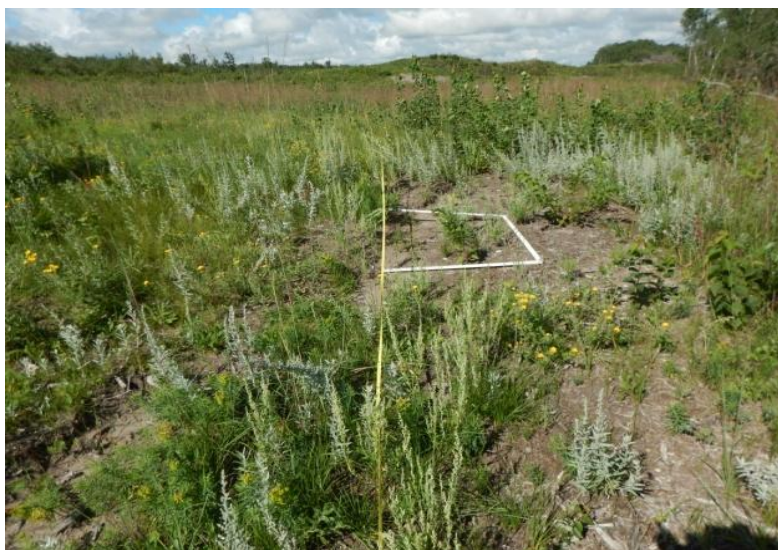
This site is a dry sandy prairie, with trembling aspen (*Populus tremuloides*) and bur oak (*Quercus macrocarpa*) along the RoW, and currently present as a regenerating layer within the RoW (Photograph 4-1a). Four rare and uncommon species were found in or incidental to site plots (Schweinitz's flatsedge - *Cyperus schweinitzii*, S2; silky prairie-clover - *Dalea villosa*, S2?; linear-leaved puccoon - *Lithospermum incisum*, S3; skeletonweed - *Lygodesmia juncea*, S3S4) and will be discussed in Section 4.6. Prairie spike-moss (*Selaginella densa*, S3), was not observed again during field sampling in 2016.

Photograph 4.1a. Mixed-grass prairie post-clearing.

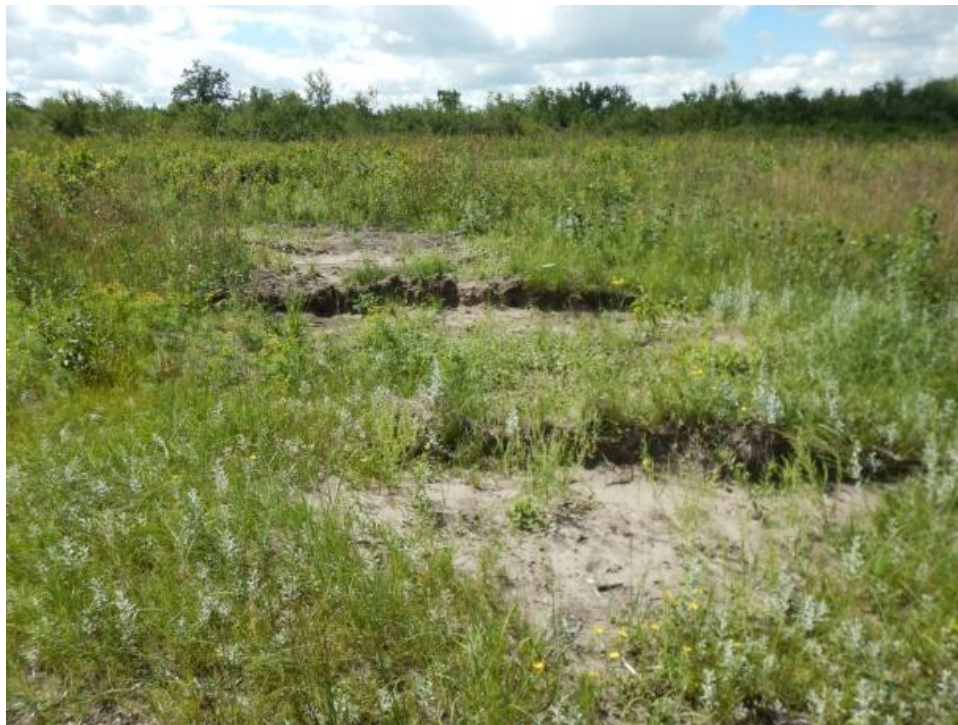
Although mitigation was implemented at the prairie monitoring site (S1-PRA-900), vegetation ground cover showed disturbance from clearing activities. Some rutting and ground disturbance was also observed in the vicinity of the monitoring site (Photograph 4-1b). The site is located along a sand ridge, where vegetation may be very sensitive to ongoing disturbance (Photograph 4-1c). ATV tracks elsewhere on the property (both on RoW and off site) have produced bare ground (i.e., sand) with very little vegetation in vehicle tracks. Clearing equipment has also likely scraped away some vegetation. Six invasive and non-native species were observed in S1-PRA-900 in 2016, and a seventh was observed in the vicinity of the plot, further discussed in Section 4.5.1.

Photograph 4.1b. Rutting and ground disturbance along the RoW.

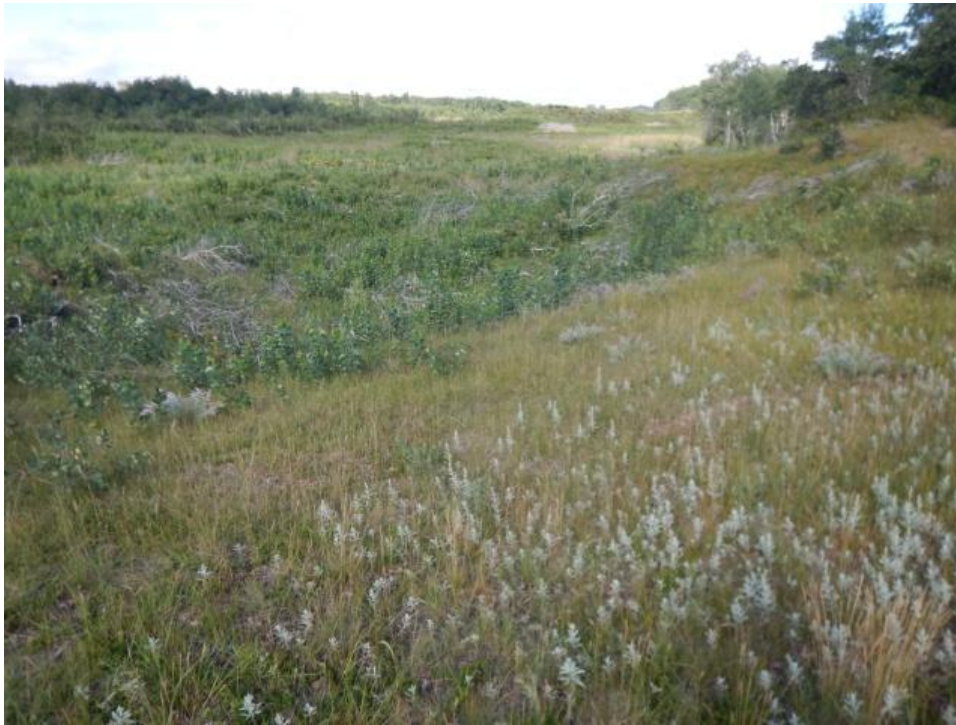
Photograph 4.1c. Mixed-grass prairie along the RoW.

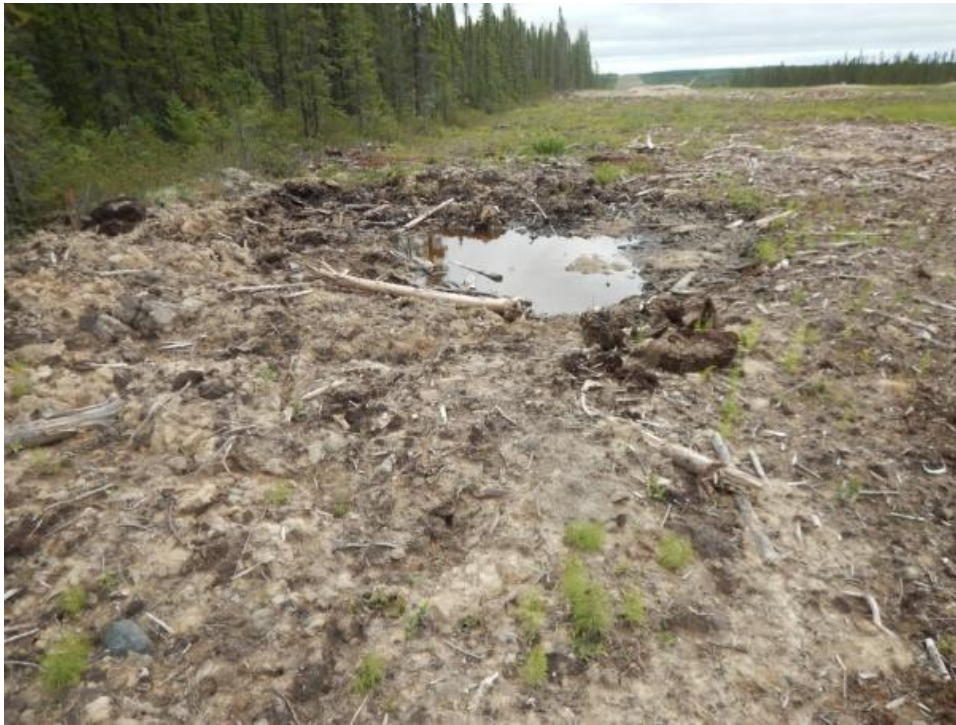
Photograph 4-2a. Dig-out areas observed along the RoW.

The RoW for the collector lines and construction power line (and occasionally along Section N1) contained newly scraped areas, as a result of tower construction and access. These areas were observed at the tower locations and occasionally along the equipment path (Photograph 4-2b). Vegetation regeneration was reduced in these newly scraped areas. Minor rutting was observed occasionally along the RoW for the collector lines and construction power line.

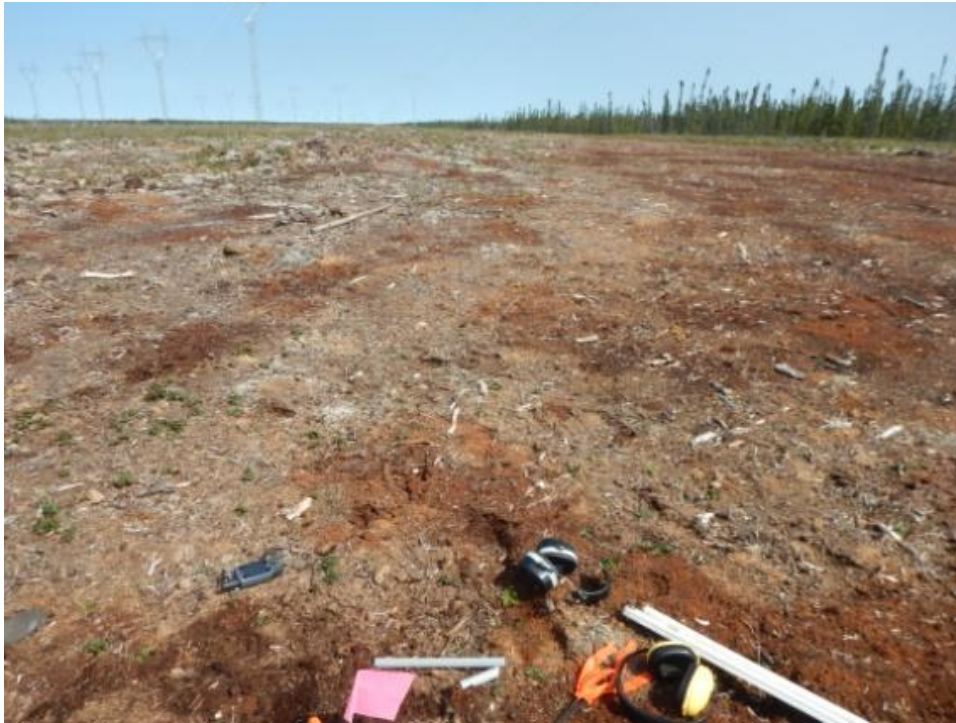
Photograph 4-2b. Scraping of vegetation.

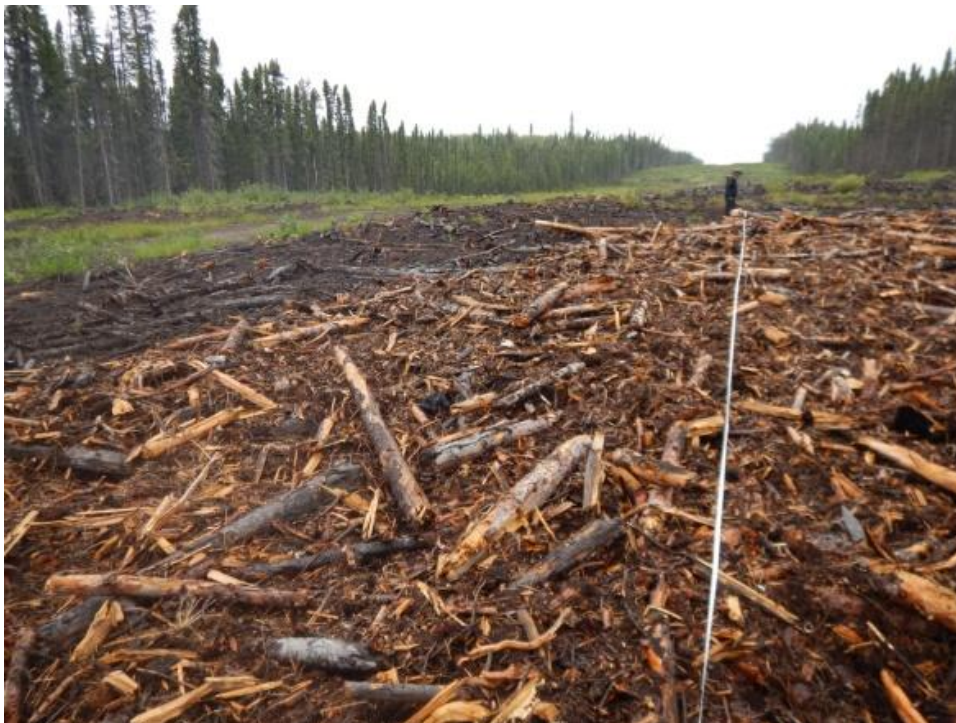
In 2016, some terrestrial plots were disrupted from RoW tower construction activities and forest slash dispersal. As an example, Plot N1-TER-500 had additional clearing for tower construction and slash material was distributed over a portion of the plot. Foundation drilling also deposited surficial materials along the end of the plot transect. Plot N2-TER-500 was disrupted from the spreading of newly mulched woody debris (Photograph 4-2c).

Photograph 4-2c. Spreading of mulched material and debris.

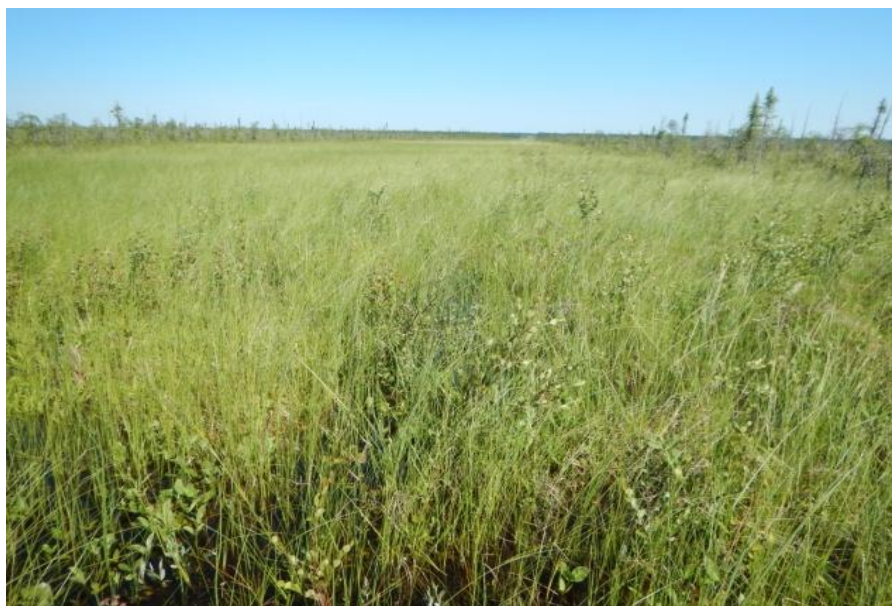
All wetlands sampled showed low disturbance (physical appearance) from construction activities, in 2016. Vehicle traffic appeared to utilize existing trails under frozen ground conditions; in several locations, the equipment path could not be identified as a result of abundant vegetation cover on the RoW (Photograph 4-3a). Natural re-vegetation is occurring in previously disturbed wetland sites.

Photograph 4-3a. Patterned fen wetland with low disturbance.

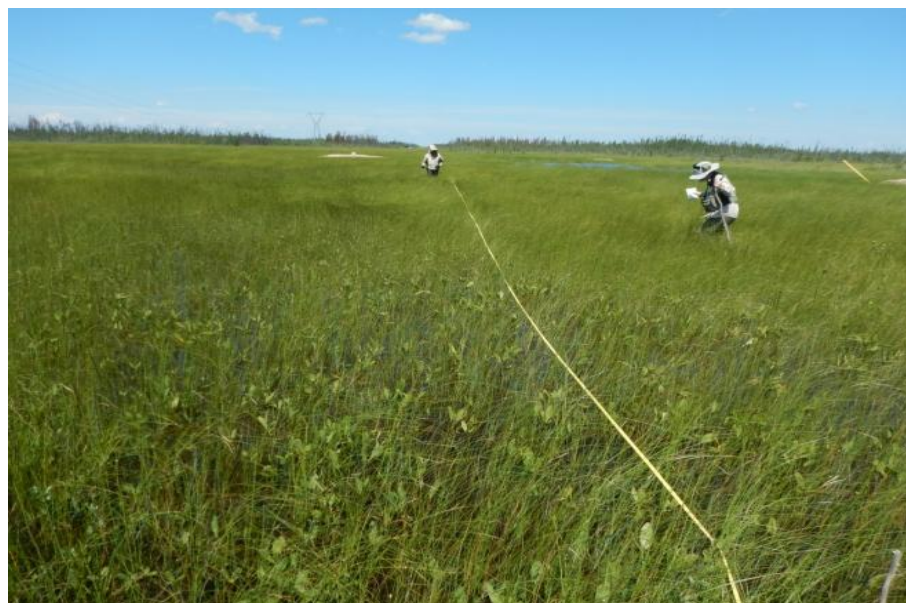
In patterned fen N4-WET-300, it was observed that the water level was higher this year, with much vegetation submerged as compared to last years growing season (Photograph 4-3b). Average cover of surface water increased from 0.6% in 2015 to 97% in 2016. This could be a natural fluctuation in water level or, possibly a result of nearby tower construction (footings) and a change in water movement, either from compaction by equipment or flow impediment caused from project drilling and exposed parent materials. Future monitoring will re-assess vegetation and ground cover conditions in this wetland site.

Photograph 4-3b. Patterned fen wetland with increased water level.

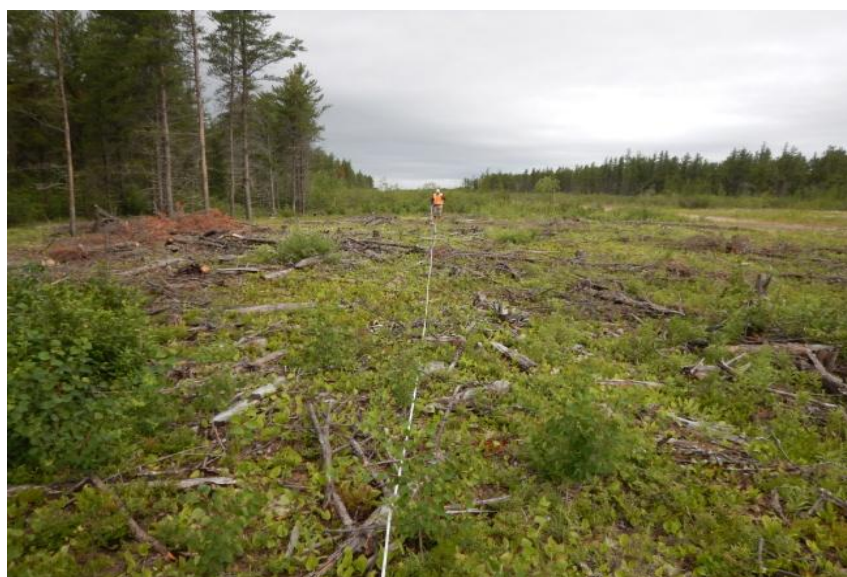
Photograph 4-4a. Blueberry sample plot in the Cowan Resource Area.

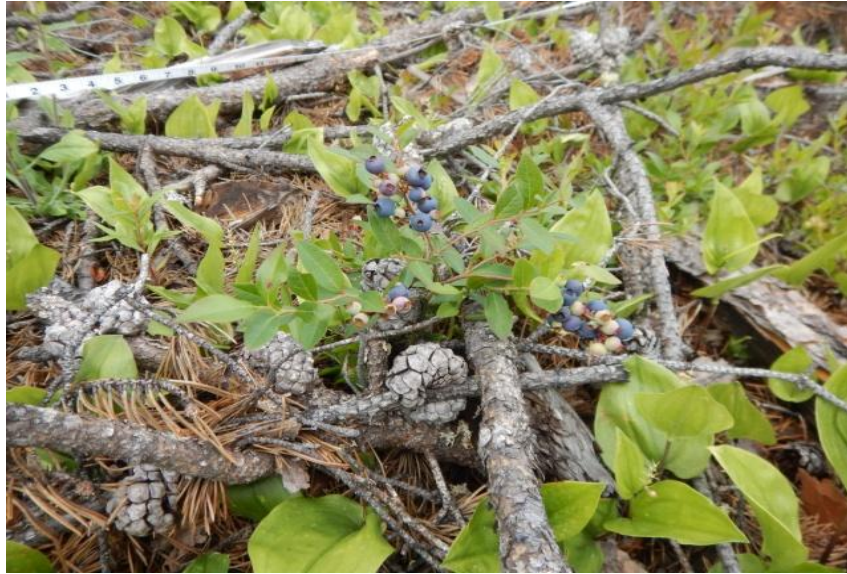
Photograph 4-4b. Blueberry plants observed during sampling.

This season, blueberry plants were observed at five sites on the RoW (C1-ATK-300, 400, 500, 600 and 950), compared to two sites in 2015. Total blueberry cover for these five sites (2016) averaged 12.7%. In 2014, six sites (twelve surveys, on and off RoW) supported blueberry plants (Table 4-4a).

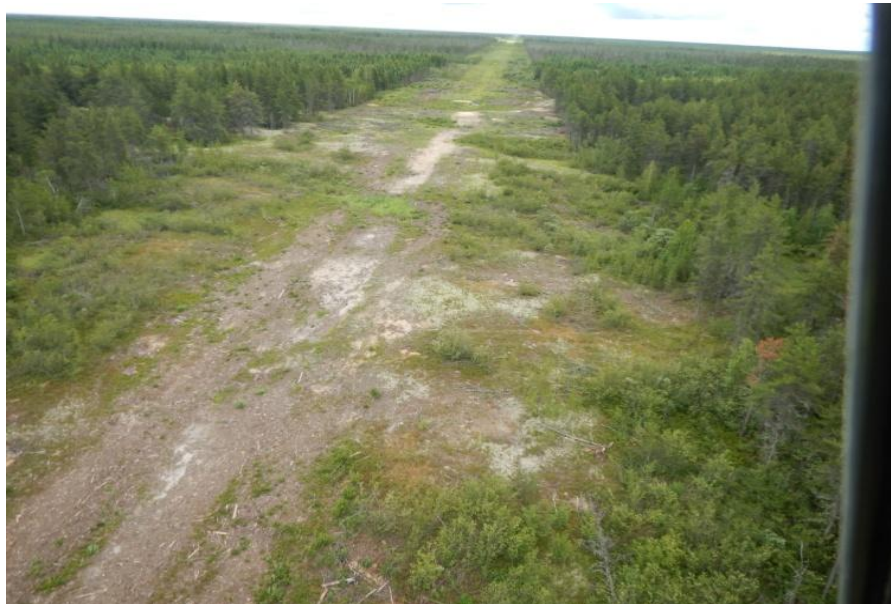
Species cover of velvetleaf blueberry increased in plots C1-ATK-300 and C1-ATK-600, and have newly established in C1-ATK-500 and C1-ATK-950. In plot C1-ATK-300, cover increased from 0.6% in 2015 to 2.0% this season, while cover consecutively increased in plot C1-ATK-600 from 0.4% in 2014 to 2.0% in 2015 and 8.6% in 2016. A reduction in cover was observed in C1-ATK-400. In 2016, cover of velvetleaf blueberry ranged from 0.2 to 8.6%, in sites surveyed. Photograph 4-4c shows an aerial view of blueberry sites in the Resource Area.

Photograph 4-4c. Aerial view of blueberry sites in the Resource Area.

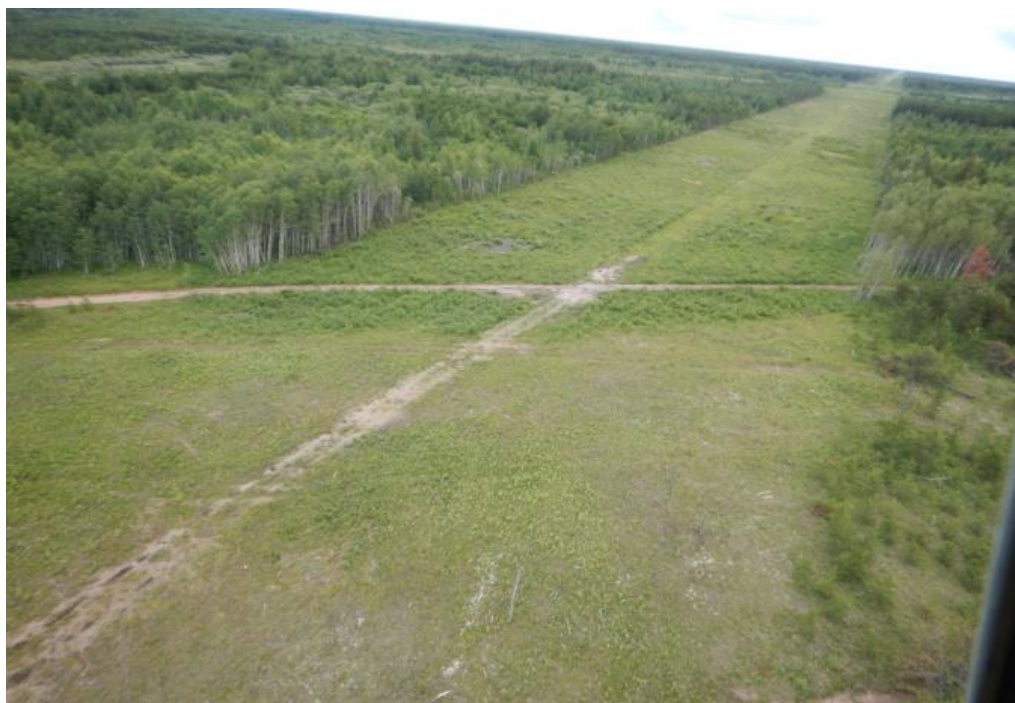
An aerial investigation of the Resource Area identified that regeneration is occurring throughout the RoW, and in some locations, shrub cover (e.g., *Populus* spp.) is approaching 1m height. Photograph 4-4d is an aerial view of the RoW showing regeneration, the equipment path and an ATV access trail.

Photograph 4-4d. Aerial view of the Cowan Resource Area.

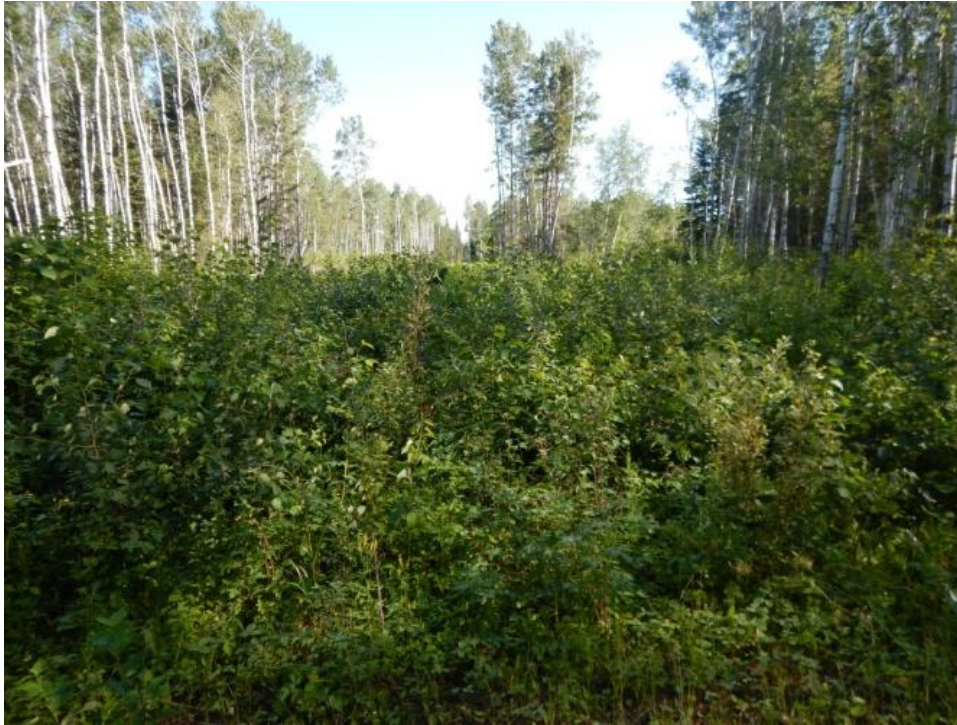
Non-native and invasive species were observed during several ground surveys in Sections C1 and C2. White sweet clover (*Melilotus albus*) was observed in high abundance throughout the RoW at plots C1-INV-200 and C1-INV-400 (Photograph 4-5b). White sweet clover was also abundant at sites C1-INV-100, C1-INV-300 and C1-INV-500, but mainly occurred in ditches and along the equipment path. Sweet clover species (*Melilotus* spp.) were observed in the RoW of Section C2, at sampling plots C2-INV-100, C2-INV-300 and C2-INV-500.

Photograph 4-5a. Incomplete clearing along the RoW.

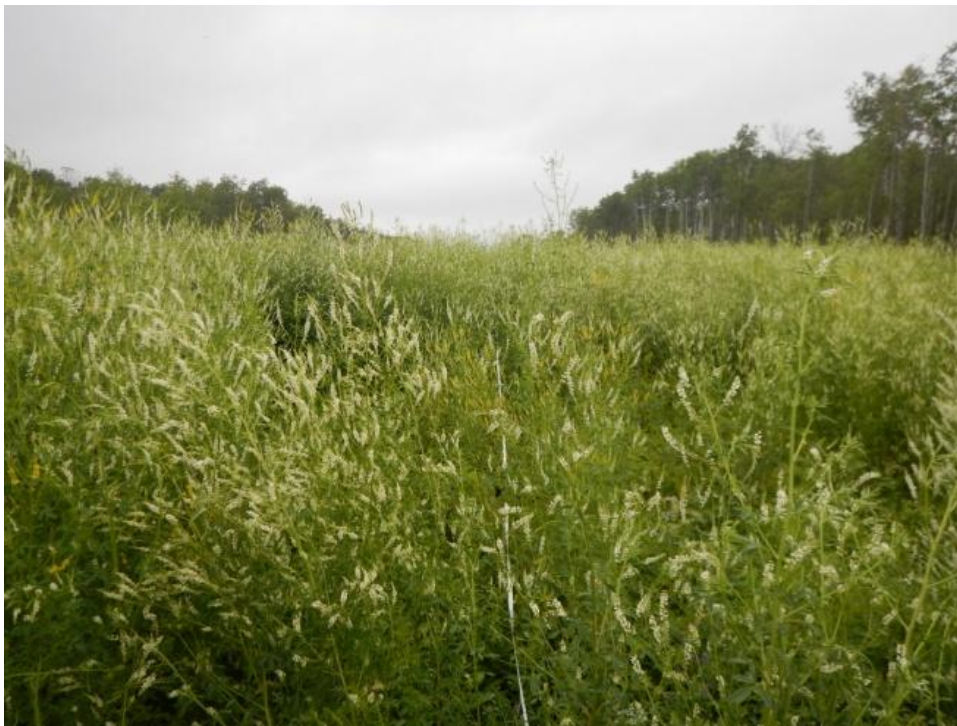
Photograph 4-5b. White sweet clover observed along the RoW in Section C1.

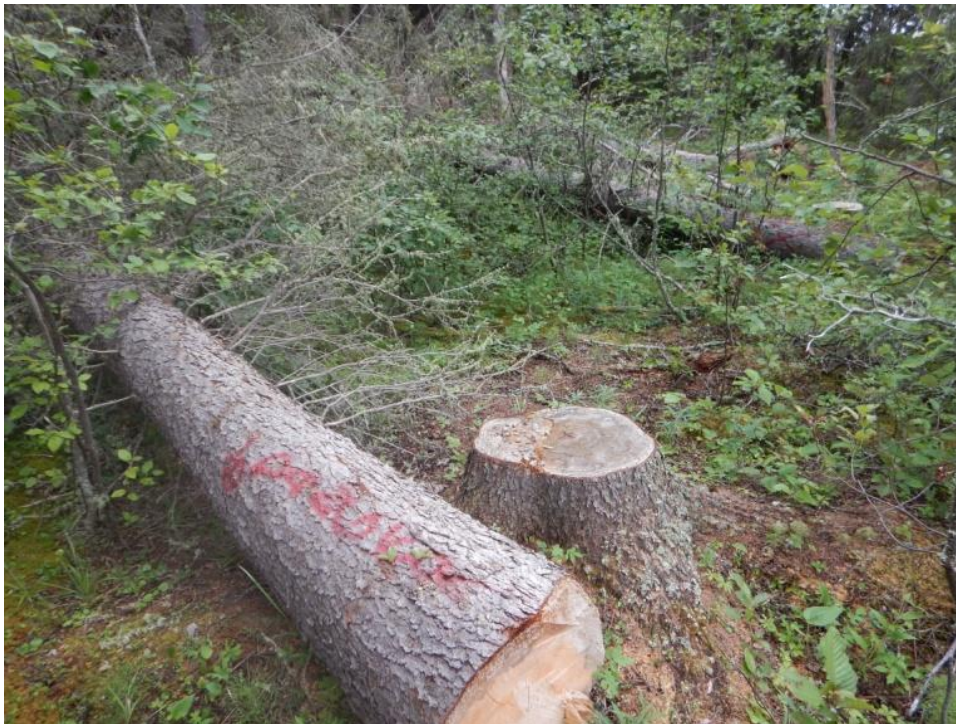
At Halfway River two very large spruce trees were recently felled into the forest (winter 2015/2016), across plot N2-INV-701. One tree felled was aged at 108 years based on growth ring counts from the stump (Photograph 4-5d). Dwarf bilberry (*Vaccinium caespitosum*), a species of conservation concern was previously located at this site. For additional clearing, the trees should have been felled into the RoW, as per mitigation recommended. The removal of forest slash, previously existing on the RoW, disrupted vegetation cover at Plot N2-INV-400.

Photograph 4-5d. Trees felled into the forest at Halfway River.

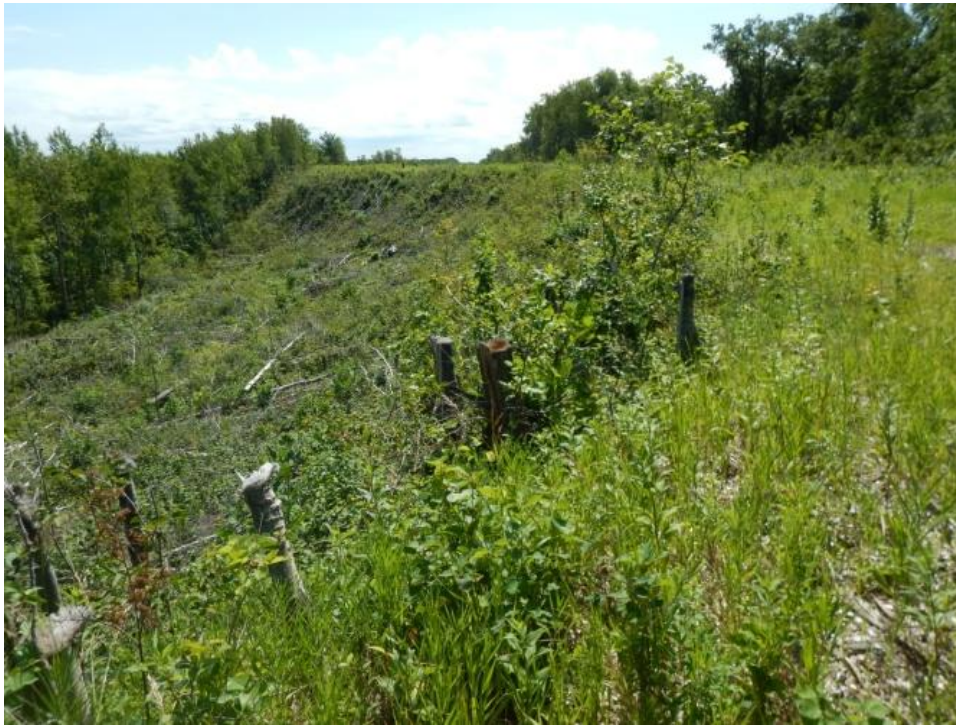
Photograph 4-6a. Relief encountered along the RoW in Section S1.

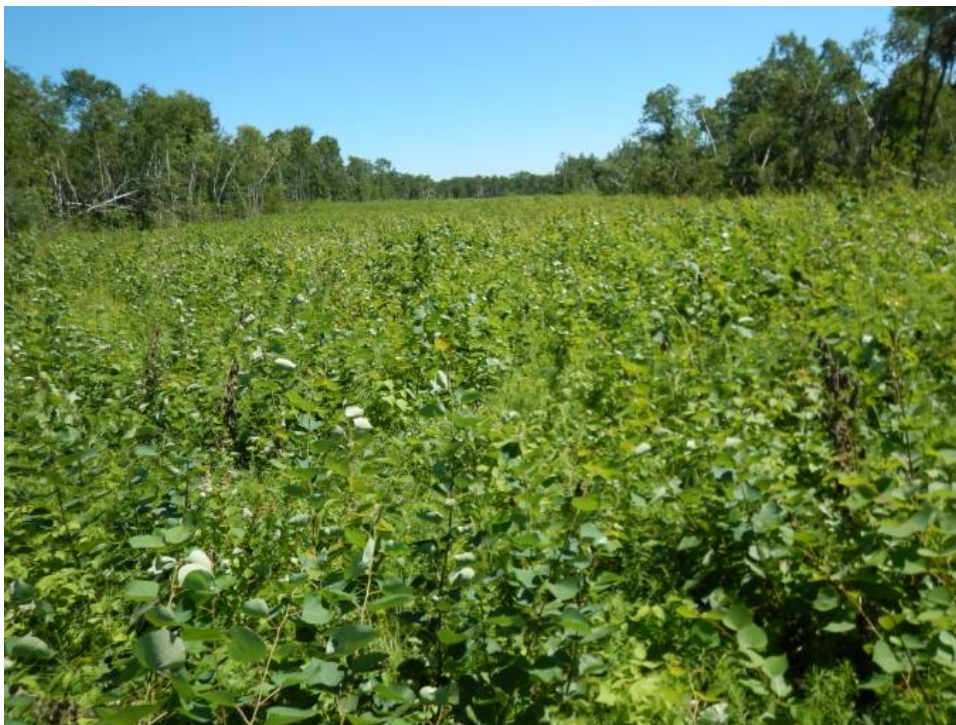
Photograph 4-6b. Trembling aspen regeneration along the RoW in Section S1.

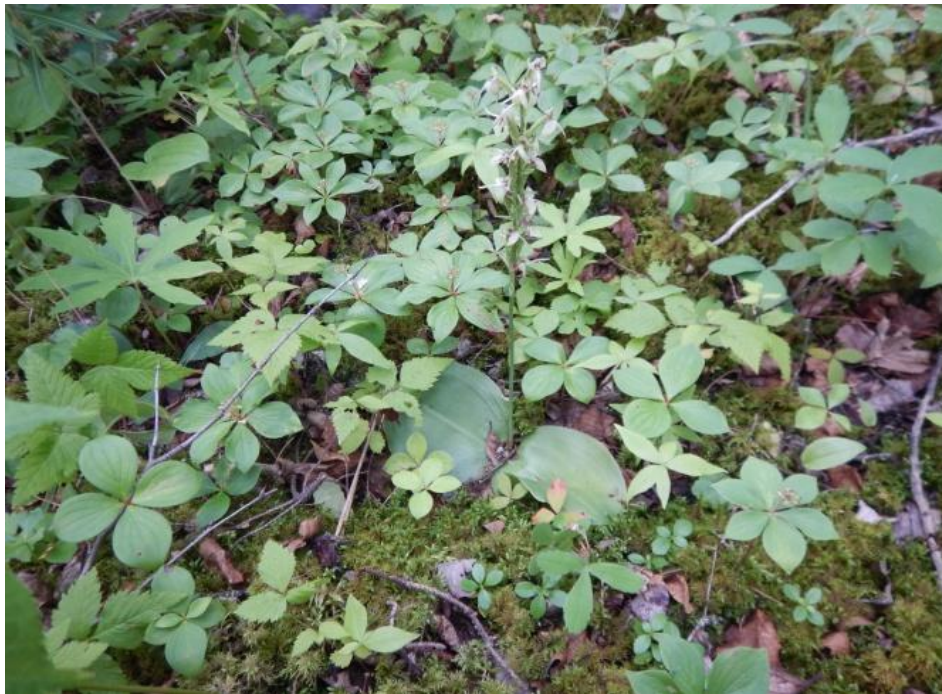
New observations for species of concern in 2016 include round-leaved bog orchid - a new occurrence near N3-INV-301, floating marsh-marigold (*Caltha natans*, S2S4) at N4-WET-300, oblong-leaved sundew and white beakrush at plot N4-WET-400, and little-tree willow (*Salix arbusculoides*, S2S3) at plots N1-INV-200 and N2-TER-200. Photograph 4-6c shows round-leaved bog orchid observed in Section N3, immediately adjacent to the RoW.

Photograph 4-6c. Round-leaved bog orchid observed in Section N3.

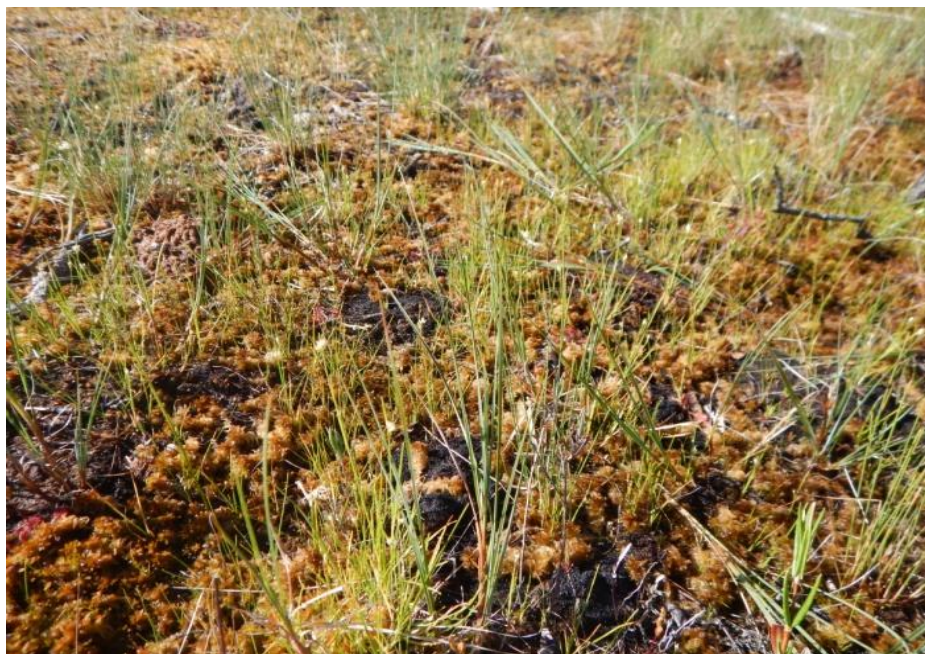
At two locations along the northern AC collector lines labeled CL-SCC-100 and CL-SCC-200, white beakrush previously was abundant in this area of the RoW (five known populations). Surveys in 2016 have identified a reduced presence of this species (Photograph 4-6d). Many plants appeared shorter in height compared to previous years' observations. Although white beakrush does appear in other patches occasionally in this area of the RoW, it's numbers have declined overall from previous growing seasons. Recent RoW activities in this area include vegetation clearing and construction activities for tower placement which could cause surface compaction and alter drainage. The surface moisture in this area now appears to range from increasingly dry conditions to areas of standing water. While this species occurs in wet habitats, a change in moisture regime may potentially affect species numbers. Future monitoring of this area will determine the success of this species due to changes in site conditions.

Photograph 4-6d. White beakrush observed along the AC collector lines.

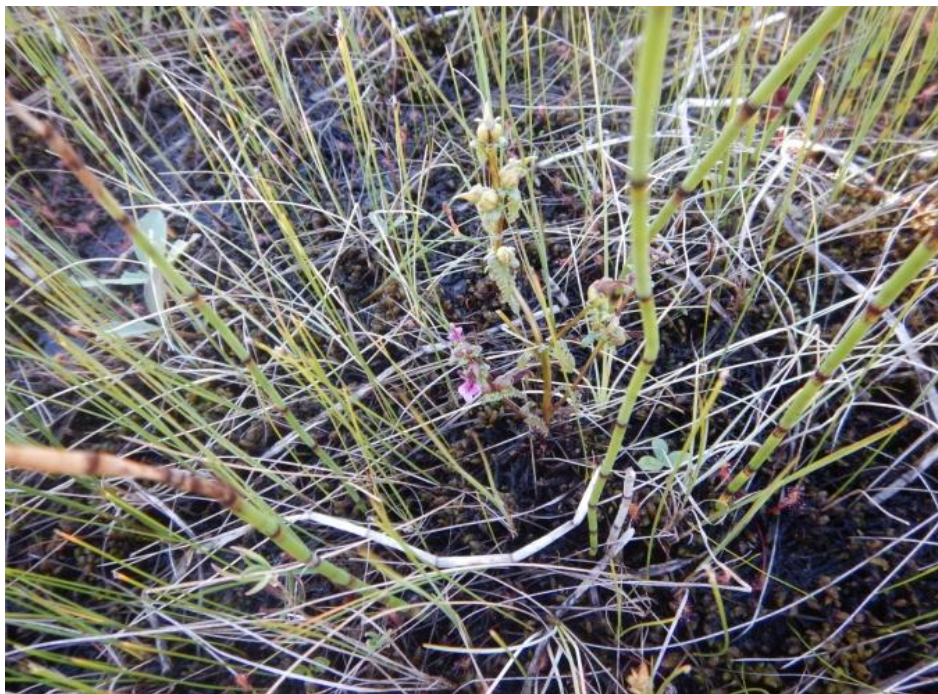
Sites monitored along the ground electrode line (GEL-SCC-100 and GEL-SCC-200) again supported four species of conservation concern including muskeg lousewort, oblong-leaved sundew, little-tree willow and rock willow. American milkvetch was observed in a clearing adjacent to the ground electrode line. Photographs 4-6e shows muskeg lousewort observed along the ground electrode line, in a wet area.

Photographs 4-6e. Muskeg lousewort observed along the ground electrode line.

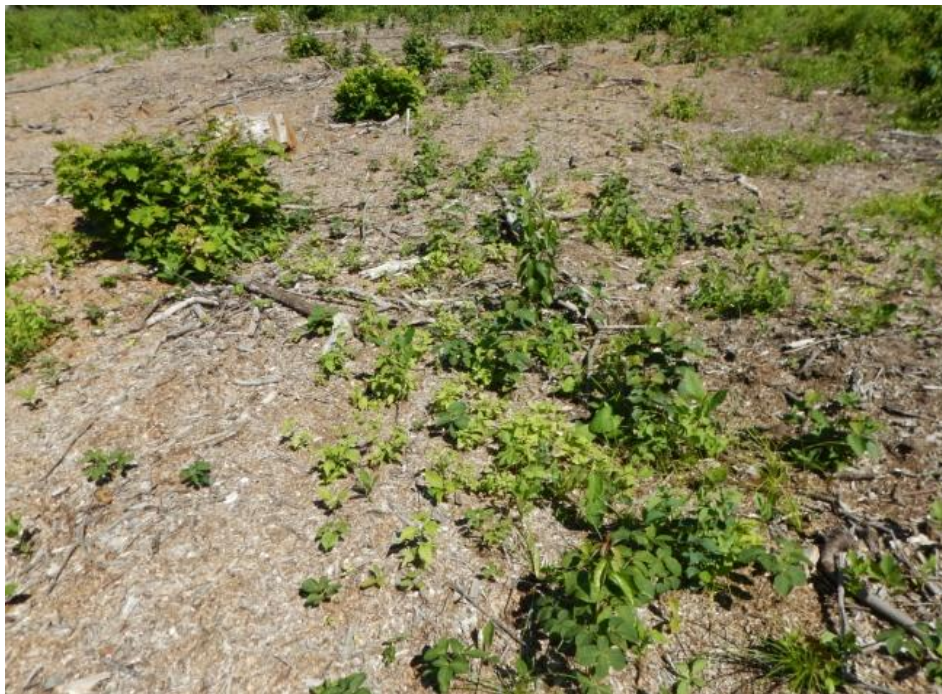
Clearing of the RoW in the Assiniboine crossing vicinity has created new conditions that may not be able to support the perserverance of shade requiring species. For example, most blood-root plants located on the RoW occurred close to the remaining forested edge, or under thick cover of shade providing herbs. However, all plants observed in the open (direct sun) were yellowed and had begun to die back. While leaves of blood-root do begin to senesce roughly around the time fieldwork was undertaken, other plants observed off site (i.e., under forest canopy) were still primarily green. Furthermore, the leaf colouration of lopseed and large enchanter's nightshade was also noted as more pale than commonly observed, possibly due to increased light from canopy clearing. Photograph 4-6f shows rare plant large enchanter's-nightshade, observed near the Assiniboine River crossing.

Photograph 4-6f. Large enchanter's-nightshade (pale green plants at center).

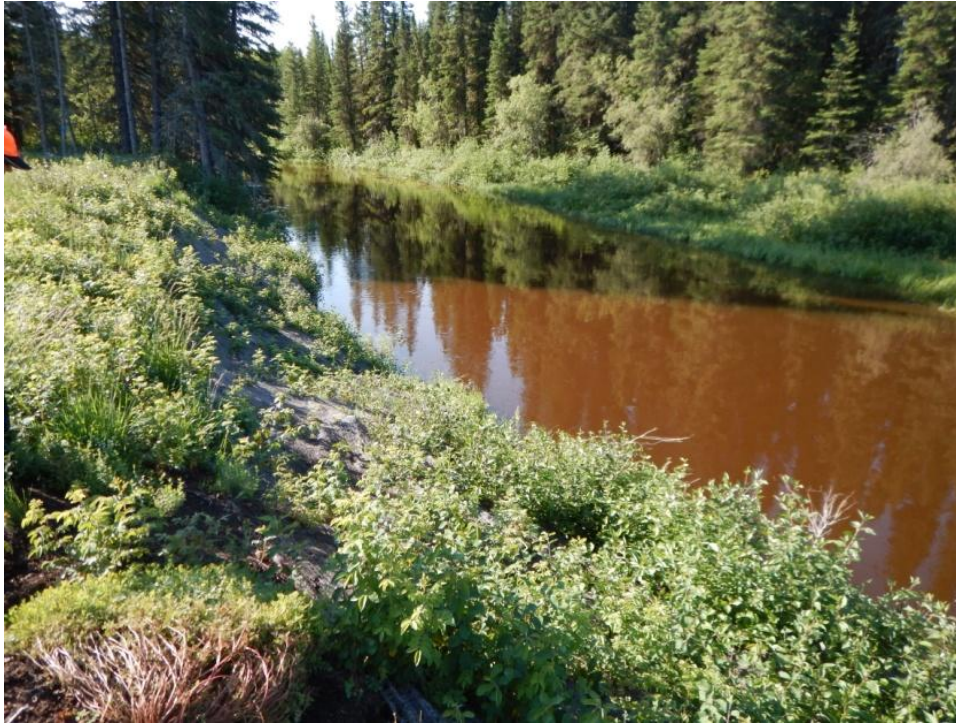
At the Mitishto River (479170 E and 6050339 N) in 2016, rehabilitation and erosion control appeared to be successful. No evidence of ongoing erosion was visible at the time of the survey in July. The erosion control blanket was observed to be intact, but not visible throughout the entire banks of river as a result of vegetation re-establishing (Photograph 4-7a). At some locations, the shrubs were pushing up the blanket while in other areas the vegetation was growing through the blanket. The re-establishment of natural vegetation was mostly continuous in distribution with abundant cover (>50%); few areas with sparse (<10%) vegetation were observed. Vegetation colonizing the banks was mostly shrub cover of red-osier dogwood (*Cornus sericea*), prickly rose (*Rosa acicularis*), Saskatoon (*Amelanchier alnifolia*), balsam poplar (*Populus balsamifera*), and willow species (*Salix* spp.). Grasses such as hairy wild rye (*Leymus innovatus*) and Canada reed grass (*Calamagrostis canadensis*) were also observed. At this time, no additional rehabilitation is being recommended for the Mitishto River crossing.

Photograph 4-7a. Erosion control at Mitishto River.

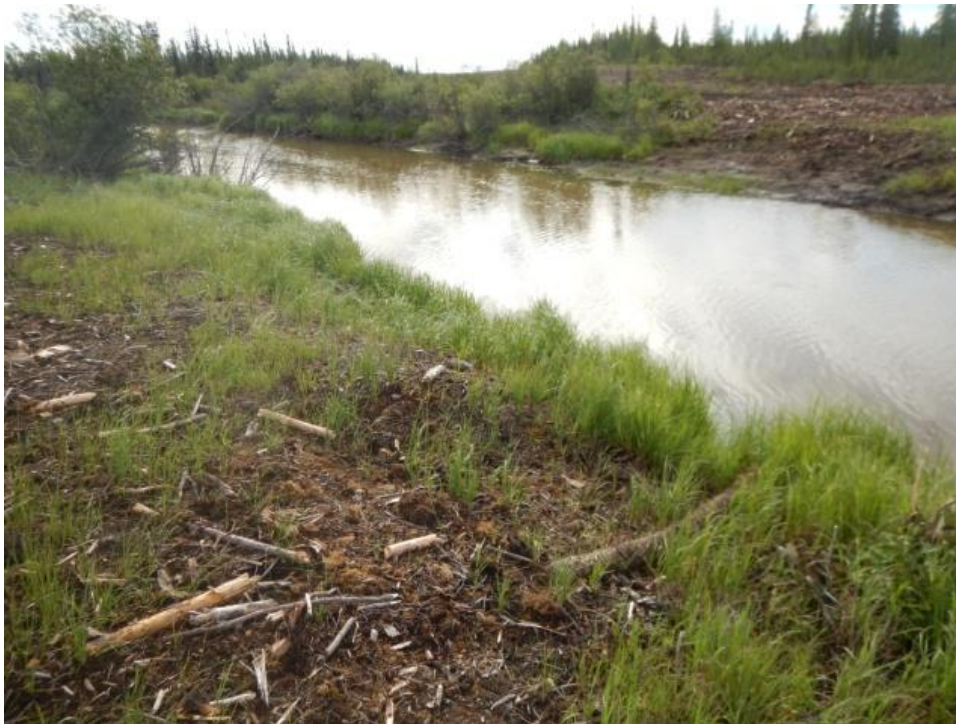
At the Hunting River (670030 E, 6248581 N) in 2016, no visible signs of ongoing erosion were observed at the time of the survey (July). The previously installed fibre blanket was not visible for most of the river bank, only remnants of the blank were observed. The fibre blanket has either begun to disintegrate or was removed by vehicles and heavy equipment during construction activity. Along the east side of the river at the centerline access trail crossing, the mineral soil material was exposed with sparse (<10%) graminoid cover (Photograph 4-7b). In comparison, the west bank had greater cover of vegetation (10-50%) and was more continuous in distribution. Species included water sedge (*Carex aquatilis*), Canada reed grass (*Calamagrostis canadensis*), water-hemlock (*Cicuta maculata*), and mare's-tail (*Hippuris vulgaris*). Here, the remaining fibre blanket supported emerging vegetation but also retained the litter layer for additional ground cover and support.

Photograph 4-7b. Erosion control at Hunting River.

Although there was no evidence of erosion or rutting of soil material, a fibre blanket could be re-installed (or other measure) along the east side of the river to help promote surface stability for re-establishing natural vegetation. Rigmats could also be used at this location, when crossing. The river bank slope was 15 to 20% and the width of the crossing was approximately 10 m.
