**BIPOLE III TERRESTRIAL ECOSYSTEMS AND VEGETATION
ENVIRONMENTAL MONITORING
ANNUAL TECHNICAL REPORT – YEAR IV**

Manitoba Hydro

Szwaluk Environmental Consulting Ltd.

November 2017

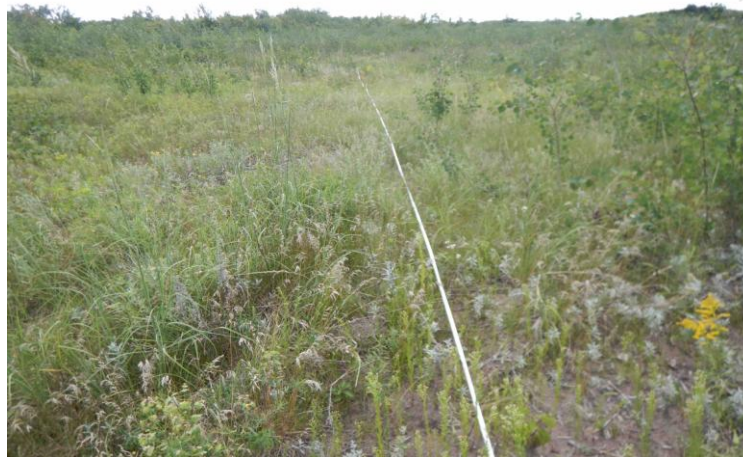
Photograph 4-1a. Regenerating aspen along the RoW.

This site is a dry sandy prairie, with trembling aspen (*Populus tremuloides*) and bur oak (*Quercus macrocarpa*) adjacent to the RoW, and currently present as a regenerating layer within the RoW (Photograph 4-1a).

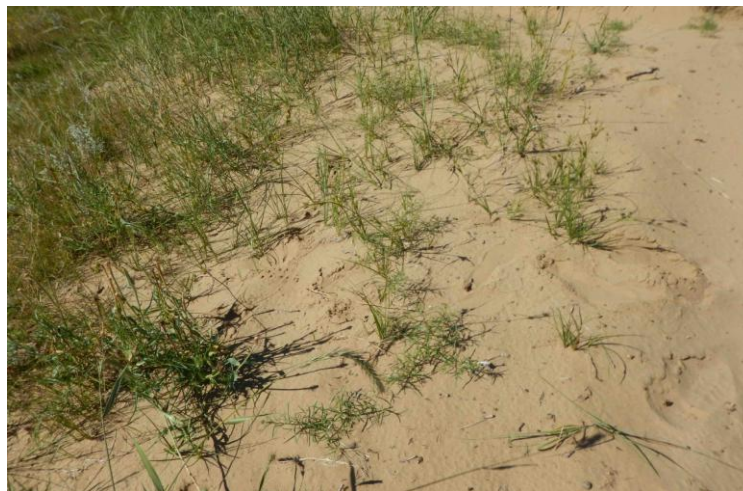
Photograph 4-1b. Exposed soils along the RoW.

Although mitigation was implemented at the prairie monitoring site (S1-PRA-900), vegetation ground cover showed disturbance from construction activities. Tower placement is located close to site S1-PRA-900. Machinery used here to establish anchor points has resulted in loss of vegetation cover around and on the tower footprint. The area is extremely sandy, and the ground vegetation is easily disturbed. Clearing equipment has also likely scraped away some vegetation. Elsewhere on this property (both on RoW and off site), ATV tracks have produced bare ground (i.e., sand) with very little vegetation in vehicle tracks. Photograph 4-1b shows exposed soils along the RoW.

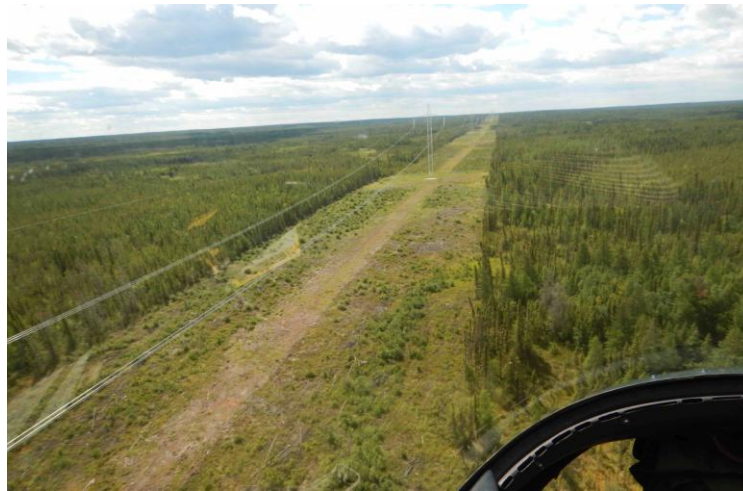
Photograph 4-2a. Regeneration of vegetation along the RoW.

During the aerial inspections and ground surveys of other Sections (N1, N2, N3, and N4 north of the Red Deer River), regeneration of vegetation was observed to be occurring largely throughout the RoW (Photograph 4-2a). Generally, low disturbance to the soils was observed off the equipment path, except for a few detected areas where construction equipment and materials were likely stored, as a staging area. The equipment path showed areas of obvious travel but rutting observed was minor and infrequent. Vegetation cover was generally less abundant at these locations. From the

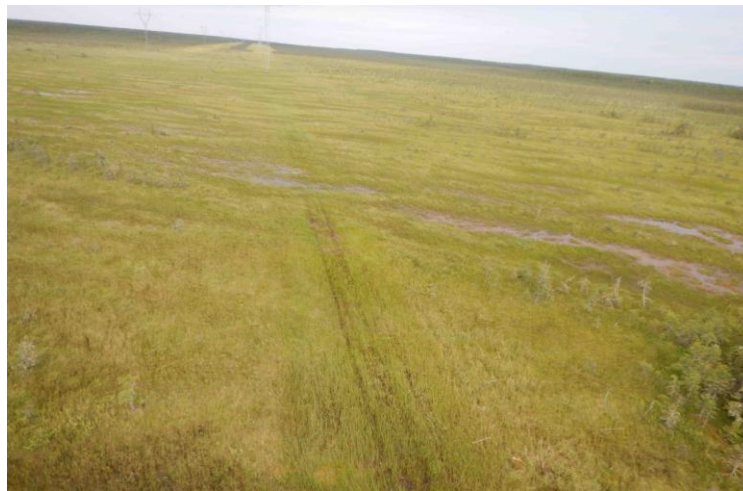
Photograph 4-3a. Patterned fen wetland with low disturbance.

From fieldwork conducted, it was determined that wetlands sampled showed low disturbance (physical appearance) from construction activities, in 2017. Vehicle traffic appeared to utilize existing trails mostly under frozen ground conditions. In several wetland locations, the RoW showed little evidence of construction activities (Photograph 4-3a). In other areas, the equipment path displayed light travel or minor rutting, on the RoW (e.g., N4-WET-200; N3-WET-200). Natural re-vegetation is occurring throughout previously disturbed wetland sites.

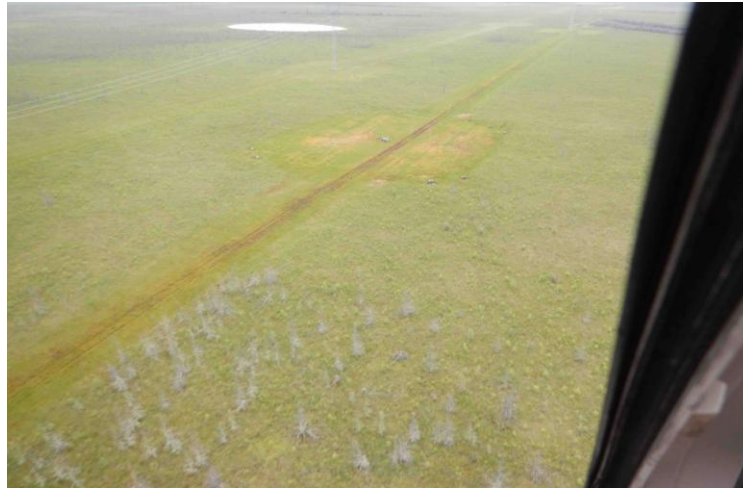
Photograph 4-3b. Rutting in wetlands from construction activities.

In Sections N2 and N3, an aerial assessment was conducted to document wetland disturbance, along the RoW. Except for initial clearing in 2014 where wetland disturbance was reported (e.g., tamarack and black spruce tree removal), overall wetland disturbance in 2017 was low. Other than wetland area displacement as a result of tower foundations, the only evidence of wetland disturbance was occasional rutting from use of the equipment path (Photograph 4-3b). Noticable rutting was observed in three wetland areas along the RoW, in Section N3:

- 1) From approximately UTM 14U 363431 E, 5962393 N to 363536 E, 5966665 N. This is a stretch of approximately 4.0 km, with the rutting disturbance contained to the centre of the RoW.
- 2) From approximately UTM 14U 389671 E, 5998468 N to 391500 E, 5999369 N. This is a stretch of approximately 2.0 km, with rutting primarily restricted to the centre of the RoW.
- 3) At approximately 14U 445063 E, 6036953 N. There is a stretch of approximately 200m of rutting leading up to a water crossing along the west side of a creek. This rutting started at the centre line and veered to the northern edge of the RoW.

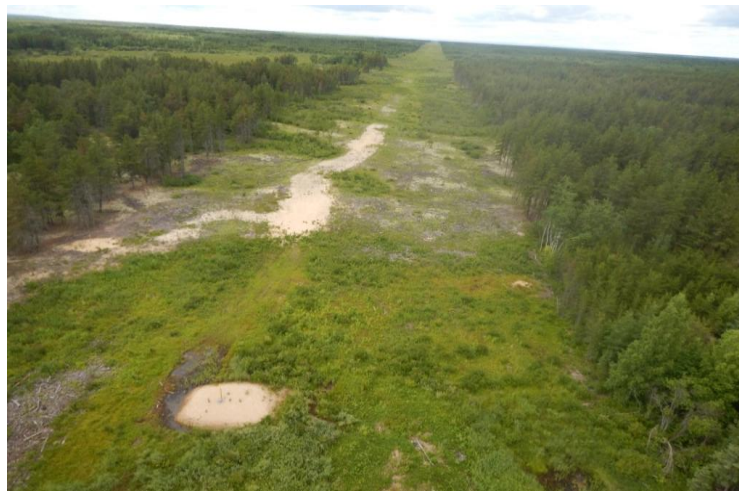
Photograph 4-4b. Aerial view of the Cowan Resource Area.

An aerial investigation of the resource area identified that regeneration is occurring throughout the RoW, and in some locations, shrub cover (e.g., green alder - *Alnus viridis* balsam poplar - *Populus balsamifera*; trembling aspen - *Populus tremuloides*; Bebb's willow - *Salix bebbiana*) is exceeding 1 m height. Photograph 4-4b is an aerial view of the RoW showing regeneration of vegetation.

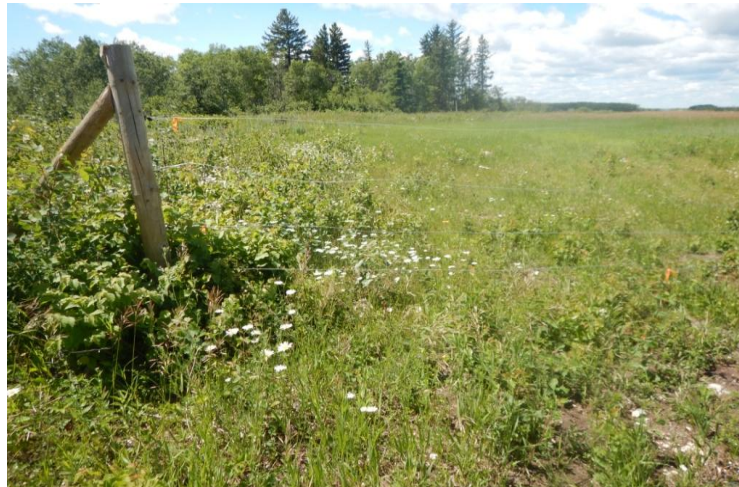
Photograph 4-5a. Ox-eye daisy observed along the RoW.

observations. Most sites this year had low distribution of sweet clovers (*Melilotus* spp.), as compared to the previous season. No large outbreaks of invasive and non-native species were observed during aerial inspections of these Sections. At one site, near sampling plot C1-INV-300 (other side of road), ox-eye daisy (*Leucanthemum vulgare*) was observed to be spreading into the RoW (Photograph 4-5a). Ox-eye daisy is designated as a Tier 2 noxious weed.

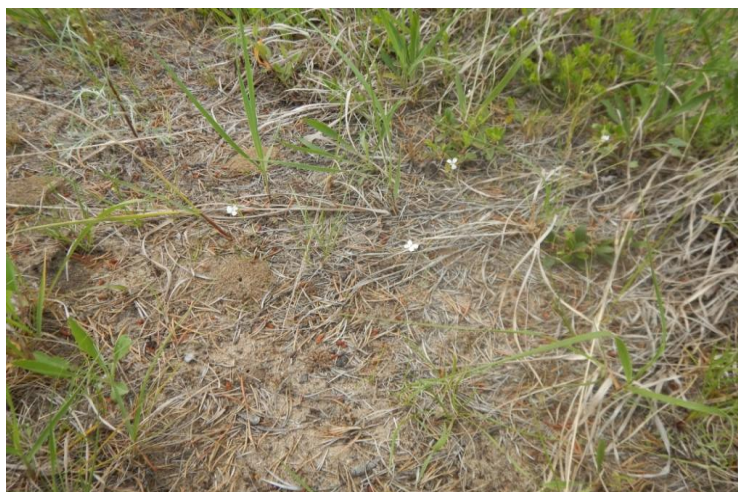
Photograph 4-6a. Lyre-leaved rock cress observed along the RoW.

Recent changes to subnational ranks have increased the number of species tracked (S3 – S3S5) as species of conservation concern (e.g., long-leaved bluets, black twinberry, little bluestem). Velvety goldenrod (*Solidago mollis*, S3), last seen in 2015, was not observed on the RoW in 2017. Off-site, and immediately adjacent to the RoW, lyre-leaved rock cress (*Arabidopsis lyrata*, S1S2) and false heather (*Hudsonia tomentosa*, S3) were relocated again in 2017, at two locations each, at four sites. Photograph 4-6a shows lyre-leaved rock cress along the RoW.

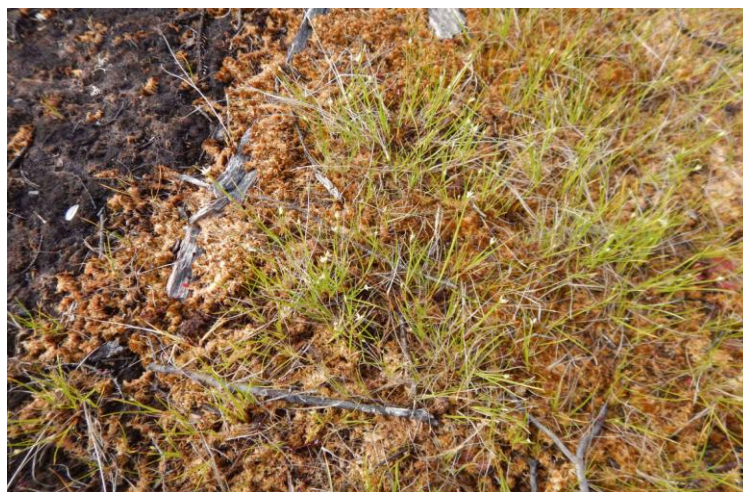
Photograph 4-6b. White beakrush observed along the RoW.

At locations along the northern AC collector lines labeled CL-SCC-100 and CL-SCC-200, white beakrush was previously abundant in this area of the RoW. In 2016, surveys identified a reduced presence of this species during construction activities, with site conditions observed as drier. Surveys in 2017 noted that white beakrush increased in abundance at CL-SCC-200, but plant numbers were again sparse in the CL-SCC-100 patches previously known supporting this species. Site conditions in the RoW again ranged from dry areas to wet sites, where the wetter depressions are preferred habitat. Approximately 10 other surface depressions were observed supporting this plant when surveying between sites CL-SCC-100 and CL-SCC-200. Numbers of white beakrush were also known to decrease at site CL-ECO-300, where condition were drier this season. Photograph 4-6b shows white beakrush along the RoW.

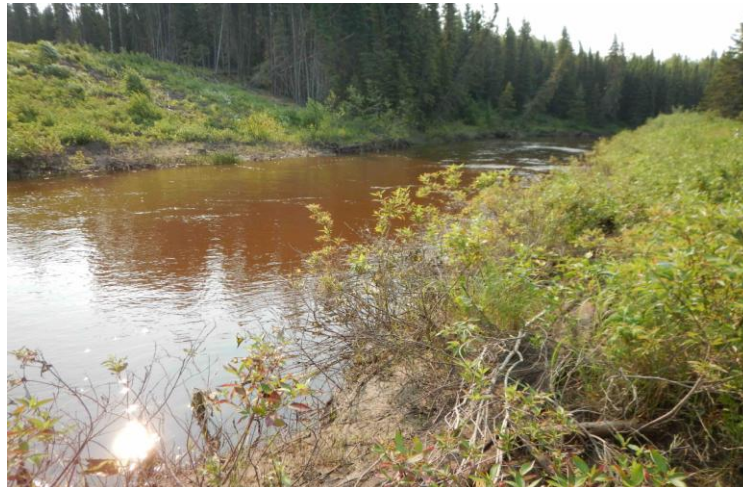
Photograph 4-7a. Mitishto River in 2017.

In 2015, two water crossings were observed to have established erosion control, using fibre blankets. One location was at the Mitishto River (479170 E and 6050339 N) in Section N3 and the other was at the Hunting River (670030 E, 6248581 N), in Section N1. Follow-up monitoring occurred to identify the erosion control and rehabilitation success. At the Mitishto River in 2017, fibre blankets were observed again on the bank slopes. Most of the installed blankets were still in place but in some areas the material has rolled back along the rivers edge, possibly from ice scouring. Natural re-vegetation was observed growing through the blankets, however some areas were still without emerging vegetation. No erosion was evident at this site. Vegetation colonizing the banks

were mostly shrub cover of red-osier dogwood (*Cornus sericea*), prickly rose (*Rosa acicularis*), Saskatoon (*Amelanchier alnifolia*), balsam poplar (*Populus balsamifera*), willow species (*Salix* spp.) and alder-leaved buckthorn (*Rhamnus alnifolia*). Grasses such as hairy wild rye (*Leymus innovatus*) and Canada reed grass (*Calamagrostis canadensis*) were established. At this time, no additional rehabilitation is required for the Mitishto River crossing. Photograph 4-7a shows the Mitishto River in 2017.

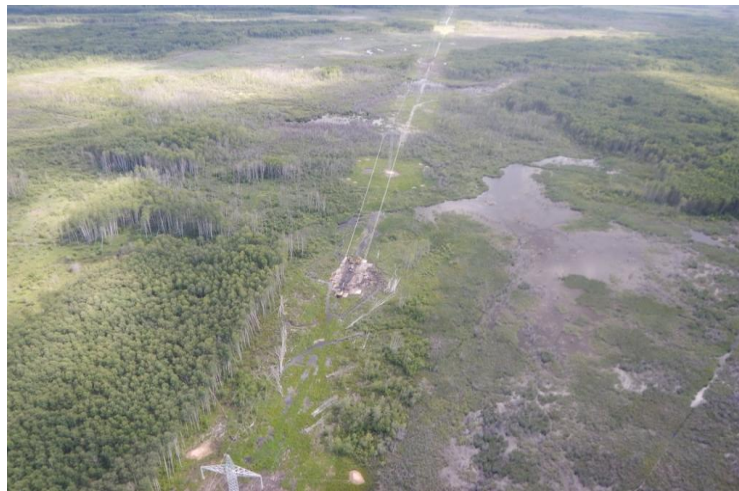
Photograph 4-7b. Vegetation recovery at Slug Site.

On July 6, Slug Site was visited, but only assessed from the air due to nearby construction activities. Helicopters were in the immediate vicinity stringing conductors, so a ground assessment could not be conducted. From the air, rutting from activities was evident but soil erosion was unable to be accurately assessed. A constructed ditch was still in place, used to divert water. Natural revegetation appeared to be occurring around the construction site and along the equipment path, although species composition was unable to be determined. The immediate equipment staging area showed little recovery of vegetation at this time. The site will be re-assessed in 2018 for native vegetation recovery, soil erosion and invasive species establishment. Photograph 4-7b. shows vegetation recovery at Slug Site.

when conditions are suitable and allow the site to re-vegetate naturally where existing seed sources in the soils can be allowed to germinate. The site can be re-assessed after one growing season.
