**BIPOLE III**  
**TRANSMISSION LINE WATERCOURSE CROSSINGS**  
**POST-CONSTRUCTION MONITORING REPORT - 2016**

October 2016

Manitoba Hydro

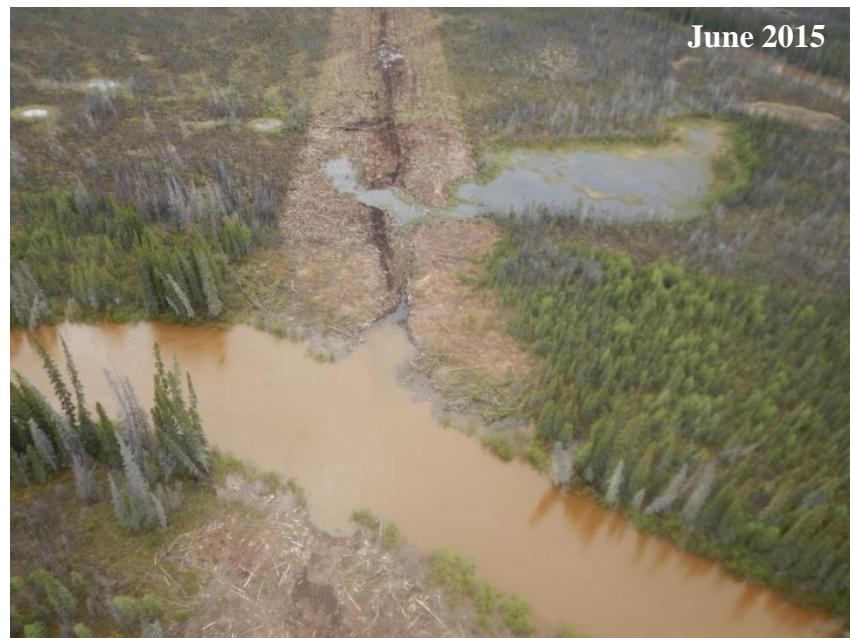
Erosion control measures were also recommended where naturally formed drainage channels were identified in the RoW across the vehicle track and draining into the main watercourse at the Limestone River (N1-Aqua-129; photos 2 and 3) and an

Photo 2. N1-Aqua-129 (Limestone River). Channel within RoW is subject to erosion, June 2015.

unnamed tributary of the South Moswakot River (N1-Aqua-133; photos 4 and 5), both considered important habitat for fish. Although no erosion control measures appeared to have been implemented, the channels have not increased in size and were dry at the time of the visit. Vegetation appears to be growing within the channels which will provide erosion protection. Erosion control measures are recommended in addition to continued monitoring and a follow-up visit in 2017.

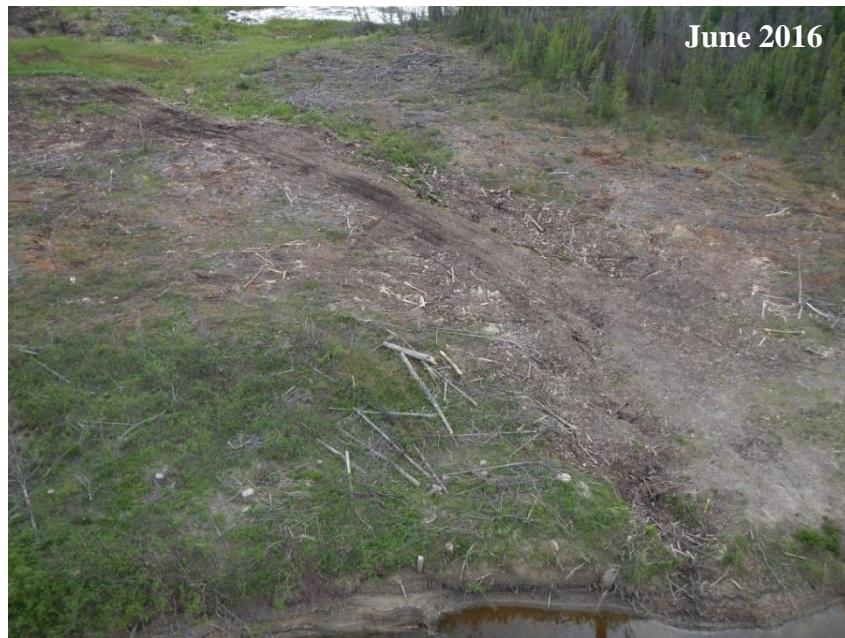
Photo 3. N1-Aqua-129 (Limestone River). Channel within RoW is subject to erosion, June 2016.

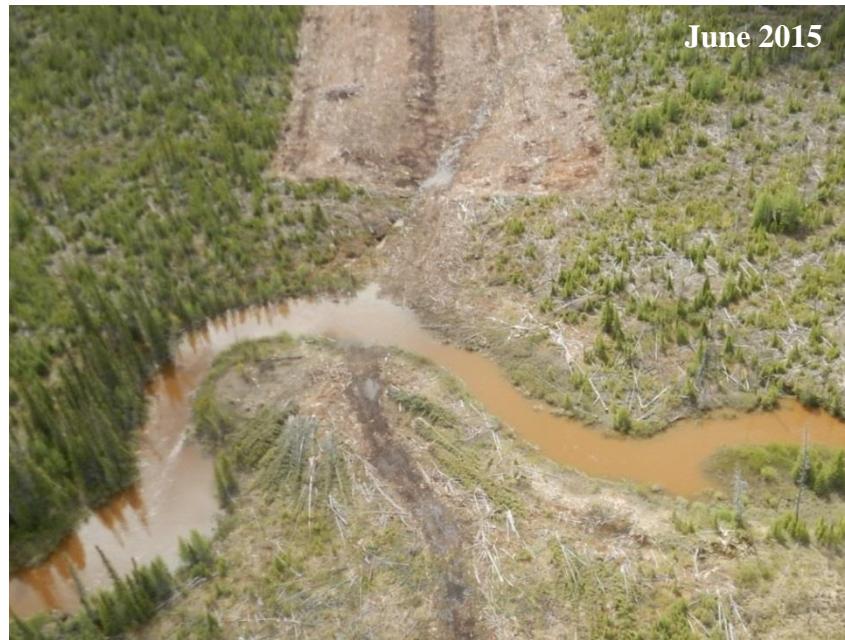
Photo 4. N1-Aqua-133 (unnamed tributary of South Moswakot River). Channel runs within the riparian buffer zone in the RoW, prone to erosion, June 2015.

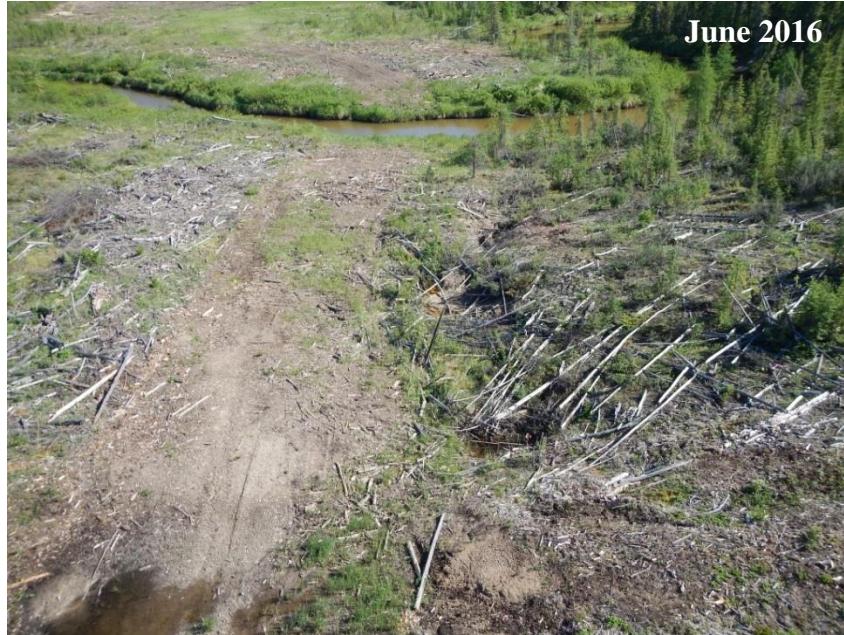
Photo 5. N1-Aqua-133 (unnamed tributary of South Moswakot River). Channel runs within the riparian buffer zone in the RoW, prone to erosion, June 2016.

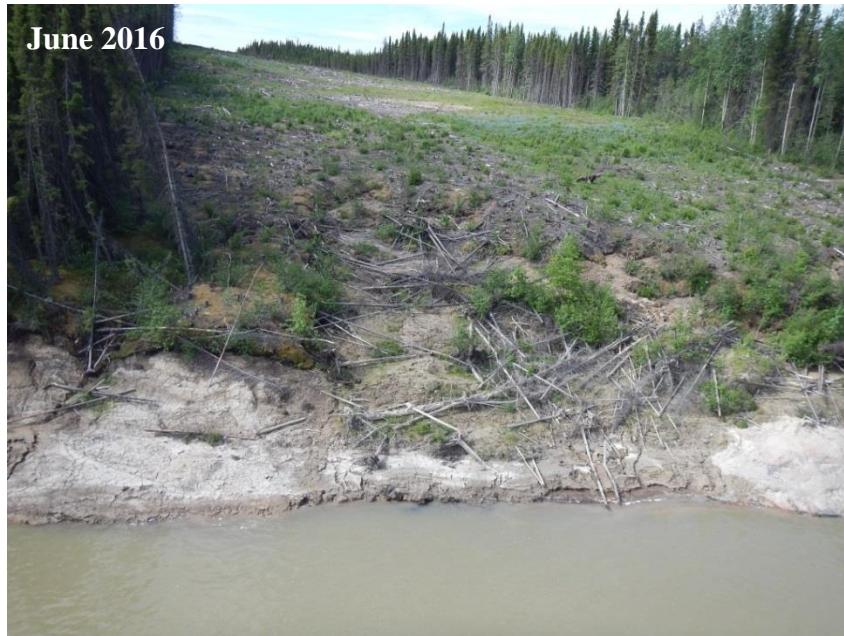
Bank slumping was noted on the southern bank of the Burntwood River (N1-Aqua-173) in 2015. The slumping was more prevalent within the RoW than outside of it. Erosion control measures were recommended for the Burntwood River where the slumping was severe and where a plume of turbid water was seen entering into the river within the RoW. During the 2016 site visit, it was noted that, although dry, the extent of the slumping had increased slightly since June 2015 and there was no evidence that erosion control measures had been implemented (photos 6, 7 and 8). Re-vegetation appears to be slow and is insufficient to stabilize the bank. Erosion control measures and a follow-up visit in 2017 are recommended.

Photo 6. N1-Aqua-173 (Burntwood River). Erosion in RBZ and slumping of southern bank (segment N1), June 2015.

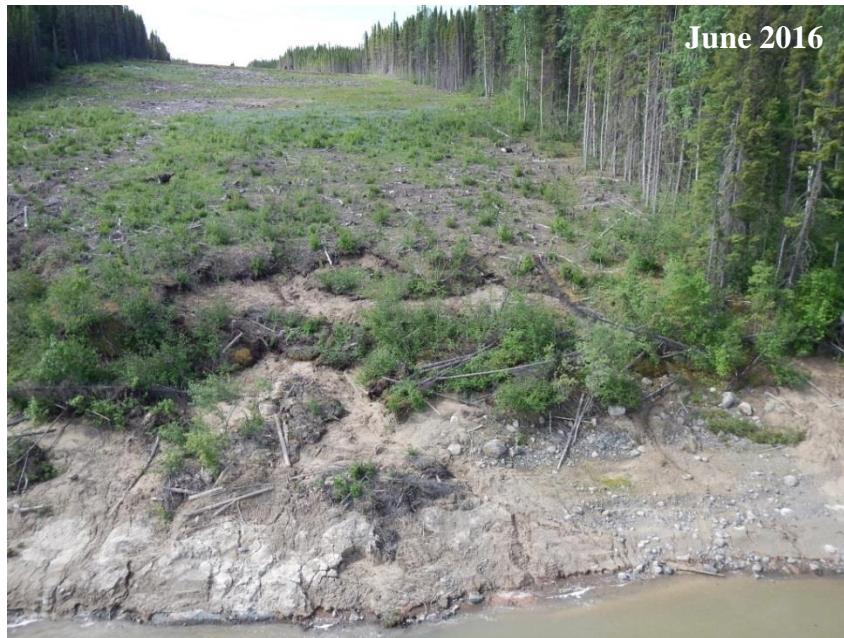
Photo 7. N1-Aqua-173 (Burntwood River). Erosion/slumping of the southern bank (segment N1) at the downstream side of the RoW, June 2016.

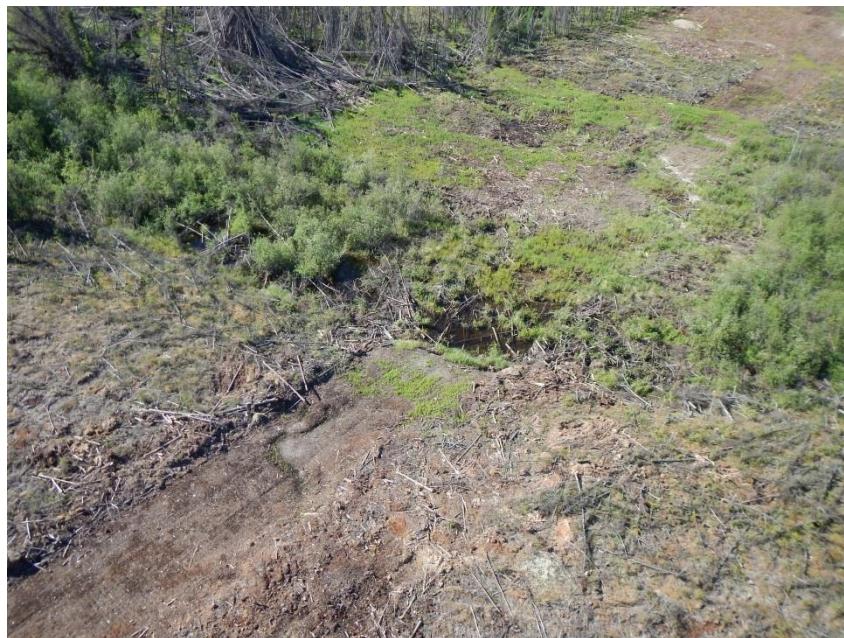
Photo 8. N1-Aqua-173 (Burntwood River). Erosion/slumping of the southern bank (segment N1) at the upstream side of the RoW, June 2016.

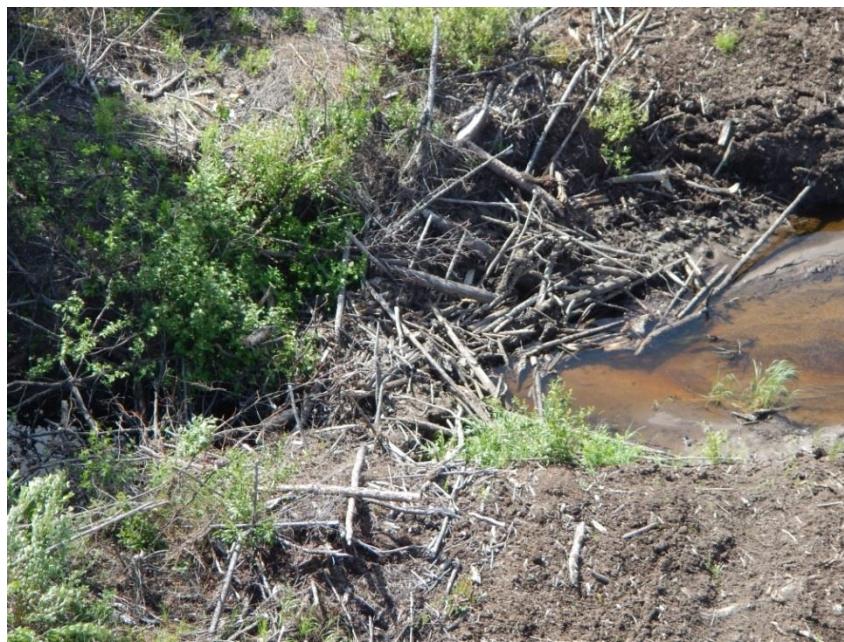
Photo 10. N1-Aqua-156 (unnamed tributary of Assean Lake). Woody debris in channel immediately downstream of the vehicle crossing, June 2016.

Felled trees and/or slash were observed instream at four sites. Removal of the trees/slash from the stream channel and a follow up site inspection in 2017 is recommended at sites N1-Aqua-135, 156 and 167 due to the potential for impairment of water flow and fish movements (photos 9, 10 and 11). At site N1-Aqua-172 the affected portion of the stream is of low/no importance to fish and as such remediation is not required. The fifth site is discussed below (Photo 12).

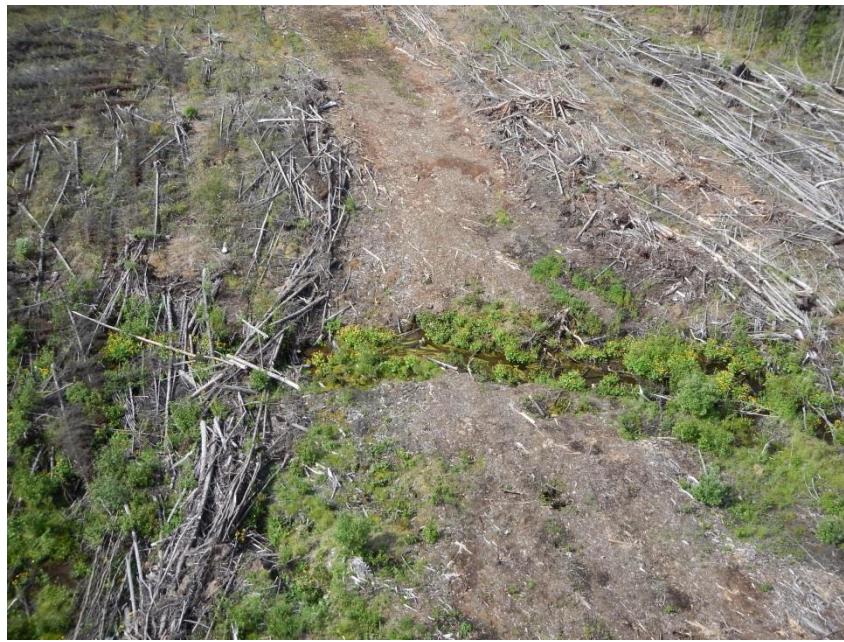
Photo 11. N1-Aqua-167 (unnamed tributary of the Burntwood River). Woody debris in channel at the vehicle crossing, June 2016.

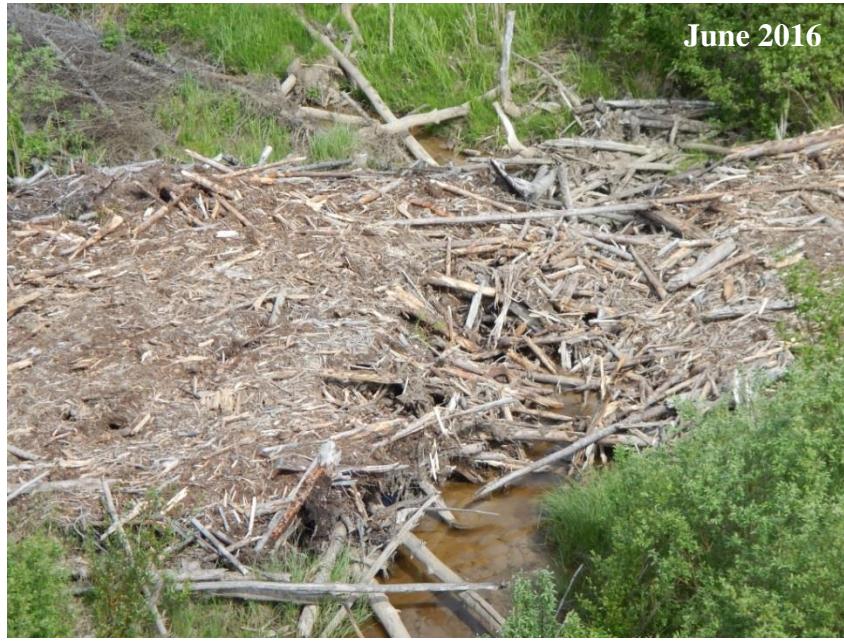
Photo 14. N1-Aqua-169 (unnamed tributary of Odei River). Temporary crossing remains in place, June 2016.

The temporary stream crossing on the road within the RoW at site N1-Aqua-169 was not removed following construction in 2015 and remained intact at the time of the site visit in 2016. The temporary crossing consists of a thick layer of wood slash and debris and if allowed to remain in the stream may restrict water flow and fish movements as well as alter fish habitat (photos 13 and 14). Although the stream is not considered important fish habitat, removal of the temporary crossing is recommended as well as a site inspection in 2017.

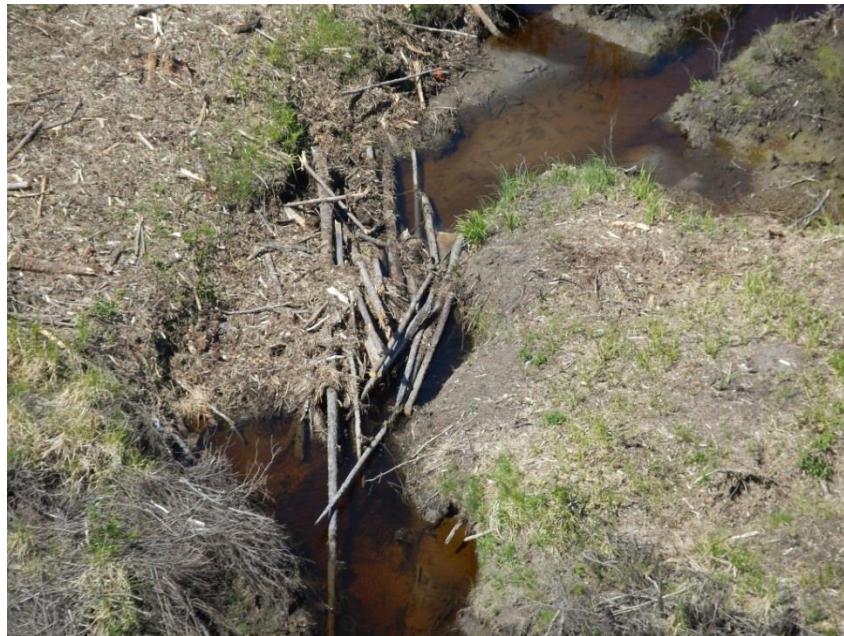
Photo 15. N2-Aqua-103 (unnamed tributary of Brannigan Creek). Woody debris in channel at the vehicle crossing, June 2016.

Woody debris was observed instream at the vehicle crossing at sites N2-Aqua-103 (Photo 15) and N2-Aqua-119 (Photo 16). To avoid the potential for the restriction of water flow and lack of fish passage it is recommended the debris be removed and placed above the HWM at site N2-Aqua-103. Due to the lack of fish habitat and the high degree of beaver activity in the vicinity of the area affected by the blockage of at N2-Aqua-119, no remediation is required.

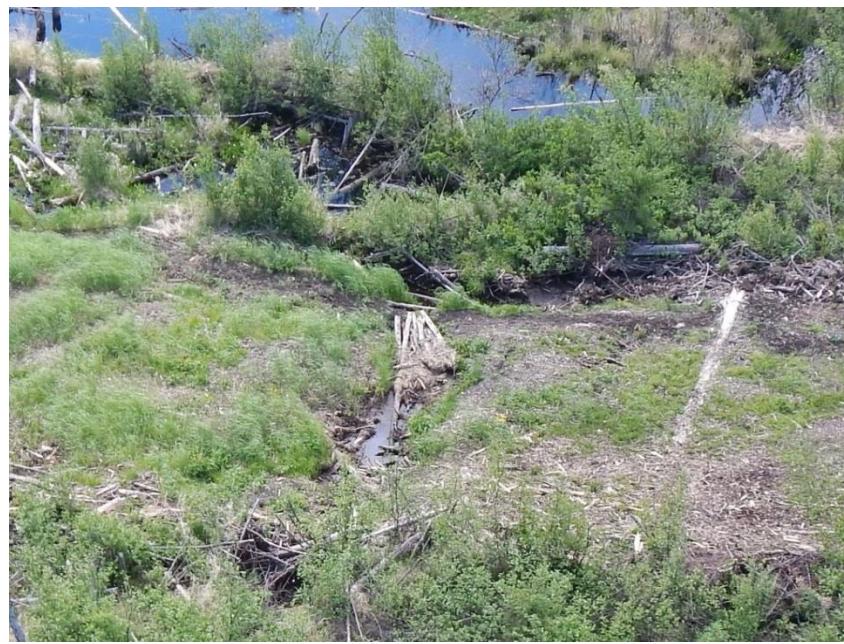
Photo 16. N2-Aqua-119 (unnamed tributary of Partridge Crop Lake). Bucked wood in channel creating a partial blockage to water flow, June 2016.

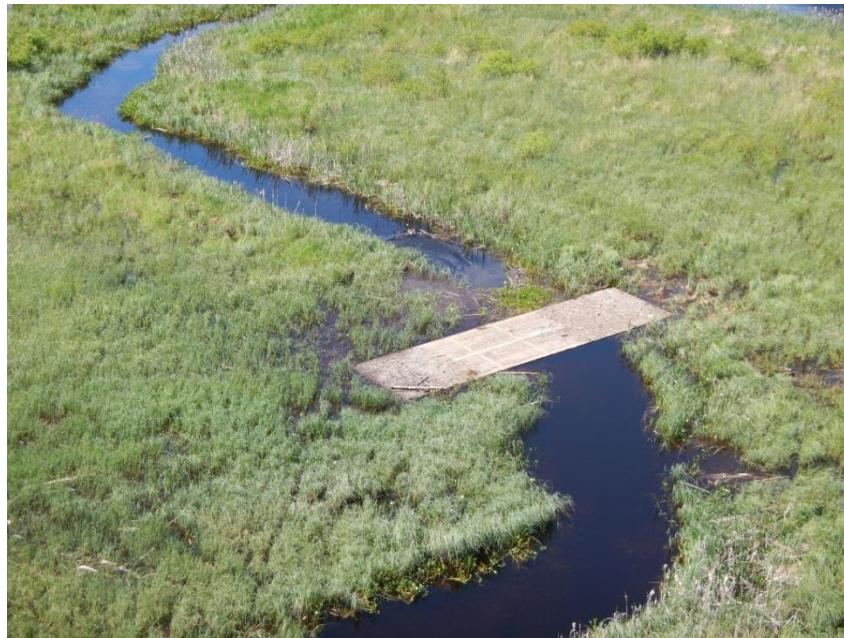
Photo 17. N2-Aqua-112 (Isbister Creek). Sediment accumulation instream and large plank functioning as a temporary bridge creating a partial blockage to water flow, June 2016.

Sediment accumulation within the channel at the vehicle crossing of Isbister Creek, as well as a large plank placed across the stream as a temporary bridge adjacent to it (likely by local resource users), was observed partially blocking the channel of Isbister Creek at vehicle crossing N2-Aqua-112 (Photo 17). Removal of the plank and continued monitoring in 2017 is recommended to determine if excavation is necessary following the 2017 spring run-off which is expected to clear the channel naturally.

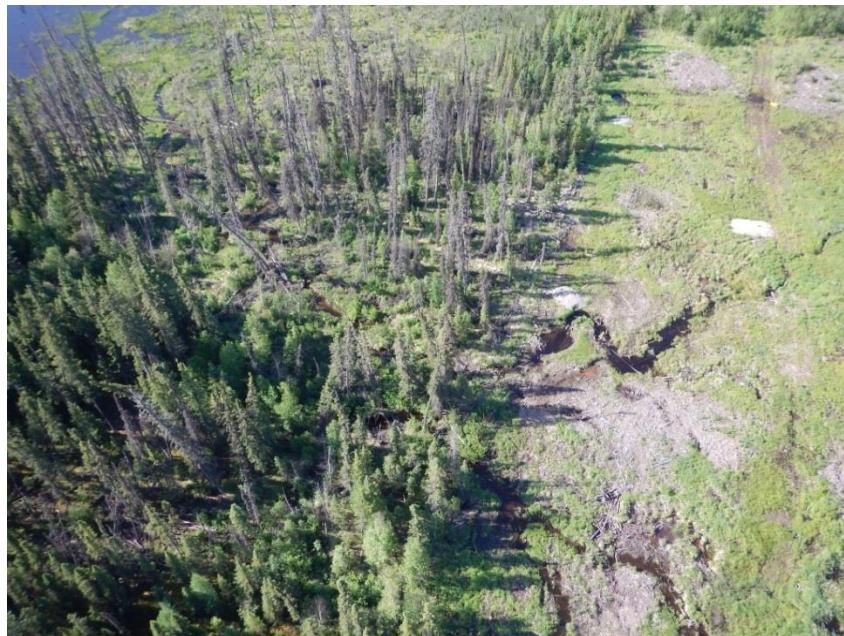
Photo 18. N2-Aqua-160 (unnamed pond) Channel encroaching on tower anchor (1349), east of the crossing, June 2016.

In 2015, water levels were high and new channels were identified beneath the tower east of the N2-Aqua-160 crossing. It was recommended by the Manitoba Hydro Environmental Inspector in 2015 that the drainage be monitored and erosion control measures implemented. The lower water levels in June 2016 revealed a channelized stream encroaching on the southeastern most anchor of tower 1349 (Photo 18). Although no erosion control measures were observed during the 2016 site visit, the extent of beaver activity in the area and the small nature of the stream suggest significant erosion is unlikely. Further erosion it is not expected to be a concern for fish and fish habitat.

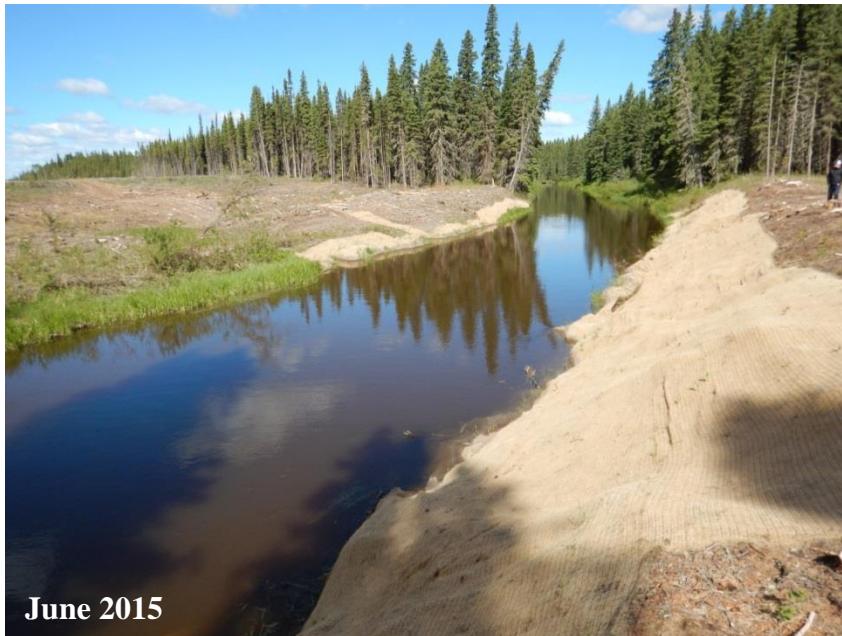
Photo 21. N3-Aqua-103 (Mitishto River). Excessive clearing in RBZ and exposed soil prone to erosion protected by erosion control matting, June 2015.

Active re-vegetation of the banks at N3-Aqua-103 was recommended in 2015 to augment the erosion control measures (i.e. straw matting) already in place on the steep banks of the Mitishto River. Shrubs and forbes are slowly re-vegetating the banks through the matting but growth remains sparse (photos 21 and 22). No erosion was noted during the site visit in 2016. Continued monitoring of the site for bank stability and state of re-vegetation is recommended in 2017.

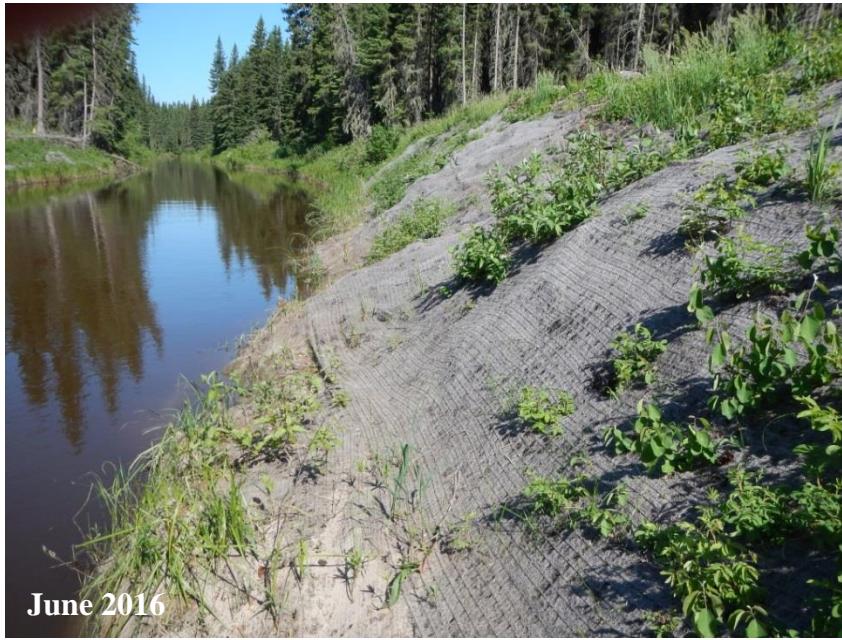
Photo 22. N3-Aqua-103 (Mitishto River). Shrubs and forbes becoming established on the steep eastern bank through erosion control matting, June 2016. No erosion was detected.

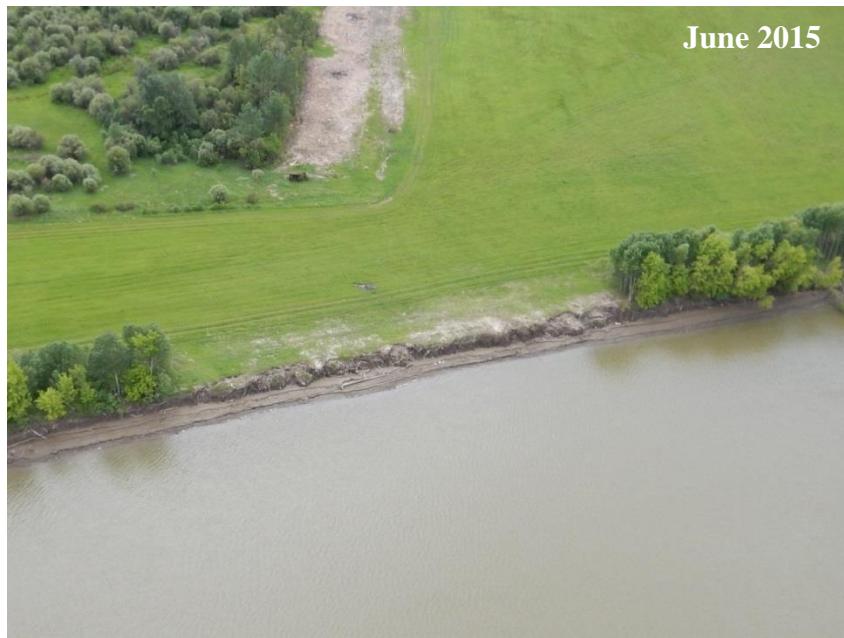
Photo 23. N3-Aqua-134 (Saskatchewan River). Excessive vegetation clearing in the RBZ, June 2015.

sufficient stability to mitigate against further slumping (photos 23 and 24). A follow-up visit in 2017 is recommended to monitor bank stability.

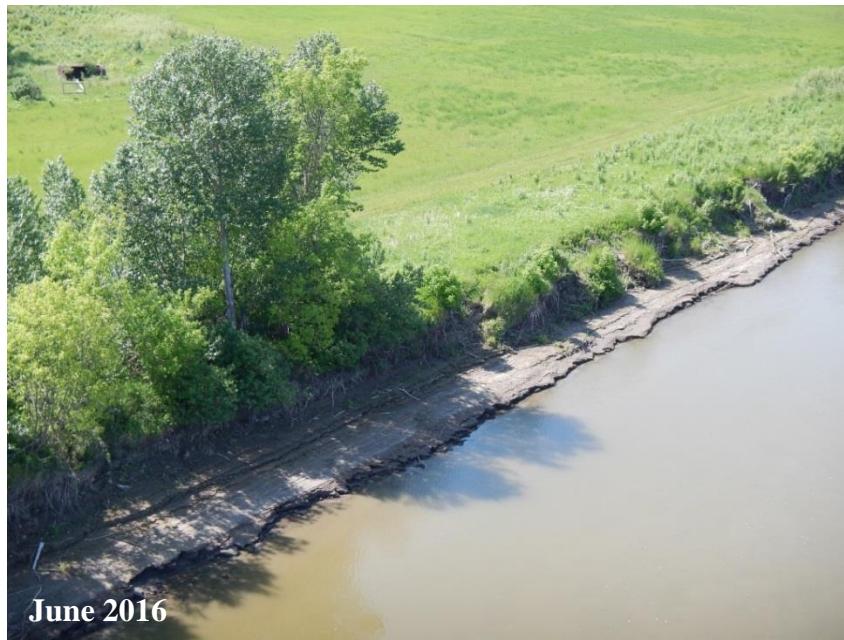
Photo 24. N3-Aqua-134 (Saskatchewan River). Shrubs and forbes becoming well established on the southern bank, June 2016. Slumping does not appear to have increased since June 2015.

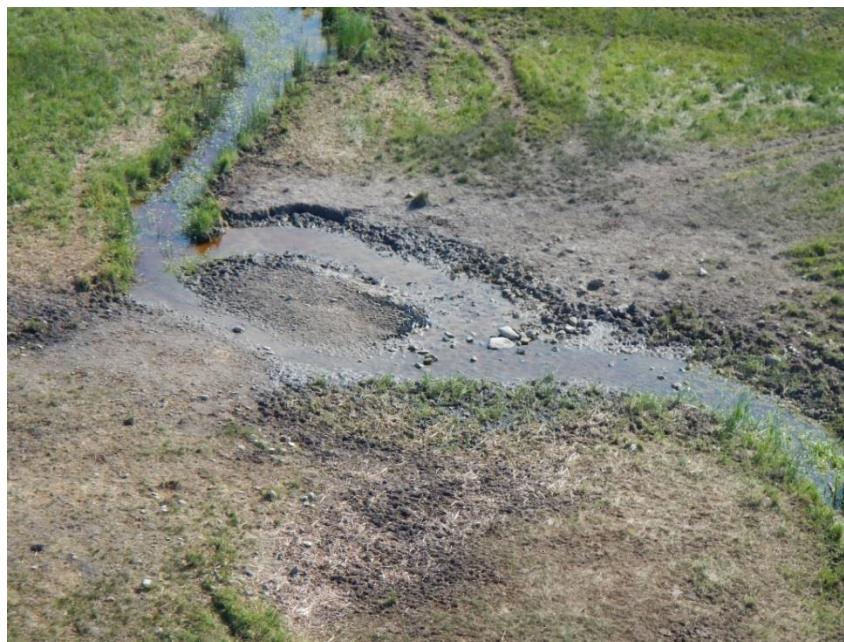
An accumulation of sediment and woody debris was noted in the channel within the RoW at N4-Aqua-112, an unnamed tributary of Lake Winnipegosis considered to be important habitat for fish (Photo 25). Although water flow was not completely blocked, removal of the woody debris and excavation of the sediment is recommended to avoid the possibility that it may develop into a barrier of sufficient size to prevent fish movement in the future. A follow up visit in 2017 is recommended for this site as it is considered important fish habitat.

Photo 25. N4-Aqua-112 (tributary of Lake Winnipegosis). Woody debris and an accumulation of sediment observed instream within the RoW, June 2016.

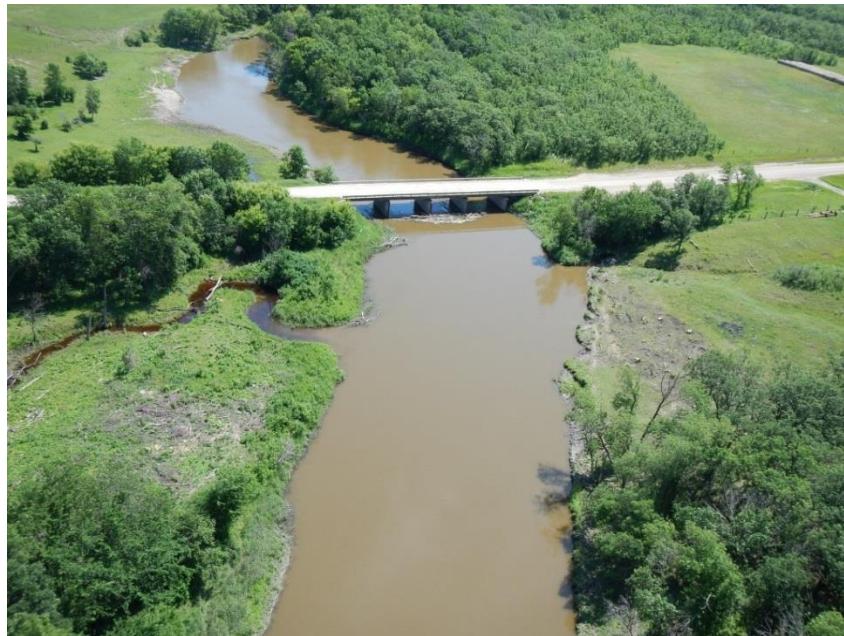
Bucked logs and other woody debris was observed accumulating against the supports of a vehicle bridge immediately downstream of the RoW on the Whitemud River (S1-Aqua-112; Photo 27). The source of the debris is unknown but it may, in time, disrupt water flow and fish passage.

Photo 27. S1-Aqua-112 (Whitemud River). Woody debris accumulated against supports of bridge immediately downstream of the RoW, June 2016.
