BIPOLE III
TRANSMISSION LINE WATERCOURSE CROSSINGS
POST-CONSTRUCTION MONITORING REPORT - 2018

October 2018

Manitoba Hydro

North/South Consultants Inc.
Aquatic Environment Specialists

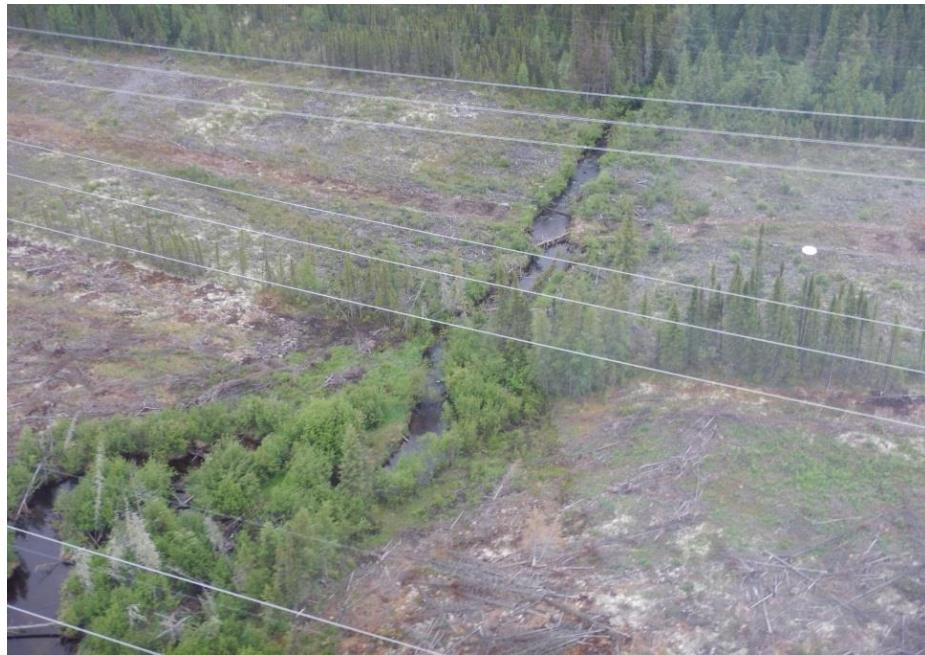
Photo 1. CL-Aqua-104 (Brooks Creek). Woody debris accumulated instream at the vehicle crossing, June 2017.

Construction of all five of the Collector Lines was complete at the time of inspection. Compliance was observed at all 37 watercourse crossings including site CL-Aqua-104 which was recommend for a follow-up visit in the 2017 monitoring report. As in 2017, woody debris was still observed accumulating instream at the vehicle crossing at Brooks Creek (CL-Aqua-104). Despite the stream being identified as important fish habitat the fallen trees are unlikely to have an effect on fish and fish habitat (photos 1 and 2).

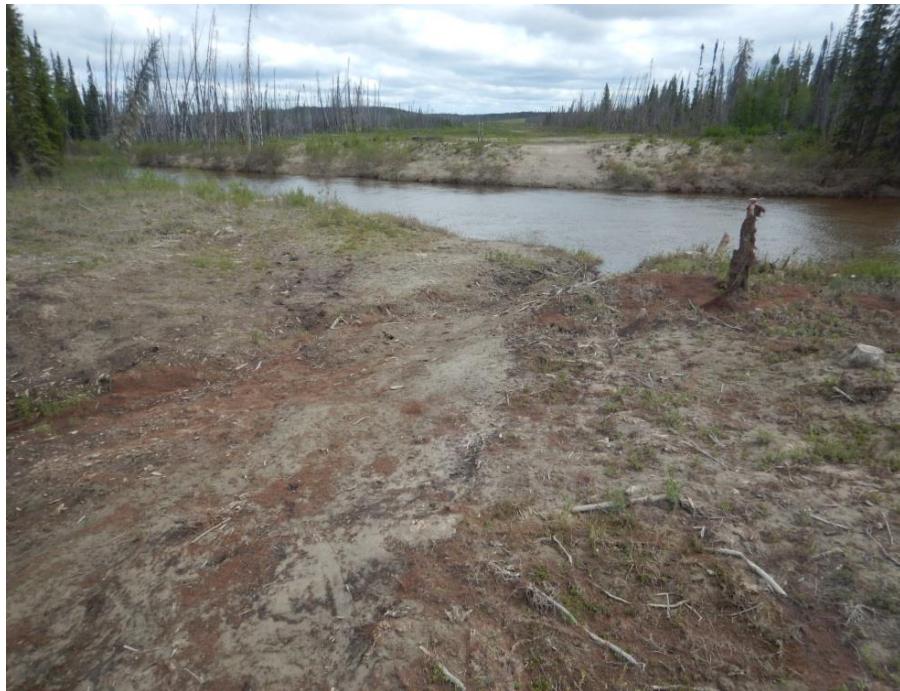
Photo 2. CL-Aqua-104 (Brooks Creek). Some woody debris still present at crossing but not deemed to cause harm to fish, June 2018.

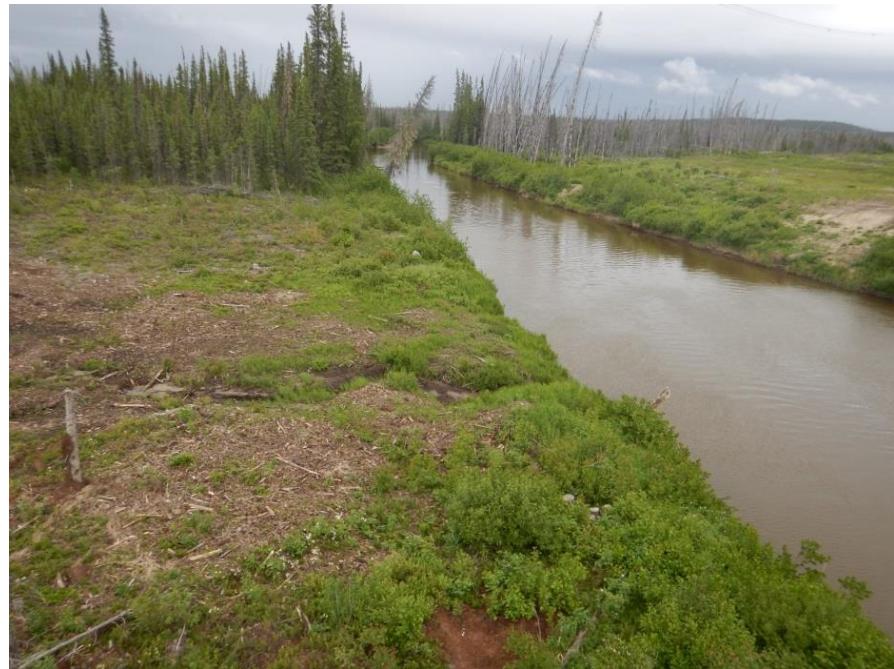
Photo 4. N1-Aqua-129 (Limestone River). Channel within RoW is subject to erosion but re-vegetation is sufficient for bank stabilization, June 2018.

In 2016 and 2017 erosion control measures were recommended at two crossings considered to have important habitat for fish, the Limestone River (N1-Aqua-129) and an unnamed tributary of the South Moswakot River (N1-Aqua-133). At each site, naturally formed drainage channels were identified in the RoW and were draining into the main watercourse. Monitoring in 2018 noted no erosion at either site. Re-vegetation at both sites, in particular N1-Aqua-129, is increasing and is likely sufficient to negate the requirement for erosion and sediment control (ESC) measures. Re-vegetation can be observed in comparative photos from 2017 and 2018 for N1-Aqua-129 (photos 3 and 4) and N1-Aqua-133 (photos 5 and 6).

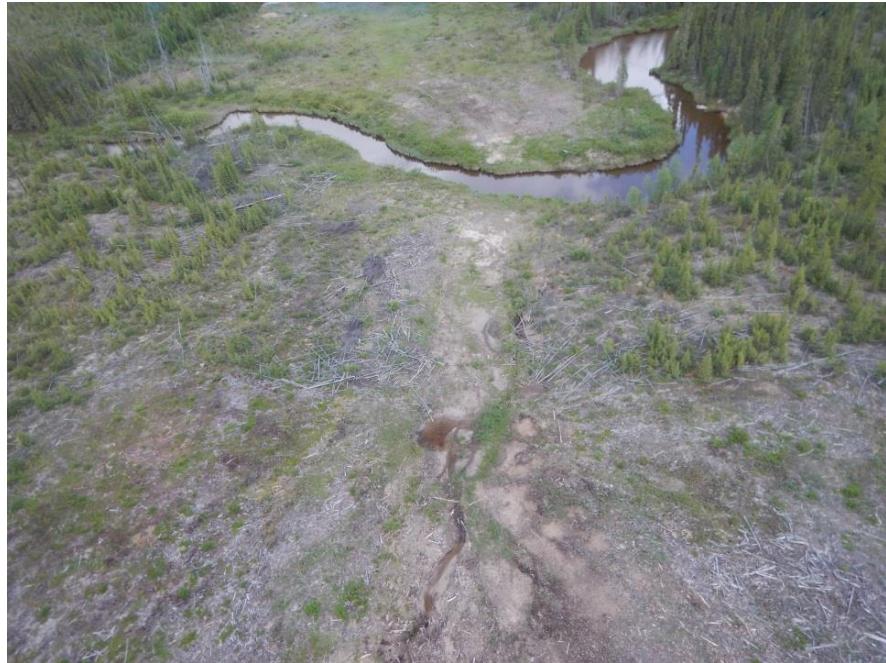
Photo 5. N1-Aqua-133 (unnamed tributary of South Moswakot River). Channel runs within the riparian buffer zone in the RoW, prone to erosion, June 2017.

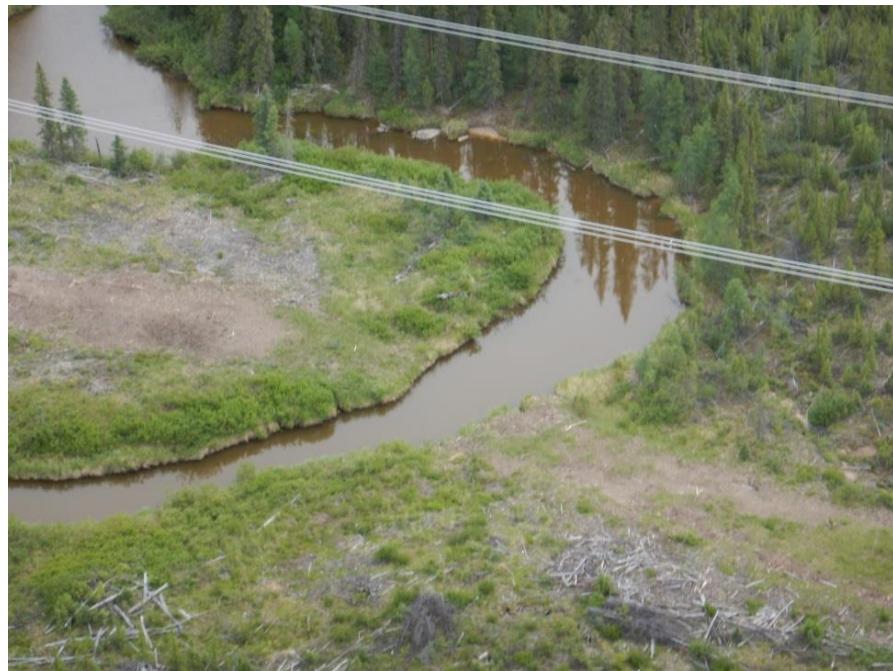
Photo 6. N1-Aqua-133 (unnamed tributary of South Moswakot River). Channel runs within the riparian buffer zone in the RoW, prone to erosion but vegetation regrowth is occurring and should be sufficient to prevent erosion, June 2018.

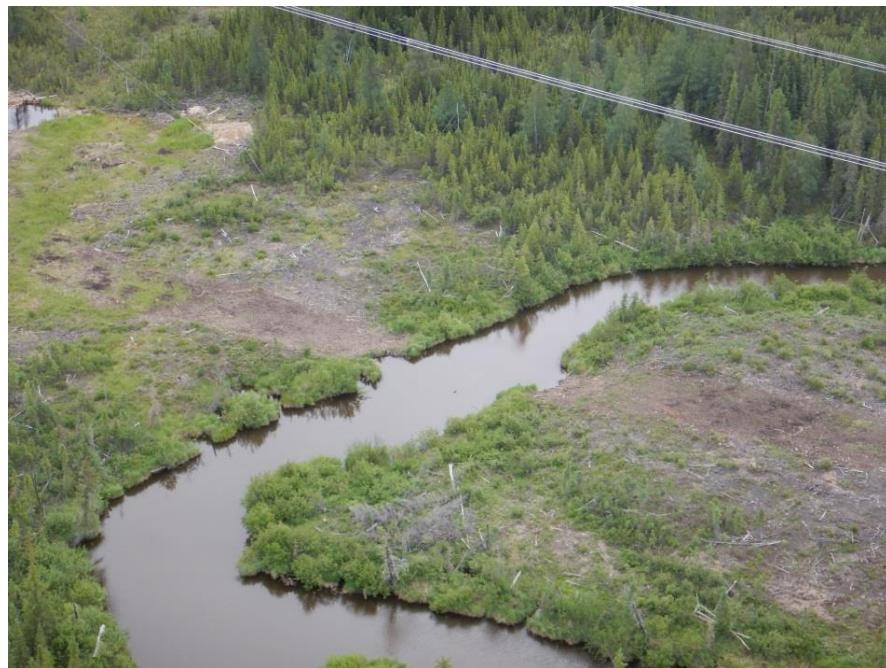
Photo 7. N1-Aqua-131 (North Moskwakot River). Presence of bare ground through the RoW at the centerline trail crossing is susceptible to erosion. regrowth occurring but suggest implementing ESC measures due to important fish habitat, June 2018.

In 2018, N1-Aqua-131 was identified as having bare ground at the centerline trail crossing and may be susceptible to erosion in high water years (photo 7). The watercourse is considered important fish habitat and despite the presence of a small amount of re-vegetation around the affected site the application of ESC measures may be beneficial in further protecting against bank erosion.

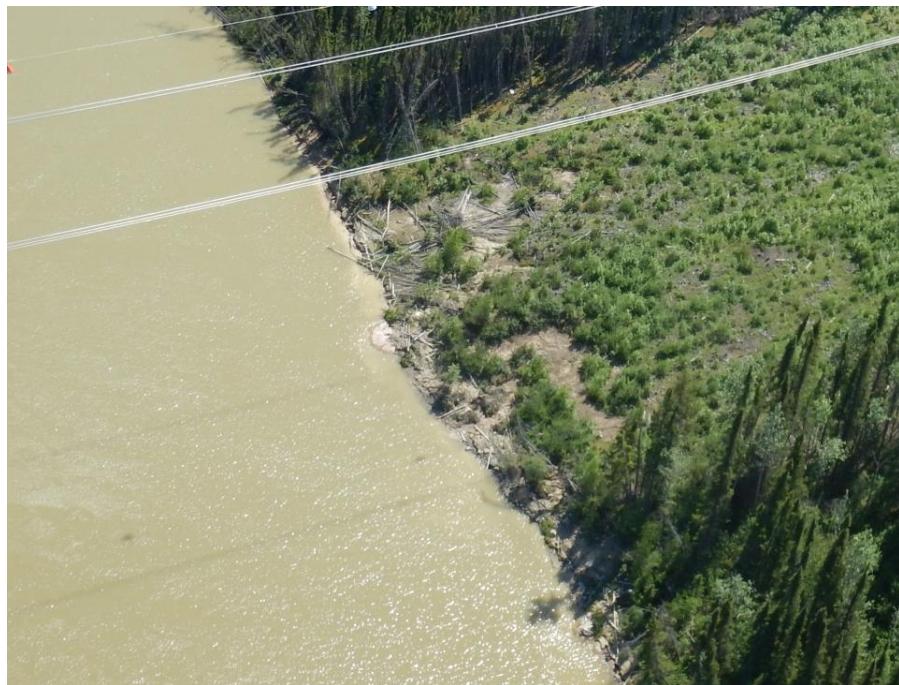
Photo 8. N1-Aqua-173 (Burntwood River). Erosion in RBZ and slumping of southern bank (segment N1), June 2017.

Bank slumping on the southern bank of the Burntwood River (N1-Aqua-173) has been noted in previous years as well as during monitoring in 2018 (photos 8 and 9). In 2018, further slumping does not appear to have occurred and re-vegetation is increasing, albeit slowly (photos 10 and 11). In addition, no erosion specific to the clearing of the RoW was observed at the study site. The banks of the Burntwood River are highly erodible and any future erosion is unlikely to be the result of excessive riparian clearing.

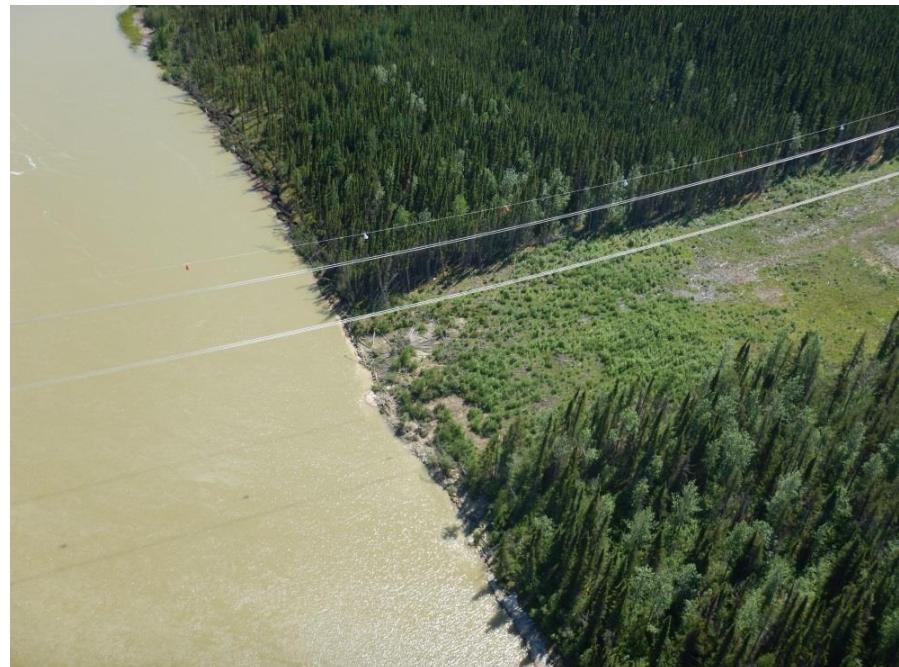
Photo 9. N1-Aqua-173 (Burntwood River). Erosion/slumping of the southern bank (segment N1) at the downstream side of the RoW showing regrowth, June 2018.

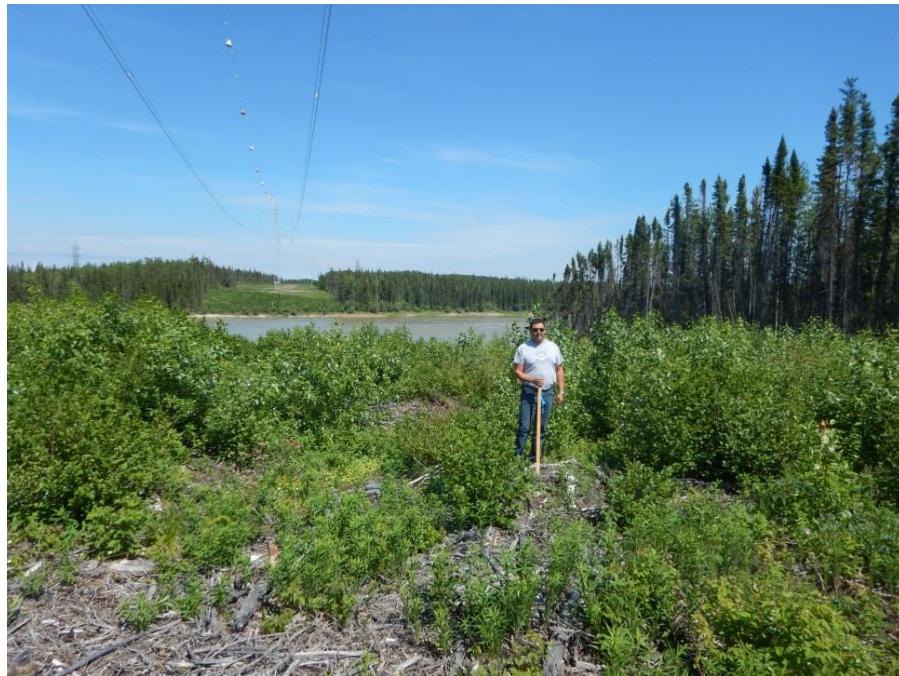
Photo 10. N1-Aqua-173 (Burntwood River). Recovery of the northern bank, June 2018.

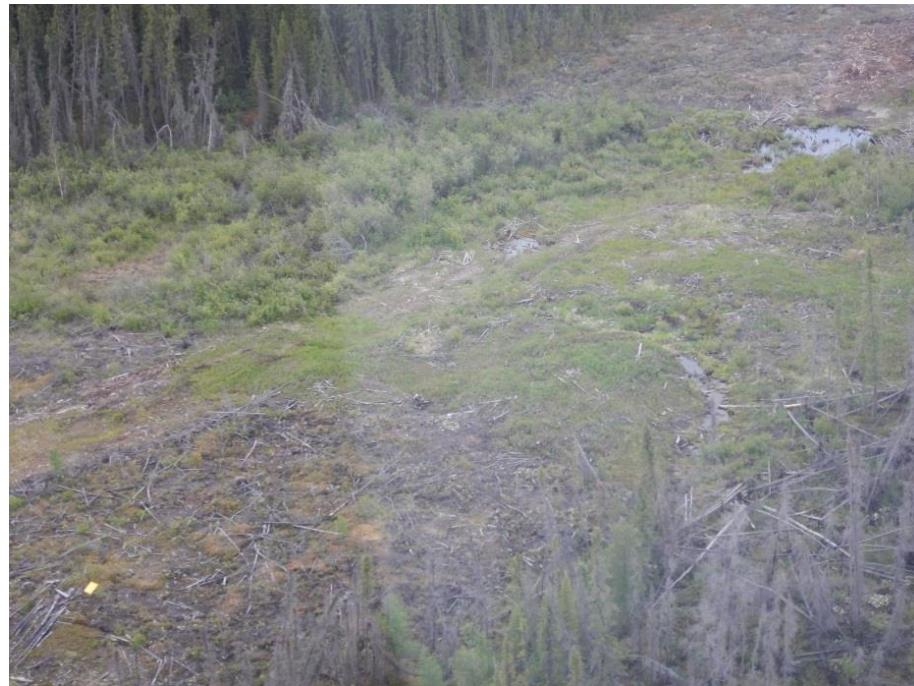
Photo 11. N1-Aqua-173 (Burntwood River). Re-vegetation of the south bank of the Burntwood River RoW, June 2018.

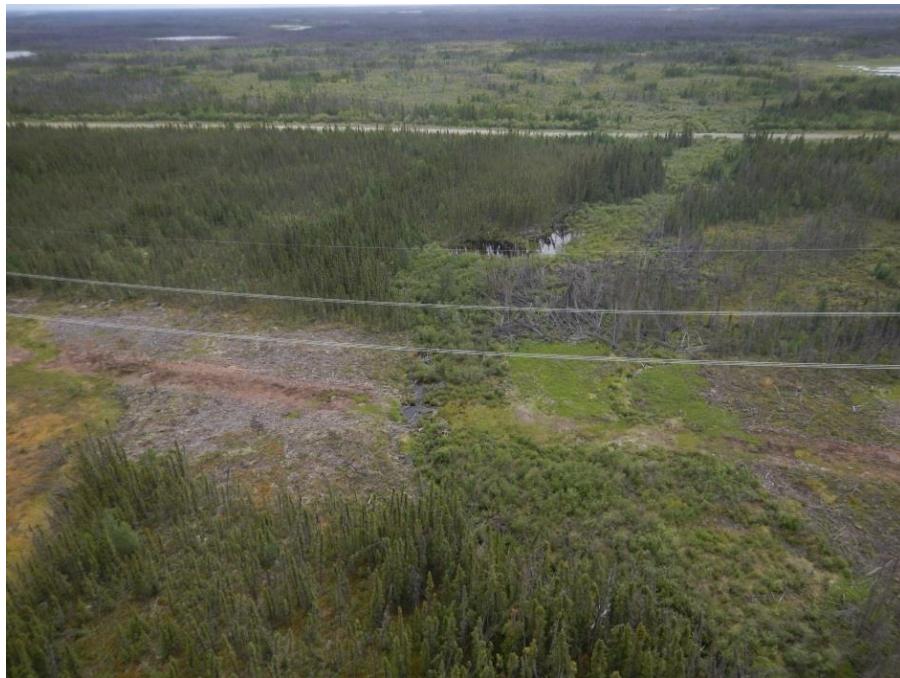
Photo 12. N1-Aqua-135 (unnamed tributary of South Moswakot River). Woody debris in channel at the vehicle crossing, June 2017.

The removal of slash from below the HWM for sites N1-Aqua-135, 156, and 167 was recommended in 2017 due to the potential for impairment of water flow and fish movements. In 2018, slash still remained below the HWM at all three sites, and at site N1-Aqua-161 identified in the current monitoring year. A closer inspection of N1-Aqua-156 showed water was still moving freely despite the presence of woody debris and slash

in the water. All four sites are deemed marginal fish habitat and therefore remediation is not recommended (photos 12-19).

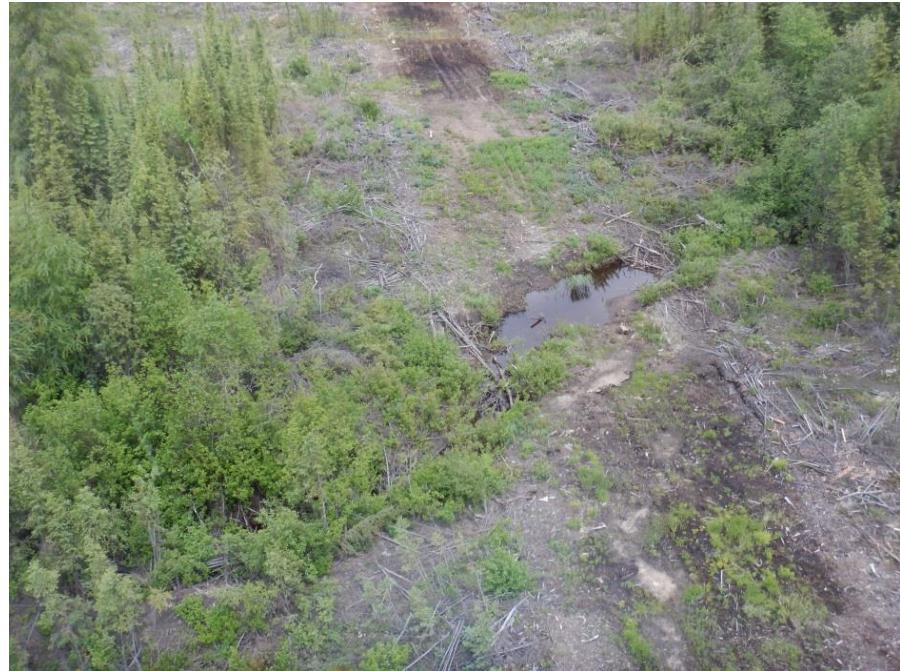
Photo 13. N1-Aqua-135 (unnamed tributary of South Moswakot River). Woody debris/deadfall in channel at the vehicle crossing but not significant to cause harm to fish. No removal required, June 2018.

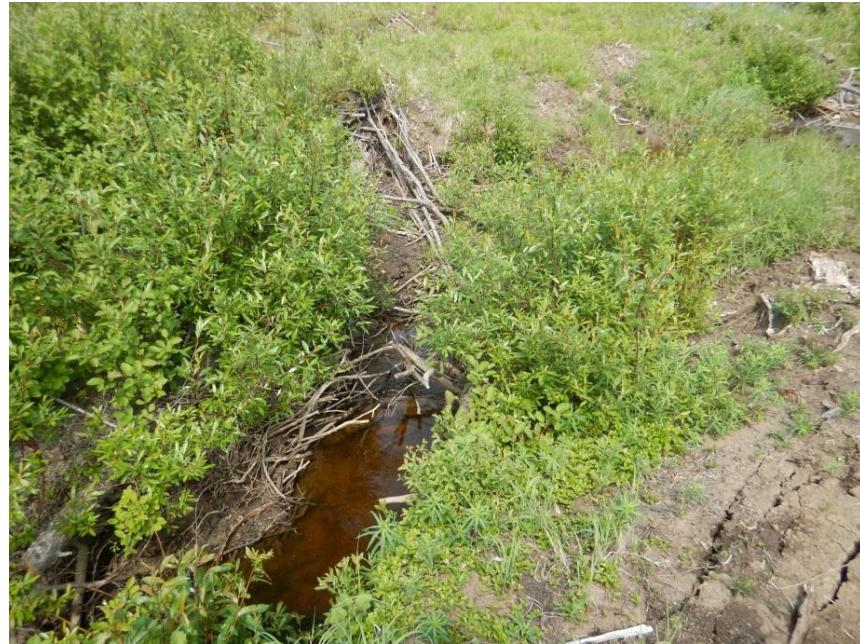
Photo 15. N1-Aqua-156 (unnamed tributary of Assean Lake). Closer inspection of the watercourse showed flow was not severely impeded by the debris, June 2018.

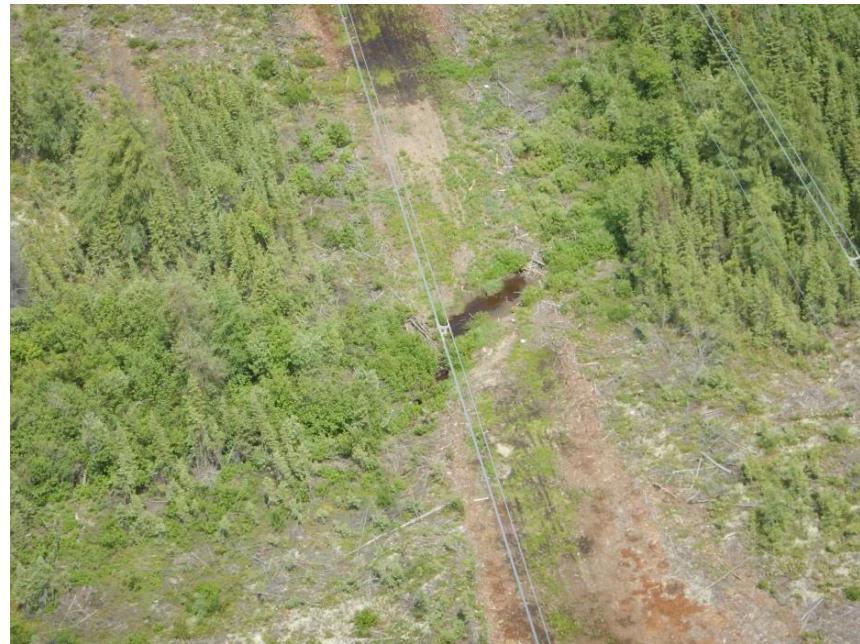
Photo 16. N1-Aqua-156 (unnamed tributary of Assean Lake). Woody debris in channel immediately downstream of the vehicle crossing, June 2018. Marginal fish habitat and debris does not completely block stream, no action required.

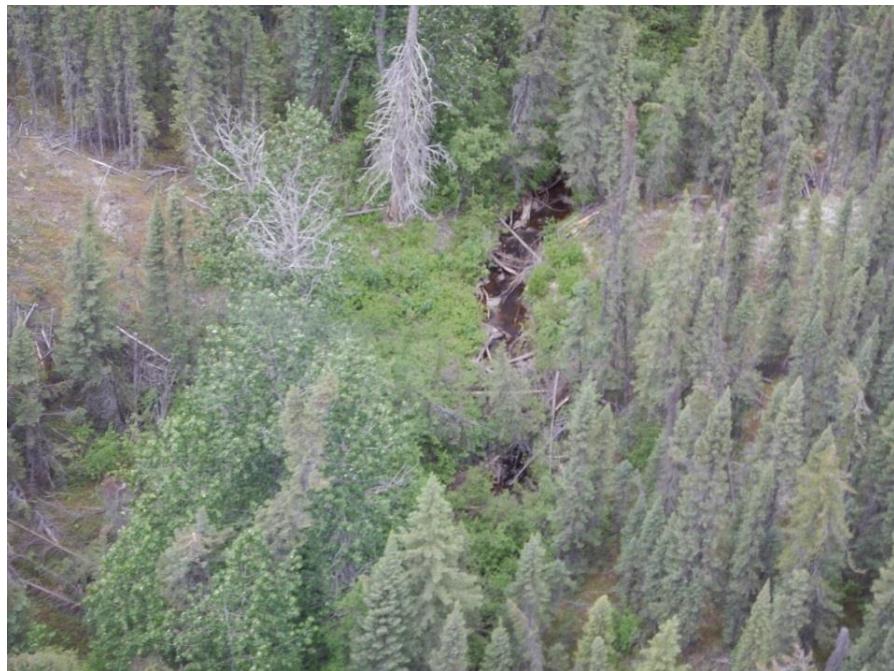
Photo 17. N1-Aqua-161 (unnamed tributary of the Burntwood River). Woody debris and slash left below the HWM and within the watercourse crossing. Marginal fish habitat but should consider removing, June 2018.

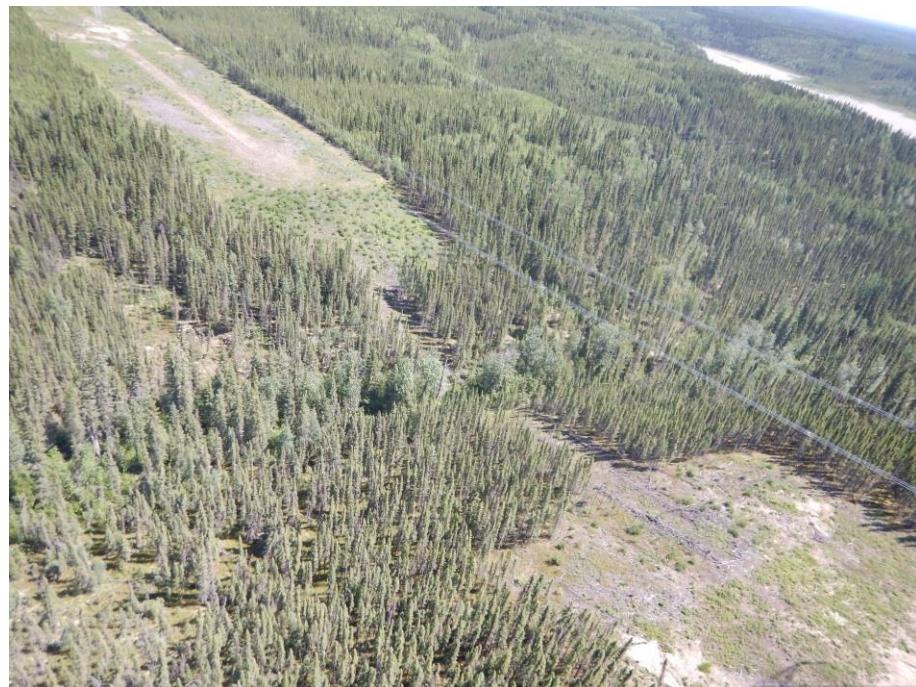
Photo 18. N1-Aqua-167 (unnamed tributary of the Burntwood River). Woody debris in channel at the vehicle crossing, June 2017.

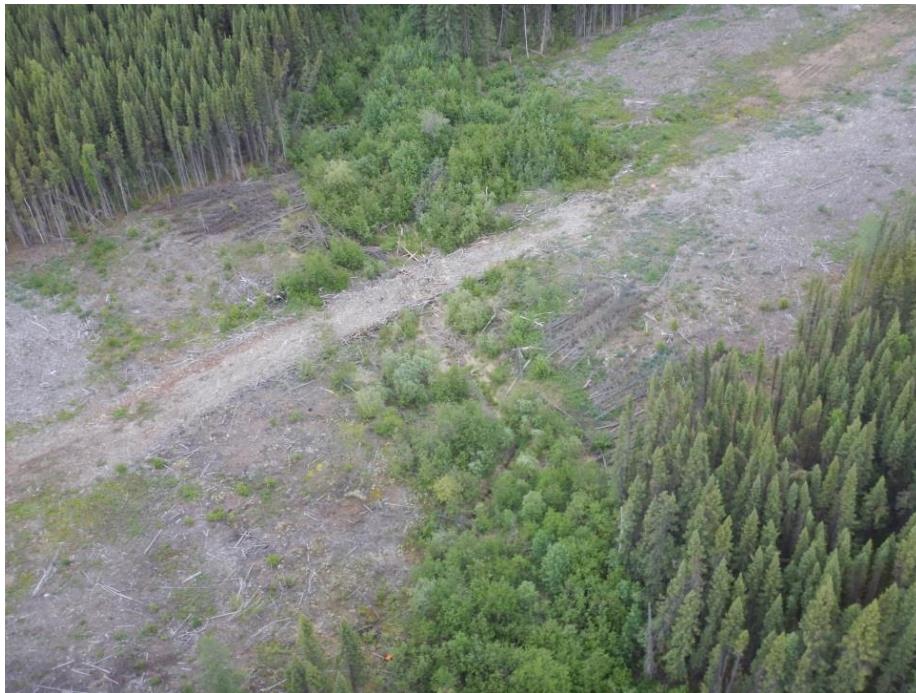
Photo 19. N1-Aqua-167 (unnamed tributary of the Burntwood River). Woody debris still present but stream largely dried up and deemed marginal fish habitat, June 2018.

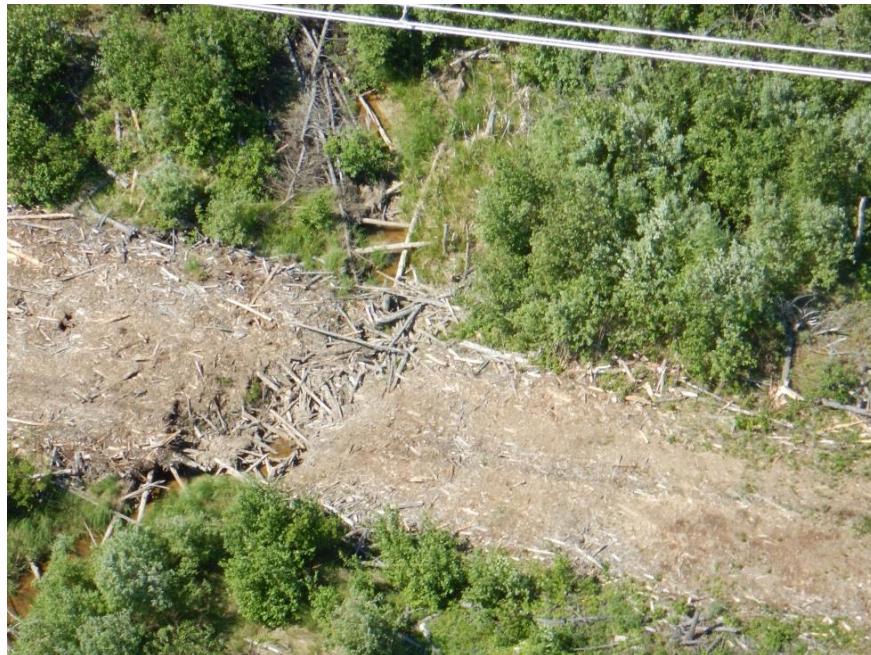
Photo 20. N1-Aqua-169 (unnamed tributary of Odei River). Temporary crossing remains in place, June 2017.

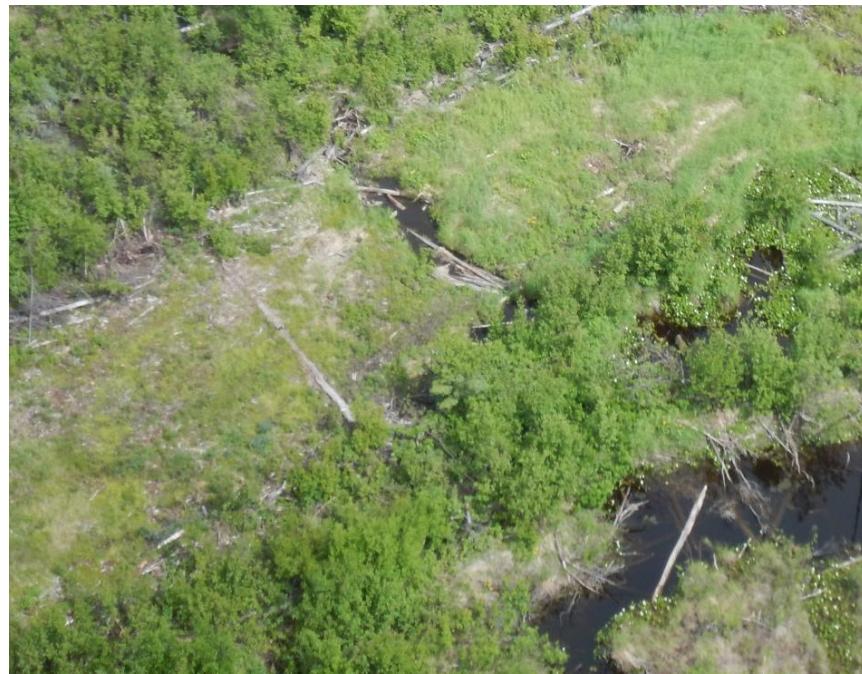
Photo 21. N1-Aqua-169 (unnamed tributary of Odei River), June 2018. Temporary crossing has remained in place since first observed in 2015. Marginal fish habitat therefore removal should be considered.

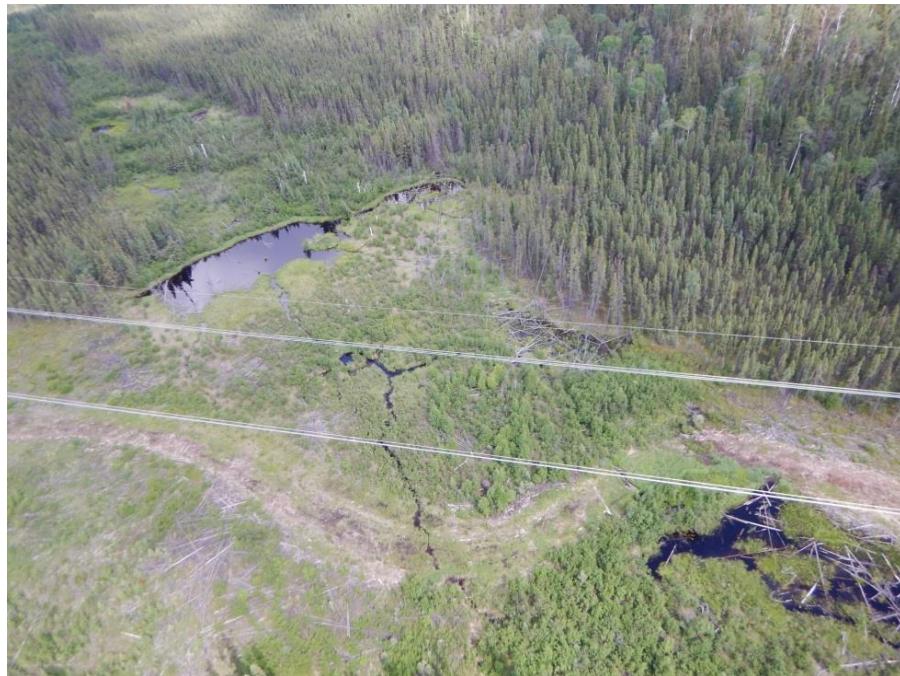
Photo 23. N2-Aqua-119 (unnamed tributary of Partridge Crop Lake). Bucked wood remains in channel but considered marginal fish habitat and may be the result of beaver activity, June 2018.

Woody debris has been observed instream at the vehicle crossing at site N2-Aqua-119 (Photo 22) for several years including in the current monitoring year (photos 23). Due to the lack of fish habitat and the high degree of beaver activity in the vicinity of the area affected by the blockage, no remediation is required.

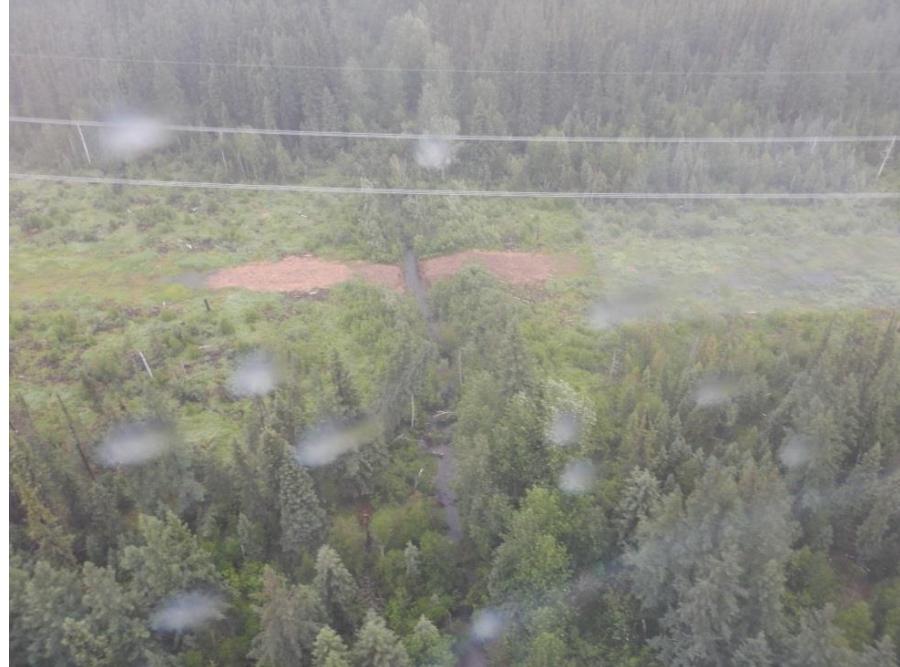
Photo 24. N3-Aqua-106 (unnamed tributary of the Mitishto River). Steep bank on the centerline trail with mulch, June 2017.

Steep banks were observed at N3-Aqua-106 and 107 which may be susceptible to erosion. In 2017, the centerline trail crossing at N3-Aqua-106 consisted of a mulch layer reducing the potential for erosion (photo 24) but at site N3-Aqua-107 there was erosion-prone soil (photo 25). Monitoring in 2018 showed sufficient bank regrowth at both sites to suggest bank stability is improving over time (photos 26 and 27).

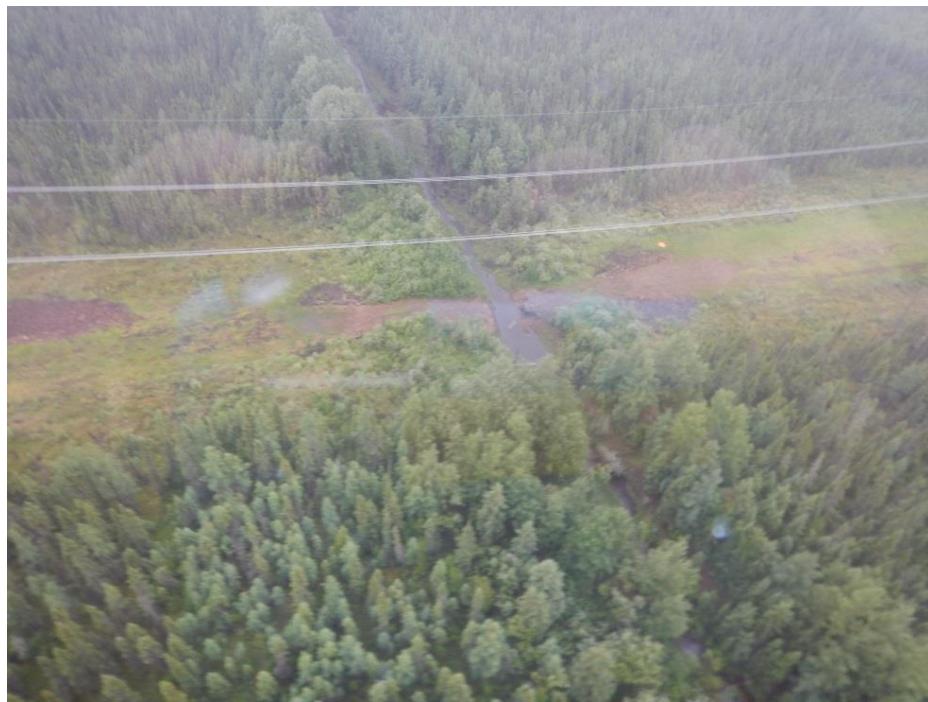
Photo 25. N3-Aqua-107 (unnamed tributary of the Mitishto River). Steep bank on the centerline trail with exposed soil, June 2017.

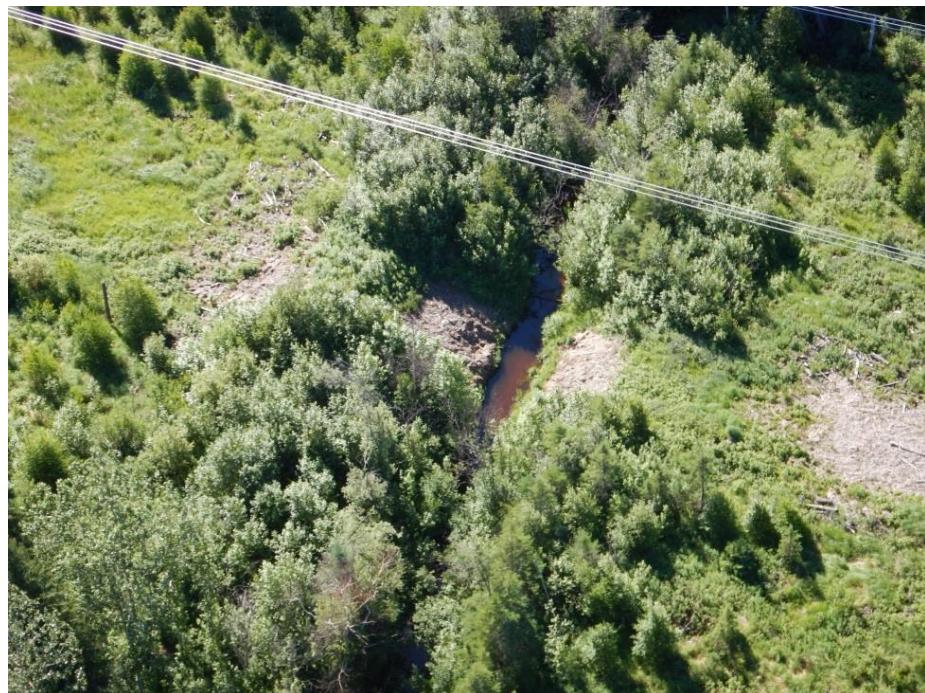
Photo 26. N3-Aqua-106 (unnamed tributary of the Mitishto River). Steep bank with good re-growth, June 2018.

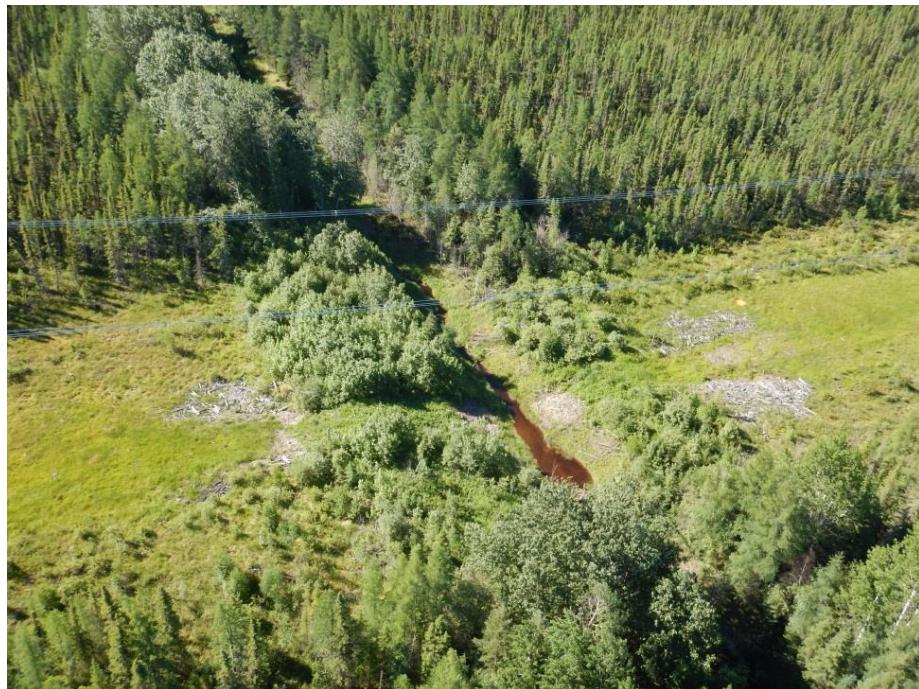
Photo 27. N3-Aqua-107 (unnamed tributary of the Mitishto River). Steep bank with good re-growth, June 2018.

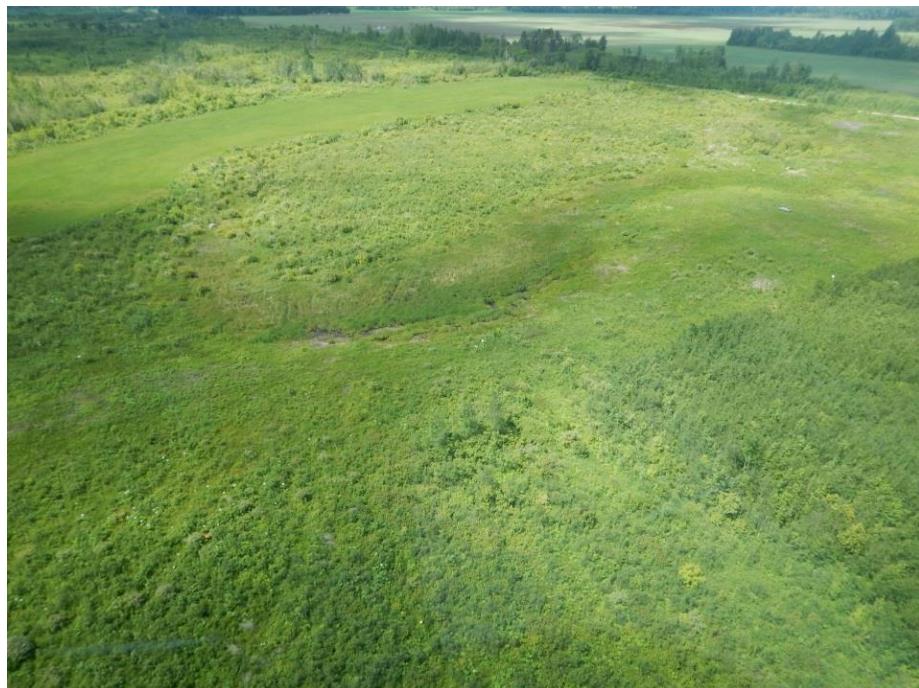
Photo 28. N4-Aqua-124 (unnamed tributary of Mafeking Creek), June 2017.

Construction was complete at all 42 watercourse crossings evaluated in segment N4 in 2018. Similar to 2017, no non-compliance issues with respect to prescribed mitigation measures were recorded at any site along N4 in 2018. However, one site (N4-Aqua-124) was cultivated, presumably by a local landowner and as such no watercourse crossing was visible during the current years monitoring (photos 28 and 29).

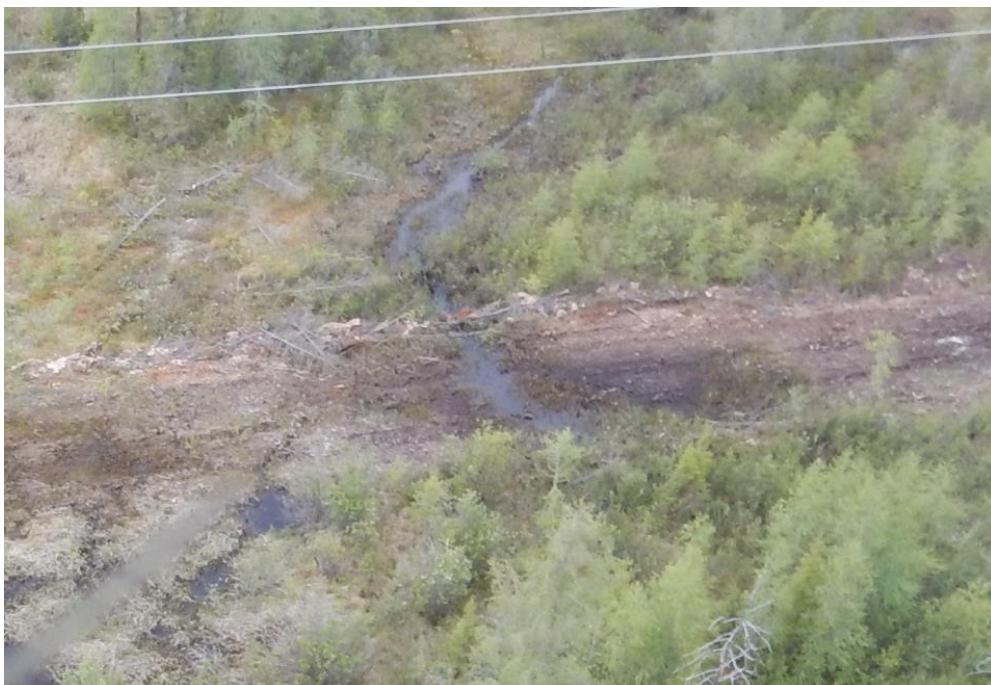
Photo 30. KGEL-Aqua-111. Debris left in channel after winter work, June 2017.

Construction was complete adjacent to all five watercourse crossings present through the KGEL and two watercourse crossings through the Northern Ground Electrode (GE) in 2018. Of the seven crossings, no site was deemed to be non-compliant with respect to the prescribed mitigation measures. In 2017, a follow-up visit was recommended at KGEL-Aqua-111 due to the presence of debris in the watercourse (photo 30). In 2018, the site looked normal and due to low water levels and a lack of suitable fish habitat was deemed in compliance with the prescribed mitigation measures (photo 31).

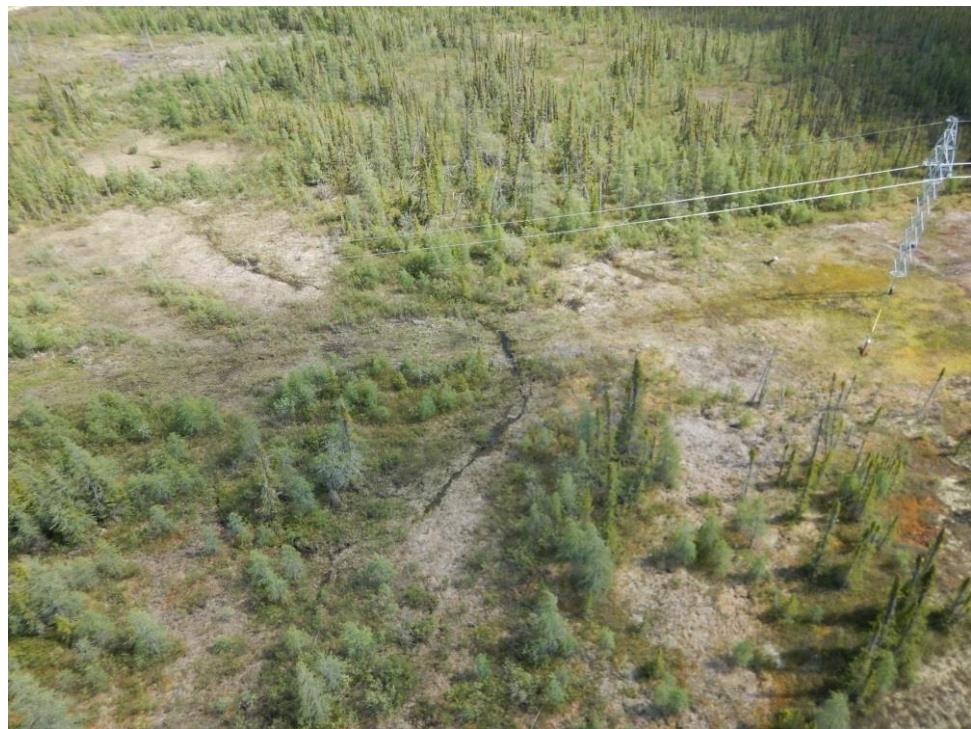
Photo 31. KGEL-Aqua-111. Debris no longer visible, June 2018.
