**BIRTLE TRANSMISSION PROJECT
BOTANICAL AND VEGETATION ENVIRONMENTAL MONITORING
ANNUAL TECHNICAL REPORT**

**Prepared for:
Manitoba Hydro**

**Prepared by:
Szwaluk Environmental Consulting Ltd.

October 2022

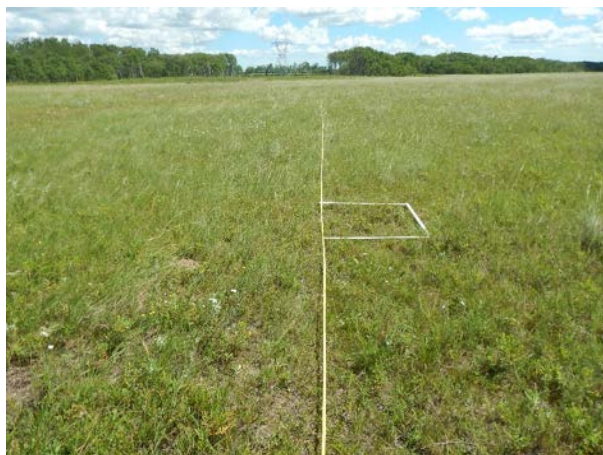
Photograph 4-1a. Community pasture grassland at monitoring site PRA-54.

Prairie sites in the community pasture are dominated by native grasses, with a diversity of native forbs, few low shrubs, and a general absence of trees and tall shrubs. Very few non-native species are observed in plots. Photograph 4-1a shows the grassland on the RoW in Year II monitoring, at PRA-54.

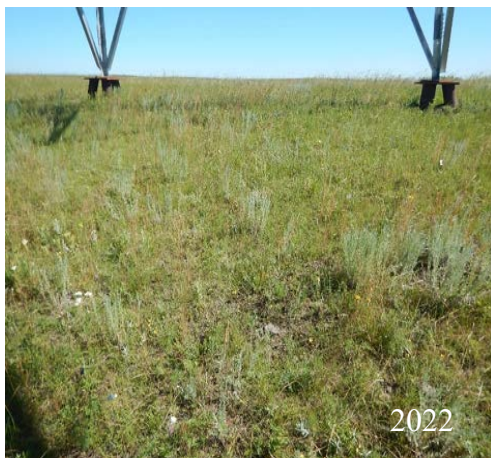
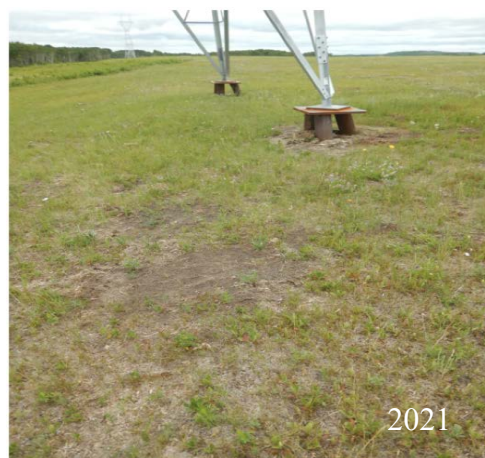
infrequent, and where present is due generally to animal activity (i.e., cattle watering areas, small mammal burrows). The equipment path (apparent in 2021 as some bare ground, minor rutting and sparse vegetation) was less apparent in 2022. Bare ground also noted previously in 2021 at Tower 122 was not observed this year (Photographs 4-1c and 4-1d).

Photographs 4-1c and 4-1d. Tower 122 near PRA-53 with vegetation cover in the current season (2022) compared to areas of bare ground in the previous year (2021).

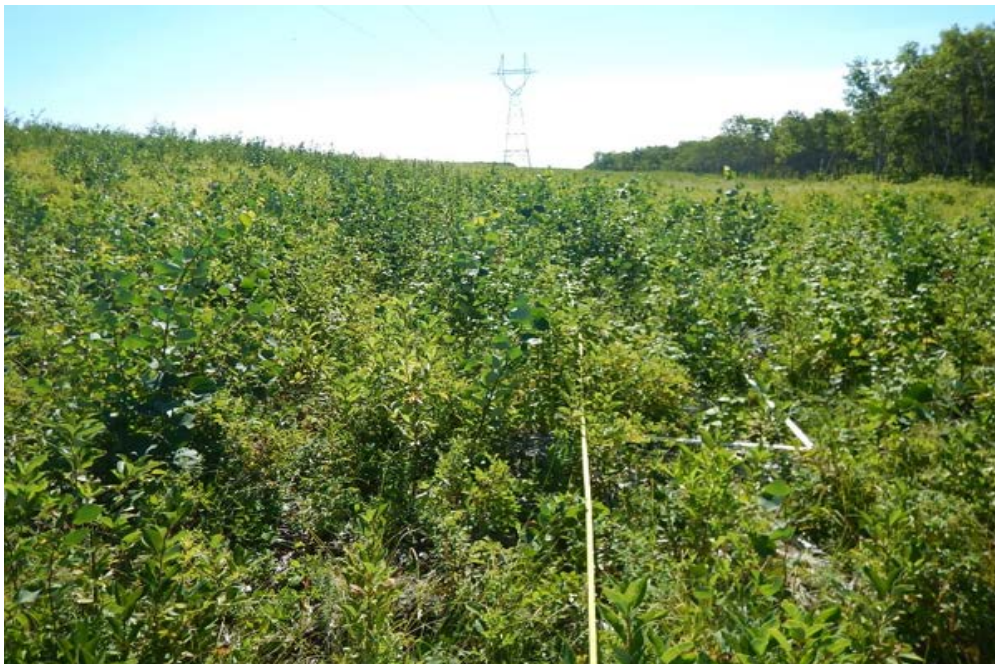
The predicted change in native vegetation cover as a result of the project was accurate for forest habitat. For safe operation of the transmission line, tree cover in the RoW is required to be removed during clearing and construction activities. This season, regeneration growth of trembling aspen (*Populus tremuloides*) is at or slightly above 1 m in height, patchy in places to moderate in distribution (Photographs 4-2a and 4-2b). Although less common, other regenerating tree species include bur oak (*Quercus macrocarpa*) and paper birch (*Betula papyrifera*). Removal and long-term loss of RoW forest cover is an effect of transmission line development (Manitoba Hydro et al. 2003). Fragmentation from large-scale corridor projects is frequently an unavoidable consequence. Windfall (blow-down) of susceptible trees along the newly created forest edges was observed in one instance into the RoW at site TER-65. With the exception of a patch of crested wheatgrass (*Agropyron cristatum*) and smooth brome (*Bromus inermis*) transitioning into nearby trees and shrubs, vegetation composition and structure adjacent to the Project footprint appeared unmodified.

Photograph 4-2a. Typical regrowth around 1 m in height, with moderately dense cover at TER-63.

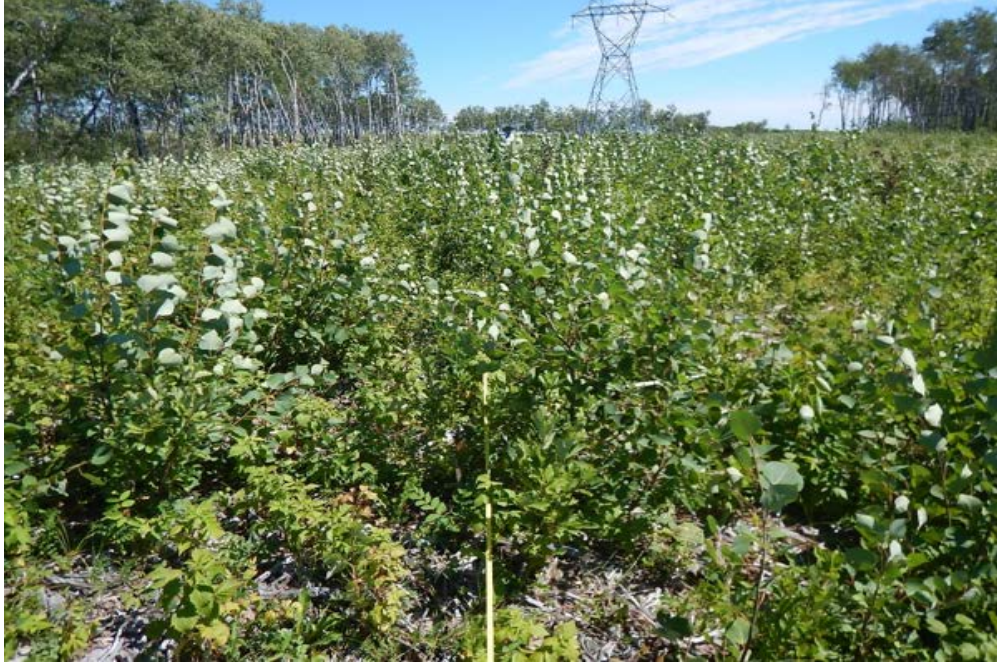
Photograph 4-2b. Regrowth at <2 m in height at TER-66.

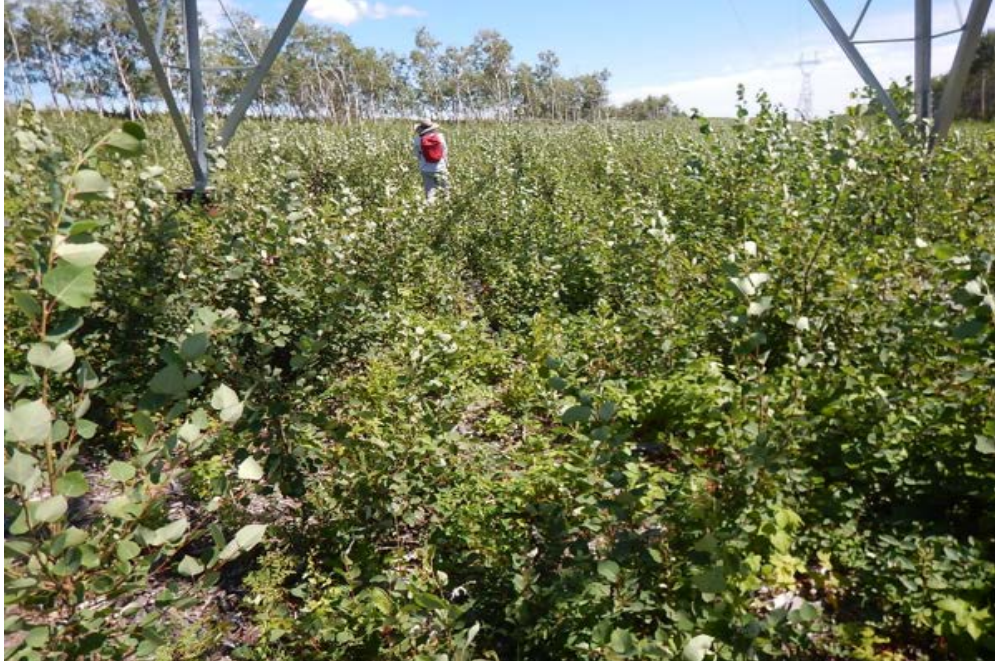
Photograph 4-2c. Angle Tower 124 with taller woody regrowth near TER-66, <2 m height.

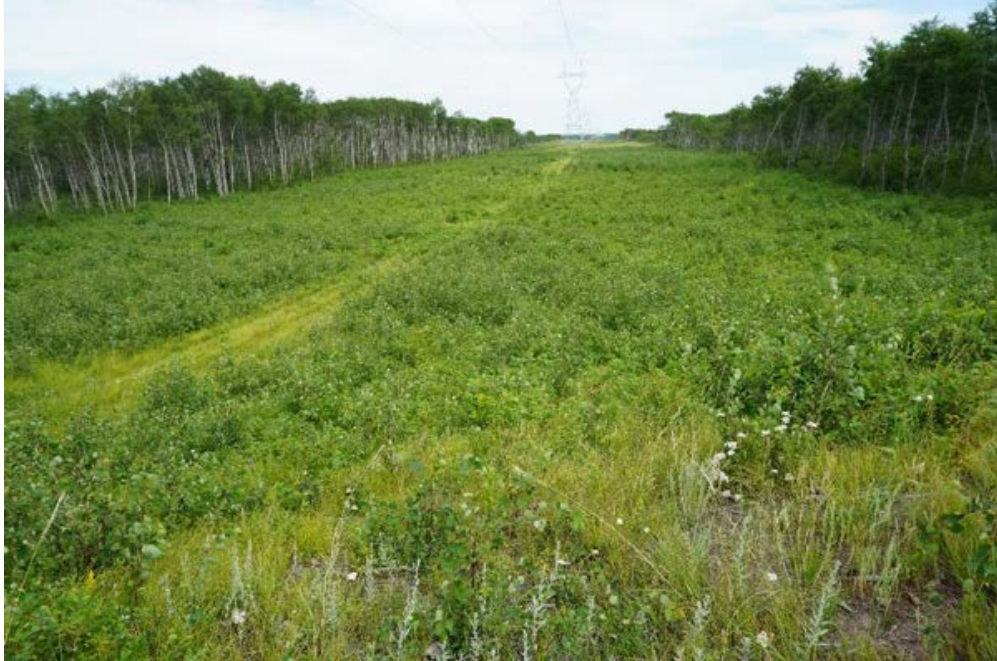
Photograph 4-2d. Previous forest clearing in the RoW.

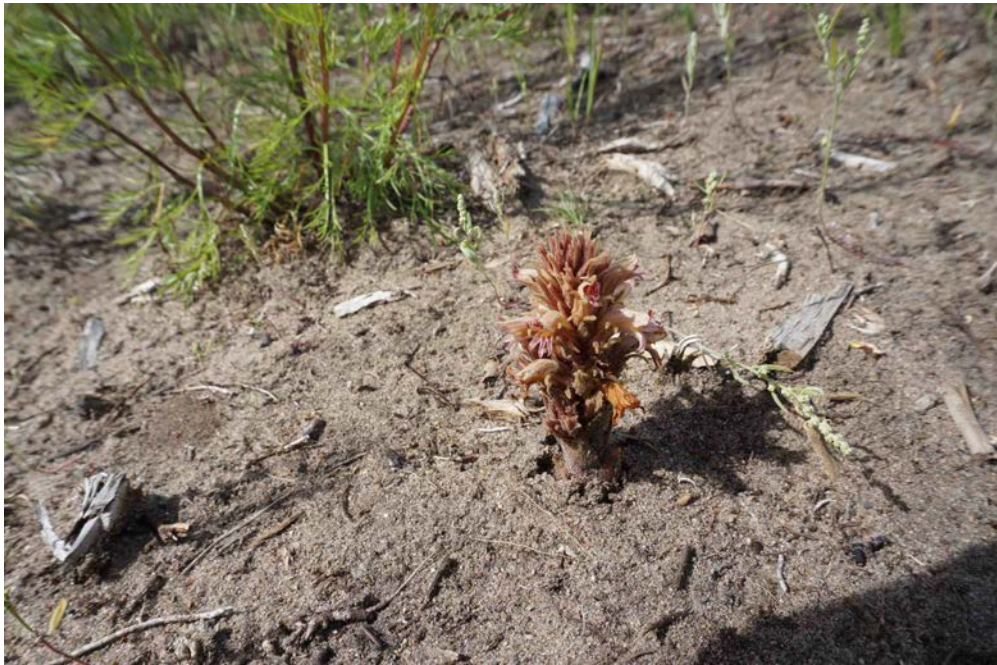
Photograph 4-5a. Louisiana broomrape seen growing near *Artemisia campestris*, in open sand at Tower 114.

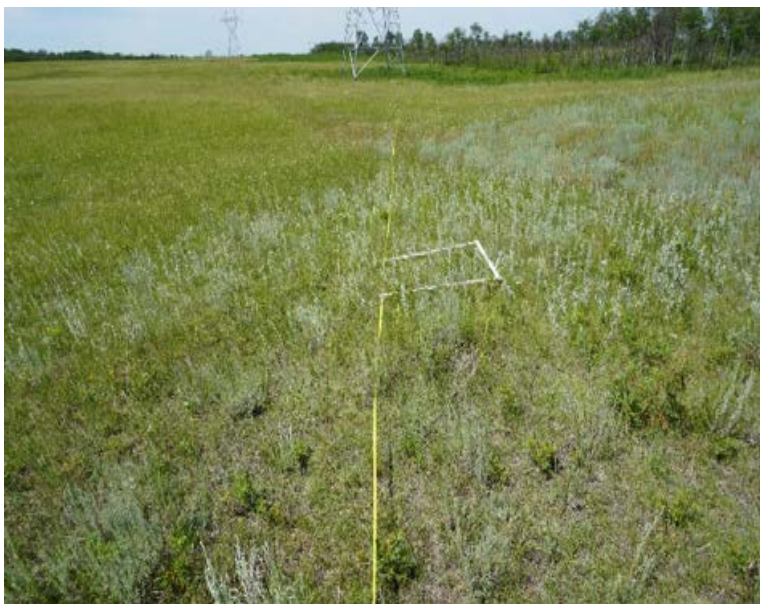
In grassland sites, the equipment path (apparent in 2021 as some bare ground and sparse vegetation) was less apparent in 2022, with continued minimal to no soil disturbance. In 2021, vegetation on the equipment path near PRA-26 was extremely sparse which has now recovered to dense regrowth of pasture sage (Photograph 4-6a below).

Photograph 4-6a. Equipment path near PRA-26 with no bare ground and dense regrowth of pasture sage (top right).

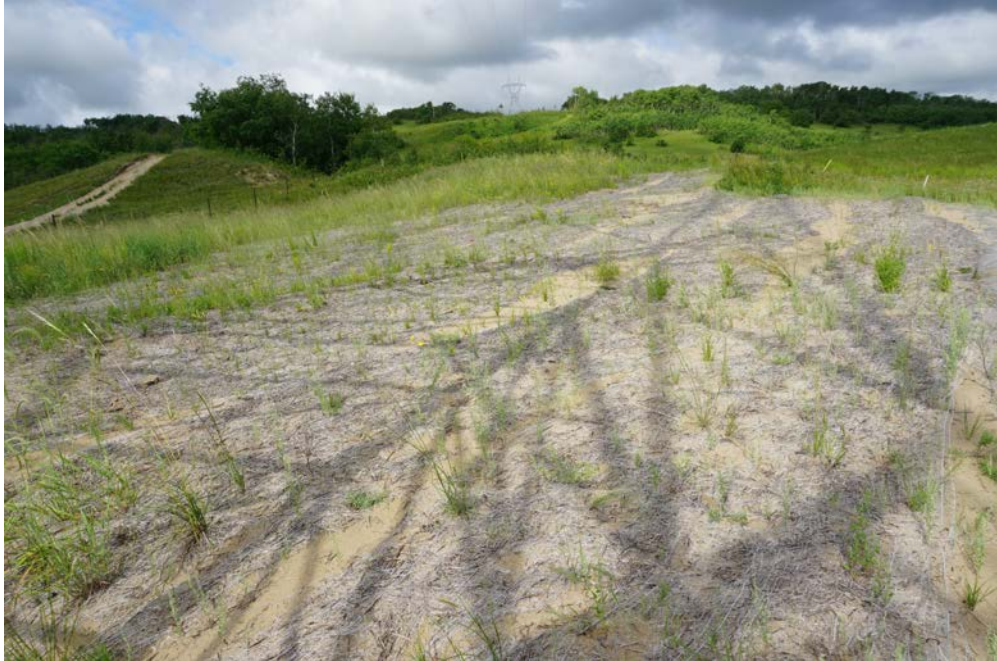
To address bare ground post construction, the site had been previously treated with straw revegetation mats, placed on the slope above the tower and at the tower footing over an area of approximately <0.2 ha. Currently, sparse regrowth of native grasses and some ruderal forbs are present at the tower footing, along with broad areas of bare sand and worn straw mats (Photographs 4-6b, 4-6c). On the upper slope at the tower site is a small patch that appears to have been seeded over the straw mats to a dense regrowth of native grasses and native and non-native showy wildflowers, (Photograph 4-6d). The density and diversity of this patch stands out in contrast to the surrounding native vegetation both adjacent to and on the RoW. There is no evidence of invasive growth from the non-native species, which include poppies (e.g. *Eschscholzia* sp. and *Papaver* sp.), a non-native tickseed (*Coreopsis* sp.), and rocket candytuft (*Iberis amara*). Other expected native prairie species are also present, in great abundance including upright prairie coneflower (*Ratidiba columnifera*), blue flax (*Linum lewisii*), purple prairie clover and white prairie clover (*Dalea candida*). Native bunch grasses are also abundant throughout replanted area and downslope along fence line. These include one-sided wheatgrass, Virginia wildrye (*E. virginicus*), needle-and-thread grass (*Hesperostipa comata*), sand ricegrass (*Eriocoma hymenoides*), sand reedgrass (*Sporobolus rigidus*), sand dropseed (*S. cryptandrus*), and Schweinitz's flatsedge (*Cyperus schweinitzii*), some of which were not previously recorded from this site (pre-construction). A small wetland spring upslope of previously planted regrowth is surrounded by small trees and shrubs within the undisturbed native pasture. Moisture from the spring may be contributing to the relatively lush regrowth in the immediate area, it seems unlikely that this site has had soil amendments.

Photograph 4-6b. Upslope of Tower 114, with remains of straw revegetation mats and sparse native vegetation regrowth, and patch of dense replanted native grasses and native and non-native wildflowers (center top, to fence line, pale green).

A custom native reclamation seed mix (Skinner's Native Seeds) was broadcast throughout the tower area where vegetation was sparse or absent, on straw mats and bare ground. Native seed content was a 60:40 mix of grasses to forb, specifically one-sided wheatgrass (20%), blue grama grass (10%), plains rough fescue (10%), little bluestem (10%), western porcupine grass (10%), and purple prairie clover (40%). Each of these species occur within the broader area, and at least half are pre-existing at the tower site specifically.

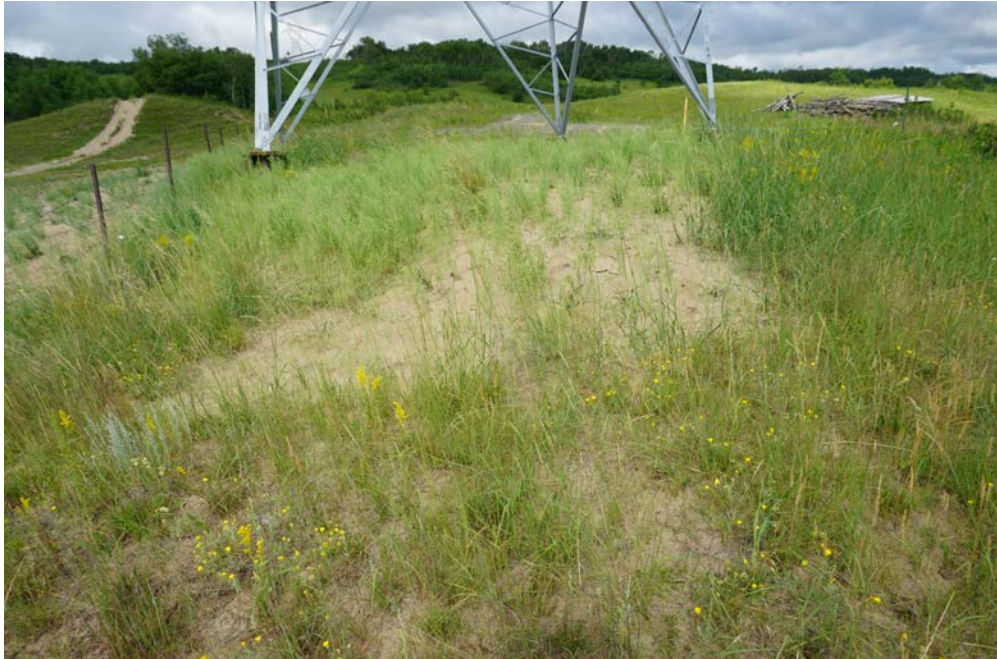
Photograph 4-6c. Downslope of Tower 114 with original native vegetation in foreground, ruderal *Chenopodium pratericola* on sand (center). Area of native and non-native wildflower planting is visible upslope below the trees.

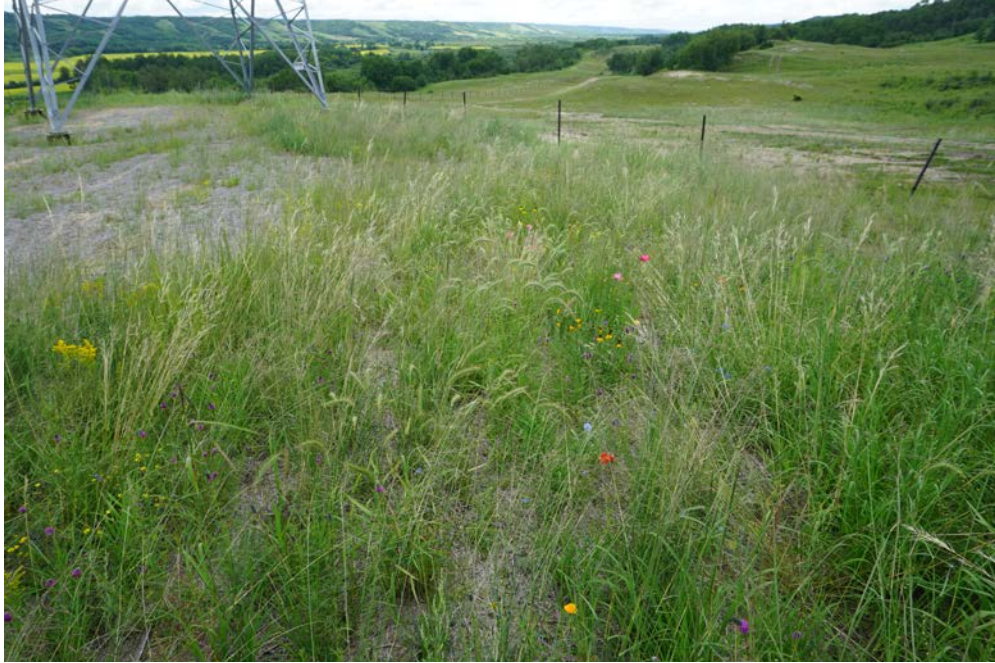
Photograph 4-6d. Upslope of Tower 114, area of dense regrowth (previously planted), with native grasses and native and non-native wildflowers over revegetation mats. Native bunch grasses continue downslope along fence line. Very sparse natural regeneration of native vegetation on remains of straw mats is visible in Tower footing. Note original sparse vegetation across fence line.
