BIRTLE TRANSMISSION PROJECT

Sharp-tailed Grouse Lek Monitoring 2017–2022

ENVIRONMENTAL MONITORING PLAN

Wildlife Resource Consulting Services MB Inc.

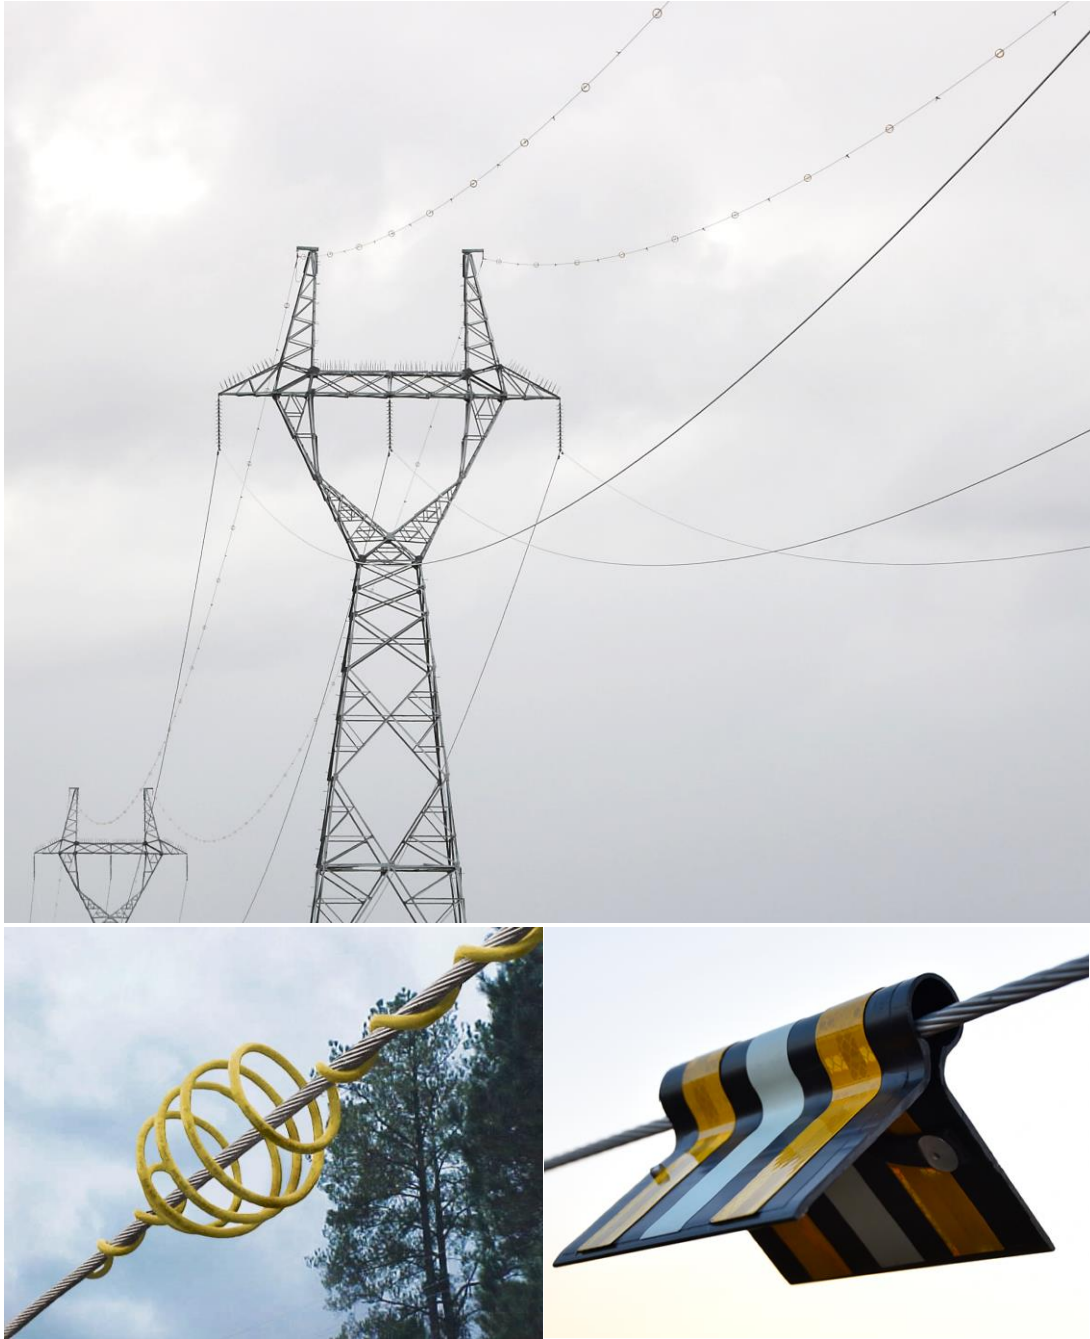
Photo 1: Alternating sequence of Swan-Flight™ Bird Diverters (bottom left) and Bird Flight Diveters (bottom right) on the Birtle Transmission Project (Linestar Utility Supply 2021; Preformed Line Products 2021)

Mitigation for the potential increase in avian predators and the risk of grouse-wire collisions included routing the Project through forested areas where possible and minimizing the number of tower spans crossing the Spy Hill-Ellice Community Pasture. Bird diverters, which have been proven to reduce bird-wire collisions (Morkill and Anderson 1991; Brown and Drewien 1995; Barrientos et al. 2012) were installed on the ground conductor wires to increase their visibility to birds. Alternating sequences of Swan-Flight™ Bird Diverters and Bird Flight Diverters (Photo 1) were employed. Perch deterrents were added to the upper arms of the support towers to dissuade avian predators from perching or nesting (Photo 2).

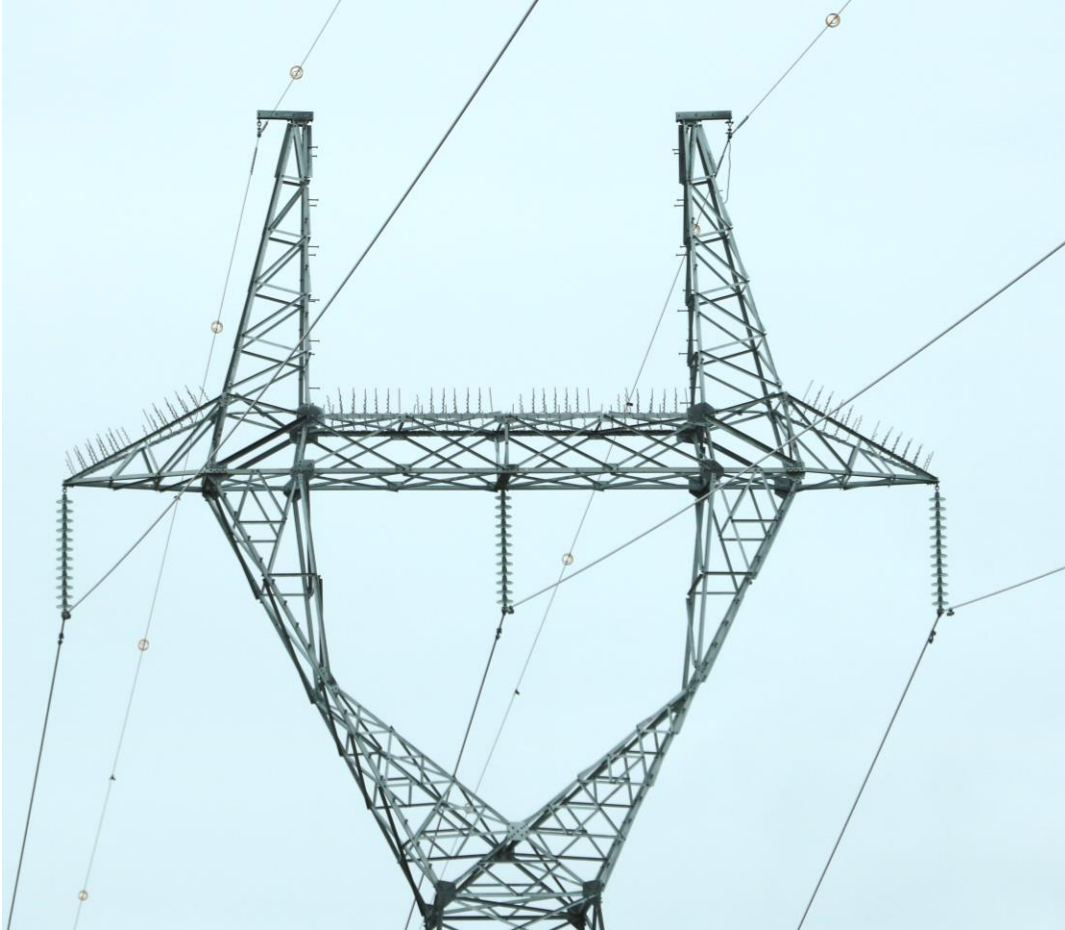
Photo 2: Perch deterrents on the upper arms of support tower

Perch deterrent effectiveness surveys that began in spring 2021 were repeated from May 2 to 5 and June 20 to 23, 2022. Six sites were surveyed, four at transmission towers where perch deterrents were installed (see Photo 2) and two at transmission towers with no deterrents (Map 2). At each site, two tower spans (three towers) were monitored for one hour by an observer who noted the species and behaviour of raptors (falcons, hawks, eagles) and of common raven (*Corvus corax*), American crow (*Corvus brachyrhynchos*), and black-billed magpie (*Pica hudsonia*), which are common nest predators. The total number of observations of each species perching was recorded each day, as it was not possible to determine whether an individual was returning to the location or if more than one was observed. Each site was surveyed daily over the four-day period in May. In June, sites with perch deterrents were surveyed daily over the four-day period and sites without deterrents were surveyed four times over three days, with morning and afternoon surveys on June 21. A total of 16 man-hours were surveyed in May and June. The number of perching avian predators was compared at sites with and without perch deterrents.

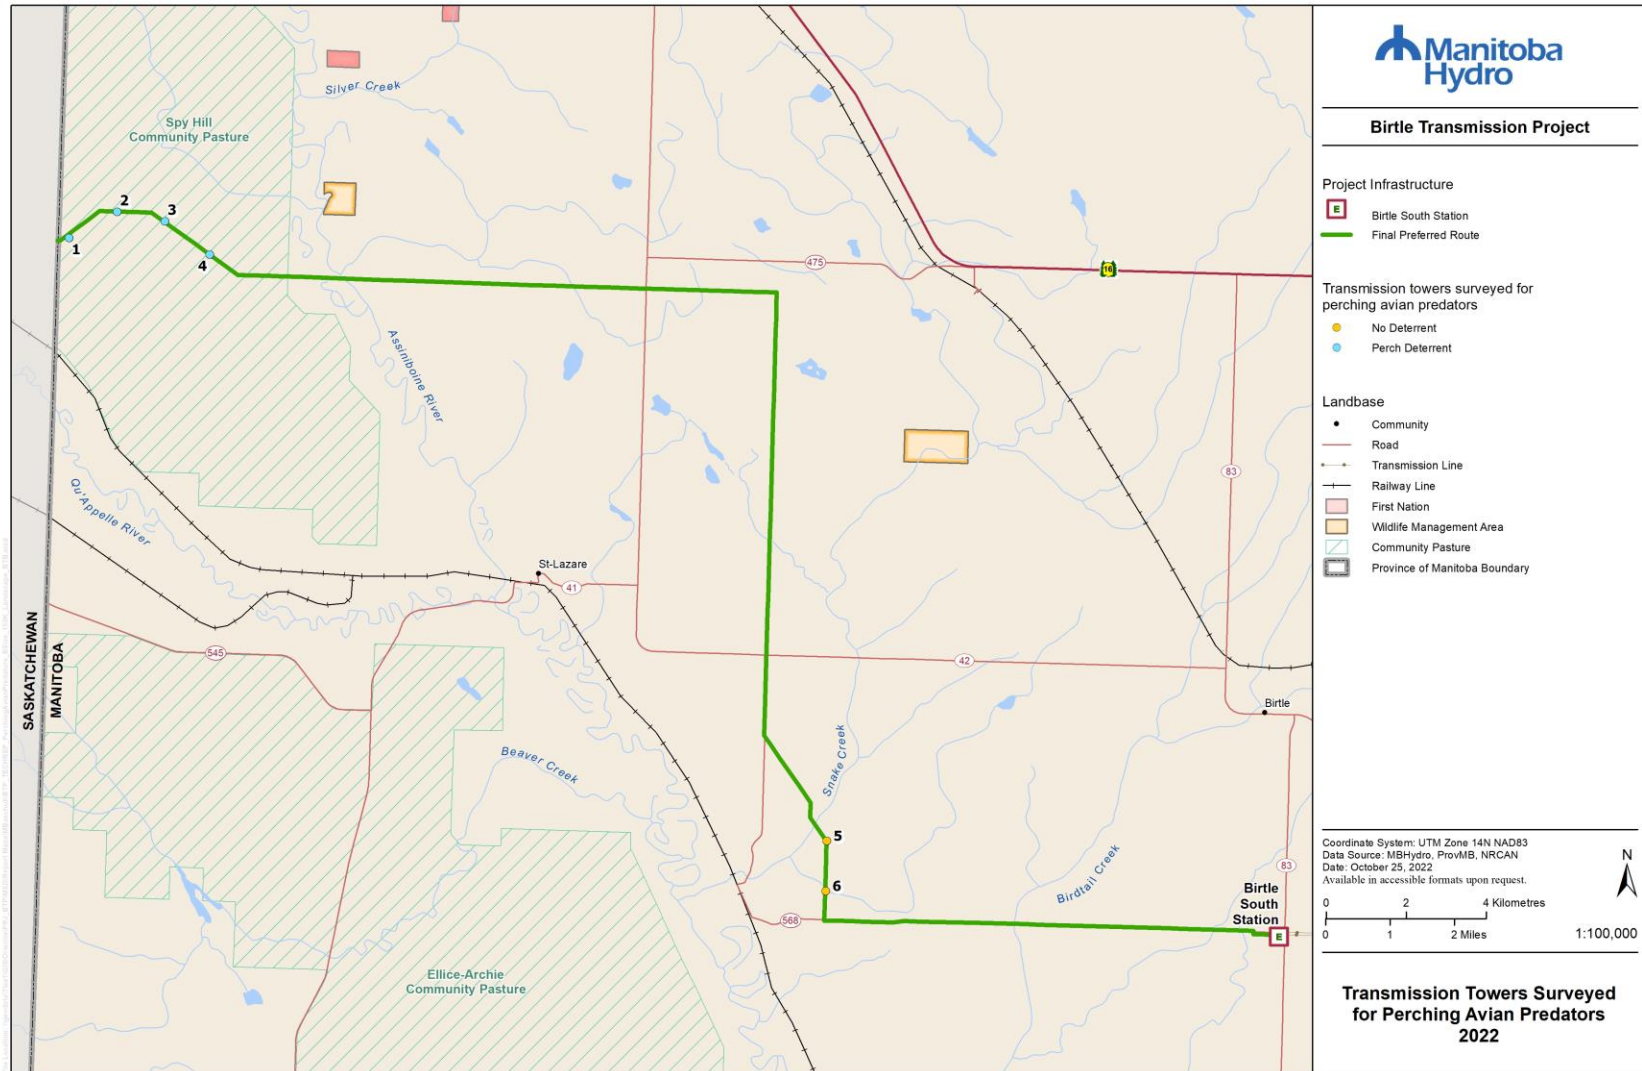
Map 2: Transmission towers surveyed for perching avian predators, 2022

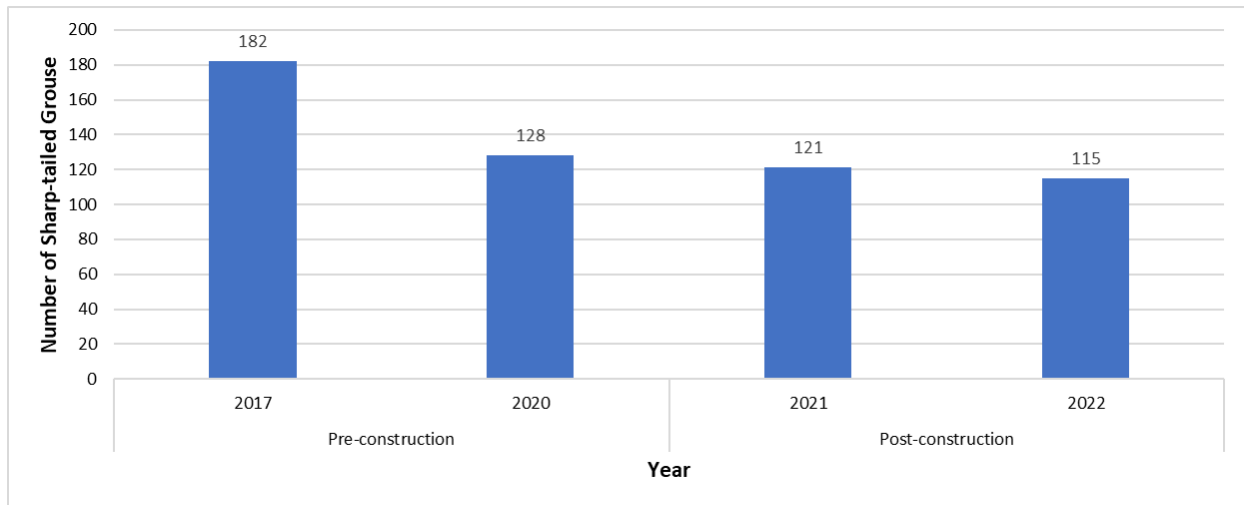
Figure 1: Number of sharp-tailed grouse observed on leks in the Spy Hill-Ellice Community Pasture before and after Project construction

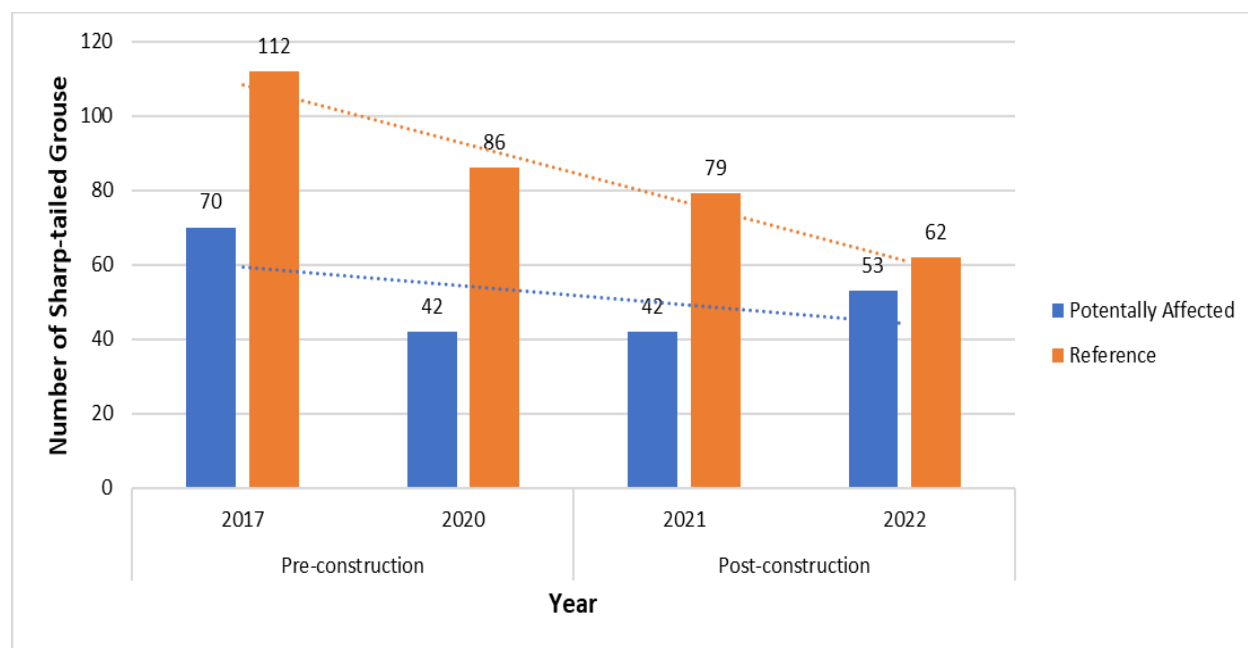
Figure 2: Number of sharp-tailed grouse observed at potentially affected and reference leks in the Spy Hill-Ellice Community Pasture before and after Project construction

The number of sharp-tailed grouse observed on potentially affected leks in the Spy Hill-Ellice Community Pasture declined from 2017 to 2020, before Project construction, remained the same in 2021, and increased in 2022 (Figure 2). There was a 50% difference in the greatest (70 in 2017) and lowest (42 in 2020 and 2021) number of grouse observed on potentially affected leks in the community pasture. The number of sharp-tailed grouse observed on reference leks declined from 2017 to 2022. There was a 57% difference in the greatest (112 in 2017) and smallest (62 in 2022) number of grouse observed on reference leks in the community pasture. The decline in the number of sharp-tailed grouse appeared to be greater on reference than potentially affected leks over the survey period (Figure 2).
