Keeyask Transmission Project **Environmental Effects Monitoring Plan** Annual Report

Prepared by:
Manitoba Hydro
Winnipeg, Manitoba
June 2020

Keeyask Transmission Project 2019/20 Environmental Effects Monitoring Report

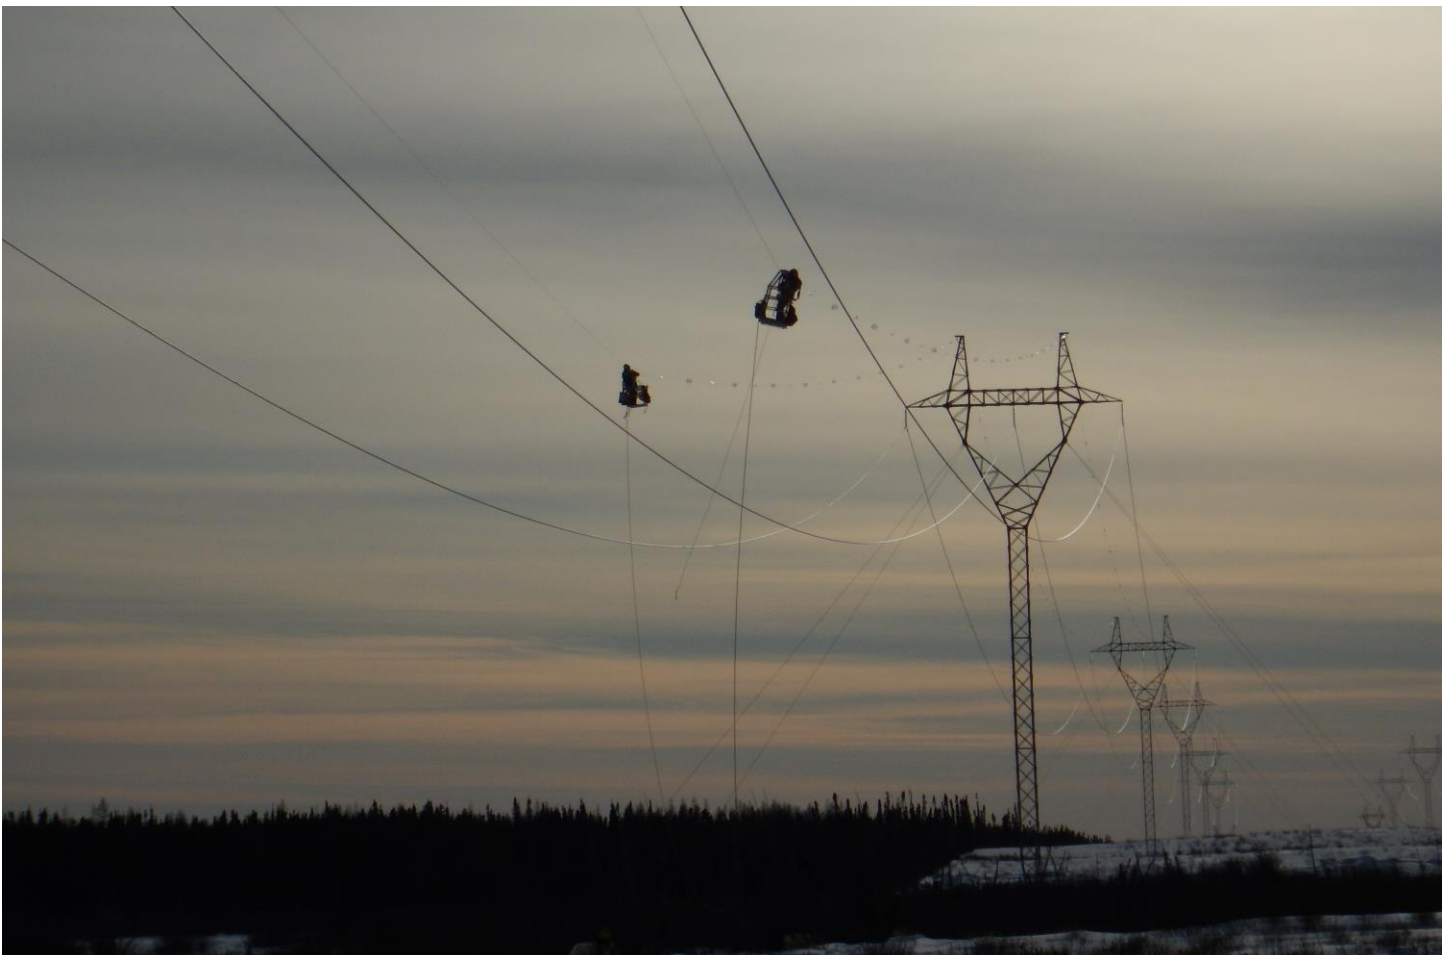
Photo 3: Bird diverter installation on the Keeyask Transmission Project.

Mitigation efforts, including bird-wire diverters, appear to be effective.

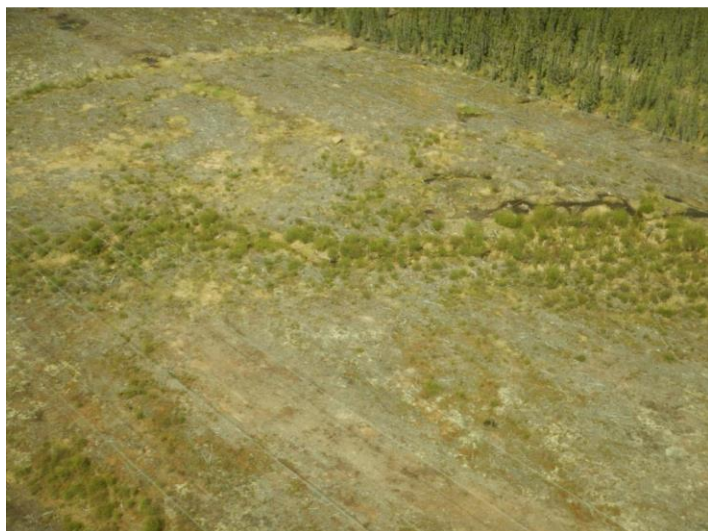
Photo 4: Vegetative regrowth along a tributary of the Butnau River photographed on June 17th, 2019.

As predicted in the EA, Project effects on stream crossings were minor and have recovered. Of the 39 watercourse sites assessed in 2019, all were

compliant with prescribed mitigation and have recovered from construction effects.

The implementation of mitigation recommendations outlined in the construction environmental protection plan was effective. Sites identified in 2015 and 2016 as being non-compliant with the prescribed mitigation showed signs of successful natural revegetation. Re-vegetation is occurring slowly, with forbs and shrubs observed growing along the stream banks and no active sedimentation of the stream being noted since being identified in 2015. As determined in previous monitoring years, due to naturally occurring re-vegetation and the marginal nature of the stream to fish, no further remediation is required.

Due to the natural revegetation of disturbed sites, no further remediation is required.

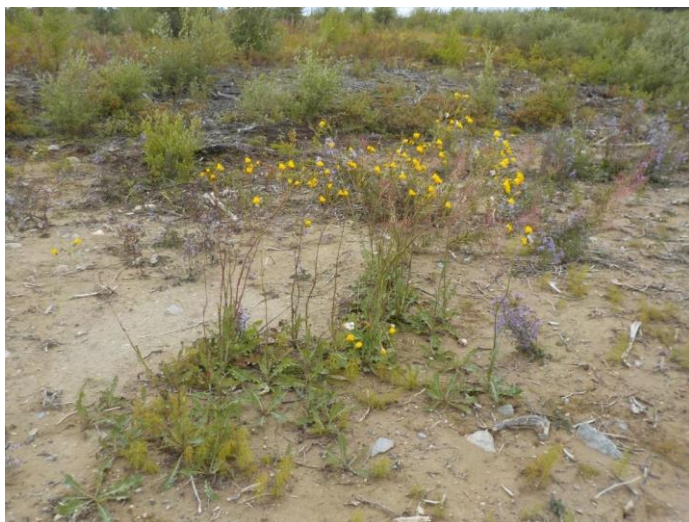
Photo 8: A patch of perennial sow-thistle growing in the ROW north of the South Access Road.

As predicted in the EA, Project construction had minimal effect on the spread of invasive species. Non-native plants were found at one site in 2016 and at four sites in 2017. Relatively large increases in the number of sites and total non-native plant cover did not occur until 2018. However, total non-native cover remained low, and distribution remained limited to a few locations in 2019. Most of the non-native plant cover was observed close to either a Keeyask Generation Project south access road ditch or the Radisson Converter Station. Seven non-native plant species were recorded during the surveys, which was five more than 2017. Of these species, perennial sow-thistle and white sweet clover were of moderate invasive concern while three were of minor invasive concern.

To date, none required. The likelihood that control efforts would be successful is limited by the close proximity of the same non-native plants in either the south access road ditch or the Radisson converter station. Also, ongoing expansion of native plant cover was expected to eventually crowd out or even eliminate non-native plants at some of the sites.

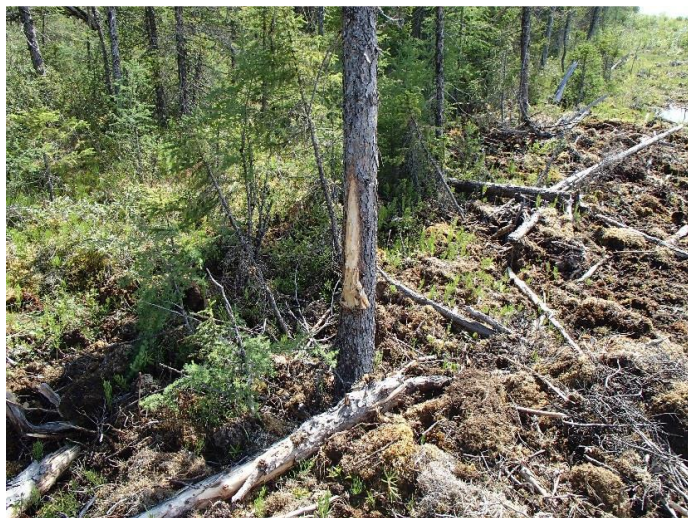
Photo 10: Mechanical damage to tree in priority habitat patch.

The monitoring found that actual Project effects on ecosystem diversity were less than predicted in the EA Report. As expected, 47 of the 125 priority habitat patches that existed along the Project footprint prior to construction were entirely or almost entirely removed by Project clearing. In contrast, there were only minor Project effects on the portions of priority habitat patches that were outside of the standard cleared ROW corridor width. Only one of the effects was large enough to be seen during low-altitude aerial surveys. All of the remaining effects were localized, small in area and never extending more than 20 meters from the edge of ROW clearing. The types of effects included tree damage, tree collapse, tree mortality, understorey vegetation mortality and understorey vegetation loss.

No follow up mitigation is required based on the survey findings.

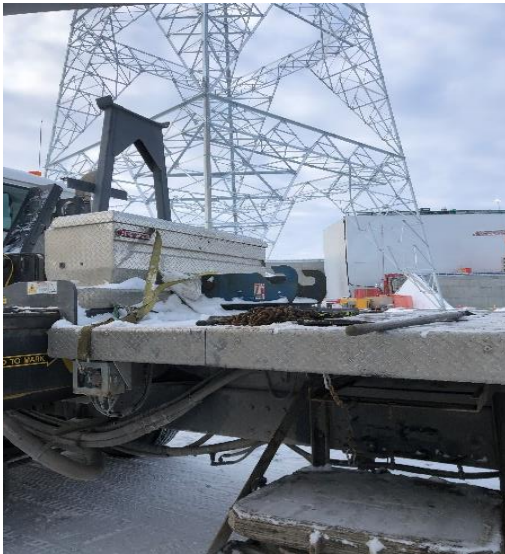
Photo 13: Environmental inspections were made of vehicles and equipment used on the construction site.

In 2019/20 all Project components of the Keyyask Transmission Project were in compliance with applicable requirements. No regulatory citations or warnings were issued. There were a number of minor hazardous material releases, however none meeting the threshold requiring a report to the Province. All spills have been identified with remediation completed. No wildlife mortalities were reported.
