Manitoba-Minnesota Transmission Project

Post-Construction Environmental Monitoring

Report

Certificate EC-059

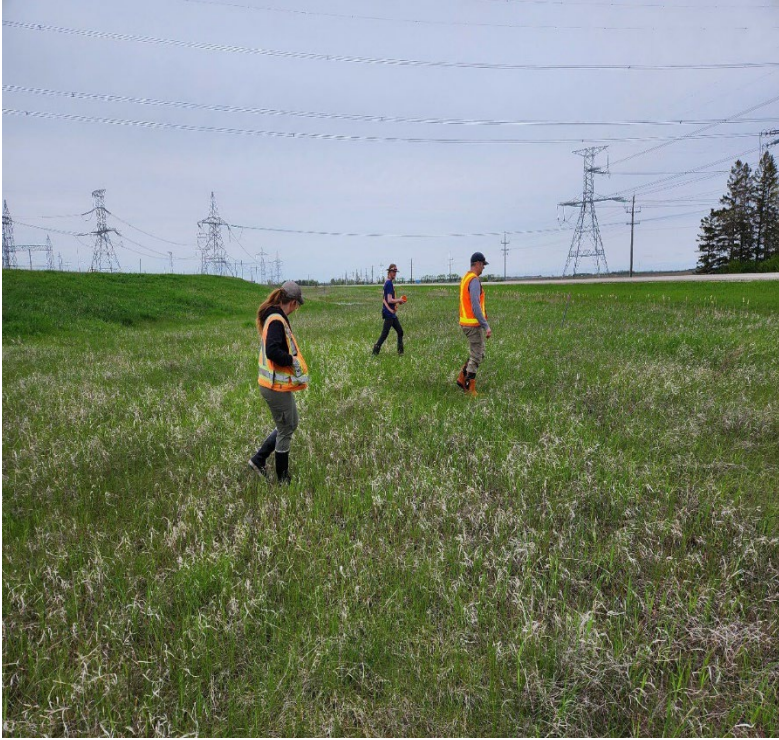
Photo 1 Bird-wire collision surveys were conducted along MMTP.

Bird-wire collision surveys using standardized methods were conducted by qualified contractors at thirteen pre-selected sites from May 14-23rd, 2024 (Photo 1). A summary of the results can be found below. Detailed information on methods, maps, and discussion found in the technical report included in Appendix B.

As predicted in the EIS, bird collisions were observed in post-construction phase of the Project. Estimated collision mortality rates were calculated based on number of collisions detected on surveyed transects, while accounting for site specific variables. In 2024, the estimated collision mortality rates were observed to decline and were comparable to those observed at other transmission lines in the Manitoba. Although annual variability in bird migration may have covariable, evidence suggests the installation of additional bird diverters contributed to this observed decline. No mortalities of species of conservation concern were identified in 2024.

The additional bird-wire diverters installed along MMTP appear to be effective at reducing the number of bird-wire collision mortalities. This survey found anecdotal evidence to suggest that increasing the density of bird diverters from one diverter per 5 m to one diverter per 2.5 m

reduced bird mortality in spring. The three sites that had more diverters added to existing diverters had lower bird mortalities compared to previous survey years, even when considering rate of bird passage over the project. One monitored site that had diverters added to it, and one site where diverter density increased, had collision mortality reduced to zero.

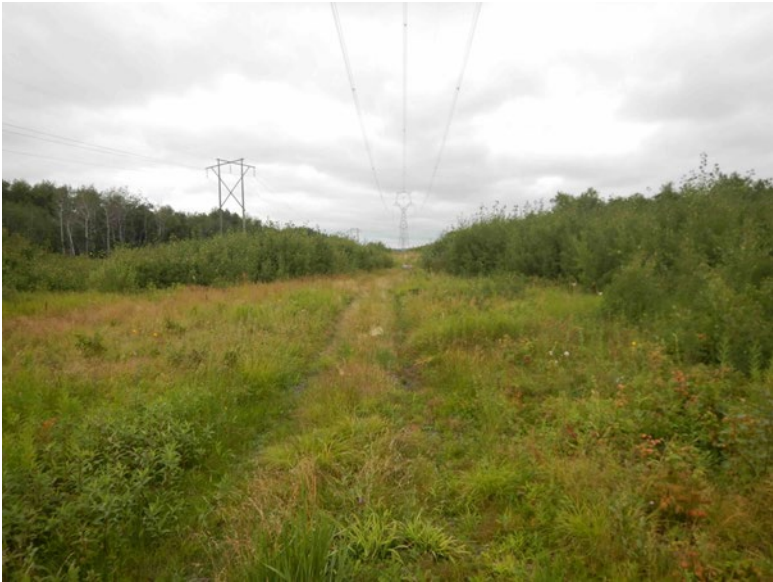
Photo 2 A golden-winged warbler (*Vermivora chrysoptera*) monitoring site with dense aspen regeneration in 2024.

Golden-winged warbler habitat surveys were conducted by qualified contractors using standardized vegetation surveys at thirteen pre-selected sites from August 6-11th, 2024 (Photo 2 and 3). A summary of the results can be found below. Detailed description of methods, maps, and results of the golden-winged warbler habitat survey can be found in the technical report included in Appendix A.

As predicted in the EIS, vegetation was selectively cleared as outlined in the habitat management plan to enhance suitability for golden-winged warblers. Overall, there was a continued general increase in vegetation cover and species richness in the lower vegetation canopies between 2021 and 2024. Average percent cover in the tall shrub layer doubled from the from 2022, and species richness is up slightly from the last monitoring year (2022). As predicted, post-construction monitoring showed mean species richness and cover have been consistent or slightly higher at monitored sites as a result of vegetation species regeneration and changing structure.

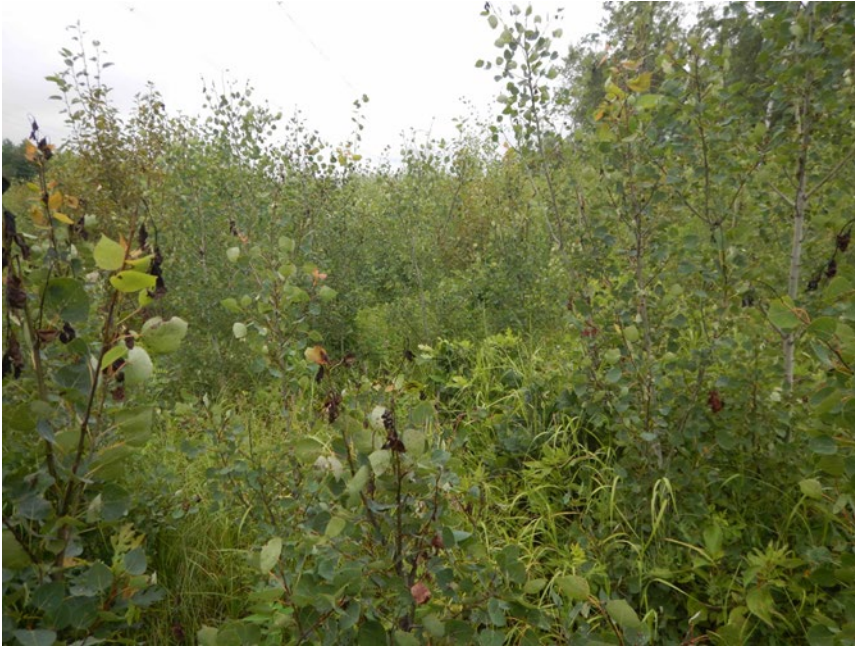
Photo 3 Dense deciduous regeneration extending into tree stratum in the MMTP right of way.
