## MANITOBA-MINNESOTA TRANSMISSION PROJECT BOTANICAL AND VEGETATION ENVIRONMENTAL MONITORING

### **ANNUAL TECHNICAL REPORT - Year III**

Prepared for: Manitoba Hydro

**Szwaluk Environmental Consulting Ltd.**

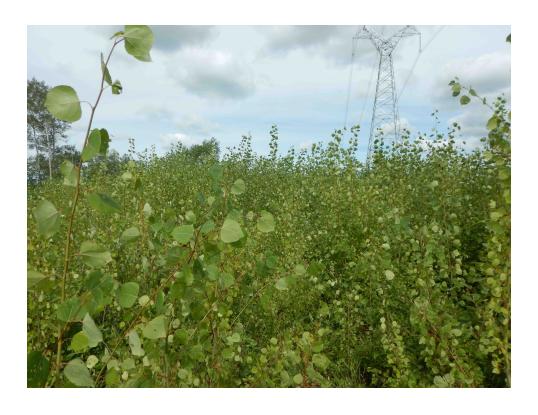
Photograph 4-1a. Dense aspen regeneration, 1 to 2.5 m in height, GWW-009.

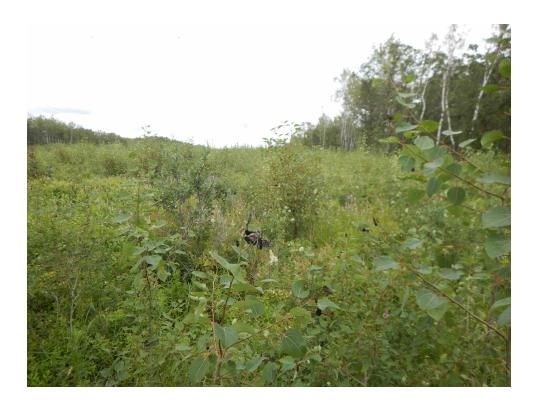
Photograph 4-1b. Vegetation regeneration at site GWW-016.

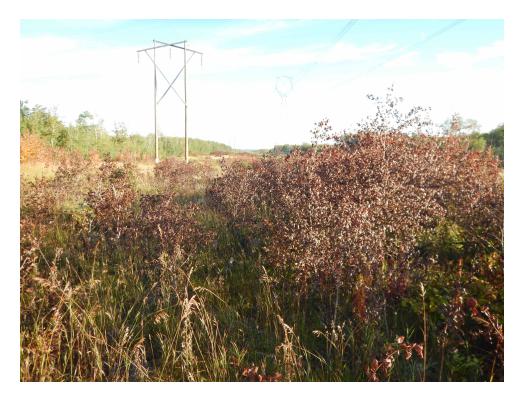
In two GWW sampling sites (GWW-006 and -015), broadleaf herbicide control occurred along an adjacent transmission line RoW, with over spraying extending extensively into areas of the MMTP RoW. Although some young saplings (e.g., trembling aspen) and other vegetation appeared to remain with living stems (in parts of the sprayed RoW), the leaves on these young regenerating shrubs and plants appeared stressed and discolored with leaves partly browning or blackening. In other areas where spraying occurred, the vegetation was more heavily damaged or destroyed in monitoring plots (Photograph 4-1c). At monitoring plot GWW-006, regenerating shrubs were also visibly trampled this season (Photograph 4-1d). According to the Habitat Management Plan (Manitoba Hydro 2016; Environment Canada IR EC/MH-003), higher quality GWW habitat was previously observed at GWW-006 compared to other sites, prior to herbicide application. Site GWW-006 supported the presence of graminoids, forbs, and a low and tall shrub layer, with patches of remaining shrub vegetation, adjacent to deciduous forest.

Photograph 4-1c. Broadleaf herbicide control extending into the MMTP RoW at GWW-015.

- 3. Broadleaf herbicide control extended into the MMTP RoW from as a result of vegetation management along an adjacent transmission line RoW. Extensive foliar damage was visible affecting species composition and cover in areas of goldenwinged warbler habitat. Direct and indirect contact with herbicide may also affect wildlife, including birds and their insect prey. It is recommended that future vegetation management in these areas follow the Right-of-Way Habitat Management Plan for Managing Critical Golden-winged Warbler Habitat (Manitoba Hydro 2016; Environment Canada IR EC/MH-003). It is also recommended that biologists be notified if future vegetation management (i.e., herbicide use) overlaps with environmental monitoring, to avoid these sites or adjust timing of surveys.

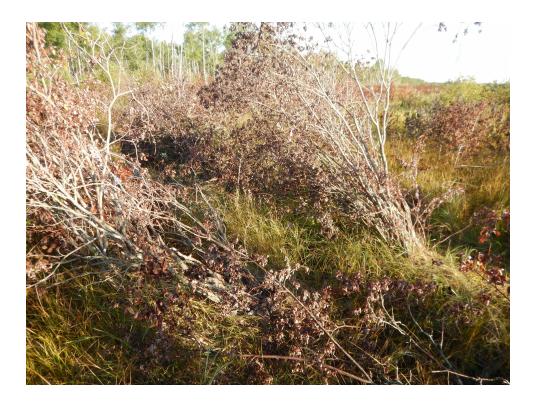
Photograph 4-1d. Broadleaf herbicide control at GWW-006 and trampling of tall shrub vegetation.

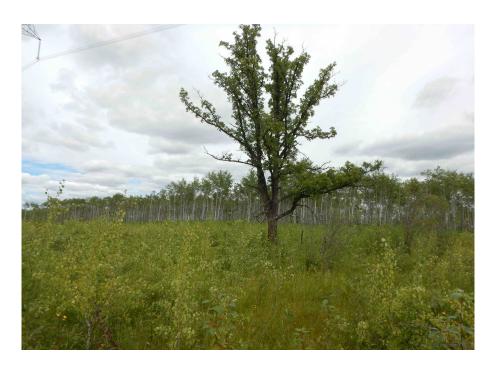
An old-growth oak tree (>100 years) remains unaffected at an environmentally sensitive site (HERT-201) on the RoW, approximately 12 m from the centerline, near monitoring plot GWW-008 (Photograph 4-1e). Slow growing old growth trees could remain in their habitat, where they do not interfere with vegetation clearance requirements for safe operation of the transmission line.

Photograph 4-1e. Old-growth bur oak remaining on the RoW in GWW habitat.

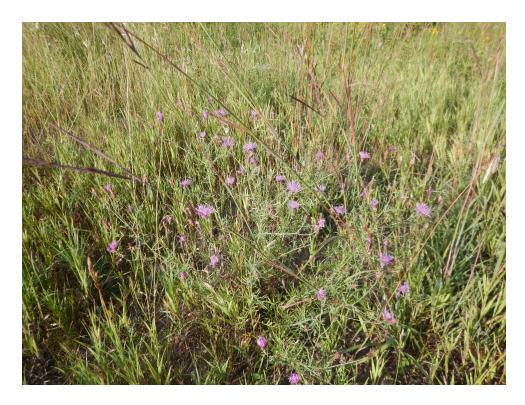
Spotted knapweed was newly recorded at INV-812-R (Photograph 4-2a) this season as a single patch, with hoary alyssum sporadically occurring at the site. In 2020, spotted knapweed was observed nearby (<1 km) at INV-377-R but not at this location in 2022. Hoary alyssum was observed roadside at three other locations this season (INV-203-R; -716-R; -813-R). Oxeye daisy was more frequently observed, recorded at 12 sites. At site INV-721-R, oxeye daisy was recorded in multiple (six) locations along a ditch ranging in distribution from a few plants to a single patch, although it was previously recorded here as a few patches with several sporadically occurring plants. While oxeye daisy was newly recorded at some sites (e.g., INV-210-R; 510-R), it was not re-recorded at others (e.g., INV-379-R; -385-R; -386-R). At one site where surveying was prevented by a gate on private land (INV-716-R), both oxeye daisy and hoary alyssum were visible along a trail from the access approach, (see Photograph 4-2b).

Photograph 4-2a. Spotted knapweed newly recorded at site 812-R (Tier 1).

- 2. Follow-up monitoring and management is recommended at five sites for Tier 2 noxious plant species observed along the final preferred route. These plant species should be managed to reduce further species spread, according to responsibilities under the current Regulation of The Noxious Weeds Act. Sites include INV-510-R, -716-R and -721-R for oxeye daisy (*Leucanthemum vulgare*) and sites INV-203-R, -716-R and 812-R for hoary alyssum (*Berteroa incana*). Noxious and invasive plant species have the ability to spread rapidly on disturbed ground and the risk of spread along the RoW or into adjacent sites may increase with each season. All regulatory requirements and license commitments should be met. For plant species management, refer to the Rehabilitation and Invasive Species Management Plan (Manitoba Hydro 2019d).

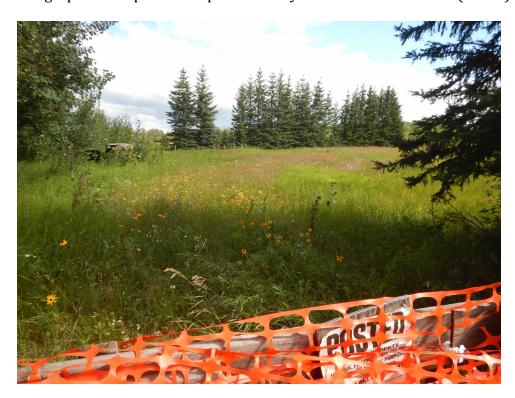
Photograph 4-2b. Oxeye daisy and hoary alyssum visible during surveys along an access approach and trail at site INV-716-R.

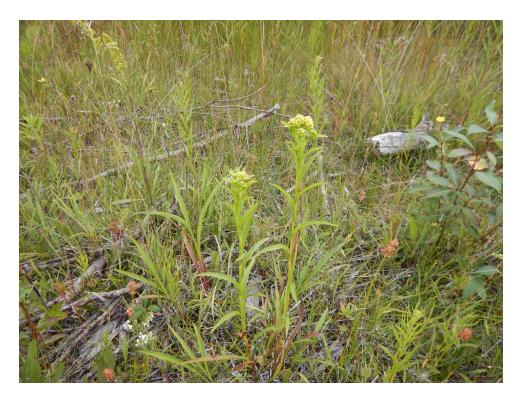
One species at risk was observed during project monitoring, listed under the Manitoba's *Endangered Species and Ecosystems Act* (ESEA) and the federal *Species at Risk Act* (SARA). Riddell's goldenrod (*Solidago riddellii*, S2S3) is listed as Threatened by ESEA and Special Concern by SARA. The Committee on the Status of Endangered Wildlife in Canada (COSEWIC) also lists this species as Special Concern. Riddell's goldenrod was incidentally observed during sampling in 2021 and observed again in 2022 at GWW-000. Riddell's goldenrod was located on the RoW, in a ditch with approximately 30 plants recorded (Photograph 4-3).

Photograph 4-3. Riddell's goldenrod observed near sampling plot GWW-018.

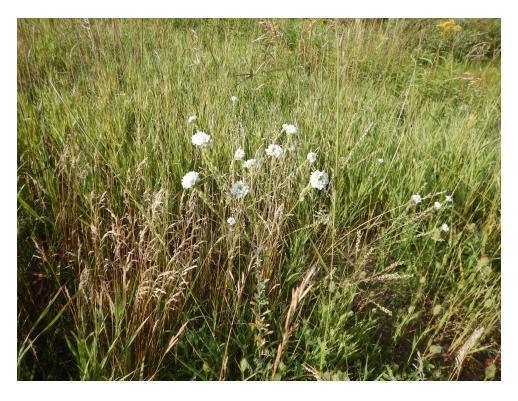
Photograph 4-4a. Hoary alyssum observed at site INV-812-R.

This season, 22 additional sites (21 select INV sites plus one tower site) were visited to investigate the presence of invasive plant species along the RoW. The most threatening noxious weeds observed this season included Tier 1 spotted knapweed (*Centaurea stoebe*), and Tier 2 hoary alyssum (*Berteroa incana*) and oxeye daisy (*Leucanthemum vulgare*). Spotted knapweed was newly recorded at site INV-812-R, and subsequently removed. Spotted knapweed was not observed at site INV-377-R this year. The distribution of Tier 1 and 2 noxious plant species was reduced this season from previous monitoring in 2020 and 2021. Photographs 4-4a and 4-4b show hoary alyssum and oxeye daisy observed at sites in 2022. Where observed and manageable, Tier 1 and 2 noxious plants were pulled, bagged and removed from sites.

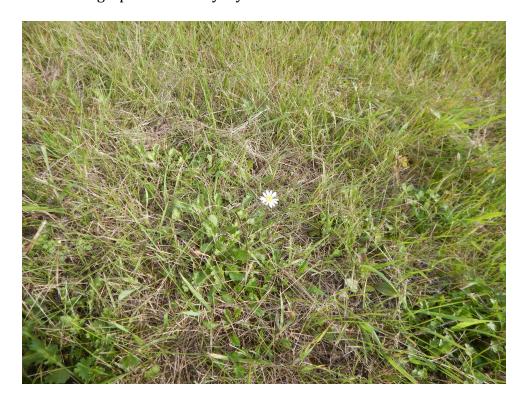
Photograph 4-4b. Oxeye daisy observed at site INV-721-R.

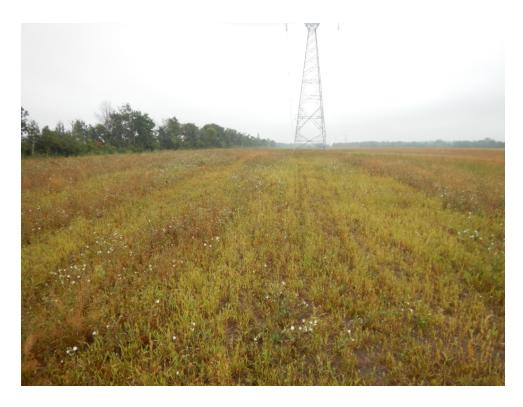
In 2021, white cockle (*Silene latifolia*, Tier 3 noxious weed) was observed at Tower 323 with a few gaps in a near continuous distribution throughout the RoW, approximately 150 m in length (Appendix V, Adams et al., 2009). The plants were knocked down with weed eaters to reduce further seed spreading from maturing plants, and follow-up management was recommended due to the size of the infestation. In 2022, white cockle was absent from the RoW at Tower 323. A native seed mix was previously broadcasted on the bare ground. Photograph 4-4c and 4-4d shows the site in 2021 and 2022, respectively.

Photograph 4-4c. Infestation of white cockle at Tower site 323 in 2021.

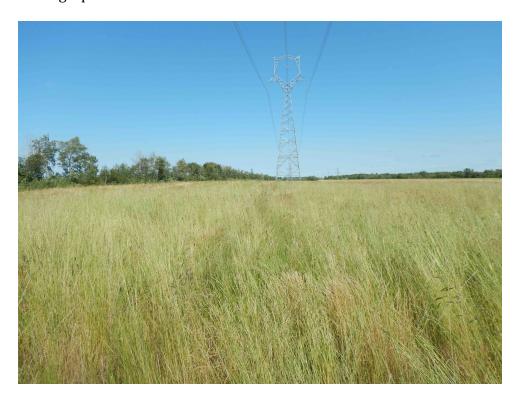
Photograph 4-4d. White cockle not observed in 2022 along RoW at Tower site 323, with establishment of grass mix previously seeded.

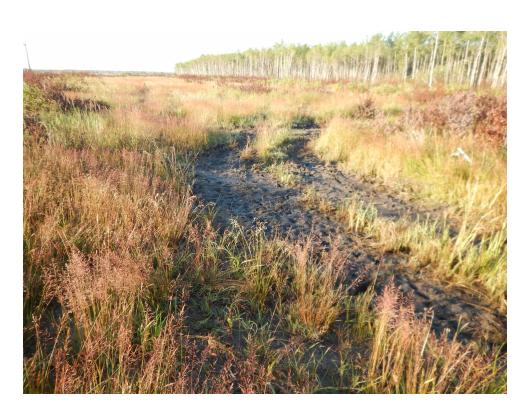
Re-seeding efforts occurred at two sites along the RoW, as bare ground was still apparent during this seasons sampling. Near GWW-006, patches of bare soil occurred off the road allowance leading into the RoW. An area approximately 5 x 15 m was broadcast seeded with a native seed mix (Photograph 4-4e). Near site GWW-019, an area 10 x 10 m of bare ground was still pervasive, as were sporadic non-native and noxious Tier 3 plants. Species observed here included creeping bentgrass (*Agrostis stolonifera*, SNA), tufted hairgrass (*Deschampsia cespitosa*, S4S5), reed canarygrass (*Phalaris arundinacea*, S5), barnyard grass (*Echinochloa crus-galli*, SNA), slender wildrye (*Elymus trachycaulus*, S5), foxtail barley (*Hordeum jubatum*, S5) and American sloughgrass (*Beckmannia syzigachne*, S5). The area was re-seeded in the RoW at the end of an access trail. The content of the native seed mix applied this season was 95:5 grass: forb, and specifically 30% Canada wildrye, 20% side oats grama, 20% slender wheatgrass, 15% tufted hairgrass, 10% Junegrass, and 5% American vetch. The native seed reclamation mix was prepared by BrettYoung.

Photograph 4-4e. Bare soil re-seeded near GWW-006. Also, damaged vegetation (brown color) from herbicide application in background.
