# Manitoba-Minnesota Transmission Project

## Post-Construction Environmental Monitoring

### Report

Certificate EC-059

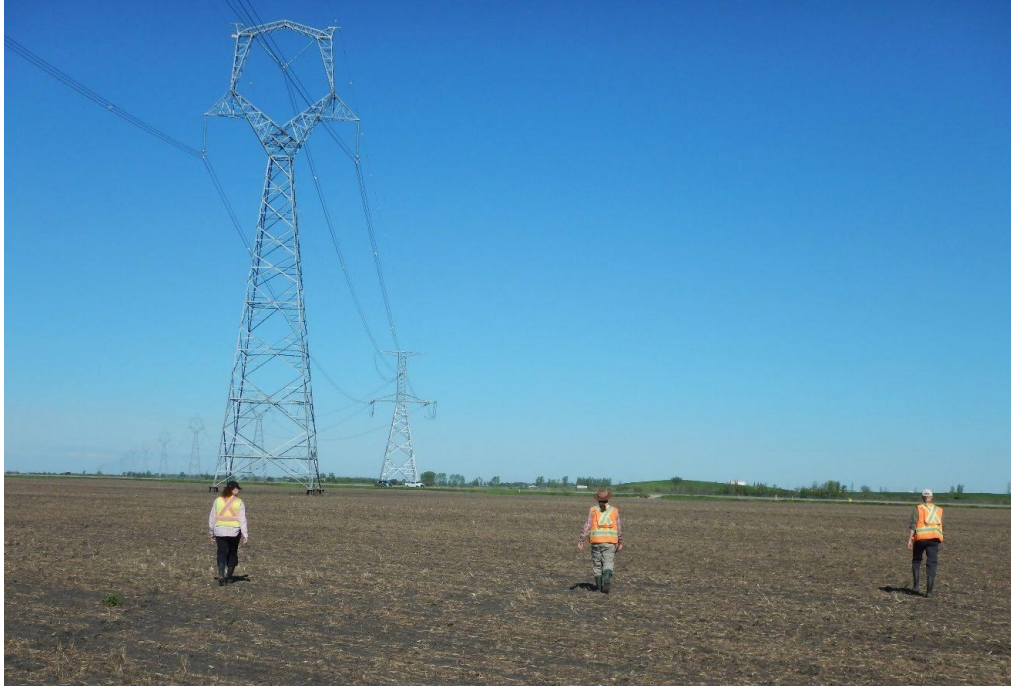
Bird-wire collision surveys using standardized methods were conducted by qualified contractors at twelve pre-selected sites from May 11-19<sup>th</sup> and June 1-9<sup>th</sup>, 2022 (Photo 1). A summary of the results can be found below. Detailed description of methods, maps, and results of the bird-collision survey can be found in Appendix B.

As predicted in the EIS, bird collisions were observed in post-construction phase of the Project. Estimated collision mortality rates were calculated based on number of collisions detected on surveyed transects, while accounting for site specific variables. The estimated collision mortality rates observed during this study were higher than those observed during the pre-construction studies conducted along the proxy transmission lines in 2014, and those observed at other transmission lines in the Manitoba. The apparent high rates of bird collision mortality along the MMTP, particularly at sites with bird diverters in the spring period, may be attributed to the high scavenging rates observed and the relatively high number of collisions observed at some sites. In spring surveys at sites with bird diverters, scavengers took 90-94% of all the planted bird carcasses, which amplified the collision mortality estimates. No mortalities of species of conservation concern were identified in 2022.

Photo 1 Bird-wire collision surveys were conducted along MMTP.

As Manitoba Hydro committed to in CER filing [A8S0X5](#), significant additional mitigation measures were implemented to improve bird-collision mitigation effectiveness at sites that showed evidence of higher rates of bird collisions. In total, over 3,000 new bird diverters were installed on MMTP and adjacent transmission lines between October 7-9<sup>th</sup>, 2023 (Appendix C). At most sites, diverter spacing intervals were doubled from the industry standard of 5 meters to 2.5 meters. Manitoba Hydro installed a relatively new model of bird diverter produced by Power Line Sentry, which have shown high rates of reliability, durability, and glow in the dark

visibility for low-light conditions. The bird diverter installation work was conducted by highly trained Manitoba Hydro crews with a specialized helicopter.

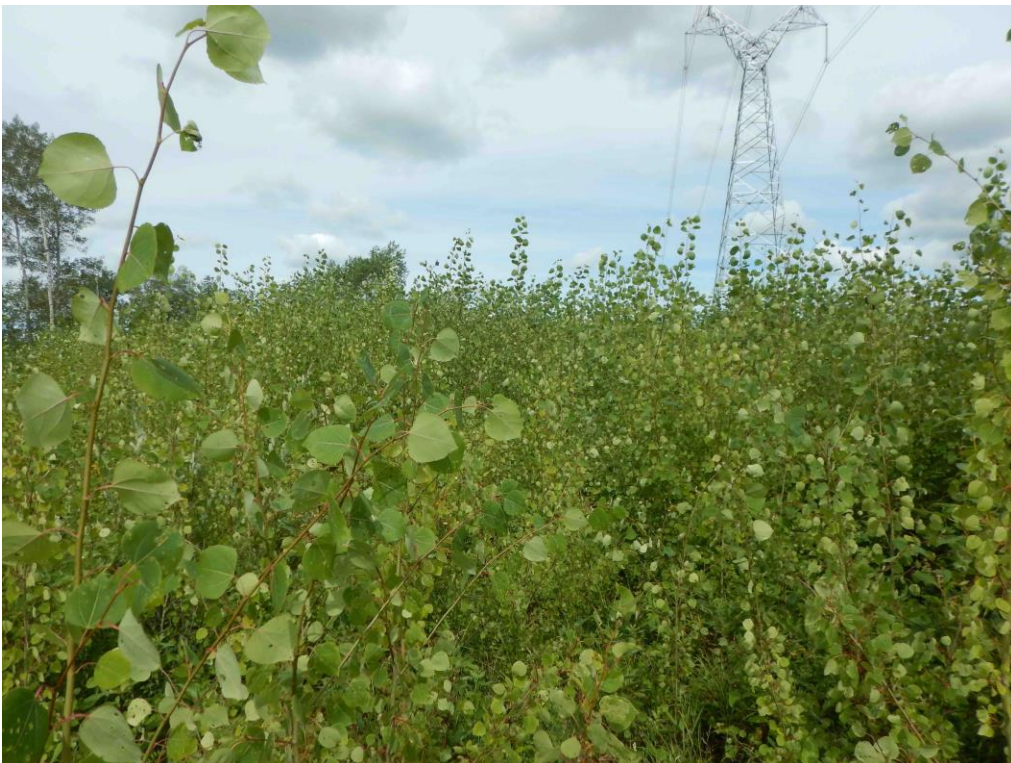
Golden-winged warbler habitat surveys were conducted by qualified contractors using standardized vegetation surveys at thirteen pre-selected sites from August 6-8<sup>th</sup>, 2022 (Photo 2). A summary of the results can be found below. Detailed description of methods, maps, and results of the golden-winged warbler habitat survey can be found in the vegetation technical report included in Appendix A.

As predicted in the EIS, vegetation was selectively cleared as outlined in the habitat management plan to enhance suitability for golden-winged warblers. Overall, there was an increase in vegetation cover and species richness in the lower vegetation canopies between 2021 and 2022. Cover and richness measures in the understory were comparable to or above their baseline values (2019), and no significant differences were found between understory cover ( $p=0.057$ ) or richness ( $p=0.223$ ) from 2019 and 2022 surveys. However, the understory diversity ( $p=0.003$ ) and evenness ( $p=0.002$ ) measured in 2022 has increased over baseline measures. As predicted, post-construction monitoring shows mean total species cover in sites has risen as a result of vegetation species regeneration and changing structure.

Photo 2 A golden-winged warbler (*Vermivora chrysoptera*) monitoring site with dense aspen regeneration in 2022.
