MANITOBA–MINNESOTA TRANSMISSION PROJECT

ENVIRONMENTAL MONITORING PLAN

GOLDEN-WINGED WARBLER MONITORING REPORT 2017–2021

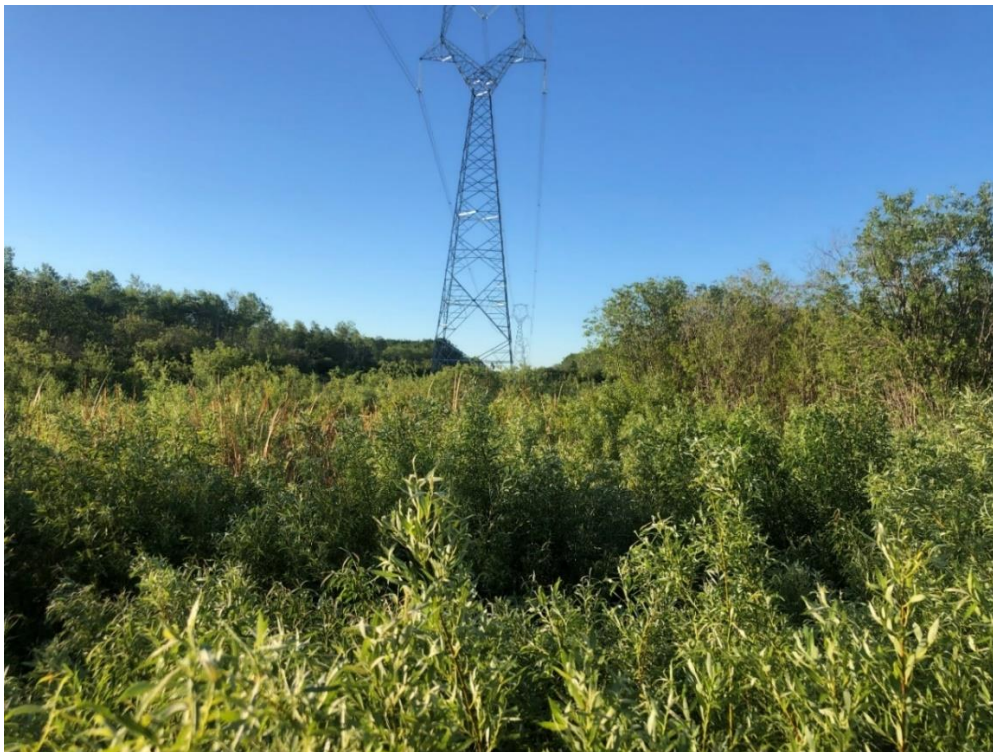
Photo 1: Golden-winged warbler habitat at a right-of-way site June 15, 2021

As prescribed in the golden-winged warbler habitat management plan, a feathered edge with a mixture of shrubs and perch trees was to remain to the extent possible on the ROW, to mitigate potential changes in habitat availability (Manitoba Hydro 2019a). Although perch trees occasionally remained along the edge of the ROW, few were retained on it and there was generally no tree canopy cover at golden-winged warbler habitat sites (Szwaluk Environmental Consulting Ltd. and Newman 2021). Previous post-construction surveys indicated that shrub growth did not appear to be retained as expected and typically remained only around small wetlands (Szwaluk 2020). During the second year of post-construction habitat monitoring, species cover, richness, and diversity measures in the mid-canopy layer were considerably lower than before construction (Szwaluk Environmental Consulting Ltd. and Newman 2021). However, low shrubs became part of the tall shrub stratum, the cover and richness in the lower canopy increased, and higher-quality golden-winged warbler habitat was identified at one site (Szwaluk Environmental Consulting Ltd. and Newman 2021). Although habitat mitigation did not appear to meet all objectives of immediately enhancing or maintaining golden-winged warbler habitat throughout the ROW, it did not appear to affect population abundance. While the tree canopy will be prevented from completely regenerating on the ROW (Szwaluk Environmental Consulting Ltd. and Newman 2021), it is expected that the amount of tall shrub cover (<4 m) will continue to increase in numerous areas along the ROW, increasing habitat suitability for breeding golden-winged warblers. Because no change in golden-winged occupancy rates was detected on the ROW after construction, no effect of construction and installation of the transmission line on golden-winged warbler habitat quality was identified and the null hypothesis was not rejected.

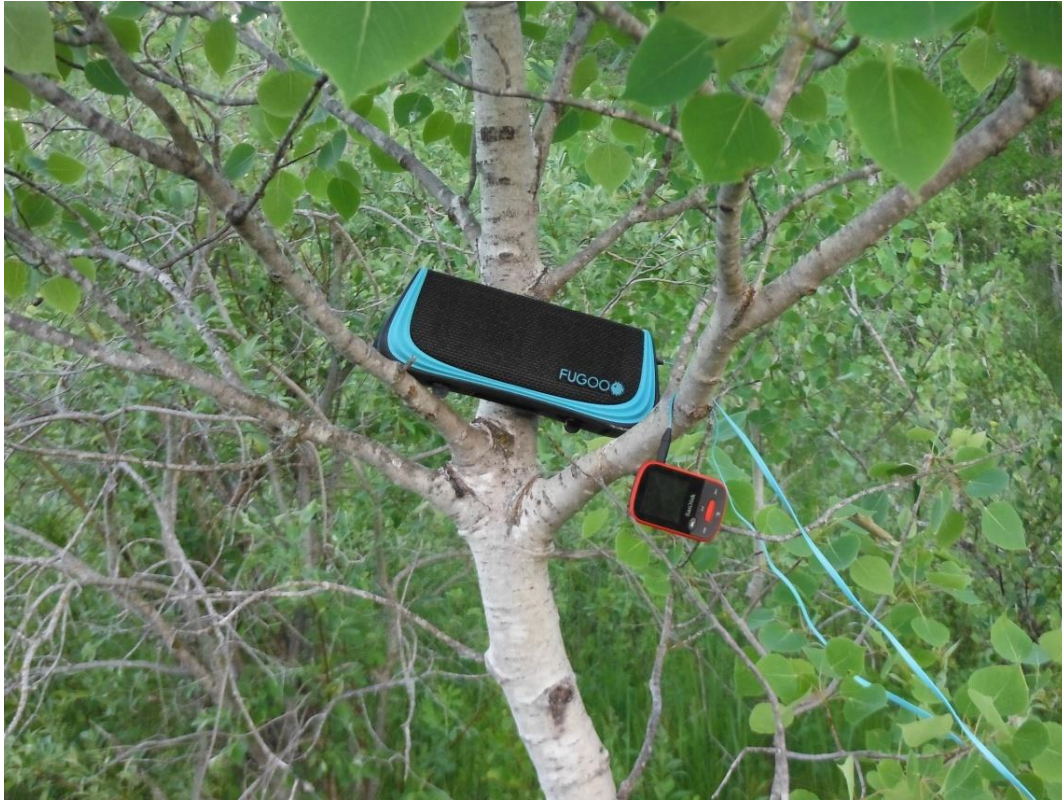
Photo 2: MP3 player (right) and speaker (left)

Point counts with and without playback recordings (Kubel and Yahner 2007) were conducted between 5:00 a.m. and 9:30 a.m. to detect golden-winged warblers. At each site surveyors listened for three minutes, played a recording of golden-winged warbler song for five minutes, and then listened for another two minutes. Recordings were played at 100 decibels with an MP3 player and speaker (Artuso 2009; Photo 2). Golden-winged warbler song broadcasting was conducted

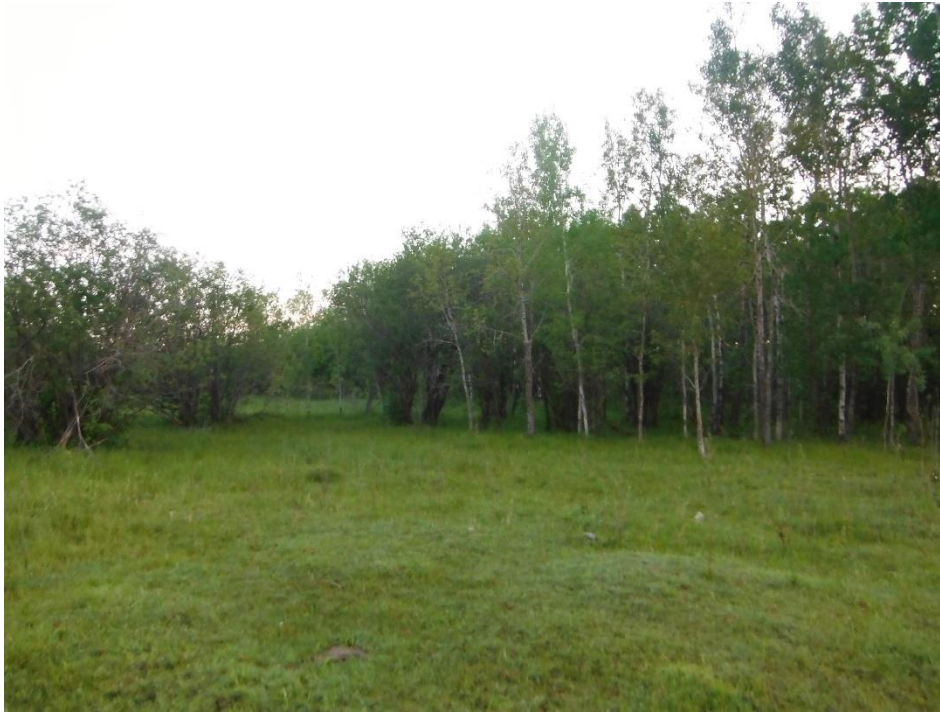
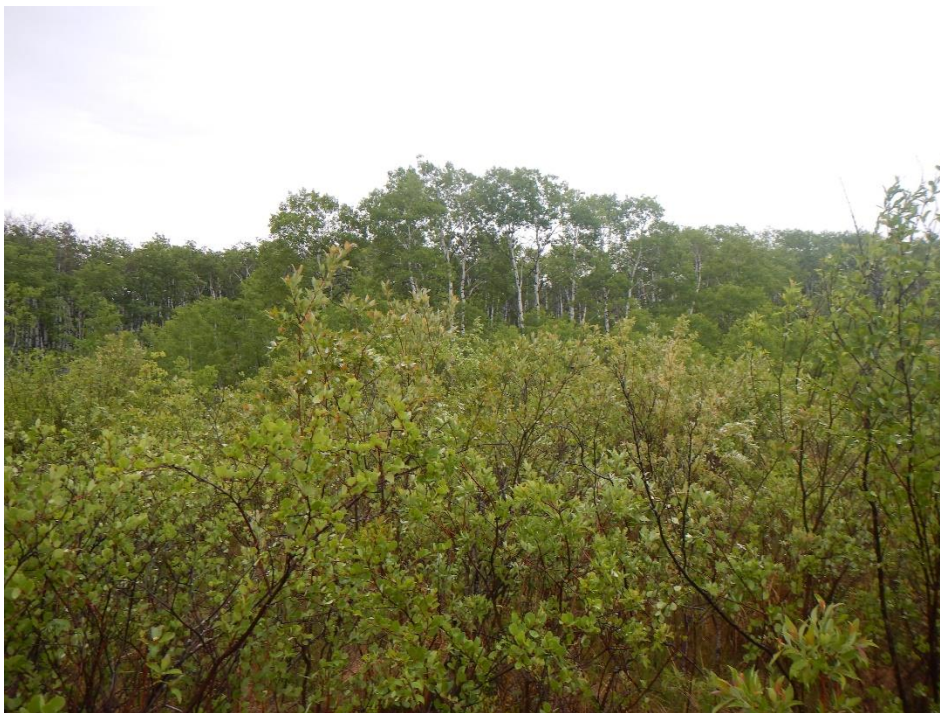
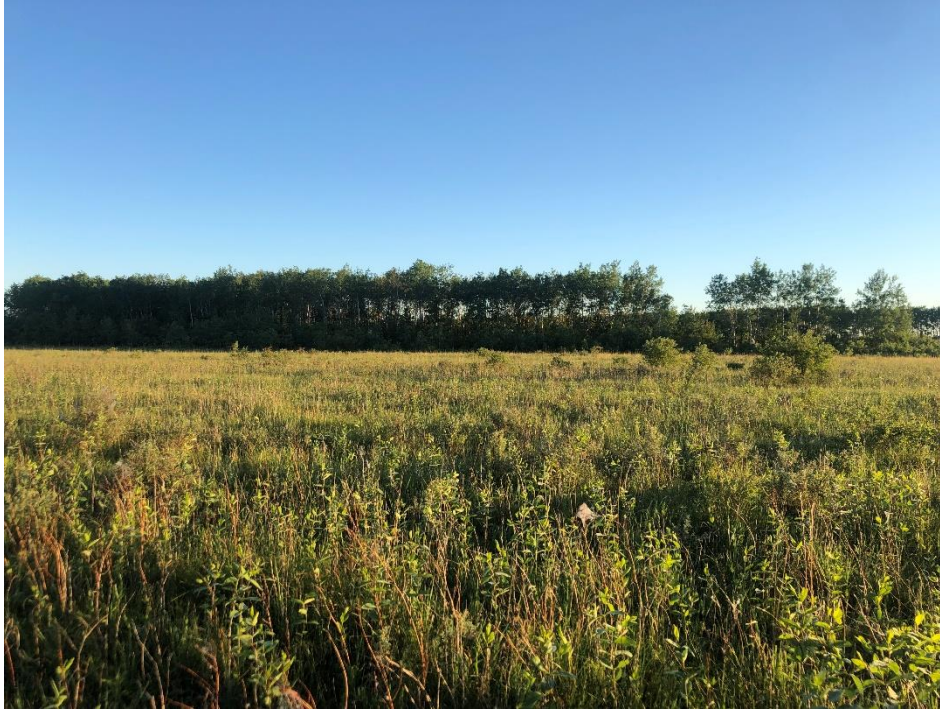
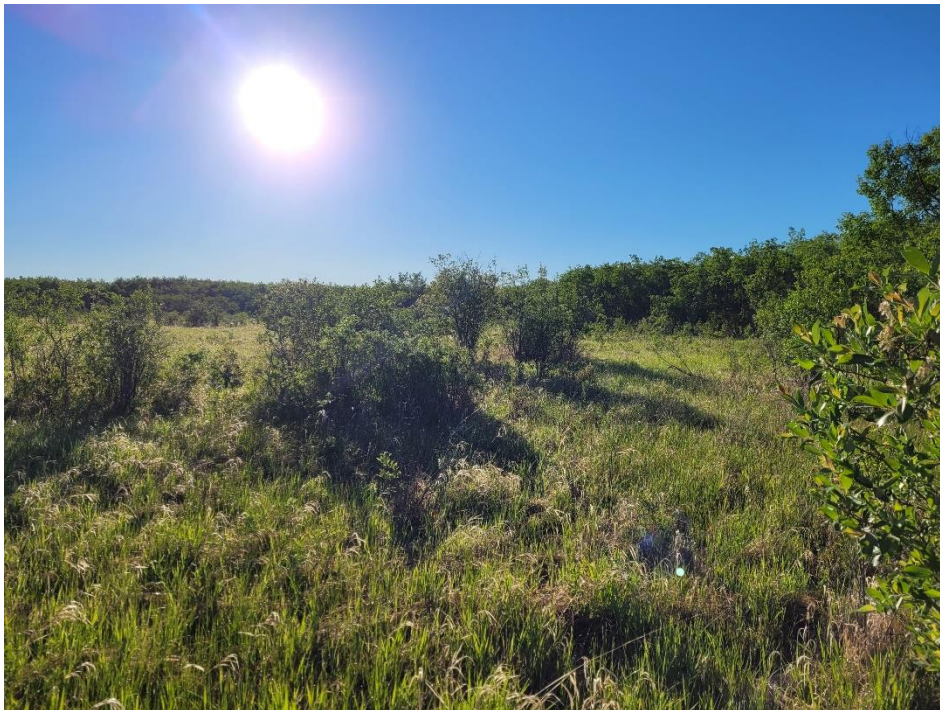
Photo B-1: Habitat at reference site 518, 2017

Photo B-2: Habitat at reference site 501, 2019

Photo B-3: Habitat at reference site 512, 2021

Photo B-4: Habitat at reference site 519, 2021

The difference in occupancy rates between 2021 and the pre-construction years was likely due to the particularly low occupancy rate at reference sites in 2021. This low occupancy rate may have been due to differences in habitat at, and variation in, reference sites surveyed (Appendix B). In 2021, no golden-winged warblers were detected at reference sites south of Highway 1, where farmland is common but there is relatively little shrubby habitat. Golden-winged warblers were observed at a minimum of one site south of the highway in previous survey years. While occupancy rates were lower at reference sites during operation than before construction, occupancy rates were similar at ROW sites over the same period. The alternative hypothesis was not supported as no effect of construction and installation of the transmission line on golden-winged warbler density was detected. The null hypothesis was not rejected.
