AGRICULTURAL SOIL PRODUCTIVITY MONITORING FOR THE MANITOBA- MINNESOTA TRANSMISSION PROJECT

POST-CONSTRUCTION YEAR 2 (2021)

Final Report

Prepared for:
Manitoba Hydro

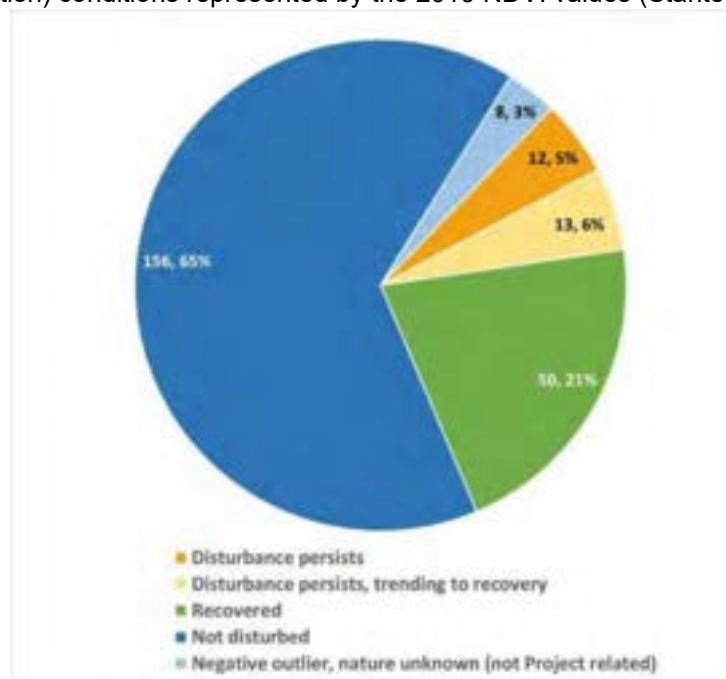
A summary of counts and proportions of individual On RoW FMUs in each of the disturbance categories in post-construction year 2 (2021) is found in the figure on the right. A total of 25 of the 239 On RoW FMUs (10.4% of all

A summary of counts and proportions of individual On RoW FMUs in each of the disturbance categories is found in **Table 3.3** and **Figure 3.2**. Following visual review and evaluation of negative outliers:

- Of the 165 On RoW FMUs (68.6%) considered to have no Project-related disturbance:
 - A total of 8 On RoW FMUs (3.3%) were found to have been negative outliers but not due to Project-related effects, rather low NDVI difference values are due to systematic errors (e.g., inappropriate FMU delineation, field management variability) or are assumed to be outliers due to random, natural variability (e.g., soil moisture conditions/soil drainage variation).

- A total of 156 On RoW FMUs (65.3%) were found to have no Project-related disturbance in 2020 or 2021.
- A total of 50 On RoW FMUs (20.9%) were found to have Project-related disturbance in 2020 but were not found to be negative outliers in 2021 and are considered to have recovered from Project-related disturbance.

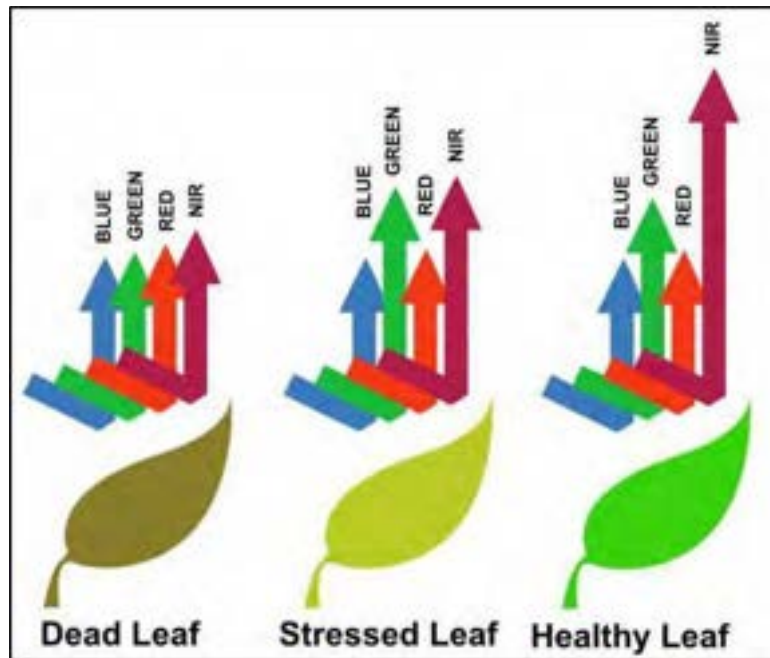
Figure 2.1 Spectral Reflectance Amount Variations for Blue, Green, Red and NIR Energy of Dead, Stressed and Healthy Crop Leaves

NDVI values range from 1 (healthy vegetation) to -1 (non-vegetation). Results of the NDVI formula can vary from one landscape to another but typically areas of water, sand, or infrastructure show very low NDVI values (for example, -0.5 or less). For instance, bare soil usually scores near 0.0 on the NDVI scale range; sparse vegetation such as shrubs and grasslands or senescing crops may result in moderate NDVI values (approximately 0.1 to 0.4); and high NDVI values (approximately 0.5 to 0.9) correspond to dense vegetation such as that found in temperate and tropical forests or crops at their peak growth stage.

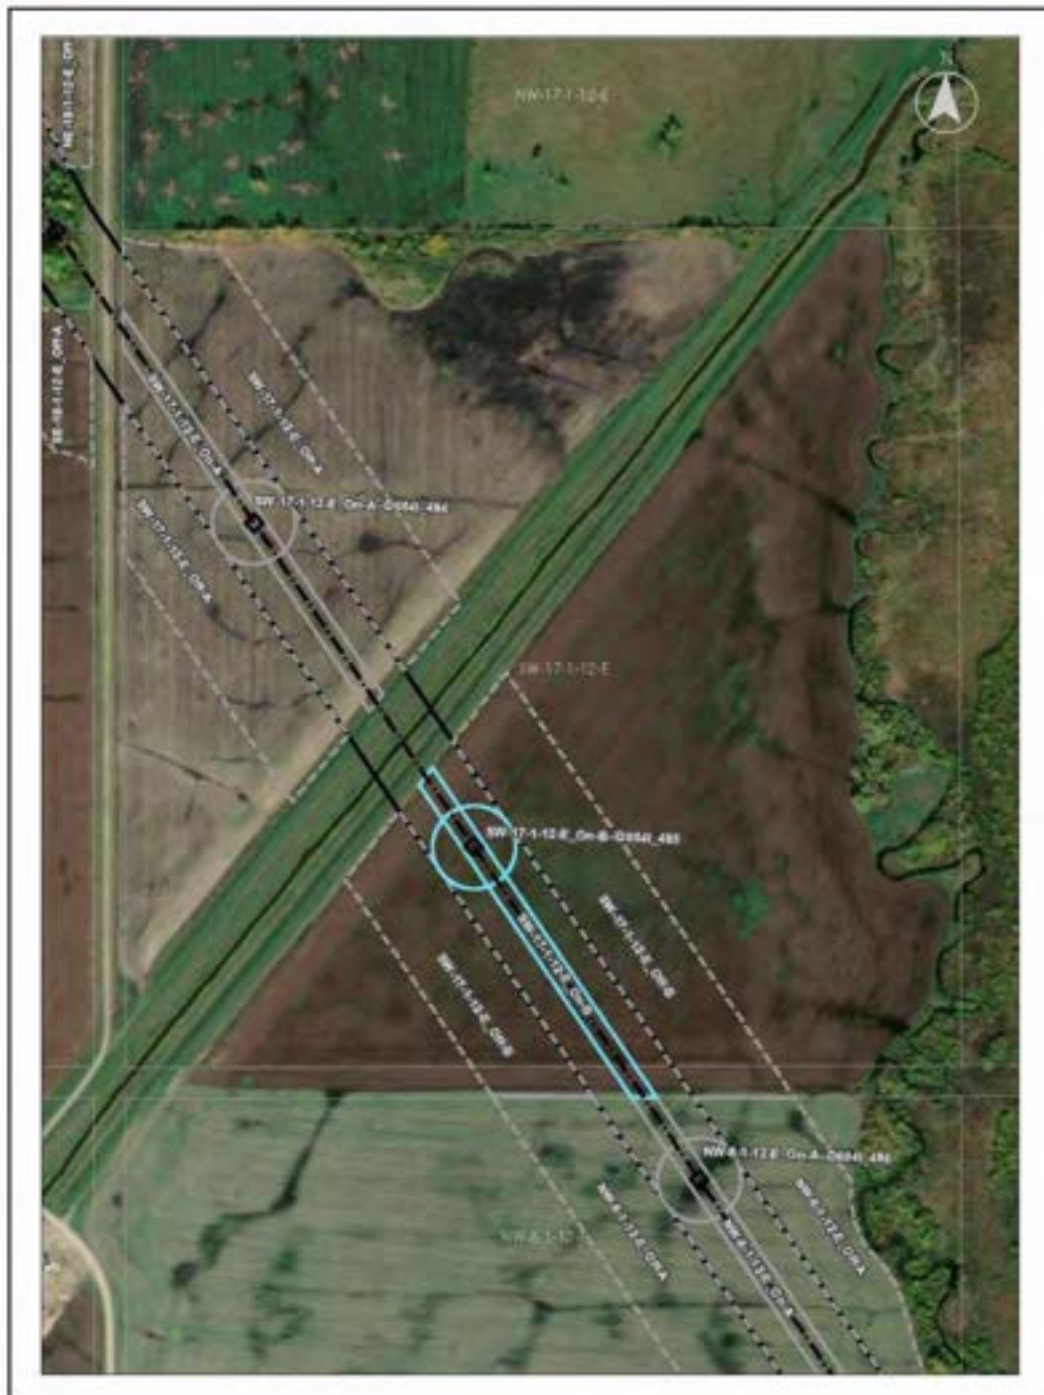
Figure 2.4 Screen Capture from ArcGIS showing On RoW FMUs, TWAs and Off RoW Comparable Areas within a Select Quarter Section

On RoW FMUs shown in solid gray and blue outlines; TWAs shown in solid gray and blue circular outlines; Off RoW FMUs shown in dashed gray outlines. Note SW-17-1-12-E has two, discrete On RoW FMUs (i.e., "A" and "B"), and On RoW FMUs and TWAs have corresponding Off RoW comparable areas denoted as "A" and "B".

An example of these evaluation areas for a select quarter section is presented in **Figure 2.4**.

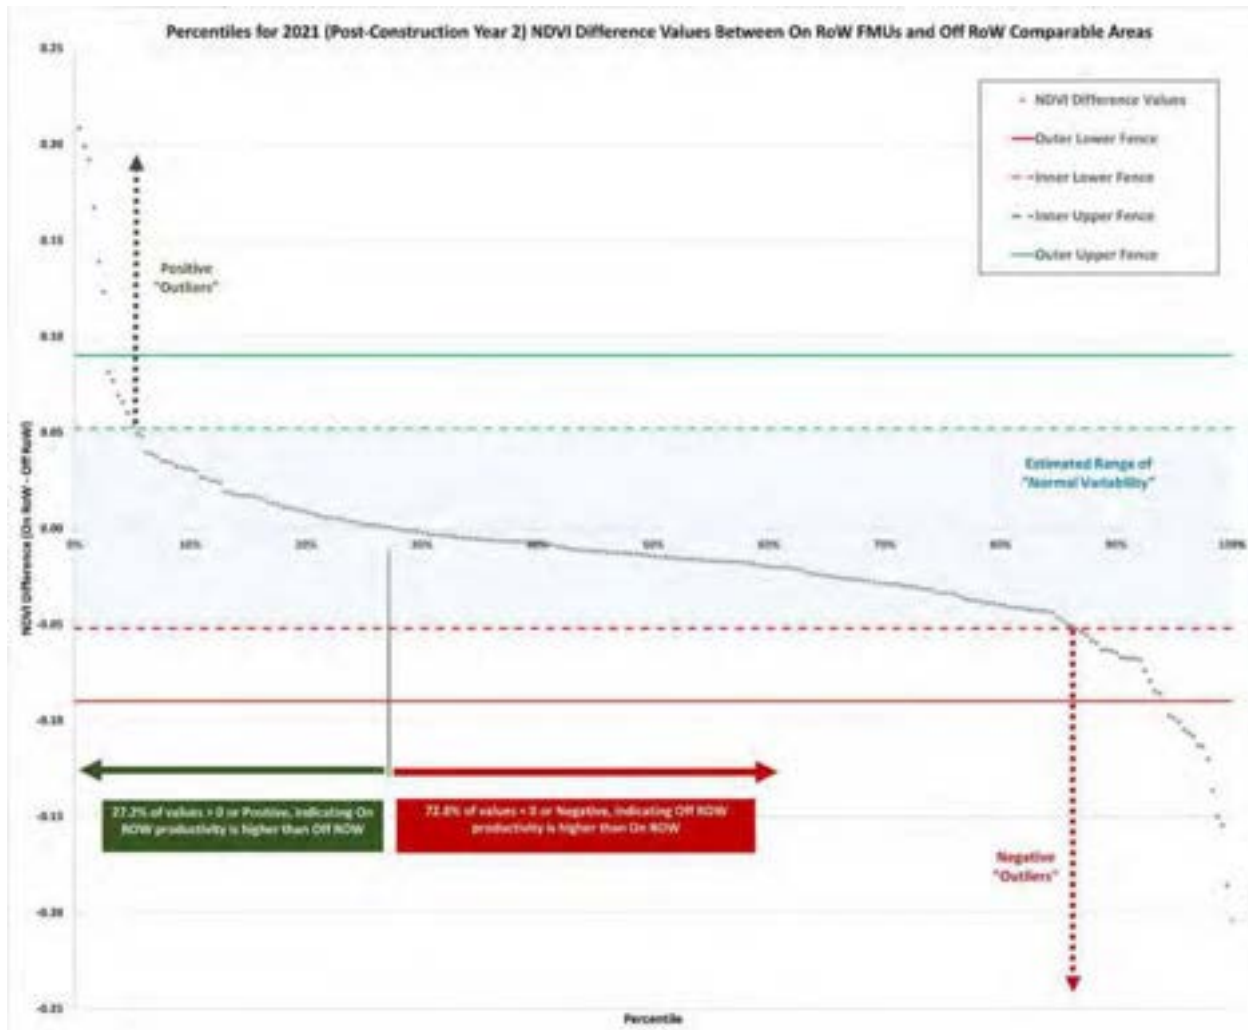
Figure B.1.4 Percentiles for 2021 NDVI Differences Between On RoW FMUs and Off RoW Comparable Areas

The percentiles chart provides a visual display of the difference values for individual FMUs. Approximately 27% of differences were found to be positive (On RoW FMU – Off RoW comparable area = ≥ 0), while 73% were found to be negative (On RoW FMU – Off RoW comparable area = ≤ 0). This is further evidence of the negative skewness of the data. The estimated range of “normal variability” around an expected difference of 0 is estimated to be -0.052 to +0.052. Therefore, values above 0.052 can be considered “positive outliers” while values below -0.052 can be considered “negative outliers”. Based on this analysis there are many more “negative outliers” than “positive outliers”. Approximately 13.8% of On RoW FMUs (33) are considered in the “negative outlier” range, while 5.0% of On RoW FMUs (12) are considered in the “positive outlier” range.

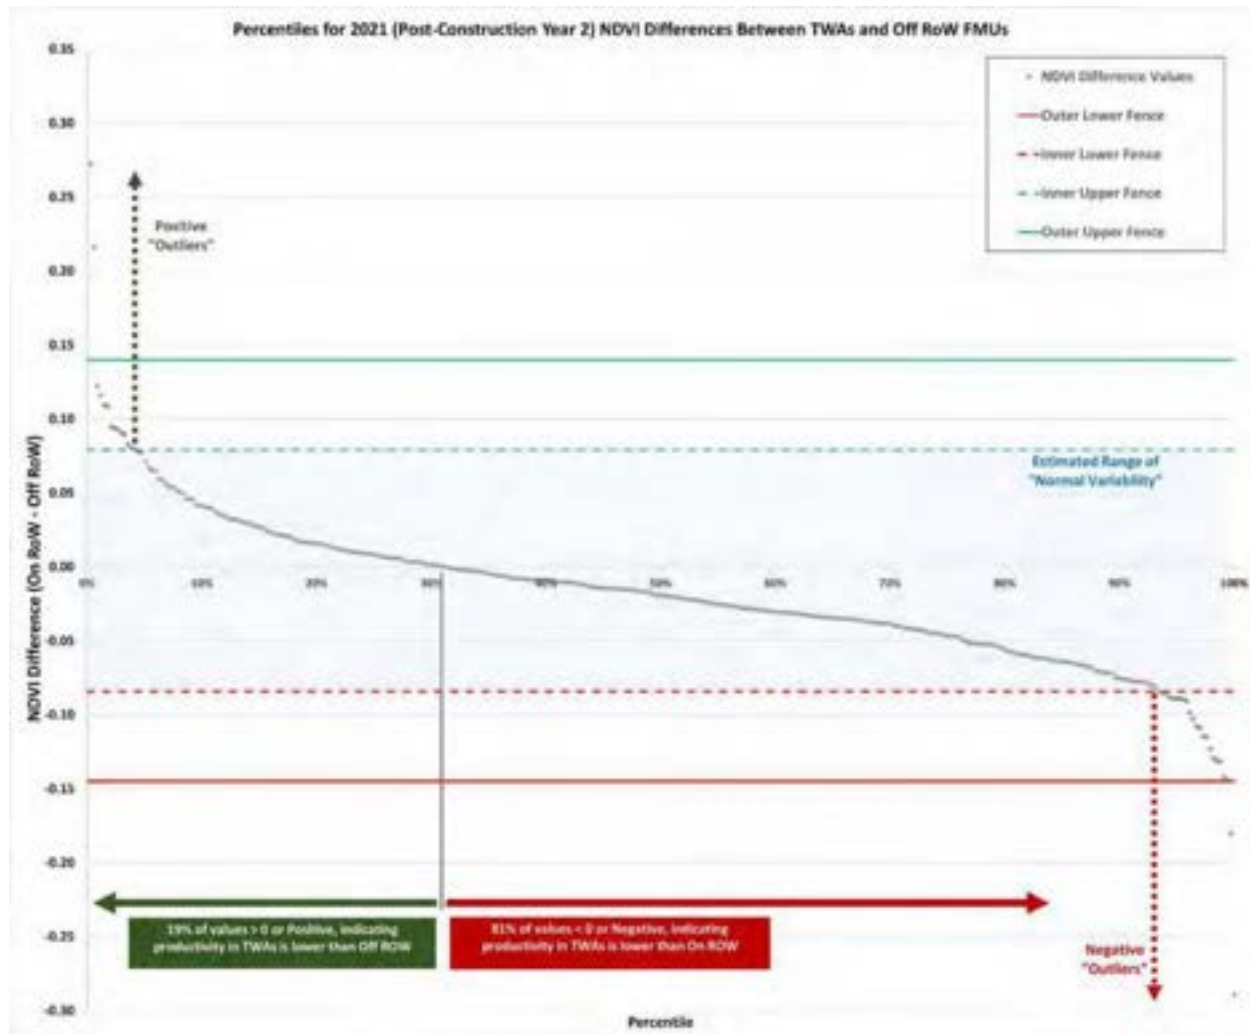
Figure B.2.4 Percentiles for 2021 NDVI Differences Between TWAs and Off RoW Comparable Areas

The percentiles chart provides a visual display of the difference values for individual TWAs. Approximately 19% of differences were found to be positive (TWA – Off RoW comparable area = >0), while 81% were found to be negative (TWA – Off RoW comparable area = <0). This is further evidence of the negative skewness of the data. The estimated range of “normal variability” around an expected difference of 0 is estimated to be -0.052 to +0.052. Therefore, values above 0.052 can be considered “positive outliers” while values below -0.052 can be considered “negative outliers”. Based on this analysis there are many more “negative outliers” than “positive outliers”. Approximately 6.8% of TWAs (23 individual TWAs) are considered in the “negative outlier” range, while 4.2% of TWAs (14 individual TWAs) are considered in the “positive outlier” range.
