MANITOBA MINNESOTA TRANSMISSION PROJECT

AMPHIBIAN MONITORING PROGRAM 2020

TECHNICAL REPORT

March 2021

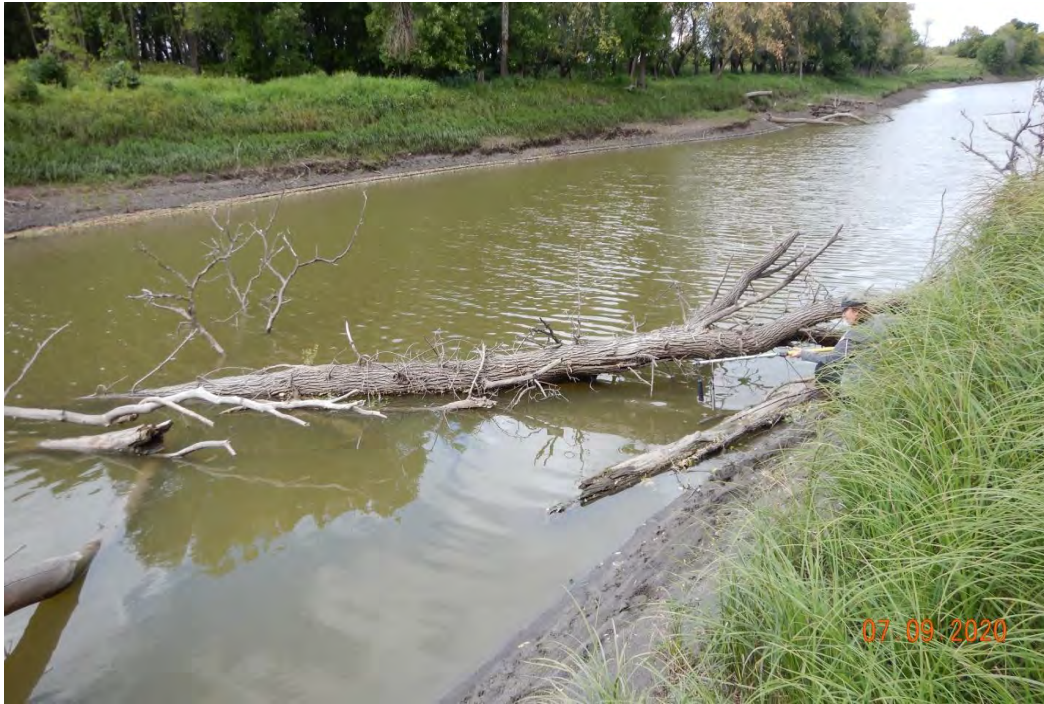
Large woody debris was observed in the channel at Site 3 (Aqua-108; La Salle River; Photo 9). Woody debris was likely the result of natural processes and was not deemed construction related therefore was not considered a non-compliance issue. Minor rutting along the PDA RoW was also noted at three sites but was likely due to local land owner use and was not considered to pose a threat to the nearby amphibian wetland sites and therefore was not considered a mitigation non-compliance issue.

Photo 9. Overview of Site 3 (La Salle River) during fall survey, at water quality site 3-1, September 8, 2020.

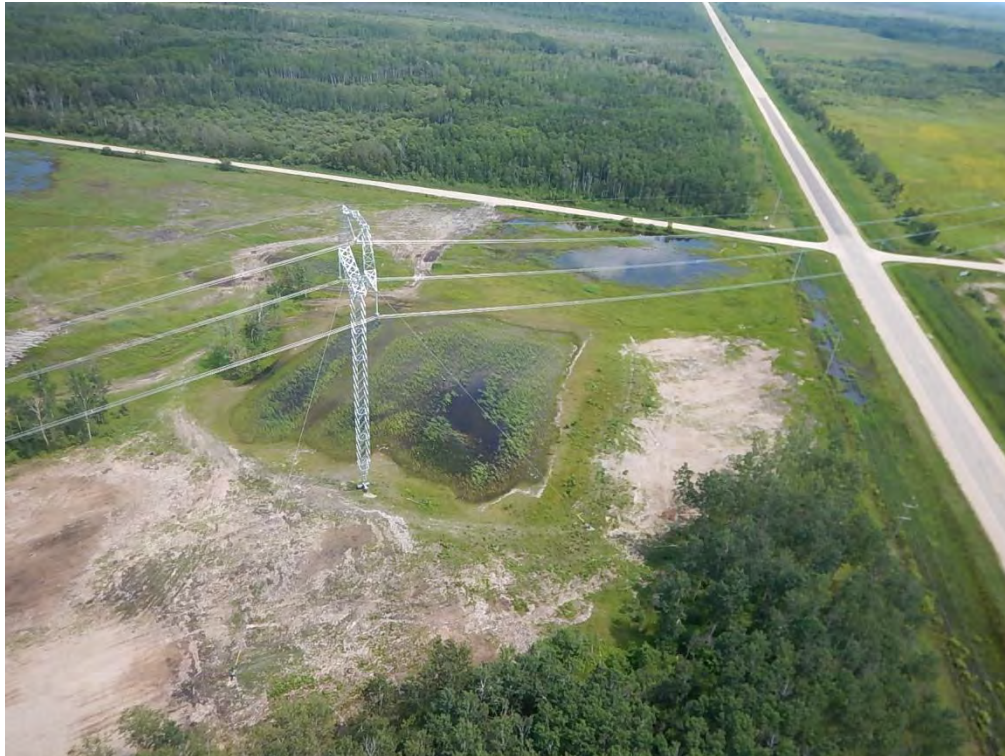
The wetland buffer was less than 30 m at the northern corners of Site 17.5 (Photo 31). According to the CEnvPP (Manitoba Hydro 2019; Appendix Table A1-5), natural vegetated buffer areas of 30 m will be established around wetlands and riparian zones will be maintained to the extent possible (EC-8.03). It is recommended that a follow up survey be conducted at the site to monitor for the re-establishment of vegetation. It should be noted that despite the absence of a vegetated buffer, other mitigation measures such as winter construction appear to have maintained the integrity of the wetland; rutting, erosion, and sedimentation were not observed, and water quality and amphibian abundance did not appear to be affected.

Photo 31. Aerial view of Site 17.5 during fly over surveys June 29, 2020.

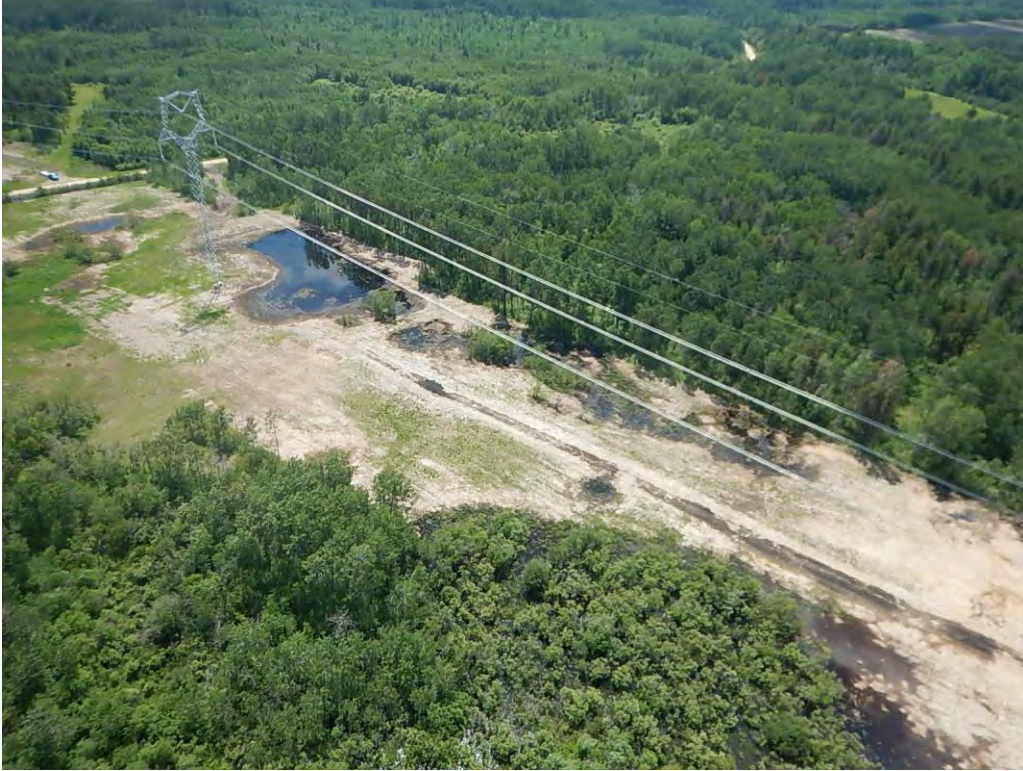
The wetland buffer was less than 30 m at Site 19 (Photo 35). According to the CEnvPP (Manitoba Hydro 2019; Table A1-5), natural vegetated buffer areas of 30 m will be established around wetlands and riparian zones will be maintained to the extent possible (EC-8.03). It is recommended that a follow up survey be conducted at this site to monitor for the re-establishment of vegetation. In consideration of the presence of Northern Leopard Frogs and Tiger Salamanders, it is also recommended that a 30 m riparian buffer be established around the wetlands at Site 19 for any future Right of Way (RoW) maintenance work. Despite the absence of a vegetated buffer, other mitigation measures such as winter construction appear to have maintained the integrity of the wetland; rutting, erosion, and sedimentation were not observed, and water quality and amphibian abundance did not appear to be affected. Although water

Photo 35. Aerial view of Site 19 during fly over surveys June 29, 2020.

quality readings were similar in pre- and post- construction surveys, subsequent water quality measurements are recommended for continued monitoring of turbidity levels.

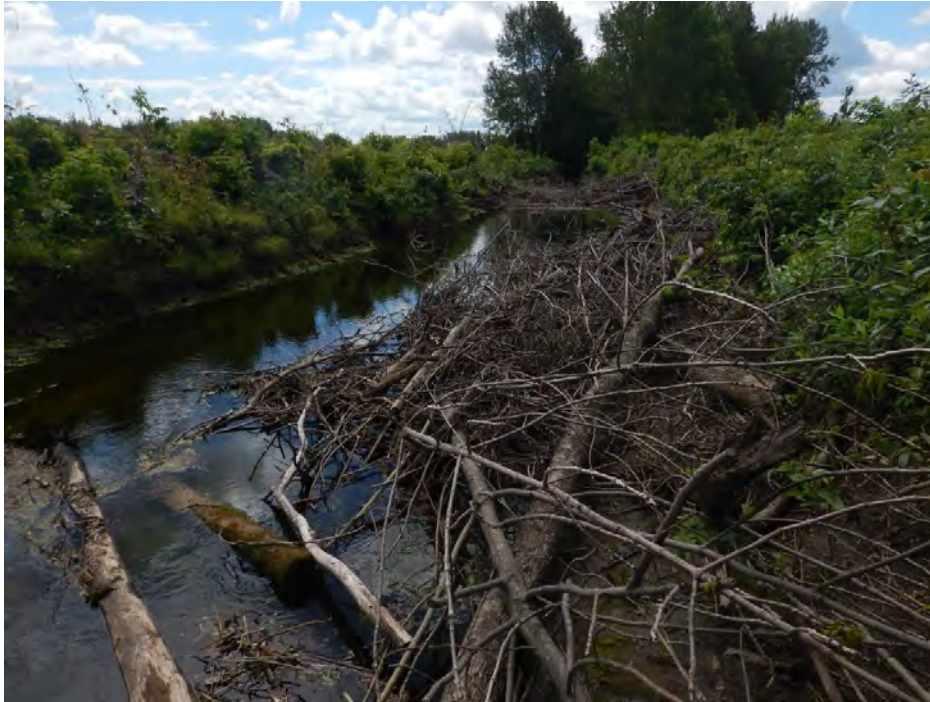
Large woody debris from riparian clearing remained in the channel at Site 27 (Pine Creek, Aqua-130; Photo 49). According to the CEnvPP (Manitoba Hydro 2019) cleared trees and woody debris should not be pushed into (or adjacent) to standing timber, or within the high-water mark of wetlands or waterbodies (EC-8.05, Table A1-5). It was recommended the woody debris be removed from the channel in order to prevent blockage of the watercourse and potentially affecting amphibian staging and overwintering habitat. Based on the above recommendations, the MMTP contractor at the request of Manitoba Hydro removed the woody debris from Aqua-130. Removal of the woody debris from the channel was confirmed by a Manitoba Hydro inspector on August 25, 2020 (Photo 50). There is no longer a mitigation concern with the watercourse crossing at Aqua-130.

Photo 49. Woody debris observed in the channel at Site 27 (Aqua-130; Pine Creek) July 11, 2020.

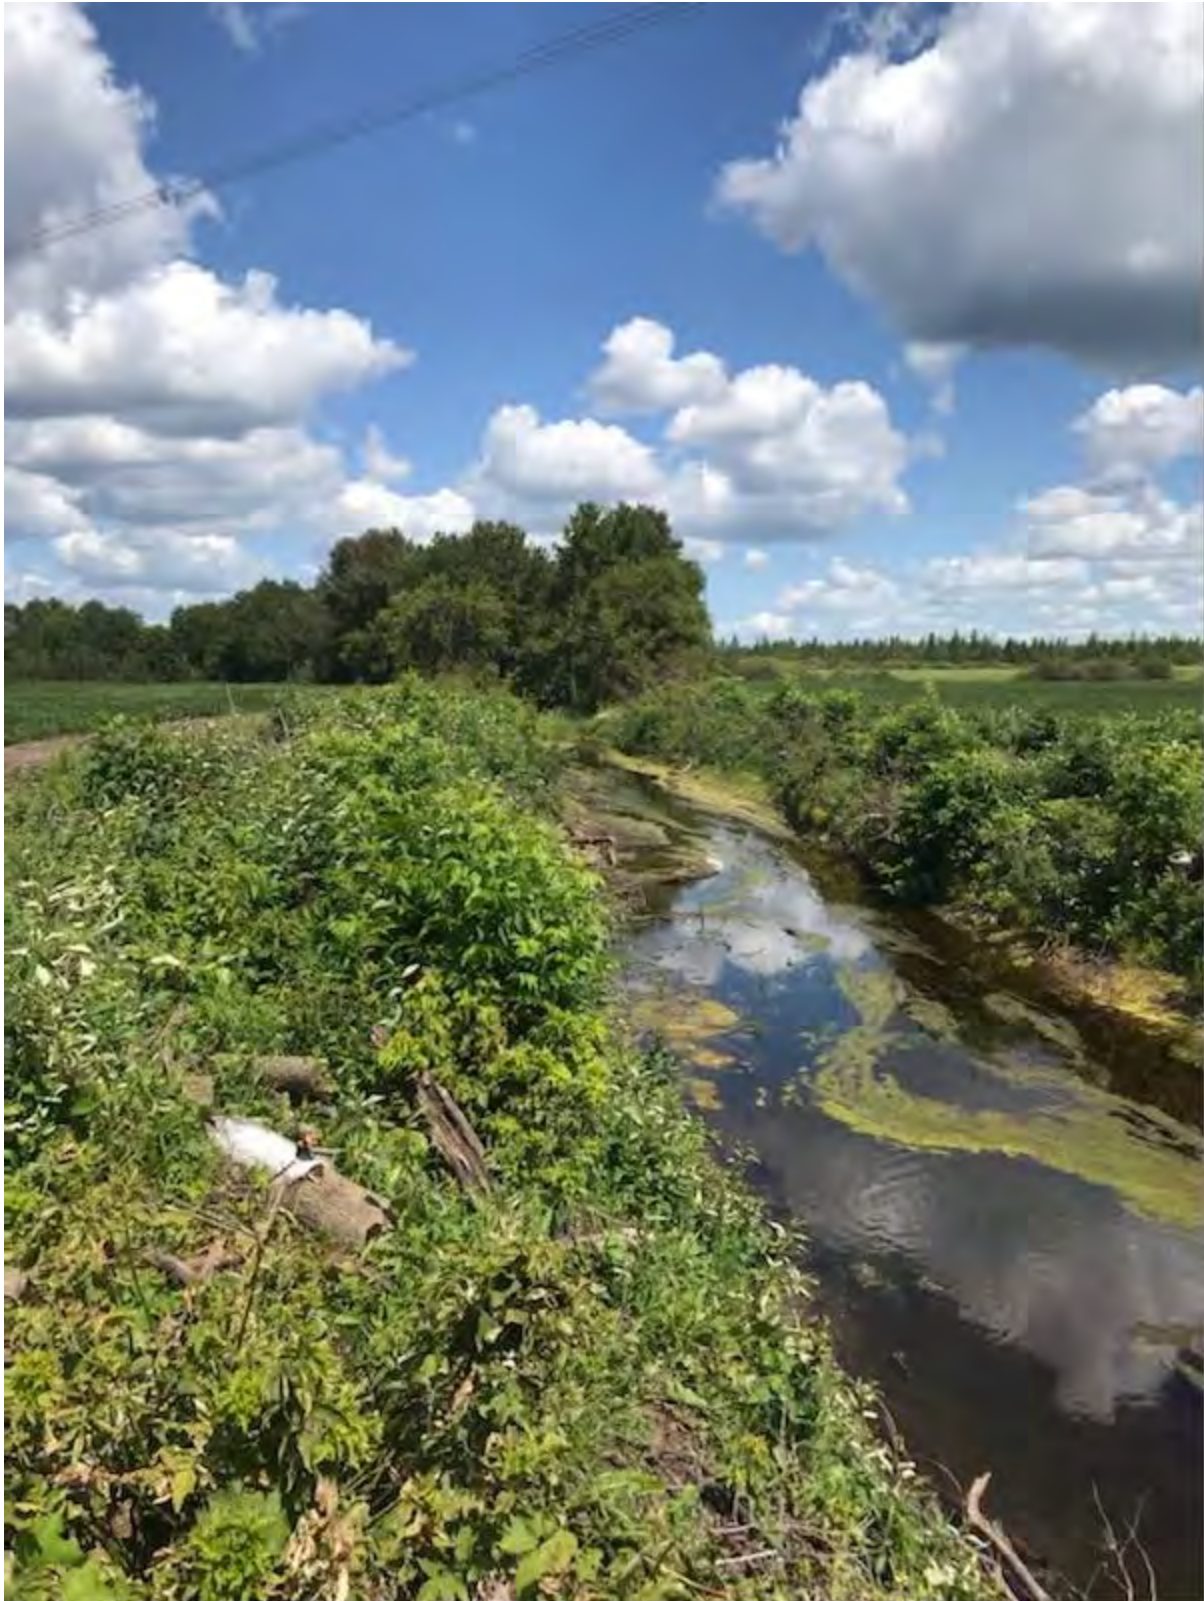
Photo 50. Woody debris removed from Site 27 (Aqua-130) by contractor, confirmed by Manitoba Hydro Project inspector on August 25, 2020.

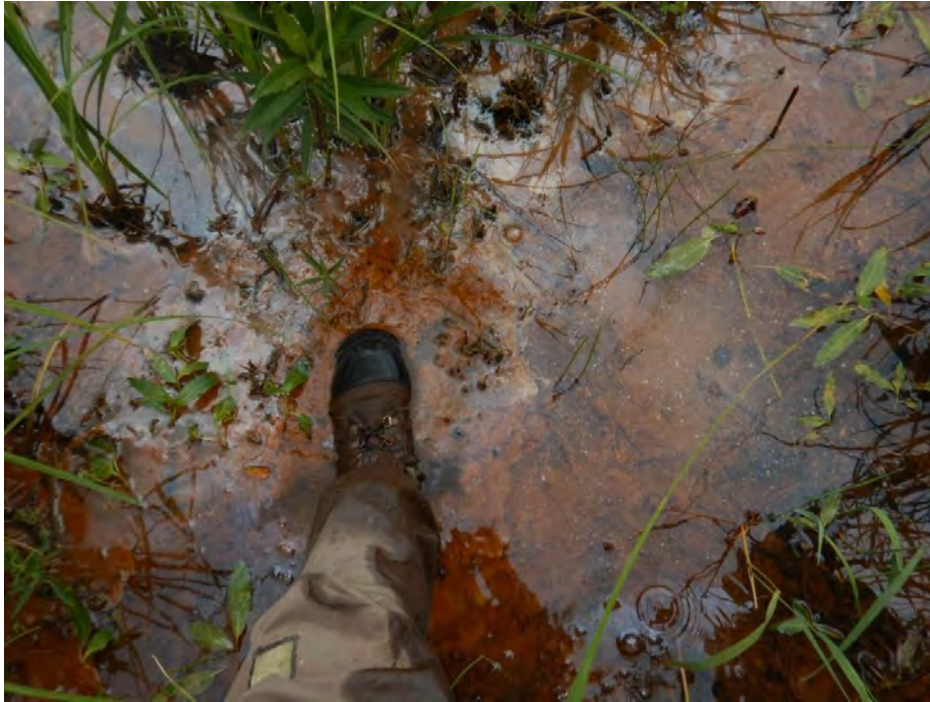
Photo 51. Oily sheen seen on water surface at Site WA10 during summer surveys, July 9, 2020, likely the result of iron bacteria naturally occurring at the survey site.

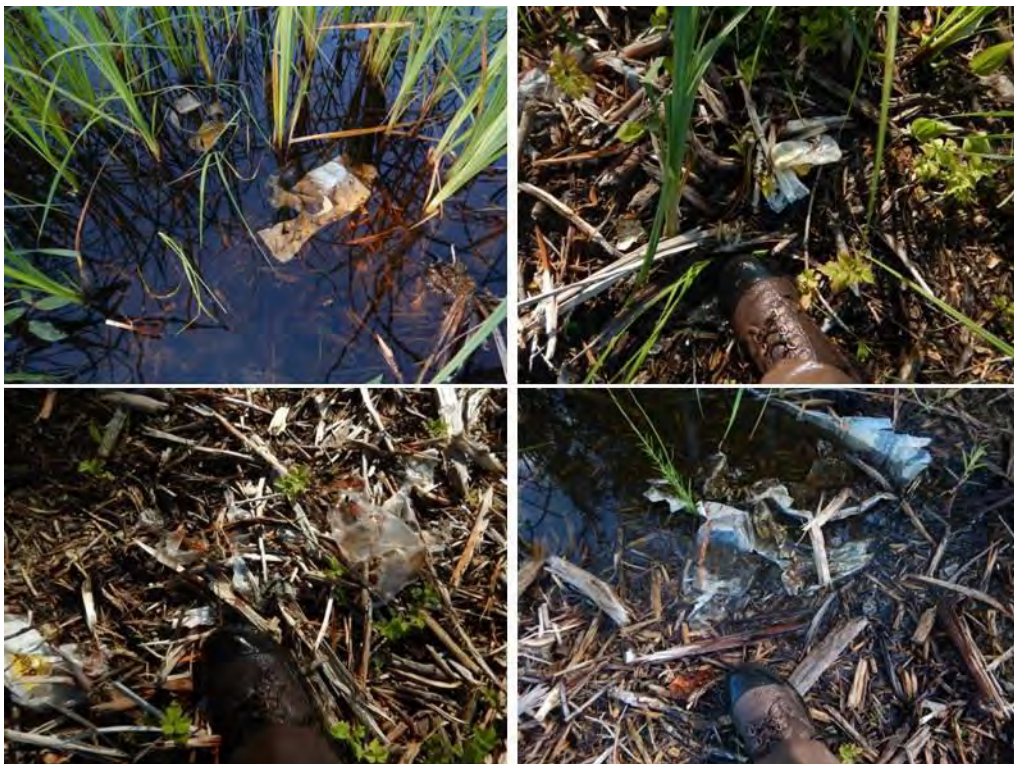
Photo 52. Refuse found along the RoW at Site 19 during summer surveys, July 9, 2020.

Refuse was present along the PDA RoW around Site 19 (Photo 52). Environmental Requirements require all project areas to be maintained clean and free of rubbish and debris, disposed of at approved facilities (Manitoba Hydro 2019). It is recommended that the refuse be cleared from the area around Site 19.
