# Manitoba-Minnesota Transmission Project

## Post-Construction Environmental Monitoring

### Report

Certificate EC-059

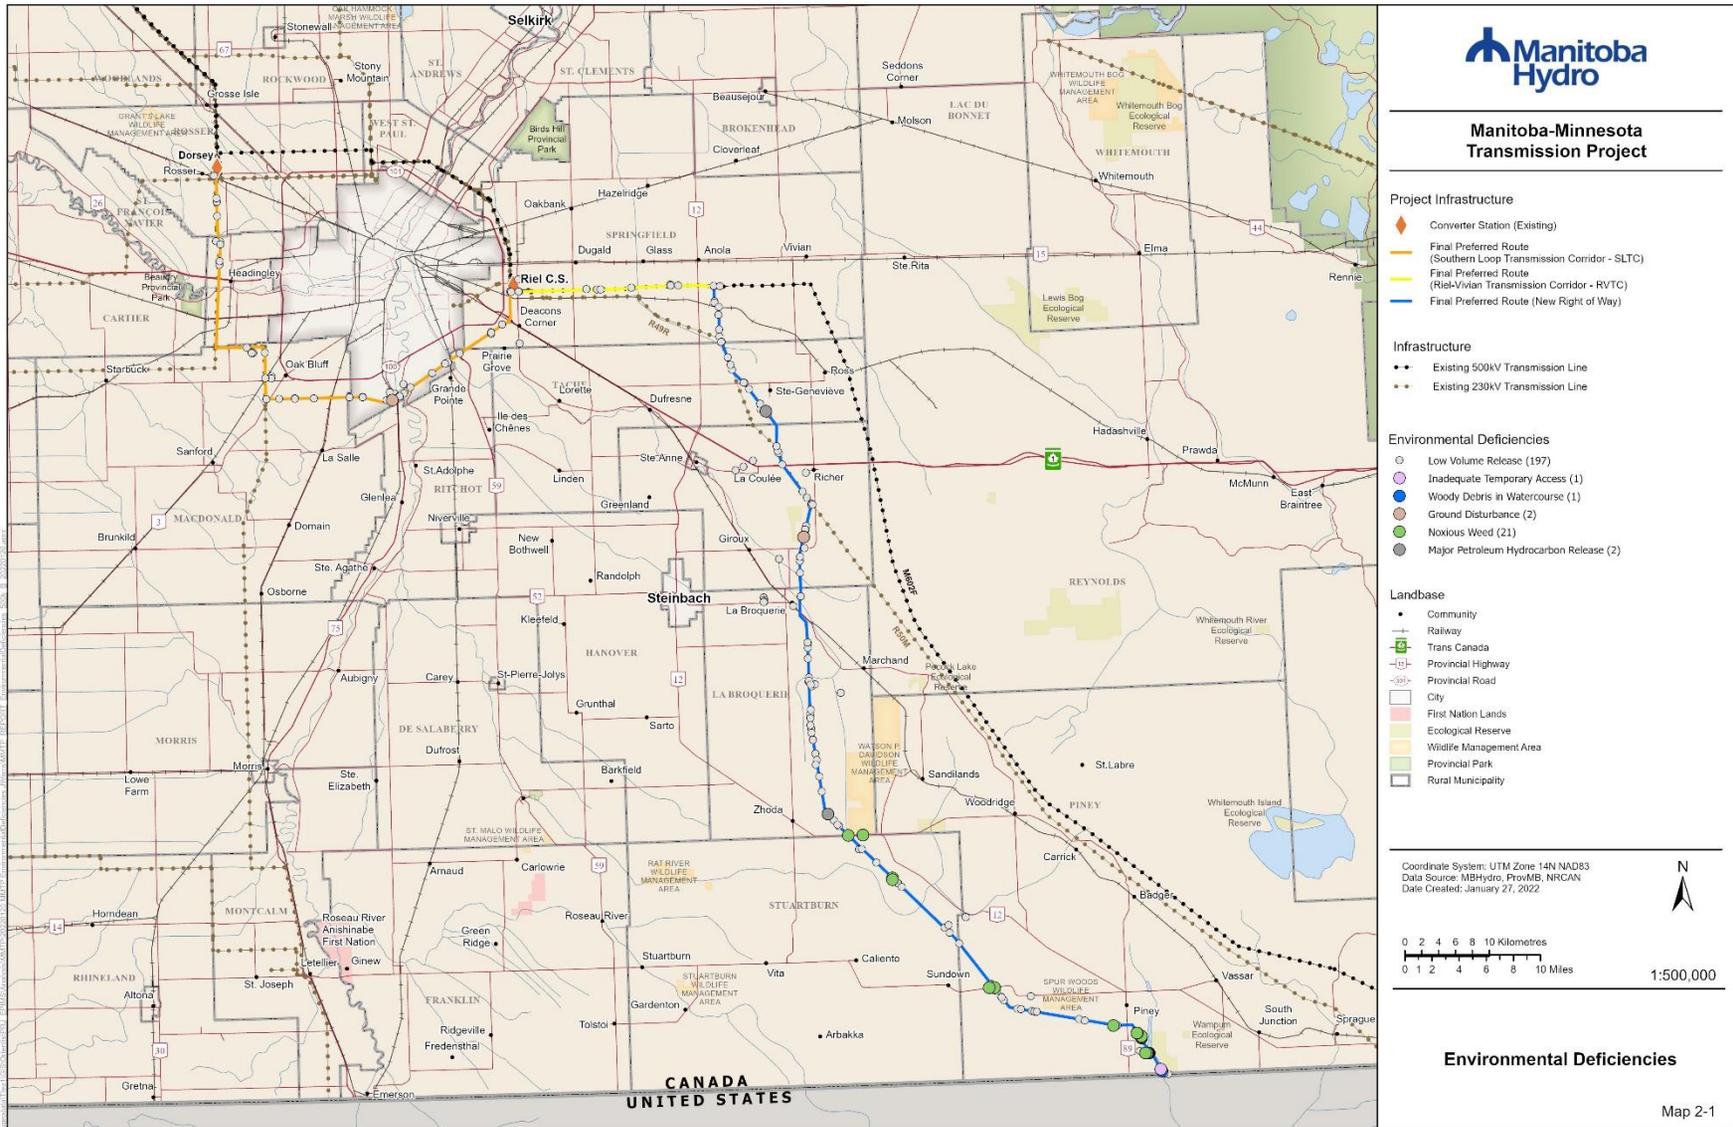
Map 2-1 Locations of environmental deficiencies that arose during construction

Major petroleum hydrocarbon release near tower 265. NE-2-9-7-E in the Rural Municipality of Tache. Map 2-1.	January 30, 2020	~200L diesel fuel release, remove contaminated material, test samples, rehabilitate.	MMTP - S2/ identified during construction phase, completed post construction phase	Release site cleaned up, remediated. Clean up work completed by February 18, 2020. Monitoring conducted until November 2020. No further action.	Resolved
Major petroleum hydrocarbon release at MMTP laydown yard. NE-9-4-8-E in the Rural Municipality of La Broquerie. Map 2-1.	March 21, 2020	60L hydraulic oil release, remove contaminated material, test samples, rehabilitate.	MMTP - S2/ identified during construction phase, completed post construction phase	Release site cleaned up, remediated. Clean up work completed by July 6, 2020. No further action.	Resolved
Six noxious weed sites identified at various locations along the ROW in Rural Municipality of Piney and Stuartburn. Map 2-1.	July 24, 2020	Tier 1 and 2 weed species sites	MMTP - S2/ identified post construction phase	Contract licensed herbicide applicator to treat weed sites. Treatment conducted on September 23, 2020. Regional weed inspector satisfied. Vegetation surveys in Year 2 may identify additional weed sites.	Resolved. Further weed sites may be identified in 2021.

Woody debris in watercourse near tower 493. SW-4-1-12-E, Rural Municipality of Piney, ESS Aqua 130. Map 2-1.	June 29, 2020	Woody debris in watercourse. A small number of woody branches and stumps.	MMTP - S2/ identified during post construction phase	Debris removed from watercourse on August 5 <sup>th</sup> , 2020. No further action.	Resolved
Ground disturbance along ROW at tower 303. NW-20-7-8E, RM of Ste. Anne. Map 2-1.	September 9, 2020	Ground disturbance	MMTP - S2/ identified during construction	Back blade and level ground on November 3, 2020, and June 21, 2021. No further action.	Resolved
Ground disturbance along ROW at towers 119A, 119B at RL-73-NO, City of Winnipeg. Map 2-1.	Spring 2020	Ground disturbance	MMTP - S1/ identified during construction	Tilled and leveled ground and repaired access between June 4-15, 2020. No further action.	Resolved

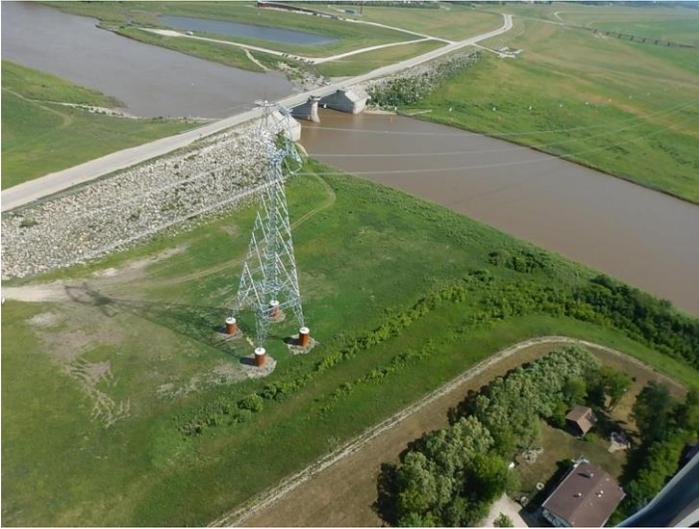
Photo 1 MMTP crossing of the Red River.

A stream crossing assessment was conducted by qualified contractors who evaluated Manitoba Hydro’s Daily Inspection Reports, aerial photography and conducted visual site inspections from the air on ground on June 29<sup>th</sup>, 2020 (Photo 1, 2, 3). A summary of the results is outlined below. Detailed results of the stream crossing assessment can be found in the technical report included in Appendix A.

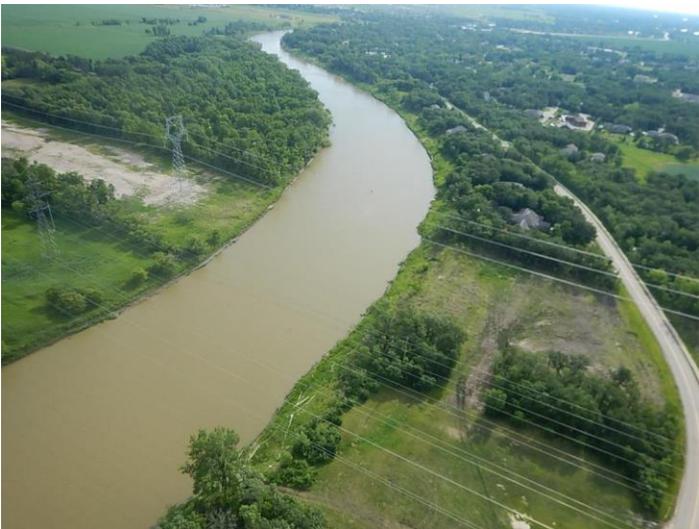
Photo 2 MMTP crossing of the Assiniboine River.

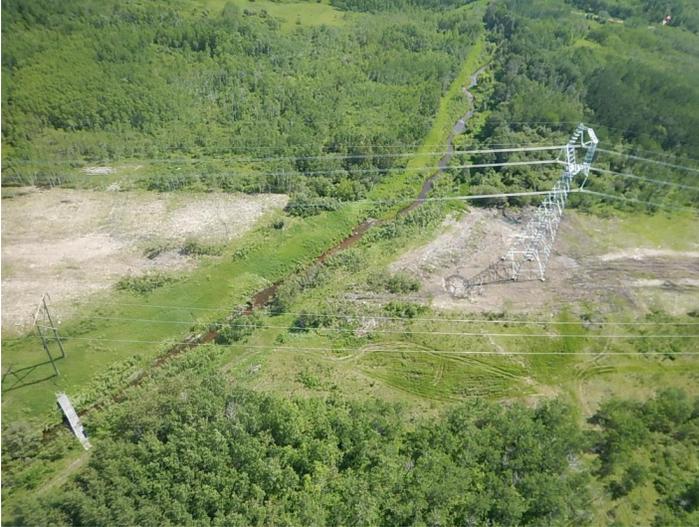
Photo 3 Aerial photo of Cooks Creek showing full compliance with prescribed mitigation.

As predicted in the EIS, project effects on watercourse crossings were minor. All 33 environmentally sensitive sites (ESS) sites observed were constructed and cleaned up in accordance with the mitigation measures outlined in the environmental protection program

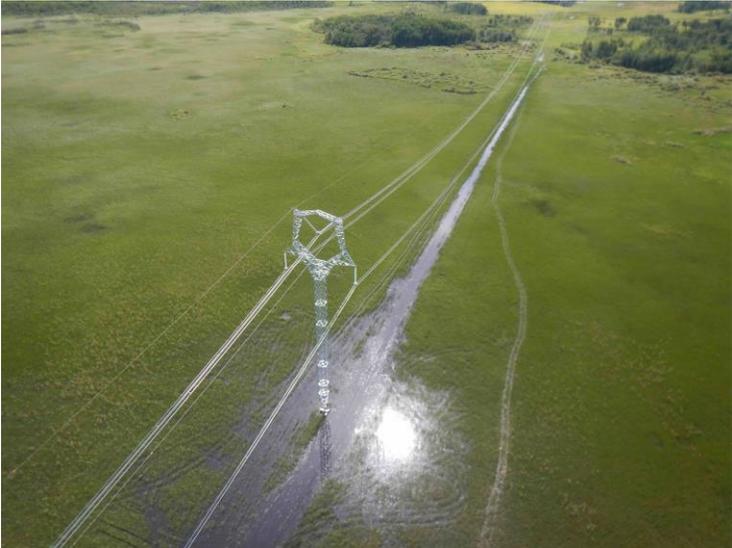
Photo 4 Tower located in a wetland.

Wetland surveys were conducted by qualified contractors who evaluated aerial photography and conducted site inspections on pre-selected long-term monitoring sites on July 21-23<sup>rd</sup>, 2020 (Photo 4). A summary of the results can be found below. Detailed description of methods, maps, and results can be found in the vegetation technical report included in Appendix B.

Mitigation measures during vegetation clearing and construction appear to have minimized surface disturbance and have been effective. No major disturbances were noted at any wetland sites, and surface soils appeared relatively undisturbed, without major rutting observed. Few wetland sites had areas with minor amounts of exposed soil.

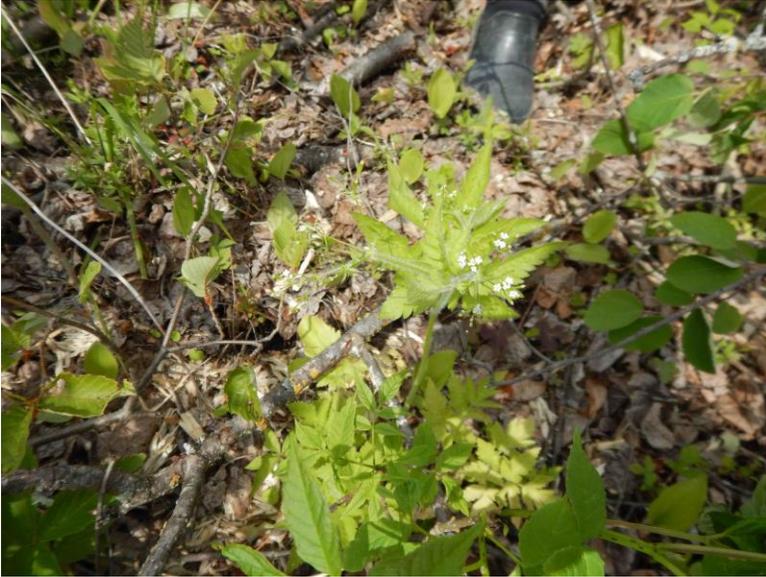
Photo 5 Hairy sweet cicely (*Osmorhiza claytonia*) observed in the right of way.

Rare plant surveys were conducted by qualified contractors who conducted meander and transect surveys in environmentally sensitive sites throughout July 2020 (Photo 5). No species at risk listed under either the Manitoba's *The Endangered Species and Ecosystems Act* or the federal *Species at Risk Act* were observed during surveys during pre or post project monitoring. A summary of the results can be found below. Detailed description of methods, maps, and results of the rare plant survey can be found in the vegetation technical report included in Appendix B.

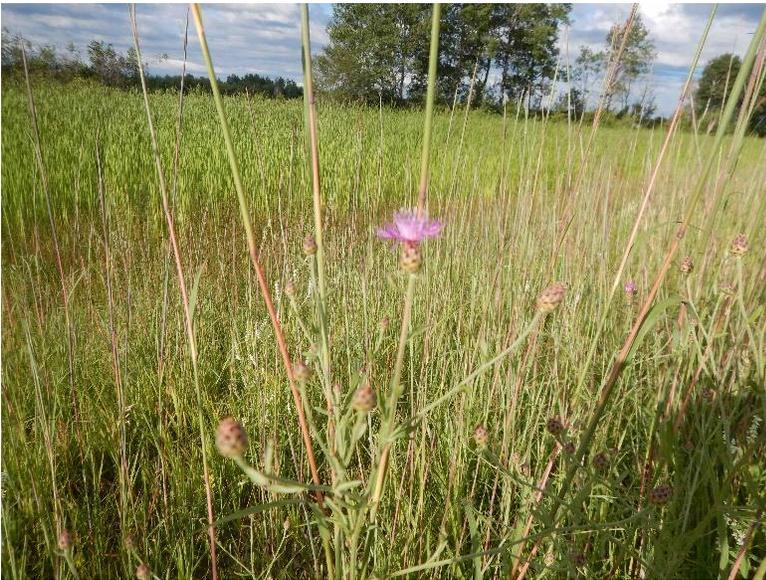
Photo 6 Invasive species detected in roadside survey.

Non-native and invasive species plant surveys were conducted by qualified contractors at pre-selected sites throughout July 2020 (Photo 6). 300 roadside surveys were conducted project

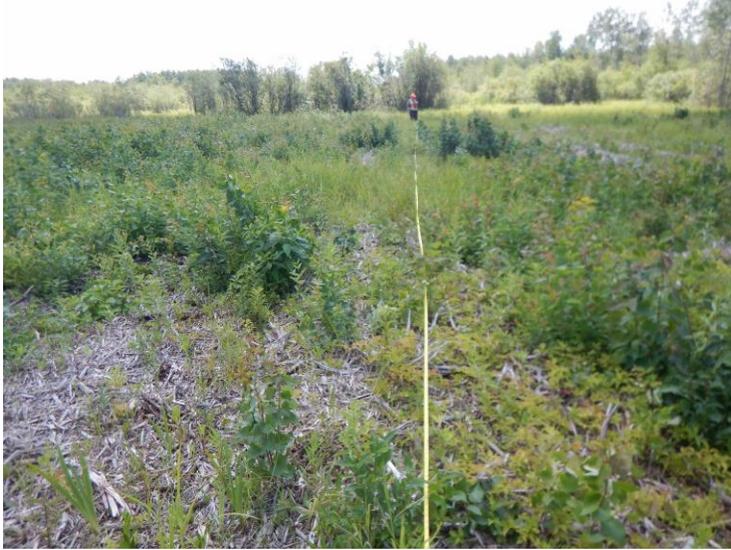
Photo 7 A well-developed herb and low shrub stratum, and regenerating and remaining tall shrubs.

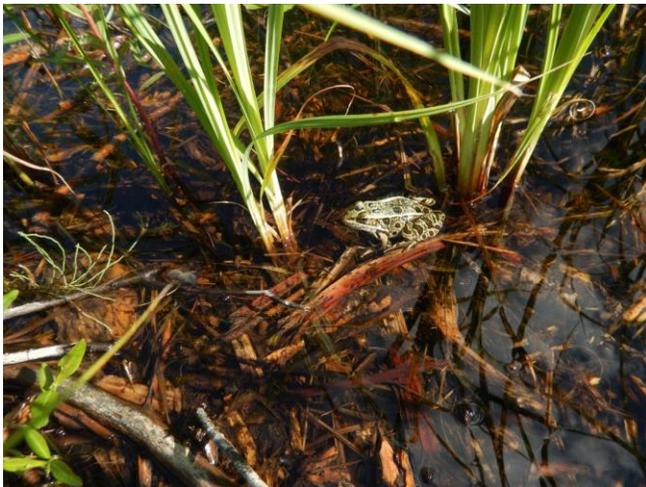
Photo 8 Northern leopard frog (*Lithobates pipiens*) adult observed on the right of way.

Wetland amphibian surveys were conducted by qualified contractors at preselected sites on July 6-11<sup>th</sup> and September 8-10<sup>th</sup>, 2020 (Photo 8 and 9). Twenty-six sites were surveyed and assessed for species presence and water quality parameters. A summary of the results can be found below. Detailed description of methods, maps, and results of the wetland amphibian survey can be found in Appendix C.

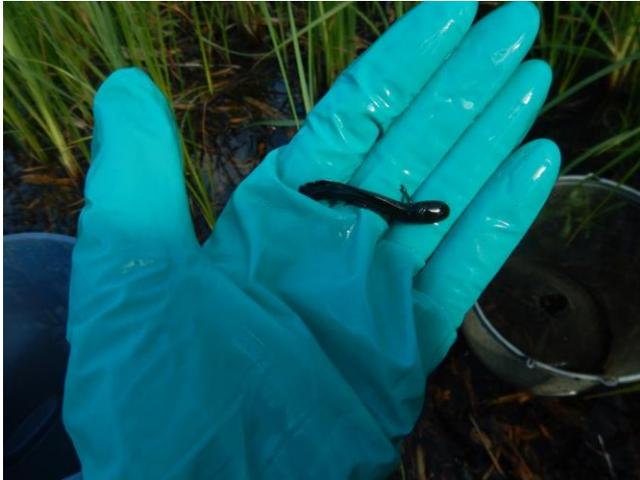
Photo 9 Eastern tiger salamander larvae (*Ambystoma tigrinum*) caught in funnel trap on the right of way.

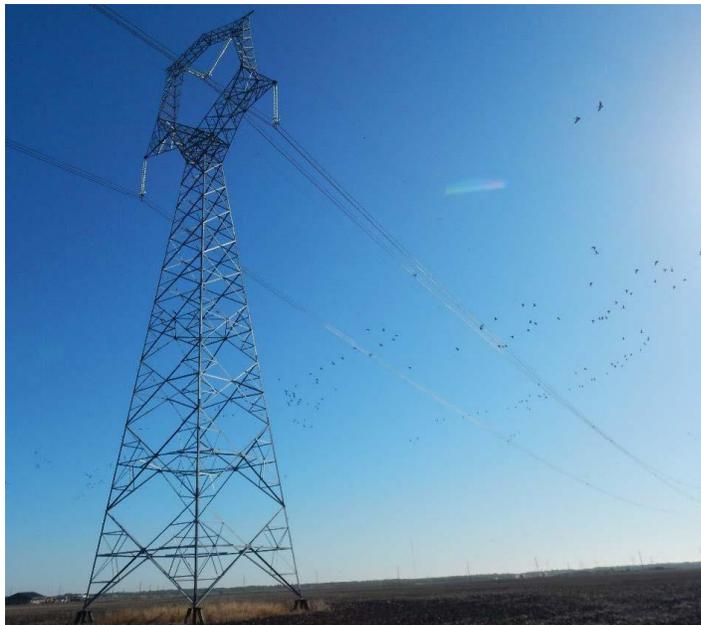
Photo 10 Bird wire collision surveys were conducted along MMTP.

Bird-wire collision surveys using standardized methods were conducted by qualified contractors at eighteen pre-selected sites from September 10-21, 2020 (Photo 10). A summary of the results can be found below. Detailed description of methods, maps, and results of the bird-collision survey can be found in Appendix D.

As predicted in the EIS, some bird collisions were observed in post-construction phase of the Project. Estimated collision mortality rates appear to be higher in comparison to other studies but may be a result of vegetation conditions and relatively low searcher efficiency metrics in 2020. No species of conservation concern, including peregrine falcons were observed. Further surveys will be conducted in 2021.

Bird-wire diverters along the MMTP appear to be effective at reducing the number of bird-wire collision mortalities. No threatened or endangered species were observed during the fall 2020 survey.

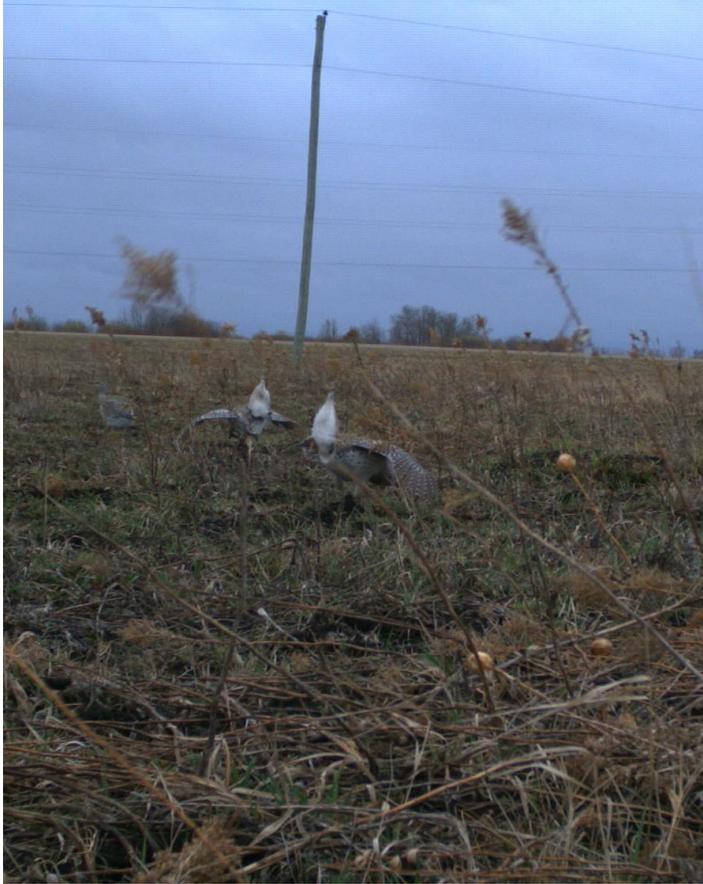
Photo 11 A sharp-tailed grouse (*Tympanuchus phasianellus*) lek near MMTP.

Sharp-tailed grouse lek surveys using standardized avian and camera trap methods were conducted by qualified contractors at 76 identified sites from April 9-May 7<sup>th</sup>, 2020 (Photo 11). A summary of the results can be found below. Detailed description of methods, maps, and results of the sharp-tailed grouse lek survey can be found in the technical report included in Appendix E.

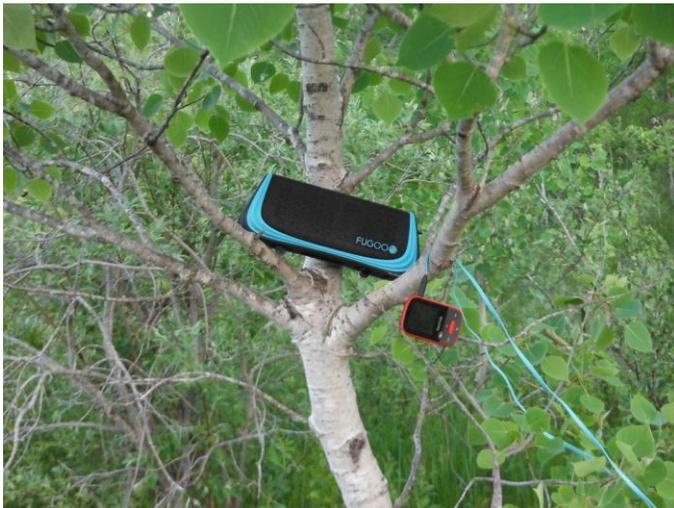
Photo 12 Callback surveys using a speaker and digital MP3 player were used to sample for golden-winged warbler.

Bird species of conservation concern surveys were conducted using standard avian point count and call-back surveys at pre-selected sites between June 16-19<sup>th</sup>, 2020 (Photo 12). A summary of the results can be found below. Detailed description of methods, maps, and results of the bird species of conservation concern survey can be found in the technical report included in Appendix F.

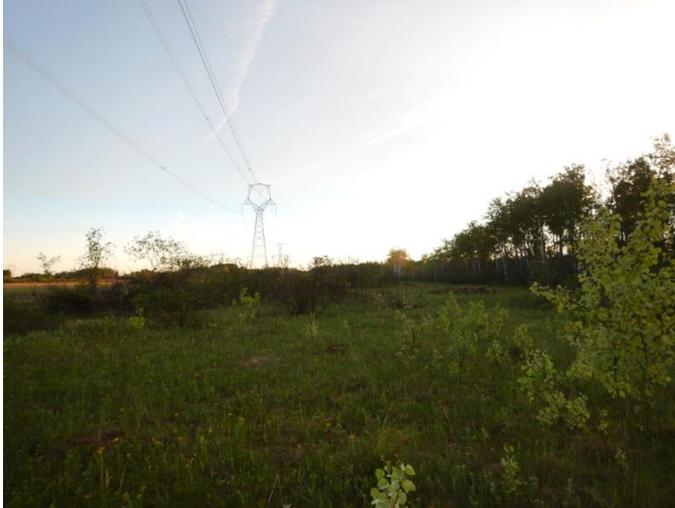
Photo 13 A golden-winged warbler (*Vermivora chrysoptera*) monitoring site on MMTP.

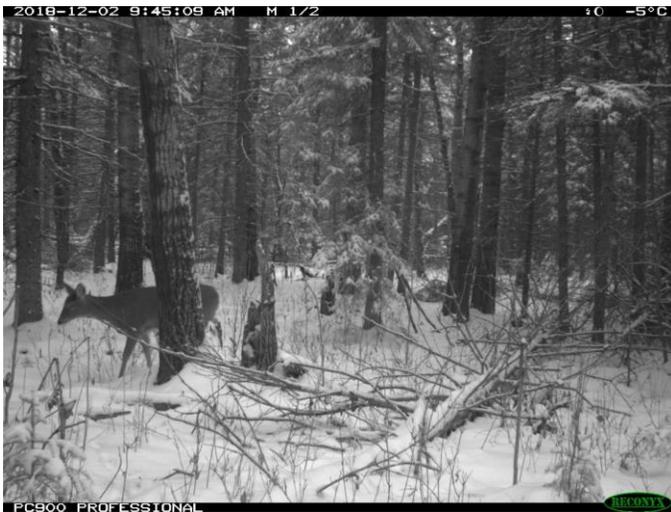
Photo 14 A white-tailed deer (*Odocoileus virginianus*) captured on a trail camera at a MMTP monitoring site.

Camera trap surveys were conducted throughout 2020 with the deployment of equipment at pre-selected sites with a focus on identifying white-tailed deer, black bear, gray wolf, and coyote (Photo14). Detailed description of methods, maps, and results of distribution and occurrence mapping survey can be found in Appendix G.

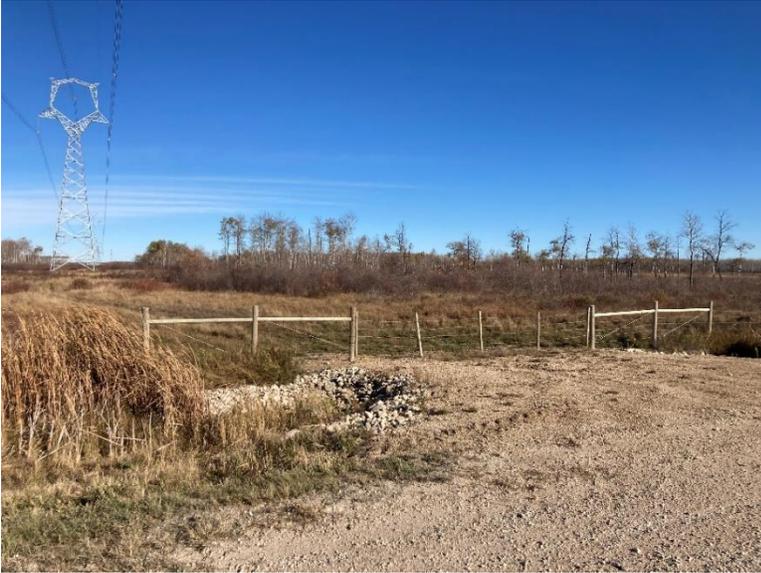
Photo 15 A completed MMTP access management point.

The EIS predicted small, low to moderate magnitude environmental effects on land and resource use, including access, which is what was found in this survey. All access controls were found to be in place and functioning with no concerns identified.
