St. Vital Transmission Complex (V78G)

Construction Environmental Protection Mapbook

Version: 1.00 Date: December 11, 2019

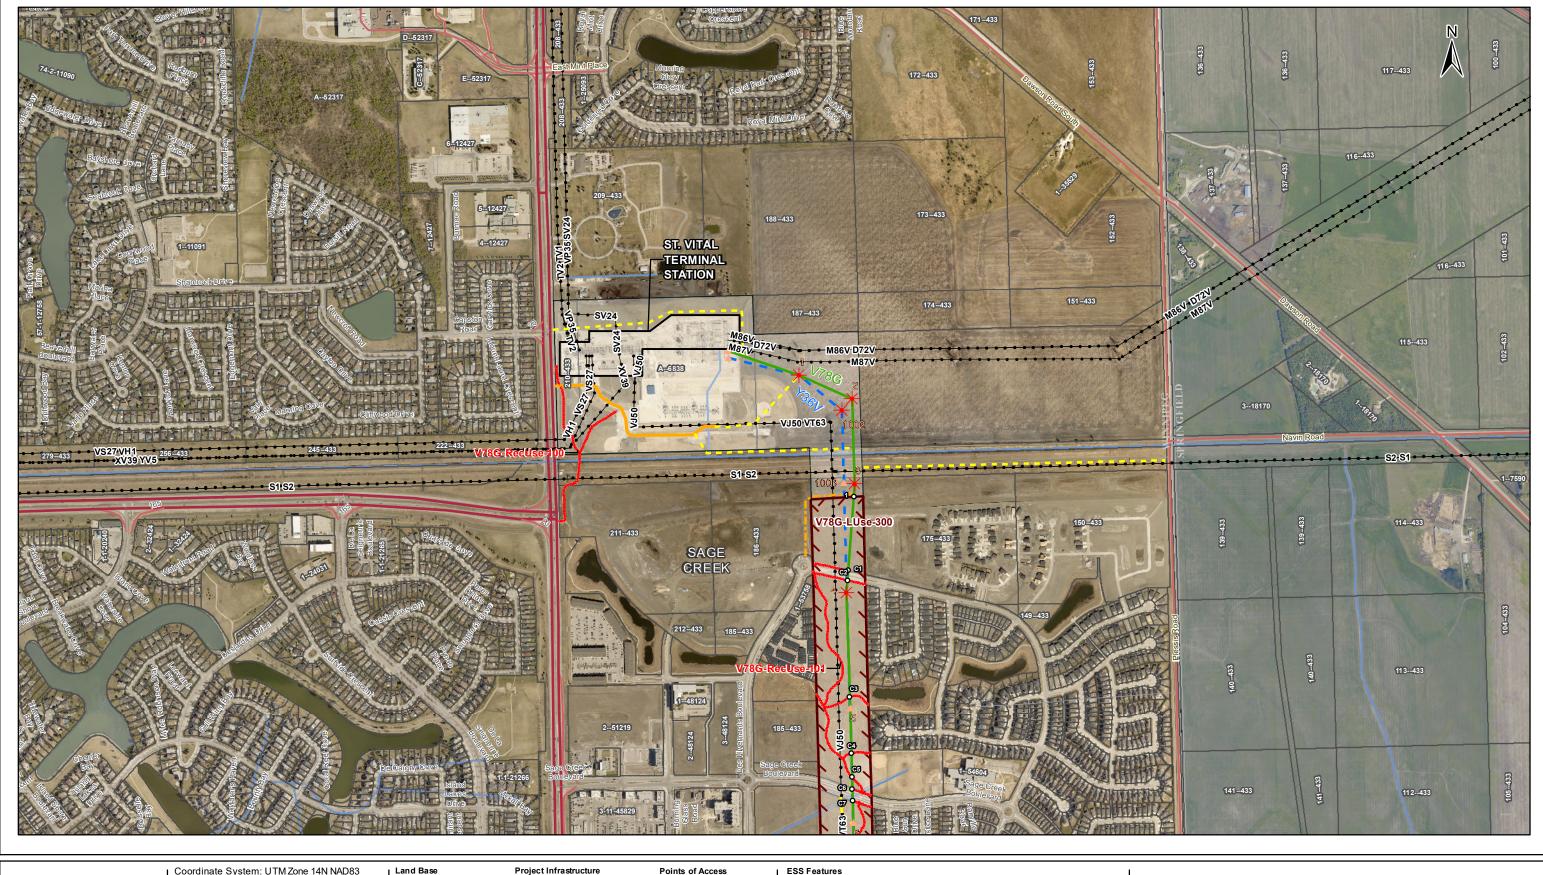
ESS ID	ESS Name	Site	Location
V78G-RecUse-101	Walking Trail	C1	E-641019 N-5522539
V78G-RecUse-101	Walking Trail	C2	E-641017 N-5522513
V78G-RecUse-101	Walking Trail	C3	E-641022 N-5522205
V78G-RecUse-101	Walking Trail	C4	E-641026 N-5522055
V78G-RecUse-101	Walking Trail	C5	E-641028 N-5521992
V78G-RecUse-101	Walking Trail	C6	E-641029 N-5521961
V78G-RecUse-101	Walking Trail	C7	E-641030 N-5521930

Potential Effects:

Potential interference with pedestrian traffic; safety issues

ESS ID	ESS Name	Site	Start	Stop	Distance (m)
V78G-LUse-300	Landscaped Prairie	1 to 2	E-641033 N-5522735	E-641048 N-5521311	1425

Potential loss or disturbance of landscaping that has been planted in native grasses and plant species

Specific Mitigation (ID# 113):

- Avoid surface damage to and obstruction of recreation route
 Post warning markers and signs at trail location
 Matting is required at the intersection point of any access trails

Specific Mitigation (ID# 216):

- Carry out construction activities on frozen or dry ground to minimize surface damage, rutting and erosion. Construction matting will be used to protect the area from rutting and exposure to soil during Non-frozen ground conditions
- Confine vehicle/equipment traffic to Designated access trails as per access management plan In the event of ground disturbance refer to Rehabilitation and Invasive Species Management Plan for mitigation measures

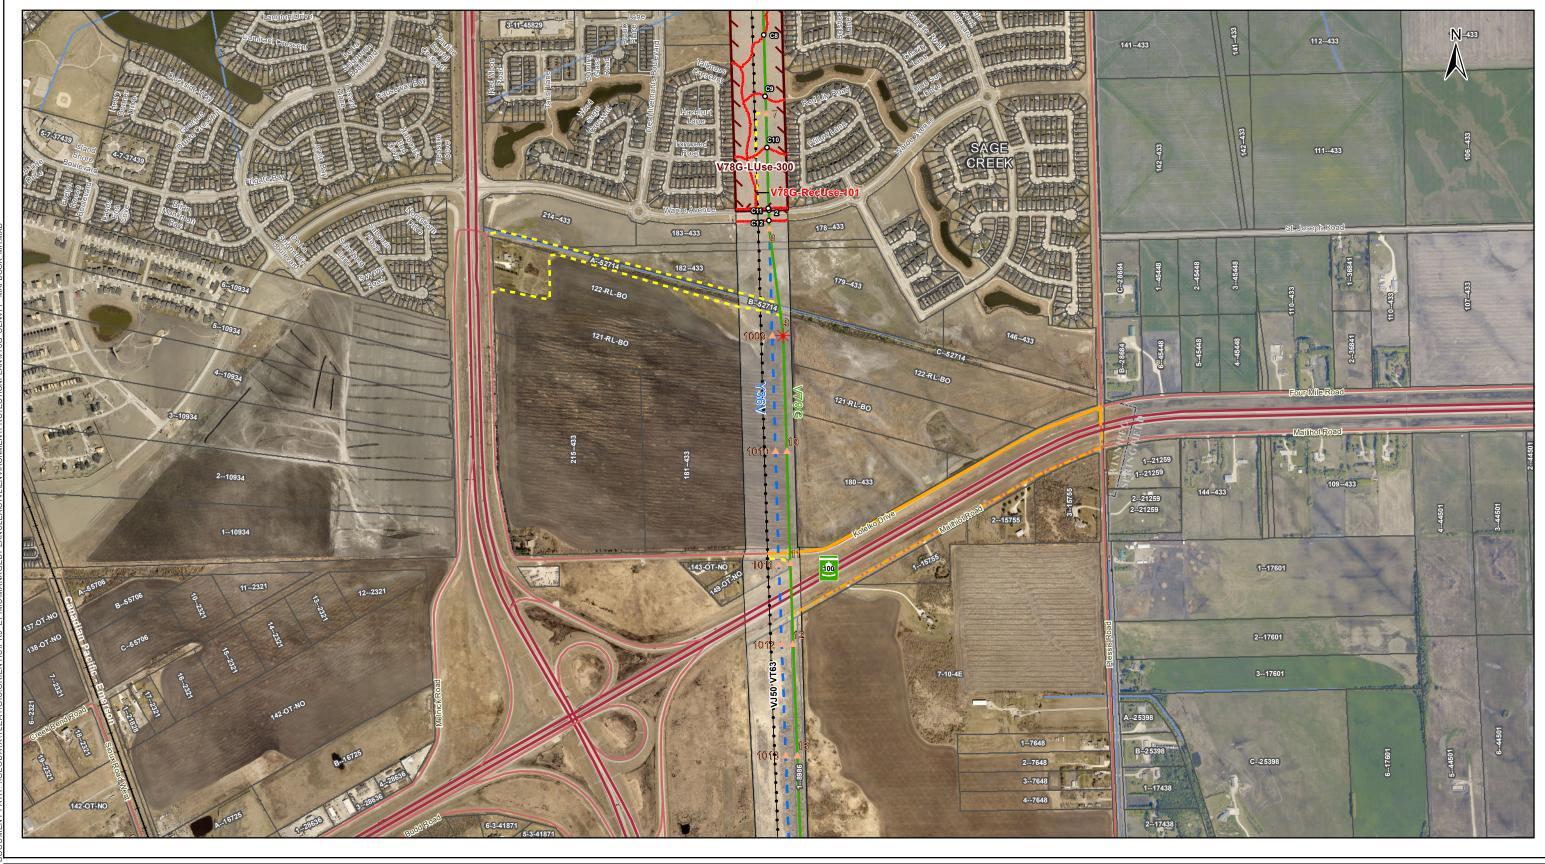
ESS ID	ESS Name	Site	Location
V78G-RecUse-101	Walking Trail	C8	E-641034 N-5521774
V78G-RecUse-101	Walking Trail	C9	E-641039 N-5521611
V78G-RecUse-101	Walking Trail	C10	E-641043 N-5521476
V78G-RecUse-101	Walking Trail	C11	E-641047 N-5521316
V78G-RecUse-101	Walking Trail	C12	E-641048 N-5521283

Potential Effects:

Potential interference with pedestrian traffic; safety issues

ESS ID	ESS Name	Site	Start	Stop	Distance (m)
V78G-LUse-300	Landscaped Prairie	1 to 2	E-641033 N-5522735	E-641048 N-5521311	1425

Potential loss or disturbance of landscaping that has been planted in native grasses and plant species

Specific Mitigation (ID# 113):

- Avoid surface damage to and obstruction of recreation route
 Post warning markers and signs at trail location
- Matting is required at the intersection point of any access trails

Specific Mitigation (ID# 216):

- Carry out construction activities on frozen or dry ground to minimize surface damage, rutting and erosion. Construction matting will be used to protect the area from rutting and exposure to soil during Non-frozen ground conditions
- Confine vehicle/equipment traffic to Designated access trails as per access management plan
- In the event of ground disturbance refer to Rehabilitation and Invasive Species Management Plan for mitigation measures

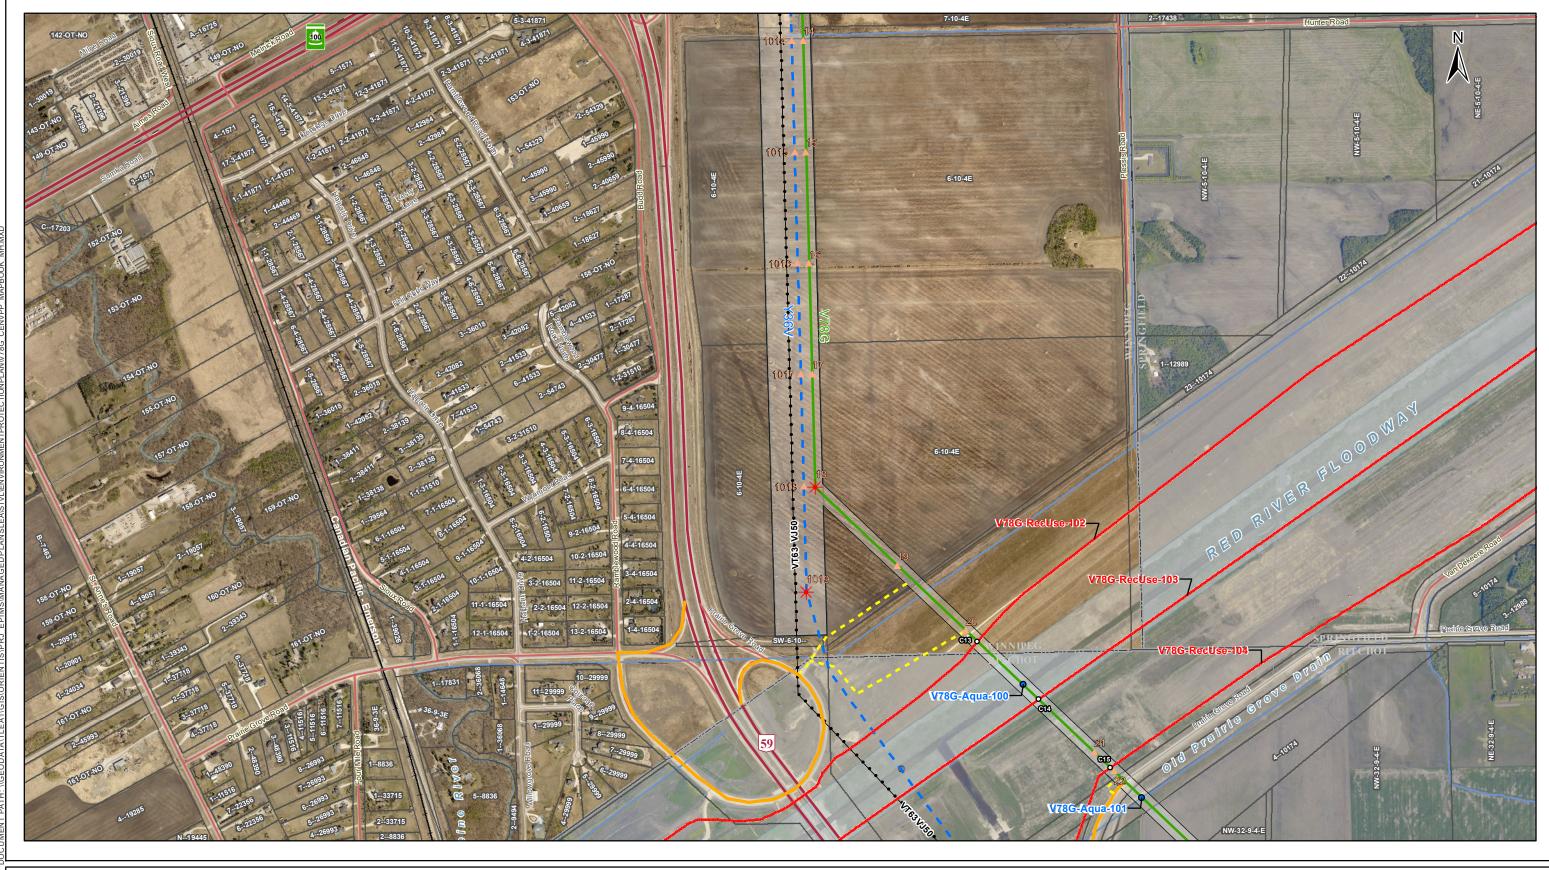
Map Number: 3

ESS ID	ESS Name	Site	Location
V78G-RecUse-103	Snowmobile Trail	C14	E-641756 N-5517834
V78G-RecUse-104	Snowmobile Trail CT710	C15	E-641946 N-5517654

Potential Effects:

Potential interference with snowmobilers; safety issues

ESS ID	ESS Name	Site	Location
V78G-RecUse-102	Duff Roblin Parkway Trail	C13	E-641594 N-5517988

Potential interference with pedestrian traffic; safety issues

ESS ID	ESS Name	Location
V78G-Aqua-100	Floodway	E-641715 - N-5517873
V78G-Aqua-101	Old Prairie Grove Drain	E-642030 - N-5517574

Habitat loss and contamination from structure foundations & installations; increased erosion & sedimentation of streams; Damage to stream banks; Loss of riparian vegetation; Fish habitat disturbances and impeded fish movement; Rutting of floodplain

Specific Mitigation (ID# 103):

- Identify and flag where trail intersects ROW Avoid surface damage to and obstruction of recreation route
- Post warning markers and signs at snowmobile trail location during construction
- Notify snowmobile club/users and local authorities regarding construction activities and schedule, and address concerns prior to construction

Specific Mitigation (ID# 113):

- Avoid surface damage to and obstruction of recreation route Post warning markers and signs at trail location
- Matting is required at the intersection point of any access trails

Specific Mitigation (ID# 64):

- Carry out construction activities on frozen ground to minimize surface damage, rutting and erosion
- Use existing trails, roads or cut lines whenever possible as access routes
- Identify and flag buffer areas prior to start of work
- Riparian Buffers shall be a minimum of 30m and increase in size based on slope of land entering waterway. Within these buffers shrub and herbaceous understory veg will be maintained along with trees that do not violate MH Veg Clearance Requirements.
- 7m no machine zone will restrict equipment in close proximity to the waterbody except at the trail crossing.

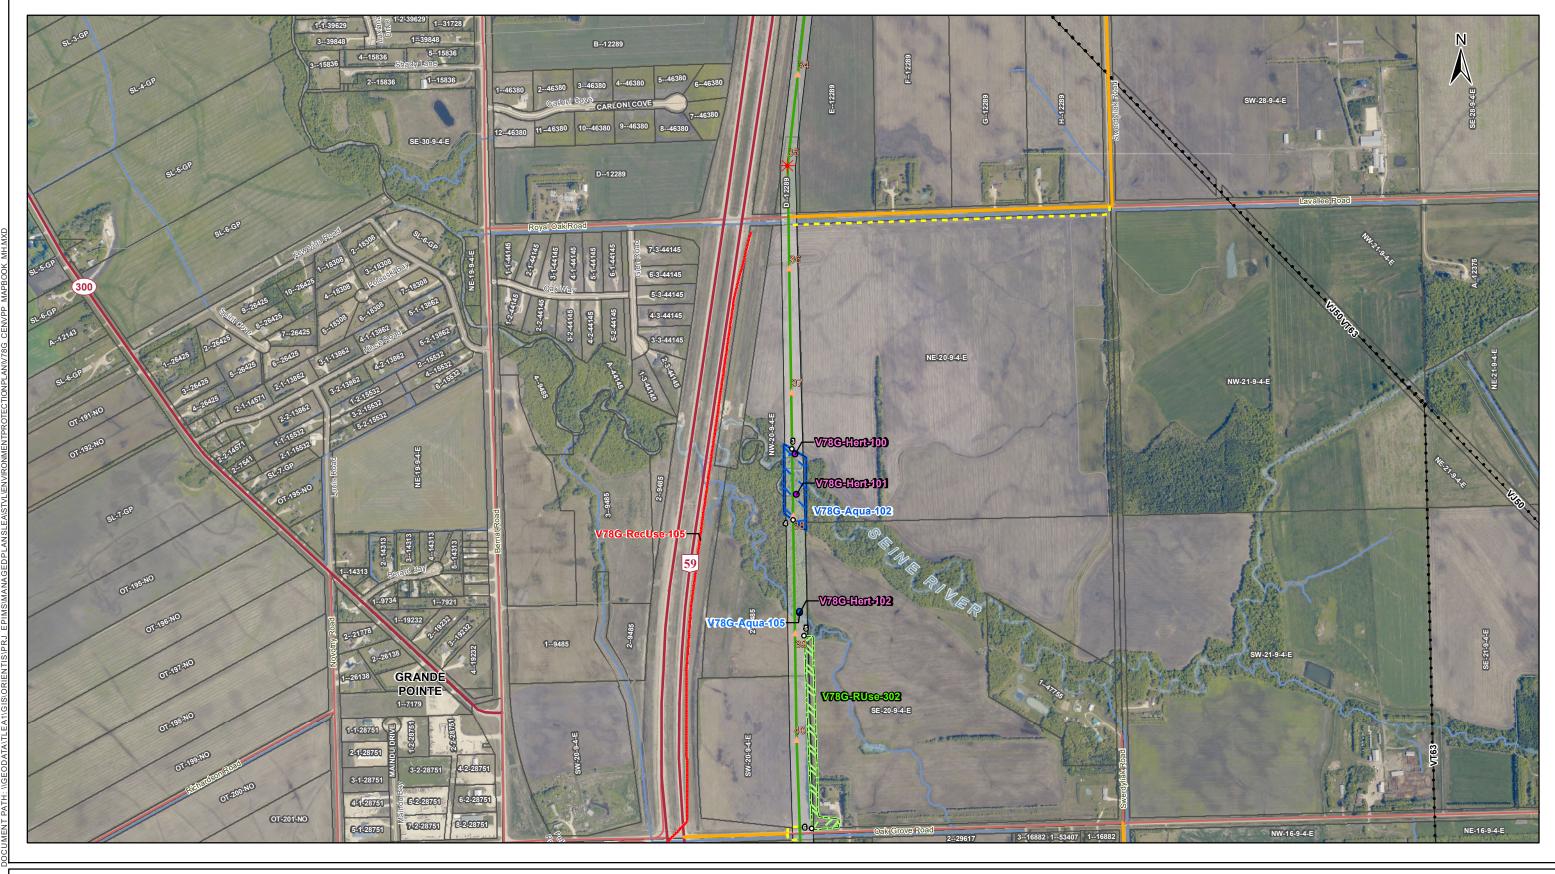
Map Number: 5

ESS ID	ESS Name	Location
V78G-Hert-100	Potential Archaeological Site Seine River	E-642904 - N-5514109
V78G-Hert-101	Potential Archaeological Site Seine River	E-642907 - N-5514001
V78G-Hert-102	Potential Archaeological Site Seine River	E-642917 - N-5513689

Potential Effects:

Potential disturbance to Heritage Resources

ESS ID	ESS Name	Site	Start	Stop	Distance (m)
V78G-RUse-302	Shelterbelt	5 to 6	E-642928 N-5513627	E-642948 N-5513117	510

Removal in area of ROW intersect

ESS ID	ESS Name	Location
V78G-Aqua-105	Intermittent Stream	E-642916 - N-5513691

Habitat loss and contamination from structure foundations & installations; increased erosion & sedimentation of streams; Damage to stream banks; Loss of riparian vegetation; Fish habitat disturbances and impeded fish movement; Rutting of floodplain

ESS ID	ESS Name	Site	Start	Stop	Distance (m)
V78G-Aqua-102	Seine River	3 to 4	E-642896 N-5514122	E-642899 N-5513933	188

Specific Mitigation (ID# 301):

- Carry out construction activities on frozen or dry ground to minimize surface damage, rutting and erosion
- Conduct site investigation with Archaeologist prior to construction
- Inspect excavated materials or surface disturbance for heritage resources and report any finds to Environmental Inspector
- Implement additional mitigation from site investigation
- Cultural and Heritage Resources Protection Plan will be followed when a suspected cultural or heritage resource is discovered
- Should heritage resources be discovered during a pre-construction survey an archaeologist may prescribe construction matting to be used to protect the area from disturbance

Specific Mitigation (ID# 505):

- Carry out construction activities on frozen or dry ground to minimize surface damage, rutting and erosion
- Identify and flag prior to start of work
- Use existing access trails, roads or cut lines whenever possible as access routes
- Limit all equipment to project footprint only, where possible
- No pushing debris into adjacent timber

Specific Mitigation (ID# 64):

- Carry out construction activities on frozen ground to minimize surface damage, rutting and erosion
- Use existing trails, roads or cut lines whenever possible as access routes
- Identify and flag buffer areas prior to start of work
- Riparian Buffers shall be a minimum of 30m and increase in size based on slope of land entering waterway. Within these buffers shrub and herbaceous understory veg will be maintained along with trees that do not violate MH Veg Clearance Requirements.
- 7m no machine zone will restrict equipment in close proximity to the waterbody except at the trail crossing.

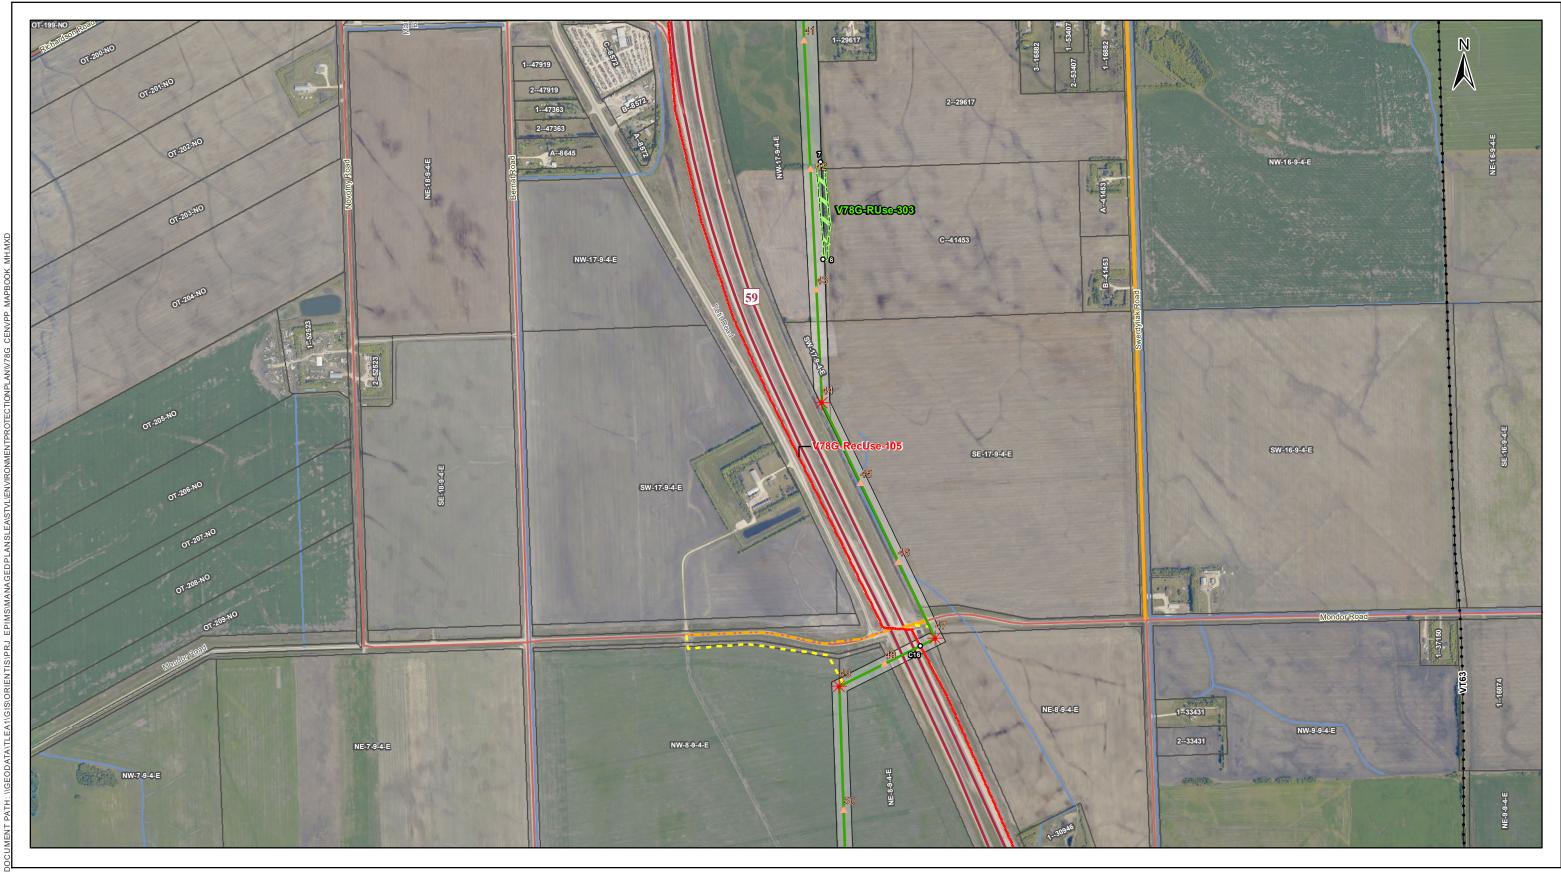
ESS ID	ESS Name	Site	Start	Stop	Distance (m)
V78G-RUse-303	Shelterbelt	7 to 8	E-642963 N-5512704	E-642971 N-5512446	257

Potential Effects:

Removal in area of ROW intersect

ESS ID	ESS Name	Site	Location
V78G-RecUse-105	Snowmobile Trail CT710	C16	E-643227 N-5511424

Potential interference with snowmobilers; safety issues

Specific Mitigation (ID# 505):

- Carry out construction activities on frozen or dry ground to minimize surface damage, rutting and erosion
 Identify and flag prior to start of work
 Use existing access trails, roads or cut lines whenever possible as access routes
 Limit all equipment to project footprint only, where possible
 No pushing debris into adjacent timber

Specific Mitigation (ID# 103):

- Identify and flag where trail intersects ROW
 Avoid surface damage to and obstruction of recreation route
 Post warning markers and signs at snowmobile trail location during construction
 Notify snowmobile club/users and local authorities regarding construction activities and schedule, and address concerns prior to construction

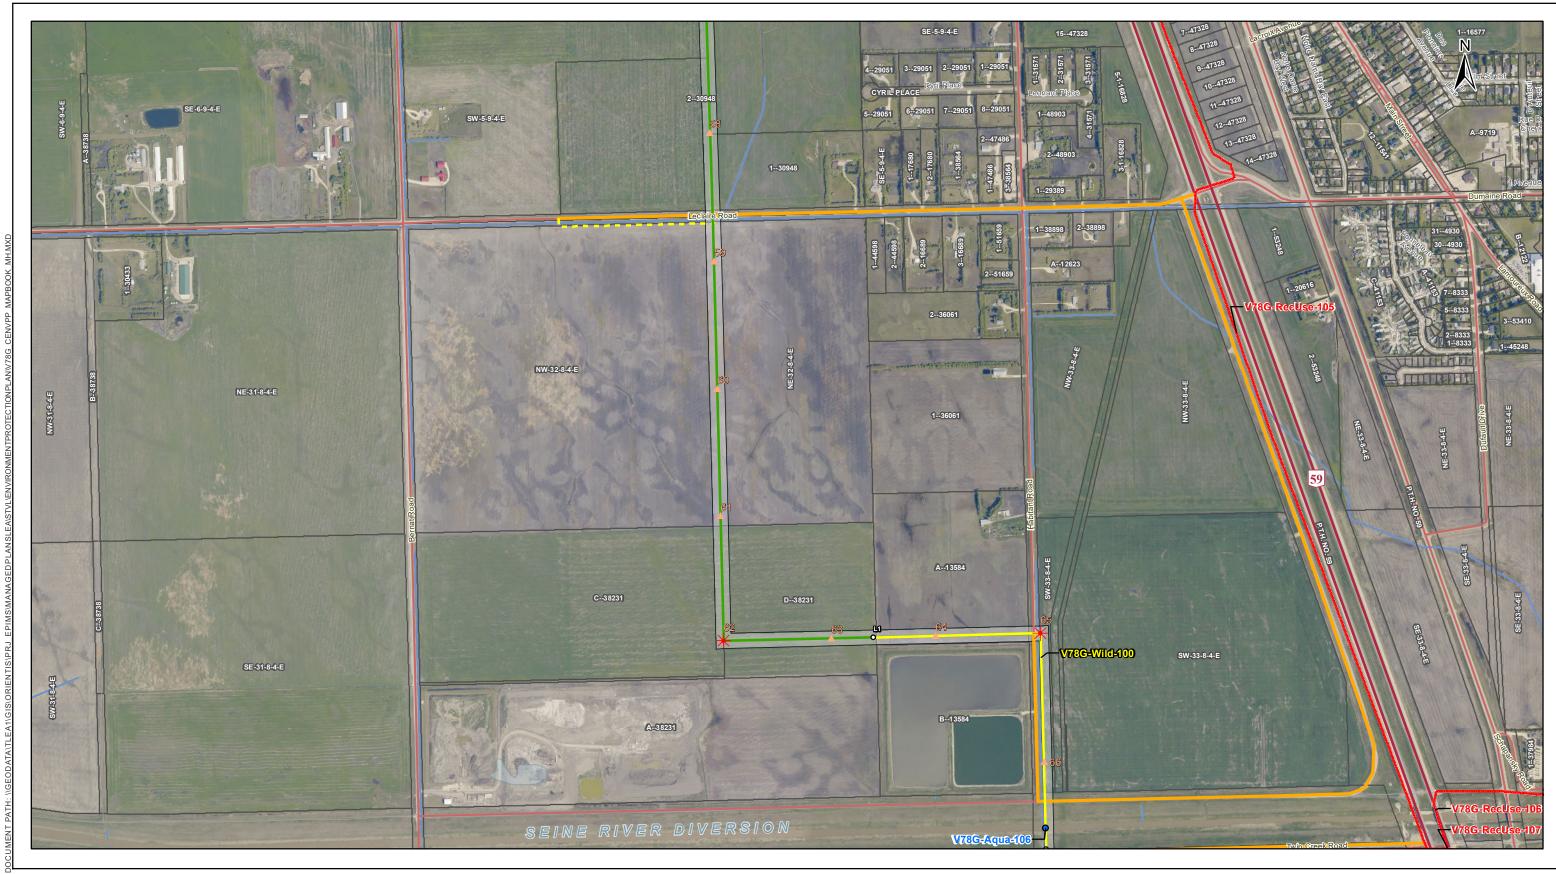
ESS ID	ESS Name	Site	Start	Stop	Distance (m)
V78G-Wild-100	Reservoir adjacent to RoW	L1 to L2	E-643544 N-5507070	E-644002 N-5506508	1015

Potential Effects:

Higher risk of wire collision, Risk of wire collision is localized to the right-of-way

ESS ID	ESS Name	Location
V78G-Aqua-106	Seine River Diversion	E-644000 - N-5506564

Habitat loss and contamination from structure foundations & installations; increased erosion & sedimentation of streams; Damage to stream banks; Loss of riparian vegetation; Fish habitat disturbances and impeded fish movement; Rutting of floodplain

Specific Mitigation (ID# 28):

- Conduct priority assessment for bird diverters and other measures prior to transmission line stringing
- Install bird diverters or other measures at high priority sites
- Bird diverters will be installed in a manner to maximize visibility by alternating between reflective and spiral diverters along the skywires
- Install bird diverter with spacing as per Transmission Line Design specifications for these spans

Specific Mitigation (ID# 64):

- Carry out construction activities on frozen ground to minimize surface damage, rutting and erosion Use existing trails, roads or cut lines whenever possible as access routes
- Identify and flag buffer areas prior to start of work
- Riparian Buffers shall be a minimum of 30m and increase in size based on slope of land entering waterway. Within these buffers shrub and herbaceous understory veg will be maintained along with trees that do not violate MH Veg Clearance Requirements.
- 7m no machine zone will restrict equipment in close proximity to the waterbody except at the trail crossing.

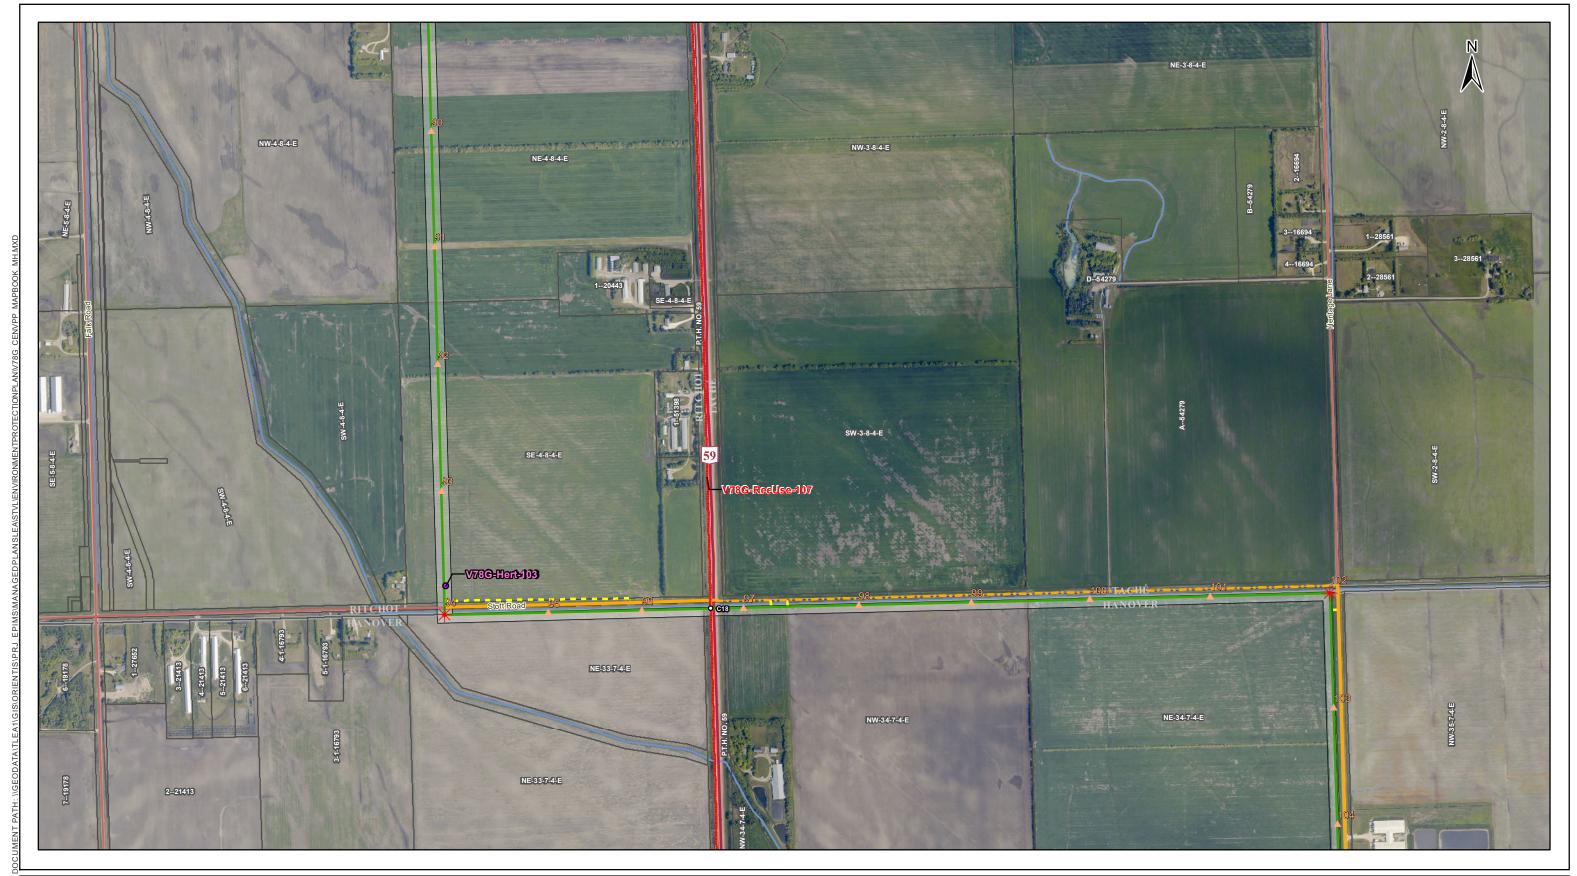
ESS ID	ESS Name	Location
V78G-Hert-103	Potential Archaeological Site	E-645145 - N-5498449

Potential Effects:

Potential disturbance to Heritage Resources

ESS ID	ESS Name	Site	Location
V78G-RecUse-107	Snowmobile Trail CT710	C18	E-645845 N-5498388

Potential interference with snowmobilers; safety issues

Specific Mitigation (ID# 301):

- Carry out construction activities on frozen or dry ground to minimize surface damage, rutting and erosion Conduct site investigation with Archaeologist prior to construction
- Inspect excavated materials or surface disturbance for heritage resources and report any finds to **Environmental Inspector**
- Implement additional mitigation from site investigation
- Cultural and Heritage Resources Protection Plan will be followed when a suspected cultural or heritage resource is discovered
- Should heritage resources be discovered during a pre-construction survey an archaeologist may prescribe construction matting to be used to protect the area from disturbance

Specific Mitigation (ID# 103):

- Identify and flag where trail intersects ROW
- Avoid surface damage to and obstruction of recreation route
- Post warning markers and signs at snowmobile trail location during construction
- Notify snowmobile club/users and local authorities regarding construction activities and schedule, and address concerns prior to construction
