Effects of Transmission Lines on Global Positioning Systems

Manitoba Hydro DC-Line GNSS Survey Report

Effects of Transmission Lines On Global Positioning Systems

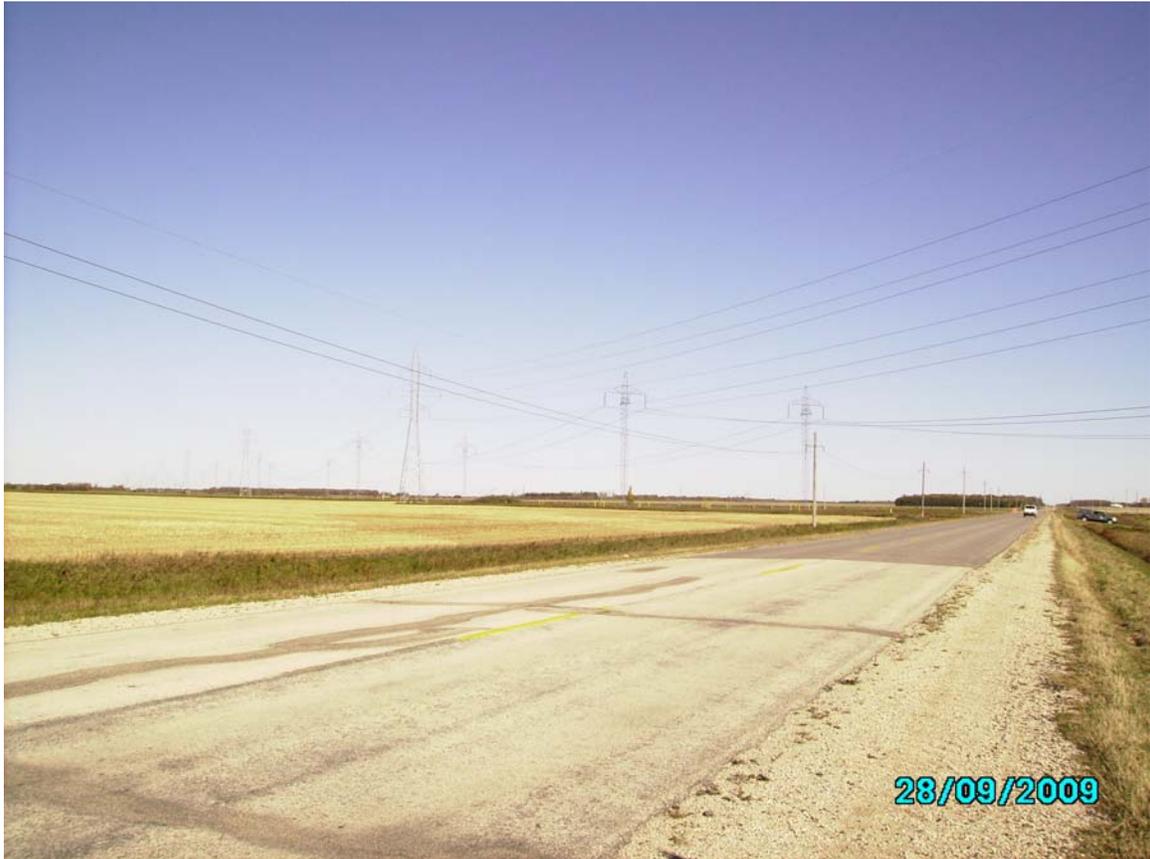
Figure 1
Test Environment

The test location was along PR# 322 located North of Grosse Isle, Manitoba. At the location there were two High Voltage DC transmission lines (Bipoles I and II) and an AC line. Two points were placed well away from the transmission line (Points 1 and 3), while three others were located directly under the middle transmission line, with two of these points being placed in close proximity to existing towers (Points 2 and 4), and the other being placed directly under the lowest point of the transmission line (Point 5). A sixth point was placed close to a tower and directly under an AC line, (Point 6). In order to assess the integrity of the network the location of all points were confirmed with a Wild 805 Total Station using conventional survey methods. The conventional survey measurements established points to within 5mm and form a reference base that was unaffected by any outside influences. Figure 1 shows the test environment and Figure 2 the network configuration. All observations were carried out between 8AM and 6PM when the lines were energized.

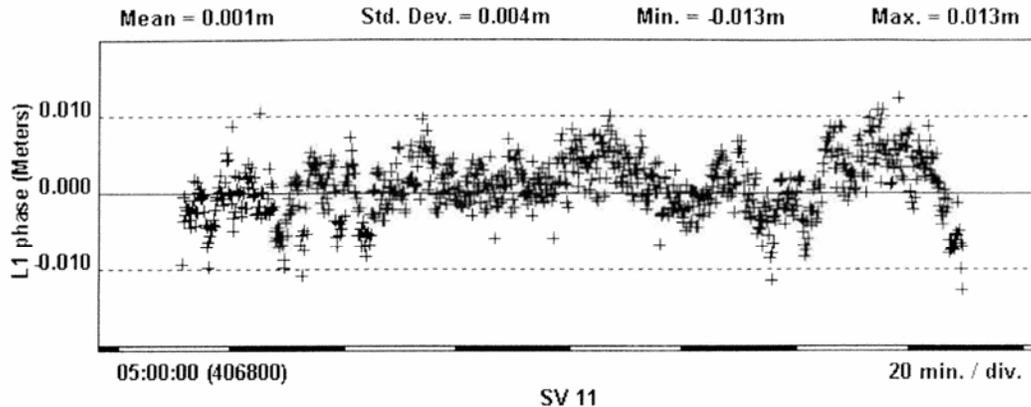
Figure 3
Typical Satellite Carrier Phase Tracking

A sample of a typical satellite tracking session is provided in Figure 3. It can be observed that the observations had a mean value of 0.001m (1 mm) with a minimum and maximum value of 0.013 M (13 mm) over the length of the observation. This was seen to be typical of all observations regardless if they were located under or away from the transmission lines.

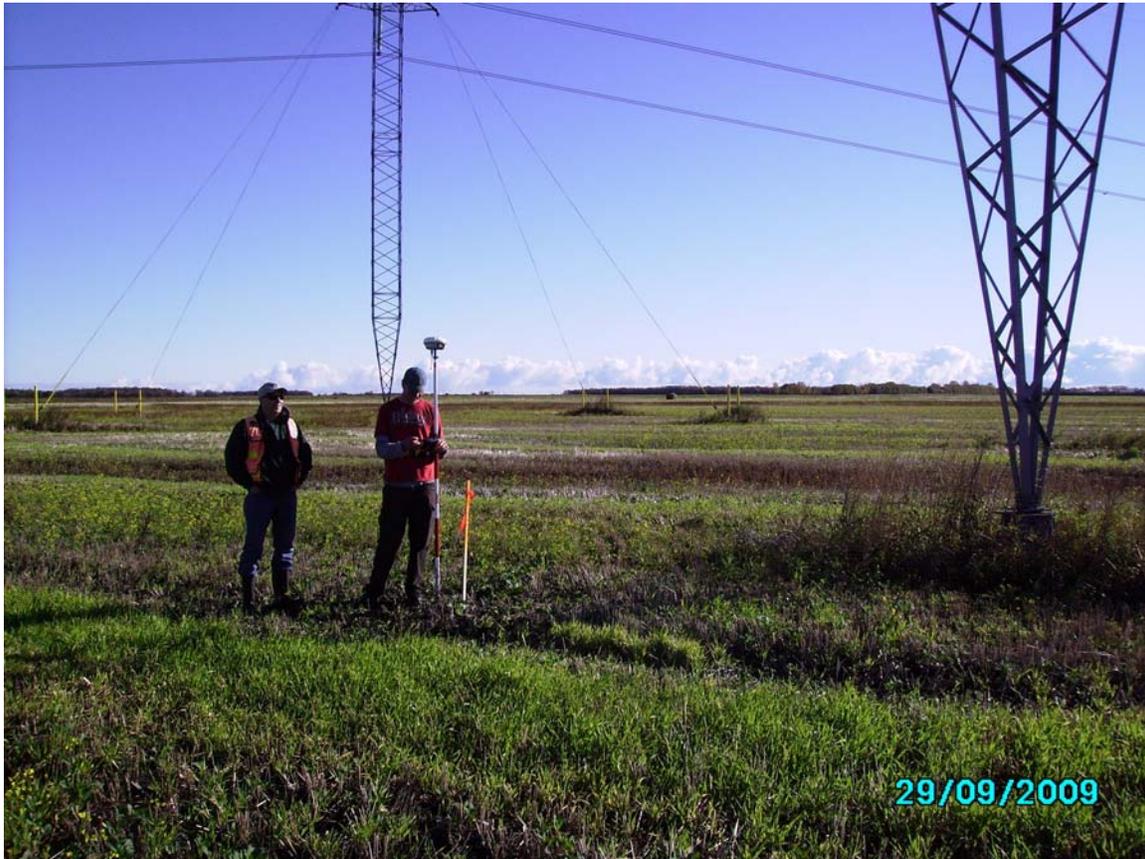
Figure 4
Typical RTK Observation

Real Time Kinematic using WAAS - Observations were carried out on the points established utilizing the WAAS System. Typically the corrections supplied in a WAAS application yield positions to accurate to within 0.5 to 1 metre. A typical GPS RTK rover observation is given in Figure5 below.

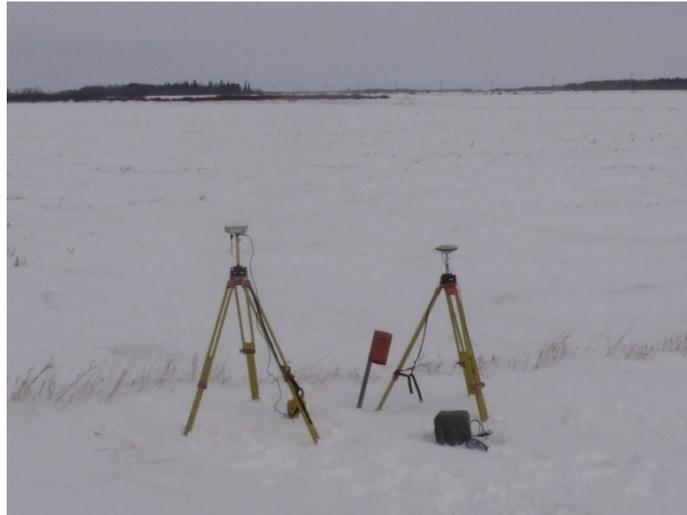
Figure 2 – Deployment of GNSS base stations on 24 January 2011. Novatel V3 receiver utilizes right tripod equipped with a Novatel 702-GG GPS+GLONASS L1+L2 antenna. Trimble R8 base unit occupies left tripod, with integrated receiver + antenna + radio module. Radio antenna is the black vertical bipole antenna visible under the R8 receiver body.

Base station deployment in support of differential data processing and real time kinematic (RTK) receiver testing was dictated by the testing profiles, the range of the Trimble R8 RTK system radio link, as well as the desire to maximize the distance between base stations and the potential effects of the power lines. In order to comply with the rated radio link limitation of 1 km while still allowing traversal testing under both DC bipoles as well as data collection parallel to and beneath multiple tower spans of the DC lines, the base stations shown in Figure 2 were deployed at the position indicated in Figure 3.

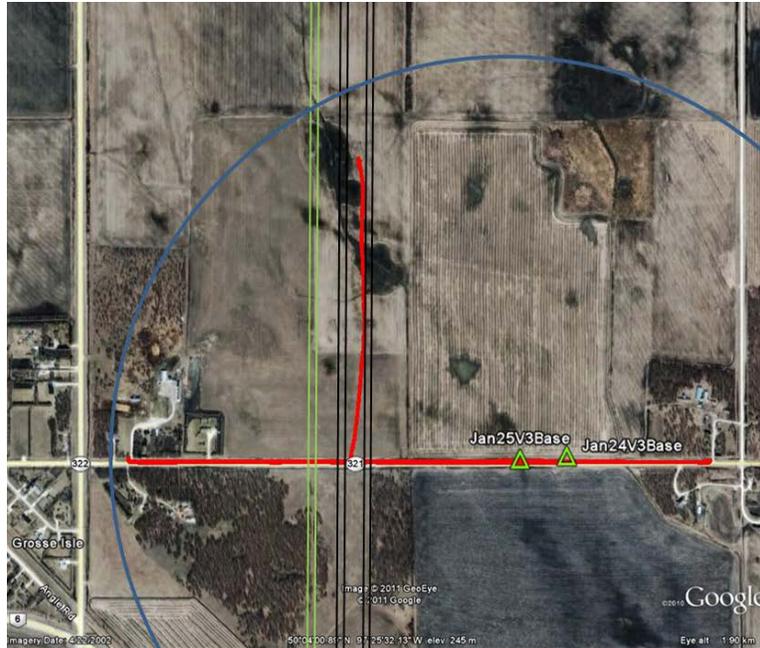
Figure 3 – Map of test location showing location of the V3 base stations for each day (green triangles), range of Trimble R8 450 MHz data link (blue circle), and position of DC bipole 1 and 2 (black lines), position of AC Line (green lines). Base map from Google (2011).

On the 2nd day of field data collection the deployment location of the base stations was transferred approximately 150 metres further west as the effective range of the radio link was found to be greater than the initial estimate.

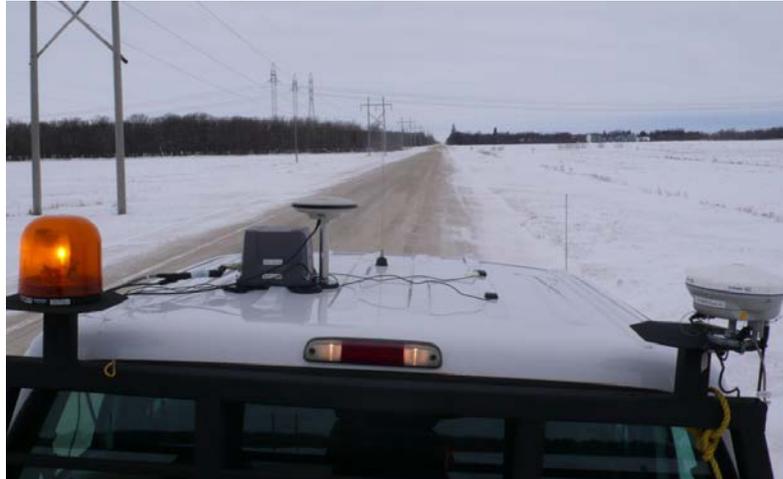
Figure 4 – Mobile GNSS, Inertial, and RF equipment elements mounted on roof of test vehicle. Trimble R8 rover unit at bottom right, high sensitivity GPS antennas on roof at right, Novatel 702 GG dome antenna centre left directly adjacent to LCI IMU (grey box) at centre left.

group Leapfrog-II L-Band Front-End module. The IMU component of the Novatel SPAN SE system was deployed on the roof of the vehicle to provide a rigid and stable mounting point via four magnets.

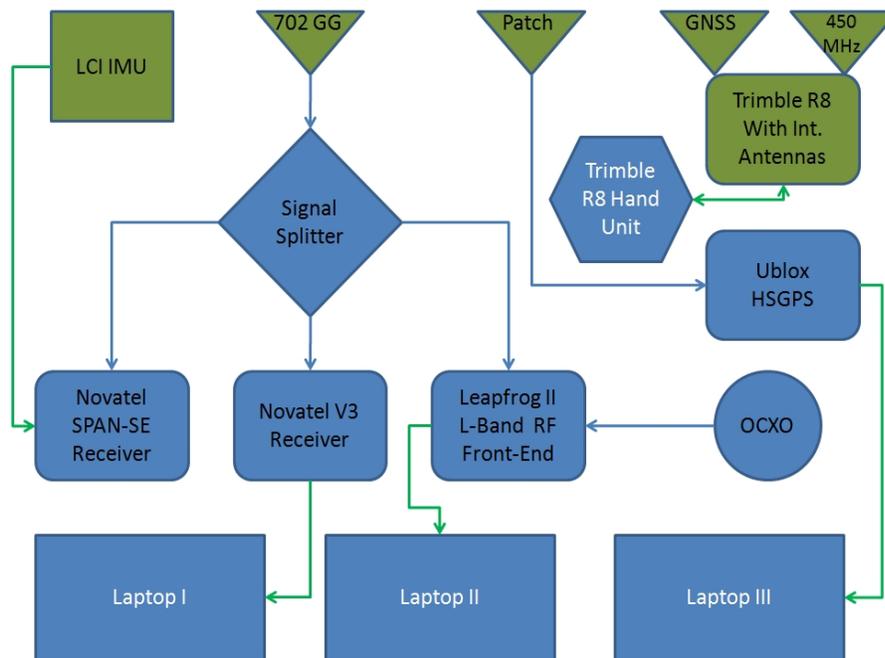
Figure 5 – Deployed equipment functional diagram. Equipment external to vehicle shown as olive green elements (antennas, IMU, Trimble R8), equipment installed inside vehicle shown in blue. Cabled RF links shown with blue arrows, digital data links shown with green arrows.

The block diagram of the complete navigation test system suite is shown in Figure 5.

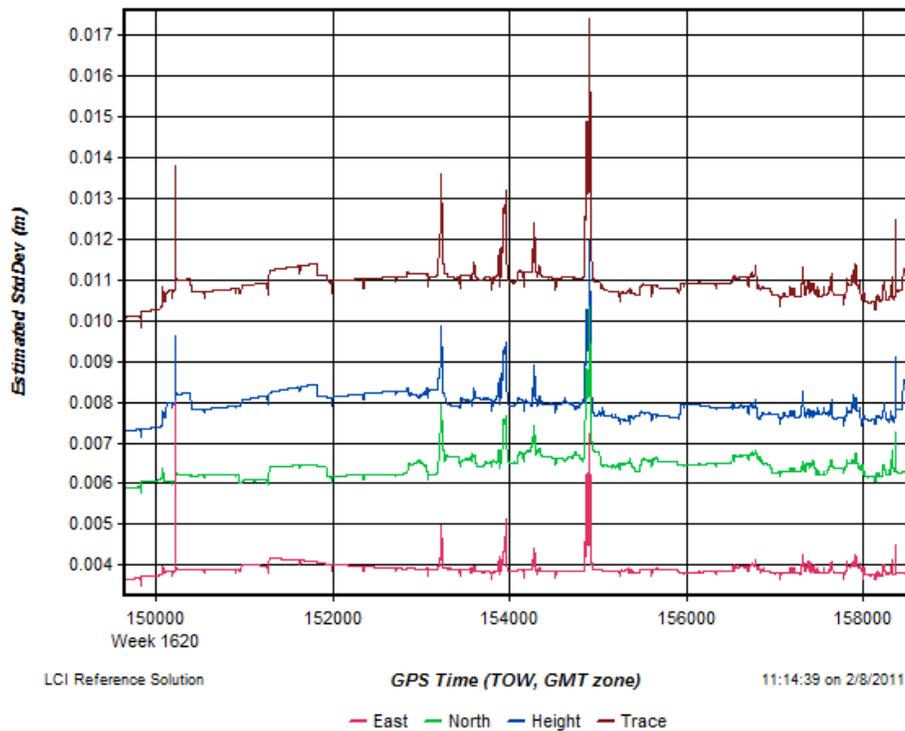
resulting from potential GNSS data outages that would hinder the solutions. Some occasional discontinuities are seen. These occur outside the test segments and are related to people working close to the antenna thereby resulting in signal shading, vehicle dynamics (the vehicle entering the ditch where it experienced a high pitch and moderate roll) and prolonged static times where the IMU biases are not as effectively estimated (i.e. IMU errors are more accurately estimated under dynamics).

Figure 6 – Estimated Standard Deviation (1σ) of the Reference Trajectory as Output by Inertial Explorer

Figure 7 shows the differences between the estimated positions derived from the IMU and the GNSS solutions used to aid the INS. The positions derived from the IMU are computed by using the mechanization equations to convert from angular velocity and specific force to changes in orientation and position. Thus Figure 7 shows that the agreement between the IMU and GNSS navigation solution is extremely good, namely better than a few centimetres. The discontinuities that occur correspond to the standard deviation increases seen in Figure 6.

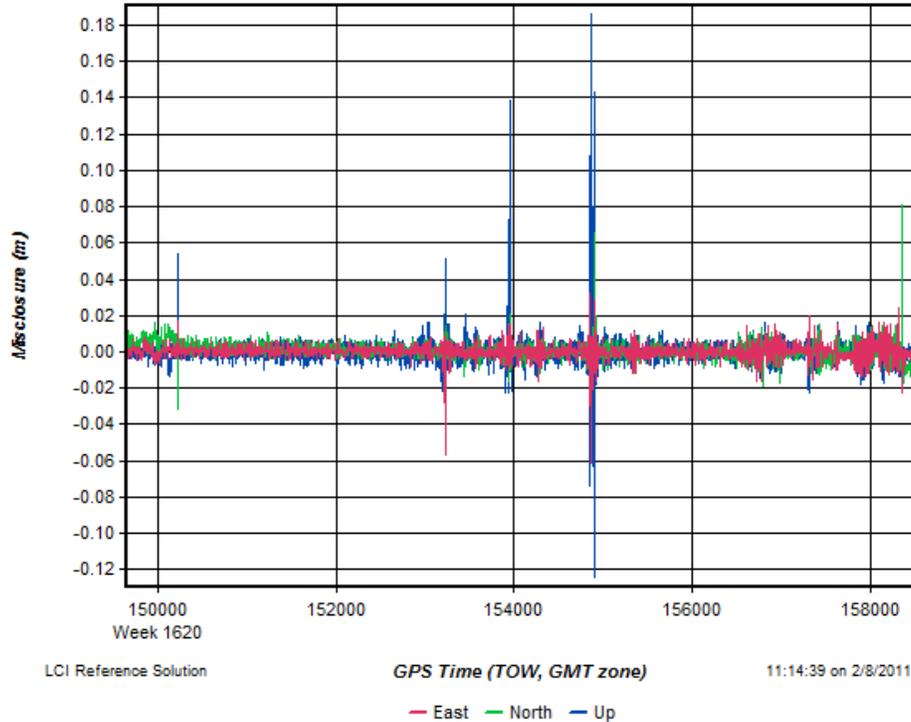
Figure 7 – Difference in IMU Mechanization Positions and GNSS Positions as Output by Inertial Explorer

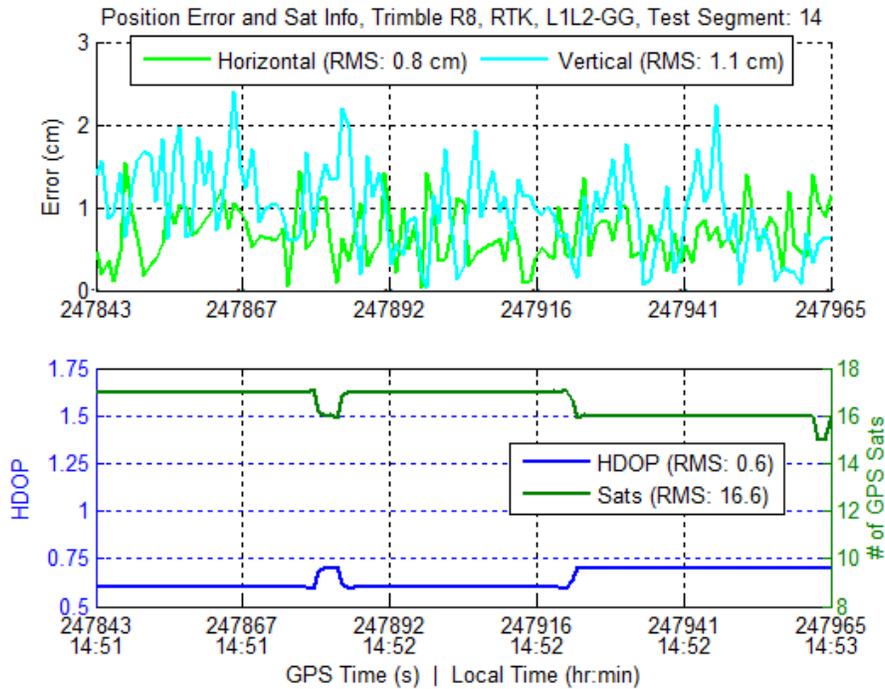
The position errors of the Trimble Real Time Kinematic (RTK) system are shown in Figure 8 and Figure 9 for segments 14 and 19, respectively. Discrepancies of several cm to 1 dm are common amongst receiver manufacturers and processing software, thus the errors shown on the top of Figure 8 are completely normal. The errors are a sum of antenna phase center variation (two systems), projection of the reference solution to the Trimble R8 antenna, carrier phase noise and multipath, and differences in filtering and estimation techniques used.

Figure 8 – Position Errors and Satellite Geometry, Receiver: Trimble R8, Processed by: Trimble Internal RTK Solution, Data: L1+L2+GPS+GLONASS, Test Segment: 14

Referring back to the two previous figures, the HDOP and number of satellites presented in the bottom half of Figure 8 and Figure 9 are consistent with expected open sky conditions. The solution of the RTK system may, for example, reject a satellite without a fixed ambiguity, occlude some satellites near the horizon or have difficulty maintaining signal lock for a low elevation satellite. The values presented in Figure 8 and Figure 9 show ideal data, with no reason to yield navigation impediments. A HDOP of 0.6 is among the best values currently available with a GPS+GLONASS receiver at the latitude of the tests.

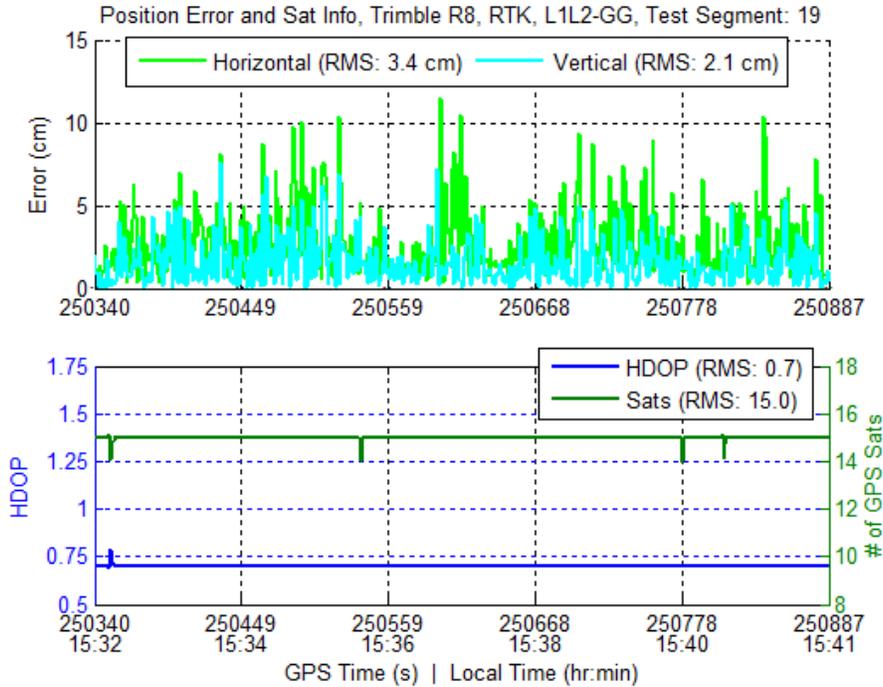
The RTK solution of segment 19, as shown in Figure 9, contains errors upwards of 12 cm, with an RMS of 3.4 cm. Segment 19 is a north/south trajectory underneath the DC bipoles and was conducted on a snow covered semi-plowed field. These positions are derived from a float solution, in which case the carrier phase ambiguities are estimated as stochastic quantities. This often used technique results in lower accuracies (of several decimetres). These errors are consistent for all North/South segments (segments 17 - 19) where the vehicle was on uneven paths. A fixed solution was maintained when the vehicle was on the paved road with minimal dynamics. During the static section of segment 18, the RTK solution was then able to fix and provide results similar to those of the perpendicular and static tests (see Figure A97). Further, the GrafNav solution, shown in Figure 11, was able to fix the ambiguities, indicating that the GNSS measurements are good and of the quality expected under line-of-sight conditions.

Figure 9 – Position Error and Satellite Geometry, Receiver: Trimble R8, Processed by: Trimble Internal RTK Solution, Data: L1+L2+GPS+GLONASS, Test Segment: 19

(excessive noise or multipath), (ii) failure or weakness in the RTK data link and (iii) the algorithm/software used to determine the ambiguity. The first potential factor was eliminated by showing that the GNSS measurement quality is normal through post-mission processing. It is not possible to fully verify (iii) due to the proprietary nature of the receiver algorithms/software implemented to fix the ambiguities. It is not possible either to verify (ii) as there is no information on the number of data packets or checksums lost in the data link. Thus, because a fixed solution was possible by processing the measurements in post-mission with GrafNav, it is only possible to confirm that the GNSS measurements were not at fault in the float solution of the Trimble RTK solution. The uneven path of section 17 – 19 (in addition to 8 and 9) resulted in vibrations and jerks in the antennas. This may have affected the quality of the data link. As explained above, it is not possible to fully verify this due to the lack of data link measurement checks available to the user. As to whether the Trimble data link performance might have been directly affected by the overhead power lines during the along-track tests but not during perpendicular tests cannot be confirmed or denied due to the lack of evidence.

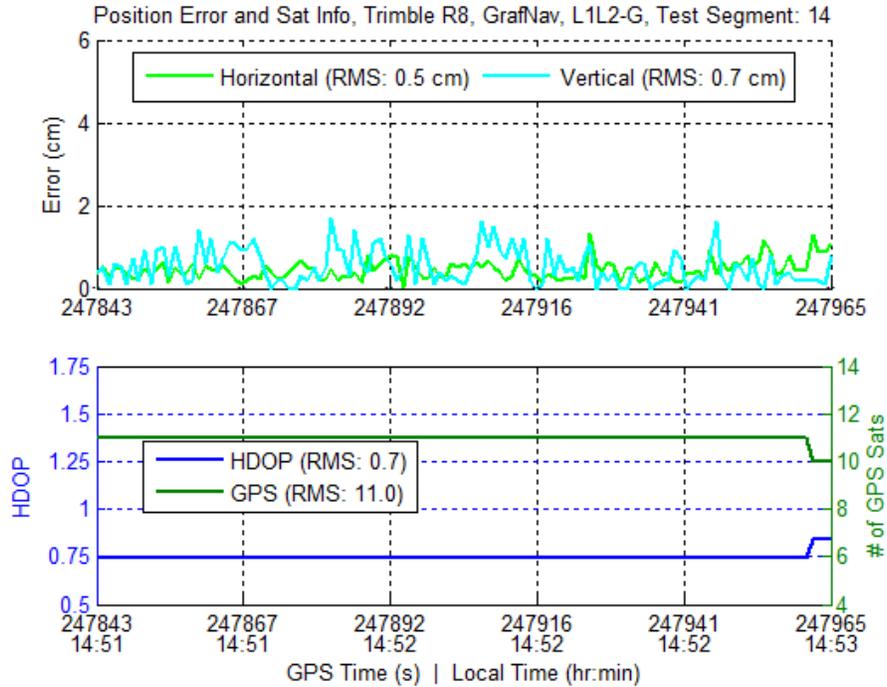
Figure 10 – Position Errors and Satellite Geometry, Receiver: Trimble R8, Processed by: NovAtel’s GrafNav, Data: L1+L2+GPS, Test Segment: 14

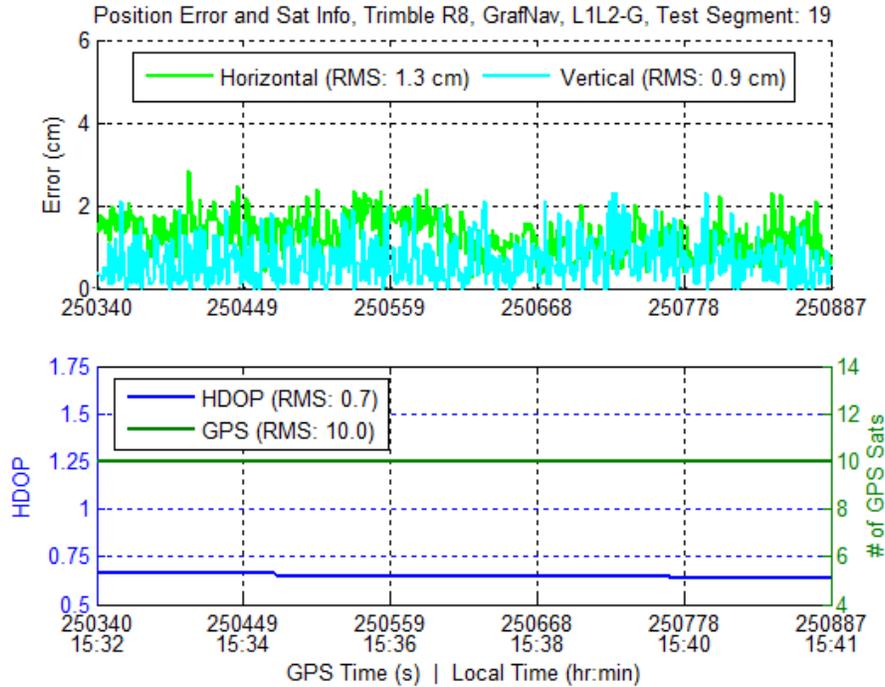
The RMS error of Segment 19, shown in Figure 11, for the GrafNav solution is 0.8 cm larger than the perpendicular case (0.5 vs. 1.3 cm). This is attributed to carrier phase multipath and noise, the dynamics experienced by the vehicle and the ability to map the reference solution to the Trimble R8 antenna phase center. The number of satellites and HDOP of the solution were still excellent.

Figure 11 – Position Error and Satellite Geometry, Receiver: Trimble R8, Processed by: NovAtel’s GrafNav, Data: L1+L2+GPS, Test Segment: 19

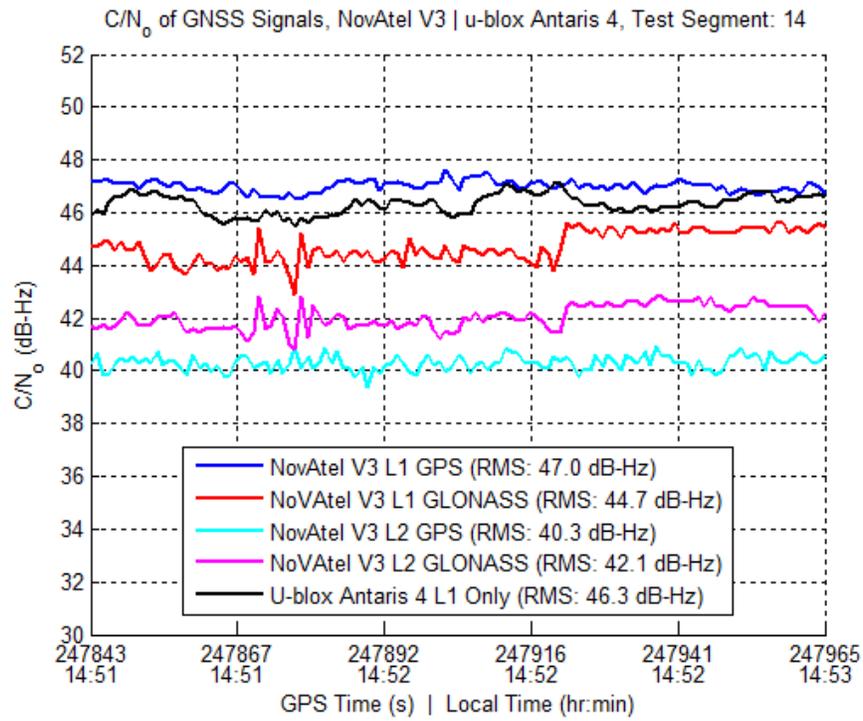
Figure 12 and Figure 13 show the average carrier to noise density (C/N_0) for all satellites tracked by the receiver for segments 14 and 19. The results are comparable to those of open sky data and no evidence of power line disturbances is present. L2 signals are broadcasted at 1.5 dB lower power (IS-GPS-200E 2010) than L1 and the 702GG antenna gain pattern amplifies the L2 signal 3 dB less than the L1 signal at zenith (NovAtel Inc. 2010).

Figure 12 – GNSS Signal Strength, Receiver: NovAtel V3, Data: L1+L2+GPS+GLONASS, Test Segment: 14

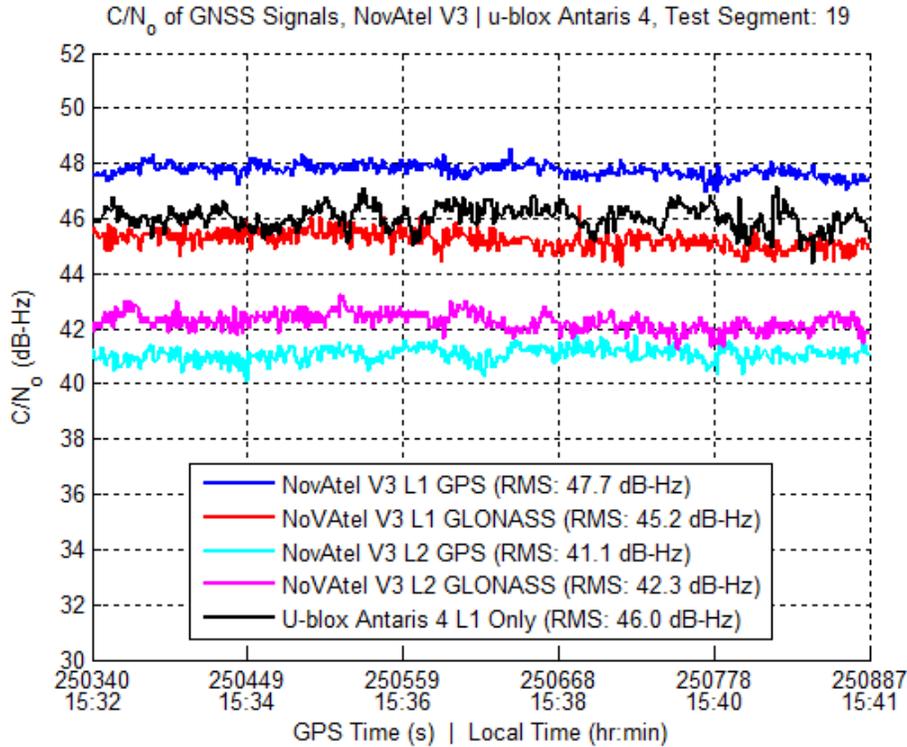
Figure 13 – GNSS Signal Strength, Receiver: NovAtel V3, Data: L1+L2+GPS+GLONASS, Test Segment: 19

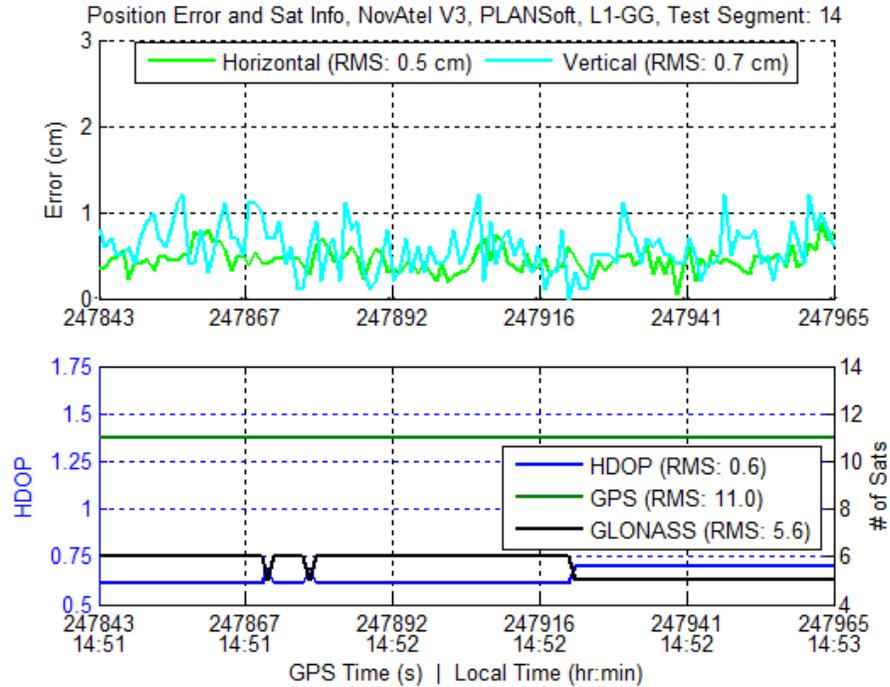
Similar to the Trimble RTK solution, position errors and satellite geometry plots were generated for all segments and are available in Appendix C. Segments 14 and 19 as processed by PLANSoft™ are shown in Figure 14 and Figure 15. Both segments exhibit errors less than 1 cm as compared to the reference trajectory. The HDOP is exceptional throughout both segments and the number of satellites remains consistent with open sky conditions. No power line effect is detected.

Figure 14 – Position Error and Satellite Geometry, Receiver: NovAtel V3, Processed by: PLANSofT, Data: L1+GPS+GLONASS, Test Segment: 14

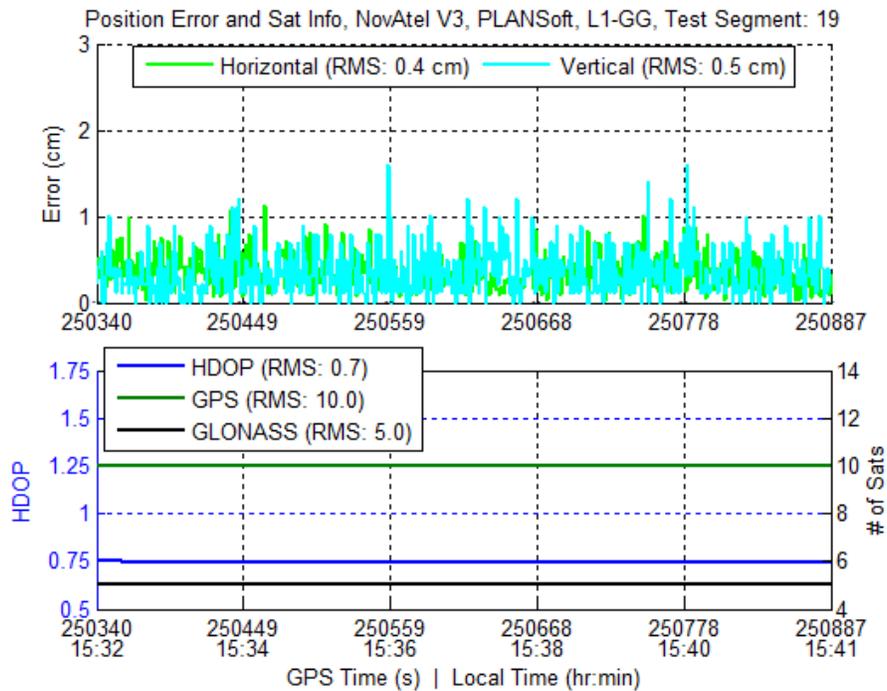
Figure 15 – Position Error and Satellite Geometry, Receiver: NovAtel V3, Processed by: PLANSofT, Data: L1+GPS+GLONASS, Test Segment: 19

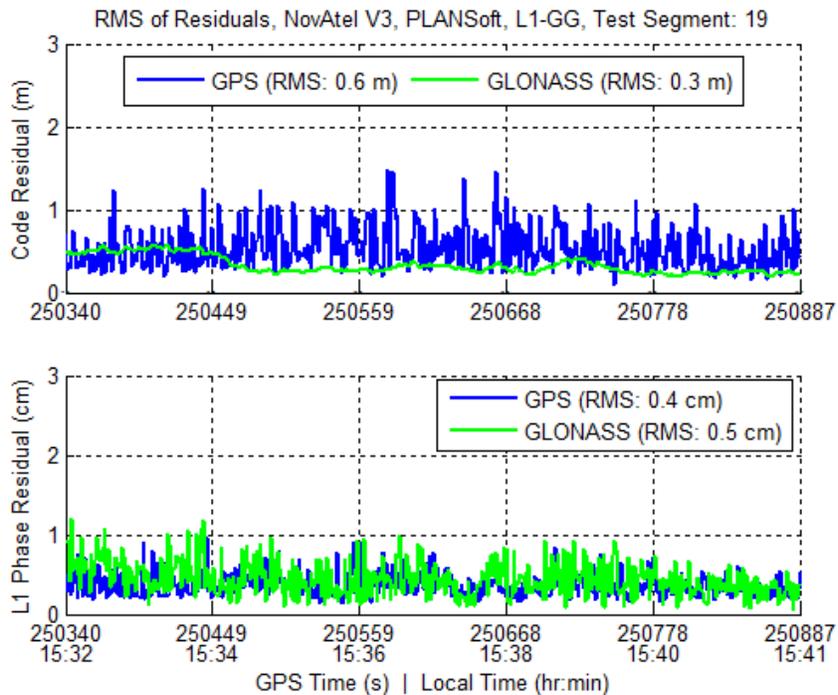
Figure 16 and Figure 17 shows the RMS of the residuals for all measurements used within an epoch. Measurements that might be rejected by the fault detection algorithm within the software are not used in the computation of the residual RMS. There was a minimal rejection rate in each data set, a common occurrence among GNSS data gathered under open sky conditions. For example, on Jan 24th there was a 0.067 % rejection rate of GPS and GLONASS observations. The rejection rate was therefore not higher than normal due to operation under the power lines. Code residuals of 0.5 m and less are exceptional and indicate quality observations with no hindrances. Phase residuals are also excellent at less than 1 cm. Given the number of satellites used, it is clear from this residual analysis that the receiver is functioning normally and with no effect from the power lines.

Figure 17 – RMS of Residuals, Receiver: NovAtel V3, Processed by: PLANSofT, Data: L1+GPS+GLONASS, Test Segment: 19

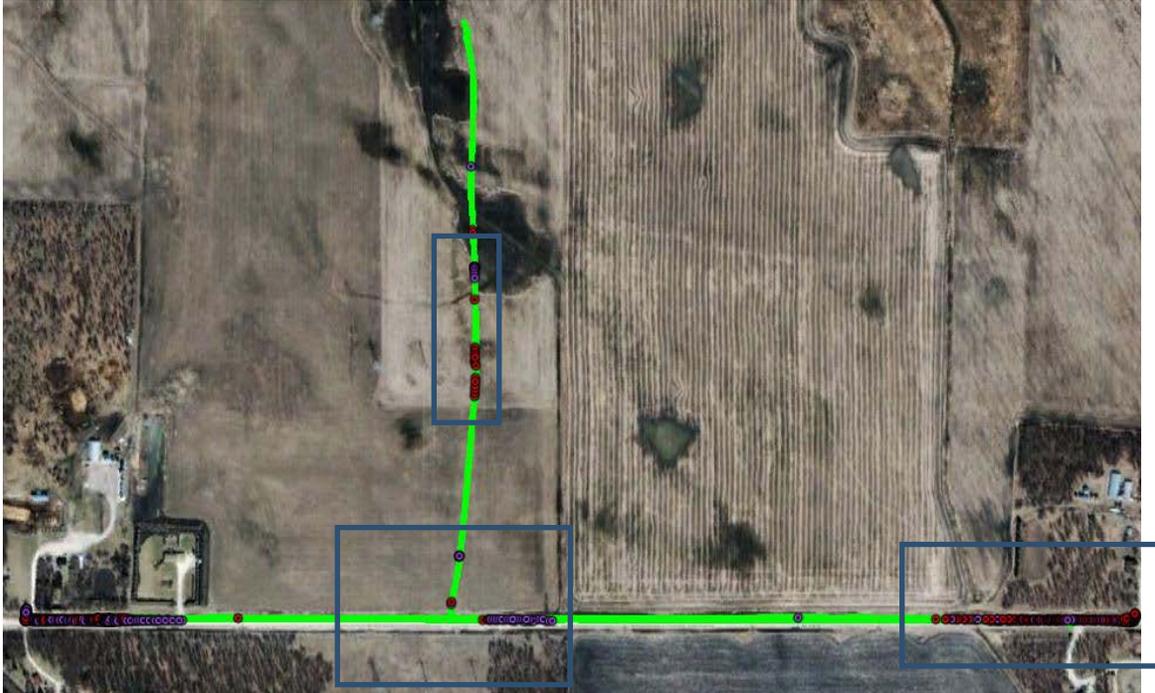
Figure 18 shows the trajectories traveled during the data collection and each cycle slip is plotted on the trajectory. Numerous cycle slips occur on the east and west ends. This is due to the trees present on either side of the road, and low elevation satellites affected by these trees experience a large number of cycle slips. This is normal and to be expected. Some slips occur just east of the north/south trajectory where trees are present south of the road. Most importantly, although a few cycle slips occur under the lines, there is only a weak correlation between the location of the power line towers and the location of the cycle slips. This indicates that the power lines (and their corresponding towers), regardless of their electric current carrying characteristics, are not causing cycle slips at a level that would impede precision navigation.

Figure 18 – Geo-Located Cycle Slips (red: 24 Jan, purple: 25 Jan), blue rectangles indicate Figure 19, Figure 20 and Figure 21

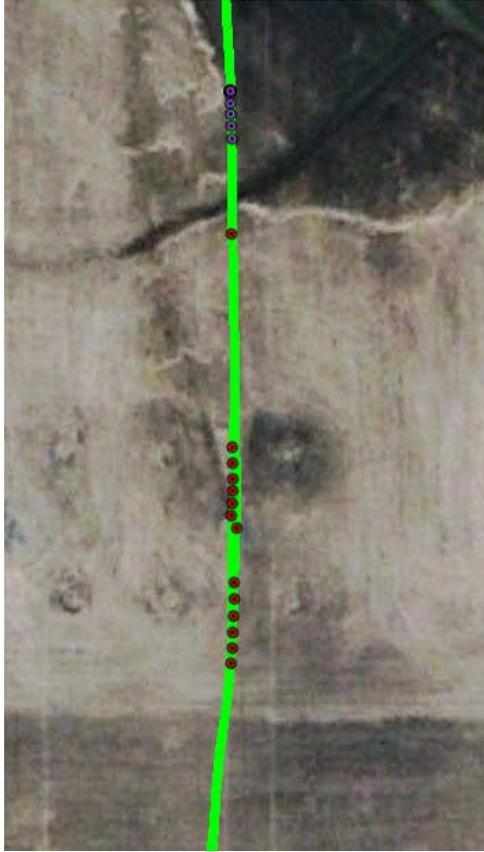
Figure 19 through Figure 21 shows close up views of Figure 18. Figure 19 shows that when passing the towers (which appear on the map as dark circular areas), there are only a few cycle slips and their frequency is minor in comparison to that of those observed near the trees in Figure 21. It is also noteworthy that, despite a tower being located a few tens of metres from the northern most point of the data collection (where the vehicle turned to return south), no cycle slips were recorded in this area, further confirming the low effects of power line towers on carrier phase measurements.

Figure 19 – Geo-Located Cycle Slips (red: 24 Jan, purple: 25 Jan)

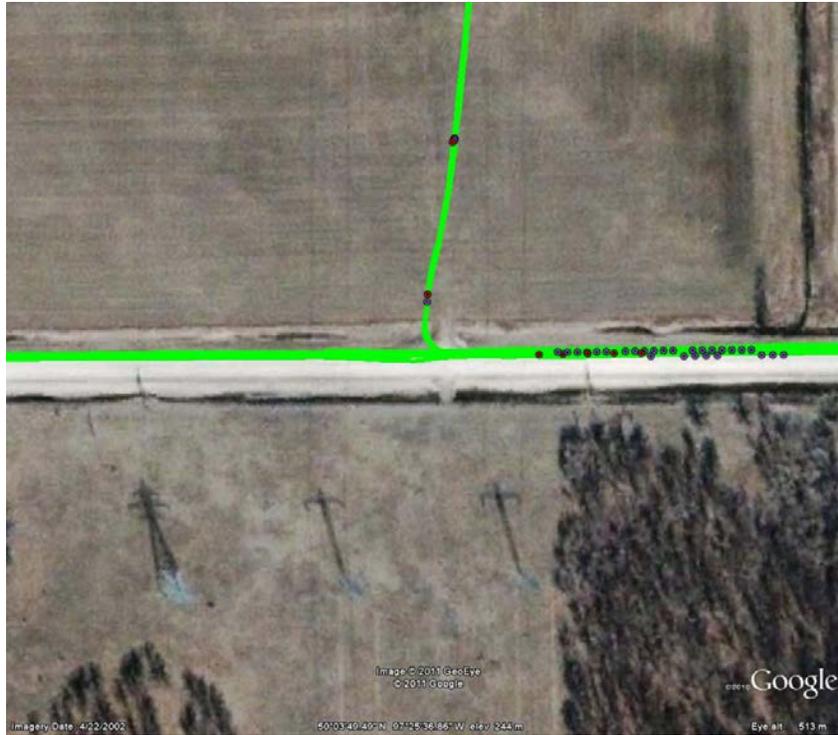
Figure 20 shows the bipole towers and few correlated cycle slips in proximity of the power lines and towers.

Figure 20 – Geo-Located Cycle Slips (red: 24 Jan, purple: 25 Jan)

It should be noted that the figures presented in this section contain all the NovAtel data collected, not just the segments analyzed (e.g. segments 1-19). This was to show the impact of trees on cycle slips versus the lines and towers overhead.

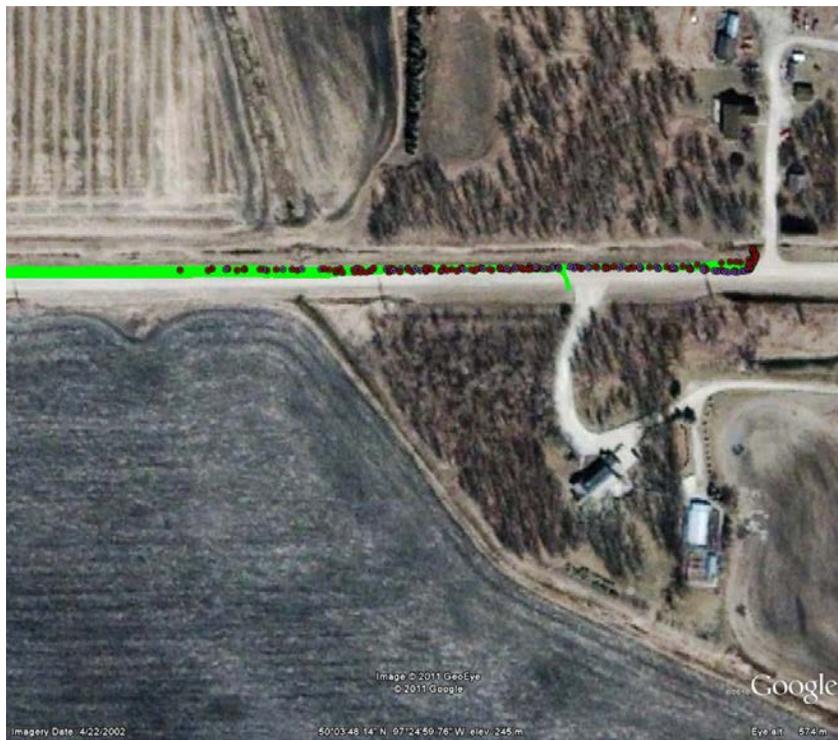
Figure 21 – Geo-Located Cycle Slips (red: 24 Jan, purple: 25 Jan)

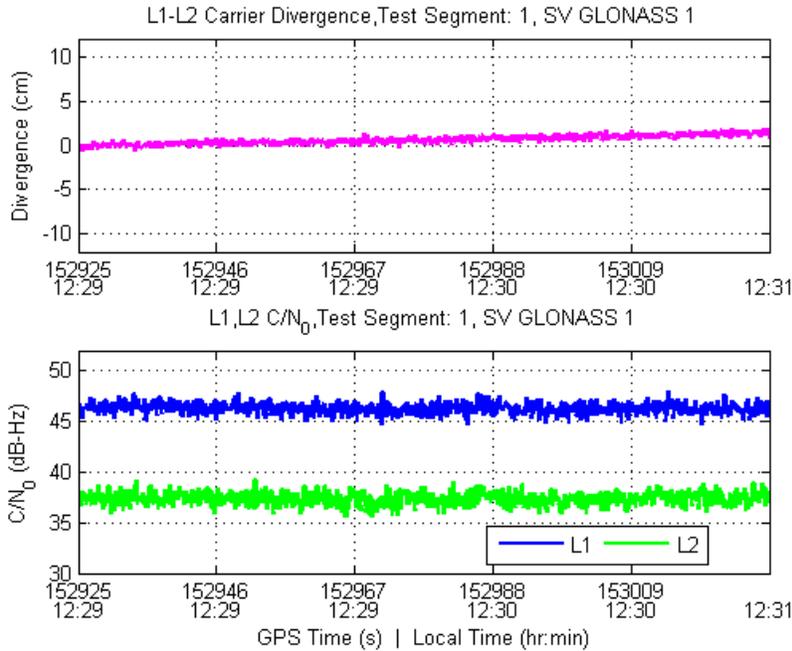
If air ionization effects were present, they would be observed as a change in the L1 minus L2 carrier phase observations as the ray path between the satellite and the user traversed the conductors of the power line, as well as the region between the conductors. If interference was emitted from the power lines, it would be observable as a decrease in the carrier-to-noise density ratio as the test vehicle approached the power lines, returning to normal as the vehicle passed to the other side of the transmission corridor. Since these effects would be most clearly discernable during a perpendicular test scenario, these results are presented first, starting with the observations from test segment 1, presented for three different satellites in Figure 22 , Figure 23 and Figure 24.

Figure 22 – Test segment 1 perpendicular crossing of power line corridor effect of two DC bipoles and 1 AC transmission line set on L1-L2 phase difference and carrier-to-noise density ratios of GLONASS M satellite in orbital slot 1. Lower L2 signal strength is due to lower transmitted signal strength from satellite in this band relative to L1 and lower gain of 702 GG antenna element at L2 frequencies. Traversal of eastern bipole centreline occurred at approximately 152962 seconds. Trend in carrier divergence is due to slowly changing ionospheric background conditions during test and is expected.

The signal characteristics presented in test segment 1 indicate no abnormal characteristics. No detectable RF interference is present in the GNSS navigation bands as evidenced by the nearly constant carrier signal strengths that show no noticeable reduction near the transmission lines. Additionally, the very slowly and smoothly varying carrier divergence measurement is indicative of normal background ionospheric effects, and shows no indication of a measurable effect due to air ionization adjacent to the transmission lines.

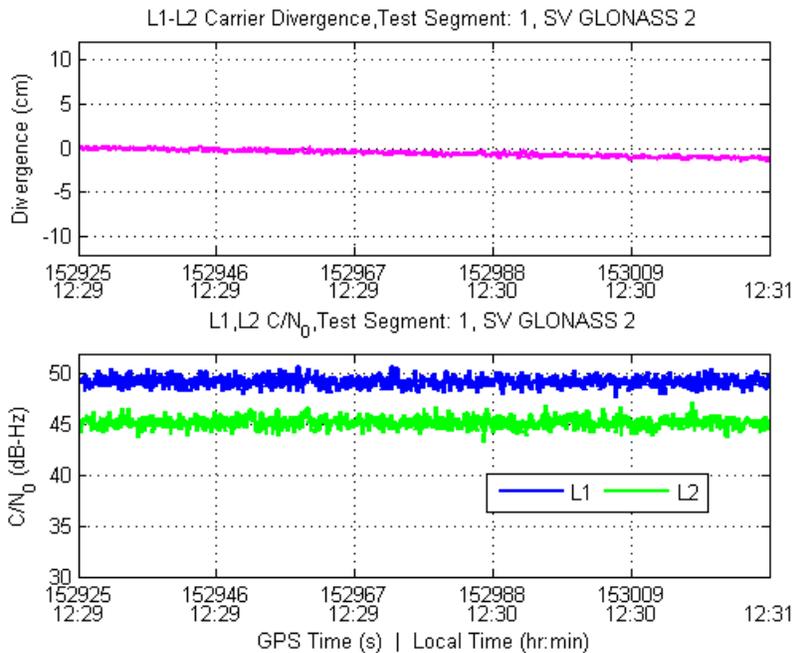
Figure 23 – Test segment 1 perpendicular crossing of power line corridor effect of two DC bipoles and 1 AC transmission line set on L1-L2 phase difference and carrier-to-noise density ratios of

GLONASS M satellite in orbital slot 2. Lower L2 signal strength is due to lower transmitted signal strength from satellite in this band relative to L1 and lower gain of 702 GG antenna element at L2 frequencies. Traversal of eastern bipole centreline occurred at approximately 152962 seconds. Trend in carrier divergence is due to slowly changing ionospheric background conditions during test and is expected.

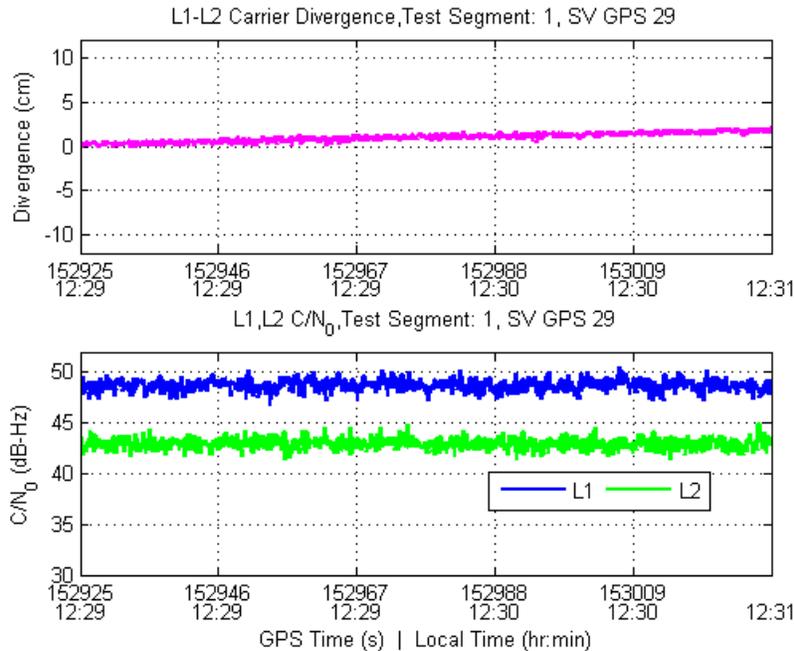
Figure 24 – Test segment 1 perpendicular crossing of power line corridor effect of two DC bipoles and 1 AC transmission line set on L1-L2 phase difference and carrier-to-noise density ratios of GPS IIR-M satellite transmitting PRN code 29. Lower L2 signal strength is due to lower transmitted signal strength from satellite in this band relative to L1 and lower gain of 702 GG antenna element at L2 frequencies. Traversal of eastern bipole centreline occurred at approximately 152962 seconds. Trend in carrier divergence is due to slowly changing ionospheric background conditions during test and is expected.

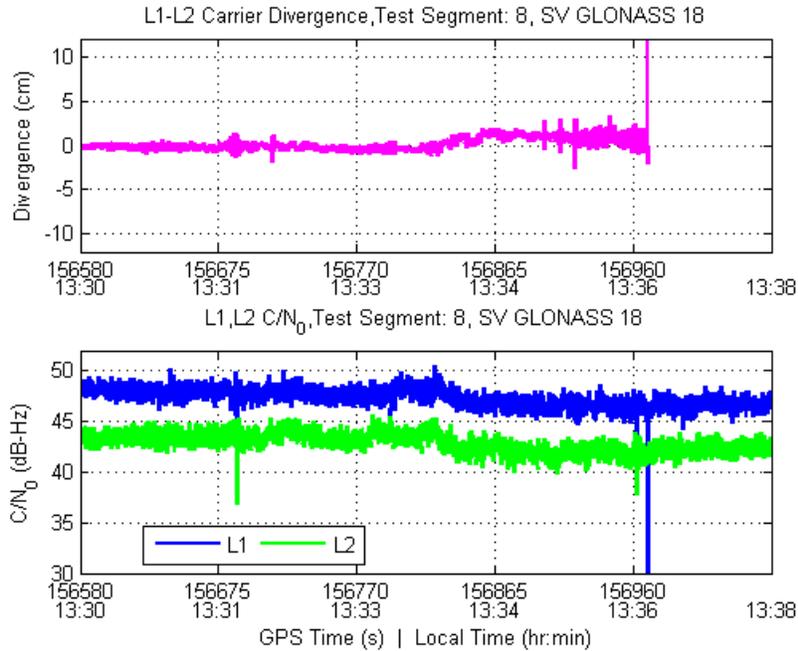
Figure 25 – Test Segment 8, parallel travel along transmission line corridor indicating brief blockage due to transmission towers on GLONASS SV 18. Deep fade on L1 results in multiple cycle slips causing off scale L1-L2 carrier difference, which is an expected result during signal blockage.

The results of the tests parallel to the conductors from the first day of field tests, specifically segments 8 and 9, are shown in Figure 25 through Figure 30.

Effects observed during the parallel motion segments 8 and 9 included changes in observed signal strength due to varying vehicle orientation, short deep fading due to blockage or multipath effects of the transmission towers, and some cycle slips as a consequence in a few instances. At no point however were consistent signal strength degradations noted simultaneously on multiple satellites that would indicate locally generated interference in the L bands.

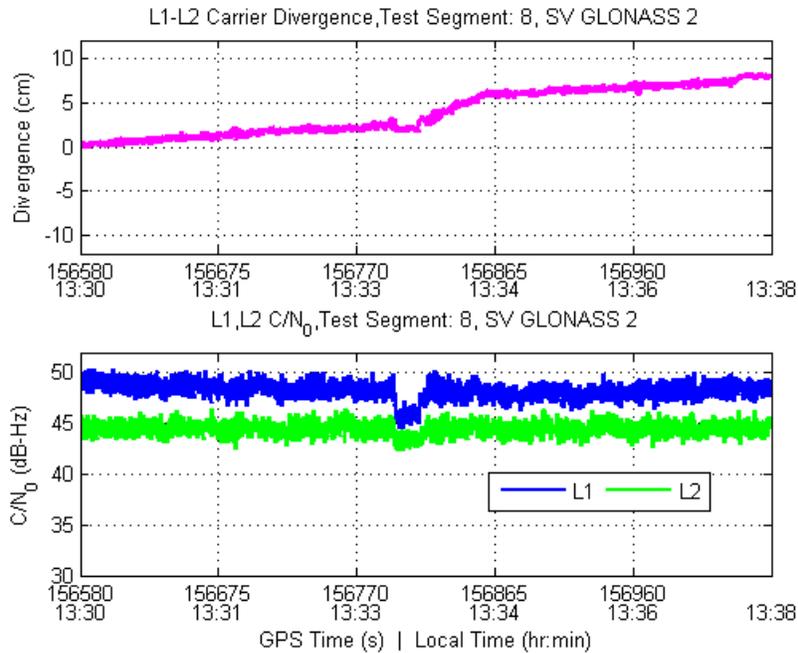
Figure 26 – Test Segment 8, parallel travel along transmission line corridor indicating brief blockage due to transmission towers on GLONASS SV 2. Shallow fade on L1 results in no cycle slip.

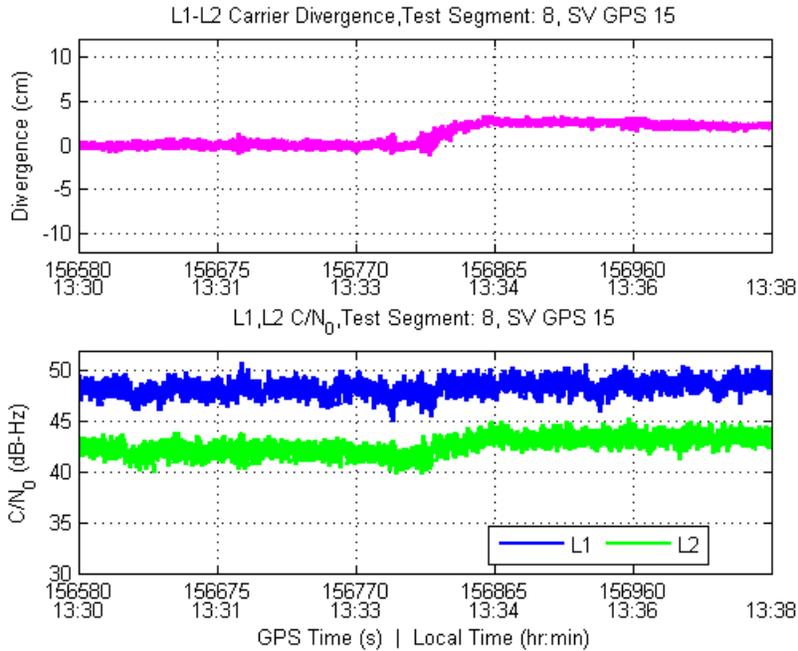
Figure 27 – Test Segment 8, parallel travel along transmission line corridor indicating brief blockage due to transmission towers on GPS PRN 15. No cycle slip occurrence.

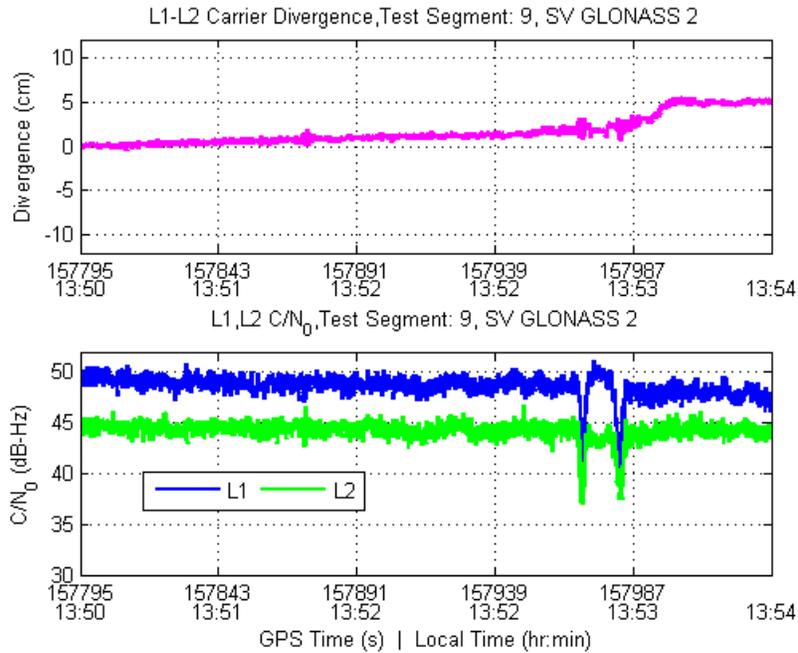
Figure 28 – Test Segment 9, parallel travel along transmission line corridor indicating two brief blockages due to transmission towers on GLONASS SV 2. No cycle slip occurrence
