Effects of Transmission Lines on Global Positioning Systems

Manitoba Hydro DC-Line GNSS Survey Report

Effects of Transmission Lines On Global Positioning Systems

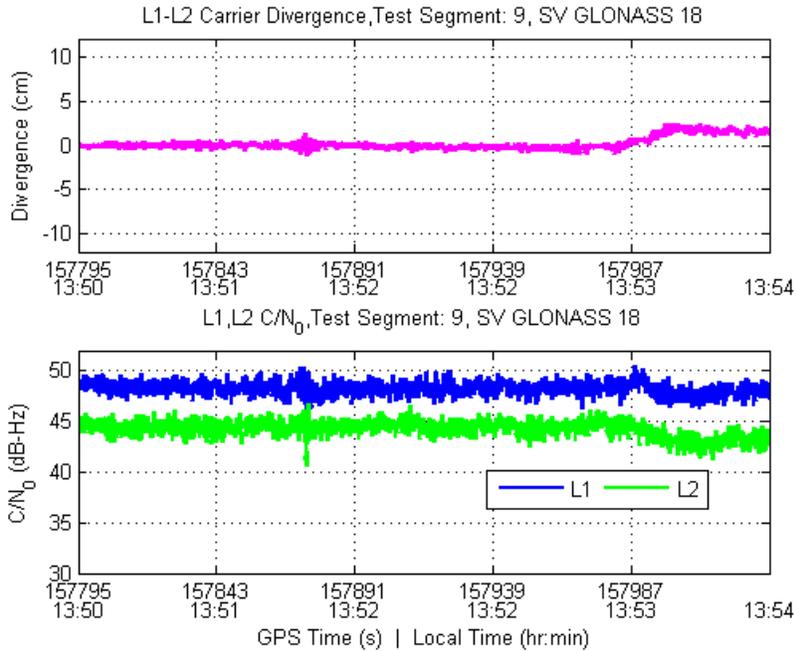
Figure 29 – Test Segment 9, parallel travel along transmission line corridor indicating brief blockage of L2 signal path on GLONASS SV 18. Apparent decrease in carrier strength in both L1 and L2 signals during final static portion of test believed to be due to change in inclination of GNSS antenna. No cycle slip occurrence

The results of the tests parallel to the conductors from the first day of field tests, specifically segments 8 and 9, are shown in Figure 25 through Figure 30.

Effects observed during the parallel motion segments 8 and 9 included changes in observed signal strength due to varying vehicle orientation, short deep fading due to blockage or multipath effects of the transmission towers, and some cycle slips as a consequence in a few instances. At no point however were consistent signal strength degradations noted simultaneously on multiple satellites that would indicate locally generated interference in the L bands.

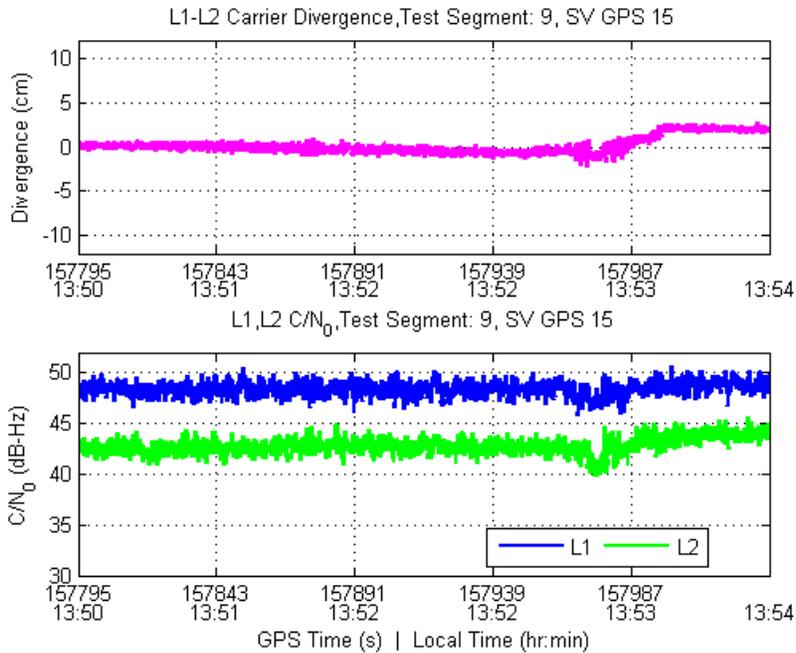
Figure 30 – Test Segment 9, parallel travel along transmission line corridor indicating brief blockage of L2 signal path on GPS PRN 158. Apparent increase in carrier strength in both L1 and L2 signals during final static portion of test believed to be due to change in inclination of GNSS antenna, increasing directional gain towards SV. No cycle slip occurrence.

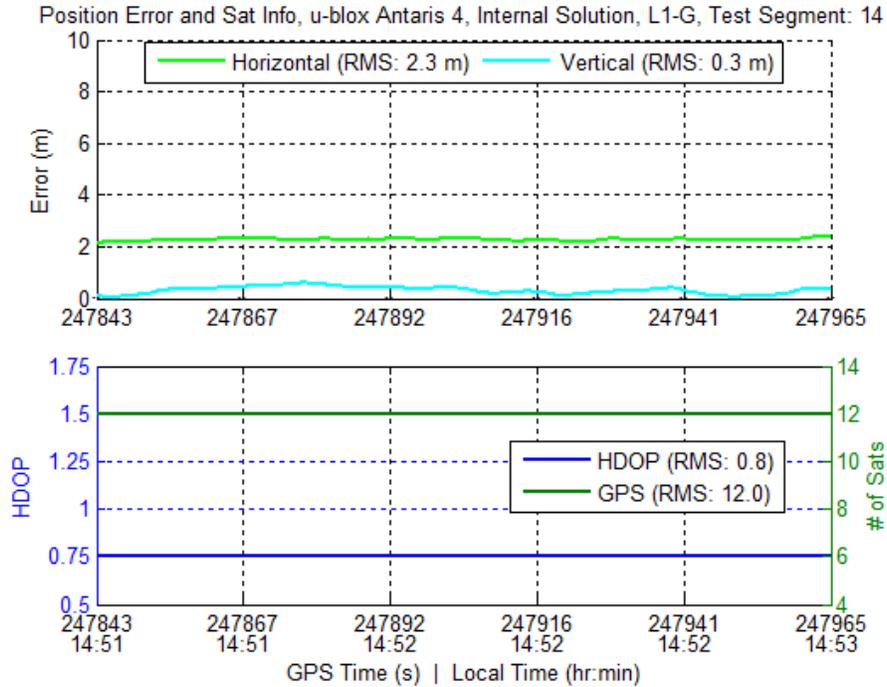
High Sensitivity GPS is not typically used in precision agriculture applications. However, the HSGPS receiver tested herein was not hindered and suffered no additional errors other than would be expected by a single point GPS L1 only solution. Figure 31 and Figure 32 show the internal solution position accuracy and satellite geometry for segments 12 and 19, respectively. In general, the single point navigation solution should be within a few metres, and these results are no exception. In segment 14, 12 satellites were tracked continuously and the HDOP was 0.8, which is extremely good for a GPS only receiver. No dropouts occurred during either segment.

Figure 31 – Position Error and Satellite Geometry, Receiver: U-blox Antaris 4, Processed by: U-blox Internal Solution, Data: L1+HSGPS, Test Segment: 14

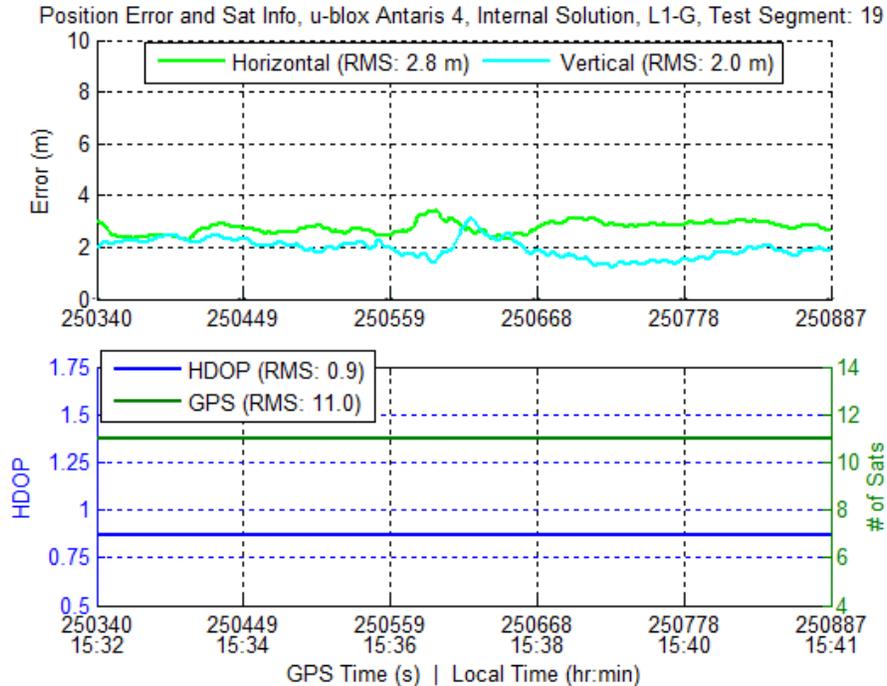
Figure 32 – Position Error and Satellite Geometry, Receiver: U-blox Antaris 4, Processed by: U-blox Internal Solution, Data: L1+HSGPS, Test Segment: 19
