Site 25

Unnamed tributary of Raindance Creek

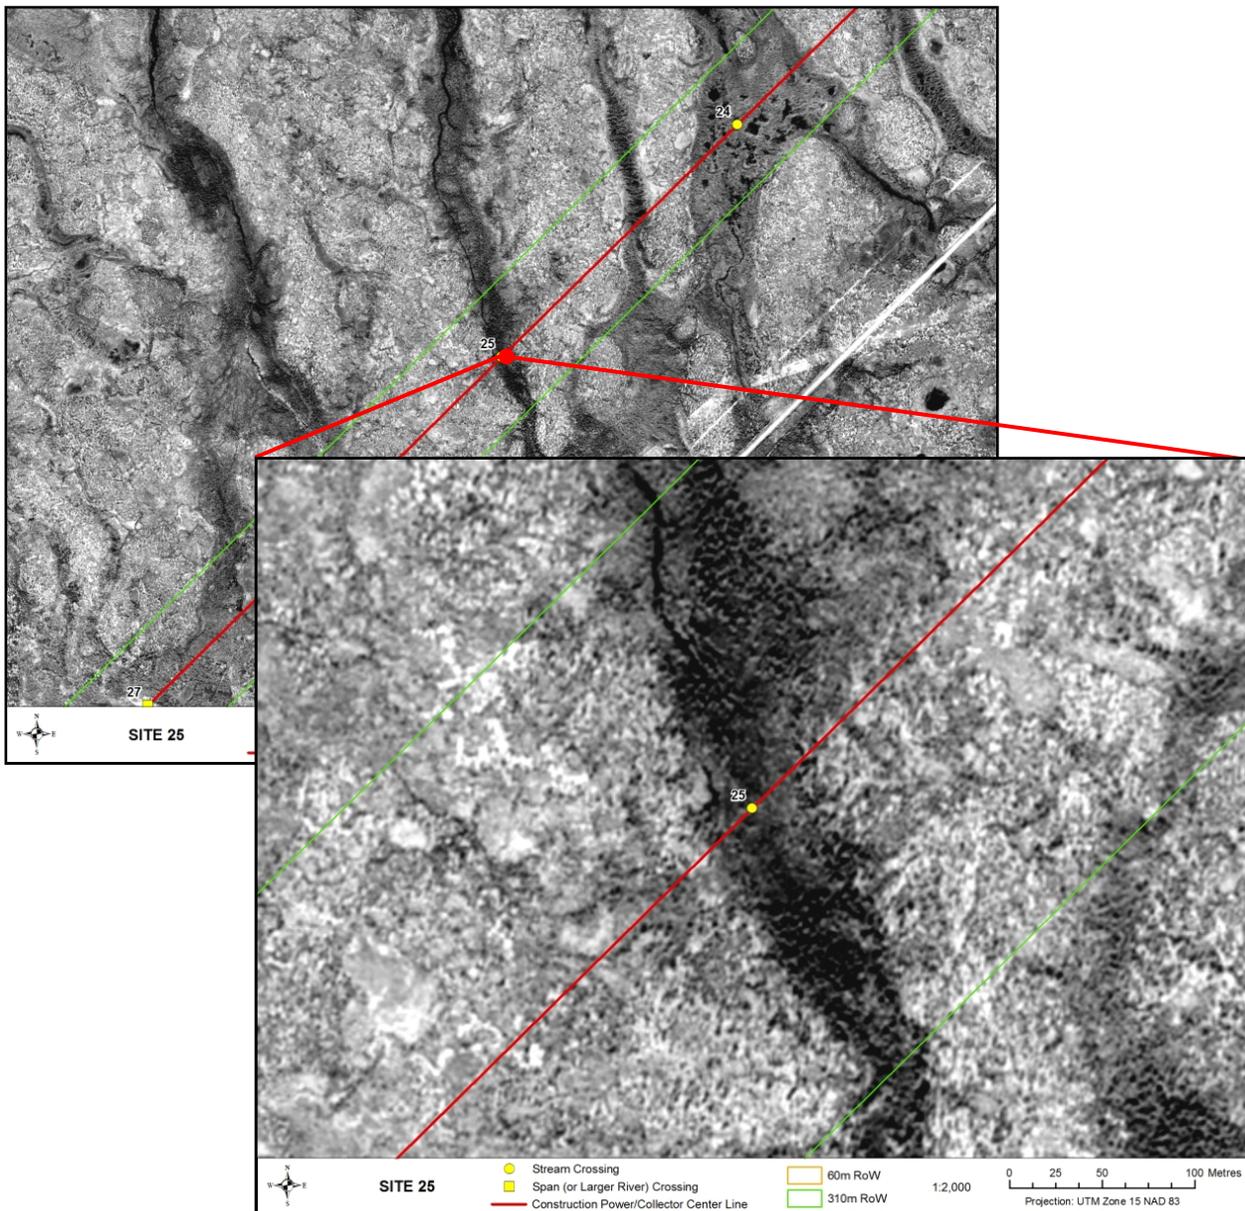
Stream/Lake: Stream
Pattern: SI
Confinement: UN
Stage: Low
Flow Regime: Intermittent
Morphology: -
U/S Drainage: 6.73 km²
Distance to Receiving Water: Raindance Creek
0.52 km

This unnamed tributary provides marginal fish habitat. The crossing consists of bog habitat with a soft floodplain and little water. Fish use will be limited to forage fish species.

The soft floodplain results in a moderate sensitivity rating, despite marginal fish habitat.

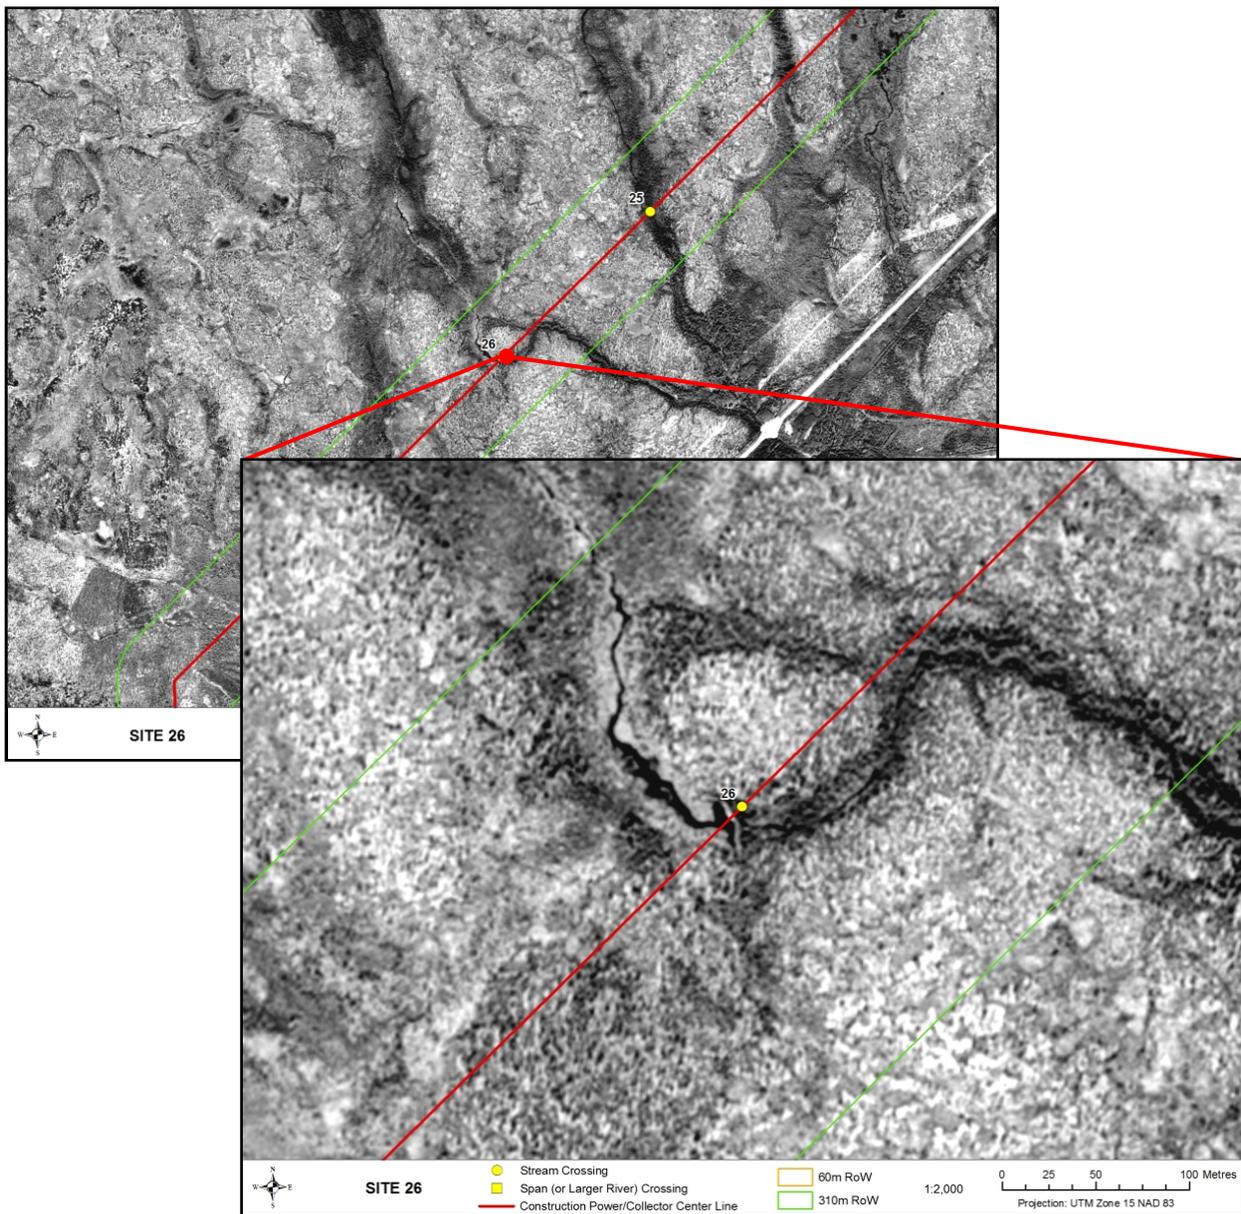
Site 26

Stream/Lake: Stream
Pattern: IW
Confinement: UN
Stage: Moderate
Flow Regime: Perennial
Morphology: -
U/S Drainage: 9.04 km²
Distance to Receiving Water: Nelson River 1.81 km

Raindance Creek likely provides only marginal fish habitat where the RoW crosses the channel, with low overwintering potential. The crossing consists of bog habitat with a soft floodplain and little water. Fish use is expected to be limited to forage fish species.

The soft floodplain results in a moderate sensitivity rating, despite marginal fish habitat.

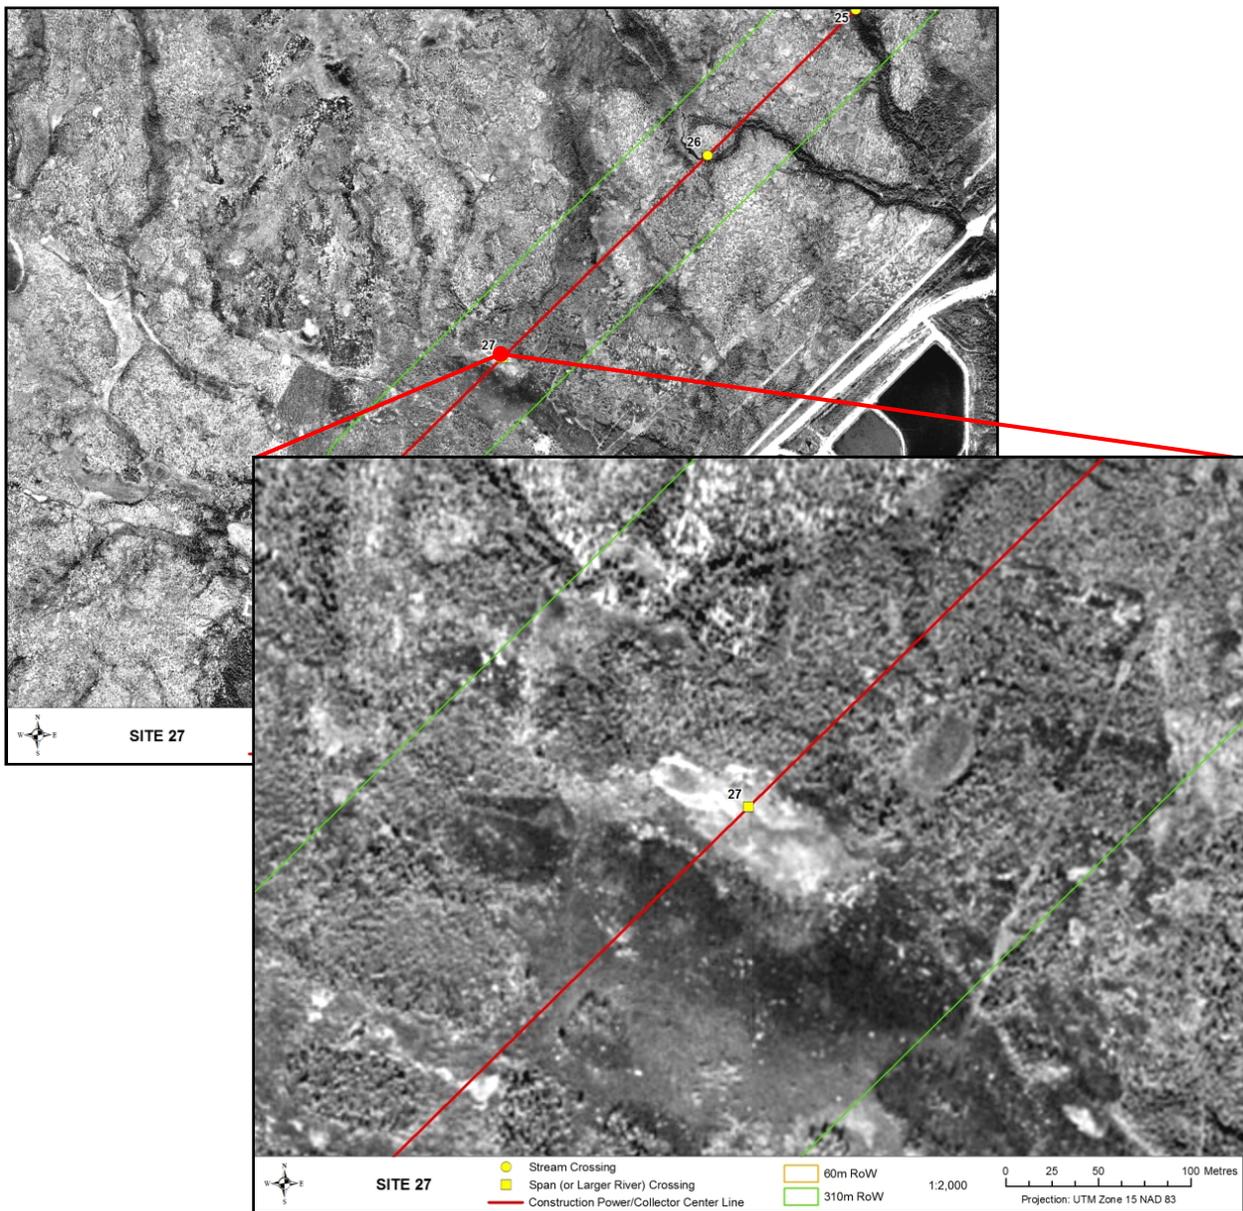
Site 27

Stream/Lake: Lake
Pattern: -
Confinement: UN
Stage: Low
Flow Regime: Ephemeral
Morphology: -
U/S Drainage: -
Distance to Receiving Water: -

There is no water or connections to other waterbodies at this crossing. No fish are anticipated.

No fish habitat results in a low sensitivity rating.

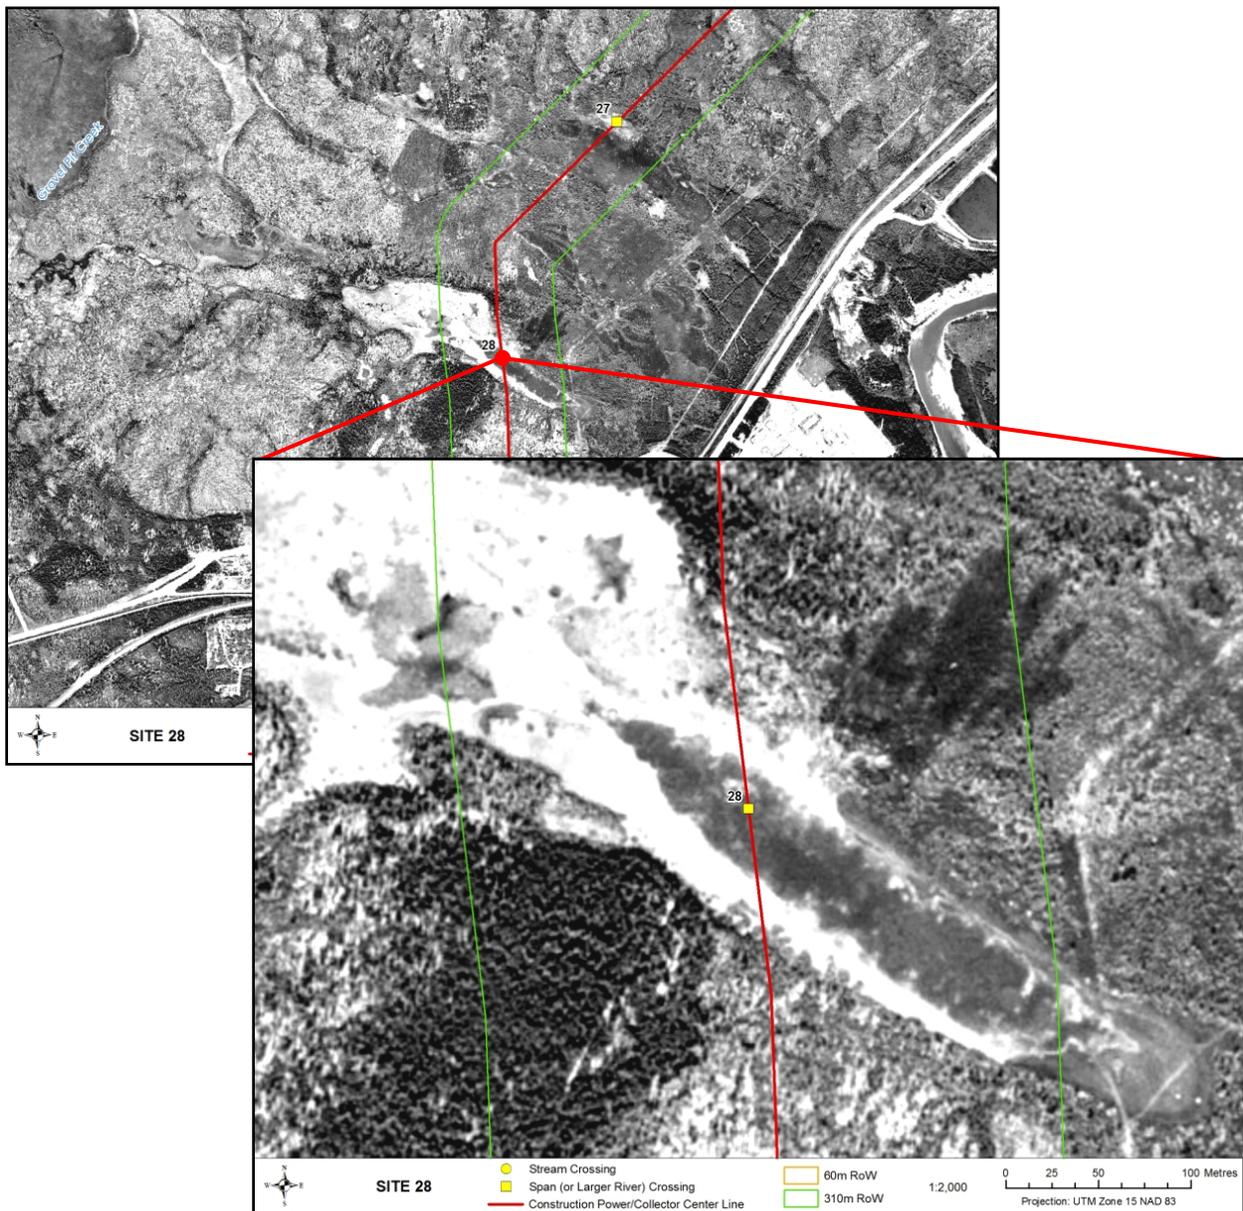
Site 28

Stream/Lake: Lake (7.79 ha)
Pattern: -
Confinement: UN
Stage: Low
Flow Regime: Ephemeral
Morphology: -
U/S Drainage: -
Distance to Receiving Water: -

There is limited water present and no apparent connection to other waterbodies at this crossing. The RoW crosses the eastern edge of the wetland. No fish are anticipated.

No fish habitat results in a low sensitivity rating.

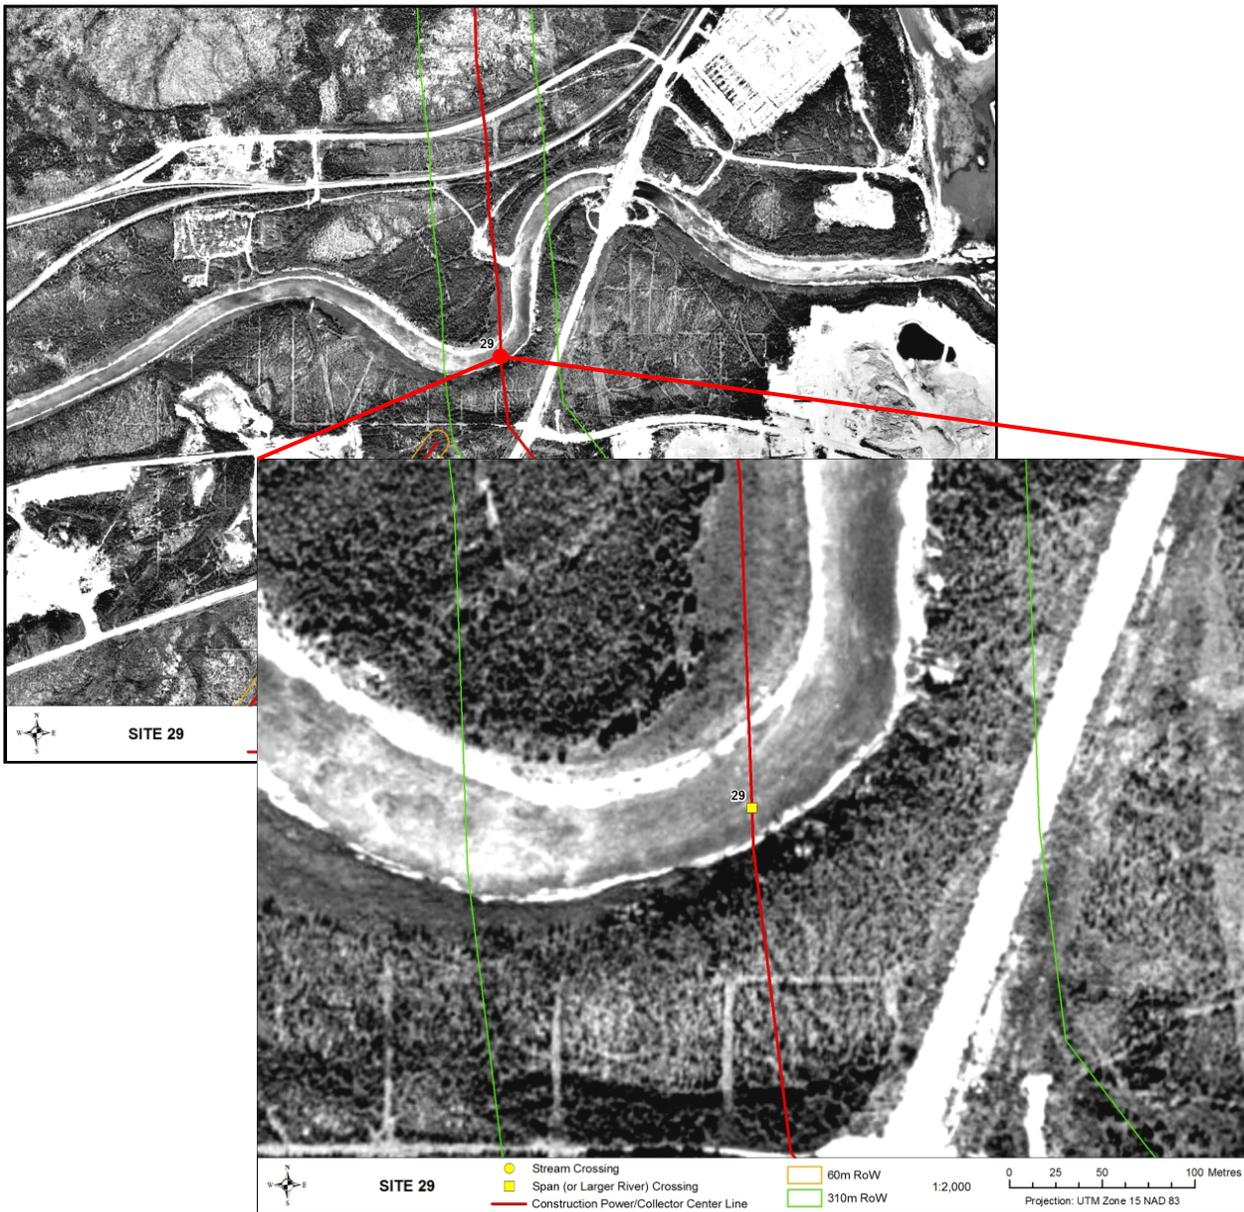
Site 29

Stream/Lake: Stream
Pattern: TM
Confinement: UN
Stage: Moderate
Flow Regime: Perennial
Morphology: LC
U/S Drainage: 3299.02 km²
Distance to Receiving Water: Nelson River 1.91 km

Limestone River is known to provide important fish habitat for both indicator and forage fish, including spawning, rearing, migration and overwintering habitat. A road approach is located 253m downstream of the site within the RoW and the highway crossing is located 193m downstream of the RoW

Comments: Bare soil banks and important fish habitat result in a moderate sensitivity rating.

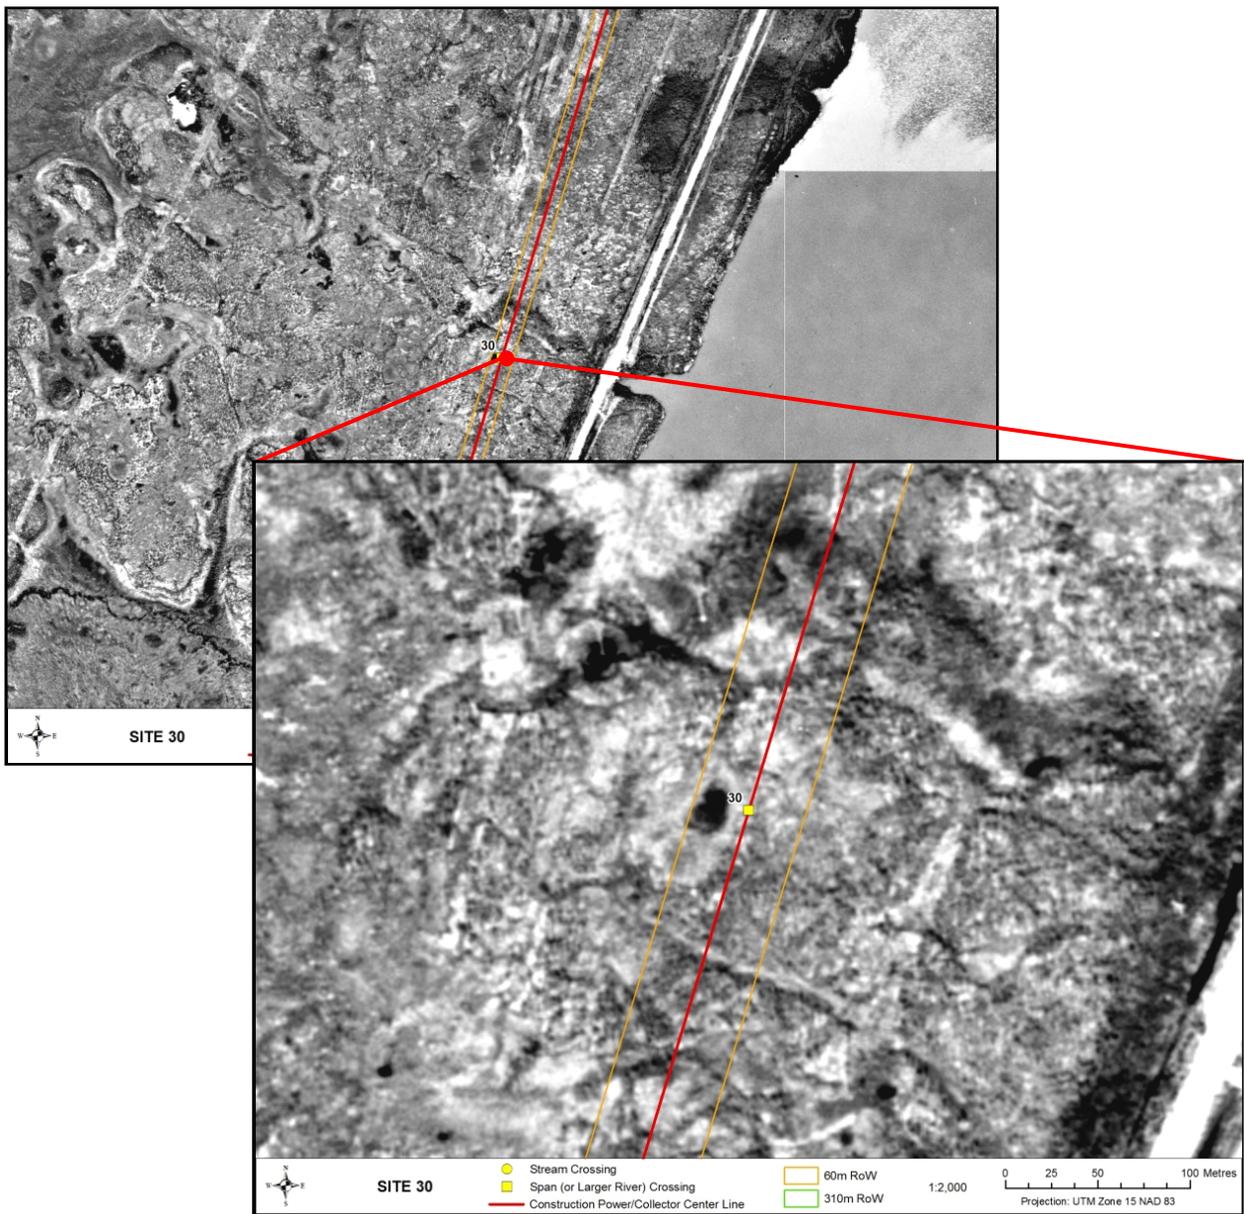
Site 30

Stream/Lake:	Lake (0.3 ha)
Pattern:	-
Confinement:	UN
Stage:	Low
Flow Regime:	Ephemeral
Morphology:	-
U/S Drainage:	-
Distance to Receiving Water:	-

There is no connection to other waterbodies at this crossing. No fish are anticipated. Existing transmission lines are located 48m east and 21m west of the RoW.

No fish habitat results in a low sensitivity rating.

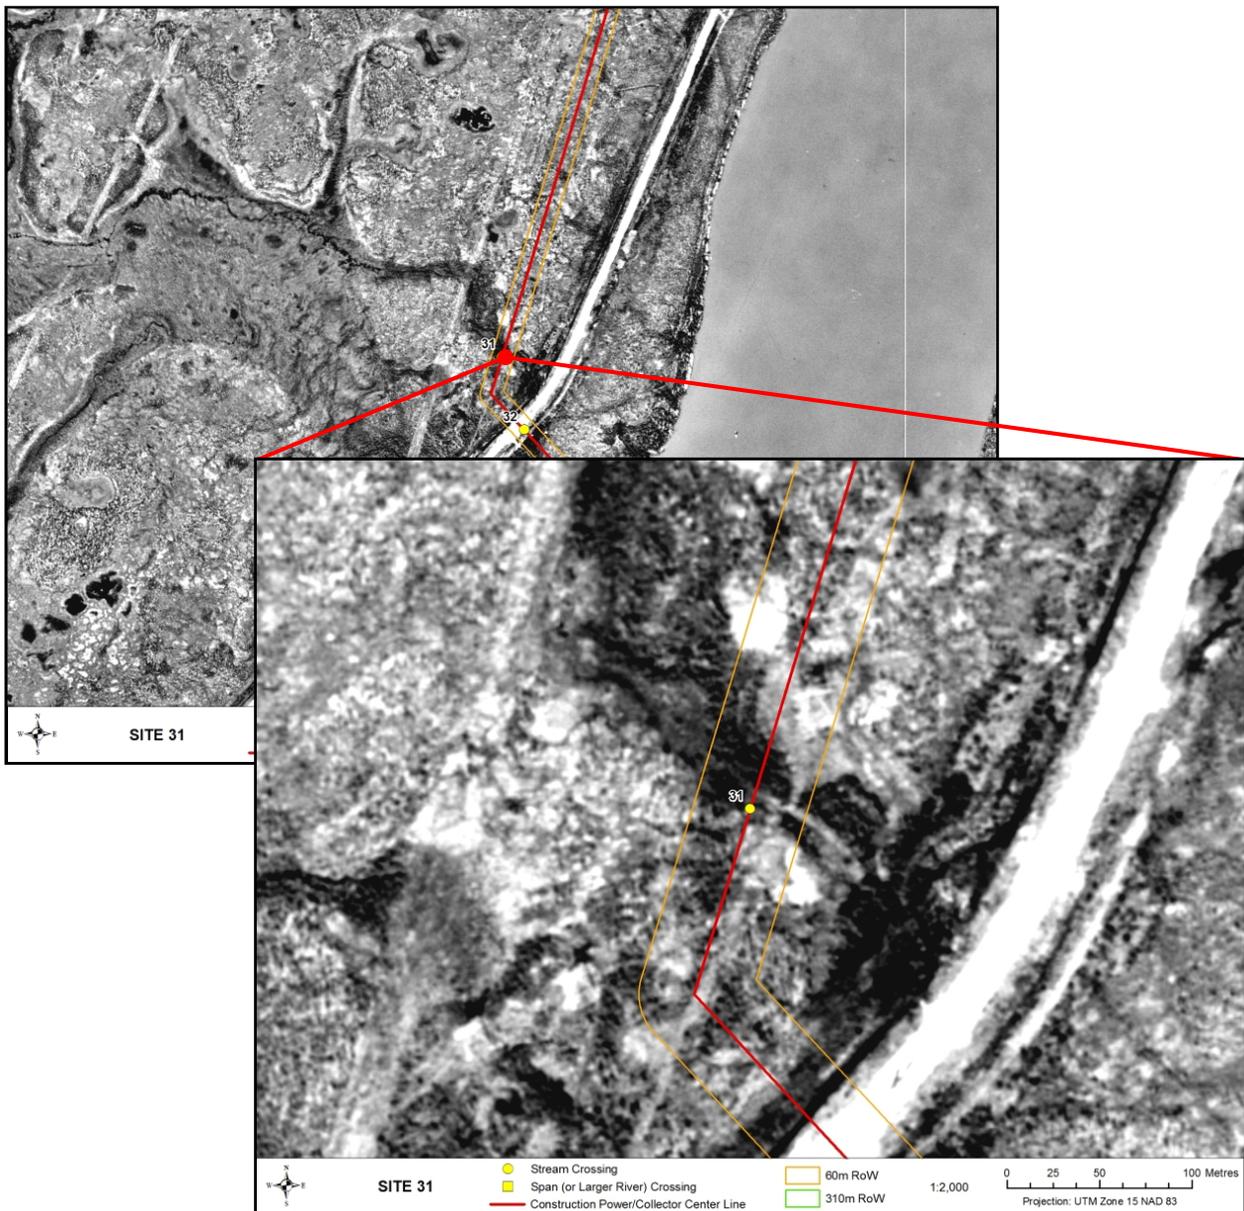
Site 31

Stream/Lake: Stream
Pattern: SI
Confinement: UN
Stage: Low
Flow Regime: Ephemeral
Morphology: -
U/S Drainage: 6.03 km²
Distance to Receiving Water: Nelson River 0.45 km

This unnamed tributary provides marginal fish habitat. The tributary has downstream connectivity to the Nelson River; however low flows likely limit fish use to forage fish species. Any large bodied fish use is likely restricted to high water conditions (i.e. spring freshet). The crossing has a soft floodplain. Existing transmission lines are found within the RoW.

The soft floodplain results in a moderate sensitivity rating, despite marginal fish habitat.

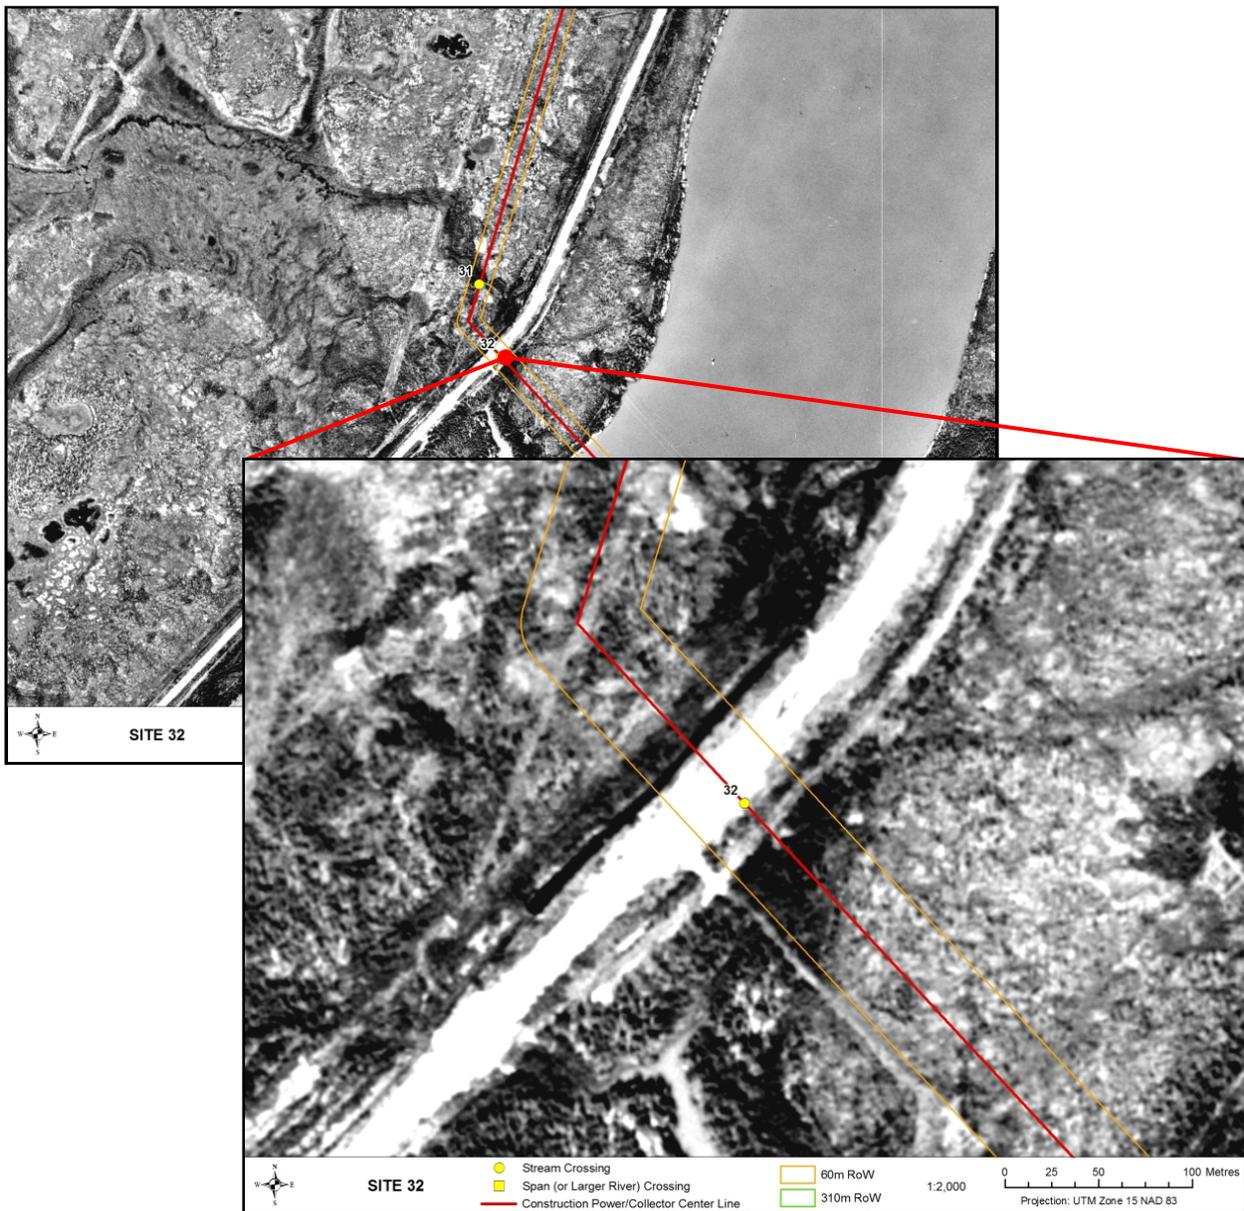
Site 32

Stream/Lake: Stream
Pattern: SI
Confinement: UN
Stage: Low
Flow Regime: Ephemeral
Morphology: -
U/S Drainage: 6.28 km²
Distance to Receiving Water: Nelson River 0.52 km

This unnamed tributary provides marginal fish habitat. The tributary has downstream connectivity to the Nelson River; however low flows likely limit fish use to forage fish species. Any large bodied fish use is likely restricted to high water conditions (i.e. spring freshet). It is surrounded by a soft floodplain. The site has been previously disturbed by a highway located on the left bank.

The soft floodplain results in a moderate sensitivity rating, despite marginal fish habitat.

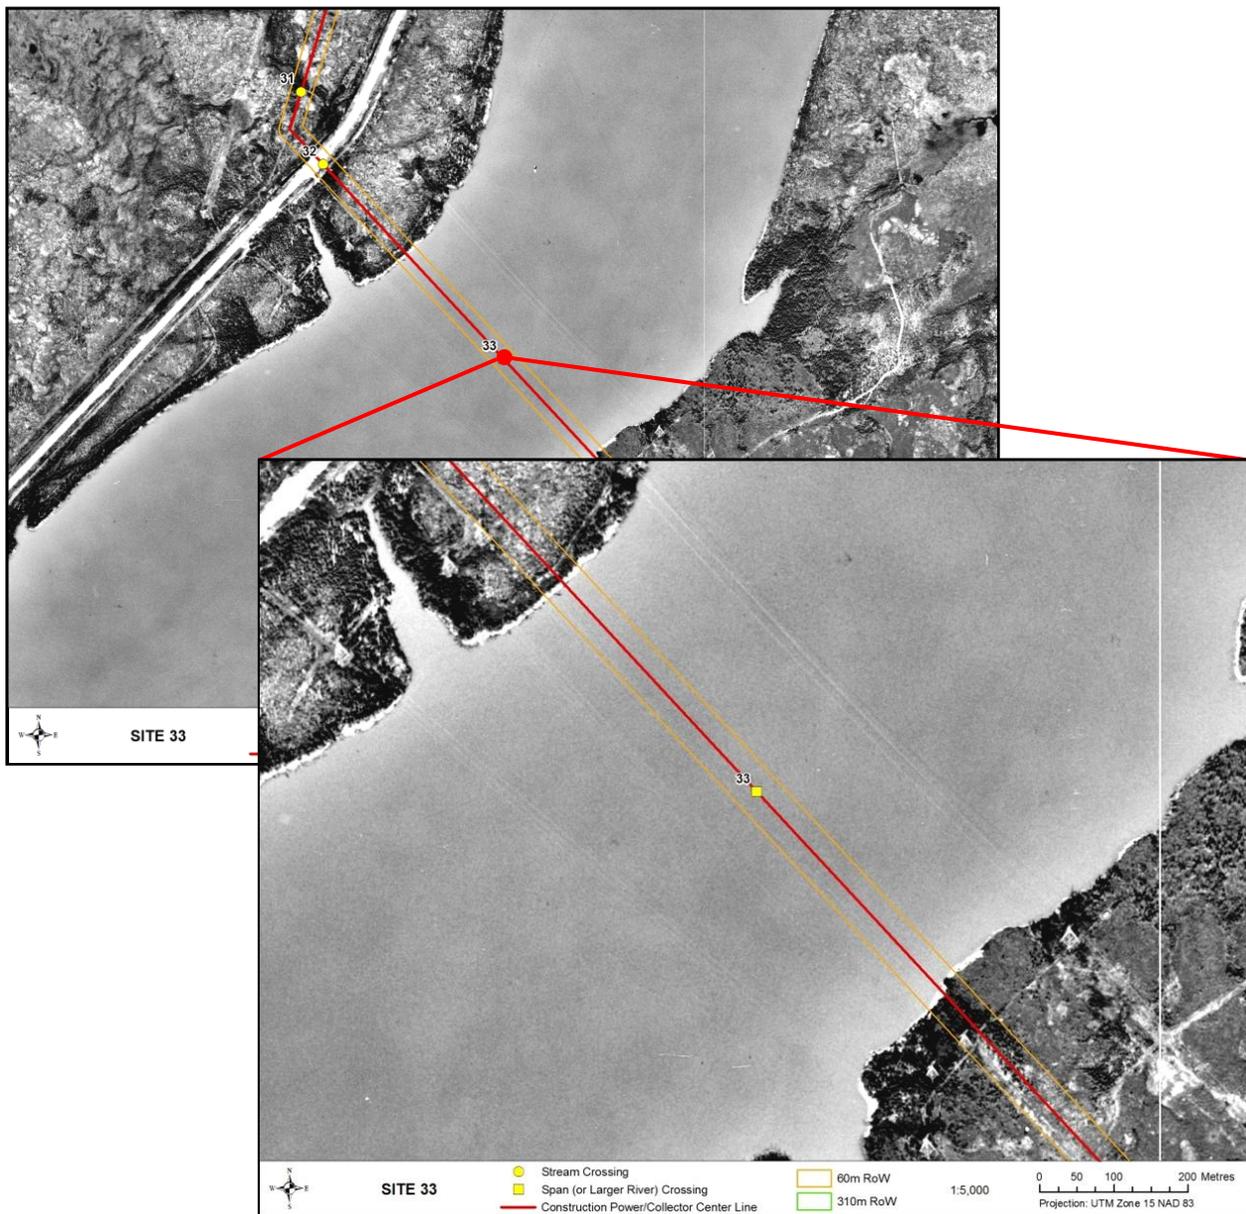
Site 33

Stream/Lake:	Stream
Pattern:	SI
Confinement:	FC
Stage:	Moderate
Flow Regime:	Perennial
Morphology:	LC
U/S Drainage:	1116804.28 km ²
Distance to Receiving Water:	Hudson Bay 139.7 km

Nelson River is known to provide important fish habitat for both indicator and forage fish. The river supports a diverse fish community, providing spawning, rearing, feeding and overwintering habitat.

Comments: Exposed banks (bare soil) and important fish habitat result in a moderate sensitivity rating.

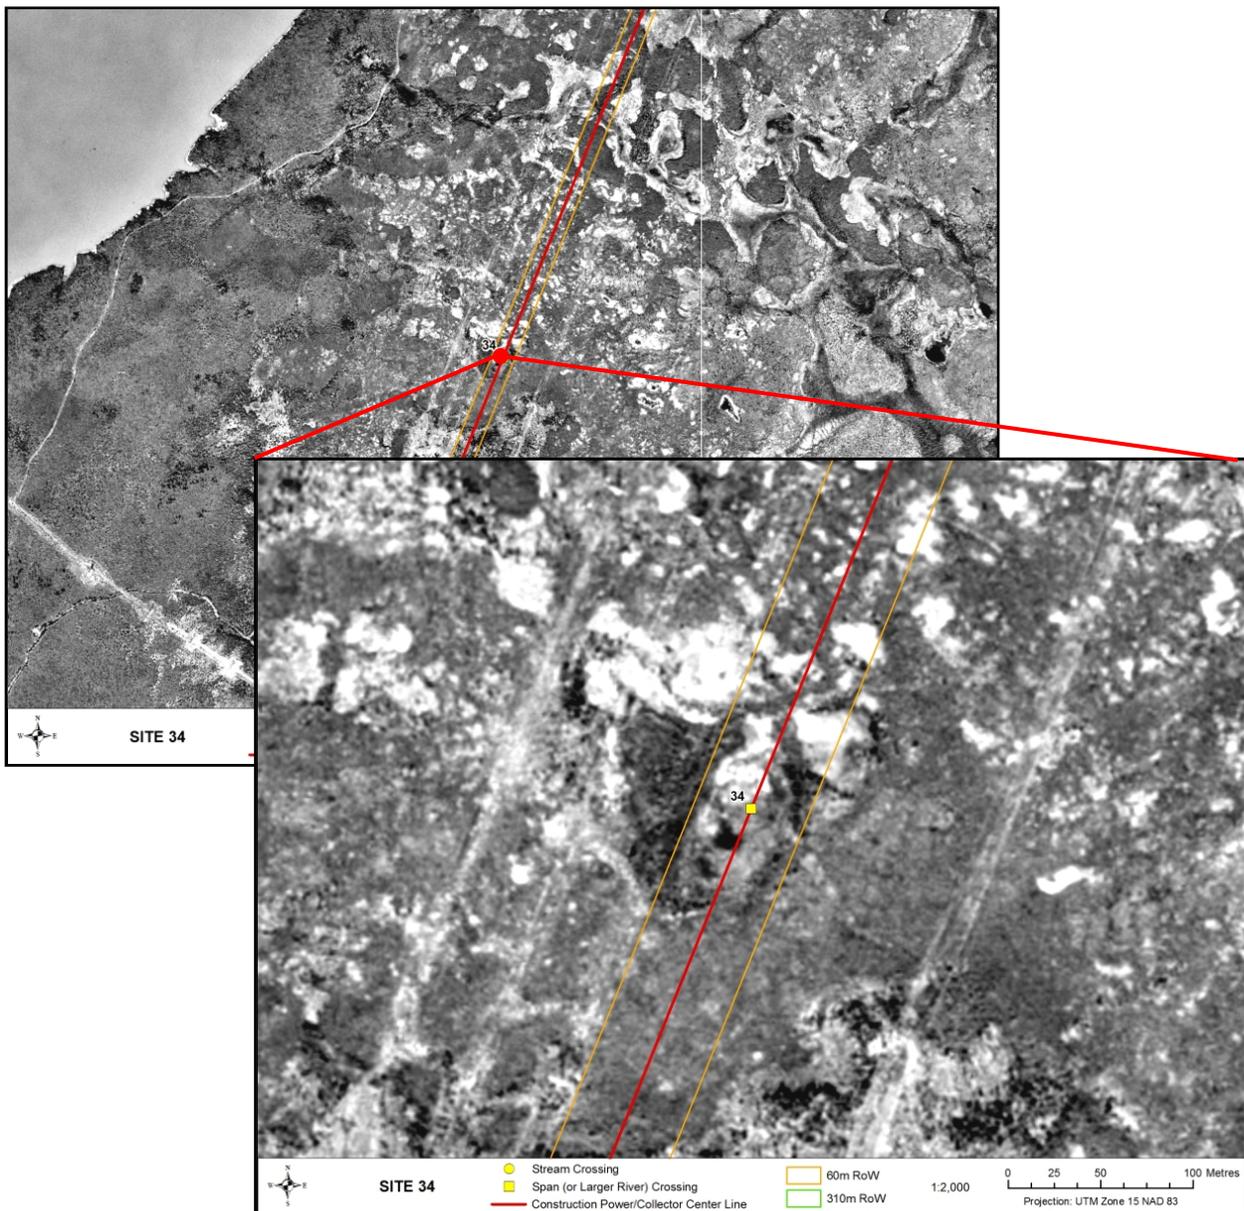
Site 34

Stream/Lake: Lake
Pattern: -
Confinement: UN
Stage: Low
Flow Regime: Ephemeral
Morphology: -
U/S Drainage: -
Distance to Receiving Water: -

There is no connection to other waterbodies at this crossing. No fish are anticipated. There is an existing transmission line located on the west side of the RoW.

No fish habitat results in a low sensitivity rating.

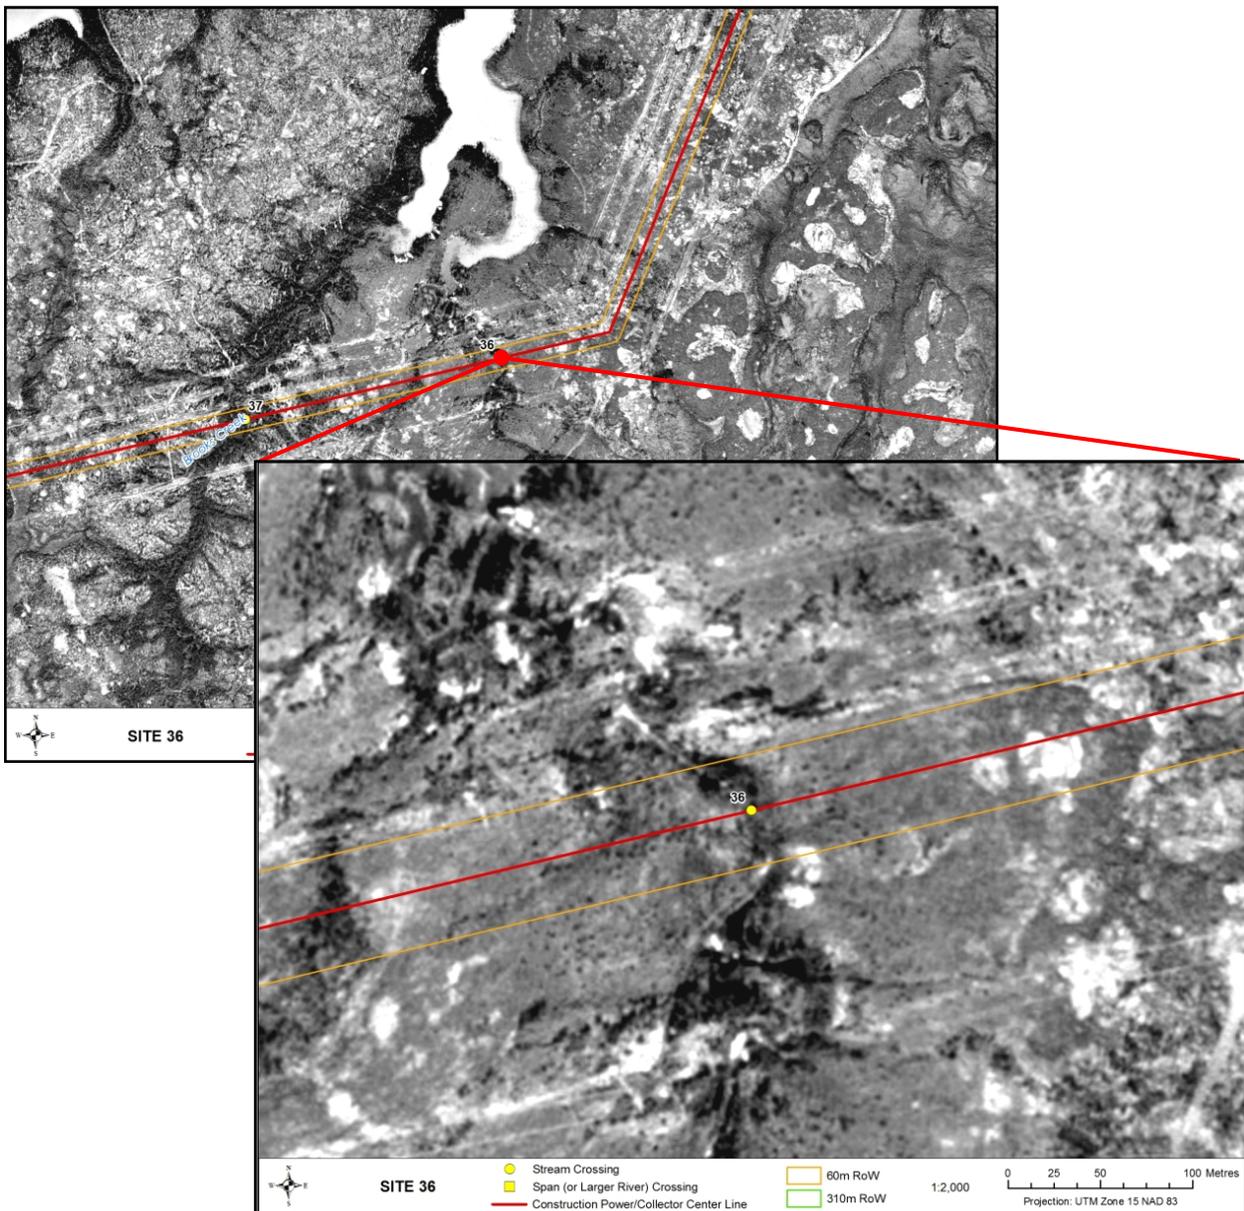
Stream/Lake: Stream
Pattern: IM
Confinement: UN
Stage: Moderate
Flow Regime: Intermittent
Morphology: LC
U/S Drainage: 29.43 km²
Distance to Receiving Water: Nelson River 1.87 km

This unnamed tributary of the Nelson River likely provides important fish habitat for forage and indicator fish species. The crossing consists of a defined channel with unknown bank conditions. The tributary likely provides low overwintering potential. Existing transmission lines are located 17 m downstream and 106 m upstream of the RoW.

Unknown bank conditions and important fish habitat results in a moderate sensitivity rating.
