BIPOLE III TRANSMISSION PROJECT

# 2014 Biophysical Monitoring and Mitigation Report

**Report to Manitoba Conservation and Water Stewardship  
In Accordance with Manitoba *Environment Act* Licence No. 3055**

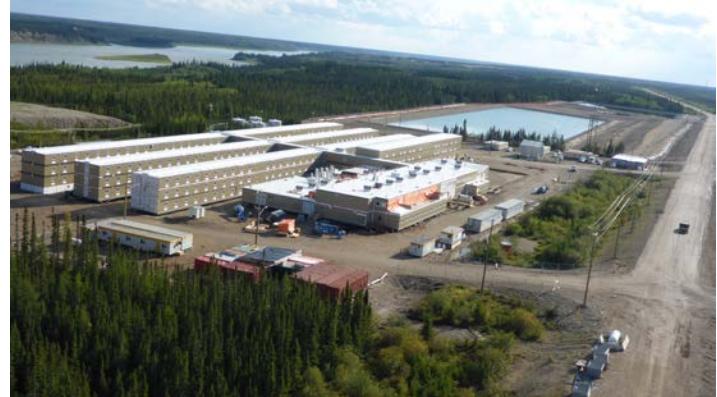
Photo 1: Aerial View of Keewatinohk Work Camp

Construction on the main work camp and supporting facilities occurred in 2014 (Photo 1). One supervisory dorm and one standard dorm were completed and occupied. As of Fall 2014, a temporary kitchen, dining facilities and a 49 person dorm were also installed.

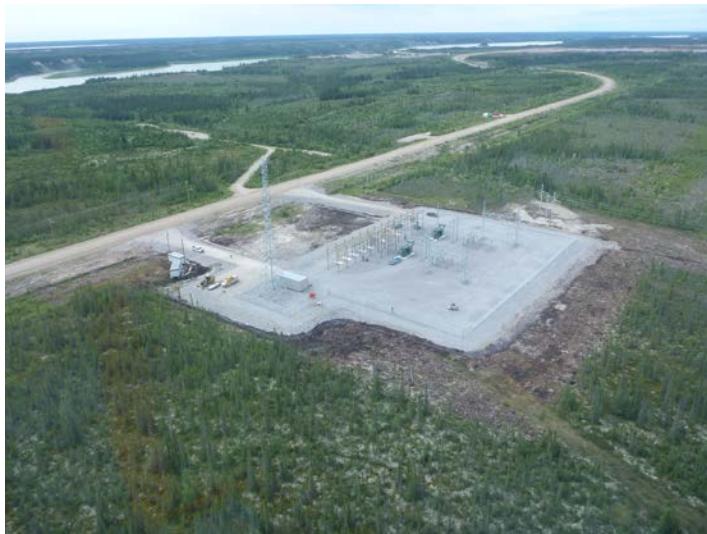
**Photo 2:** Keewatinohk Construction Power Station

A new 138 kV to 12 kV construction power station was built in the Keewatinohk area to provide the power needed to build the converter station and facilities. This was completed during this first construction season and placed in-service as of July 10, 2014.

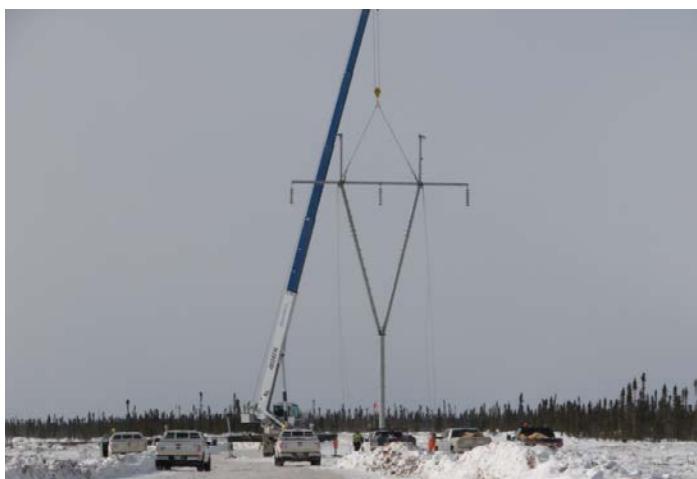
**Photo 3:** Installation of a Transmission Structure for the Construction Powerline

The construction power line (KN36) is also on this ROW. All 30 km of line KN36 were cleared, towers installed and stringing completed in order to provide construction power to the area (Photo 3). These construction activities were carried out through a joint venture between Fox Lake Cree Nation and Valard Construction.

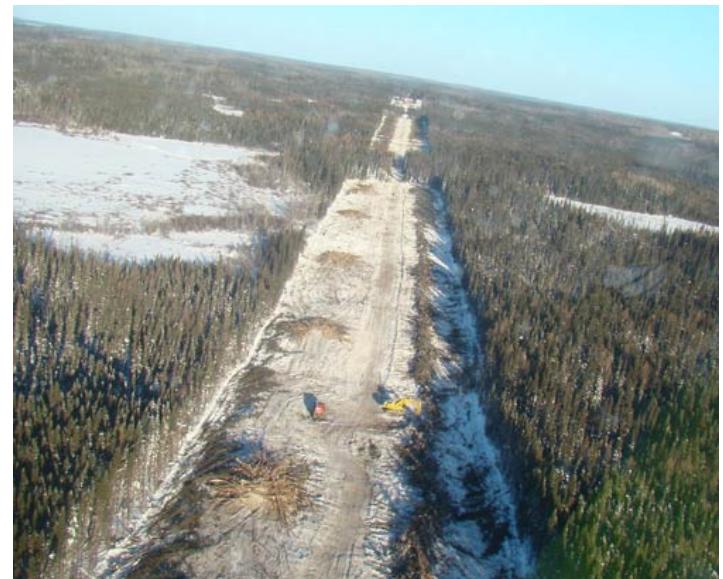
**Photo 4:** Aerial Shot of Clearing of Bipole III Transmission Line

Transmission line construction activities also began with ROW clearing in sections N2B and N3 in early 2014 through a joint venture between Swampy Cree Tribal Council and Sigfusson Northern (Photo 4).

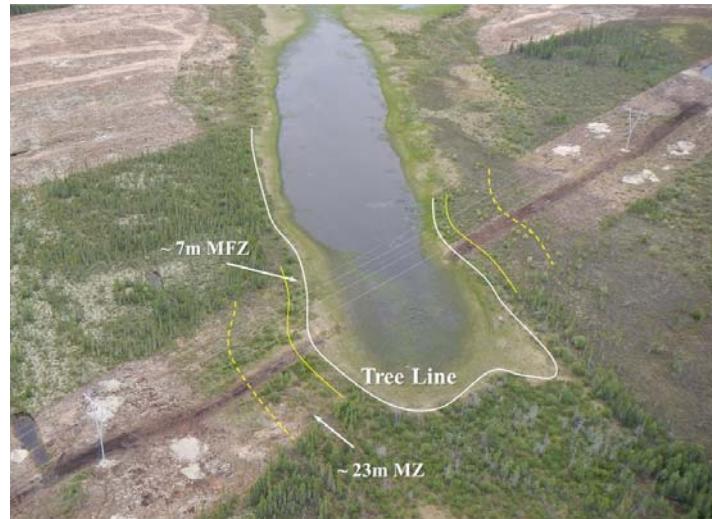
**Photo 5: Riparian Zone Measurements**

against the list of prescribed mitigation to determine level of compliance as well as recording observations of the conditions of sites. Riparian buffers, vehicle crossings, tower and anchor locations, and rutting and erosion were some of the parameters evaluated.

Of the 29 stream crossings surveyed, all sites were in compliance with 13 of the 21 mitigation measures. Of the 8 mitigation measures in non-compliance, the most common deviations from the prescribed mitigation were slash present below the tree line and minor rutting and stream bank damage. As well permanent structures (tower and/or anchors) for the Construction Power line were situated within the floodplain at five sites, including Goose Creek. During tower spotting it became apparent that previous design decisions and feedback from public engagement regarding minimizing right of way width to 310 metres for the AC Collector and Construction Power lines resulted in towers placed within the floodplain making it impossible to maintain the full riparian buffer of 30 metres at four sites. Manitoba Hydro took special measures during the installation of the towers/anchors under frozen ground conditions to minimize effects to the floodplain. Care was also taken during tower spotting when within the floodplain as to not affect the active channel, so as to not directly impact fish.

Manitoba Hydro went to great efforts in the field to identify and flag appropriate boundaries for riparian zones and buffers under difficult winter conditions in a complex riparian environment. Decisions were made in the field and in conjunction with MCWS to mark buffer zones under deep snow conditions and where there was difficulty in identifying the location of some stream channels. The riparian zones adjacent to most streams were adequately protected based on inspection and MCWS review. All inspection reports indicated that there were no major issues and that the work was in compliance with the applicable approvals and permits.

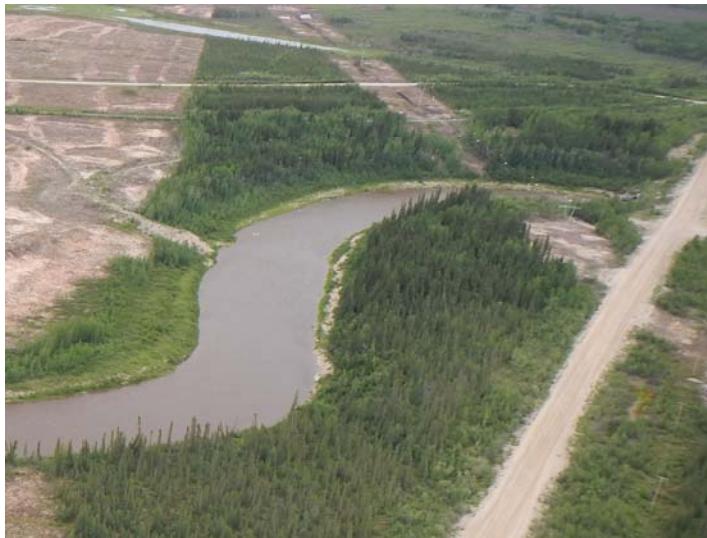
**Photo 6: Limestone River crossing**

Generally, monitoring activities determined the portion of the buffer closest to stream channels was hand-cleared and machinery was used for selective clearing further from the bank within the riparian buffer zone. At some sites the majority of trees as required for vegetation clearance requirements and shrubs were removed within the buffer, but ground cover remained intact.

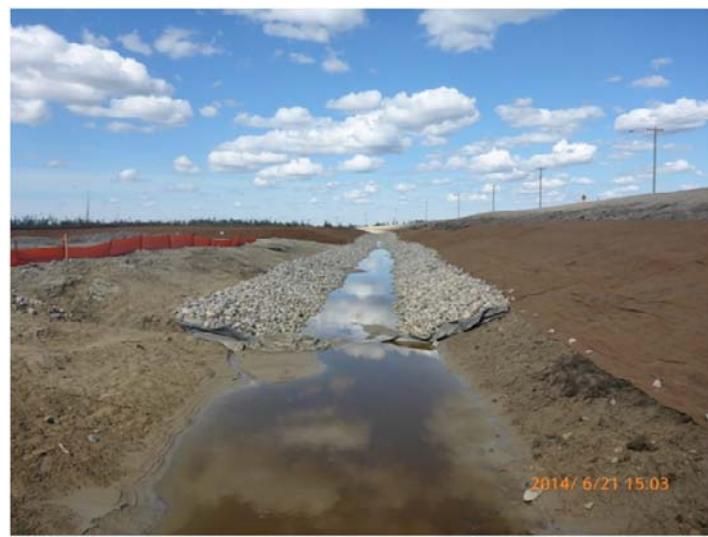
**Photo 7: Erosion Control Measures on a Drain Leading to Goose Creek**

Rock lining of collector drains, use of rock berms, and natural contouring of landscape were all measures used to keep soil and sediment in place at the Keewatinohk Converter Station site (Photo 7). Silt fencing, coconut fibre mats and permanent geo-textiles were installed in exposed areas to prevent sediment entering channels and streams where it could harm fish habitat in Goose Creek. During construction activities, daily monitoring of water quality was undertaken to ensure measures were effective and that any remedial action could be taken immediately. The suspended load of sediment appeared to be relatively low and sediment control measures effective.

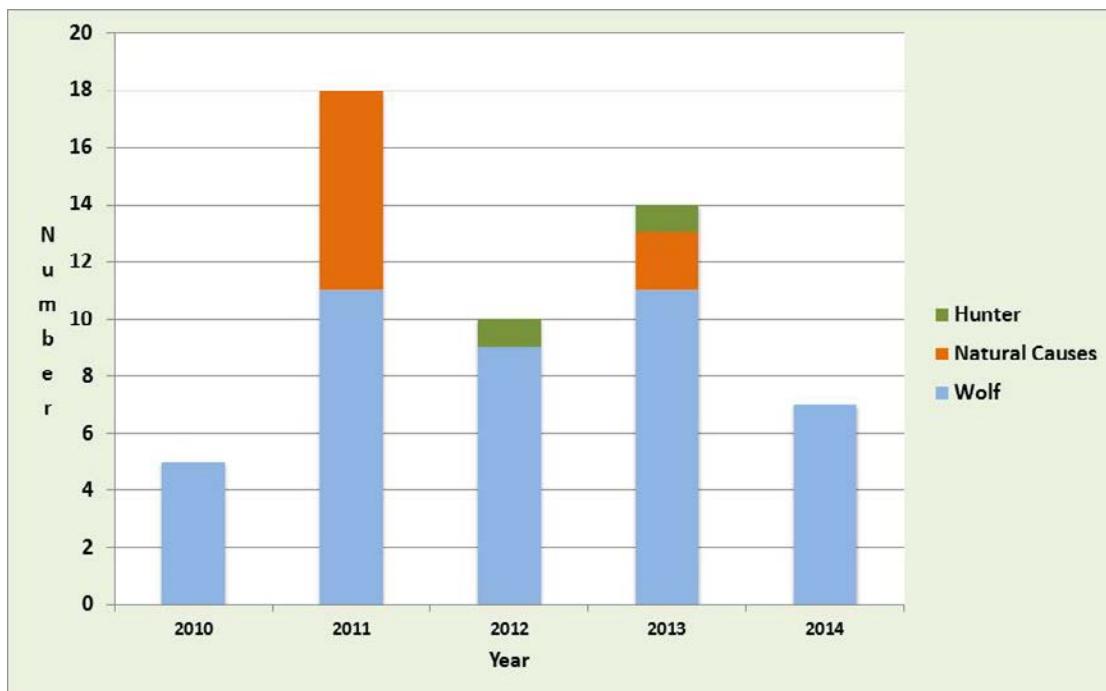
**Figure 2: Collared Caribou Mortalities**

Mortality investigations of collared boreal caribou continue to be undertaken when a mortality signal from an active satellite collar is received. Predation by wolves is the most frequent cause of death of collared caribou. Seven caribou mortalities were recorded in 2014 collar monitoring work all of which were by wolves (Figure 2).

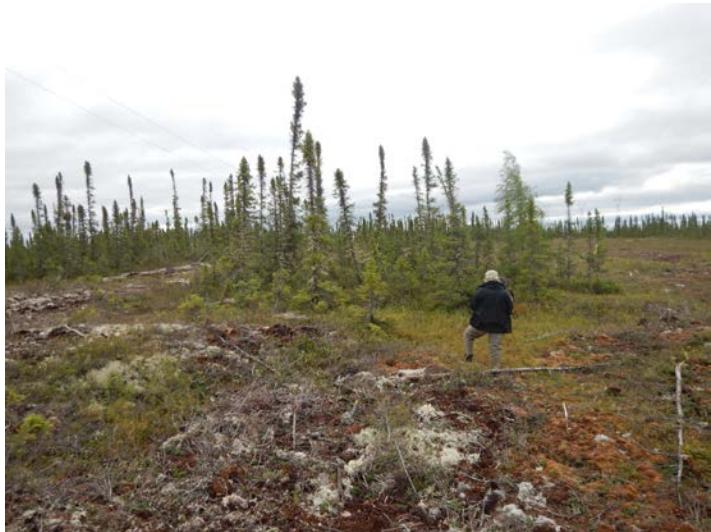
**Photo 10: Uncleared Buffer Around Vegetation Species of Conservation Concern**

Through fieldwork, it was determined that recommended mitigation was implemented during clearing activities for most sites and effective where implemented (Photo 10). From surveys a further mitigation measure is recommended around the Assiniboine River crossing. Eliminating tree removal by spanning the steep slope or, where possible, reducing clearing at this location is desired to protect populations of several species of conservation concern observed.

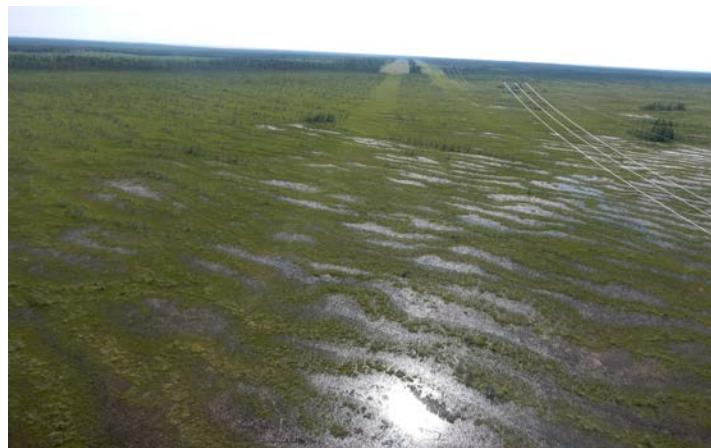
**Photo 12: Patterned Fen Wetland Along Bipole III Right-of-Way**

Through field work, map review and discussion, it was determined that while some recommended mitigation measures were implemented during clearing activities, others were implemented partially or not at all. Where implemented, mitigation was determined to be effective. In the absence of mitigation, some site disturbance were apparent. All sites appeared to utilize existing access roads and trails, had vehicle traffic confined to established trails, and construction activities were carried out on frozen ground to minimize surface damage. Approximately 42 hectares were disturbed by clearing activities in the environmentally sensitive wetlands and all sites did not retain a 30 m vegetated buffer surrounding the ends of the wetlands. However, no rehabilitation was prescribed as natural revegetation is expected to repair the disturbance caused by construction.

As a result of this information, protection of wetland zones are being reviewed with the Environmental Inspectors for potential improvements in ESS flagging and communication with clearing contractors. Riparian zones were previously noted in the aquatic section and remedial actions described.

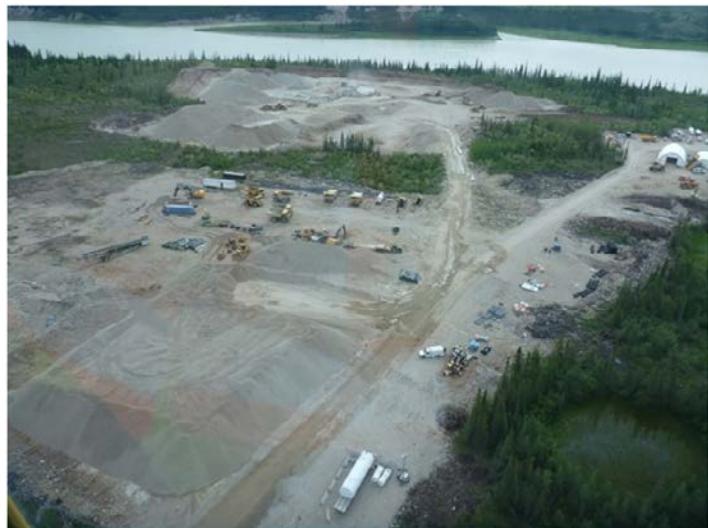
**Photo 13: Borrow Pit Requiring Rehabilitation Post Construction**

The degree of disturbance was assessed at all sites visited to determine whether natural re-vegetation was feasible (Photo 13). It is recommended the Keewatinohk Construction Camp lagoon, Conawapa Road ditch immediately adjacent to the lagoon and the ditches surrounding the Keewatinohk Converter Station be re-vegetated using native seed.

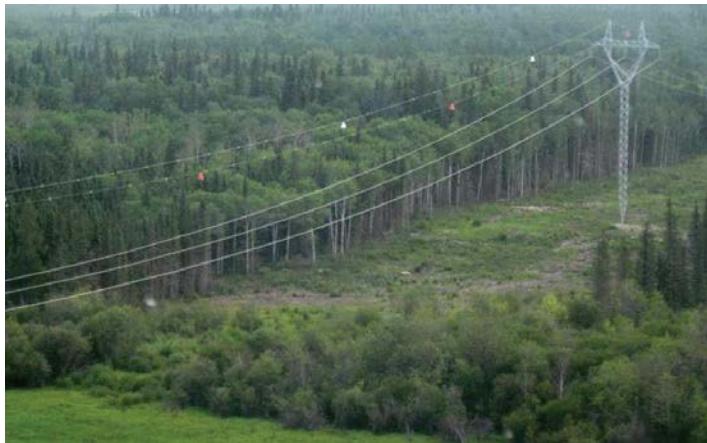
**Photo 15:** Bird Diverters on a Transmission Line

The 2014 surveys consisted of verification surveys to determine the relative significance of each ESS identified in the EIS based on the density and richness of bird species that have a greater potential for bird-wire collision (e.g., waterfowl, waterbirds, colonial nesting birds). The relative significance of ESS's will allow for a priority assessment for the placement of bird diverters and for bird diverter effectiveness monitoring (Photo 15).

As a result of additional aerial surveys carried out in 2014, a number of the original 144 sites and some new sites have been deemed to be candidate high risk ESS that are recommended for installation of bird diverters when the Bipole III conductors are installed. These sites will be monitored after construction for occurrences of bird-wire collisions in accordance with the BMP. Comparison will be made between high risk sites with bird diverters versus lower risk sites with no diverters.

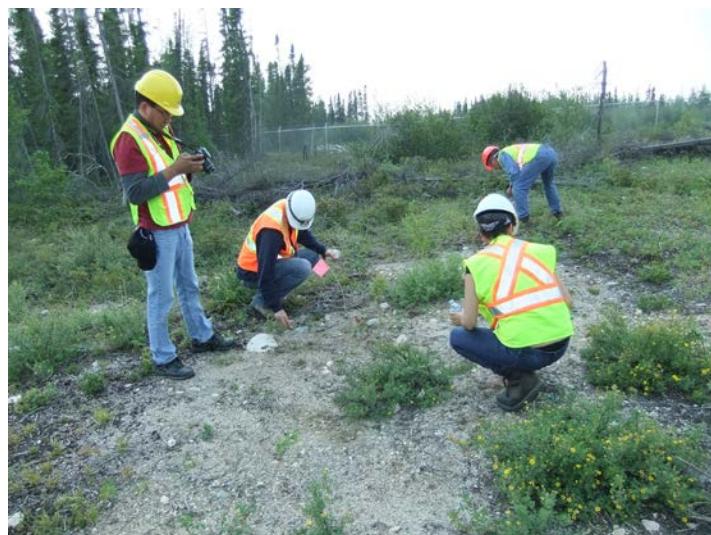
**Photo 17: Survey of Heritage Site**

In November 2013, one of two known heritage sites was accidentally accessed by snow clearing equipment. The incident was immediately investigated by the Site Environmental Officer and the impact assessed as minimal. The Project Archeologist was notified and visited the site that winter and again in the summer for a full impact assessment. The heritage assessment conducted in July 2014 included a pedestrian survey and GPS documentation of exposed artifacts or any stone features identified (Photo 17). The site assessment included the Project Archaeologist, Fox Lake Cree Nation community members and others. Evidence of ground scraping was noted, however, it appeared that only the very top of the organic humus layer was affected and not the substrate below. Both heritage sites are now protected with permanent chain link fencing. In light of the incident steps have been taken to train site contractors to recognize potential heritage resources in the field and how to respond when artifacts are accidentally discovered. This training is now a component of all site orientation.

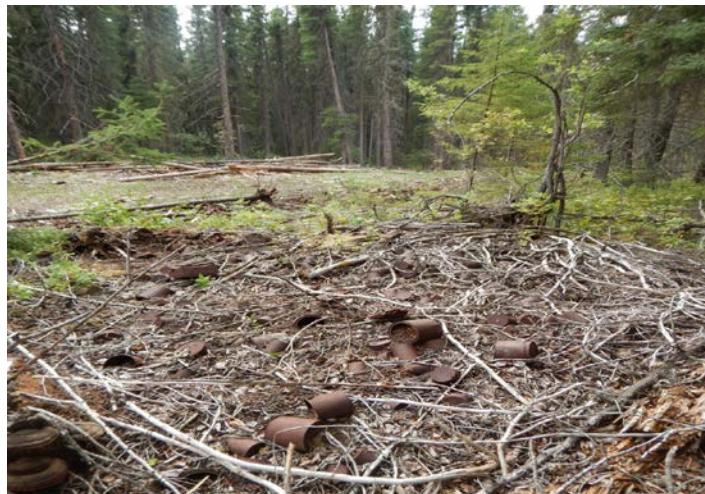
**Photo 18: Tin Cans and Refuse Pile Related to Hudson Bay Railway Construction**

Three out of four water crossings identified as ESS for heritage were surveyed. At the Saskatchewan River crossing, a historic steam boiler was discovered along the edge of the ROW but was not considered a heritage concern. Two crossings of the Mitishto River were investigated. At one site, tin cans, animal bones and glass bottles were discovered along an access trail (Photo 18).

The material was likely from construction of the Hudson's Bay Railroad in the 1930's and was not of heritage value to warrant designation as an archeological site. In the future, it is recommended Environmental Monitors be on-site to observe all tower footing excavations within 100 metres of heritage environmentally sensitive site locations in case unknown heritage resources are revealed.

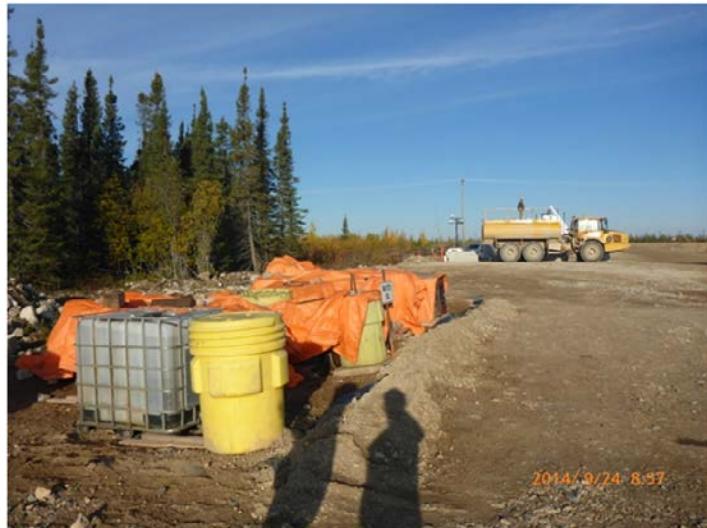
**Photo 19: Temporary Hazardous Materials Storage Area at Keewatinohk Converter Station Work Area**

Manitoba Hydro requires all contractors to have a spill response plan. All contractor spills, regardless of quantity are reported to Manitoba Hydro. All hazardous materials on Keewatinohk Converter Station site are segregated and stored in lined temporary storage cells (Photo 19).
