Coordinate System: UTM Zone 14N NAD83  
 Data Source: MB Hydro, ProvMB, NRCAN  
 Date Created: November 03, 2016  
 Version: 4.0

**Bipole III Transmission Project  
 Construction Environmental Protection Plan  
 Construction Section C1  
 Environmentally Sensitive Site Locations**

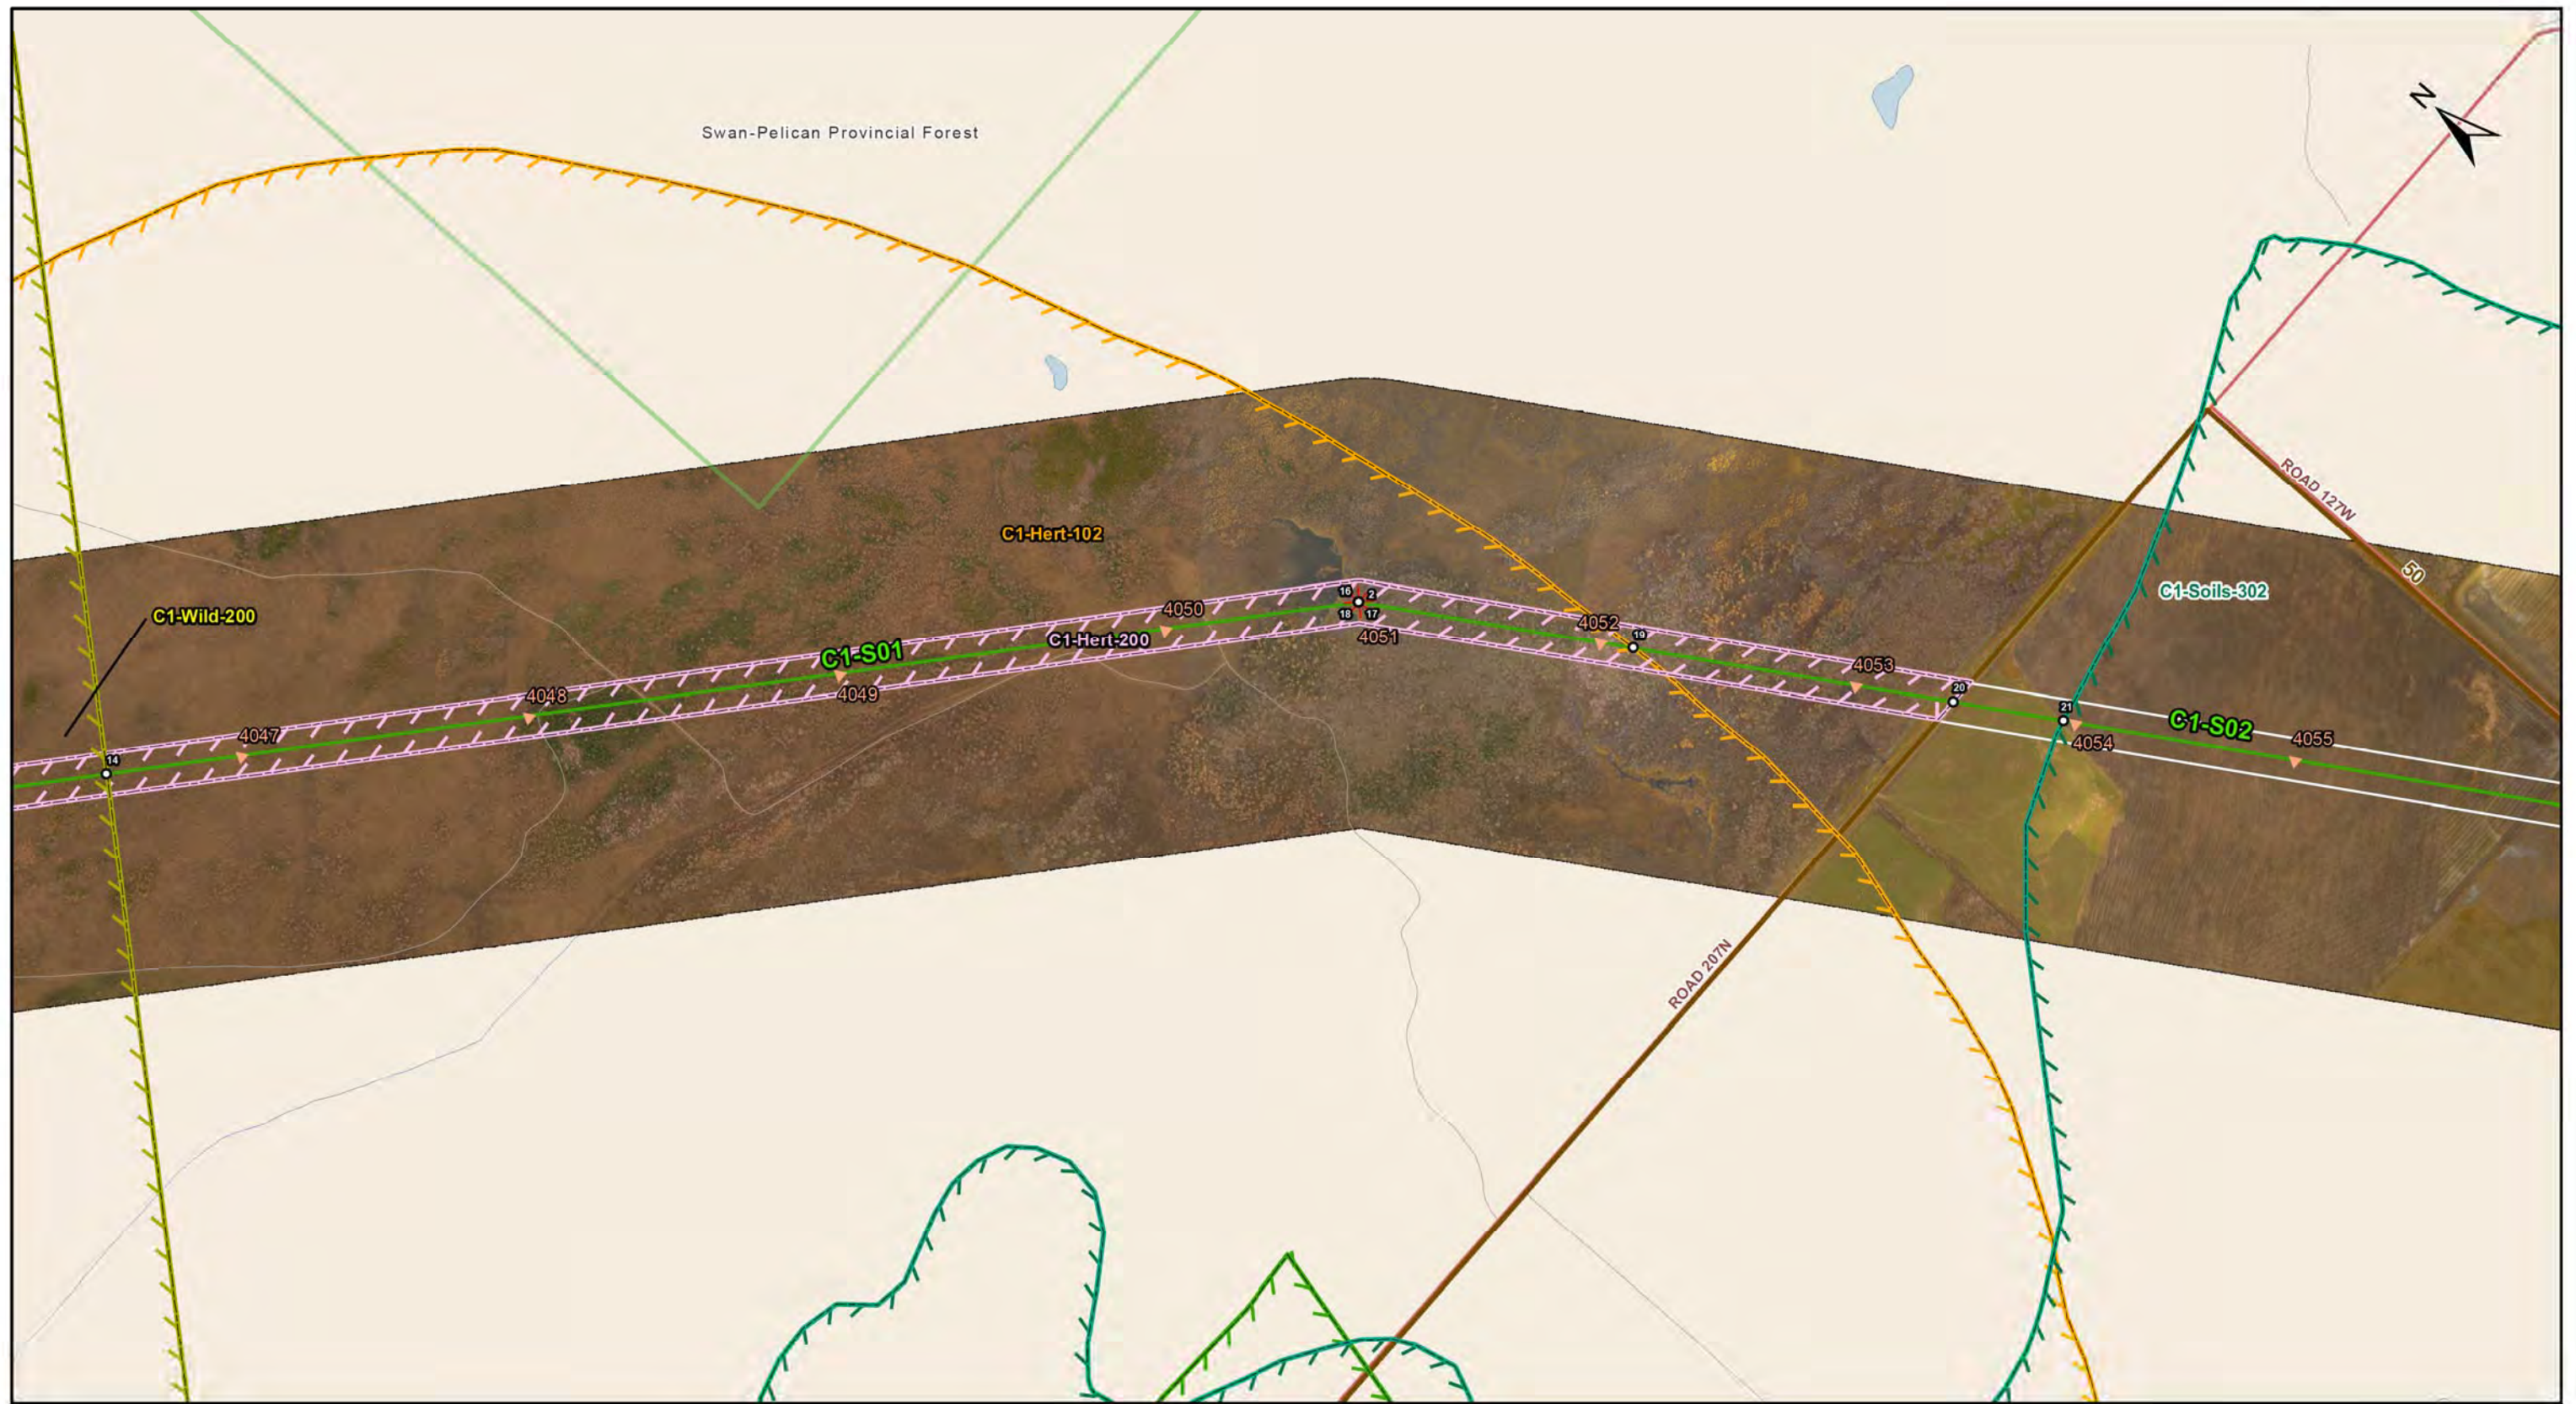
Sec-Seg ID	ESS ID	ESS Name	Location	Start	Stop	UTM Zone	Distance
C1-S01	C1-Wild-200	Moose Sensitive Area	Site: 13 to 14	E-389782 N-5770528	E-395210 N-5765631	14N	7310 m

*GHA 14A Sensitive Moose Range*

Sec-Seg ID	ESS ID	ESS Name	Location	Start	Stop	UTM Zone	Distance
C1-S02	C1-Soils-302	Water Erosion Risk	Site: 21 to 22	E-397253 N-5763336	E-398794 N-5760723	14N	3033 m

*Loss of topsoil due to water erosion (e.g. sheet, rill, gully) on disturbed surfaces.*

Sec-Seg ID	ESS ID	ESS Name	Location	Start	Stop	UTM Zone	Distance
C1-S01	C1-Hert-102	arrowheads/Spearheads	Site: 15 to 16	E-394349 N-5766407	E-396683 N-5764303	14N	3142m
C1-S02	C1-Hert-102	arrowheads/Spearheads	Site: 18 to 19	E-396683 N-5764303	E-396905 N-5763926	14N	436m

*Loss of heritage resources due to inadvertent disturbance of sites. Ref: Duck Bay Group I - Lines - 1664 - 1752*

Sec-Seg ID	ESS ID	ESS Name	Location	Start	Stop	UTM Zone	Distance
C1-S01	C1-Hert-200	Gathering Area	Site: 1 to 2	E-379493 N-5779808	E-396683 N-5764303	14N	23149 m
C1-S02	C1-Hert-200	Gathering Area	Site: 17 to 20	E-396683 N-5764303	E-397163 N-5763488	14N	946 m

*Potential loss of vegetation during Project construction; potential for increased access to a traditional gathering area by non-community members*

- For mitigation for this area refer to the "Moose and Woodland Caribou Sensitive Range Delineation and Mitigation Plans" document

- Carry out construction activities on frozen ground to minimize surface damage, rutting and erosion
- Use existing trails, roads or cut lines whenever possible as access routes
- Avoid dry soil conditions with high and severe wind erosion risk to the extent possible
- Maintain shrub and herbaceous vegetation to the extent possible
- Remove trees by low-disturbance methods
- Confine vehicle traffic to established trails to the extent possible
- Implement erosion protection before commencing construction in accordance with Erosion/Sediment Control Plan

- Carry out construction activities on frozen or dry ground to minimize surface damage, rutting and erosion
- Identify and flag prior to start of work
- Conduct site investigation with Archaeologist post clearing and prior to construction
- Minimize surface disturbance around the site to the extent possible
- Inspect excavated materials or surface disturbance for heritage resources and report any finds to Environmental Inspector
- Implement additional mitigation from site investigation

- Carry out construction activities on frozen or dry ground to minimize surface damage, rutting and erosion
- Minimize surface disturbance around the site to the extent possible
- Remove trees by low-disturbance methods
- No Herbicide to be applied during construction
- Confine vehicle traffic to established trails to the extent possible

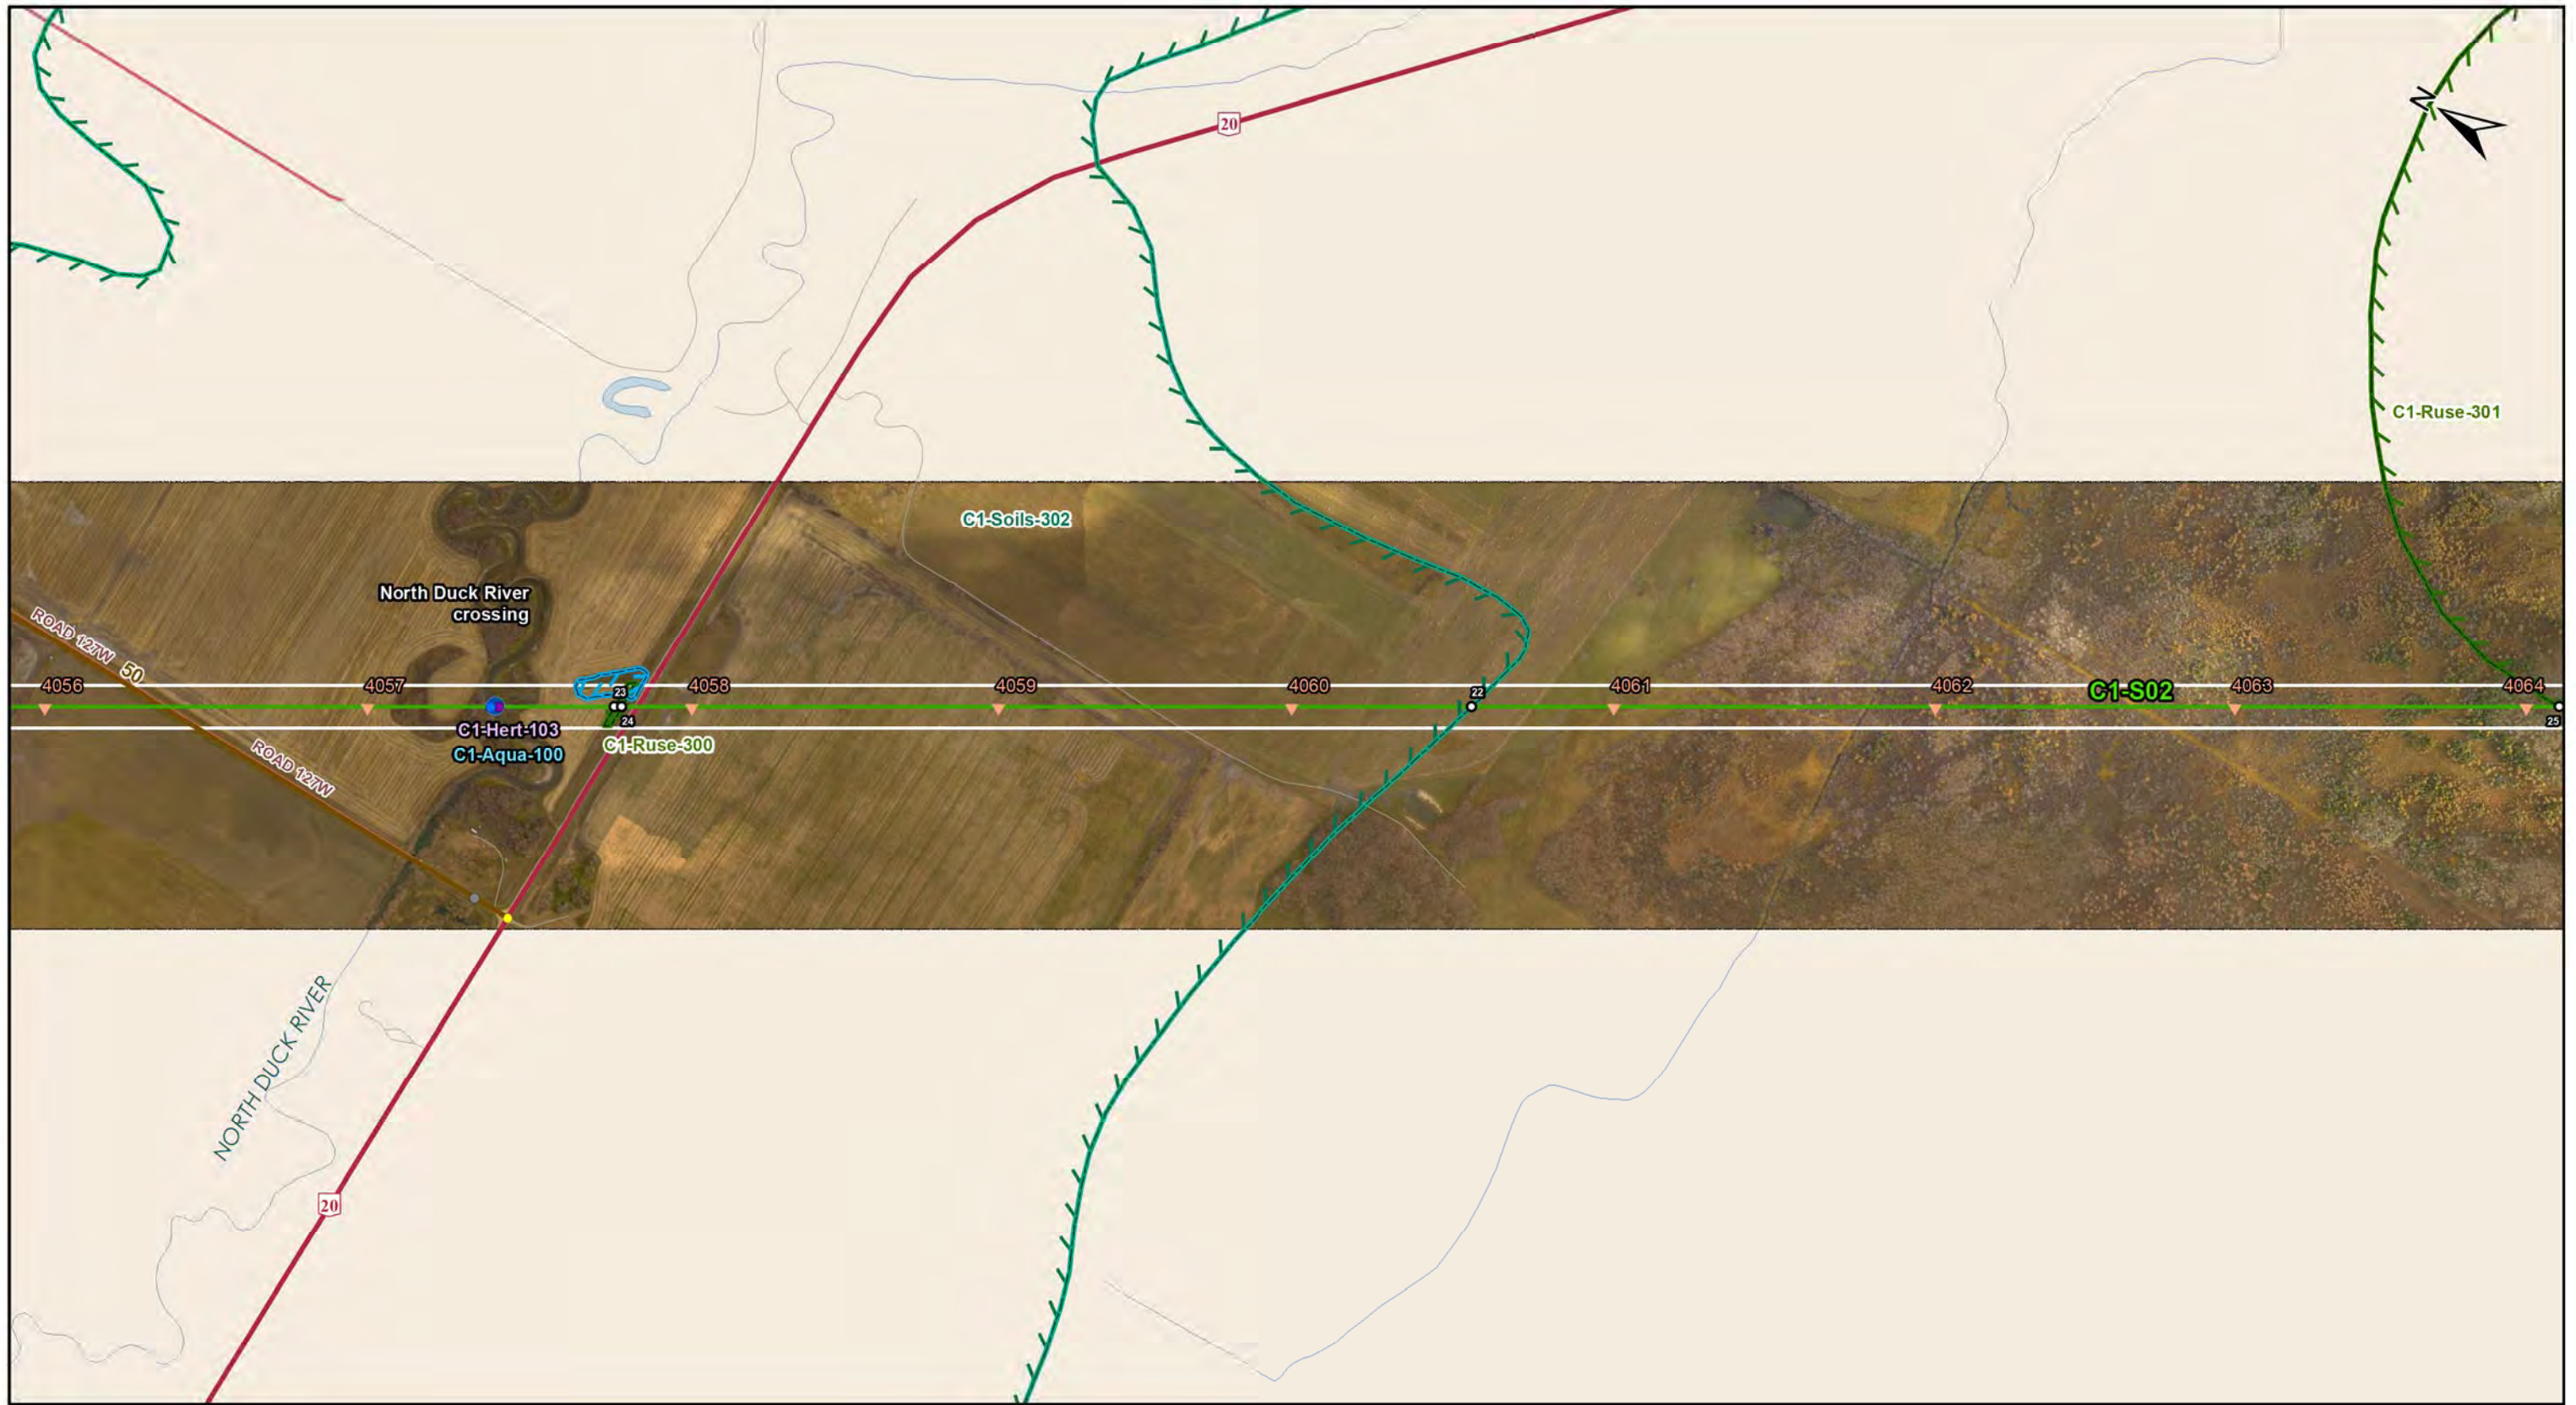
Sec-Seg ID	ESS ID	ESS Name	Easting	Northing	UTM Zone
C1-S02	C1-Hert-103	Duck River	398020	5762037	14N

*Potential disturbance to Heritage Resources*

Sec-Seg ID	ESS ID	ESS Name	Easting	Northing	UTM Zone	Channel Width	Wet Width	Fish Habitat Class	Habitat Sensitivity
C1-S02	C1-Aqua-100	North Duck River	398014	5762047	14N	16.5m	15.5m	High	Important

*Habitat loss and contamination from structure foundations & installations; increased erosion & sedimentation of streams; Damage to stream banks; Loss of riparian vegetation; Fish habitat disturbances and impeded fish movement; Rutting of floodplain*

Sec-Seg ID	ESS ID	ESS Name	Location	Start	Stop	UTM Zone	Distance
C1-S02	C1-Soils-302	Water Erosion Risk	Site: 21 to 22	E-397253 N-5763336	E-398794 N-5760723	14N	3033 m

*Loss of topsoil due to water erosion (e.g. sheet, rill, gully) on disturbed surfaces.*

Sec-Seg ID	ESS ID	ESS Name	Location	Start	Stop	UTM Zone	Distance
C1-S02	C1-RUse-301	ATK-97 Duck Bay	Site: 25 to 26	E-399660 N-5759256	E-400498 N-5757836	14N	1649m

*Potential to disrupt access to fuel wood area*

Sec-Seg ID	ESS ID	ESS Name	Location	Start	Stop	UTM Zone	Distance
C1-S02	C1-RUse-300	Shelterbelt	Site: 23 to 24	E-398112 N-5761880	E-398118 N-5761870	14N	11 m

*Removal in area of ROW intersect*

- Carry out construction activities on frozen or dry ground to minimize surface damage, rutting and erosion
- Identify and flag prior to start of work
- Conduct site investigation with Archaeologist post clearing and prior to construction
- Minimize surface disturbance around the site to the extent possible
- Inspect excavated materials or surface disturbance for heritage resources and report any finds to Environmental Inspector
- Implement additional mitigation from site investigation

- Carry out construction activities on frozen ground to minimize surface damage, rutting and erosion
- Use existing trails, roads or cut lines whenever possible as access routes
- Identify and flag buffer areas prior to start of work
- Riparian Buffers shall be a minimum of 30m and increase in size based on slope of land entering waterway. Within these buffers shrub and herbaceous understory veg will be maintained along with trees that do not violate MH Veg Clearance Requirements.
- 7m no machine zone will restrict equipment in close proximity to the waterbody except at the trail crossing.
- No instream works or fording from April 1 - July 15

- Carry out construction activities on frozen ground to minimize surface damage, rutting and erosion
- Use existing trails, roads or cut lines whenever possible as access routes
- Avoid dry soil conditions with high and severe wind erosion risk to the extent possible
- Maintain shrub and herbaceous vegetation to the extent possible
- Remove trees by low-disturbance methods
- Confine vehicle traffic to established trails to the extent possible
- Implement erosion protection before commencing construction in accordance with Erosion/Sediment Control Plan

- Carry out construction activities on frozen or dry ground to minimize surface damage, rutting and erosion
- Avoid surface damage to and obstruction of access route
- Make fuel wood from ROW clearing available to local community where demand exists

- Carry out construction activities on frozen or dry ground to minimize surface damage, rutting and erosion
- Identify and flag prior to start of work
- If Burning of clearing debris is required it must be conducted during winter months only and ensure that all fires are extinguished prior to spring break-up
- Notify landowner regarding construction activities and schedule, and address concerns prior to start of work
- Use existing access trails, roads or cut lines whenever possible as access routes
- Limit all equipment to project footprint only, where possible
- No damage to Vegetation on the edge of the Right of Way
- No pushing debris into adjacent timber

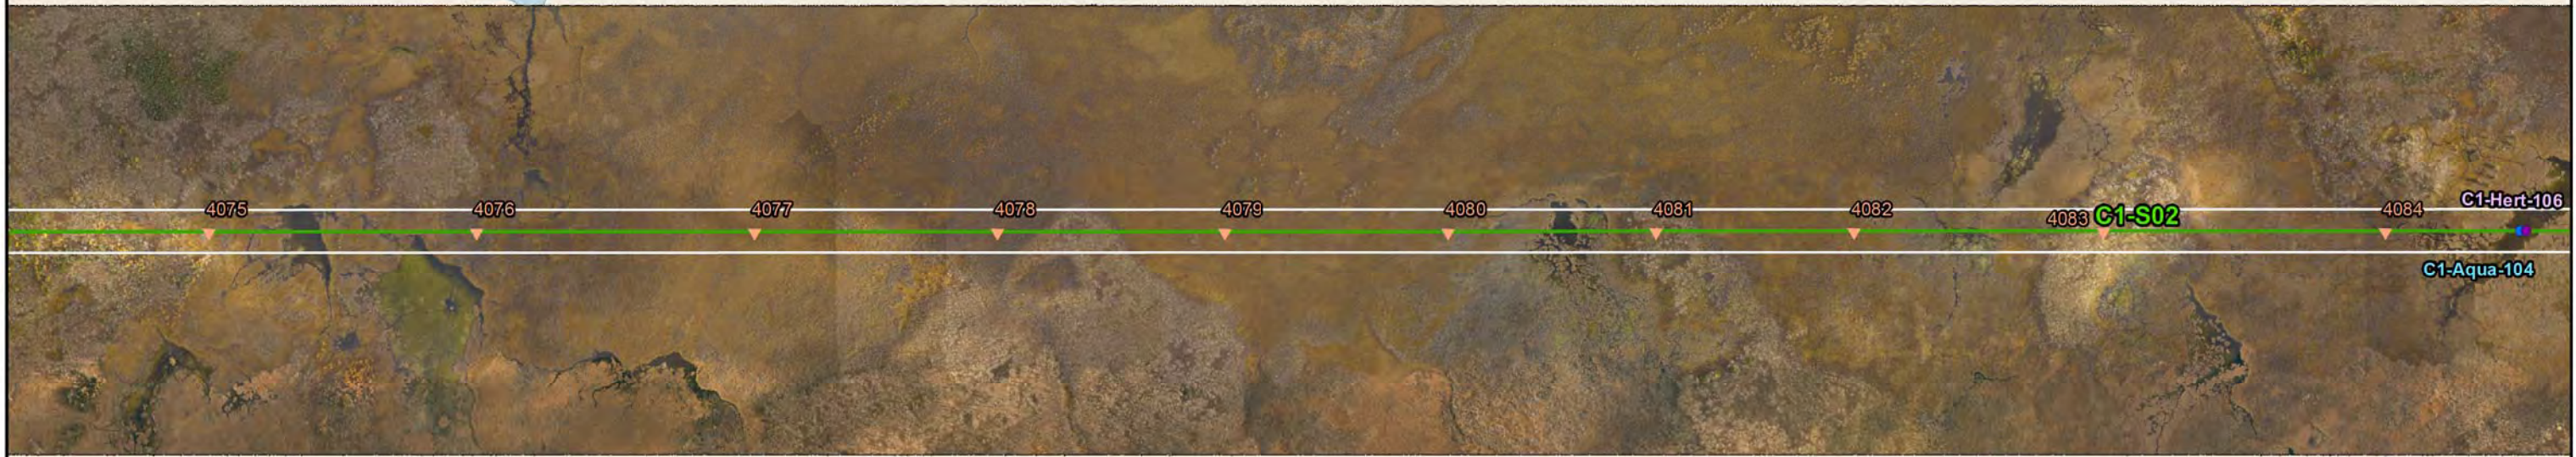
\*MAP SHEET FULLY WITHIN THE C1-WILD-201 FEATURE

Sec-Seg ID	ESS ID	ESS Name	Easting	Northing	UTM Zone	Channel Width	Wet Width	Fish Habitat Class	Habitat Sensitivity
C1-S02	C1-Aqua-104	Unnamed tributary of Sclater River	403650	5752497	14N	N/A	29m	Moderate	Important

*Habitat loss and contamination from structure foundations & installations; increased erosion & sedimentation of streams; Damage to stream banks; Loss of riparian vegetation; Fish habitat disturbances and impeded fish movement; Rutting of floodplain*

Sec-Seg ID	ESS ID	ESS Name	Location	Start	Stop	UTM Zone	Distance
C1-S02	C1-Wild-201	Moose Sensitive Area	Site: 27 to 28	E-400330 N-5758121	E-404690 N-5750732	14N	8579m

*GHA 19A Sensitive Moose Range*

Sec-Seg ID	ESS ID	ESS Name	Easting	Northing	UTM Zone
C1-S02	C1-Hert-106	Wasyliuk Drain	403653	5752490	14N

*Potential disturbance to Heritage Resources*

- Carry out construction activities on frozen ground to minimize surface damage, rutting and erosion
- Use existing trails, roads or cut lines whenever possible as access routes
- Identify and flag buffer areas prior to start of work
- Riparian Buffers shall be a minimum of 30m and increase in size based on slope of land entering waterway. Within these buffers shrub and herbaceous understory veg will be maintained along with trees that do not violate MH Veg Clearance Requirements
- 7m no machine zone will restrict equipment in close proximity to the waterbody except at the trail crossing.
- No instream works or fording from April 1 - July 15

- For mitigation for this area refer to the "Moose and Woodland Caribou Sensitive Range Delineation and Mitigation Plans" document

- Carry out construction activities on frozen or dry ground to minimize surface damage, rutting and erosion
- Identify and flag prior to start of work
- Conduct site investigation with Archaeologist post clearing and prior to construction
- Minimize surface disturbance around the site to the extent possible
- Inspect excavated materials or surface disturbance for heritage resources and report any finds to Environmental Inspector
- Implement additional mitigation from site investigation

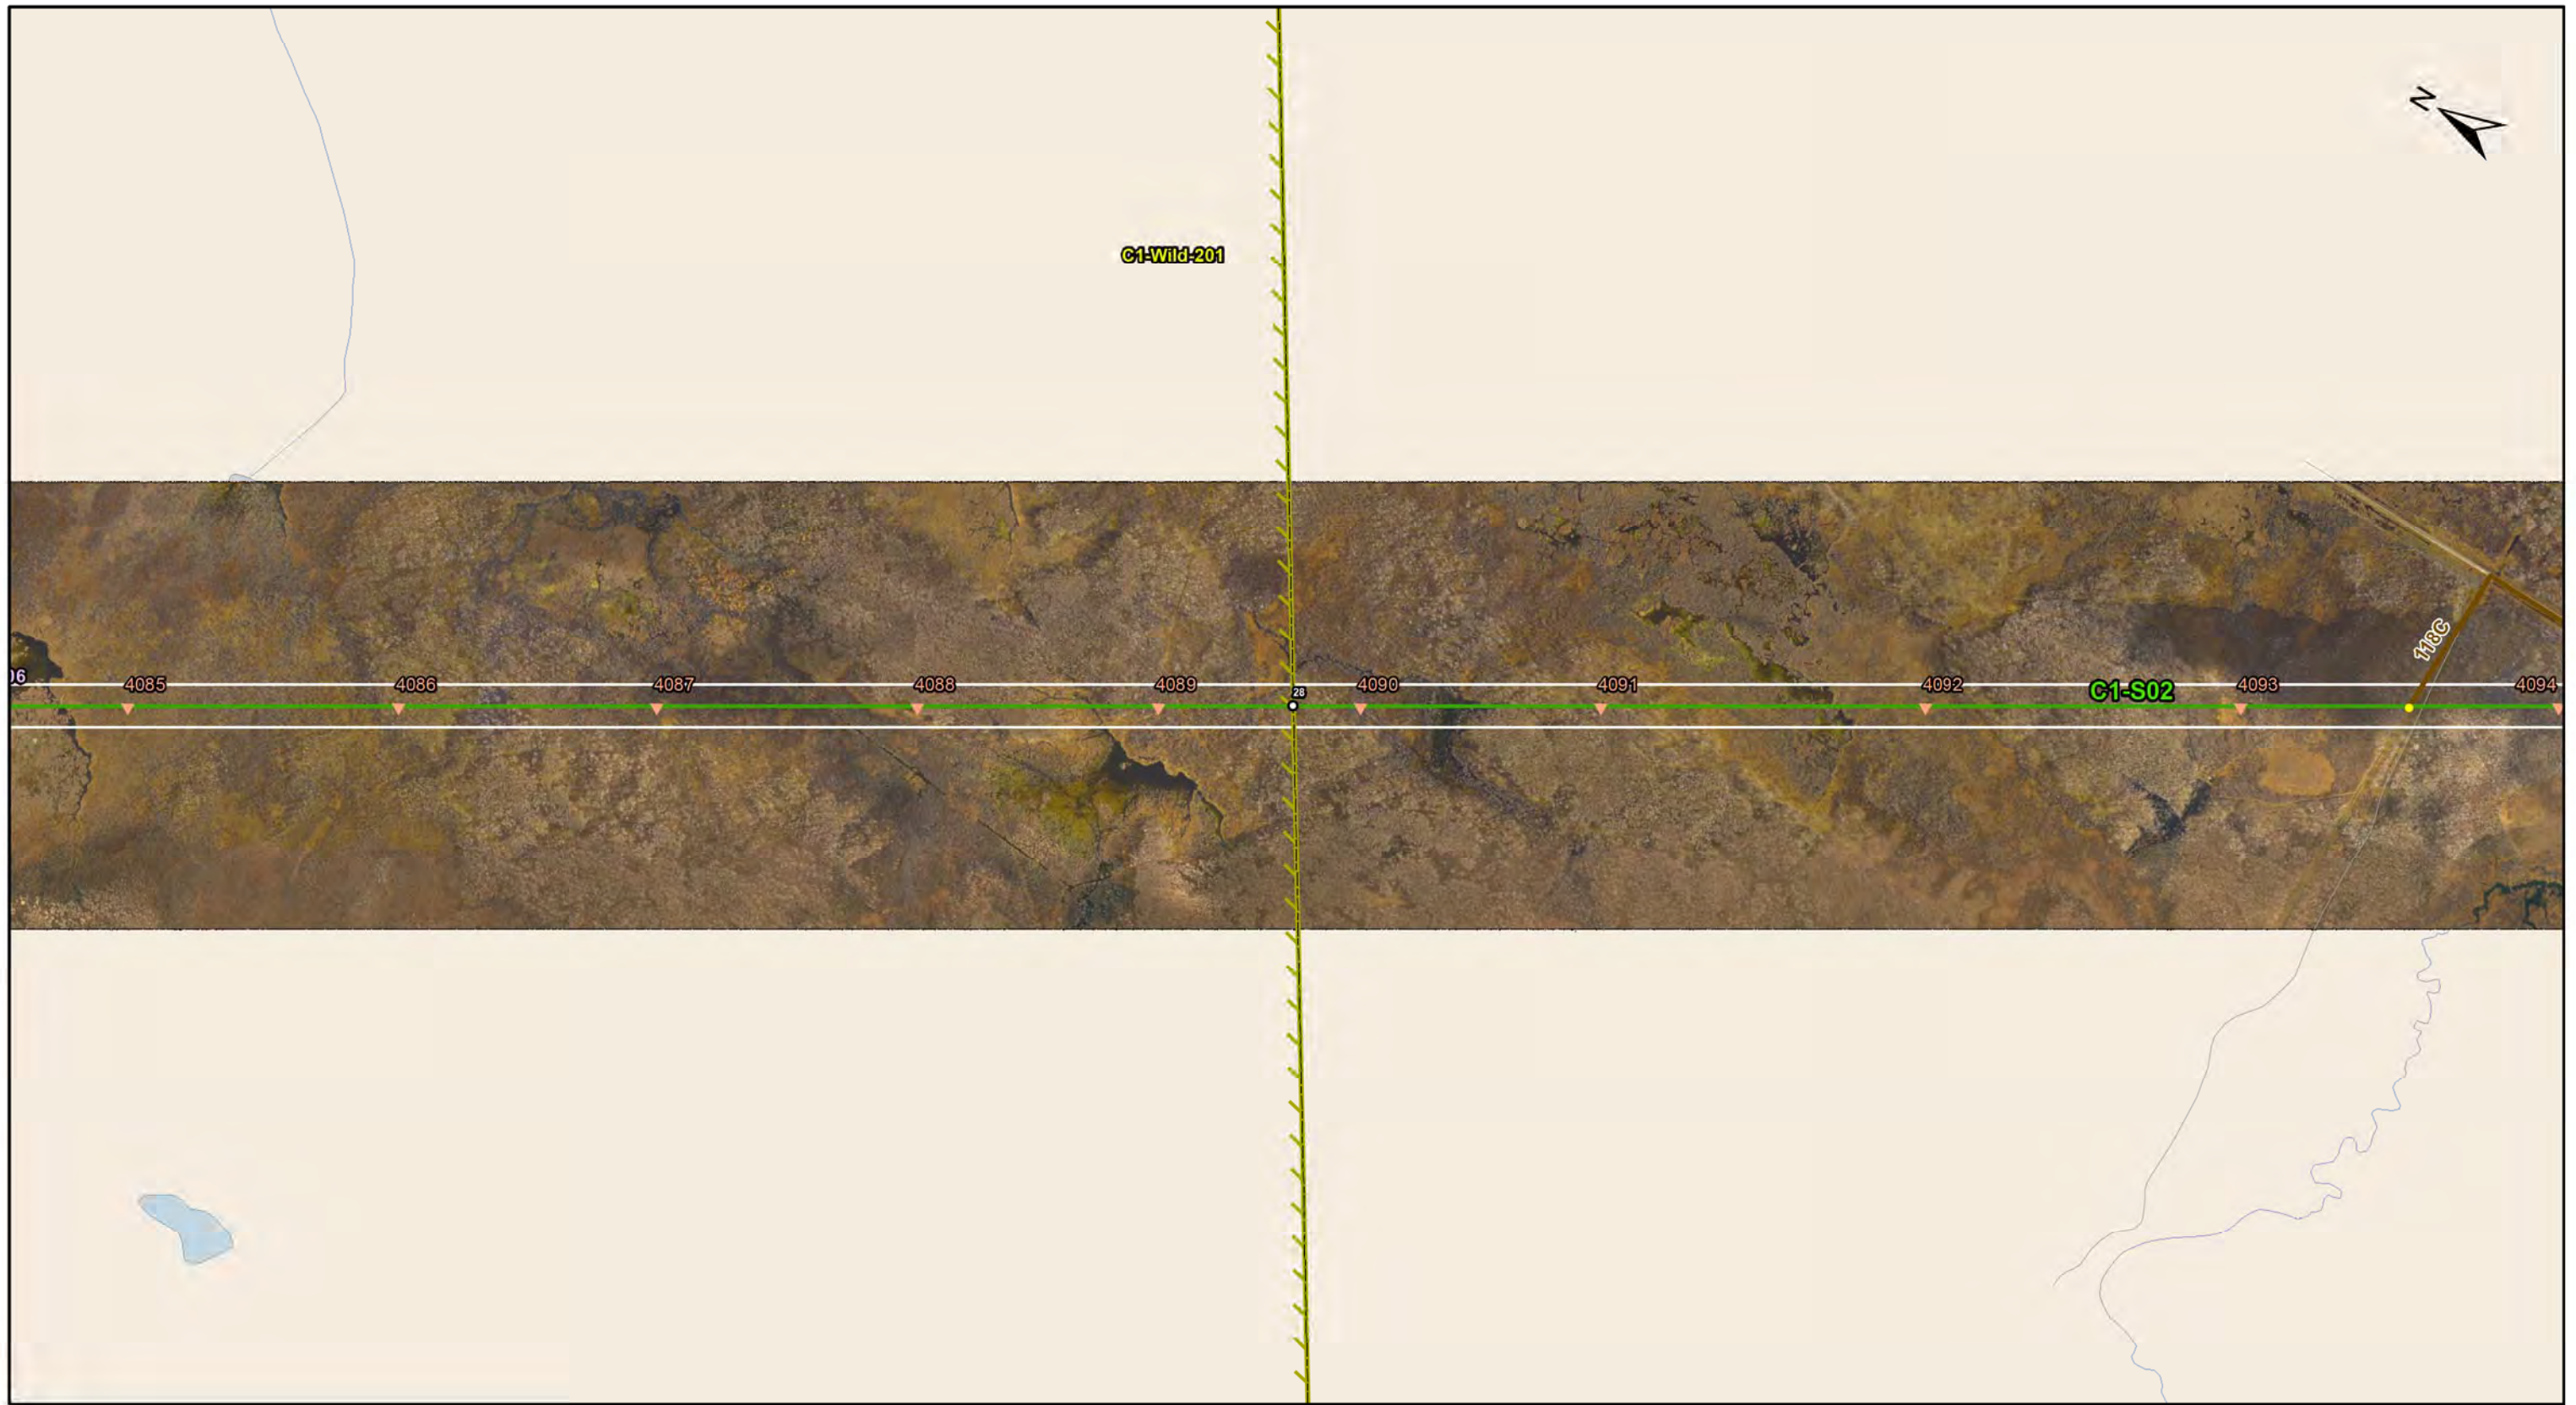
Sec-Seg ID	ESS ID	ESS Name	Location	Start	Stop	UTM Zone	Distance
C1-S02	C1-Wild-201	Moose Sensitive Area	Site: 27 to 28	E-400330 N-5758121	E-404690 N-5750732	14N	8579m

*GHA 19A Sensitive Moose Range*

- For mitigation for this area refer to the "Moose and Woodland Caribou Sensitive Range Delineation and Mitigation Plans" document

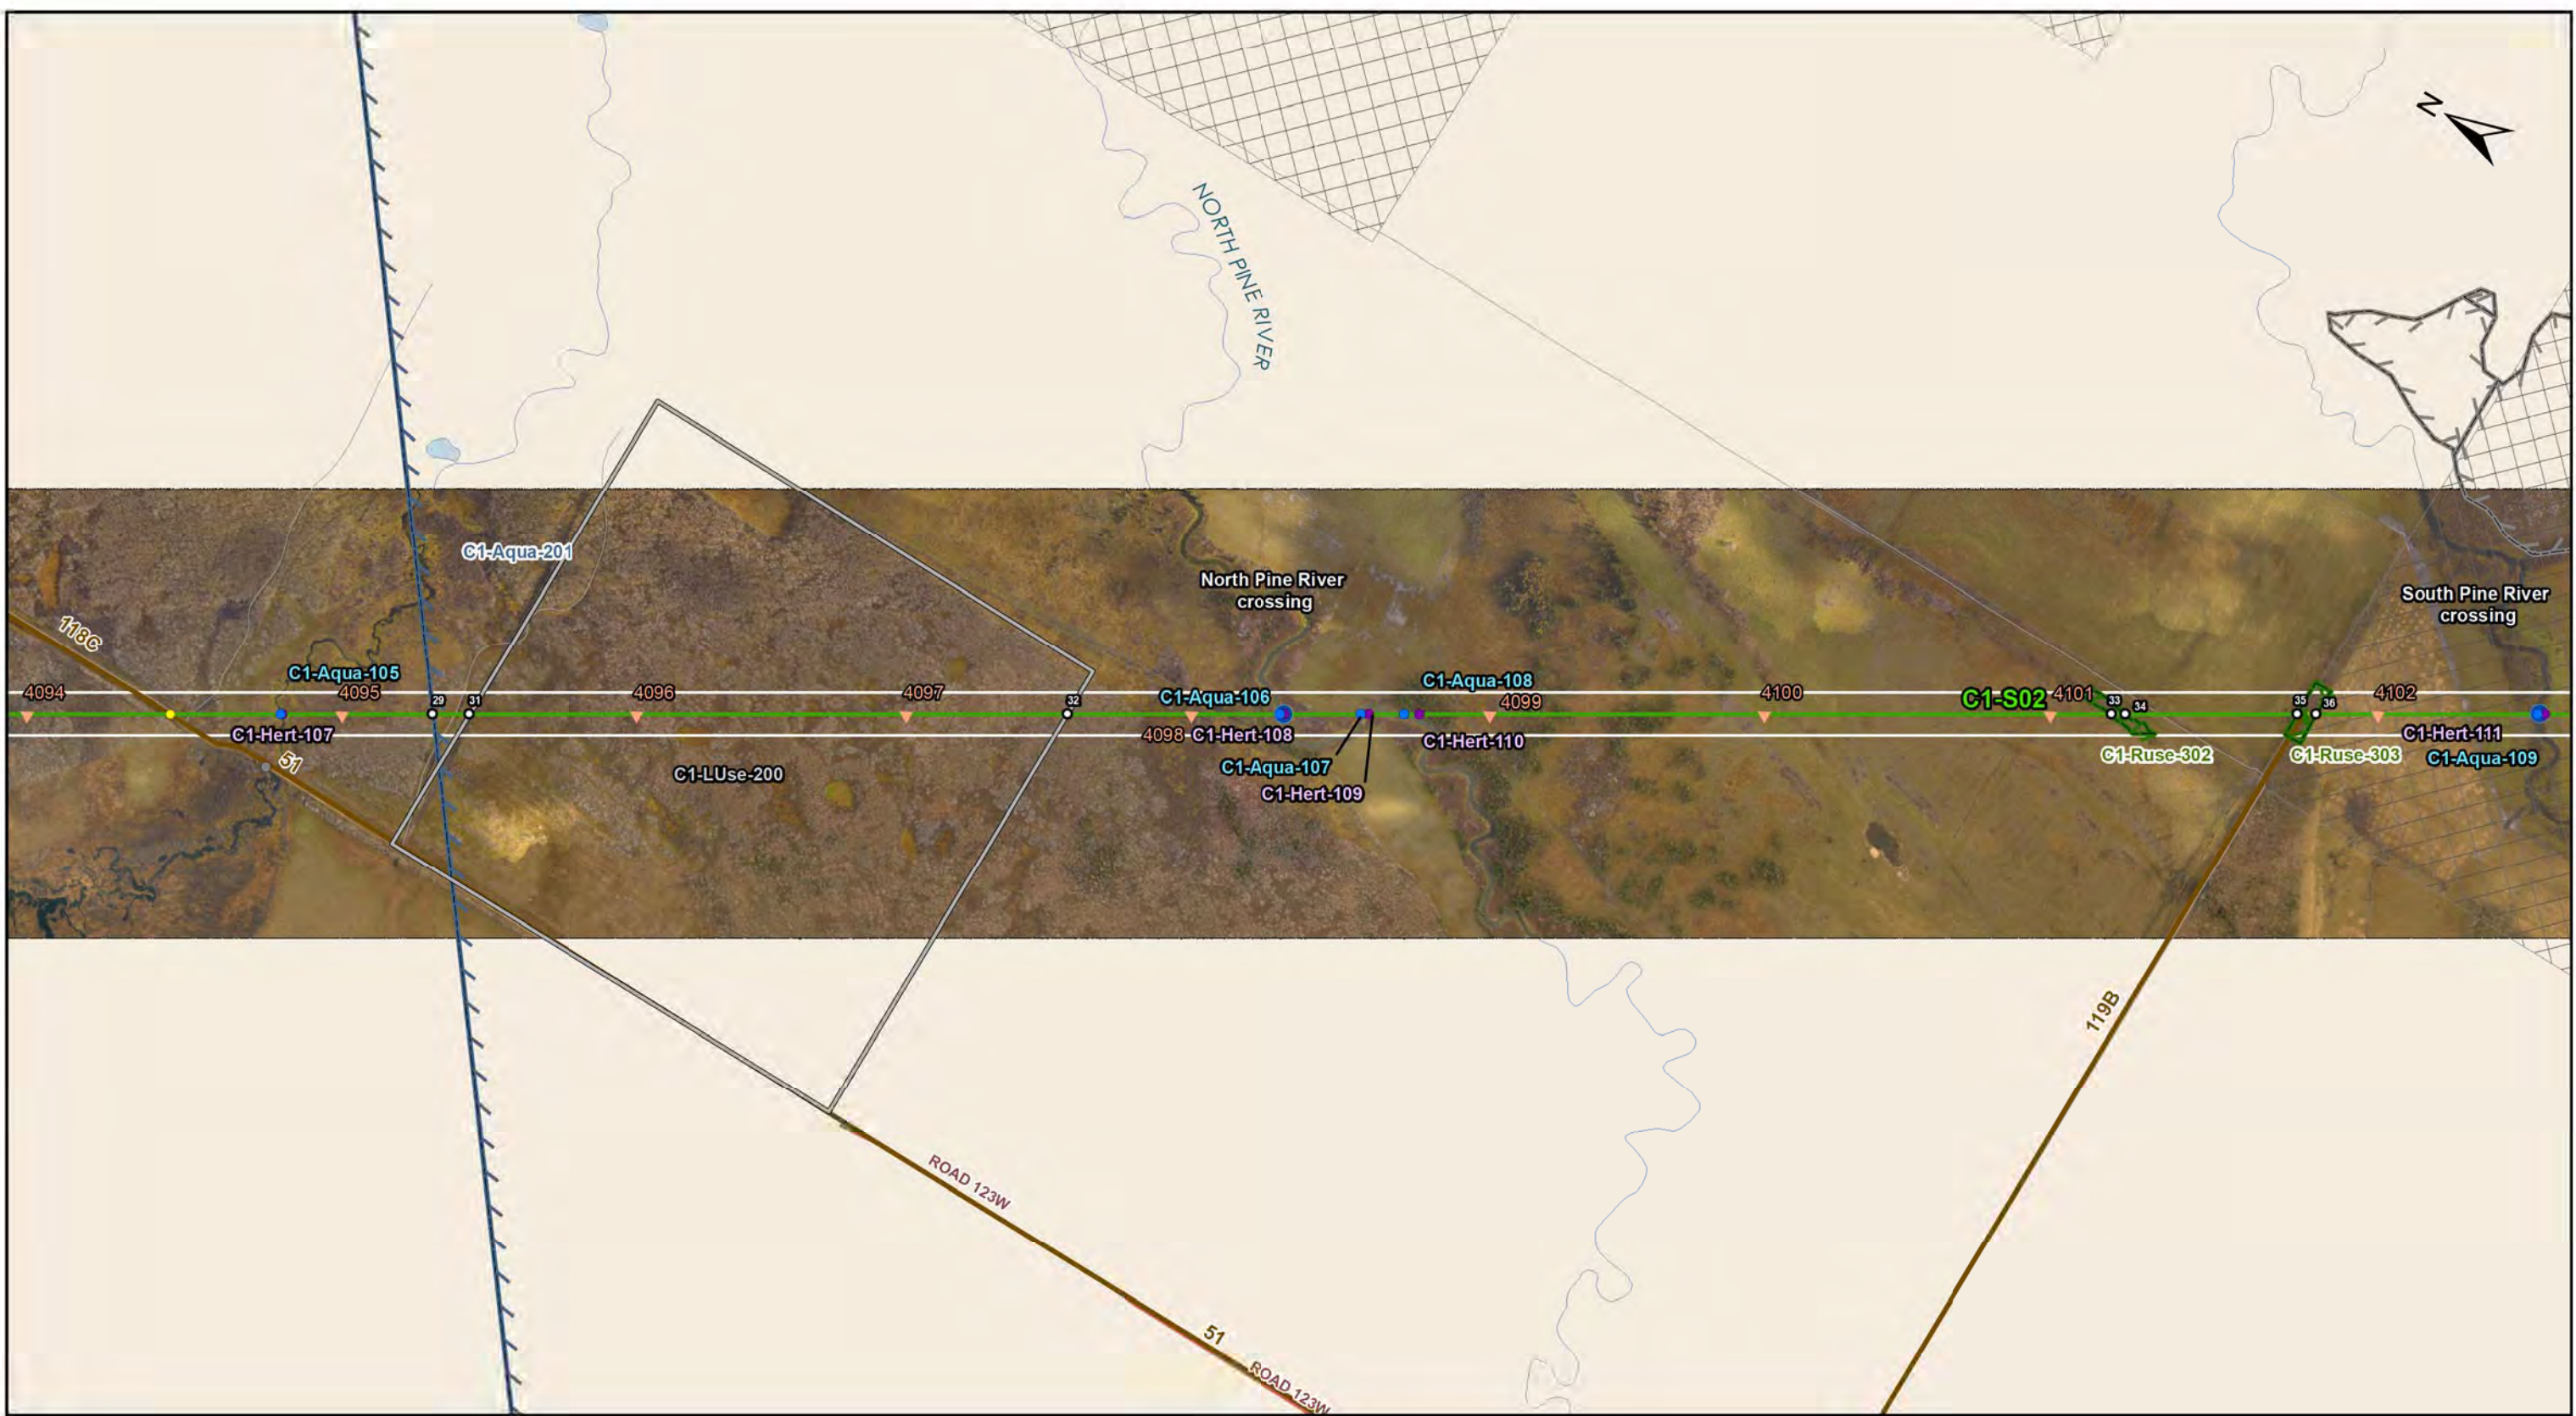
Sec-Seg ID	ESS ID	ESS Name	Easting	Northing	UTM Zone
C1-S02	C1-Hert-107	North branch of North Pine River	405900	5748685	14N
C1-S02	C1-Hert-108	North Pine River	406694	5747338	14N
C1-S02	C1-Hert-109	North Pine River	406762	5747223	14N
C1-S02	C1-Hert-110	North Pine River	406799	5747161	14N
C1-S02	C1-Hert-111	South Pine River	407694	5745645	14N

*Potential disturbance to Heritage Resources*

Sec-Seg ID	ESS ID	ESS Name	Easting	Northing	UTM Zone	Channel Width	Wet Width	Fish Habitat Class	Habitat Sensitivity
C1-S02	C1-Aqua-105	Unnamed tributary of North Pine River	405898	5748687	14N	6.6m	3.5m	Moderate	Marginal
C1-S02	C1-Aqua-106	North Pine River	406691	5747344	14N	13m	10m	Moderate	Important
C1-S02	C1-Aqua-107	North Pine River	406755	5747235	14N	N/A	7m	Moderate	Important
C1-S02	C1-Aqua-108	North Pine River	406789	5747177	14N	N/A	7m	Moderate	Important
C1-S02	C1-Aqua-109	South Pine River	407691	5745651	14N	7m	7m	Moderate	Important

*Habitat loss and contamination from structure foundations & installations; increased erosion & sedimentation of streams; Damage to stream banks; Loss of riparian vegetation; Fish habitat disturbances and impeded fish movement; Rutting of floodplain*

Sec-Seg ID	ESS ID	ESS Name	Location	Start	Stop	UTM Zone	Distance
C1-S02	C1-Aqua-201	Artesian areas with uncertain water quality	Site: 29 to 30	E-406018 N-5748482	E-407883 N-5745321	14N	3670 m

- Carry out construction activities on frozen or dry ground to minimize surface damage, rutting and erosion
- Identify and flag prior to start of work
- Conduct site investigation with Archaeologist post clearing and prior to construction
- Minimize surface disturbance around the site to the extent possible
- Inspect excavated materials or surface disturbance for heritage resources and report any finds to Environmental Inspector
- Implement additional mitigation from site investigation

- Carry out construction activities on frozen ground to minimize surface damage, rutting and erosion
- Use existing trails, roads or cut lines whenever possible as access routes
- Identify and flag buffer areas prior to start of work
- Riparian Buffers shall be a minimum of 30m and increase in size based on slope of land entering waterway. Within these buffers shrub and herbaceous understory veg will be maintained along with trees that do not violate MH Veg Clearance Requirements.
- 7m no machine zone will restrict equipment in close proximity to the waterbody except at the trail crossing.
- No instream works or fording from April 1 - July 15

- Qualified driller with appropriate experience will be contracted to work in areas affected by artesian conditions.
- Emergency response plans for sealing/grouting and pumping will be implemented as required.
- Follow up inspections of installed foundations will be undertaken to monitor for excess moisture.

- Carry out construction activities on frozen or dry ground to minimize surface damage, rutting and erosion
- Identify and flag prior to start of work
- If Burning of clearing debris is required it must be conducted during winter months only and ensure that all fires are extinguished prior to spring break-up
- Notify landowner regarding construction activities and schedule, and address concerns prior to start of work
- Use existing access trails, roads or cut lines whenever possible as access routes
- Limit all equipment to project footprint only, where possible
- No damage to Vegetation on the edge of the Right of Way
- No pushing debris into adjacent timber
