# 2017

Bipole III Transmission Project

Summary of Environmental Monitoring

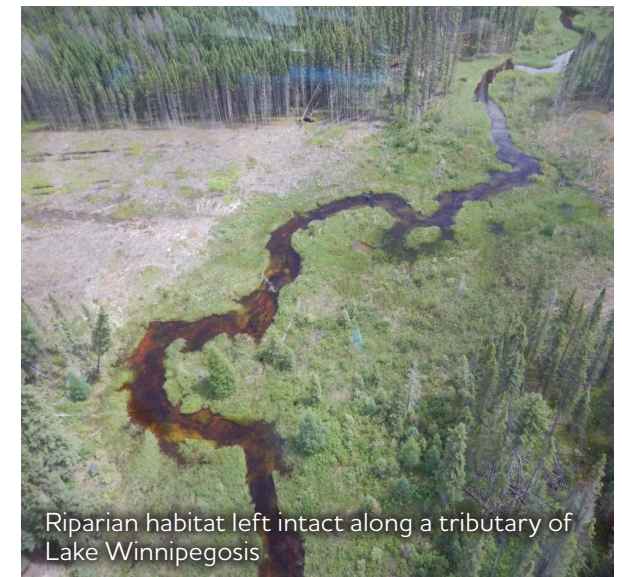
Riparian habitat left intact along a tributary of Lake Winnipegosis

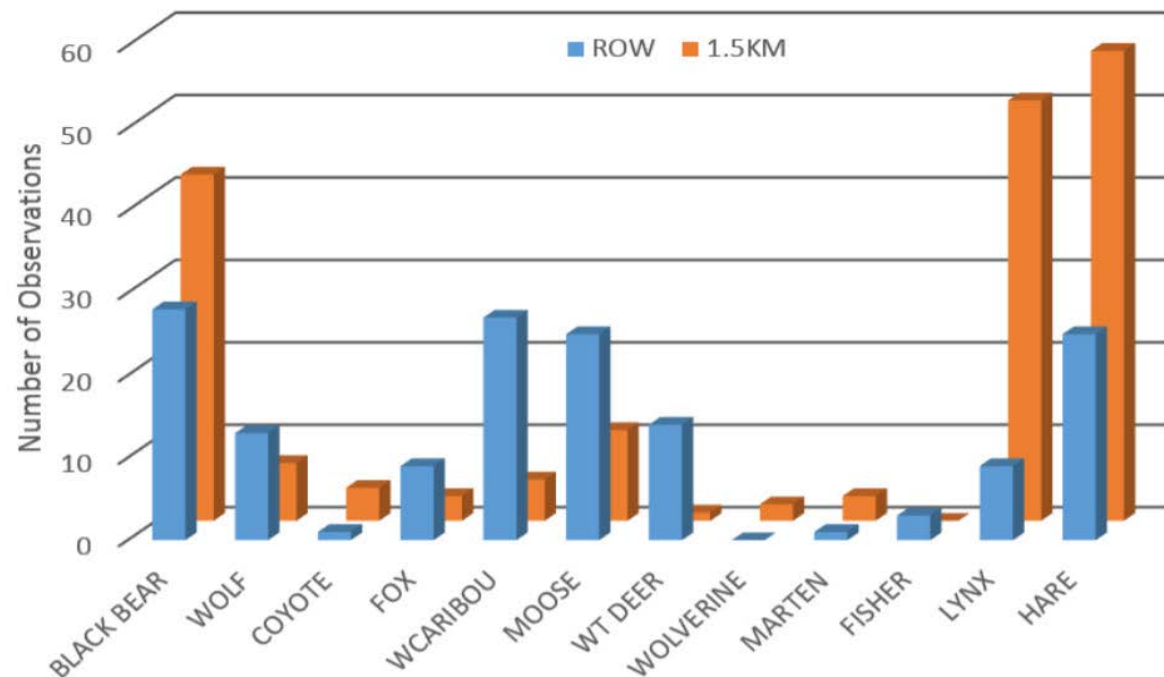
There were more observations of white tailed deer at camera traps positioned close to the right-of-way compared to those 1.5 km from the ROW. In fact, there were more observations of wolves, fox, fisher, woodland caribou, moose and white-tailed deer at camera traps positioned close to the right-of-way compared to those 1.5 km from the ROW (see Figure 1, at right)

The above graph shows the number of mammals photographed on the right-of-way (in blue) compared to those photographed 1.5 km away from the right-of-way (in orange)

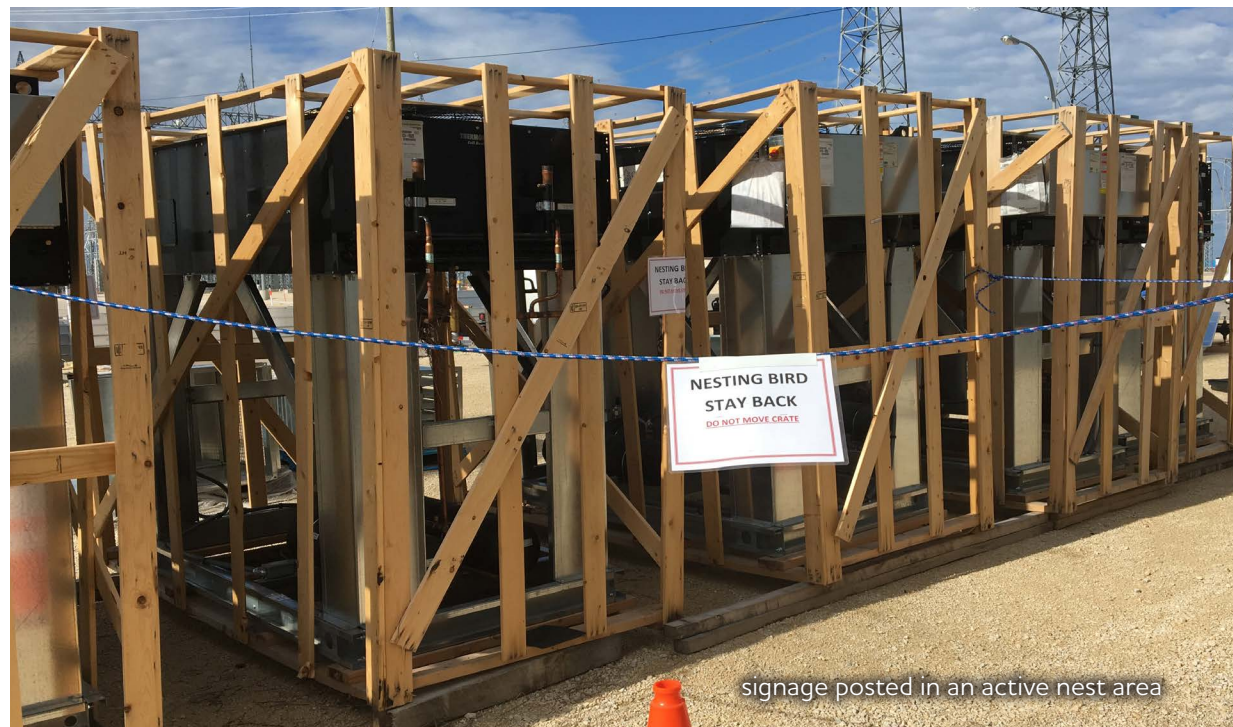
Bank swallows had been making nests in Keewatinohk CS borrow stockpiles for the last three years. To prevent nesting, contractors kept piles angled, but the swallows were persistent. To protect the nesting sites for the

signage posted in an active nest area

duration of their stay, nesting areas were taped off and contractors were asked to keep clear of the areas. The intent was to keep bird nests clear of construction disturbance until birds fledged; however, foxes raided the nests before that time. The stockpiles have since been removed.
