BIRTLE TRANSMISSION PROJECT
POST-CONSTRUCTION AQUATIC HABITAT MONITORING REPORT –
2021

June 2021

Manitoba Hydro

North/South Consultants Inc.
Aquatic Environment Specialists

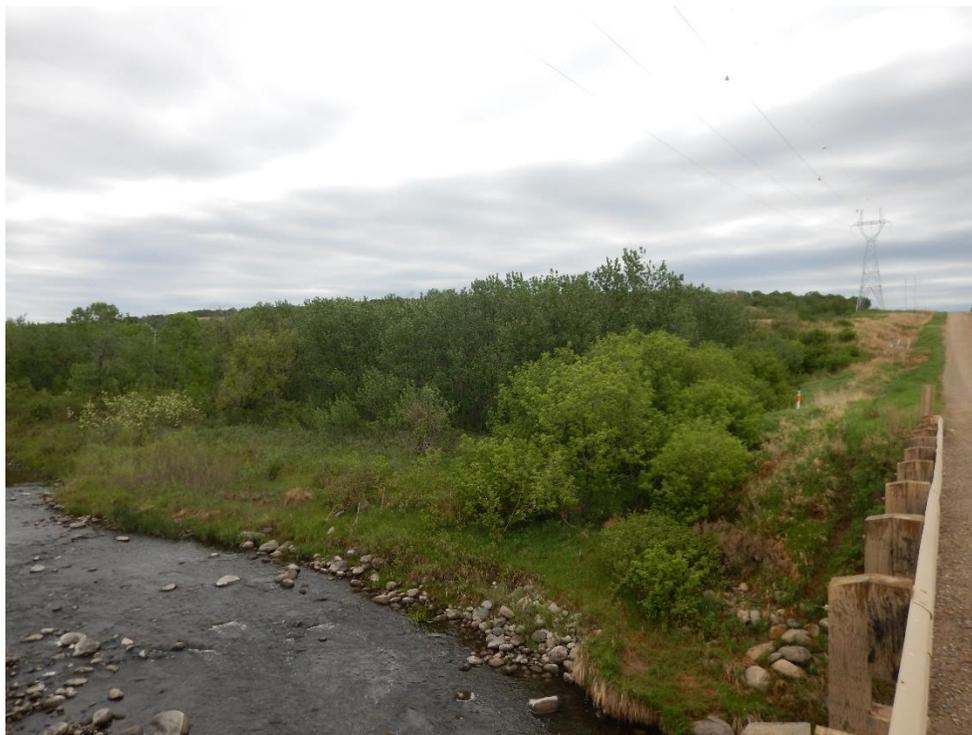
Photo 1. Ground photo of Aqua-103 (Birdtail Creek) showing the east shoreline in full compliance with prescribed mitigation, June 7, 2021.

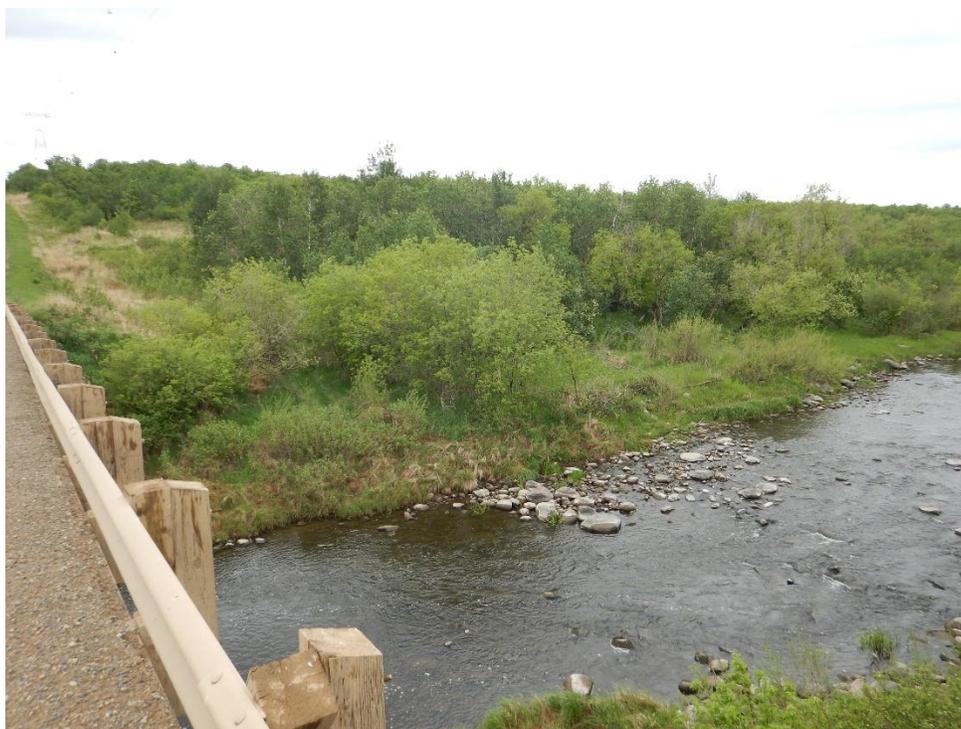
Photo 2. Aqua-103 (Birdtail Creek) showing the west shoreline in full compliance with prescribed mitigation, June 7, 2021.

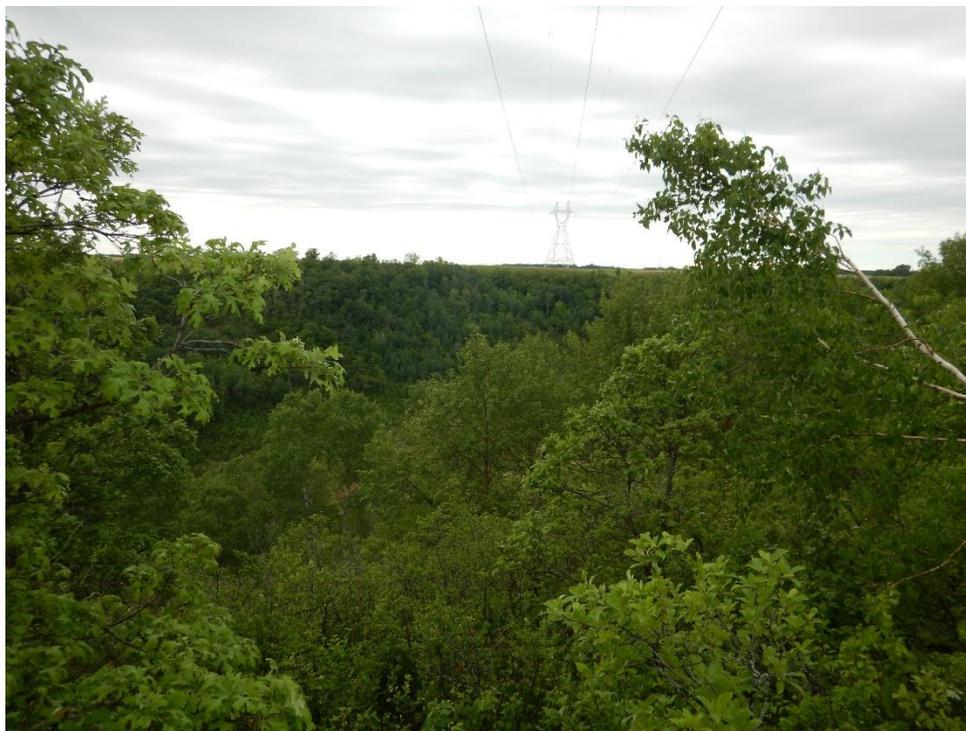
Photo 3. Aqua-105 (Snake Creek) showing good riparian coverage and growth with no apparent clearing at or approaching the crossing. June 7, 2021.

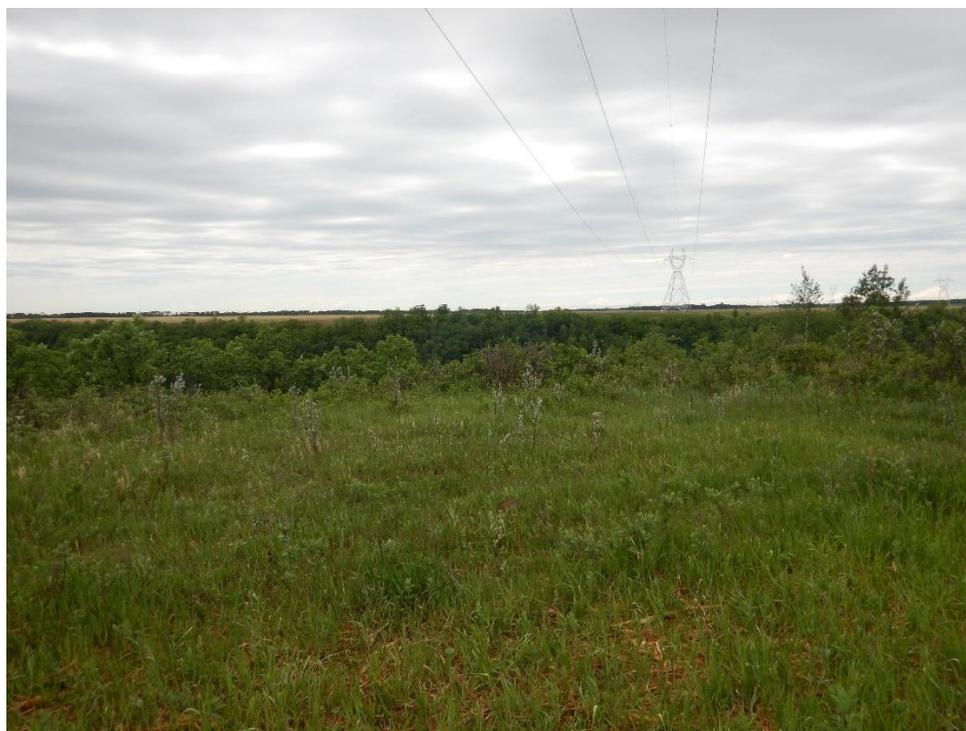
Photo 4. Aqua-105 (Snake Creek) showing a small amount of riparian clearing at the top of the valley and full compliance with prescribed mitigation, June 7, 2021.

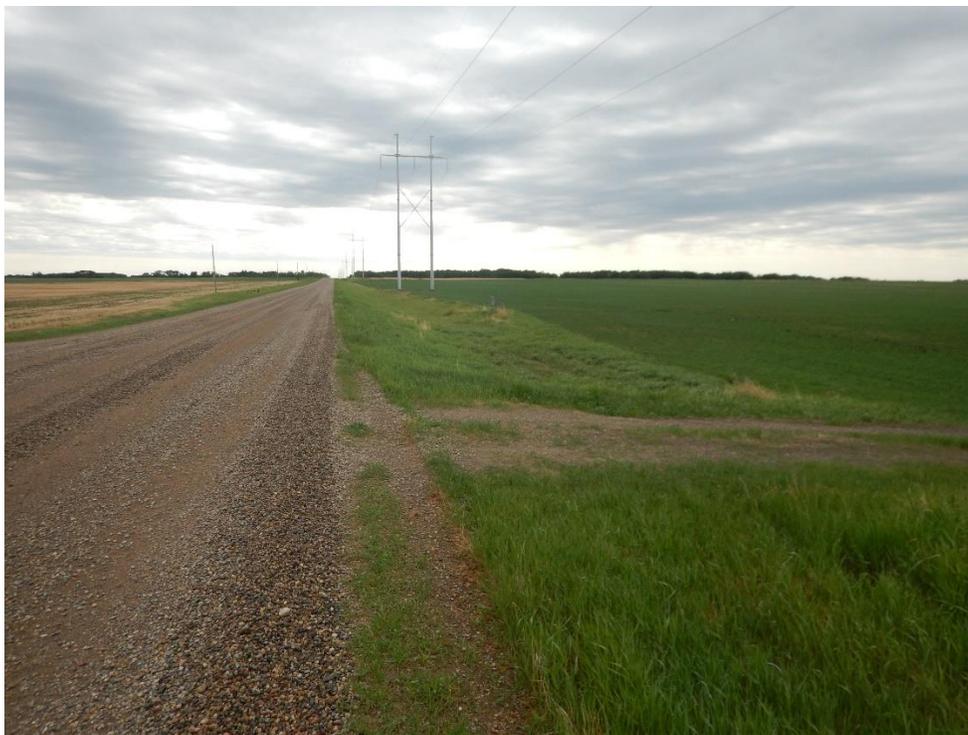
Photo 5. Aqua-106 (Unnamed Trib. of Snake Creek) showing no distinct channel and no water present, June 7, 2021.

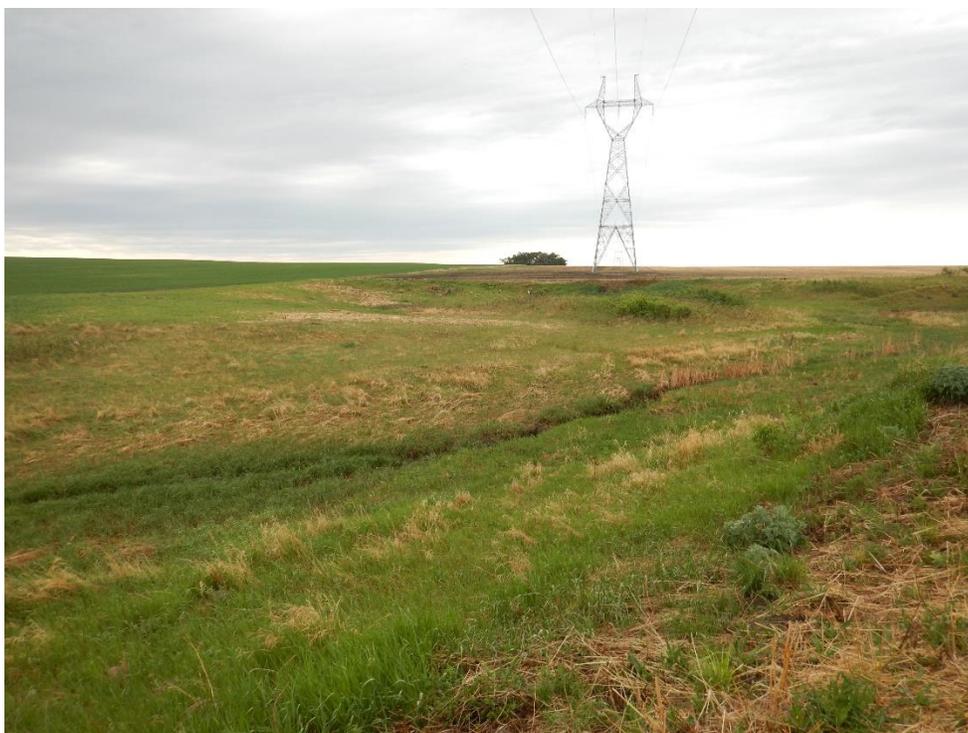
Photo 6. Aqua-107 (Armstrong Creek) showing full compliance with prescribed mitigation, June 7, 2021.

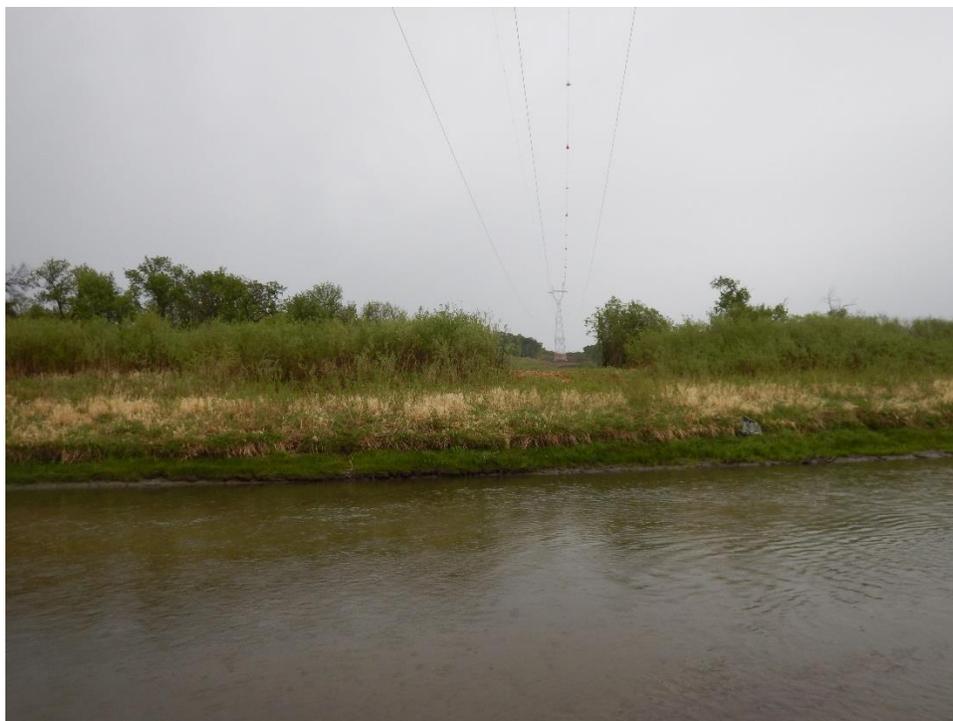
Photo 7. East shoreline of Aqua-108 (Assiniboine River) showing full compliance with prescribed mitigation, June 7, 2021.

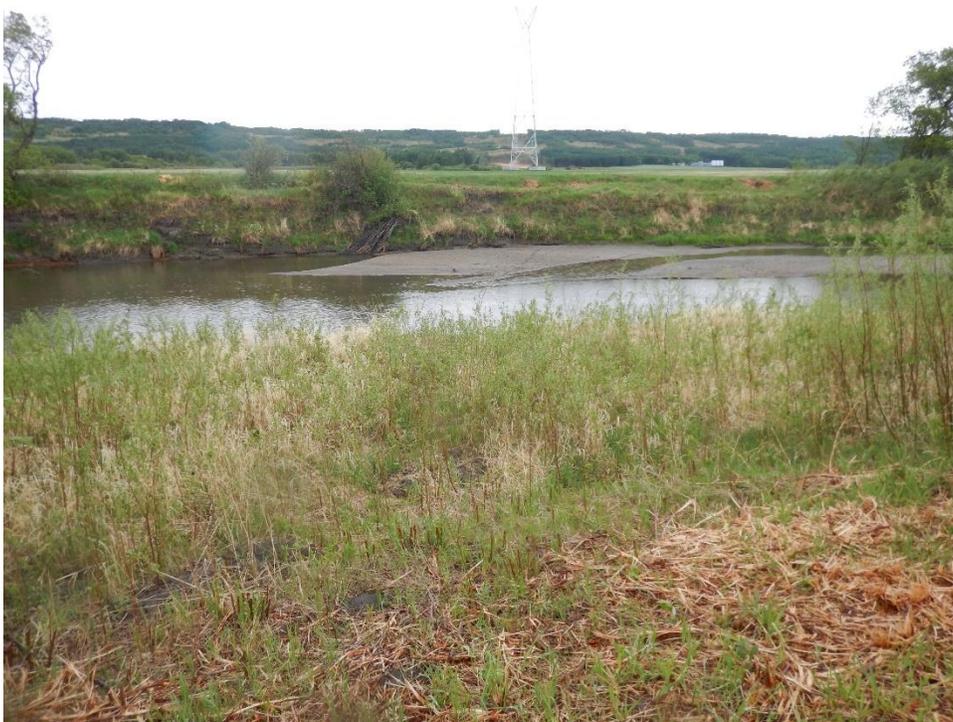
Photo 8. View of west shoreline of Aqua-108 (Assiniboine River) showing full compliance with prescribed mitigation, June 7, 2021.
