**BIRTLE TRANSMISSION PROJECT
BOTANICAL AND VEGETATION ENVIRONMENTAL MONITORING
ANNUAL TECHNICAL REPORT**

**Prepared for:
Manitoba Hydro**

**Prepared by:
Szwaluk Environmental Consulting Ltd.
and
K. Newman**

December 2021

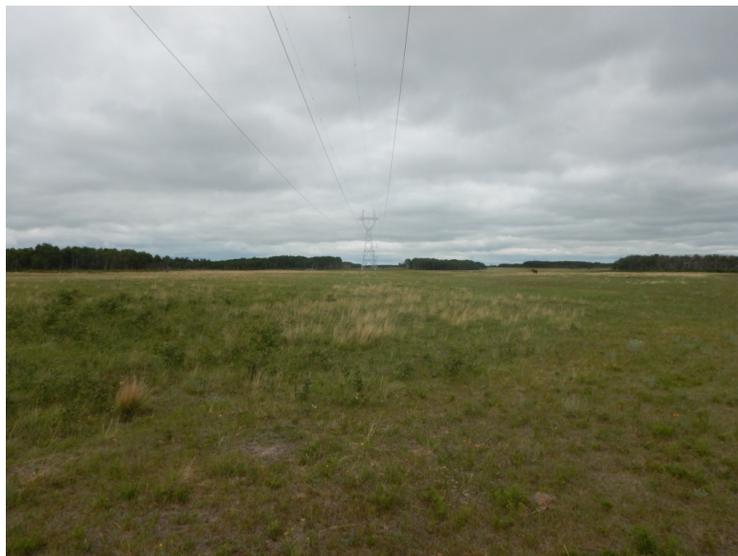
Prairie sites in the community pasture are dominated by native grasses, with a diversity of native forbs, few low shrubs, and a general absence of trees and tall shrubs. Very few non-native species are observed in plots. Photograph 4-1a shows the grassland after construction activities, near Tower 129.

Photograph 4-1a. Community pasture grassland post-construction, near Tower 129.

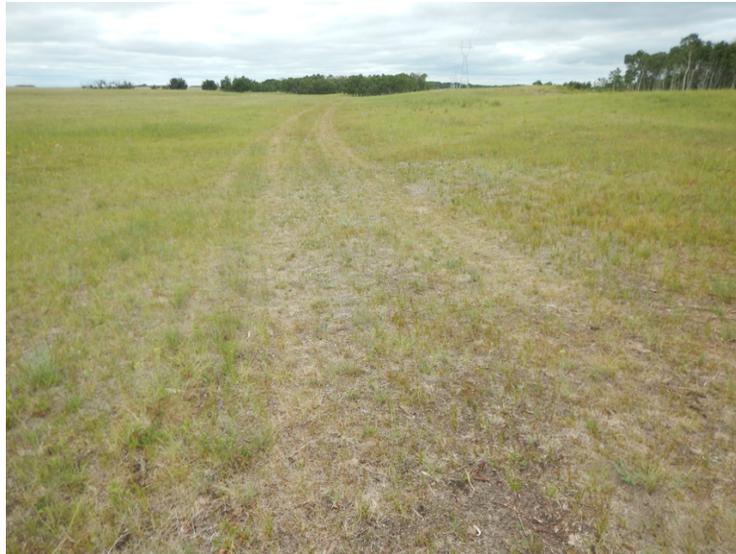
Photograph 4-1b. Equipment path on the RoW of the community pasture.

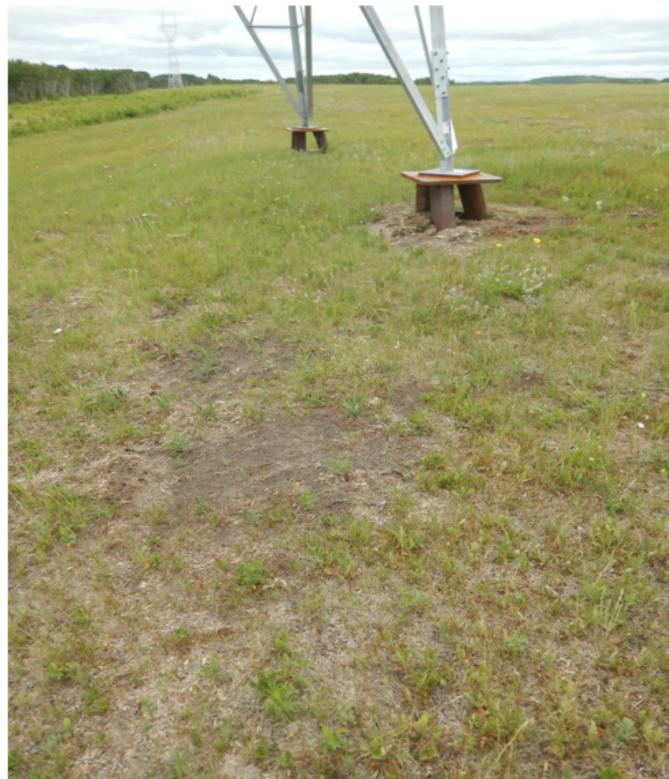
The predicted effects on grassland habitat were minimal or did not occur as a result of the project, and are discussed below. The grassland sites in the community pasture appear to be in excellent condition after recent clearing and construction activities last winter. The presence of bare ground along the RoW in the vicinity of PRA sites continues to be infrequent, generally due to animal activity. The equipment path is apparent however in some areas of the community pasture on the RoW but appeared to have minimal soil disturbance (Photograph 4-1b). Horizontal juniper (*Juniperus horizontalis*), a low shrub that grows abundantly in some areas of the pasture has appeared to have sustained mechanical damage (broken or dead branches) where juniper growth intersected the equipment path. Tower sites visited had minimal disturbance to soil and vegetation in the footing area, generally restricted to only a small patch (<2 x 2 m) of soil disturbance under each of the four supporting tower feet (Photograph 4-1c). Some tower feet appeared to have a small bowl

Photograph 4-1c. Minimal ground disturbance at Tower footing 122, near site PRA-53.

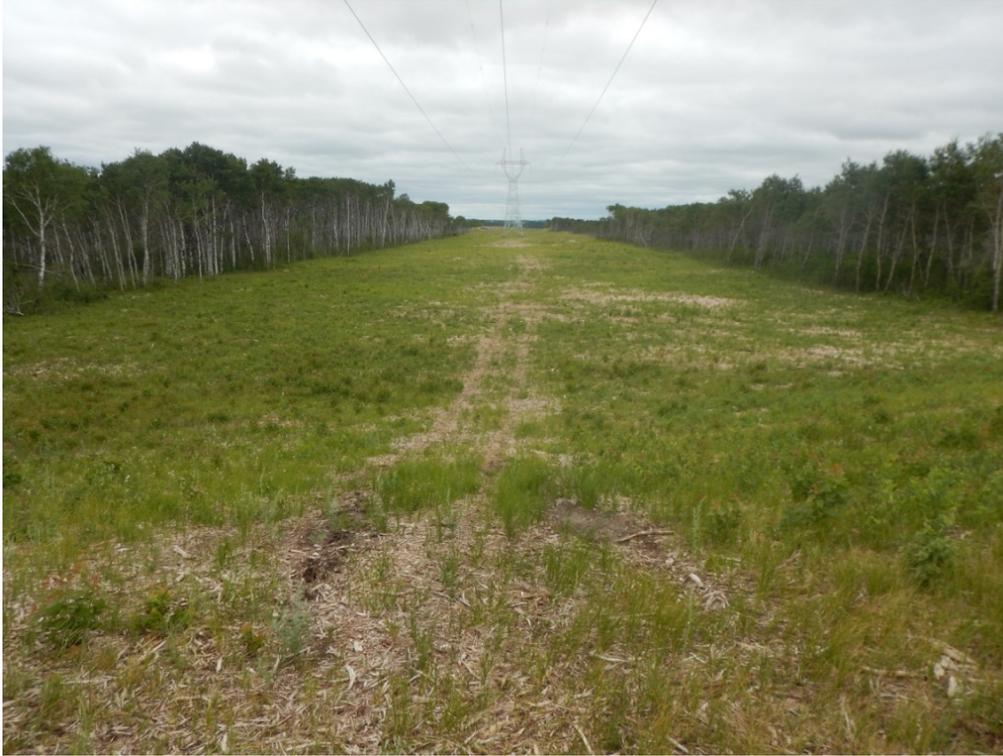
The effect predictions on forest habitat are discussed below. The predicted change in native vegetation cover as a result of the project was accurate for forest habitat. Tree cover in the RoW is required to be removed during clearing and construction activities for safe operation of the transmission line. Removal and long-term loss of RoW forest cover is an effect of transmission line development (Manitoba Hydro et al. 2003). Fragmentation from large-scale corridor projects is frequently an unavoidable consequence. Tree removal was confined to the limits of the RoW and trees were felled into the RoW, to not damage existing forest vegetation. Windfall (blow-down) of susceptible trees along the newly created forest edges was not observed from increased exposure. Modification of vegetation composition and structure adjacent to the Project Footprint due to clearing activities was not observed in the field. Photograph 4-2a shows clearing in forest habitat with low disturbance along the RoW.

Photograph 4-2a. Low disturbance from clearing activities along the RoW in forest habitat.

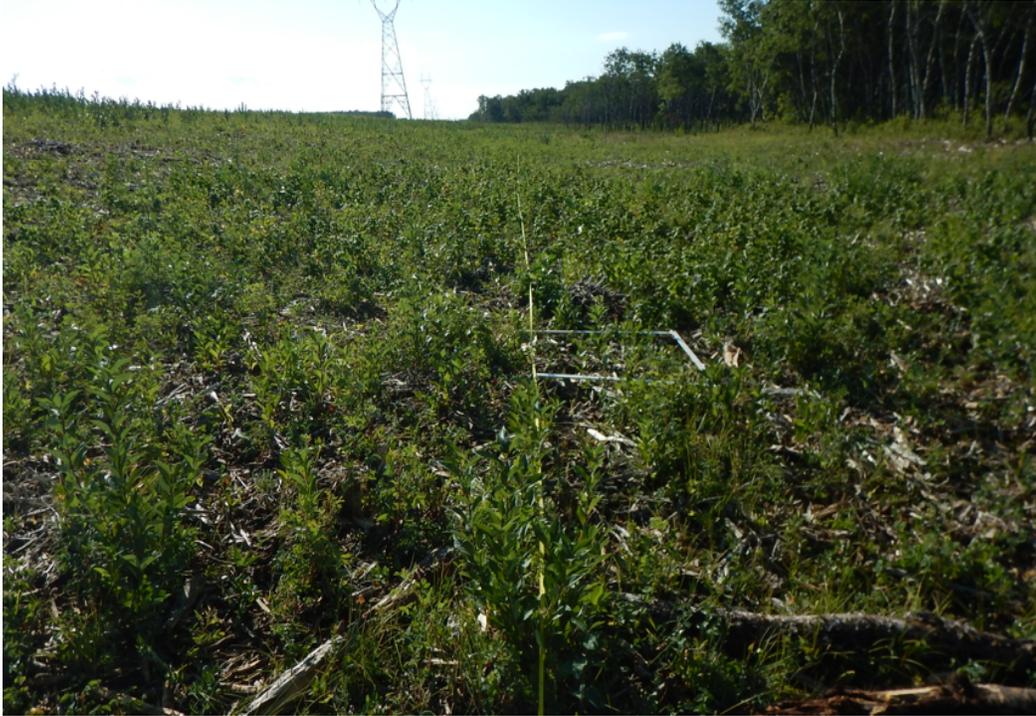
Photograph 4-2b. Moderate to dense regeneration of trembling aspen and woody shrubs at site TER-64.

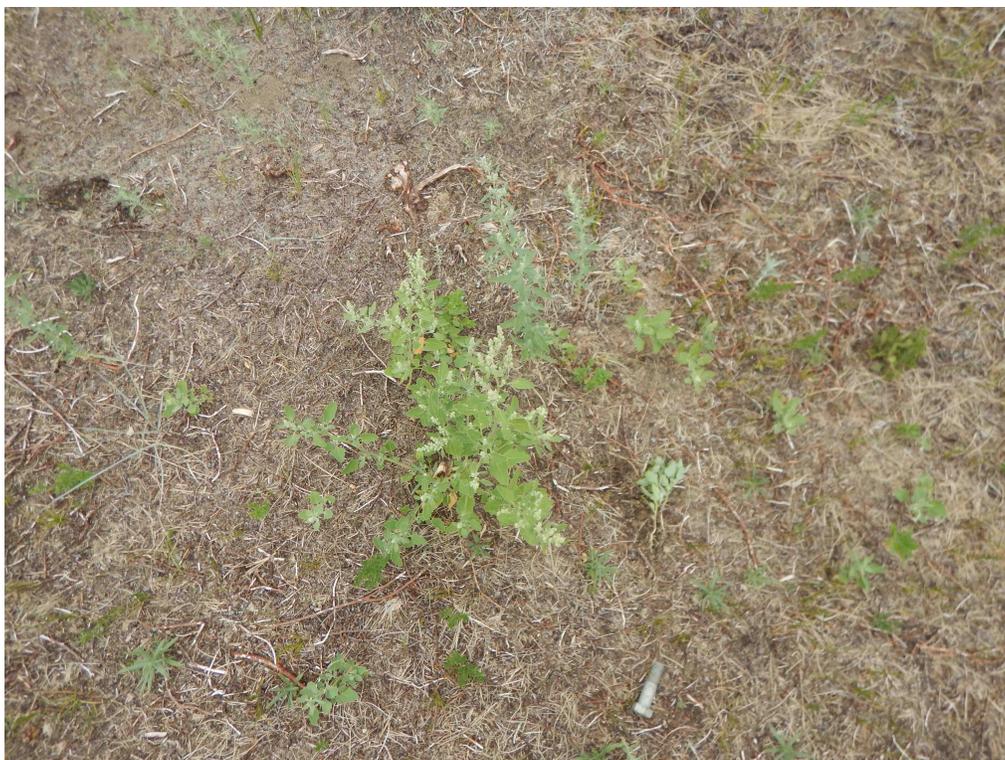
Photograph 4-3. Common lamb's-quarters observed at Tower 121.

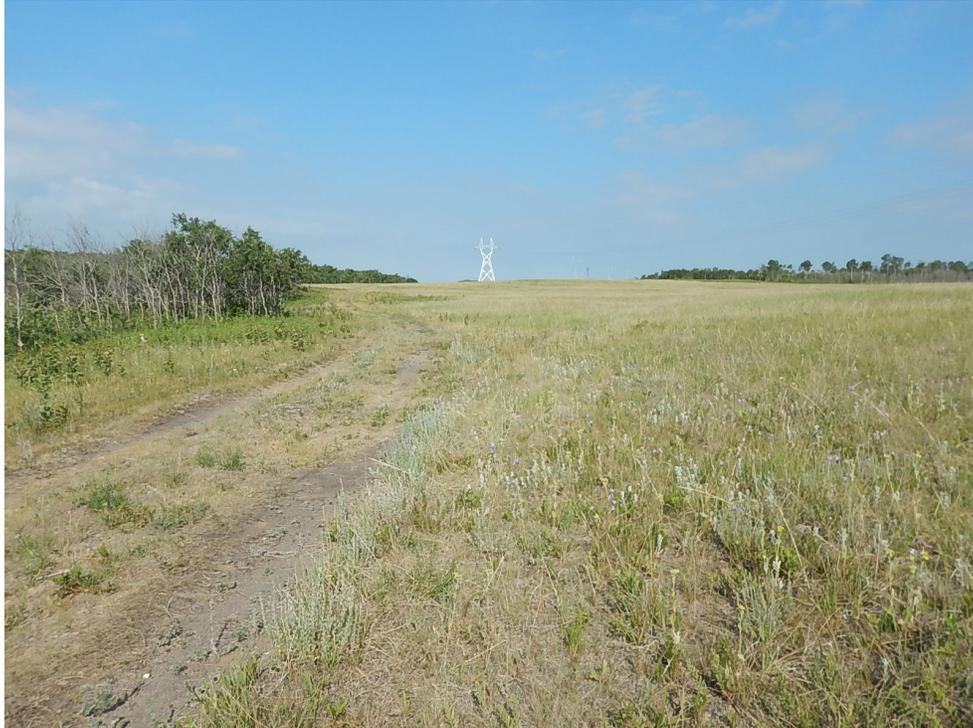
Photograph 4-4 shows a grassland site (PRA-26) sampled with higher cover of traditional use plants. In forested sites, a high cover of traditional use plants is generally represented by sites with good woody regeneration (see also previous Photograph 4-2b).

Photograph 4-4. Grassland site PRA-26 with higher cover of traditional use plants, adjacent to existing trail.

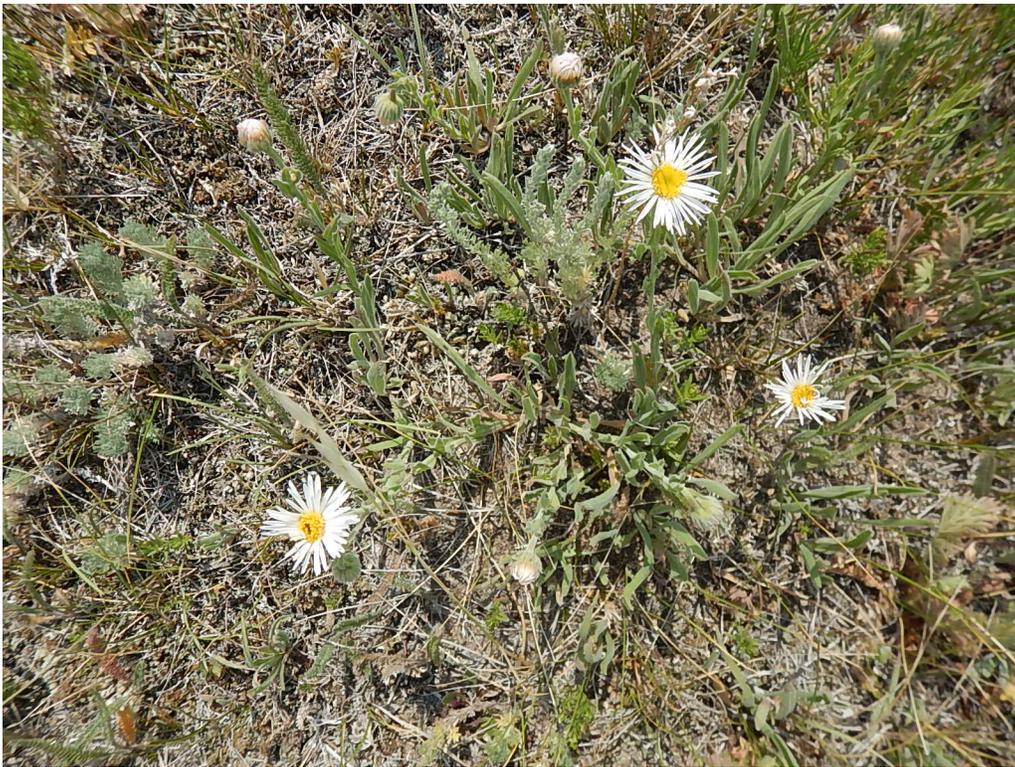
- *Erigeron caespitosus* (Tufted Fleabane) S1; N5; G5. Dry prairie, and rocky or sandy, grassy hills, sagebrush-aspen. Tufted Fleabane is found in five grassland sites in the western portion of the community pasture, sometimes occurring abundantly. White

daisy-like flowers with yellow centers bloom in July-August, (SK: S4) (Photograph 4-5a).

Photograph 4-5a. Tufted fleabane observed at site PRA-57.

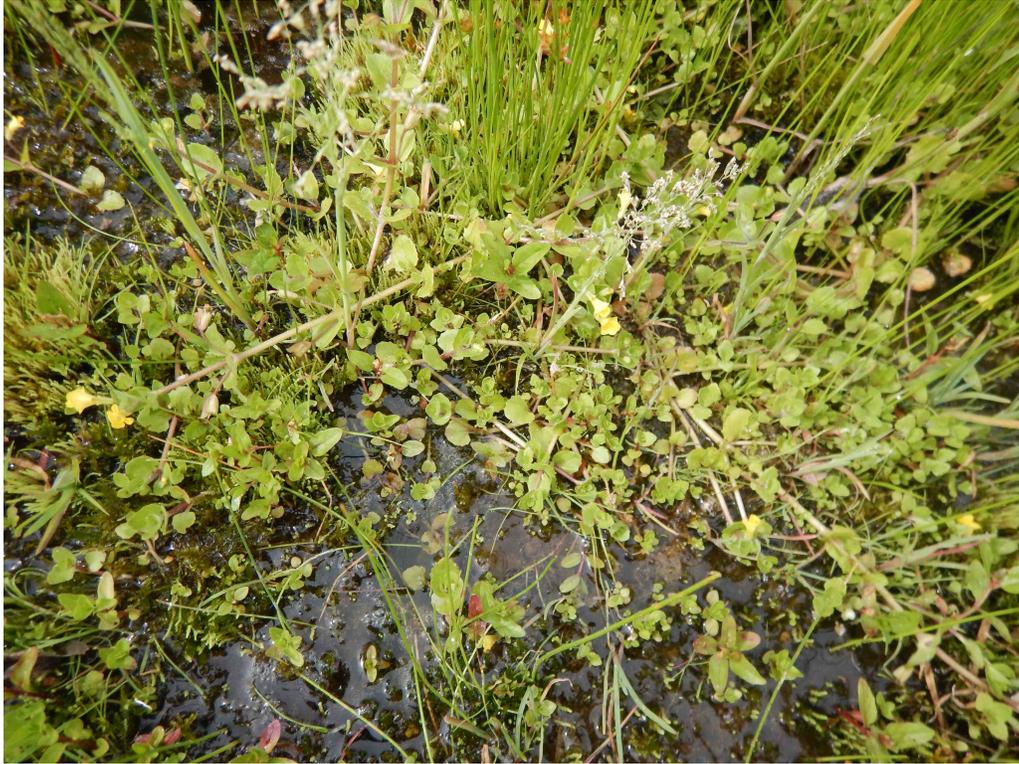
- *Erythranthe geyeri* (Geyer's Monkeyflower) S1; N2; G5T5. Wet places, springs, southeastern parklands, creeping habit, yellow blooms July-August. This species was abundant along the edge of the water at the spring site (BTP-SCC-73), (SK: S2) (Photograph 4-5b).
- *Oxytropis campestris* var. *spicata* (Showy Locoweed) S1; N5; G5. Dry hillsides, grasslands open woods and prairie openings. Pale yellow blooms, May to July. This species was present or abundant in five grassland sites, (SK: S4).

Photograph 4-5b. Geyer's monkeyflower observed at SCC-73.

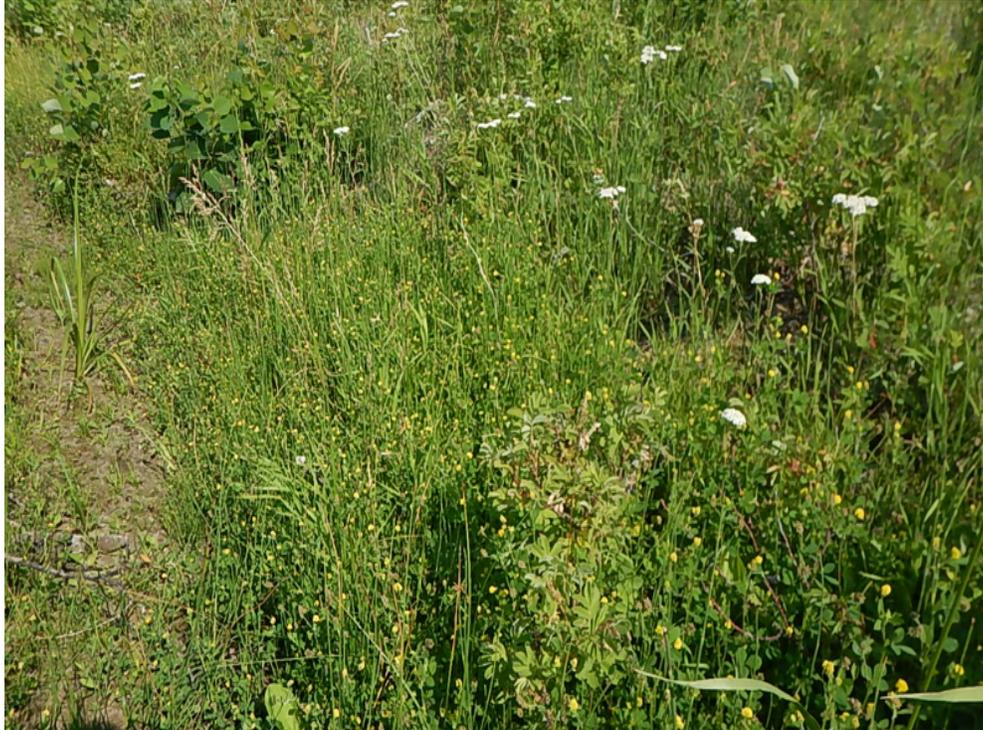
Adjacent to the wetland spring on the community pasture, certain Tier 3 and non-native species were recorded in disturbed sandy soil on the RoW, early in the season (July), Photograph 4-6a. Whether due to cattle grazing and trampling of the soil later in the season (August), the cover of some of the weedy ruderals was absent or reduced. No weed control was required at the time of the surveys.

Photograph 4-6a. Abundant black medic (SNA) observed along the wetland spring.

4. Greater soil disturbance was noted at the site of the freshwater spring and resulting stream (SCC-73), particularly where clearing was required. Several Tier 3 noxious species (e.g., common dandelion, sow-thistle, common lamb's-quarters, Canada thistle, flixweed) and non-native species (smooth brome, black medick, sweetclovers, green foxtail, a goat's-beard, and bristly stickseed) were observed adjacent to the spring source and along the stream on the RoW where ground disturbance is apparent. Soil in areas where trees were cleared under the wires and adjacent to the spring were most disturbed, as well as along the bare sandy path around the spring. Many of these species were not recorded along the RoW previously in either 2017 or 2019. It is recommended that follow-up monitoring occur in the freshwater spring site to determine if future weed management may be required.

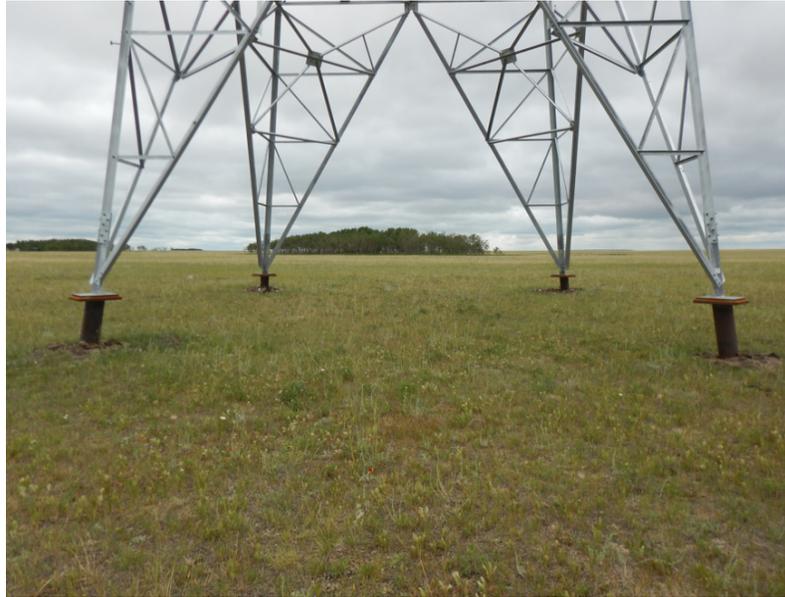
Frequently the towers were installed, showing minimal soil disturbance at the footing (e.g., Tower 120), Photograph 4-6b. Little to no bare ground was noted from construction activities, which should contribute to the prairie's resilience against the colonization of non-native and invasive species. Where occasional disturbance was observed, these were small areas of exposed soil 1 to 2 m² (to 4 m²), generally on the equipment path, on slopes, or near tower footings. Photograph 4-6c shows disturbance from a cattle trail in sandy soil. With no larger areas of disturbance during sampling in the pasture, these areas were rehabilitated by hand broadcasting with a prescribed native species blend. After seeding, soil was lightly harrowed to ensure greater seed contact with soil. A custom native reclamation mix was

Photograph 4-6b. Tower 120 installed with minimal soil disturbance.

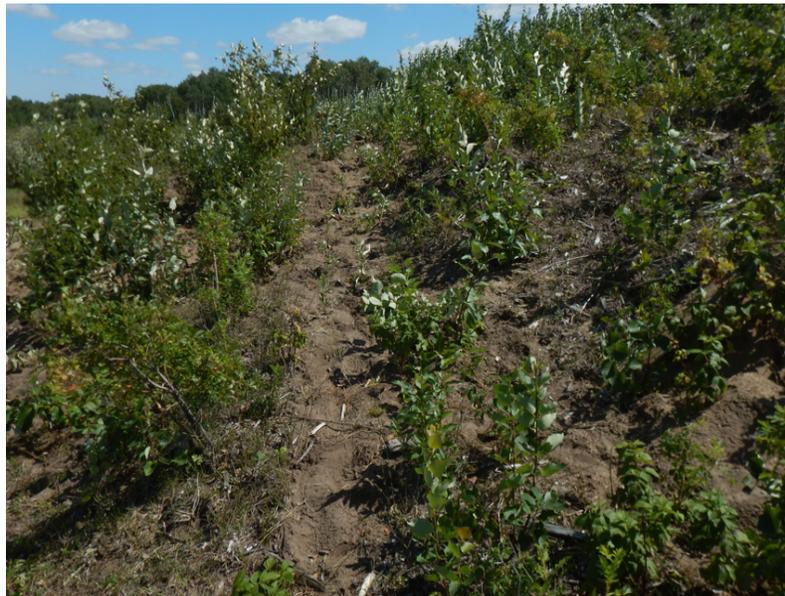
Photograph 4-6c. Cattle trail along a slope adjacent to TER-63.
