BIRTLE TRANSMISSION PROJECT
Sharp-tailed Grouse Lek Survey Report 2021

Prepared for

Manitoba Hydro, Licensing & Environmental Assessment Department,

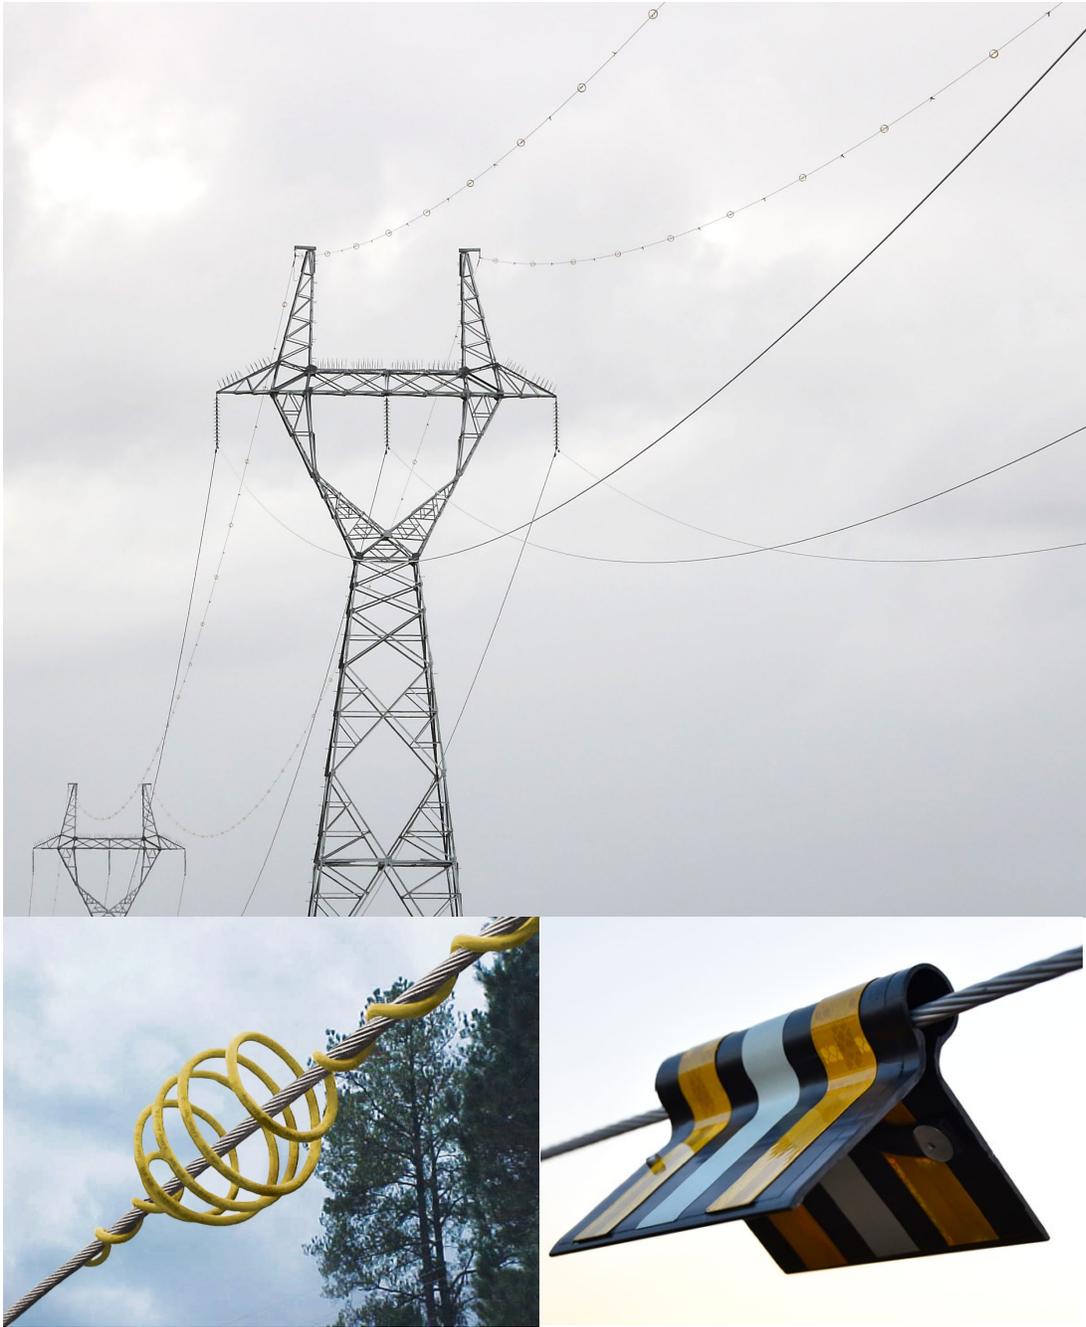
Photo 1: Alternating Sequence of Swan-Flight Bird Diverters (bottom left) and Bird Flight Diverters (bottom right) on the Birtle Transmission Project (Linestar Utility Supply 2021; Preformed Line Products 2021)

To mitigate for the potential increase of avian predators and the increased risk of wire collisions, the Project was routed through existing forested areas and the number of tower spans was minimized in the portions that crossed the SHECP. Additionally, measures to increase the visibility of the line to birds and reduce the appeal of the towers to perching avian predators were installed on the Project where it crosses the SHECP. These measures included bird diverters that were installed on the ground conductor wires, to increase the visibility of the line to birds and have been proven to reduce bird collisions (Barrientos *et al.* 2012; Brown and Drewien 1995; Morkill and Anderson 1991). The bird diverters were installed in alternating sequence of Swan-Flight™ Bird Diverters and Bird Flight Diverters (Photo 1). Additional measures, including perch deterrents were installed along the upper arms of the support towers to dissuade avian raptors from perching or nesting in these areas (Photo 2).

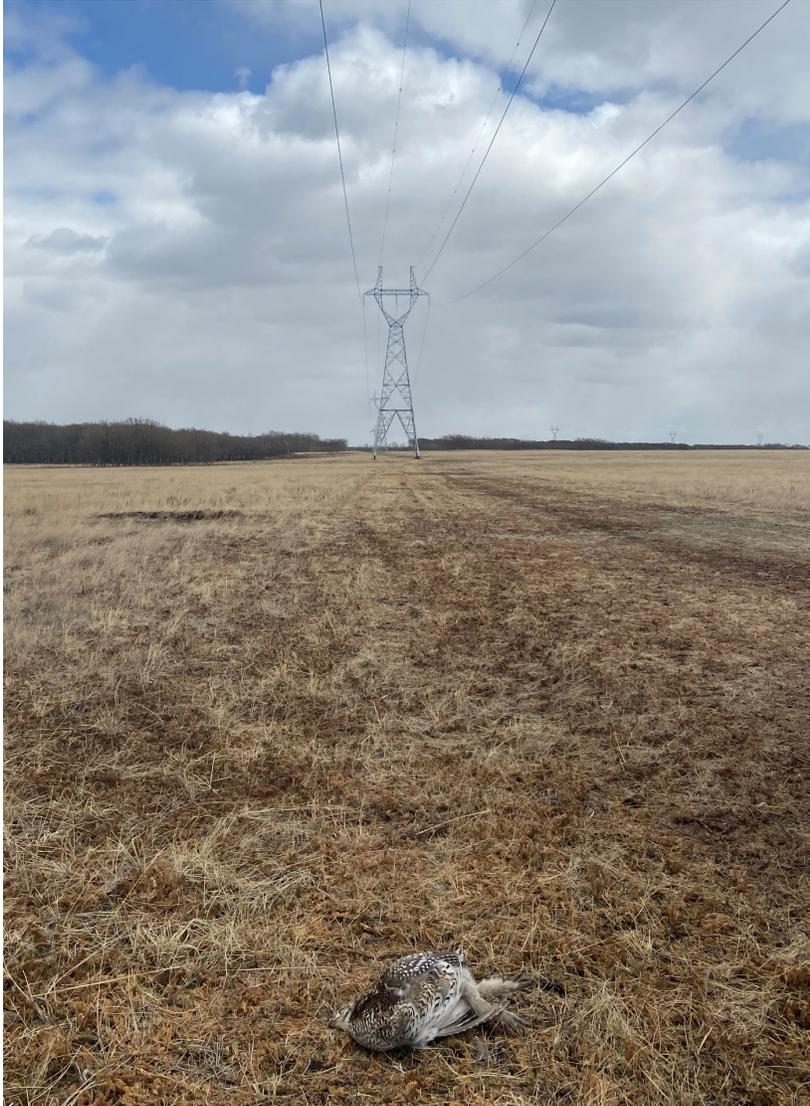
Photo 3: Potential collision mortality of a sharp-tailed grouse, April 2021

Two potential bird collisions were also observed incidentally along the ROW. One sharp-tailed grouse and one Canada goose were found within the SHECP.
