Keeyask Transmission Project **Environmental Effects Monitoring Plan** Annual Report

Keeyask Transmission Project 2017/18
Environmental Effects Monitoring Report

Prepared by Manitoba Hydro

July 2018

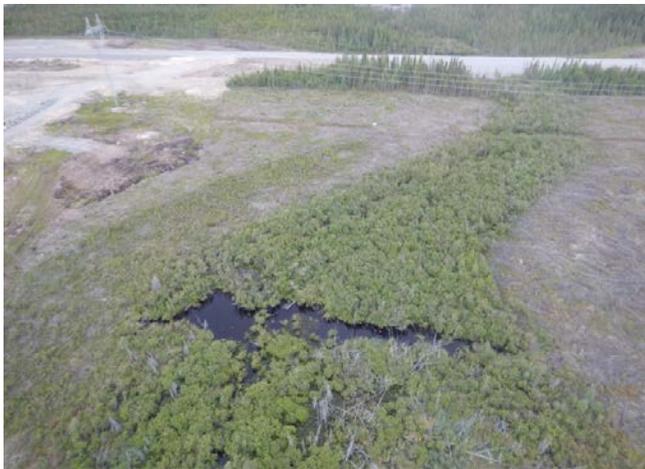
Photo 4: No evidence of vehicle track damage in 2017 with shrub re-growth present throughout this water course crossing.

The implementation of mitigation recommendations outlined in the construction Environmental Protection Plan was effective. Sites identified in 2015 and 2016 as being non-compliant with the prescribed mitigation showed signs of successful natural revegetation with small shrubs and forbs, with no further remediation warranted (Photo 4).

Due to the natural revegetation of disturbed sites, no further remediation is required.

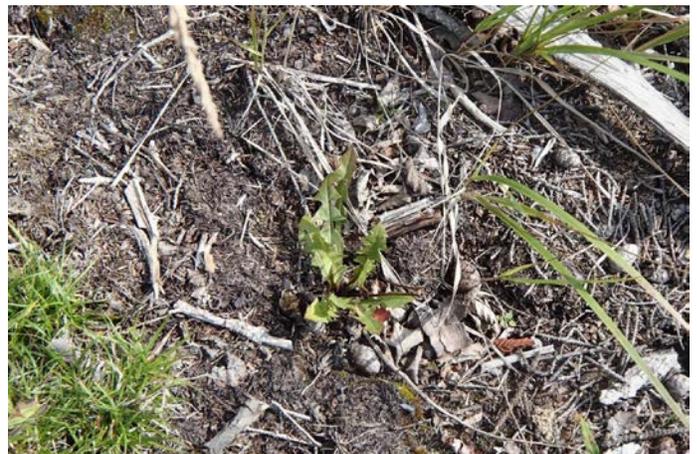
Photo 8: A common dandelion growing in the transmission ROW.

As predicted in the EA, Project construction had minimal effect on the spread invasive species. Non-native or invasive plants were not observed in the cleared Project ROW with the exception of 4 single plants; three common dandelion (*Taraxacum officinale*), and one common plantain (*Plantago major*). Two of the common dandelion plants and the single common plantain plant were found in the ROW near the south access road ditch. It was apparent that the western most common dandelion had already seeded, but no other plants were found nearby. The third common dandelion was found near the eastern end of the ROW, on a machine trail extending through the clearing.

To date, none required. Control recommendations were not developed for the four observed plants for several reasons. While the common dandelion is considered a Tier 3 noxious weed in Manitoba, both that and common plantain are not listed as an invasive species of concern in Canada (White et al. 1993) or by the ISCM (2017).

These species are not known to crowd out native vegetation. Also, both species are difficult to control since they are ubiquitous in human-disturbed areas. In the case of dandelion, winds readily spread its light airborne seeds. Finally, given the limited amount of vegetation clearing and ground disturbance, it is expected that native plant regeneration will eventually control dandelion and plantain along most of the ROW.

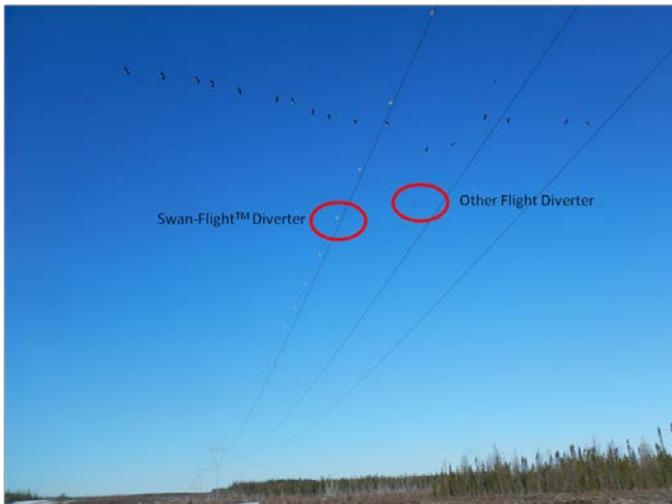
Photo 11: Canada geese flying over bird diverters installed on the generation outlet transmission line.

Mitigation efforts, including the installation of bird wire diverters appears to be effective.
