Keeyask Transmission Project **Environmental Effects Monitoring Plan** Annual Report

Keeyask Transmission Project 2018/19

Environmental Effects Monitoring Report

Prepared by Manitoba Hydro

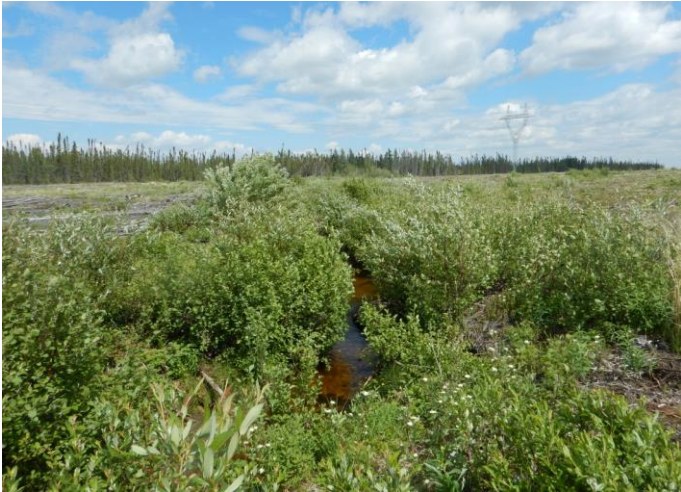
Photo 4: Vegetative regrowth along a tributary of the Butnau River.

The implementation of mitigation recommendations outlined in the construction Environmental Protection Plan was effective. Sites identified in 2015 and 2016 as being non-compliant with the prescribed mitigation showed signs of successful natural revegetation. Small shrubs and forbs were observed growing along the stream banks and no active sedimentation of the stream has been noted since being identified in 2015. Due to the naturally occurring re-vegetation and the marginal value of the stream to fish, no further remediation is recommended (Photo 4).

Due to the natural revegetation of disturbed sites, no further remediation is required.

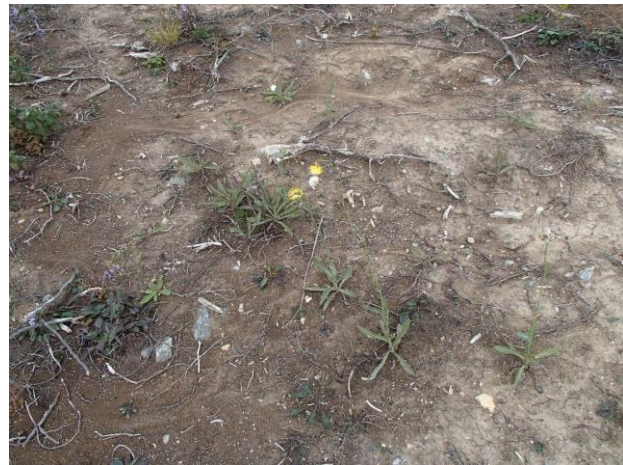
Photo 8: A patch of perennial sow-thistle growing in the GOT ROW near the South Access Road.

As predicted in the EA, Project construction had minimal effect on the spread invasive species. During these surveys, 15.3 m² of non-native plant cover was recorded as a few individual plants or small patches of plants at 26 sites. Most of the non-native plant cover was observed close to either a Keeyask Generation Project south access road ditch or the Radisson Converter Station. Seven non-native plant species recorded during the surveys, which was five more than 2017. Of these species, perennial sow-thistle and white sweet clover

were of moderate invasive concern while three were of minor invasive concern.

To date, none required. Control recommendations were not developed for the sites with plants of invasive concern for several reasons. At two of the three perennial sow-thistle sites, the plants were immediately removed by vegetation surveyors due to their degree of invasive concern and the small number of plants present. Control recommendations were not developed for the remaining sites, primarily for two reasons. The likelihood that control efforts would be successful was limited by the close proximity of the same non-native plants in either the south access road ditch or the Radisson converter station. Also, ongoing expansion of native plant cover was expected to eventually crowd out or even eliminate non-native plants at some of the sites.

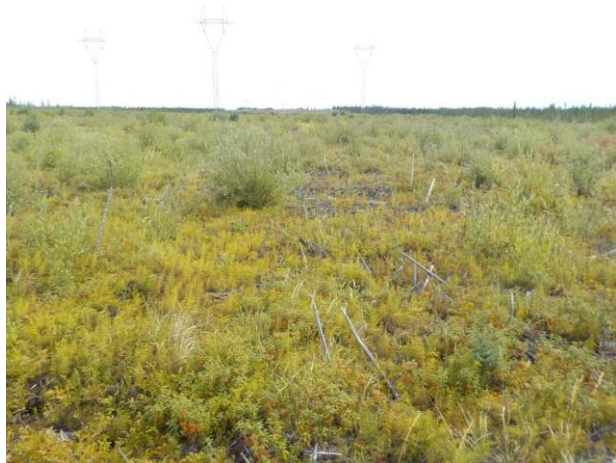
Photo 9: Regenerating native vegetation in the transmission ROW.

Mitigation actions prescribed in the Construction Environmental Protection Plan, to limit the exposure of mineral soils by clearing equipment were successfully implemented. The extremely low cover of non-native plants in the surveyed areas (0.001% of the area) was likely due to a combination of factors including the low proportion of the ROW area with exposed mineral substrates, the relatively short time since clearing, limitations on potential sources of seeds, and increasing native vegetation cover.

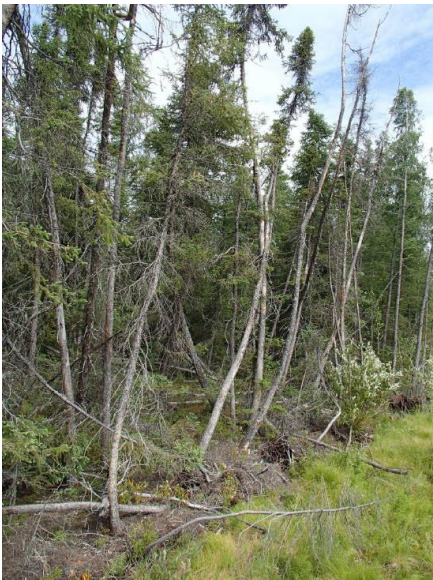
Photo 10: Leaning trees adjacent to ROW in priority habitat patch.

Surveys found that overall impacts on the 63 priority habitat patches situated along the Project ROW were minor and were consistent with those predicted in the EA Report. Ground surveys found 14 additional minor effects outside of the cleared ROW at 12 priority habitat patches. All of these effects were localized, small in area and did not extend more than a few meters into the habitat patch.

No follow up mitigation is required based on the survey findings.

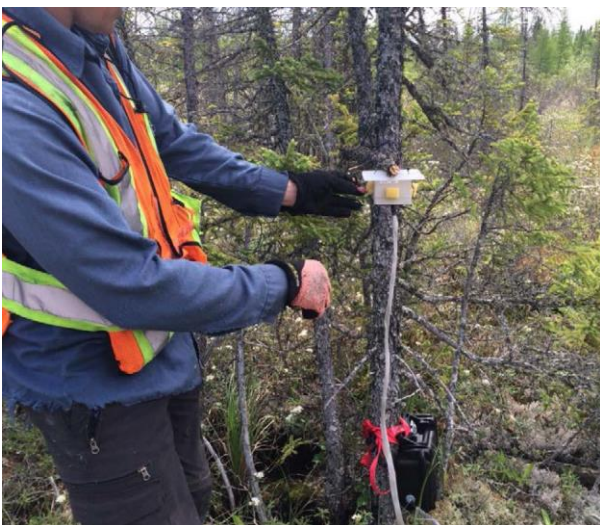
Photo 12: A passive audio recorder is used to monitor bird species of conservation concern.

Sensory disturbance surveys for olive-sided flycatcher and rusty blackbird also continued in 2018, to monitor the effects of sensory disturbance on the distribution and relative abundance of these species at risk. Territories for breeding pairs were mapped and programmable four-microphone audio recorders were placed within, at varying distances from the nearest source of disturbance- the north or south access roads, construction power or generation

outlet transmission lines, or Provincial Road 280. Recorders were programmed to record six times each hour during the early morning hours of the spring breeding season to record olive-sided flycatcher or rusty blackbird songs. The direction and distance of each bird to the fixed location of the recorder will be estimated and the positions of the bird in its territory will be mapped. The result of audio recording analysis has been delayed, but results are expected for the next reporting period. Survey support was provided by members of the Keeyask Cree Nations, including Tataskweyak, War Lake, York Factory and Fox Lake Cree Nations.

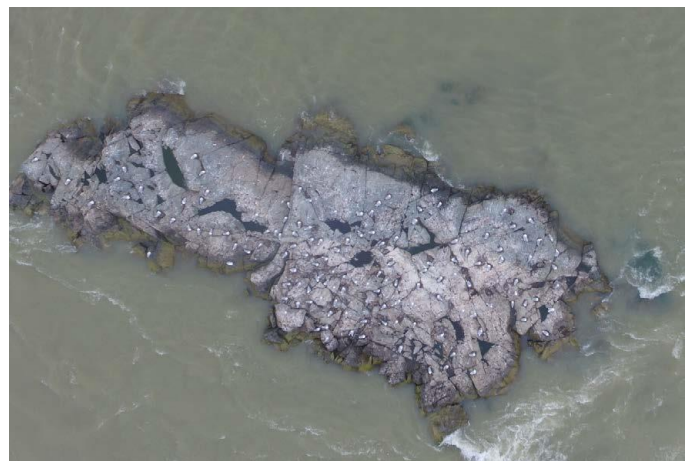
Photo 13: An unmanned aerial vehicle used to monitor islands in Gull Rapids.

Mitigation efforts, including bird-wire diverters, appear to be effective. The results of the surveys suggest that Project construction is not negatively affecting colonial waterbirds. The consistent number and locations of colonies of colonial waterbirds observed in the Gull
