Keeyask Transmission Project **Environmental Effects Monitoring Plan** Technical Reports

KEYYASK TRANSMISSION PROJECT

BIRD-WIRE COLLISION MONITORING 2016

Wildlife Resource Consulting Services MB Inc. 2017. Bird-wire Collision Monitoring 2016. Keyyask Transmission Project. A report prepared for Licensing and Environmental Assessment Department, Manitoba Hydro, Winnipeg by Wildlife Resource Consulting Services MB Inc., June 2017. 25pp.

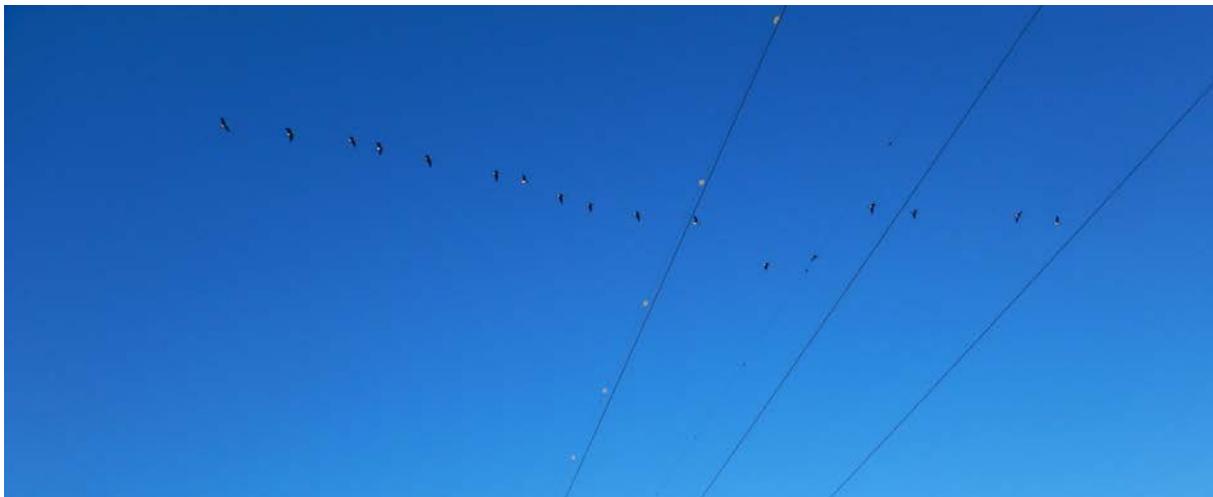
Canada geese flying above the Keeyask Transmission Project's generation outlet transmission lines. Bird diverters can be seen on the sky wires.

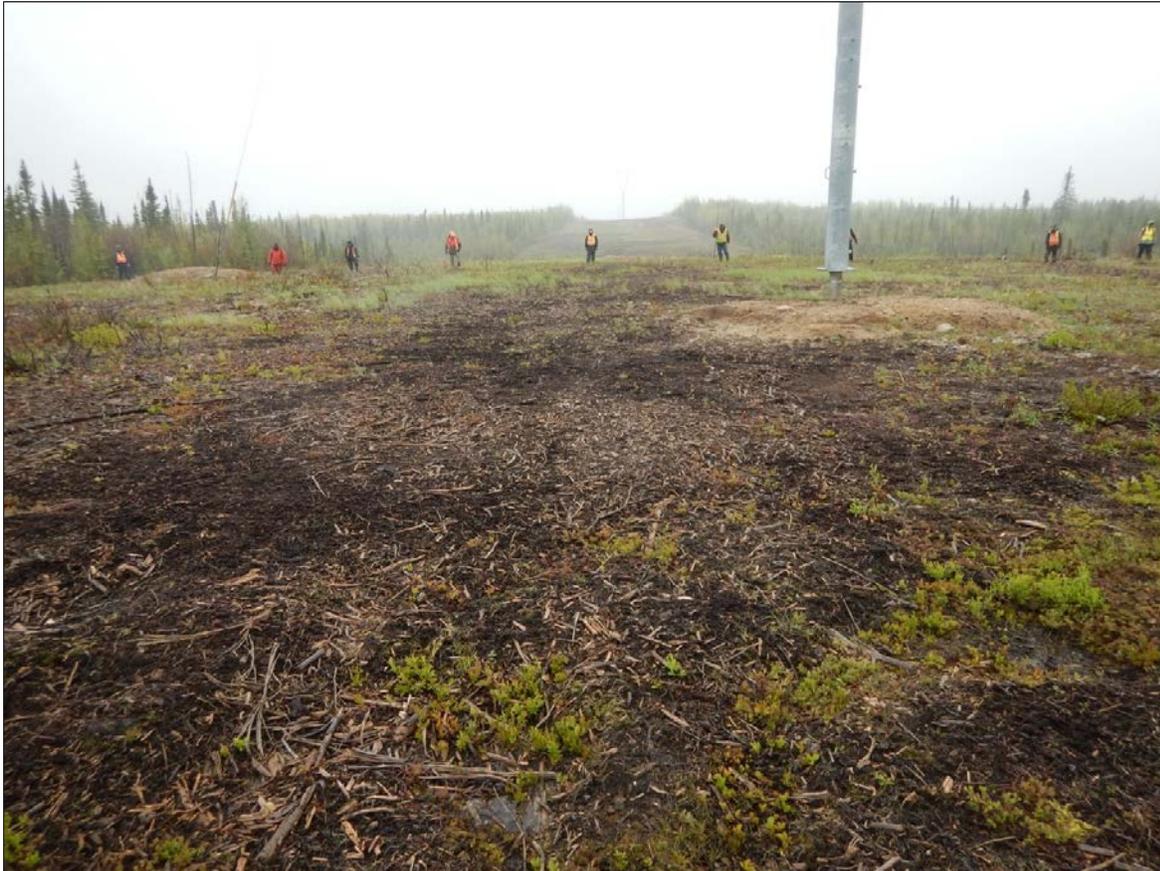
Photo 2. Survey personnel searching for evidence of bird-wire collisions under the Keeyask generation outlet transmission lines on June 10, 2016.

Surveys were conducted on foot and documented the date, time, species, location, and the state of encountered bird remains. During each survey, the searchers walked in a survey grid with parallel survey lines close to one another (Photo 2) to assure complete coverage of the ground. Spacing between searchers varied between 3 m and 7 m depending on the relative density of vegetation within the search areas. In areas with shrub and tree growth, that required closer scrutiny, 3 m spacing was used, whereas 7 m spacing was used in open areas.

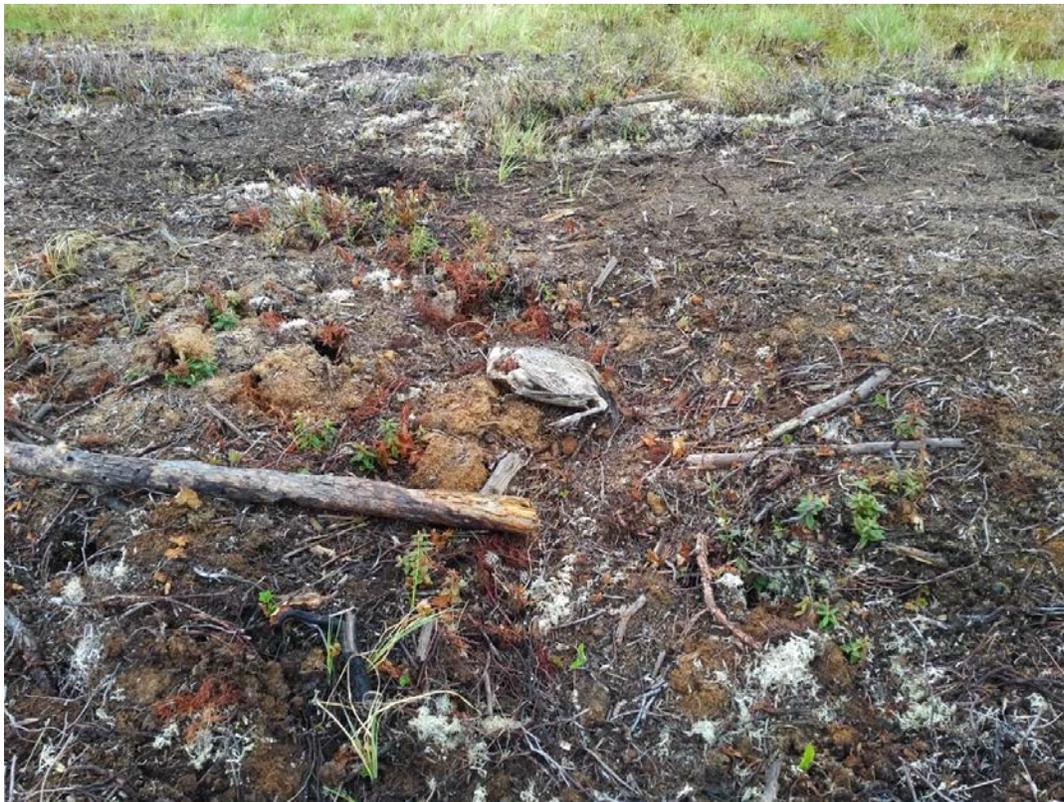
Photo 3. Juvenile ring-necked pheasant (*Phasianus colchicus*) planted for searcher efficiency and scavenger removal trials.

To account for the efficiency of the search team and scavengers removing evidence of bird collision mortalities, dead juvenile ring-necked pheasants (*Phasianus colchicus*; hereafter referred to as pheasants)(Photo 3) purchased from a commercial supplier were used to conduct searcher efficiency and scavenger removal trials. Planting carcasses in blind trials is a commonly used technique to estimate searcher efficiency and scavenger removal bias (CEC 2003, CWS 2007, APLIC 2012). Juvenile pheasants were selected for their moderate size and because their cryptic plumage makes finding them challenging. Searcher efficiency is a measure of the ability of the search team, not individual searcher efficiency, to find evidence of bird collision mortality occurring within the search area. The search team was tested during each site visit where pheasants were planted. In knowing that planted birds are in the search area, searcher efficiency can be high as the searchers are "on guard" during the search (CWS 2007). Frozen pheasants were thawed before being placed within search areas at locations unknown to the searcher team. Following the search, the proportion of carcasses found by the search team was recorded. Searcher efficiency was assessed by pooling the results all searcher efficiency trials under both the GOT and CP lines in June and September. Planted birds were similarly used to estimate the proportion of birds not removed by scavengers.

We planted a limited number of pheasants ($n = 12$) in 2016 to avoid creating an excessive attraction to scavengers (NYSDEC 2007) and to not make carcasses unattractive by providing more carcasses than scavengers can consume/remove (Smallwood 2007). In the ROW under the GOT lines, three pheasants were planted on June 10 and three were planted on September 12. Under the CP line, three pheasants were planted on June 10 and three were planted on September 12.

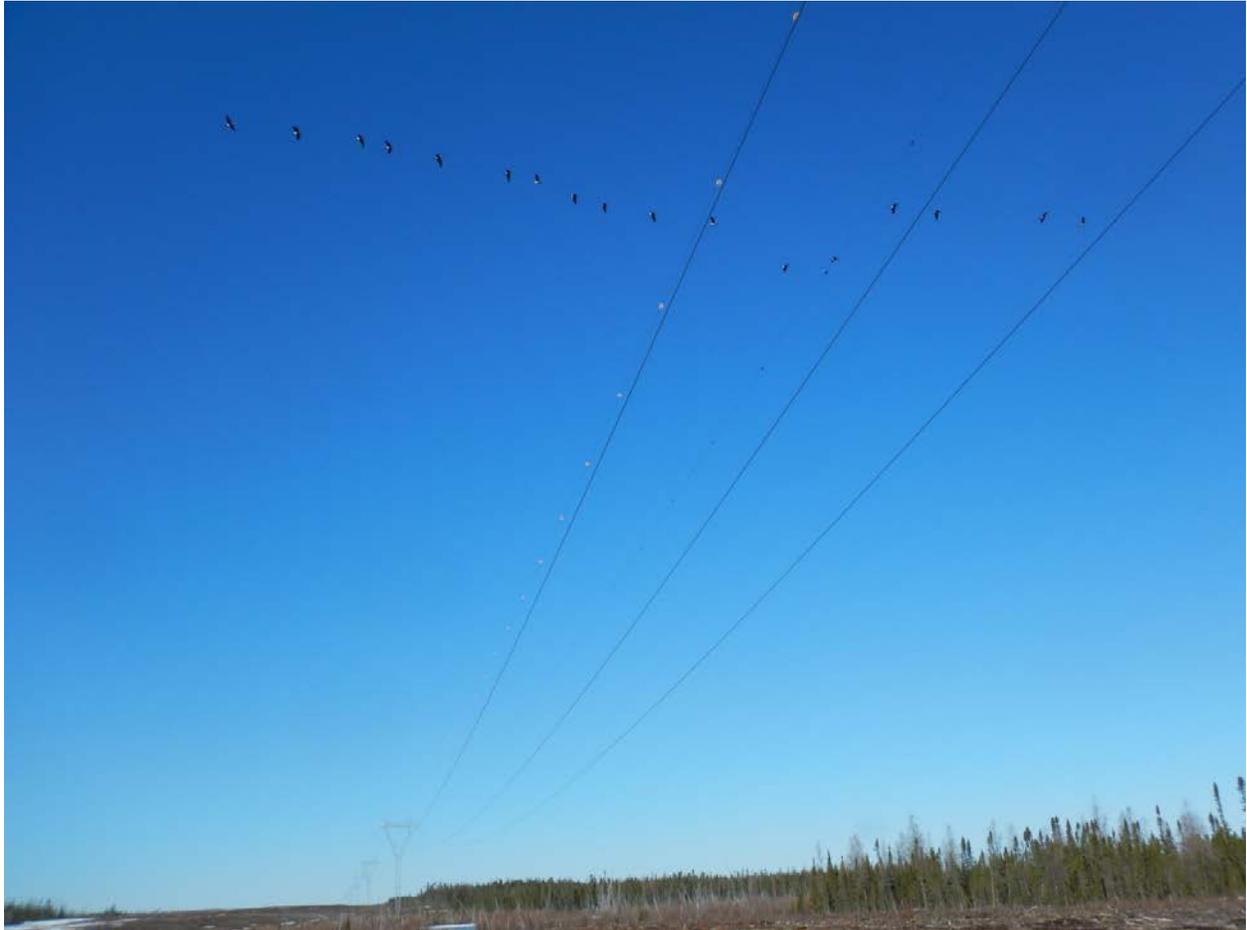
Photo 4. Flock of Canada geese (*Branta canadensis*) flying above the Keeyask Transmission Project's generation outlet transmission lines. Swan Flight™ diverters can be seen on the sky wires.

collision mortalities. Bird diverters have been shown to effectively reduce bird-wire mortalities (Photo 4), however effectiveness can vary from reductions of 9.6% to 80% (Beaulaurier 1981, Morkill and Anderson 1991, APLIC 2012). The cost-effective mitigation technique of installing bird diverters appears to have been successful to date at protecting birds from collision mortality with the Keeyask Transmission Project transmission lines.
