Keeyask Transmission Project **Environmental Effects Monitoring Plan** Technical Reports

KEYYASK TRANSMISSION PROJECT

ENVIRONMENTAL EFFECTS MONITORING

INVASIVE PLANT MONITORING IN 2016

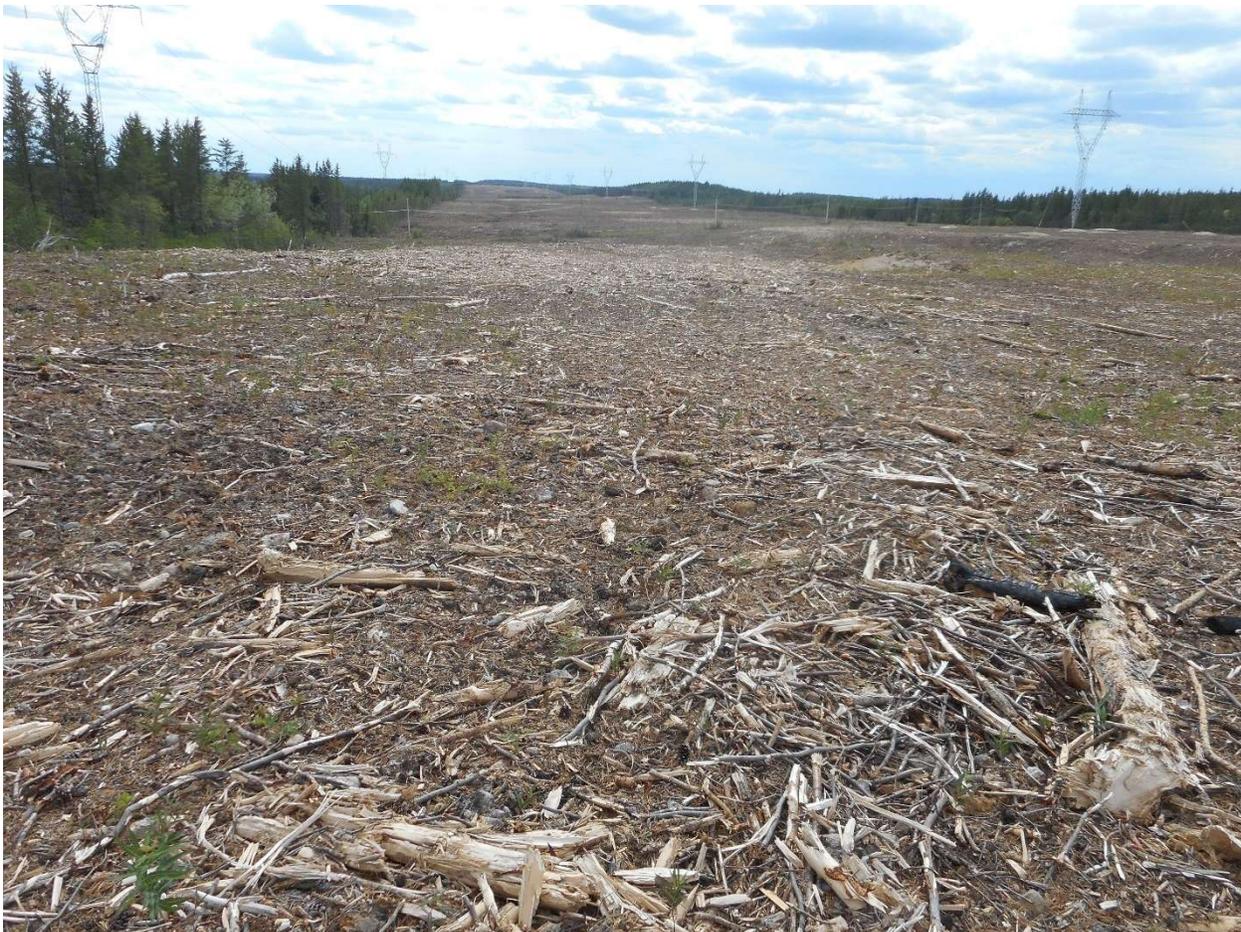
Photo 3-1: Example of minimal exposure of mineral substrates in cleared ROW

Mineral substrate exposure in the cleared ROW was quite limited (Photo 3-1), which lowered the availability of higher quality seedbed for non-native plant species.

Other studies in the region have found that the non-native plant species are most common on exposed mineral substrates (ECOSTEM unpublished data). Most of the vegetation clearing occurred when the ground was frozen, minimizing the creation of mineral substrates through disturbance of the surface organic layer (see Photo 3-1 for an example).
