KEYYASK TRANSMISSION PROJECT

ENVIRONMENTAL EFFECTS MONITORING PLAN

ECOSYSTEM DIVERSITY, PRIORITY PLANT AND INVASIVE PLANT MONITORING FROM 2016 TO 2019

May 2020

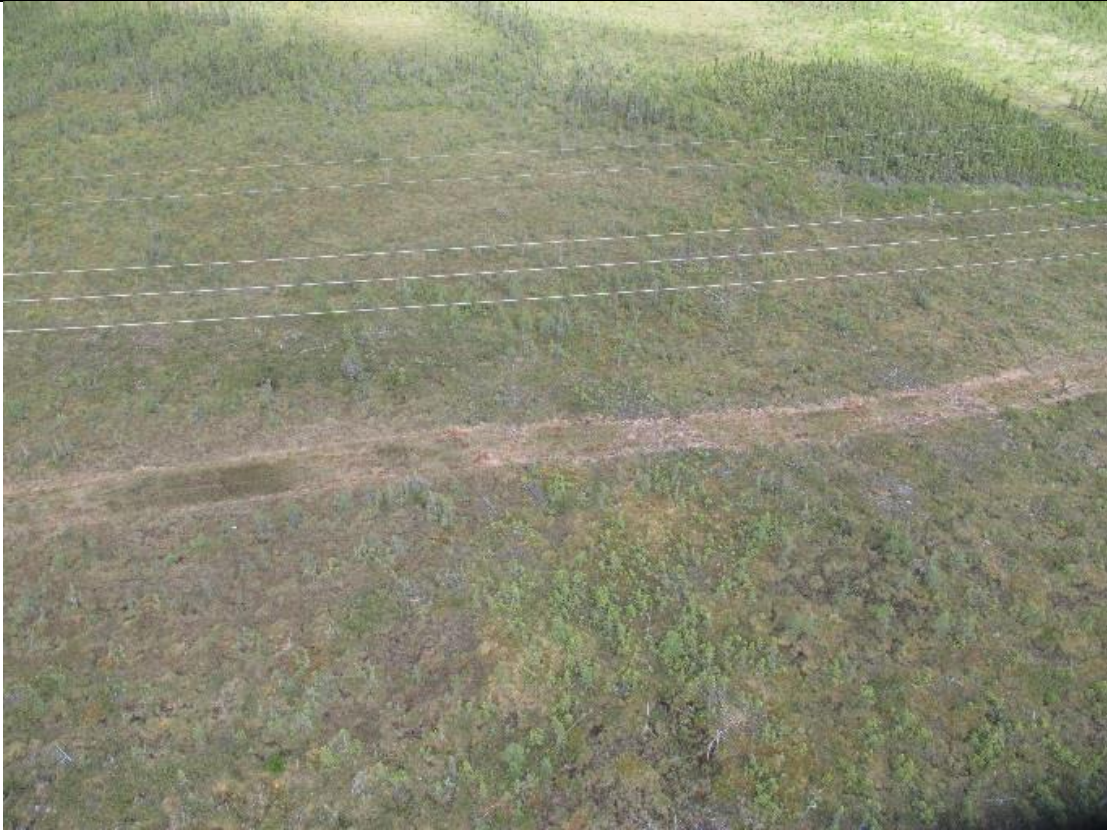
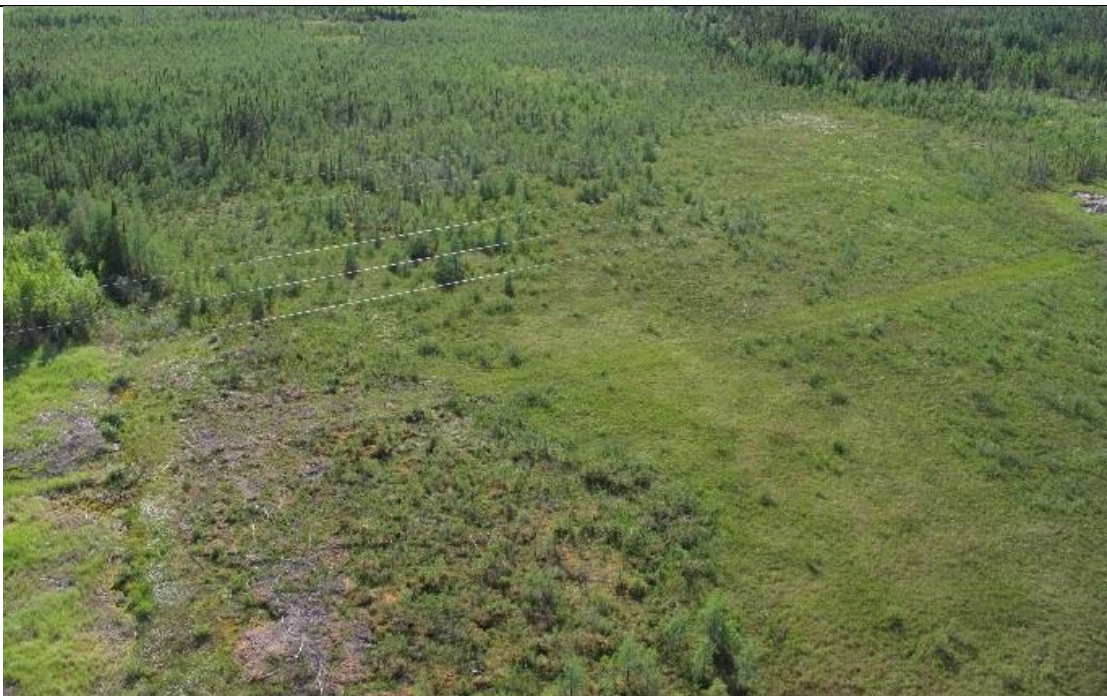
Photo 2-1: Two priority habitat patches adjacent to a ROW segment having a reduced cleared width or minimal clearing.

PH9998

PH9997

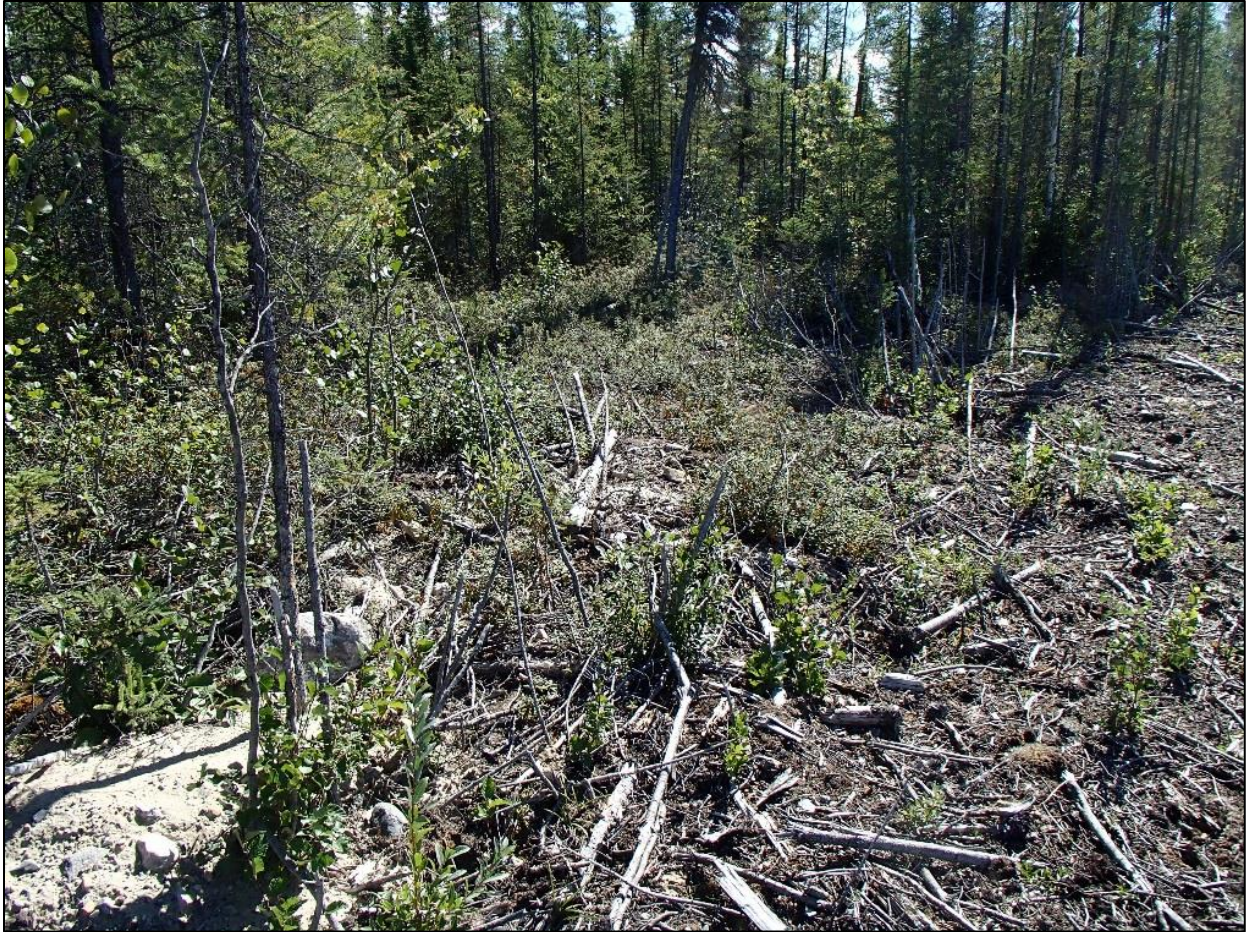
Photo 2-2: Clearing and disturbance adjacent to the ROW in priority habitat patch PH0938.

One priority habitat patch (PH0938) had clearing that extended into the patch beyond the standard ROW clearing width. The additional impact was an approximately 20 m² area that included cleared trees, mechanical damage to the surrounding trees and mechanical disturbance of the substrate (Photo 2-2).

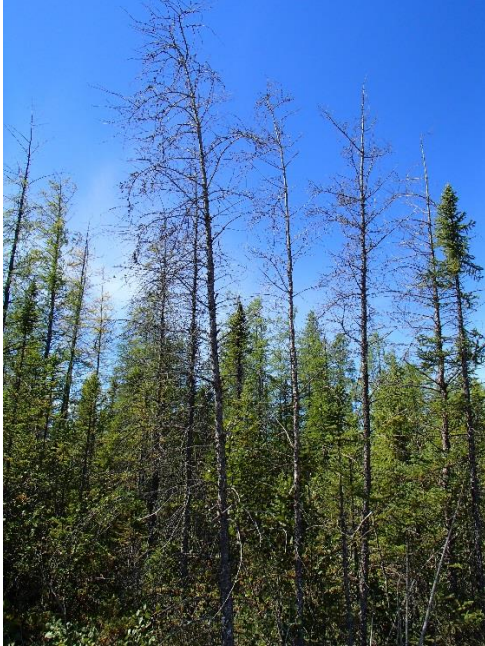
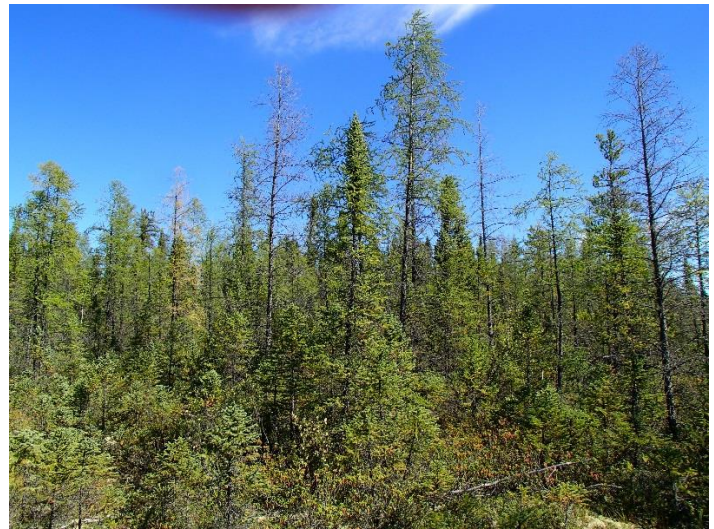
Photo 2-3: Tamarack mortality in two priority habitat patches adjacent to the ROW.

PH1271

PH0910

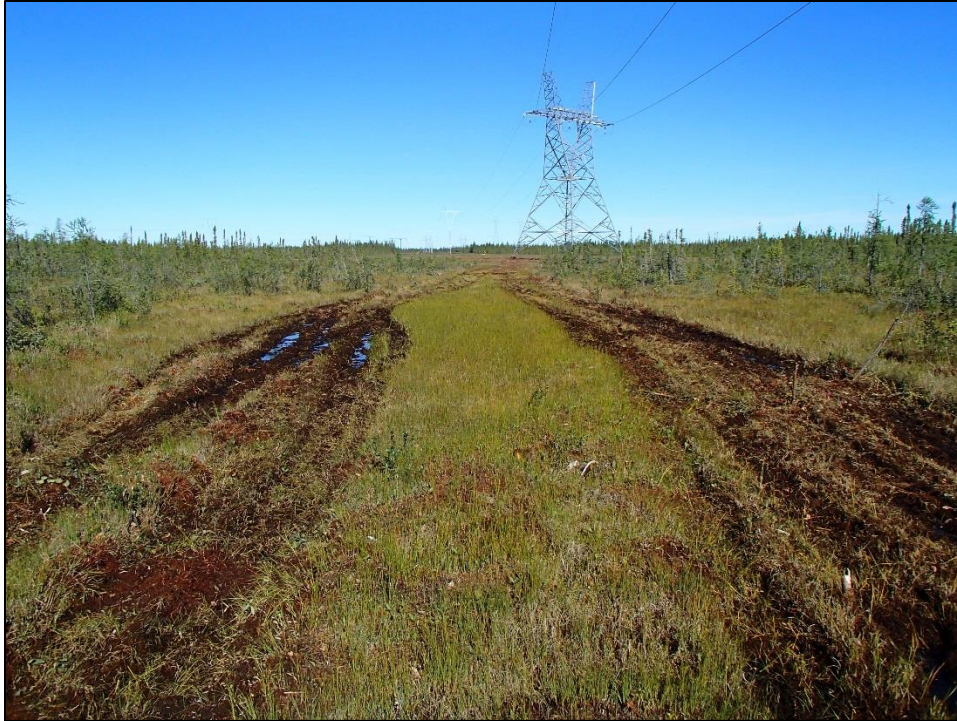
Photo 2-4: Deep Rutting in ROW adjacent to priority habitat patch PH9998.

Deep rutting from two sets of vehicle tracks was present within the ROW adjacent to patch PH9998 (Photo 2-8). At other locations within the ROW with shallow organic substrates, deep excavations were also present. These excavations were deep enough to collect water, and potentially affect local drainage. While these usually appeared to be places where material for transmission tower foundation construction was excavated, these excavations or disturbances were at least 80 m from towers at locations near priority habitat patches PH9998 and PH0001 (Photo 2-5).

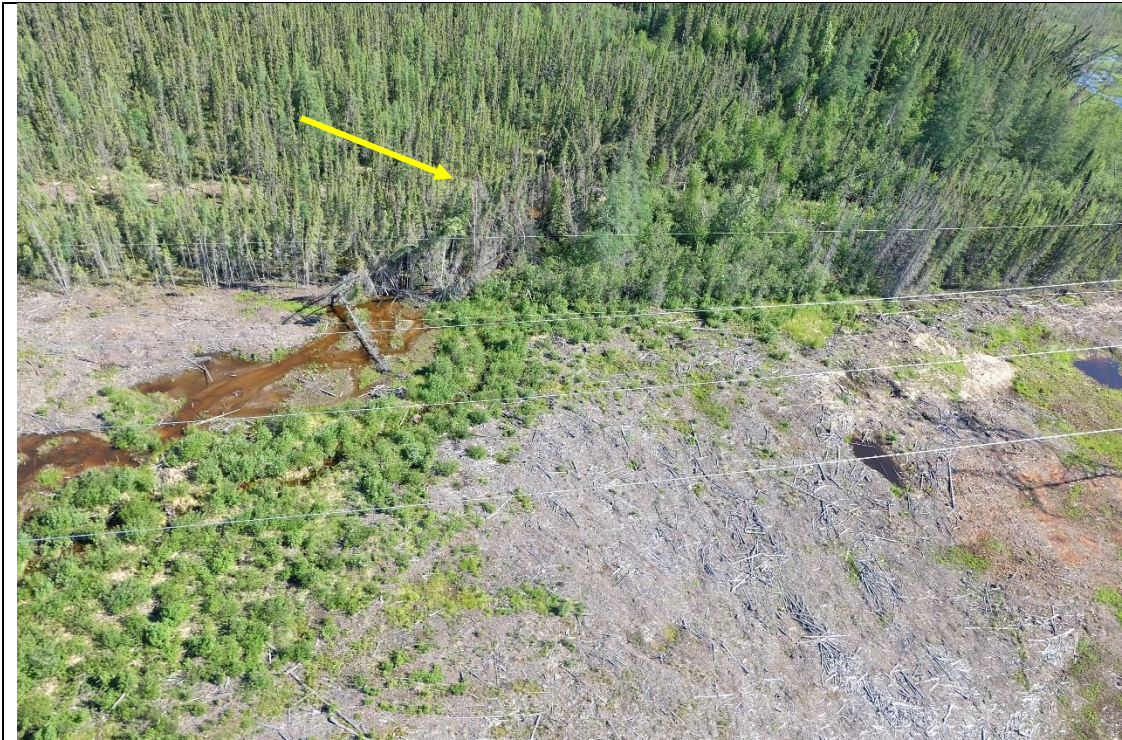
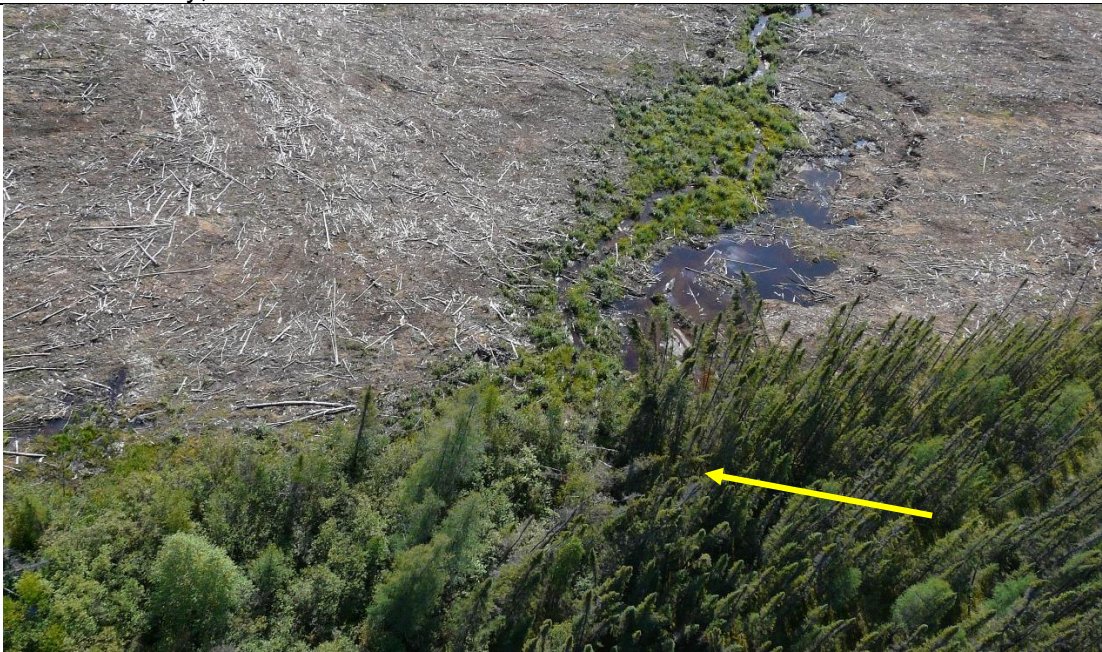
Photo 2-6: Erosion and sediment deposition with tree mortality in priority habitat patch PH1874.

The largest effect by far was the one observed in patch PH1874 during aerial surveys. In this patch, collapsing and dying trees extended for approximately 70 m along a pre-existing runnel. Also, runoff from the ROW was flowing in this runnel and depositing sediment into the patch. Examination of aerial photos of the area taken in 2015 showed that the majority of the tree collapse and mortality that was near the ROW edge occurred after clearing. It is uncertain how much of the total observed tree collapse was due to Project effects. At minimum, some of the effects at the ROW edge were definitely Project-related while the rest was likely accelerated by indirect Project effects.

the ROW was carrying sediment down a runnel that extended into the patch, and this sediment was covering vegetation in the understorey. The tree collapse in this patch was also very likely caused, or at least accelerated by the Project.

PH1874 in July, 2018

PH1874 in August, 2015

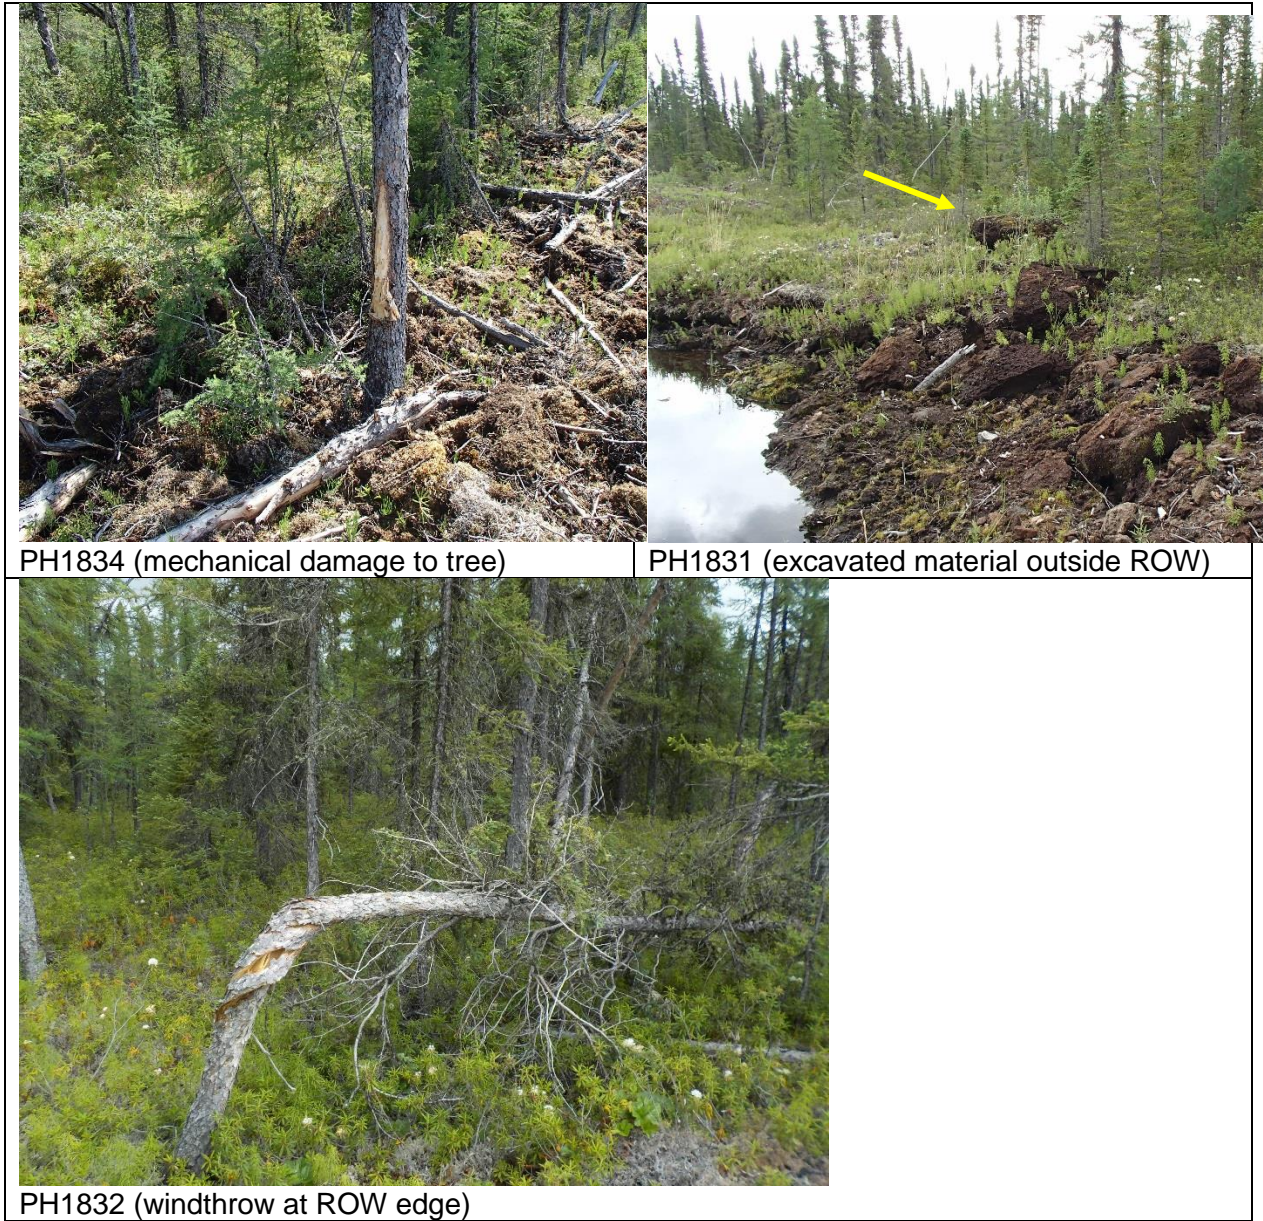
Photo 2-7: Examples of mechanical damage observed in priority habitat patches in 2018.

The five definite Project effects were very minor, and affected trees or understorey vegetation (Table 2-4). At one patch (PH1834) the bark and trunk of a tree adjacent to the clearing was damaged. In patches PH1839, PH1831 and PH1833, excavation was present, or excavated material was deposited over understorey vegetation near the ROW edge. At PH1874, erosion in

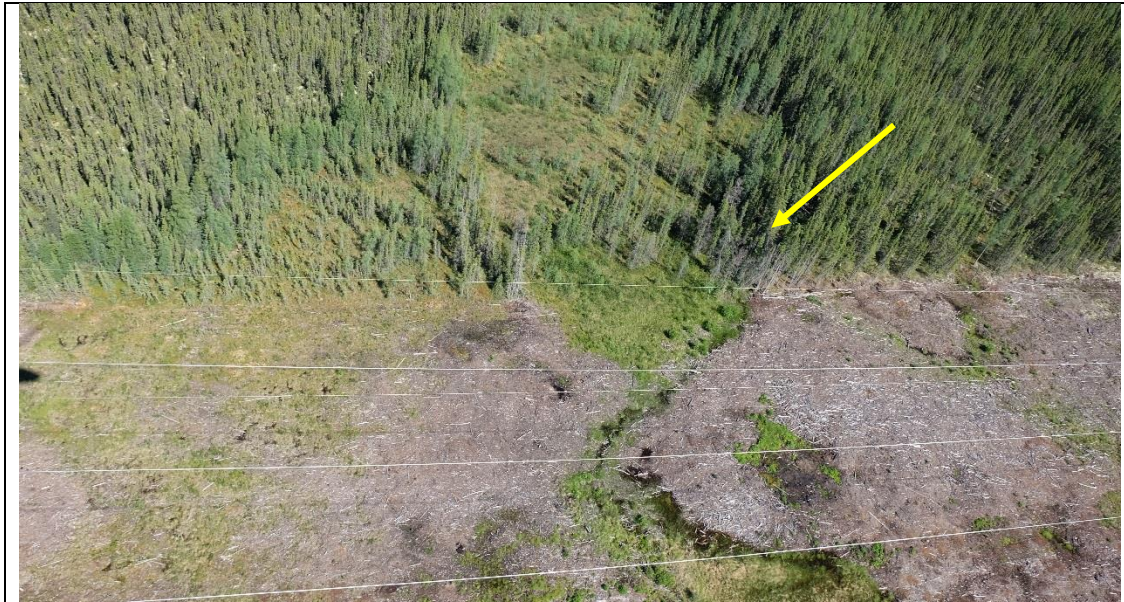
Photo 2-9: Tree collapse and mortality observed beside ROW clearing in 2018 that was present prior to the Project.

Natural processes were determined to be the cause for one of the 15 observed effects. At the edge of patch PH1840 (adjacent to a pre-existing deep, wet peatland), tree mortality and collapse extended into the patch for approximately 10 m from the cleared ROW edge (Photo 2-9). While some of the tree collapse closest to the ROW and further away from the wet peatland was likely due to the Project (see below), photography of this particular location from 2009 showed that the tree mortality and collapse adjacent to the wet peatland was already underway before the Project. That habitat change appeared to be caused by natural permafrost melting.

PH1840 (aerial view July 6, 2018)

PH1840 (aerial view July 18, 2009)

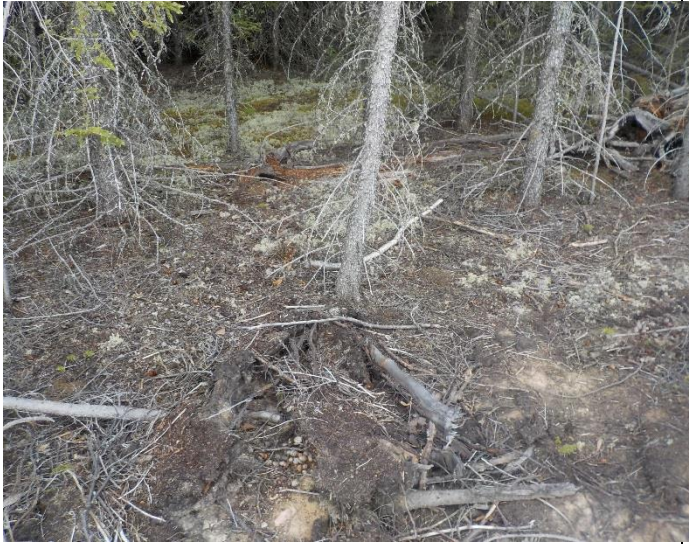
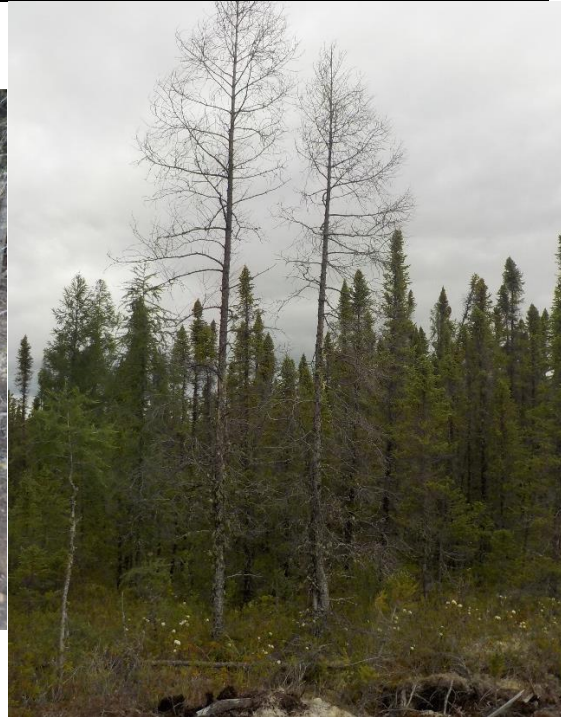
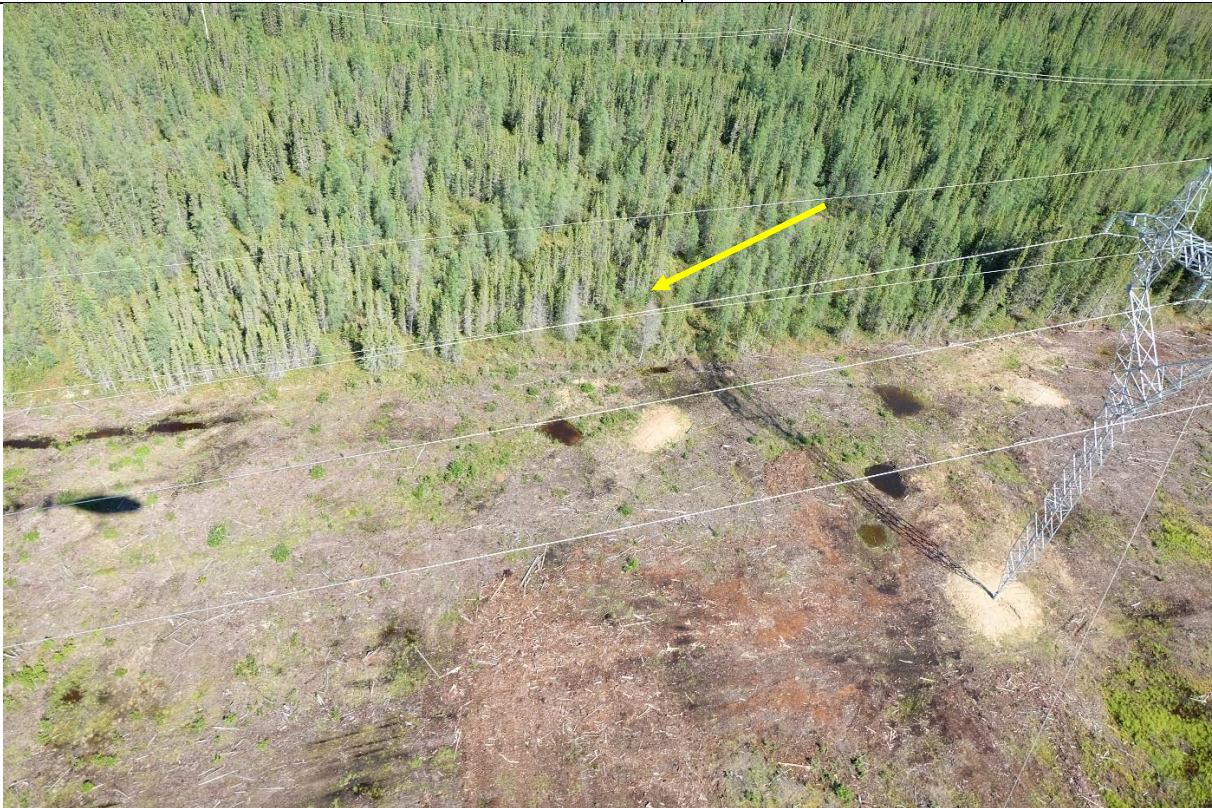
Photo 2-10: Examples of vegetation mortality observed in priority habitat patches in 2018.

The three effects possibly due to the Project were on tamarack (*Larix laricina*) trees at patches PH1828, PH1840 and PH1839. At each patch, dead or dying tamarack trees were observed within 20 metres of the cleared ROW. This was the only tree species with dead stems in the patch, and the black spruce appeared to be healthy. Tamarack further from the clearing and at other areas along the ROW edge appeared healthy. The mortality was possibly caused by a combination of root damage and change in the soil moisture regime resulting from the ROW clearing and peat scalping (Photo 2-10).

PH1837 (dead and dying moss and lichen adjacent to edge of ROW)

PH1839 (dead tamarack)

PH1828 (dead tamarack concentrated at edge of ROW)

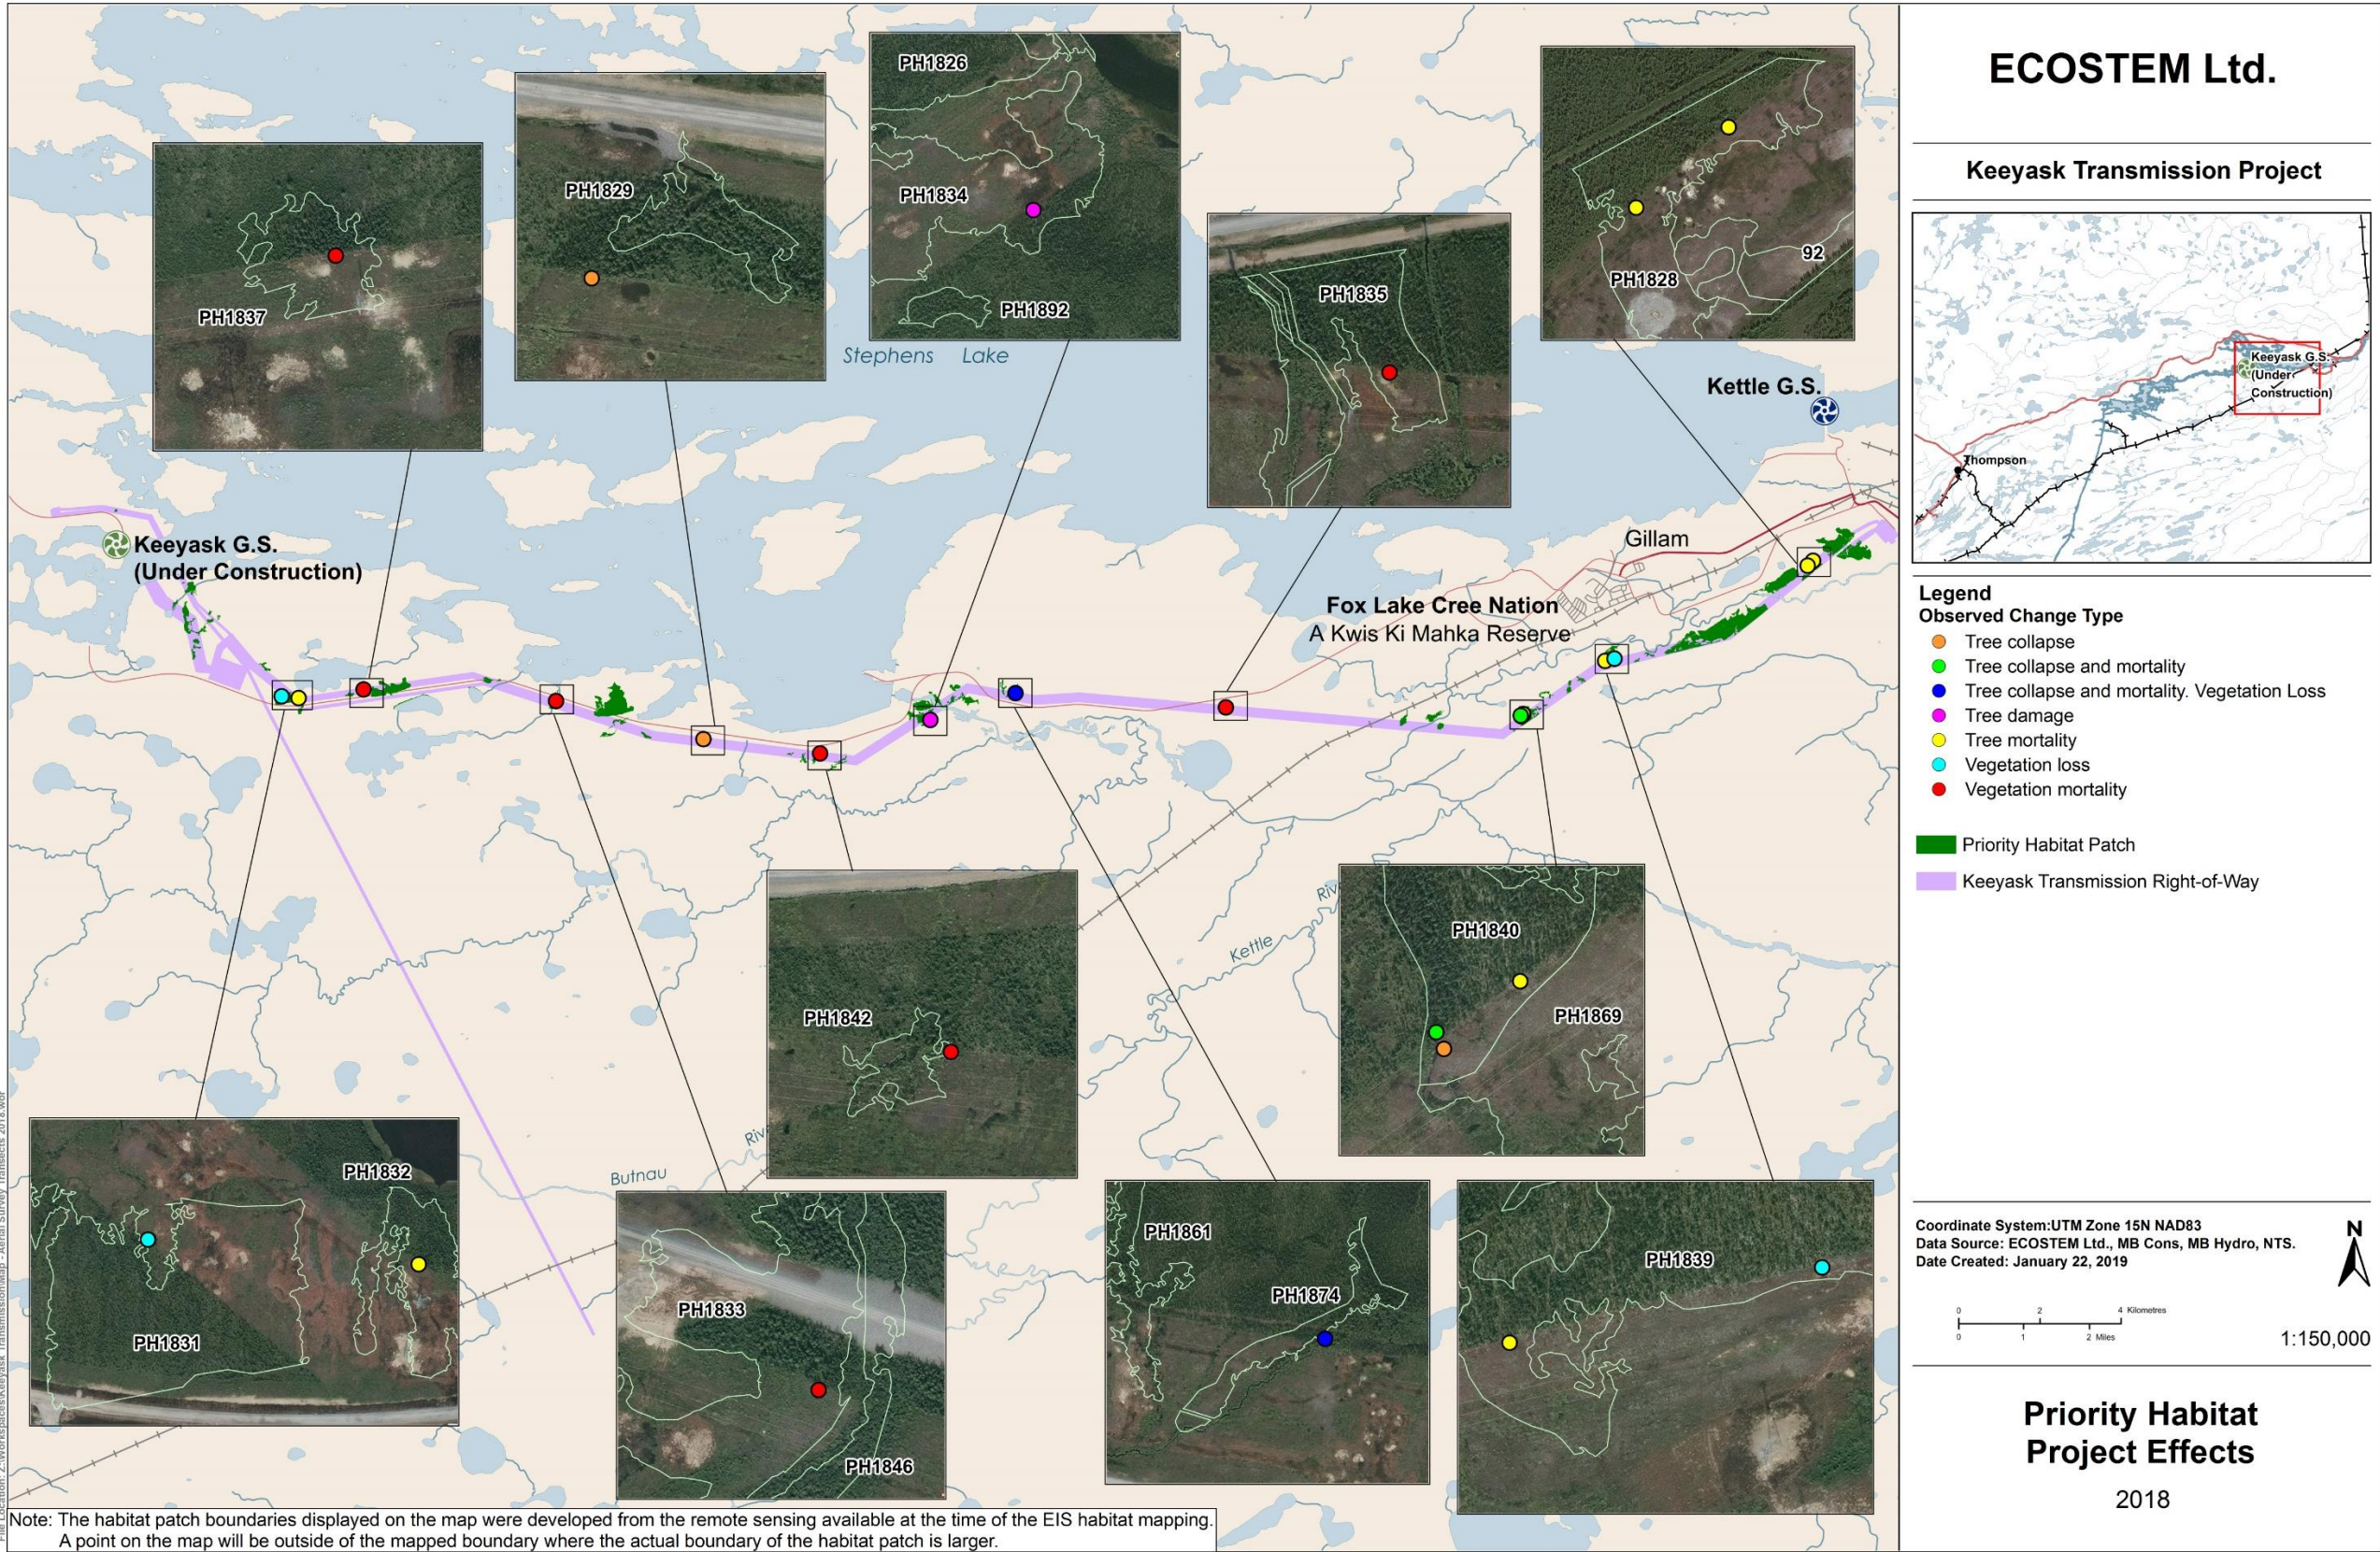
Map 2-3: The status of priority habitat patches, and locations where effects occurred outside of the standard cleared ROW width

The ground surveys at 23 patches (Map 2-3) recorded 14 minor effects outside of the cleared ROW (Table 2-4). All of these effects were localized, small in area and not extending more than a few meters from the edge of ROW clearing. Map 2-3 shows the status of the priority habitat patches as observed during the aerial and ground surveys, including the type of effect at each patch.

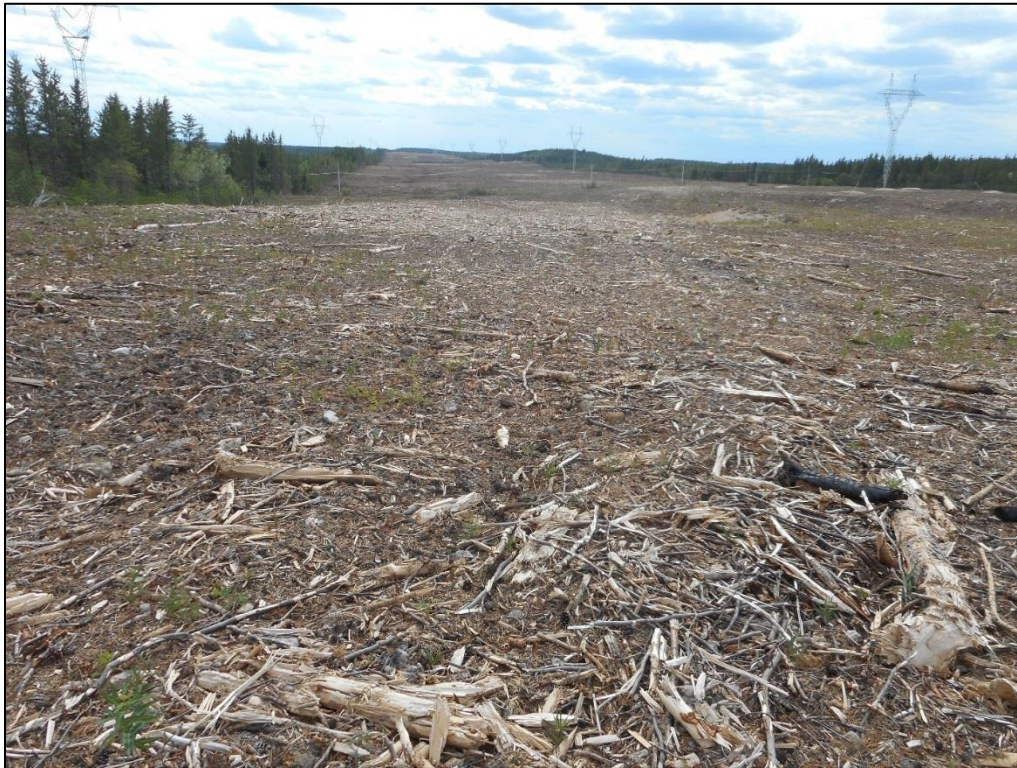
Photo 4-1: Example of minimal exposure of mineral substrates in cleared ROW

Exposed mineral substrates in the cleared ROW were quite limited following clearing (Photo 4-1).

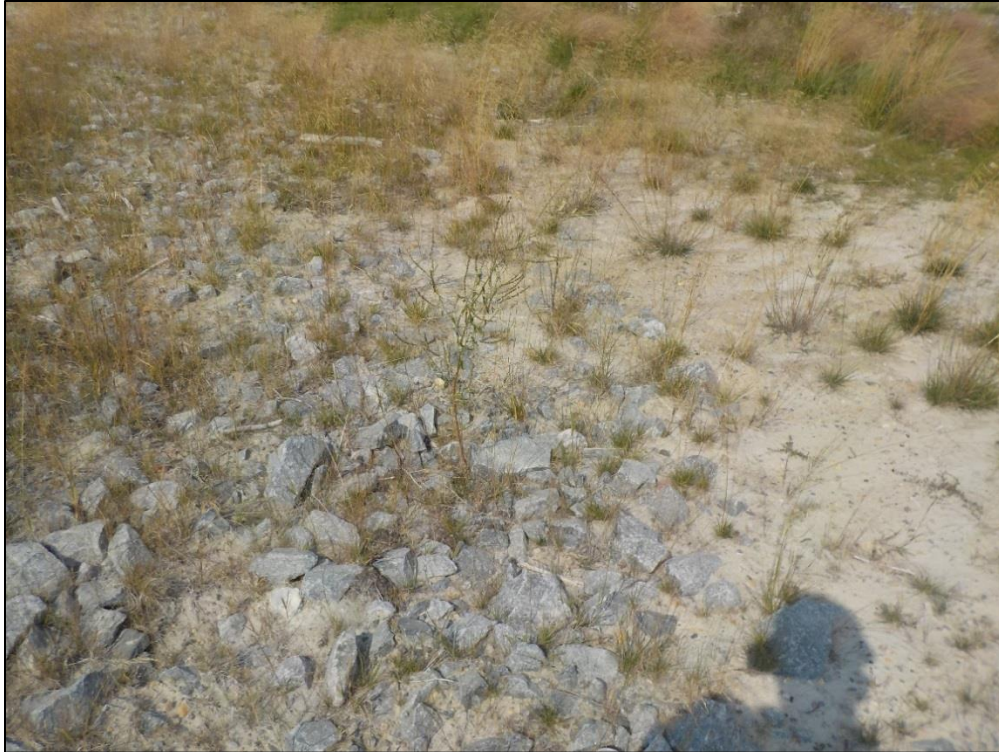
Photo 4-3: White sweet clover growing beside the South Access Road where it crosses the GOT ROW in 2018.

White sweet clover was found at two sites (Map 4-4), both of which were near or adjacent to where the ROW crossed the South Access Road. These plants were not removed by ECOSTEM staff, because they were already becoming established along the South Access Road.

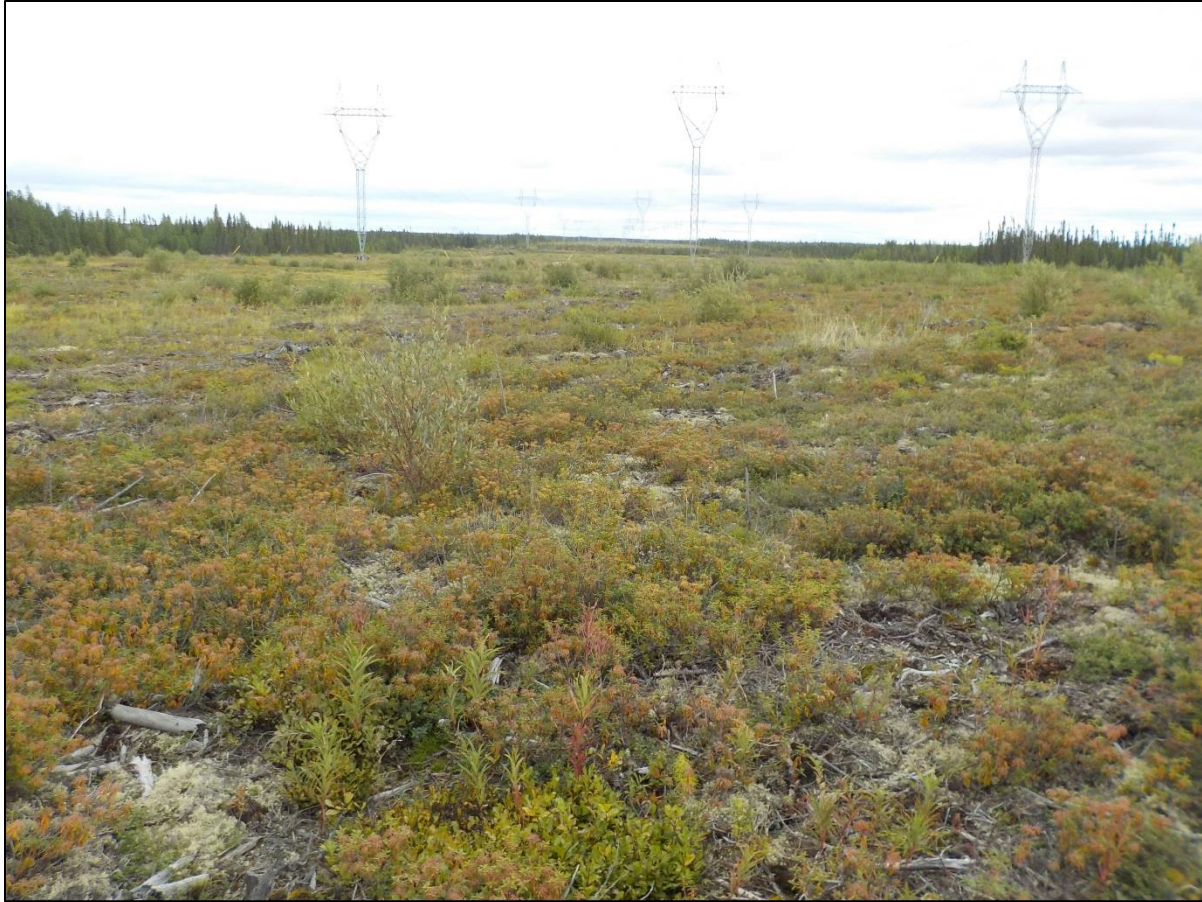
Photo 4-5: Regenerating native vegetation in transmission ROW in 2019

Finally, the expanding native plant cover in the ROW in 2019 (Photo 4-5) continued to be a possible factor that was limiting the establishment or spreading of non-native plants. Expanding native plant cover should at least somewhat reduce non-native plant cover through shading and competition for resources. Native plant cover should also create a hindrance to the colonization of new non-native plants as plant litter and live plant parts gradually reduce the surface area of exposed mineral substrates.
