The Lake Winnipeg East System Improvement  
Transmission Project  
Environmental Effects Monitoring  
Summary

This document is a summary of the results of the environmental effects monitoring plan for the Lake Winnipeg East System Improvement (LWESI) Transmission Project.

This environmental monitoring summary outlines activities from 2015 through 2020.

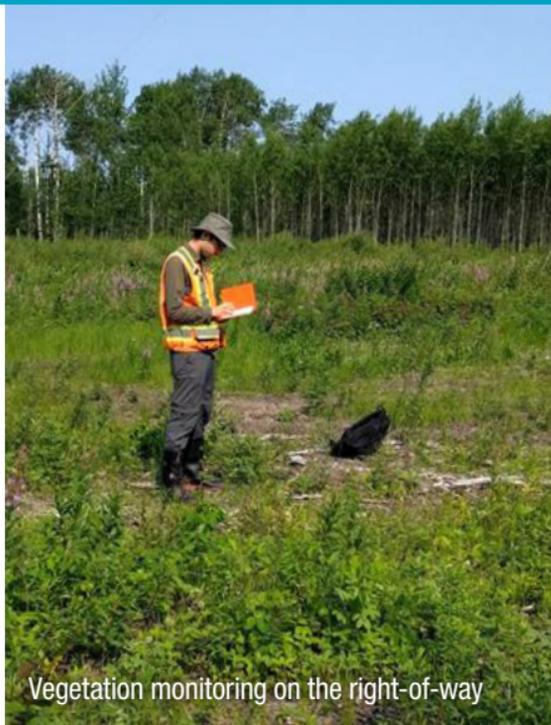
Vegetation monitoring on the right-of-way

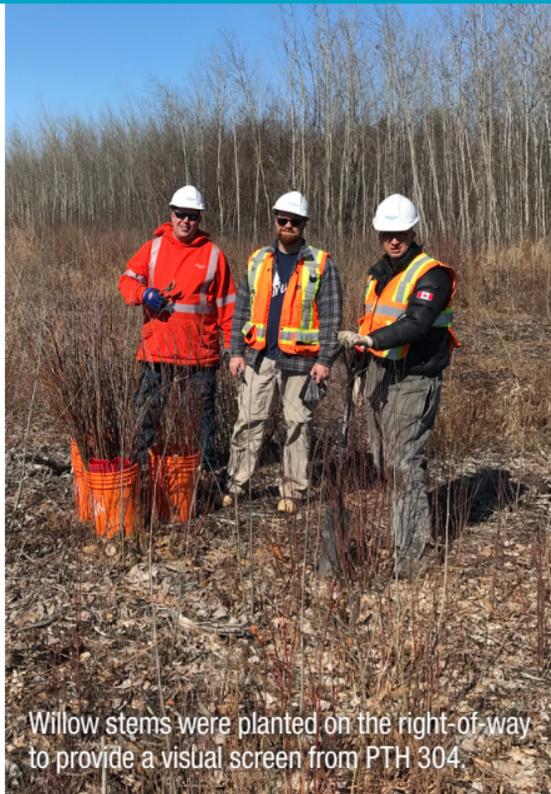
In addition to vegetation monitoring activities, willow stems were planted at three locations after construction to provide an enhanced visual screen from PTH 304 down the transmission right-of-way. Although these planted willow stems experienced some dieback, they supplemented natural willow regrowth and achieved their objective.

Willow stems were planted on the right-of-way to provide a visual screen from PTH 304.

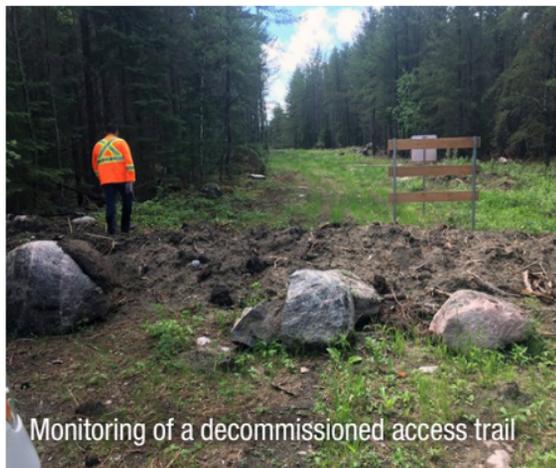
After the Project construction was completed, decommissioning of access trails was conducted as required by Manitoba Sustainable Development. This involved placing large boulders, ditches/trenches, and trees over unnecessary access trails to prevent future vehicular traffic. This was intended to minimize the potential for increased accessibility to the Project area which may have resulted in additional pressure on moose populations. These decommissioning

efforts appear to have been effective at preventing truck usage while allowing off road vehicle access..

Monitoring of a decommissioned access trail
