# Manitoba-Minnesota Transmission Project

## Post-Construction Environmental Monitoring Report

Certificate EC-059

Manitoba Hydro

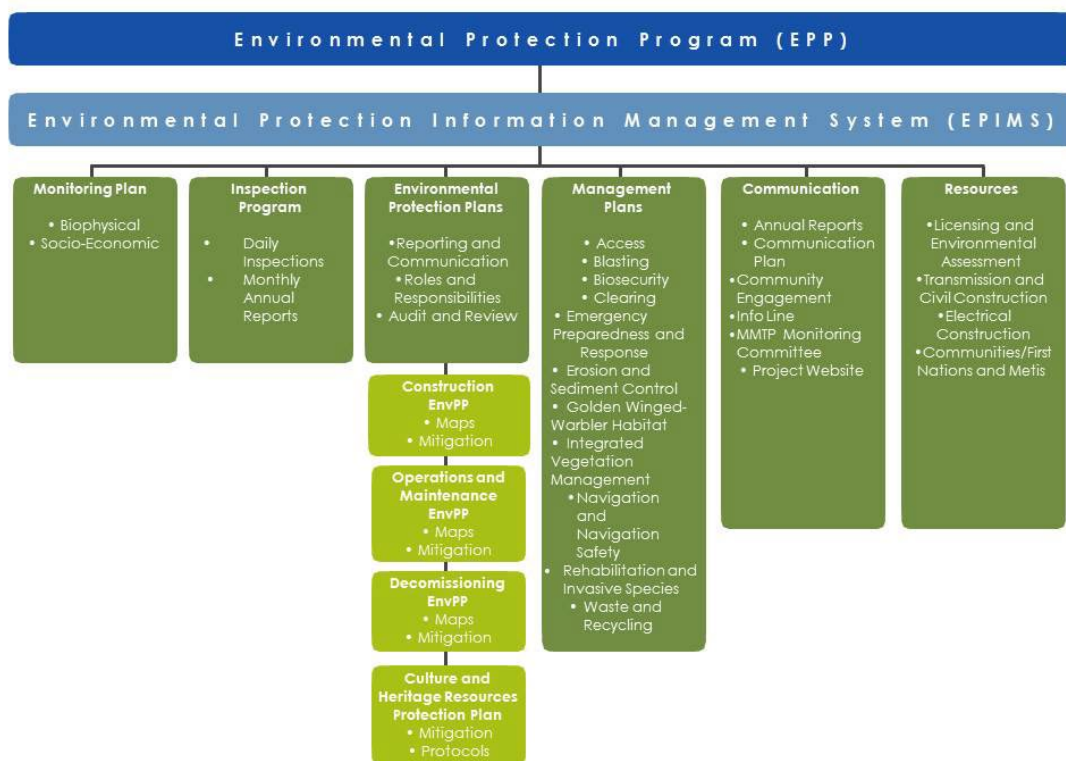
Figure 1: Environmental Protection Program Chart

Part of Manitoba Hydro's commitment to environmental protection includes the development of a comprehensive Environmental Protection Program (EPP), this is further described in chapter 22 of the EIS, found here at NEB Ex. [A81182-38](#). The purpose of the EPP is to provide the framework for implementing, managing, monitoring and evaluating environmental protection measures that are consistent with regulatory requirements and environmental guidelines. This EMP is a component of the EPP as illustrated in Figure 1.
