MANITOBA–MINNESOTA TRANSMISSION PROJECT Environmental Monitoring Plan

SHARP-TAILED GROUSE MONITORING REPORT 2020

Prepared for
Manitoba Hydro

By
Wildlife Resource Consulting Services MB Inc.

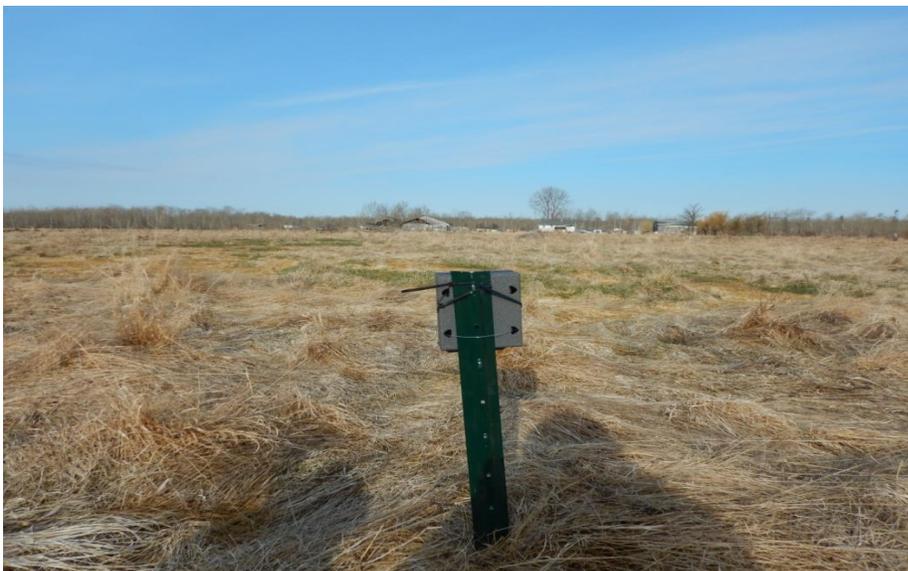
Photo 1: Trail camera at a sharp-tailed grouse lek

Pre-construction surveys for sharp-tailed grouse conducted in spring 2017 and 2019 were repeated in 2020, the first year after Project construction. From March 27 to April 13, 2020, trail cameras were placed at eight known leks after receiving permission from landowners (Map 1). Surveyors walked to the lek, marked its location with a Global Positioning System (GPS) unit, and conducted an active count, where all birds in the area were flushed out and counted. Data were collected in a manner similar to sharp-tailed grouse lek survey protocols previously established by Manitoba Sustainable Development (B. Kiss 2017, pers. comm.). Two Reconyx™ PM35C31 trail cameras, one facing north and the other east, were set up to photograph sharp-tailed grouse activity (Photo 1). Short metal stakes were driven into the ground, to which trail cameras were fastened with zip ties. Cameras were programmed to take a series of 30 rapid-fire photos every five minutes from 4:00 a.m. until 8:00 a.m.

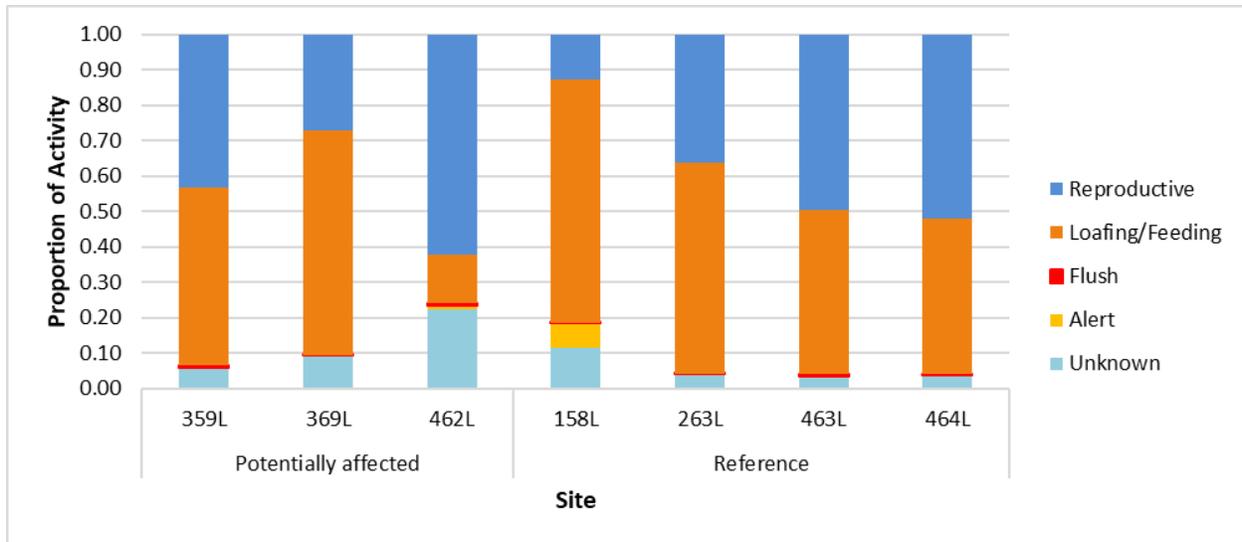
Figure 1: Proportion of sharp-tailed grouse behaviours photographed at seven leks from April 9 to May 7, 2020

The greatest proportion of grouse activity photographed was loafing/feeding at four of seven leks (Table 2). Reproductive behaviour (Photo 2), which was observed as early as 5:00 a.m. and typically continued until the end of the programmed photo period at 8:00 a.m., was photographed at all seven leks and was the most frequent activity at three. Flush and alert behaviours were observed at all sites, but there was very little of each (Figure 1). Flush and alert behaviours were greatest at reference sites 463L and 158L, respectively. There was a weak positive correlation between the greatest number of sharp-tailed grouse observed during active counts or in photos and the proportion of behaviours that were reproductive at each lek (Figure 2).

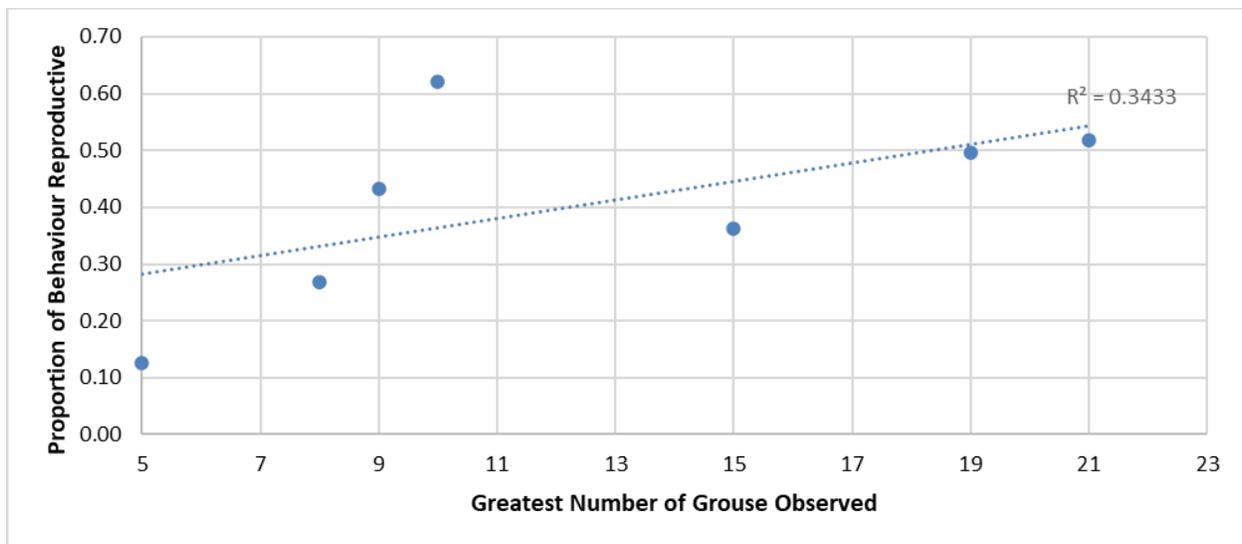
Figure 2: Relationship between the greatest number of sharp-tailed grouse actively counted or photographed and the proportion of behaviours that were reproductive at seven leks from April 8 to May 7, 2020

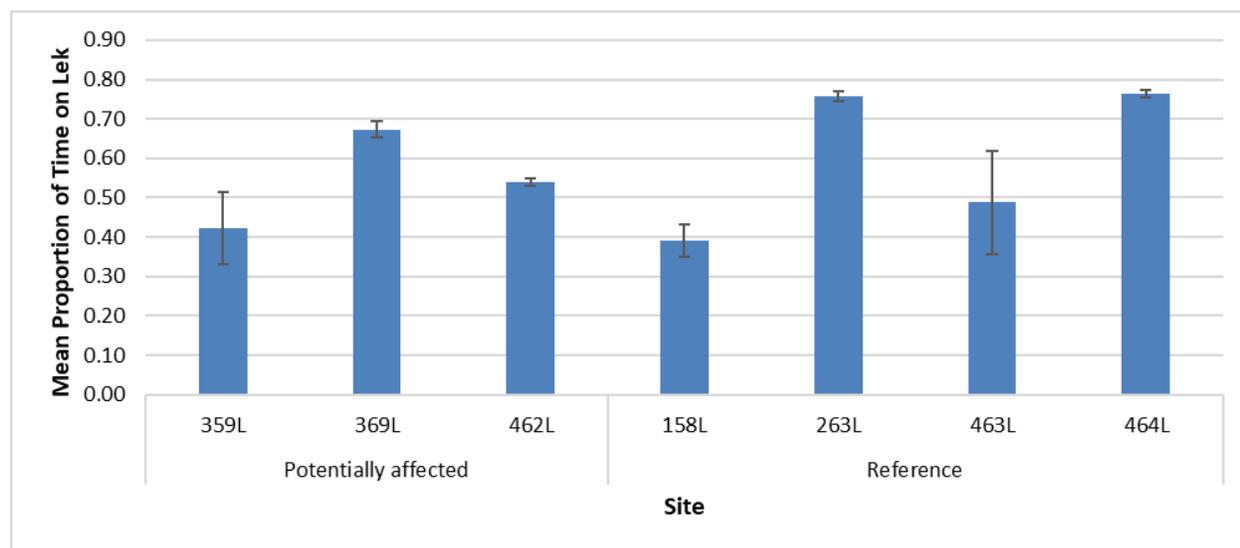
Figure 3: Mean proportion of time sharp-tailed grouse spent on seven leks from April 9 to May 7, 2020

On average, sharp-tailed grouse spent the greatest proportion of time on-lek at reference sites 263L and 464L in 2020 (0.76; Figure 3). Grouse were photographed on-lek at least 39% of the time at all other sites. Grouse were photographed on-lek an average of 55% of the time at potentially affected sites and 60% of the time on-lek at reference sites. The difference was not significant ($t = 1.98$, $p = 0.21$). During the pre-construction period, trail camera photos were taken at 5 leks in 2017 and 10 leks in 2019 (Wildlife Resource Consulting Services MB Inc. [WRCS] 2018, 2020). A total of five leks were at potentially affected sites and nine leks were at reference sites, one of which (010L) was surveyed both years (Appendix E). Because grouse behaviour was photographed at a small number of leks in 2017 the results were combined with those of
