Marketing & Customer Service

Natural Gas System Asset Condition Assessment

Date Prepared: November 2, 2016

File Number: 2016-04073

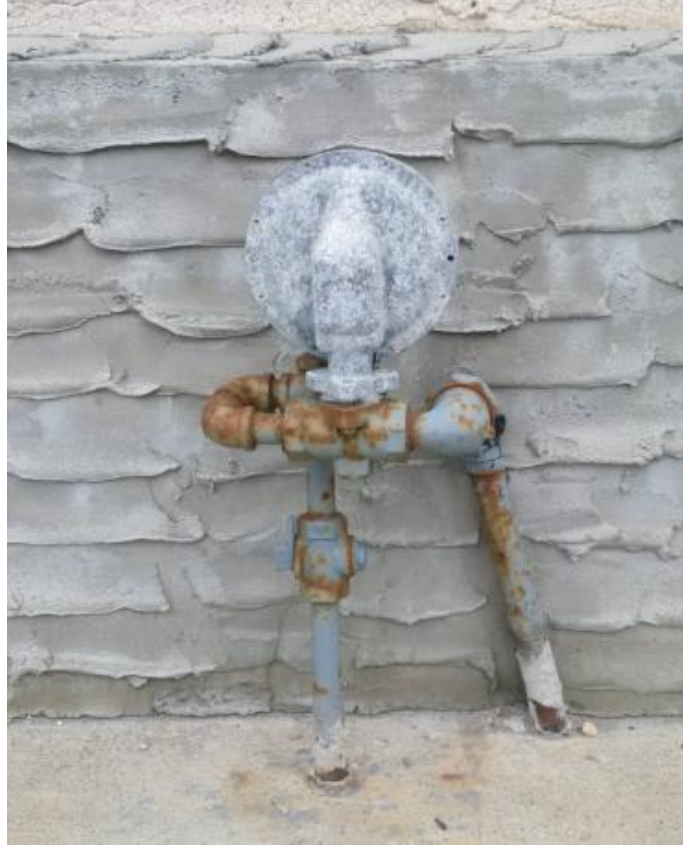
Figure 6: Corroded riser in concrete with below grade entry and delaminated coating

Soil types with mixed clay based soils tend to lead to ground movement which impacts a riser. Manitoba Hydro previously operated a riser rehabilitation program that focused on high risk risers identified through a survey of risers and meter set piping. The age and season of installation were considered in identifying high risk risers. Winter riser installations are most troublesome due to frozen backfilling material. During dry season conditions when clay soil dries and shrink causing riser settlement, a number of riser failures have led to uncontrolled releases of natural gas which pose a safety risk for the public and employees. High risk risers that have been identified have been rehabilitated.

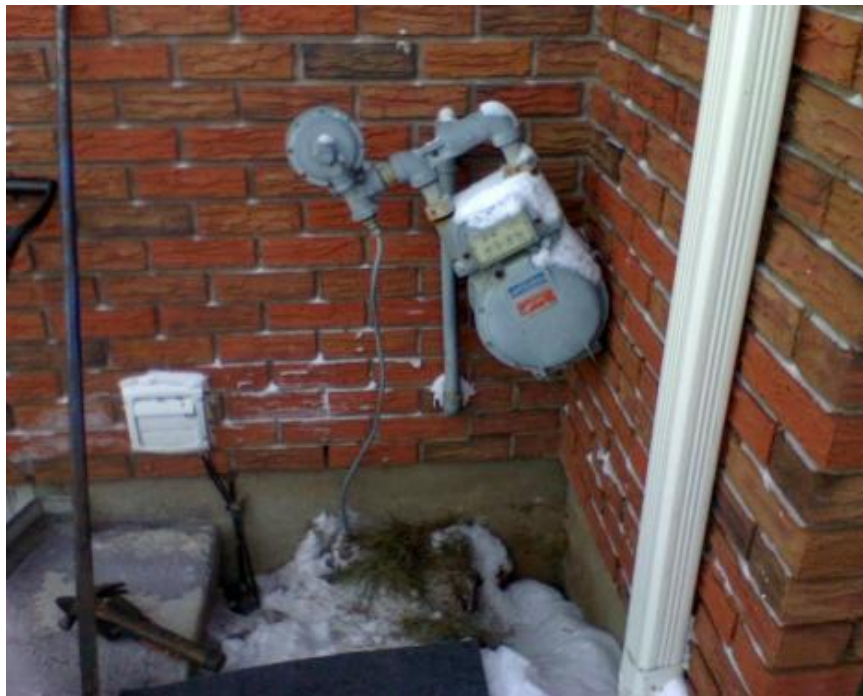
A subset of steel service risers consist of “S” tube risers which are also subject to settling and prone to leaks on compression fittings. “S” tube risers are pre-manufactured risers that are attached to polyethylene service lines. “S” tubes are intended to allow movement for soil settlement by the design by allowing the tube to flex. However, when risers settled to the limit of the “S” tube’s capability, leaks can occur on compression fittings and valves may become inaccessible. The risers are not attached to a foundation or wall and require replacement when they sink and leave the service valve inaccessible.

Figure 8: Residential service with “S” tube riser.

All new installations on polyethylene services include a riser which is double bracketed to the foundation wall which eliminates any further movement above the service valve. Additionally, polyethylene service lines are installed with slack below grade to allow for movement.

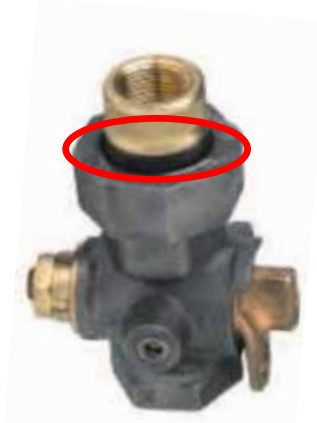
Service valves, like all other threaded fittings, can result in minor above grade gas leaks. Insulated meter stops in particular are prone to leaking at the joint of the nylon insulator and the brass nut as shown in Figure 10. Leaks can be repaired by replacing the insulated meter stop top nut. A service valve is an integral safety device that requires access to shut off. Sinking of the

Figure 10: Insulated residential service valves (red circle indicates insulation)

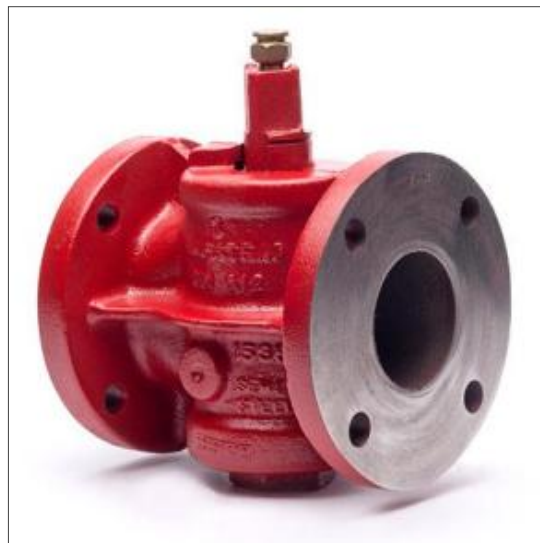
Figure 11: Large commercial valve

Commercial valves require greasing to maintain operational function. Valves in proximity to moisture, salt, and other adverse environmental elements are prone to seizing, leaks and corrosion. These conditions contribute to a high rate of malfunction. Due to corrosive environments sometimes present in industrial and commercial applications, degradation risks are heightened.

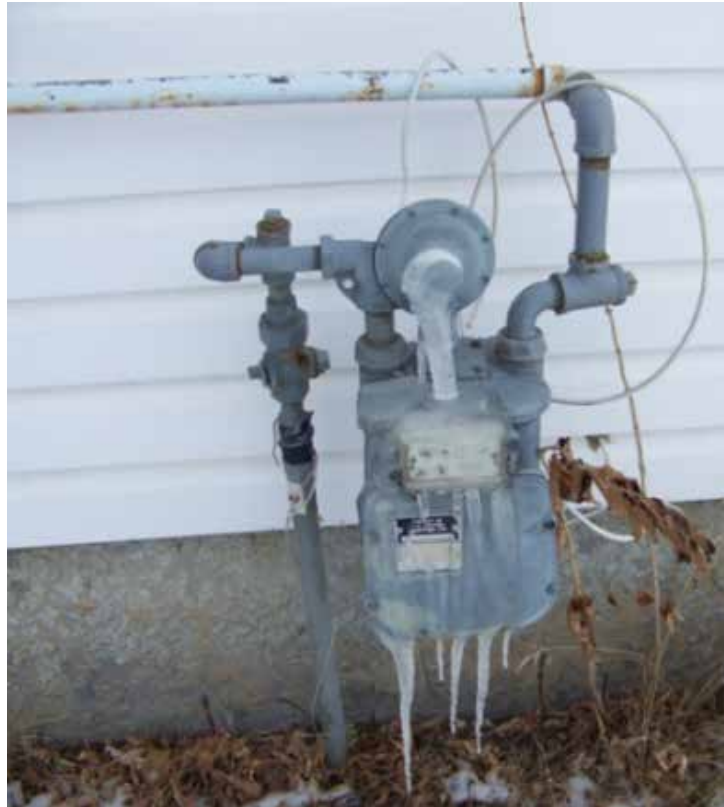
In Manitoba's climate, early spring thaws which lead to melting snow off roof tops can accumulate on meter sets and regulators. Colder nighttime temperatures can then lead to regulators freezing over as shown in Figure 14. This condition can be hazardous if the relief feature of regulator cannot operate and could result in system rated gas pressure entering a residence.²

Figure 14: Frozen over relief vent on residential meter set

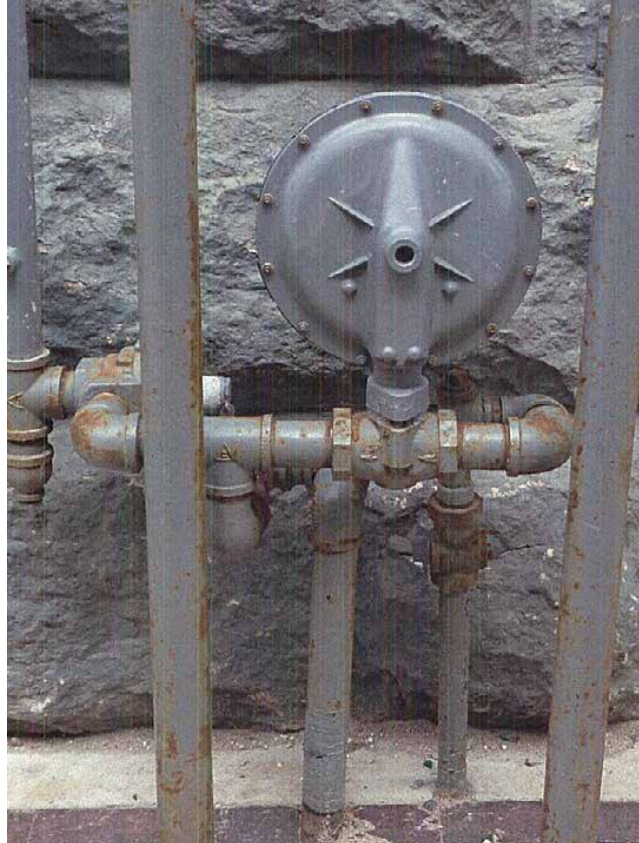
The wall pipe which extends from outside to the inside of a service address is also subject to degradation. Wall pipes on older services often entered the service address below the ground and into a basement. The services are known as below grade entries and an example is shown in Figure 17 below.

Figure 17: Commercial Regulator with Inside Meter Riser installation below grade entry

Unprotected steel pipe that is buried is subject to corrosion, if not adequately coated or cathodically protected.

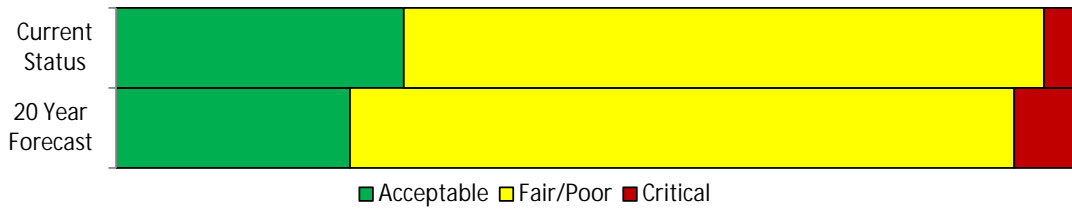
Figure 18 below shows the current and 20 year forecasted asset health for services. The quantity of assets in a state of fair/poor and critical will increase in the next 20 years based on the current rate of replacement. At this current rate, it will take over 100 years to replace all riser assets.

Figure 18: Services “Soccer Field”

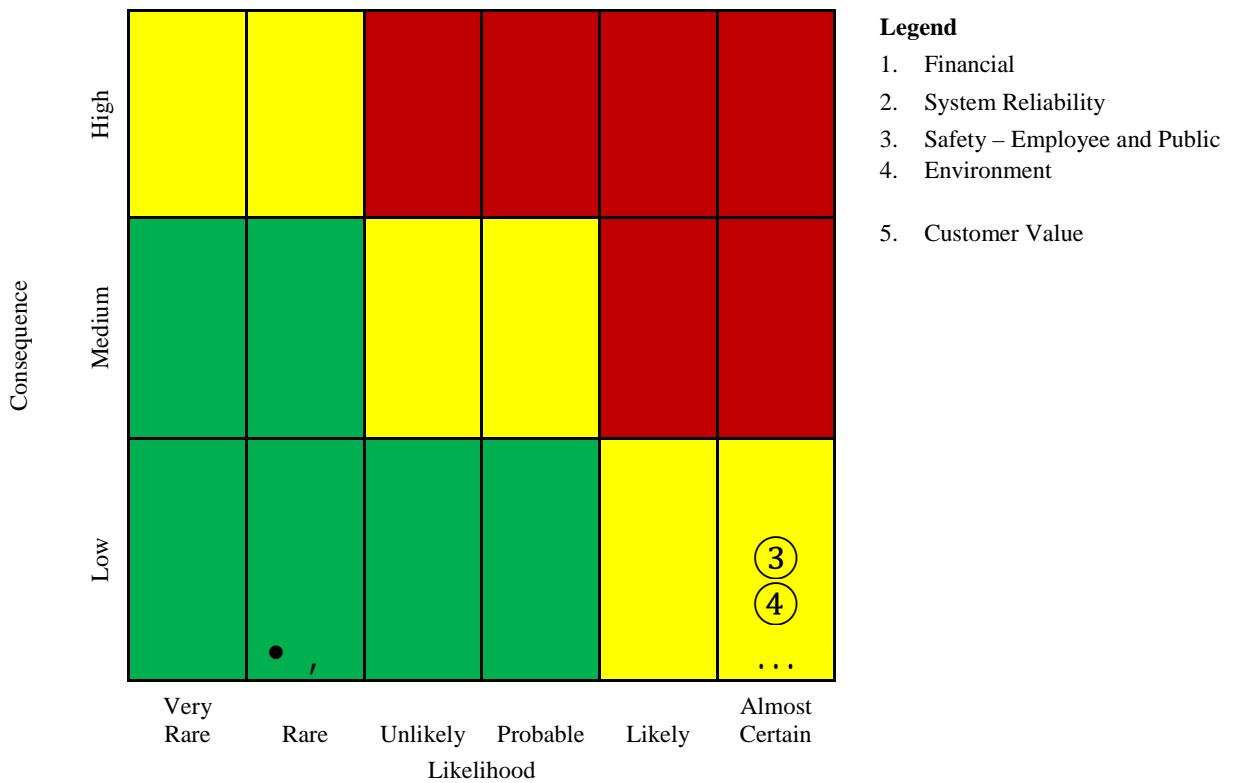
Figure 19: Natural Gas Riser Asset Risk Map and Risk Scoring

1. Financial: An acceleration in the number of risers that reach end of life and require replacement could result in a low financial consequence.
2. System Reliability: A riser failure due to degradation resulting in loss of service to significant number of customers is unlikely and if occurs, would be addressed immediately.
3. Safety – Employee and public: Every year gas blowing occurs due to riser degradation which carries with it a safety risk for employee and public injury.
