BIPOLE III TERRESTRIAL ECOSYSTEMS AND VEGETATION ENVIRONMENTAL MONITORING ANNUAL TECHNICAL REPORT – YEAR V

Prepared for: Manitoba Hydro

Szwaluk Environmental Consulting Ltd.

November 2018

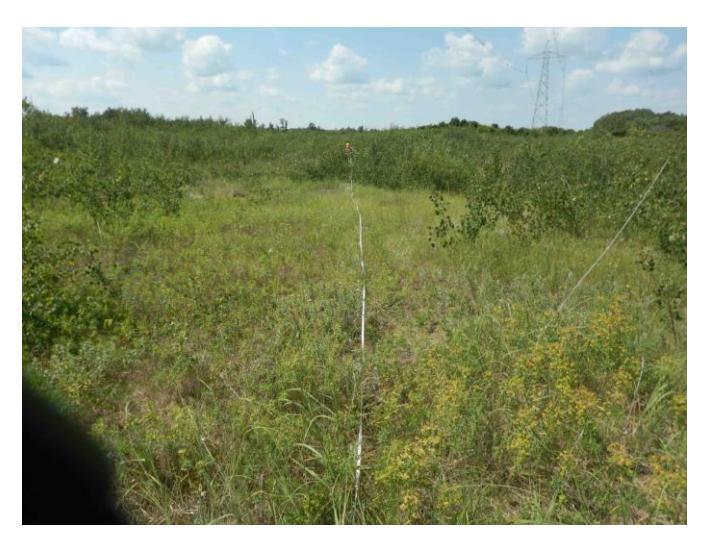
This site is a dry sandy prairie, with trembling aspen (*Populus tremuloides*) and bur oak (*Quercus macrocarpa*) adjacent to the RoW, and currently present as a regenerating layer within the RoW (Photograph 4-1a). Eight rare or uncommon species were found in or incidental to plots (Sand grass –*Calamovilfa longifolia* S3S5; Schweinitz's flatsedge – *Cyperus schweinitzii* S2; silky prairie-clover –*Dalea villosa* S2S3; sand millet – *Dichanthelium wilcoxianum* S2?; beautiful sunflower –*Helianthus pauciflorus* ssp. *subrhomboideus* S3S4; linear-leaved puccoon –*Lithospermum incisum* S3; skeletonweed – *Lygodesmia juncea* S3S4; and sand dropseed –*Sporobolus cryptandrus* S3S5).

Photograph 4-1a. Aspen regeneration and encroachment on the RoW.

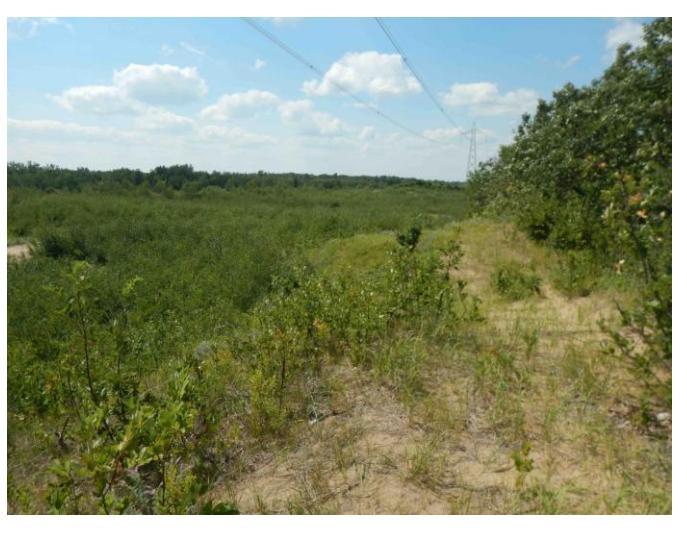
Although mitigation was implemented at the prairie monitoring site (S1-PRA-900), vegetation ground cover showed some disturbance from construction activities. A tower placement is located close to site S1-PRA-900. Machinery used here to establish anchor points has resulted in loss of vegetation cover in and around the tower footprint. The area is extremely sandy, and the ground vegetation is easily disturbed. Abundant bare ground was observed in and around the tower footing area, where outbreaks of several invasive species were also noted this year. ATV tracks elsewhere on the property (both on RoW and off site) have produced bare ground (i.e., sand) with very little vegetation in vehicle tracks. Photograph 4-1b shows sandy soils on the RoW. Noxious and invasive species observed in S1-PRA-900 are discussed in Section 4.5.1. Species of conservation concern - prairie spike-moss (*Selaginella densa*, S3) has not been relocated at sites in this area since 2015, prior to clearing.

Photograph 4-1b. Sandy soils on the RoW.

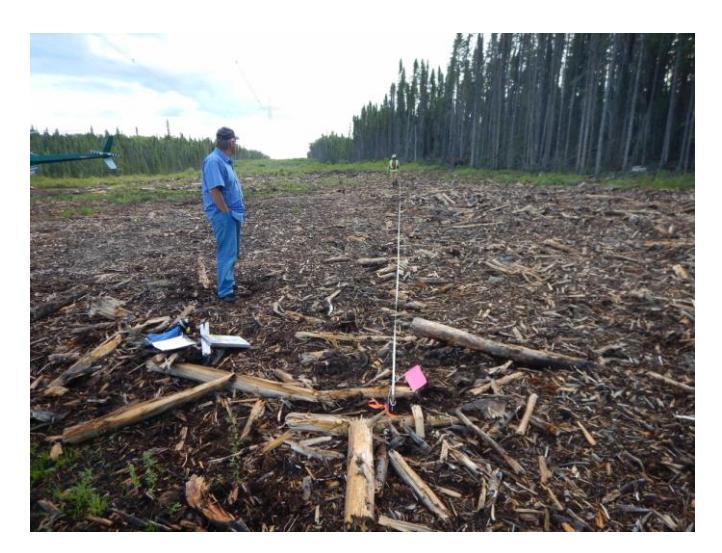
In 2018, all towers were erected and conductor stringing was completed. At monitoring sites, rutting and soil disturbance from construction activities were infrequently observed during ground surveys. However, at plots N1-TER-300 and N2-TER-500 (Photograph 4-2a), construction activity from the previous winter season resulted in ground disturbance and reduced cover of vegetation. At other monitoring sites, construction activity appeared to be confined mostly to the centerline equipment path and tower foundations.

Photograph 4-2a. Ground disturbance on RoW at Plot N2-TER-500.

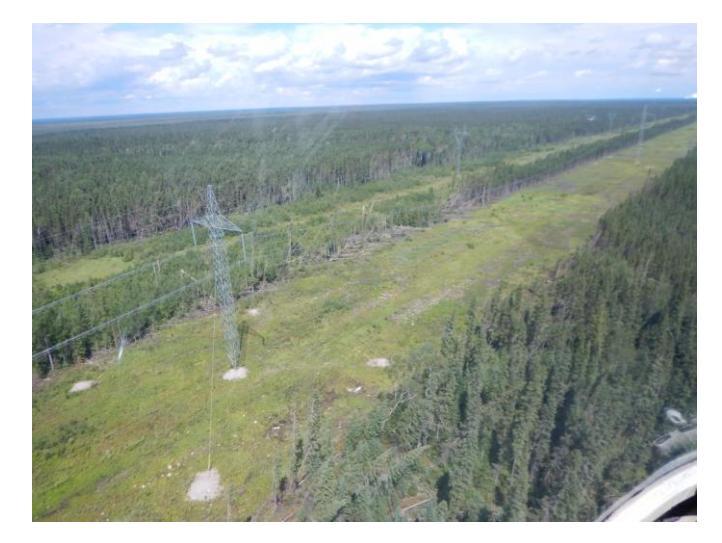
Windthrow or blowdown (uprooted trees) was commonly observed north of The Pas, along the Wuskwatim transmission line (Photograph 4-2b). Both forest edges of the Bipole RoW (east and west) had areas of windthrow. In some sections, the narrow buffer between the two RoW's no longer exists.

Photograph 4-2b. Windthrow observed along the RoW boundary.

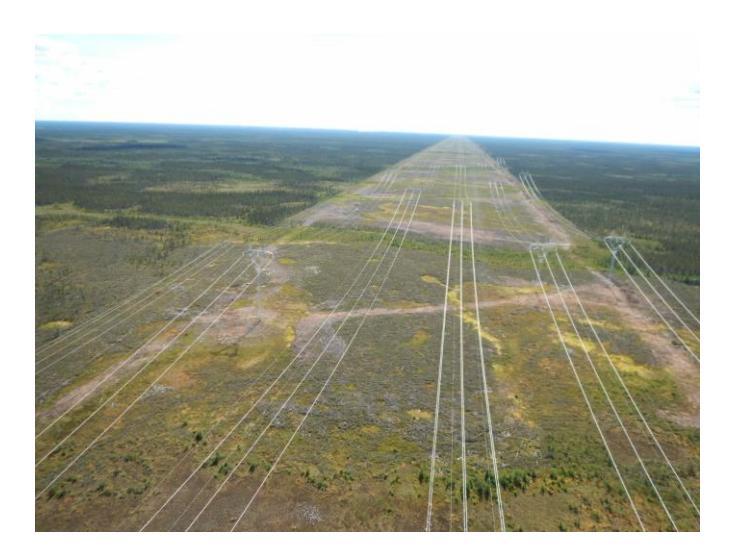
On the AC collector lines/construction power line RoW, vegetation regeneration is occurring in many areas (Photograph 4-2c). Sphagnum moss is beginning to recover in moist places and increased ground cover of herbaceous material was observed on the RoW (i.e., greener appearance this season).

Photograph 4-2c. Vegetation regeneration along the collector lines.
Scraped areas are still present with minimal to no vegetation in some areas. This portion of the RoW appears to have drier site conditions this season. Areas of ground disturbance will be discussed under Recommendations, Section 5.0.

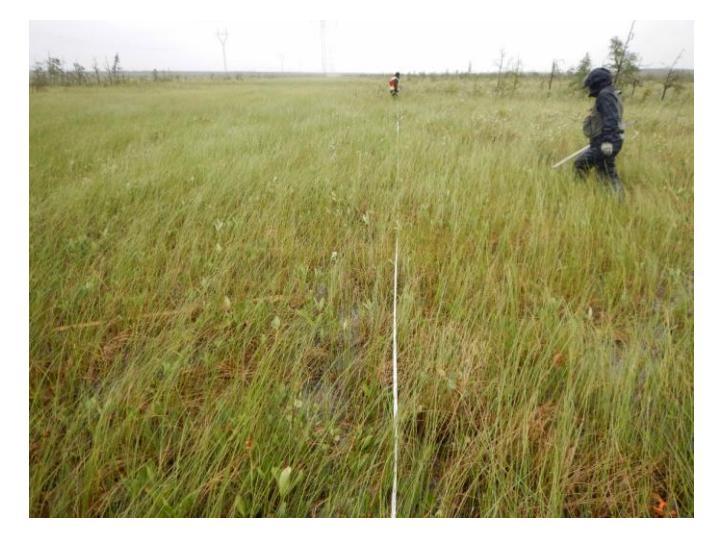
In 2018, all towers were erected and conductor stringing was completed in wetlands sampled. During ground surveys, the wetlands (Sections N3 and N4) showed relatively low disturbance from the recent construction activities. All trees have been previously removed and recent vehicle traffic appeared to utilize mainly existing trails under frozen ground conditions. In several areas, the equipment path showed evidence of travel, but natural revegetation will occur in these areas. Site N3-WET-100 is shown below with low wetland disturbance (Photograph 4-3a).

Photograph 4-3a. Site N3-WET-100 with low wetland disturbance.

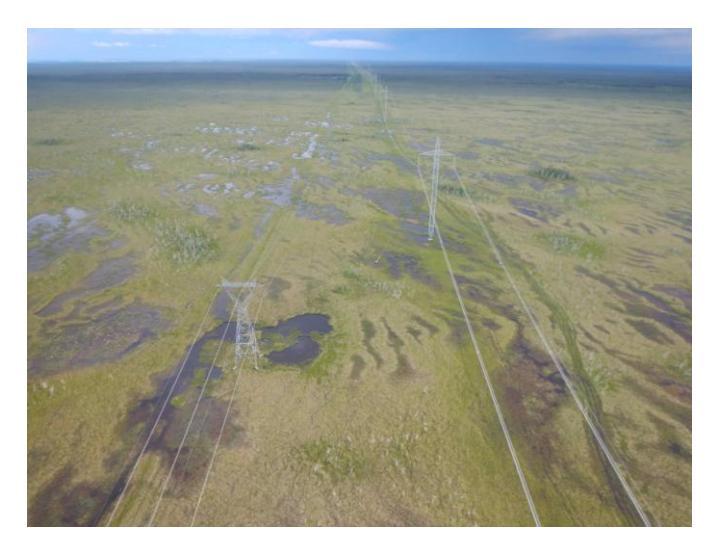
Water levels in many areas of the RoW were observed to be higher than in previous years, possibly a result of increased winter snow melt or greater precipitation during the spring and early summer season. Several sampled wetlands were observed with high water levels (e.g., N3-WET-200 - 90%; N3-WET-300 - 100%; N4-WET-400 - 100%). High water levels were recorded in previous years in some wetlands sampled (e.g., N4-WET-400). Photograph 4-3b shows wetland N4-WET-400, with high water levels, where the equipment path deviated from the RoW centreline path. This was a result of avoiding the tower foundation and construction activities.

Photograph 4-3b. Wetland showing equipment path off centreline.

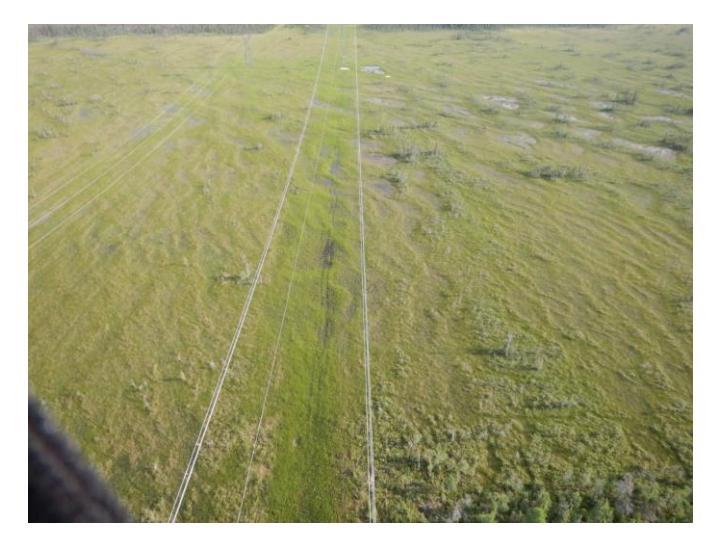
Wetland disturbance was also documented during aerial inspection of Sections N1, N2, N3 and N4. Except for initial clearing in 2014 where disturbance and tree removal were reported, wetland disturbance on the RoW was low overall in 2018 from construction activities. The equipment path and tower foundations showed evidence of recent construction activity and travel (Photograph 4-3c), but disturbance beyond these areas was generally low.

Photograph 4-3c. Patterned fen wetland with low disturbance.

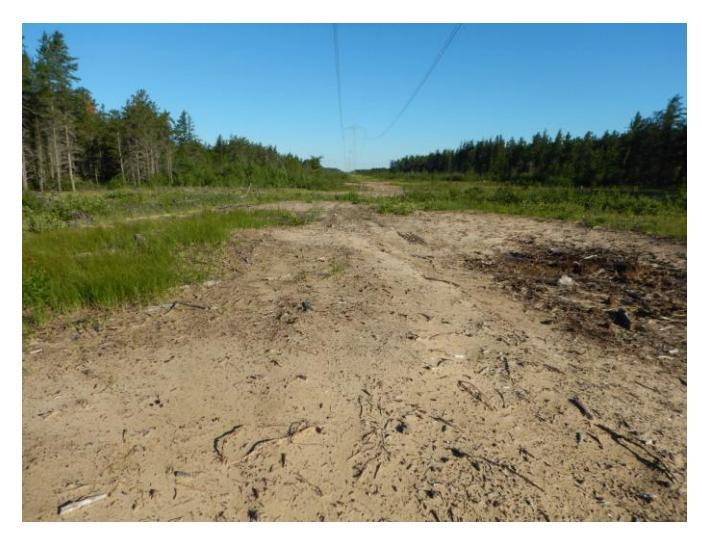
Low ground disturbance from construction activities was observed in the Cowan Resource Area, except at foundation sites where soils were generally exposed. Vegetation cover along the equipment path was noted as sparse in areas from equipment travel. In a localized area, near monitoring plots C1-ATK-300 and C1-ATK-400, exposed sandy soils were again observed along the equipment path (Photograph 4-4b). Exposed soils were previously observed at this site, and false heather (*Hudsonia tomentosa*, S3) was recorded in this sensitive area. Vegetation in these habitats is easily disturbed from heavy equipment travel and construction activities. Similar sandy areas adjacent to the

Photograph 4-4b. Exposed sandy soils along the equipment path.

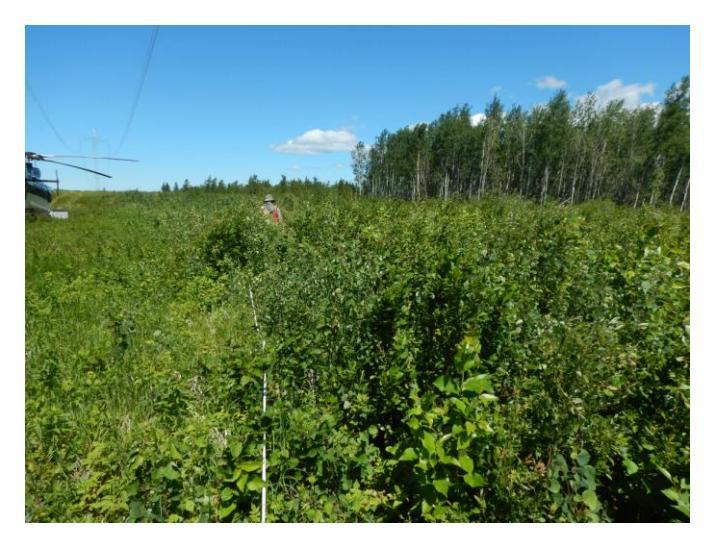
In other parts of the RoW, open areas supported dominantly native grasses and forbs. Little regeneration was observed at some sites where ground cover was mostly litter (e.g., C1-ATK-100, C1-ATK-700). Elsewhere, tall shrub cover (>1m height) is dominating the RoW with species of trembling aspen (*Populus tremuloides*) and green alder (*Alnus viridis*). Bebb's willow (*Salix bebbiana*), pin cherry (*Prunus pensylvanica*) and Saskatoon (*Amelanchier alnifolia*) were also observed as tall shrubs on the RoW. Photograph 4-4c shows the regeneration of tall shrub vegetation on the RoW.

Photograph 4-4c. Regeneration of tall shrub vegetation.

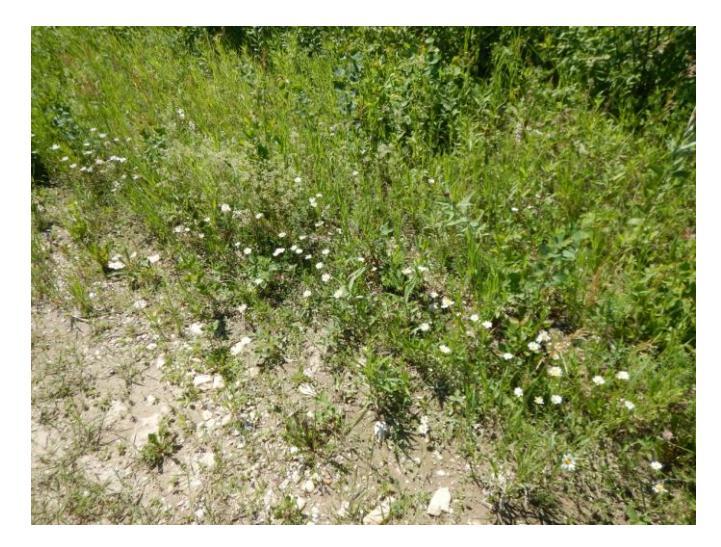
In Sections C1, C2, and N4 (south of the Red Deer River), non-native and invasive species were observed during ground surveys in monitoring plots. Management should occur to reduce their potential spread. Invasive outbreaks of field sow-thistle were observed at C1-INV-500 and N4-INV-500; Canada thistle (*Cirsium arvense*) at C1-INV-200; and sweet clover (*Melilotus* spp.) at C1-INV-400 and N4-INV-500. Ox-eye daisy was observed again near plot C1-INV-300, throughout the ditch (Photograph 4-5a). This species has the ability to spread rapidly in favorable habitats. No major rutting issues or soil disturbances from the previous year of construction activities were observed during ground surveys at monitoring sites. Construction activity appeared to be confined to the centerline equipment path and tower foundations.

Photograph 4-5a. Ox-eye daisy observed at C1-INV-300 along the RoW.

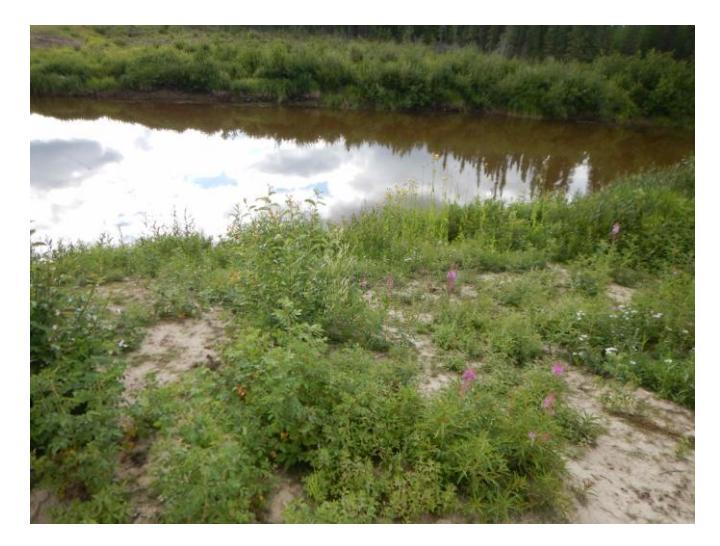
Few non-native and invasive species were observed during plot surveys in Section N1, east of Hunting River and along the northern AC collector lines and construction power line. Invasive species were not problematic in this area of the Project in 2018. Field sow-thistle and white sweet clover were observed along the centerline equipment path at the Limestone River, near N1-INV-500 (Photograph 4-5b).

Photograph 4-5b. Invasive species observed near N1-INV-500.

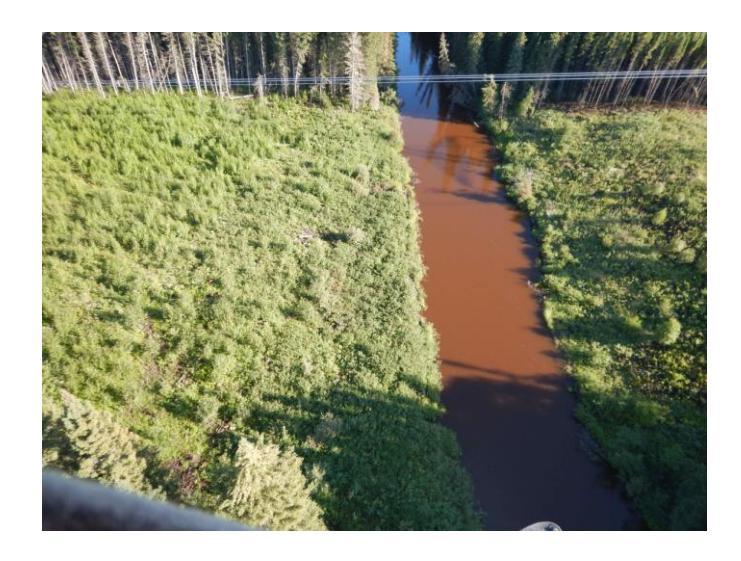
In 2015, two water crossings were observed with established erosion control measures. Follow-up monitoring occurred again in 2018, to evaluate erosion control and rehabilitation success. At the Mitishto River (479170 E and 6050339 N) in Section N3, an aerial evaluation could only be conducted. The helicopter (Bell 207) was unable to access the site as a result of tall trees adjacent to the RoW and increased shrub cover on the RoW, limiting access with the conductors strung. Fibre blankets were formerly installed at this site to maintain the river bank from exposed soil. No disturbance or erosion were visible and river banks were vegetated with shrub and graminoid cover (Photograph 4-7a). The water level of the Mitishto River was high this season.

Photograph 4-7a. Mitishto River with vegetated river banks.

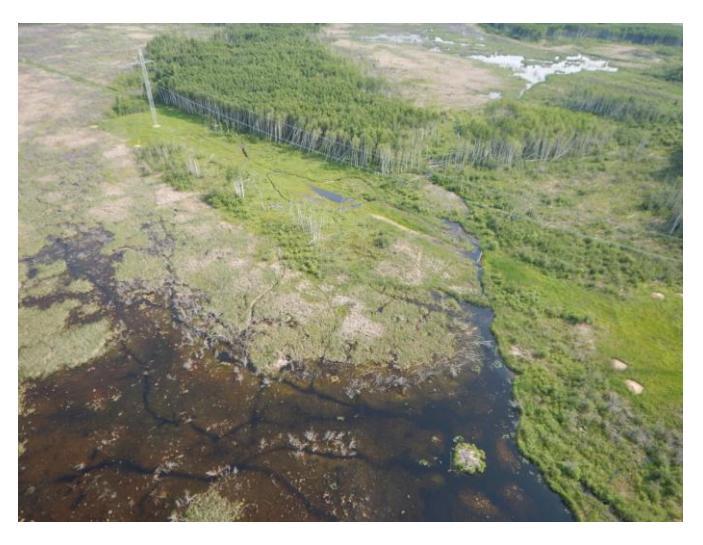
In early spring of 2017, construction activities resulted in disturbance of vegetation and ground conditions at Slug Site (404388 E, 5751244 N) in Section C1. Ground disturbance included heavy rutting and a trench that was excavated to divert water flow during construction. Rehabilitation recommendations were identified to include stabilizing the watercourse, grading material during suitable ground conditions and to allow for natural revegetation. In 2018, the site was revisited but was assessed from the air as a result of unsafe landing conditions at the site (Photograph 4-7b). The trench was still visible at the site and rehabilitation at this time would not be possible as a result of wet ground conditions. The nearest tower immediately to the south provided a landing spot to assess the site at ground level. The vegetation was naturally regenerating with increased cover of shrubs and marsh vegetation (e.g., common cat-tail - *Typha latifolia*) as compared to last season. This site should be re-assessed in 2019.

Photograph 4-7b. Vegetation recovery at Slug Site.

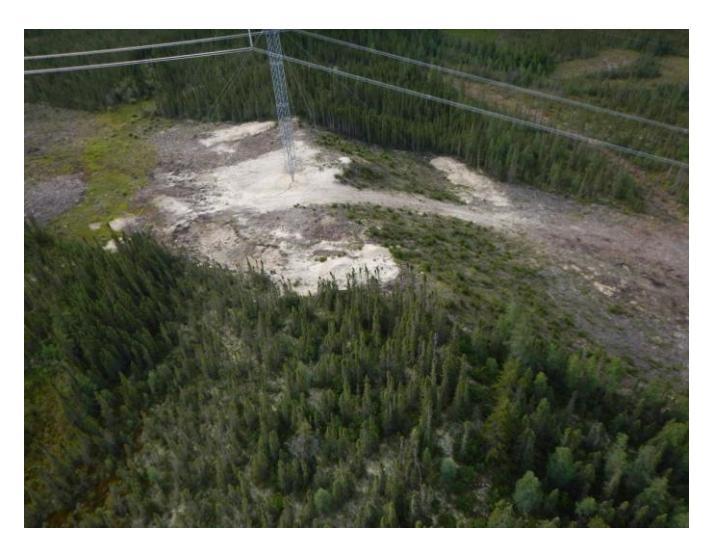
At RHB-516 and RHB-517, erosion control blankets were also installed on moderate (10-15%) and strong slopes respectively but sparse vegetation cover was observed at the sites. Rills causing erosion occurred on surface slopes at RHB-491 and RHB-510, both without erosion control. Other sites without erosion control and sparse vegetation on slopes (moderate to strong) include RHB-70 (Photograph 4-7c) and RHB-81.

Photograph 4-7c. Exposed soil on sloping terrain at RHB-70.
