# Birtle Transmission Project Environmental Effects Monitoring Report

Prepared by: Manitoba Hydro Winnipeg, Manitoba March 2023

### **Environmental Effects Monitoring Report 2022**

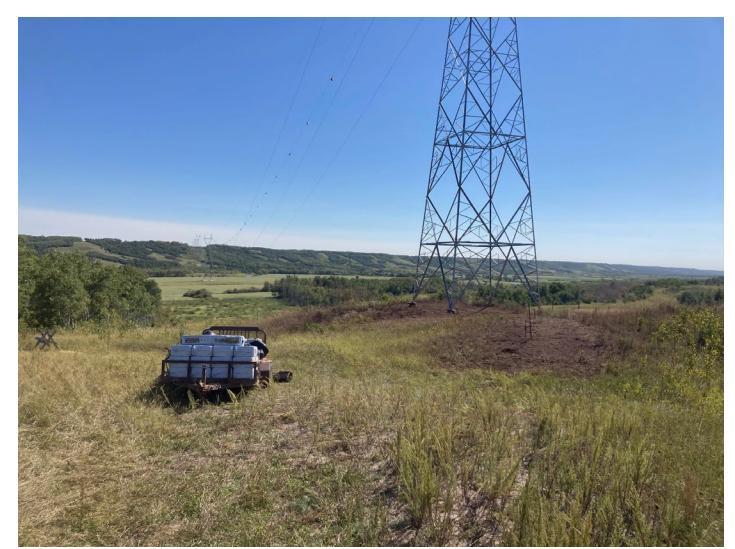
Photo 1. The Birtle Transmission Project was completed in March 2021.

The project began with public and Indigenous engagement in fall 2016 to spring 2017. Manitoba Conservation and Climate (MCC) granted a licence for the Project on January 14, 2020. Construction activities began in July 2020. The construction contract was awarded to a joint venture between Birdtail Sioux Dakota Nation and Forbes Bros (BFJV). The project was completed in March 2021 (Photo 1).

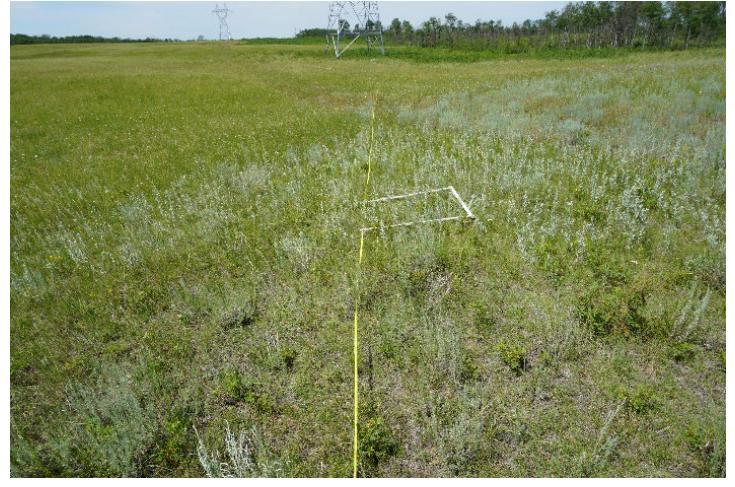
Photo 3. Grassland site with higher cover of traditional use plants, adjacent to an existing trail.

The EA predicted a decline in traditional use plant species. This result was not identified in the 2022 monitoring program. The composition and abundance of traditional plants were comparable with preconstruction conditions. In 2022, a total of 22 traditional use plant species were observed, comparable to preconstruction surveys (21 species) and 2021 (23 species) (Photo 3).

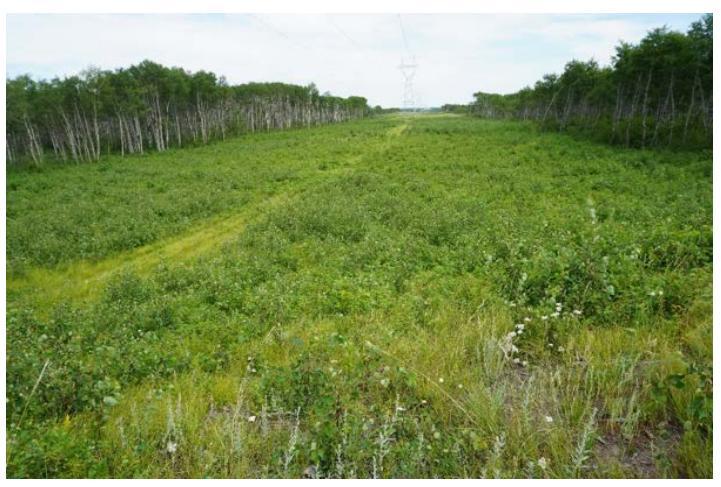
Photo 4. Previous forest clearing in the ROW.

The EA predicted an increase in invasive and non-native plants in grassland habitats. This result was not identified in the 2022 monitoring program. Surveys showed nonnative species were virtually absent from grassland sites on the ROW. Only two non-native species were recorded within the grassland survey plots within the Spy Hill Community Pasture; common dandelion and smooth brome. No Tier 1 or 2 noxious species were observed during the monitoring program (Photo 4).

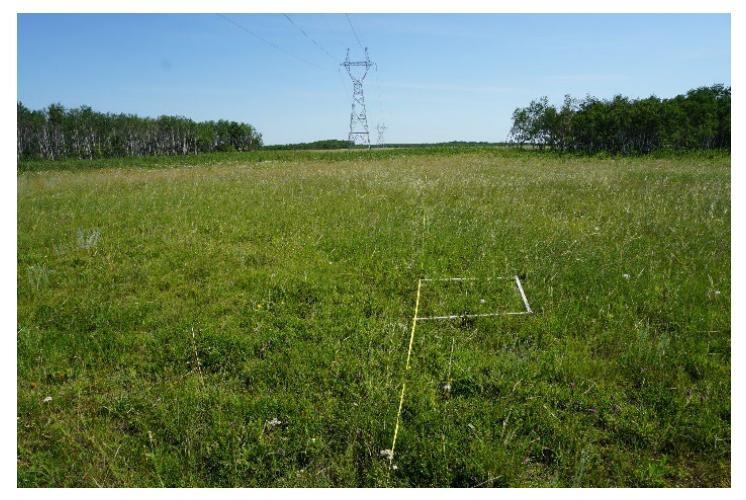
Photo 6. Grassland site within the right of way in the Spy Hill Community Pasture.

Mitigation measures included project routing to avoid open grasslands and the installation of bird flight diverters and avian perch deterrents (Photo 6). Project routing and bird diverters appeared to be effective at lowering effects on grassland bird species. Although some breeding bird species declines were observed, they were unlikely directly attributable to the Project.

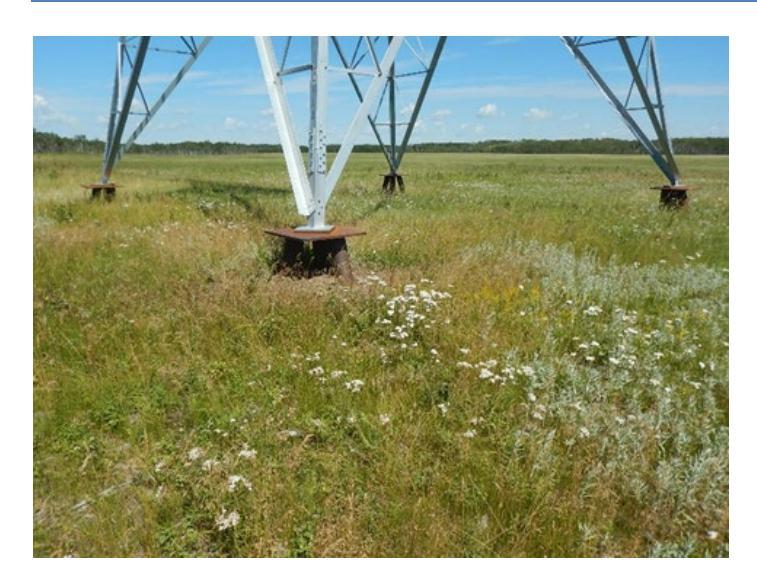
Photo 7. Grassland habitat under a tower foundation.

Through environmental monitoring, it was determined that the recommended mitigation was implemented and effective for forested habitat, according to the minimal disturbance observed from construction activities (Photo 7). In particular, the mitigation techniques used to address soil and vegetation disturbance through surface damage, rutting and erosion, and the mitigation around tower erection and foundations were all successful in reducing or eliminating instances of forested habitat disturbance. Although an approved native seed mix was purchased and on hand, it was not required for use in the Spy Hill Community Pasture. A patch of sweet clover plants was found on the right of way in the pasture and picked by hand and removed.

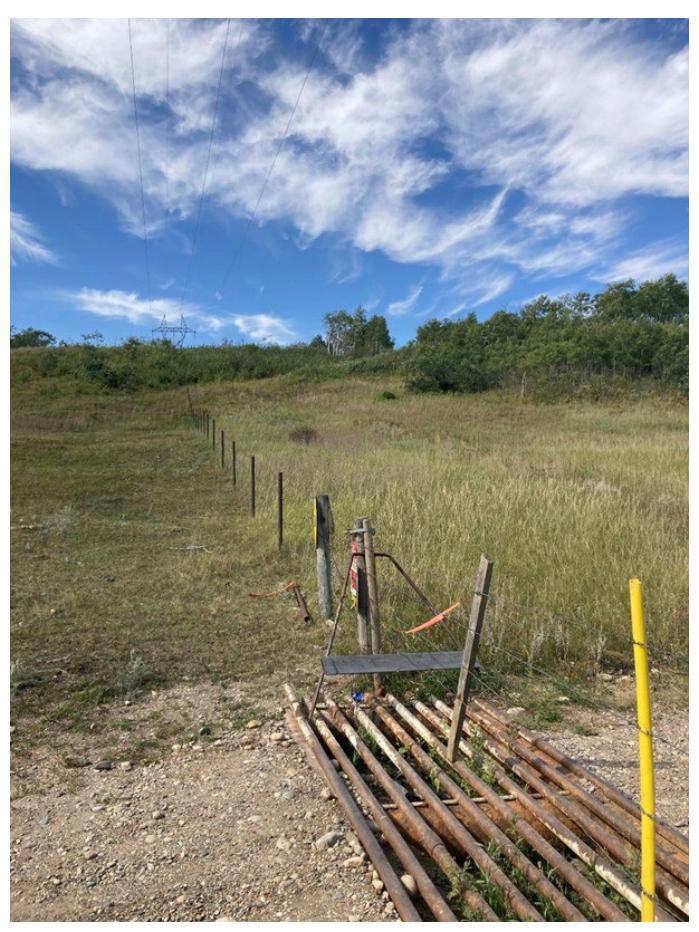
Photo 8. The decommisioned access trail into the Spy Hill Community Pasture was fenced and gated by the private landowner after construction.

Predator and resource user access monitoring was conducted in 2022. The new access trail into Spy Hill Community Pasture has been re vegetating and remains largely inaccessible as the private landowner has fenced and gated their property. A site visit in September and November 2022 showed no evidence of vehicle traffic on the access trail since its decommissioning (Photo 8).

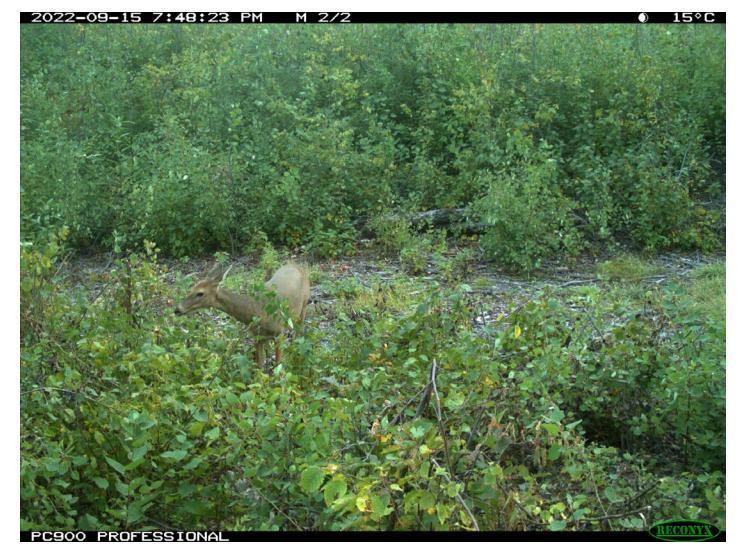
Photo 9. White-tailed deer on the decommisioned access trail in the Spy Hill Community Pasture in 2022.

Trail camera monitoring of the decommissioned access trail on the Spy Hill Community Pasture was primarily used by white-tailed deer. (Photo 9). Although the Spy Hill Community Pasture property boundary is fenced and maintained with no defined vehicle trail, two instances of a black bear and coyote movements were captured on a trail camera (Photo 10). Vehicle use included four pick-up trucks and three ATVs travelling near the ROW or along the boundary fence line. All vehicles turned around when they encountered the boundary fence. Two people on foot, who appeared to be hunters, were also detected.

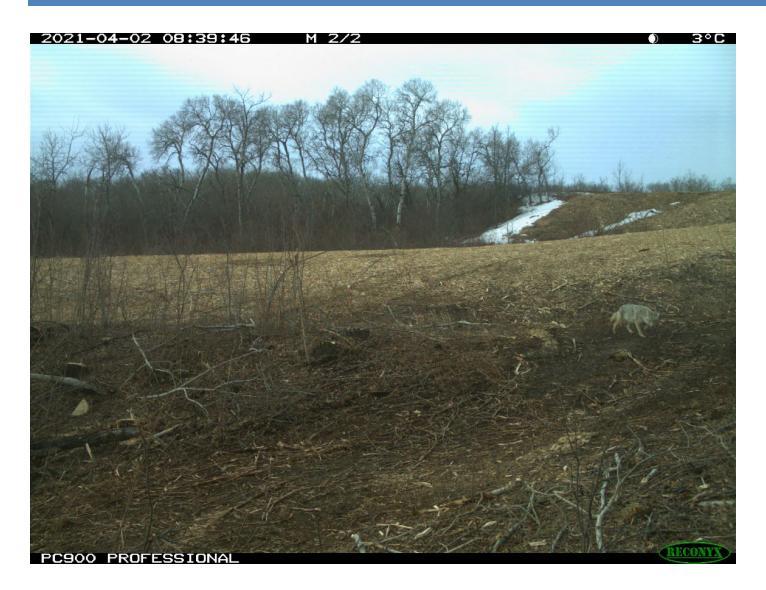
Photo 10. A coyote captured on a camera trap shortly after decommissioning.

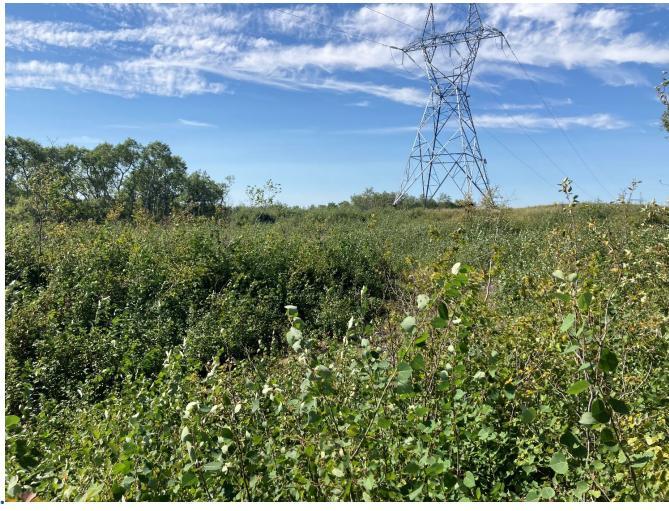
Photo 11. Vegetation regrowth on the decommissioned access trail in the Spy Hill Community Pasture in 2022.

Overall, there was little observed effect of the decommissioned access point on predators and no increase in access by resource users (Photo 11).
