BIRTLE TRANSMISSION PROJECT Construction Environmental Protection Mapbook

Version: Final 1.0

Date: June 08, 2020

Document Owner: Licensing and Environmental Assessment Department Transmission Planning and Design Division Transmission Business Unit Manitoba Hydro

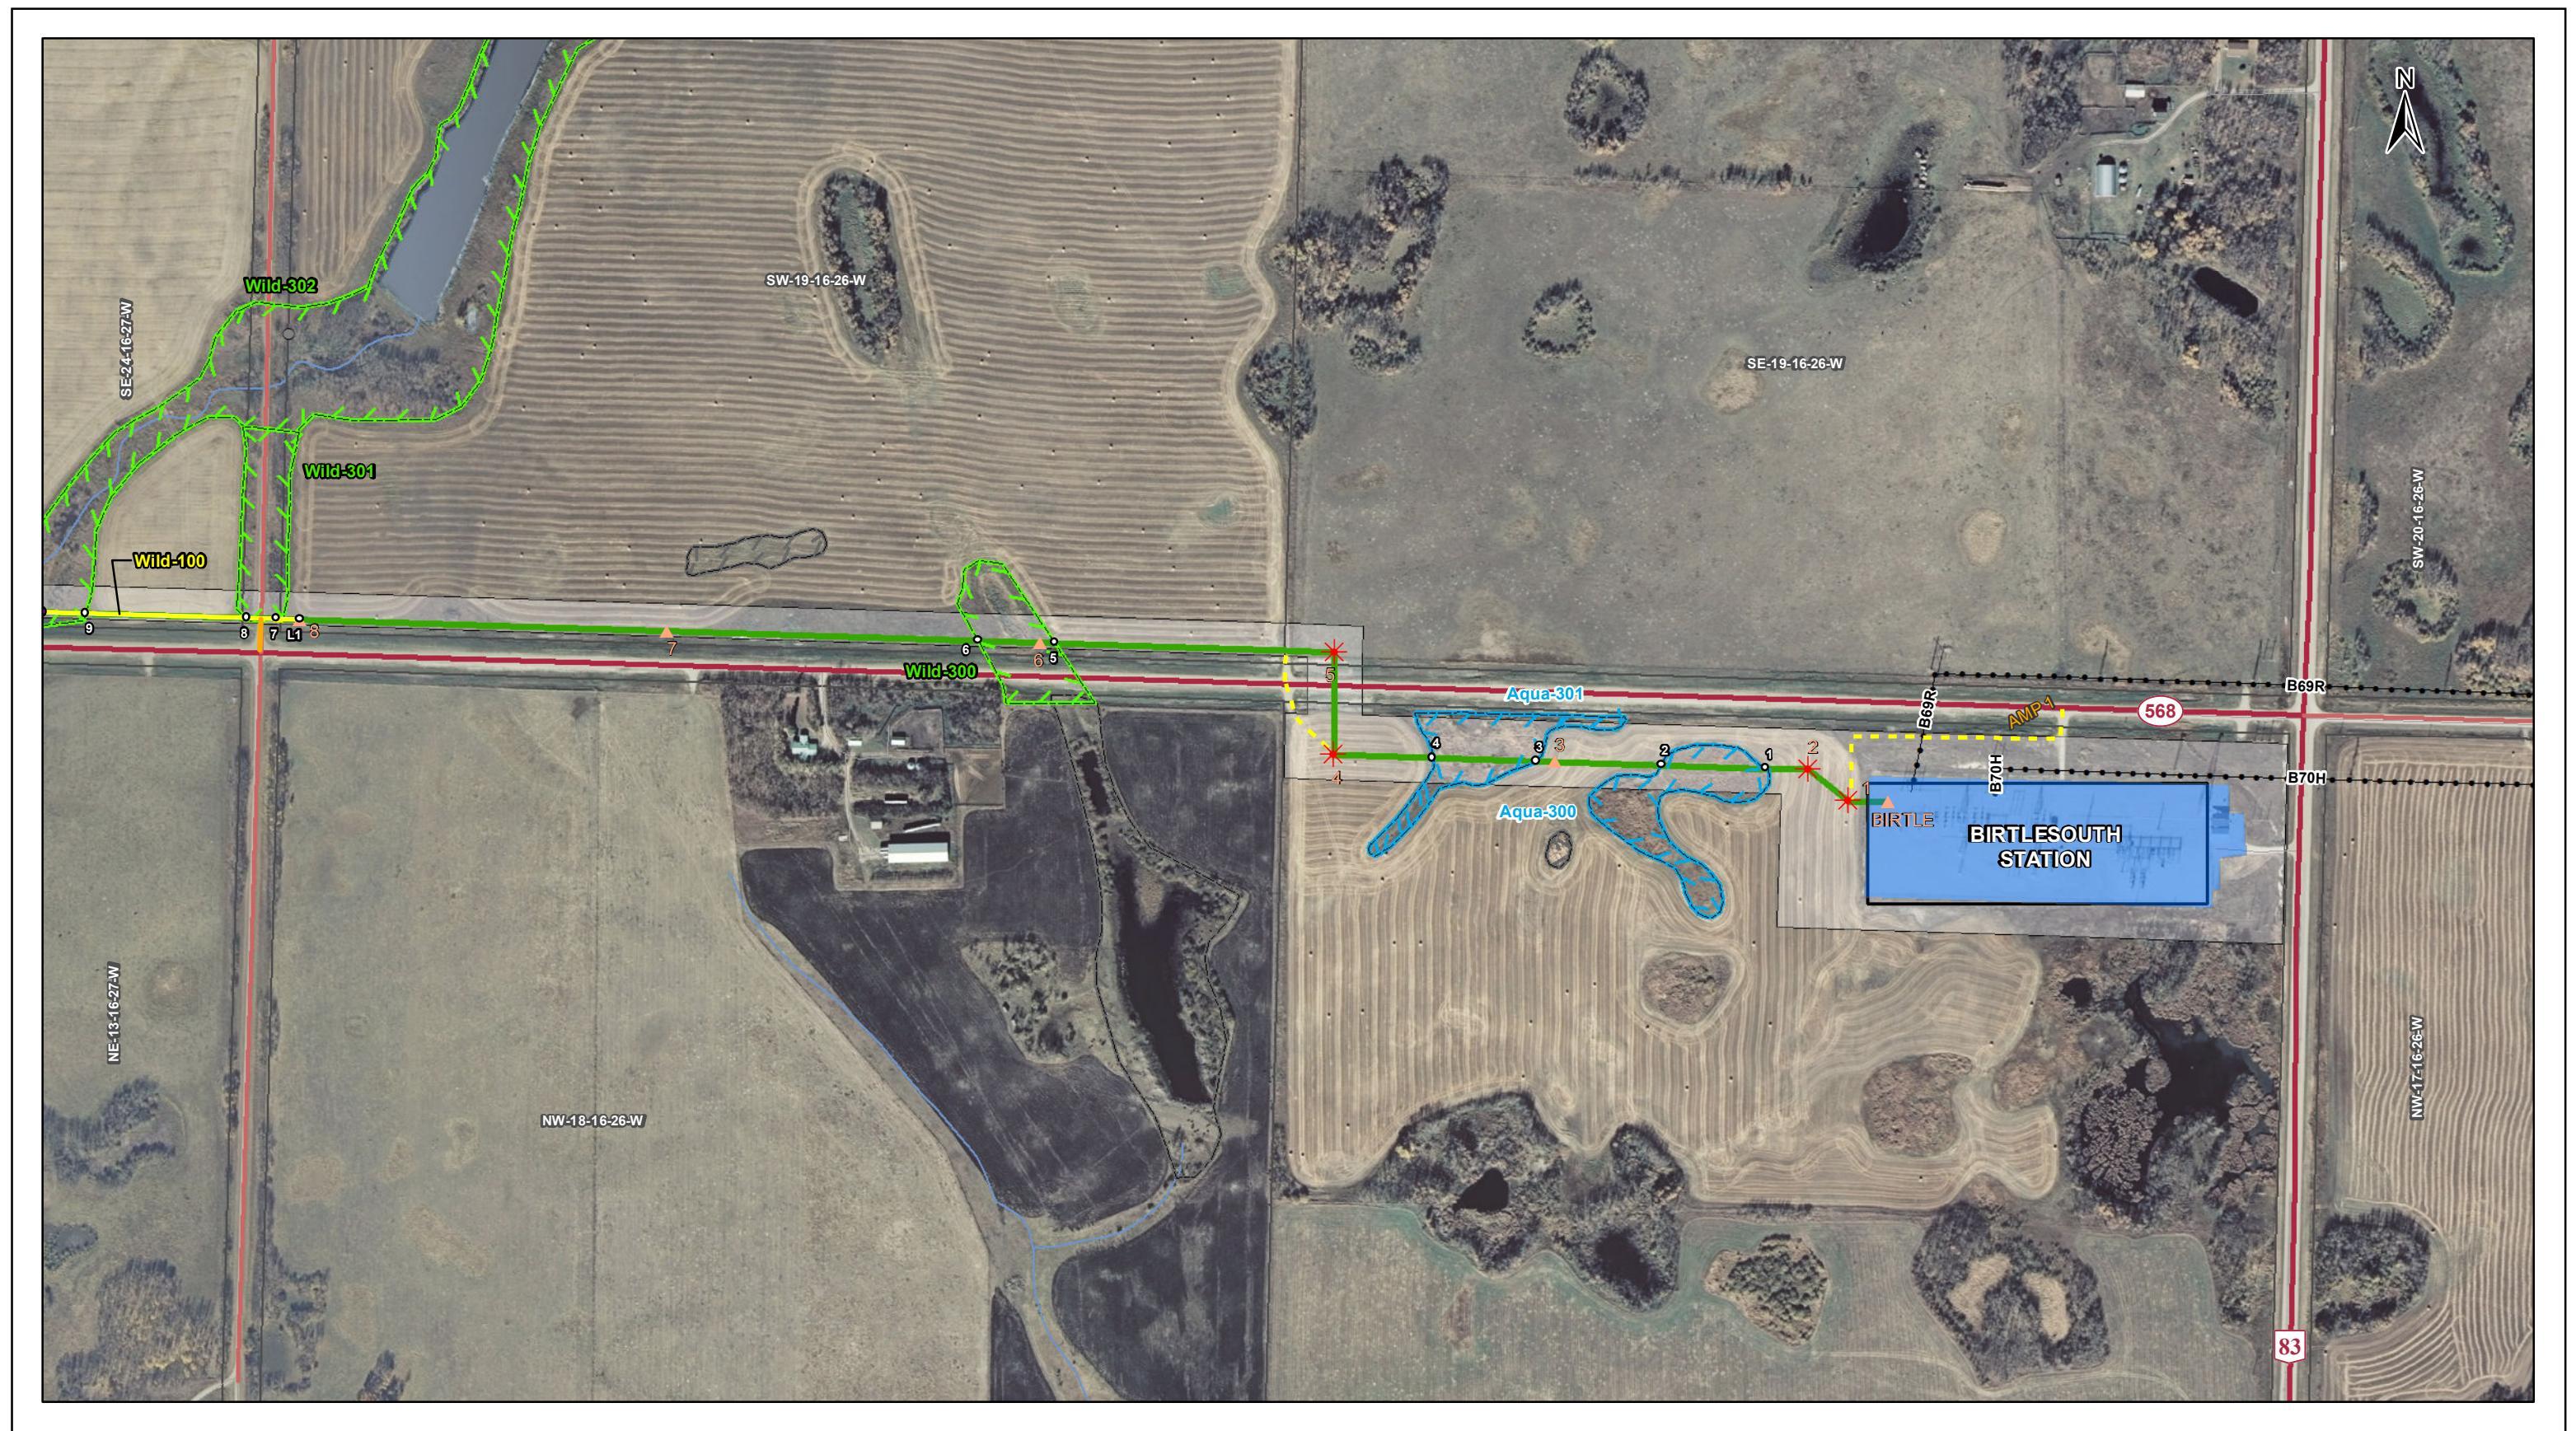
ESS ID	ESS Name	Site	Start	Stop	Distance (m)
Wild-100	Bird diverter installation area	L1 to L2	E-353440 N-5582185	E-353097 N-5582195	343

Potential Effects:

Higher risk of wire collision, Risk of wire collision is localized to the right-of-way

Specific Mitigation (ID# 827):

- As per industry standards, bird diverters will be installed in a manner to maximize visibility by alternating between reflective and spiral diverters along the two skywires
- Install bird diverter with spacing as per Transmission Line Design specifications for these spans

ESS ID	ESS Name	Site	Start	Stop	Distance (m)
Wild-300	Western tiger salamander site	5 to 6	E-354047 N-5582166	E-353984 N-5582168	62

Habitat loss and contamination from structure foundations & installations; wetland contamination and loss of breeding and summering habitat from loss/deterioration of riparian vegetation

Specific Mitigation (ID# 831):

- Carry out construction activities on frozen or dry ground to minimize surface damage, rutting and erosion. Construction matting will be used to protect the area from rutting and exposure to mineral soil during nonfrozen ground conditions
- Identify and flag a 30 m vegetated (shrub and herbaceous) buffer around site
- Remove trees by low ground disturbance methods within buffer
- The application of herbicides is prohibited
- Maintain shrub and herbaceous vegetation to the extent possible
- If construction activity is required within this area between April 15 to June 1st all lifestages of amphibian will be captured and removed during a sweep survey
- If construction activity is required within this area between April 15 to June 1st exclusion fencing needs to be installed around the site after a sweep survey and prior to work taking place

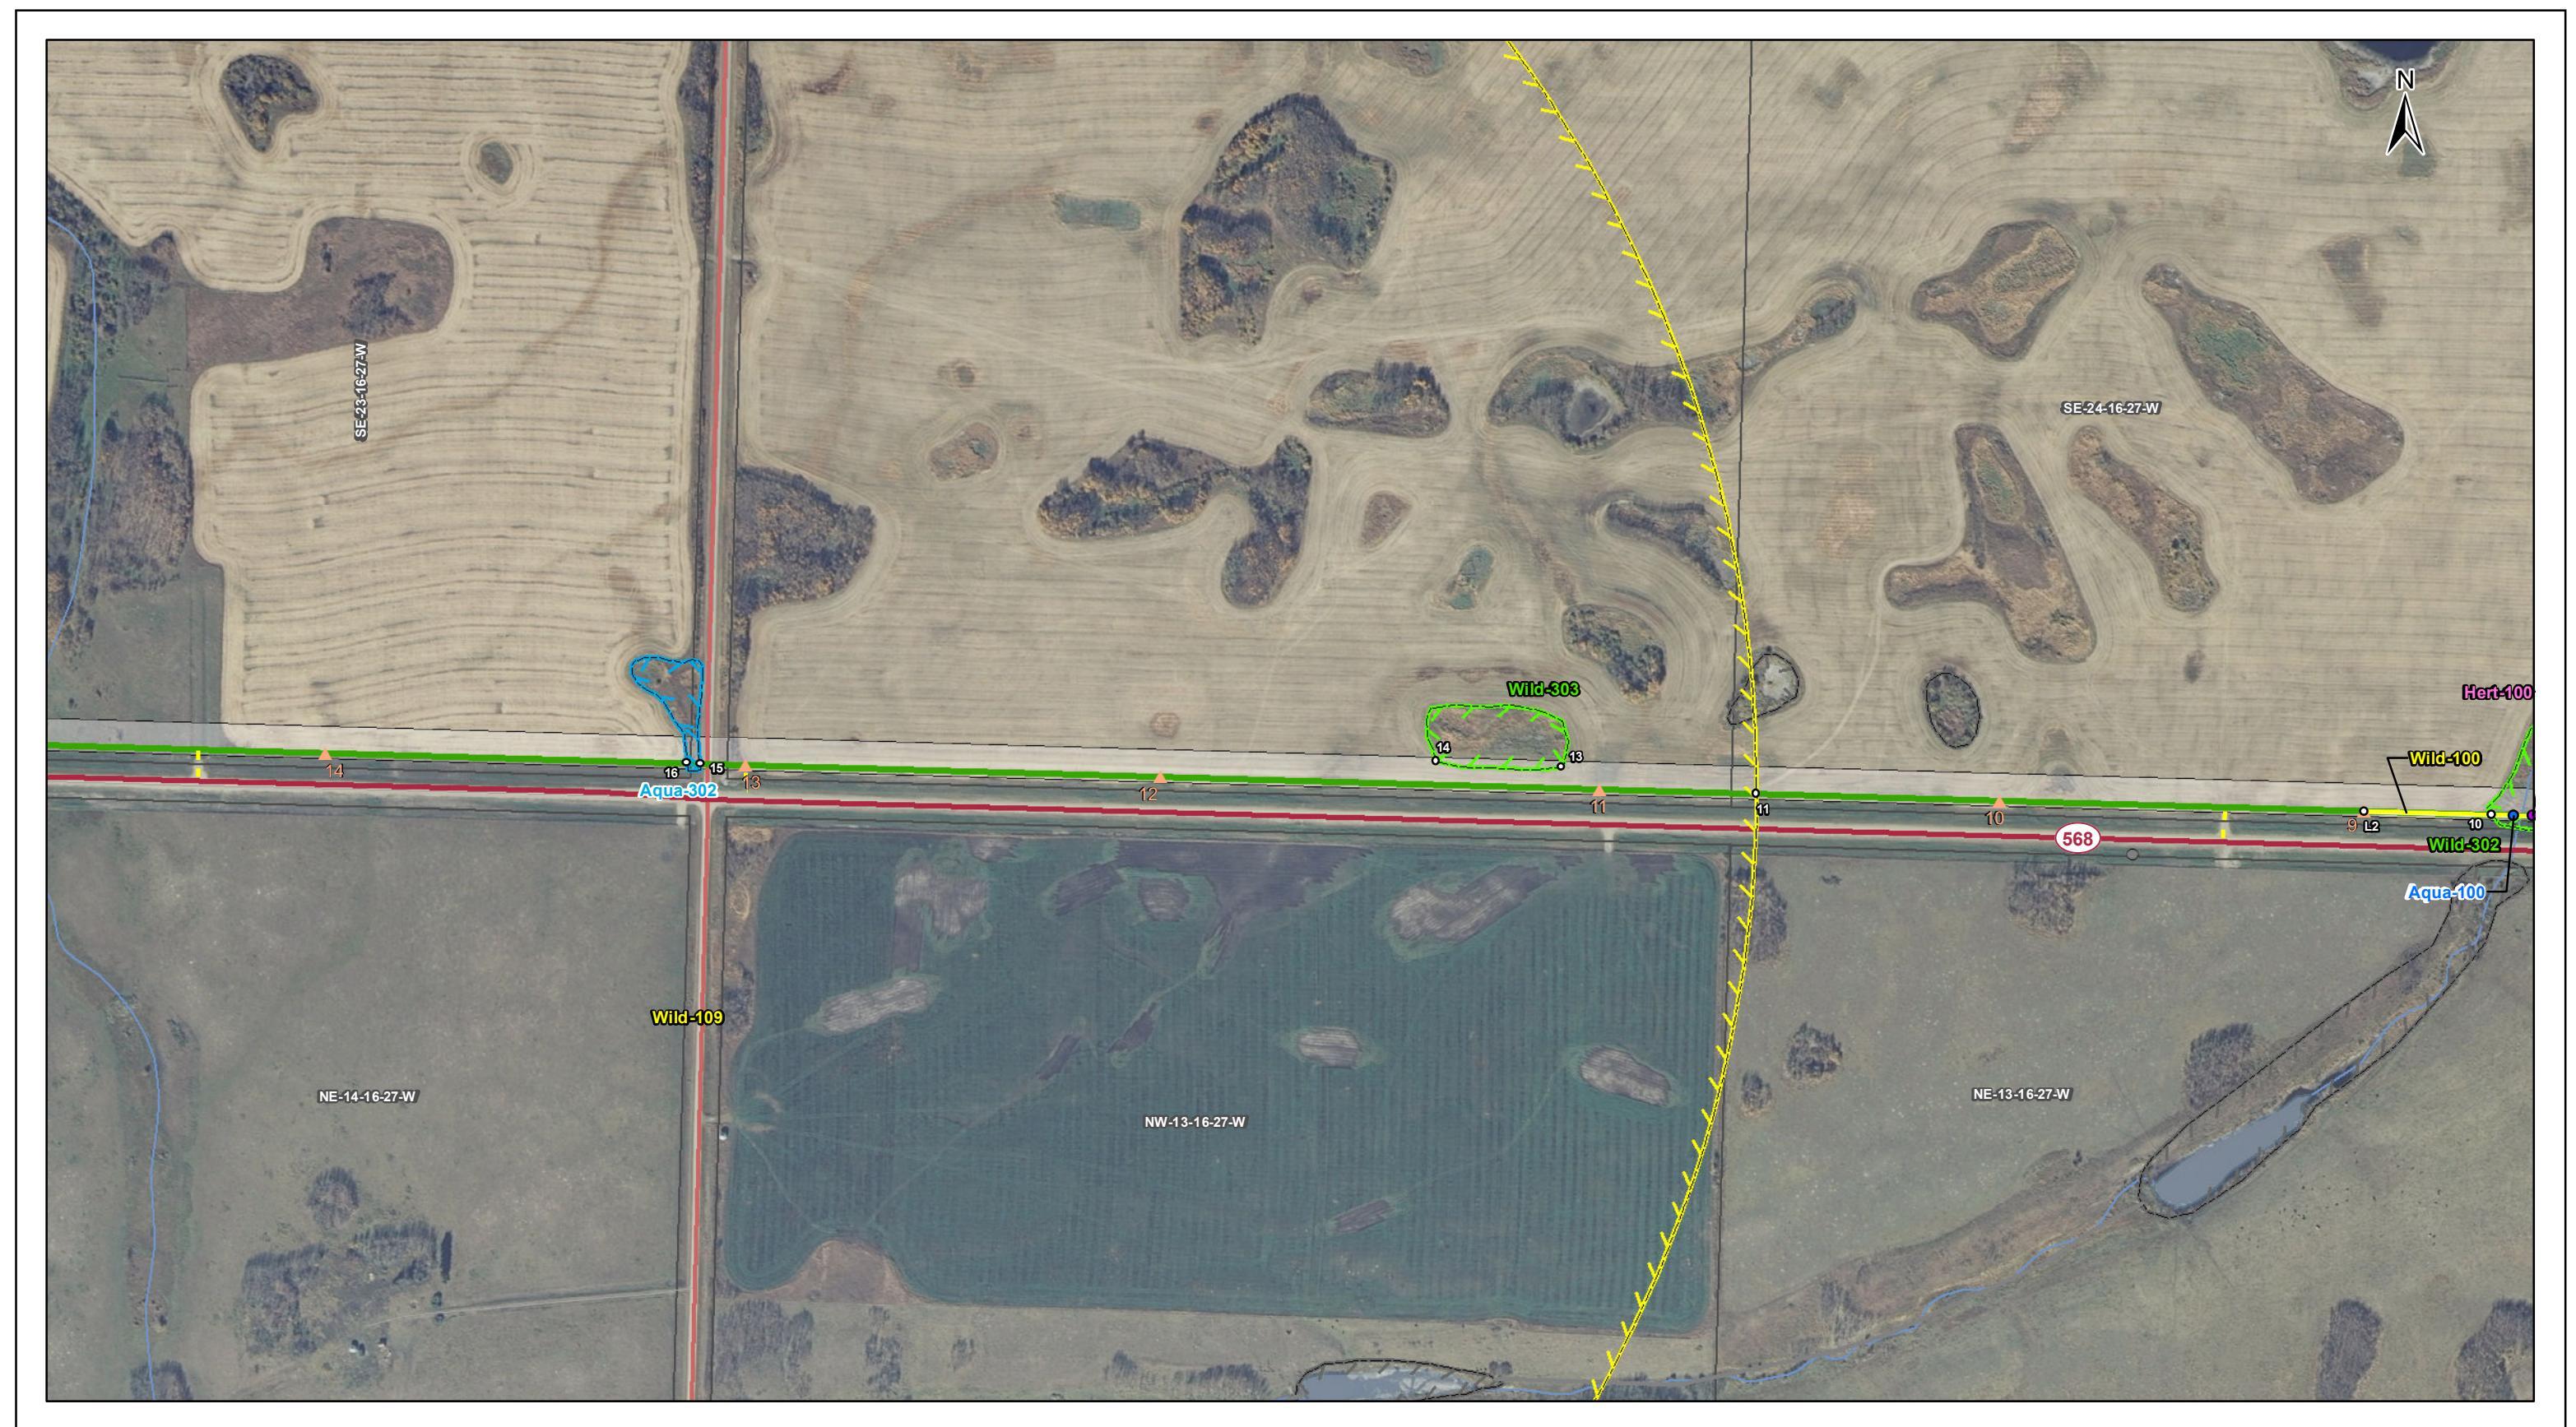
ESS Group: Archaeological

- Carry out construction activities on frozen or dry ground to minimize surface damage, rutting and erosion. Construction matting will be used to protect the area from rutting and exposure to mineral soil during nonfrozen ground conditions
- Confine traffic to established trail
- Hand-clearing or other low disturbance clearing approved by the Project Archaeologist within the area
- Identify and flag a 30m buffer around site, if not within designated riparian buffer
- In the event of a discovery stop work in area and contact the Project Archaeologist immediately. Refer to Cultural and Heritage Resources Protection Plan for further guidance
- Should heritage resources be discovered during a pre-construction survey the project Archaeologist may prescribe additional mitigation measures

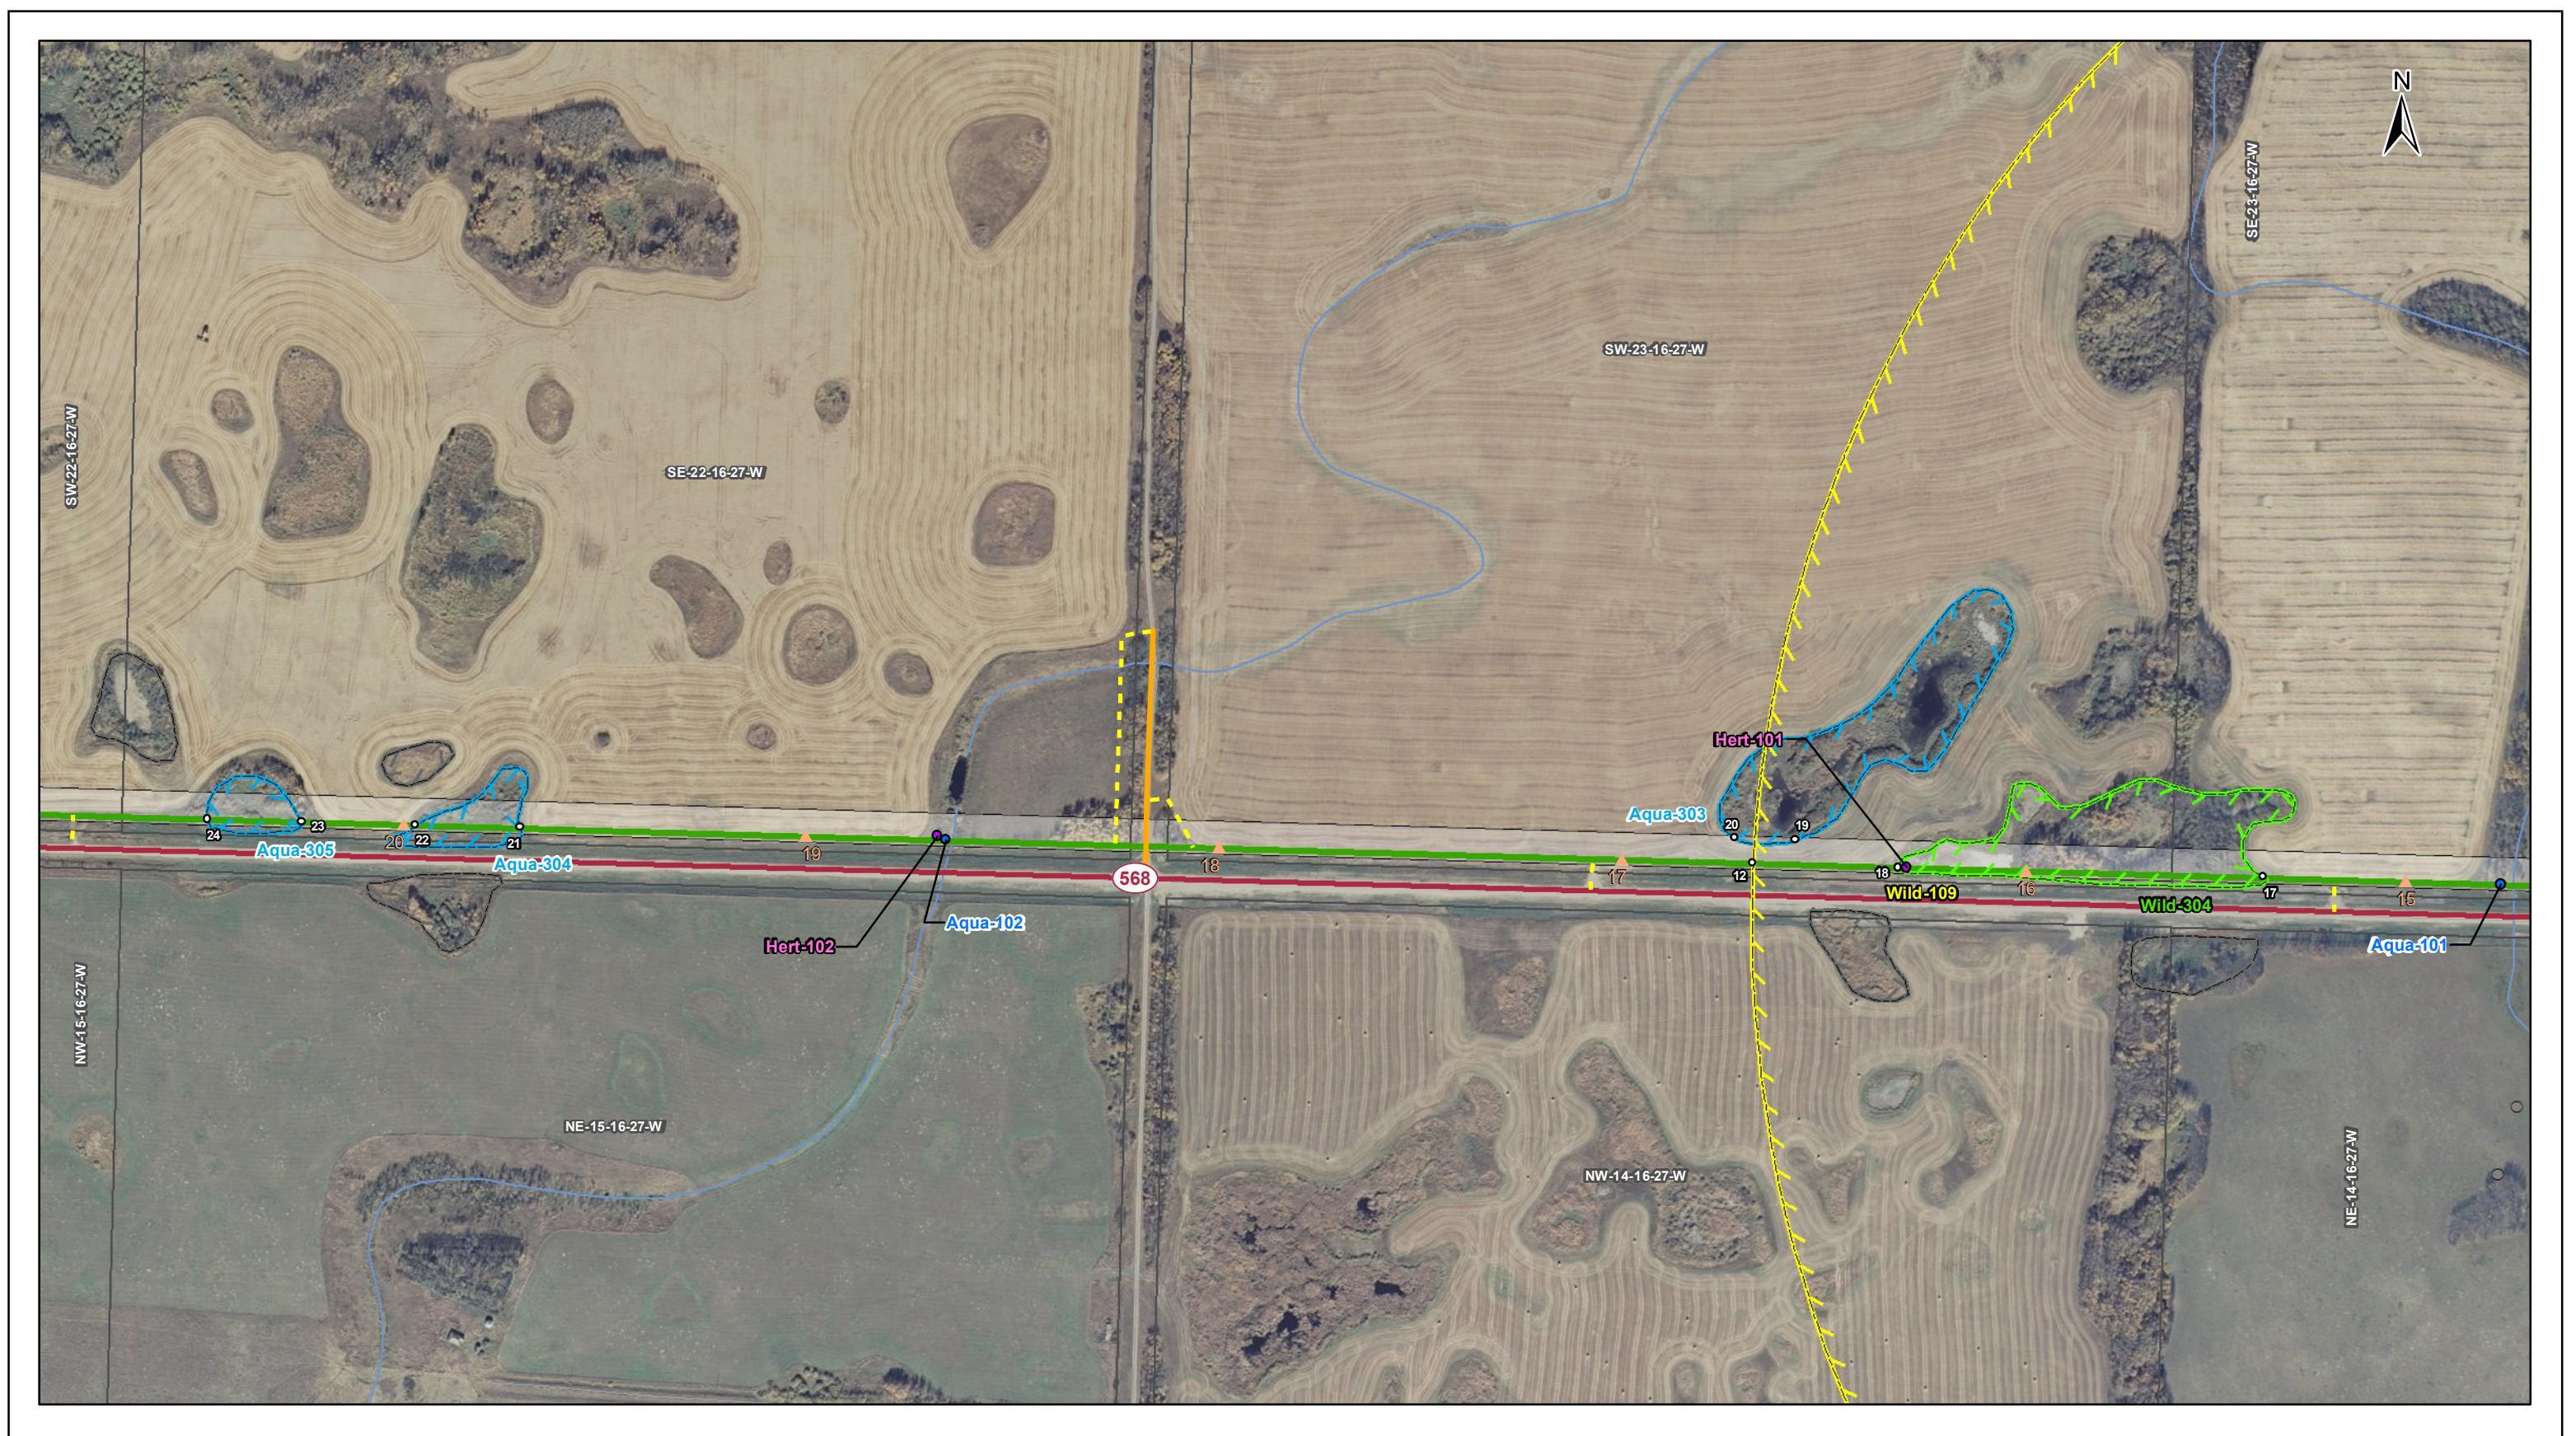
ESS Group: Archaeological

- Carry out construction activities on frozen or dry ground to minimize surface damage, rutting and erosion. Construction matting will be used to protect the area from rutting and exposure to mineral soil during nonfrozen ground conditions
- Confine traffic to established trail
- Hand-clearing or other low disturbance clearing approved by the Project Archaeologist within the area
- Identify and flag a 30m buffer around site, if not within designated riparian buffer
- In the event of a discovery stop work in area and contact the Project Archaeologist immediately. Refer to Cultural and Heritage Resources Protection Plan for further guidance
- Should heritage resources be discovered during a pre-construction survey the project Archaeologist may prescribe additional mitigation measures

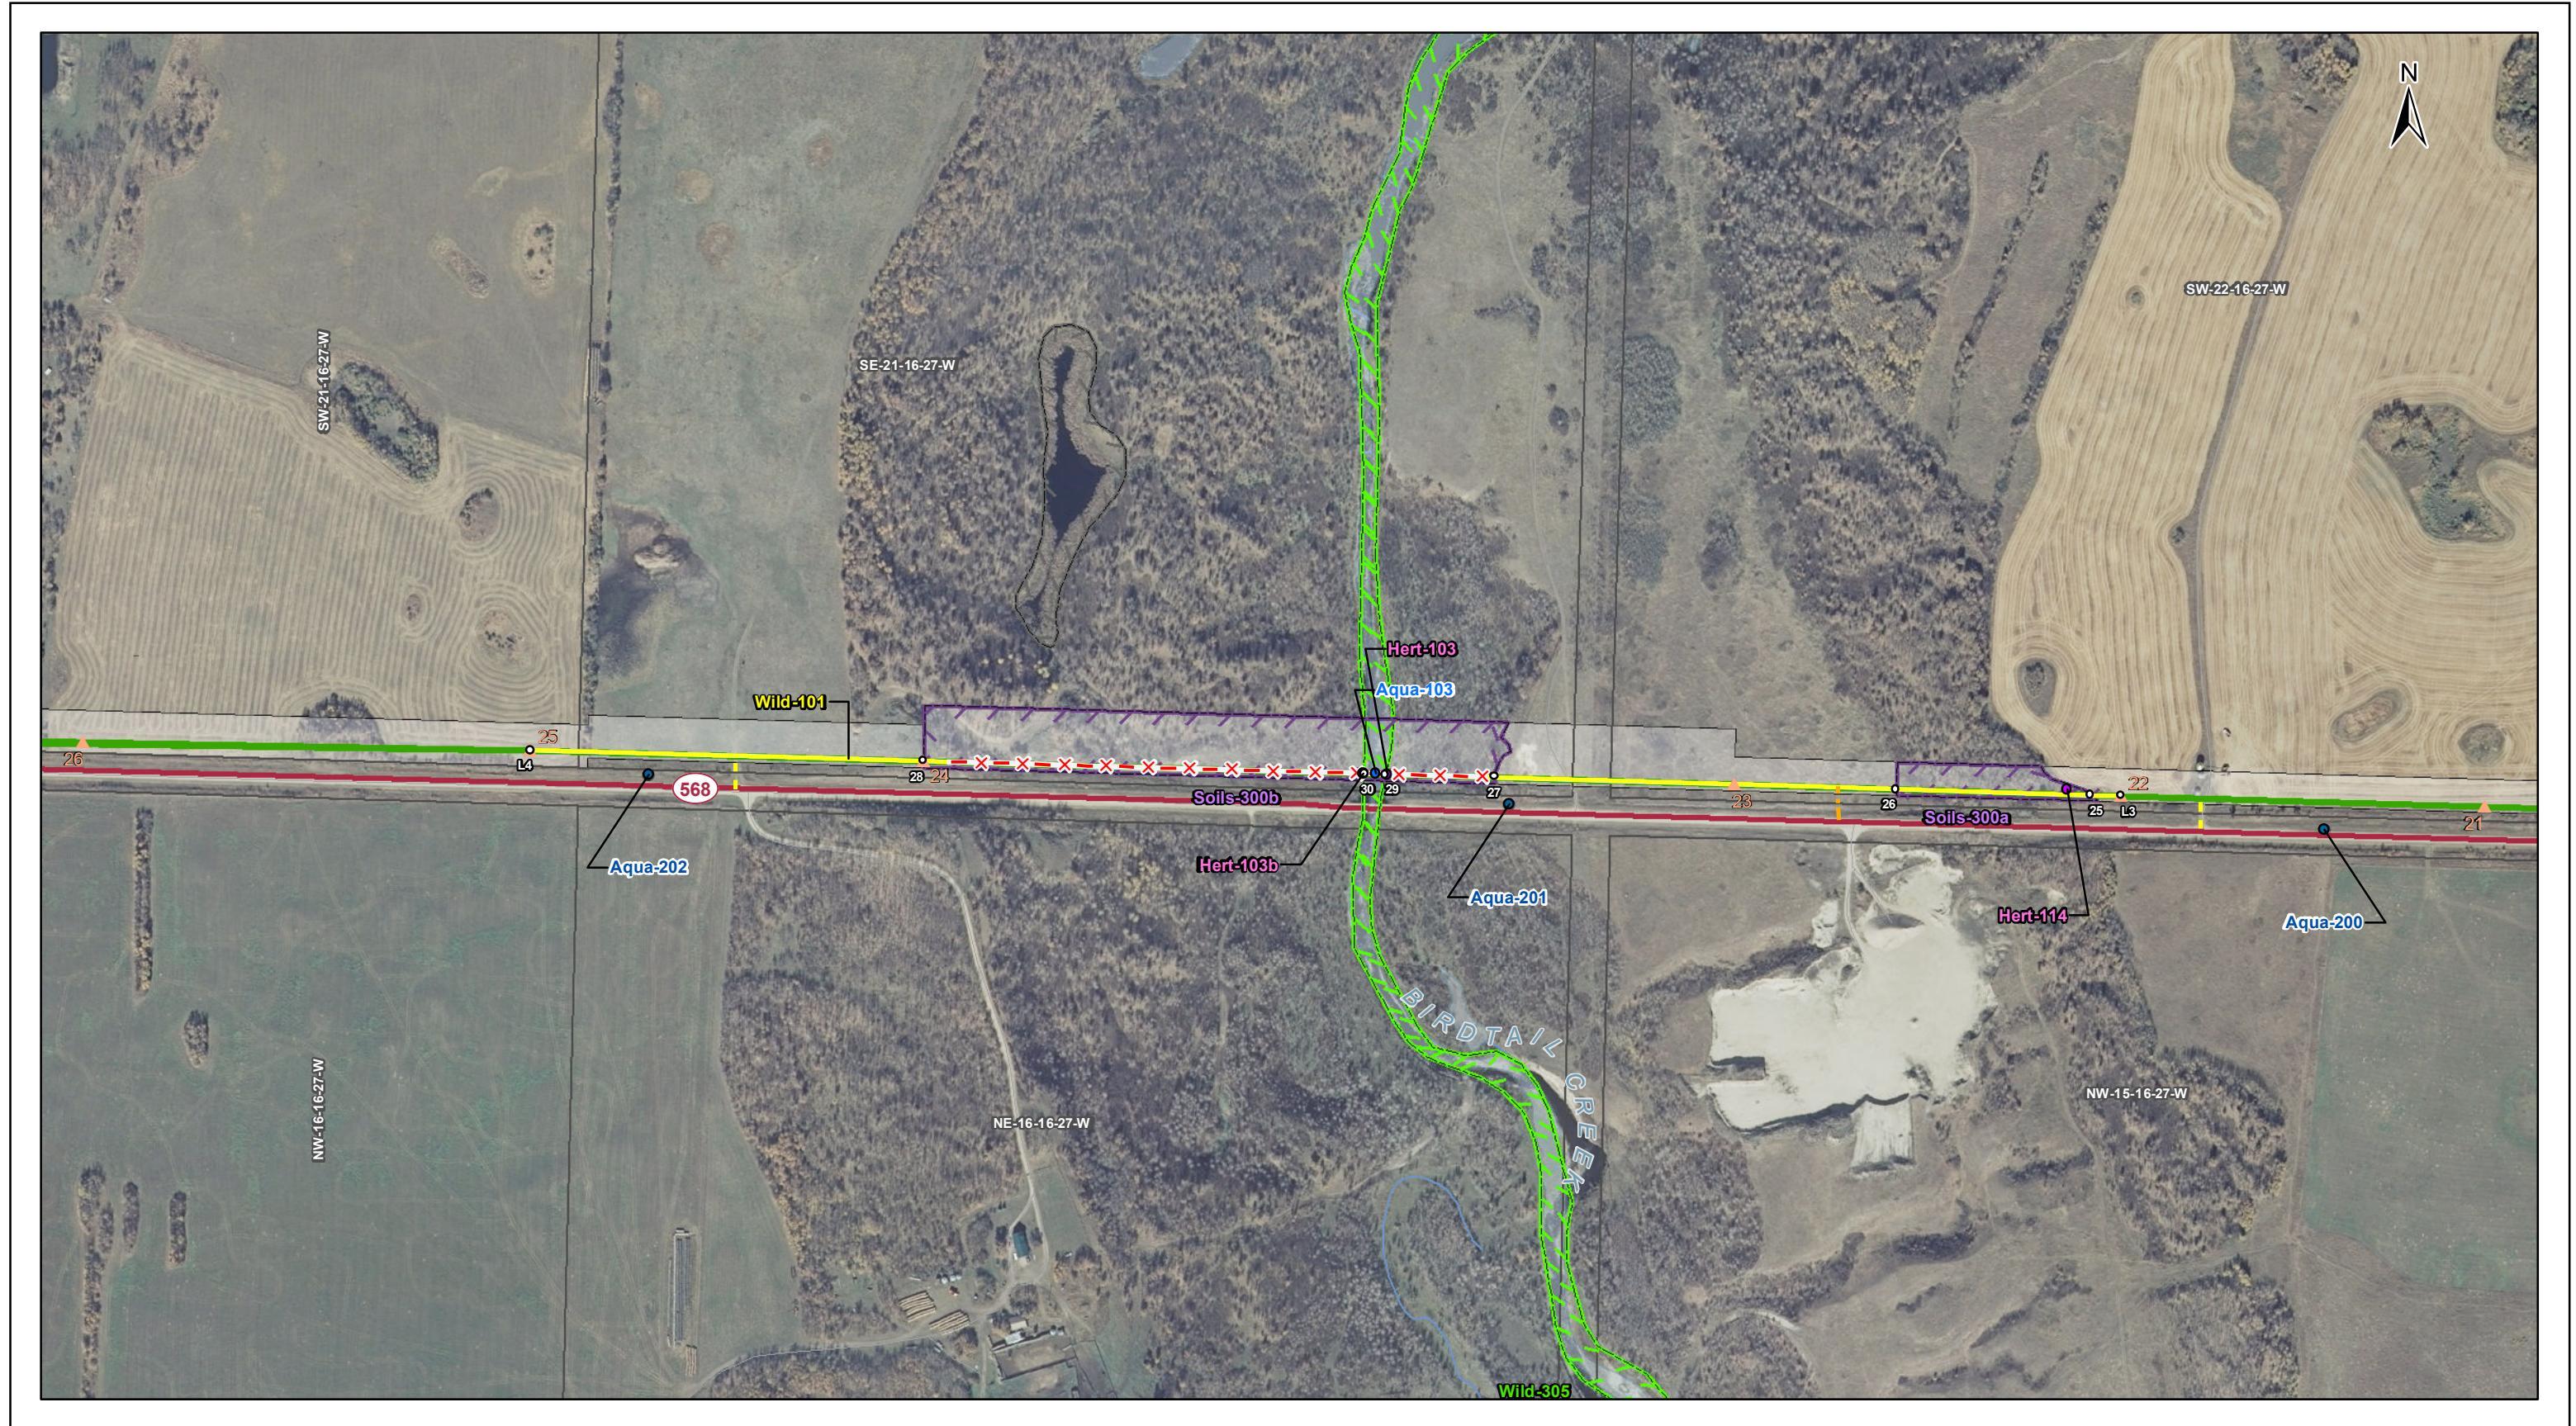
ESS Group: Archaeological

- Carry out construction activities on frozen or dry ground to minimize surface damage, rutting and erosion. Construction matting will be used to protect the area from rutting and exposure to mineral soil during nonfrozen ground conditions
- Confine traffic to established trail
- Hand-clearing or other low disturbance clearing approved by the Project Archaeologist within the area
- Identify and flag a 30m buffer around site, if not within designated riparian buffer
- In the event of a discovery stop work in area and contact the Project Archaeologist immediately. Refer to Cultural and Heritage Resources Protection Plan for further guidance
- Should heritage resources be discovered during a pre-construction survey the project Archaeologist may prescribe additional mitigation measures

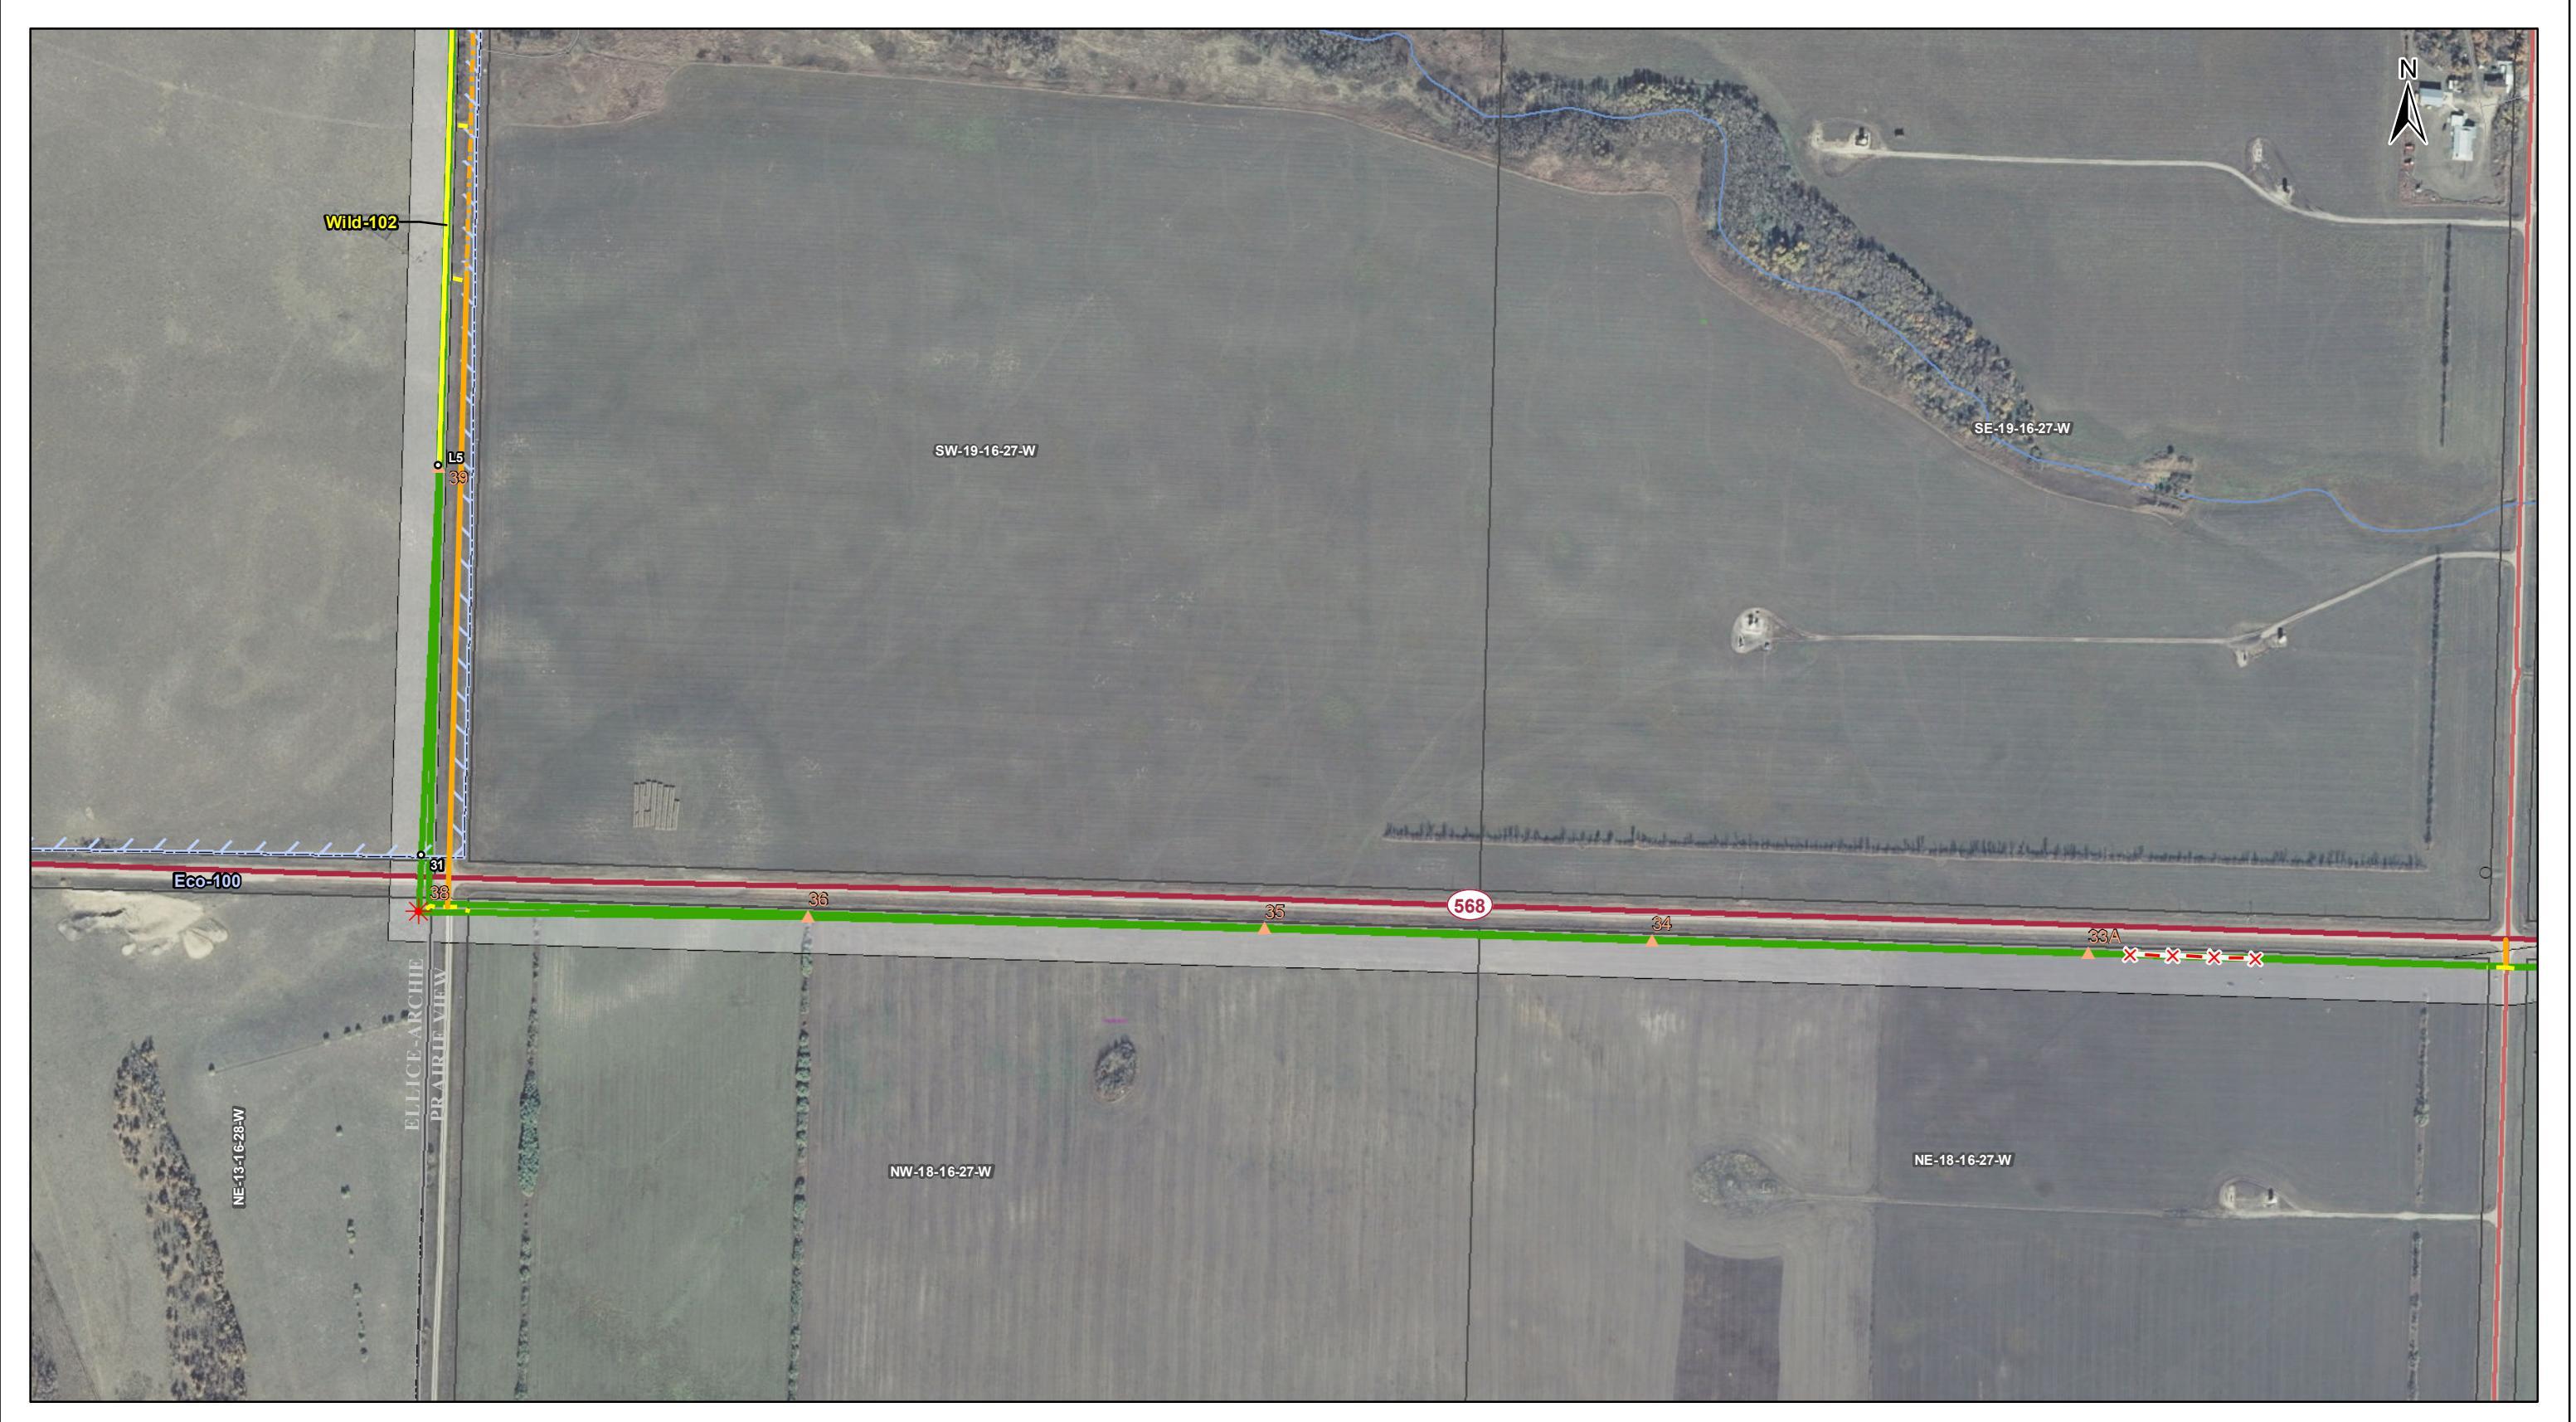
ESS Group: Birds and Habitat

- Marshalling yards, borrow sites and worker accommodations will not be developed within the grassland habitat areas
- MH to conduct site investigation with vegetation specialist prior to construction to verify the existence of natural grassland habitat
