BIRTLE TRANSMISSION PROJECT Construction Environmental Protection Mapbook

Version: Final 1.0

Date: June 08, 2020

Document Owner: Licensing and Environmental Assessment Department Transmission Planning and Design Division Transmission Business Unit Manitoba Hydro

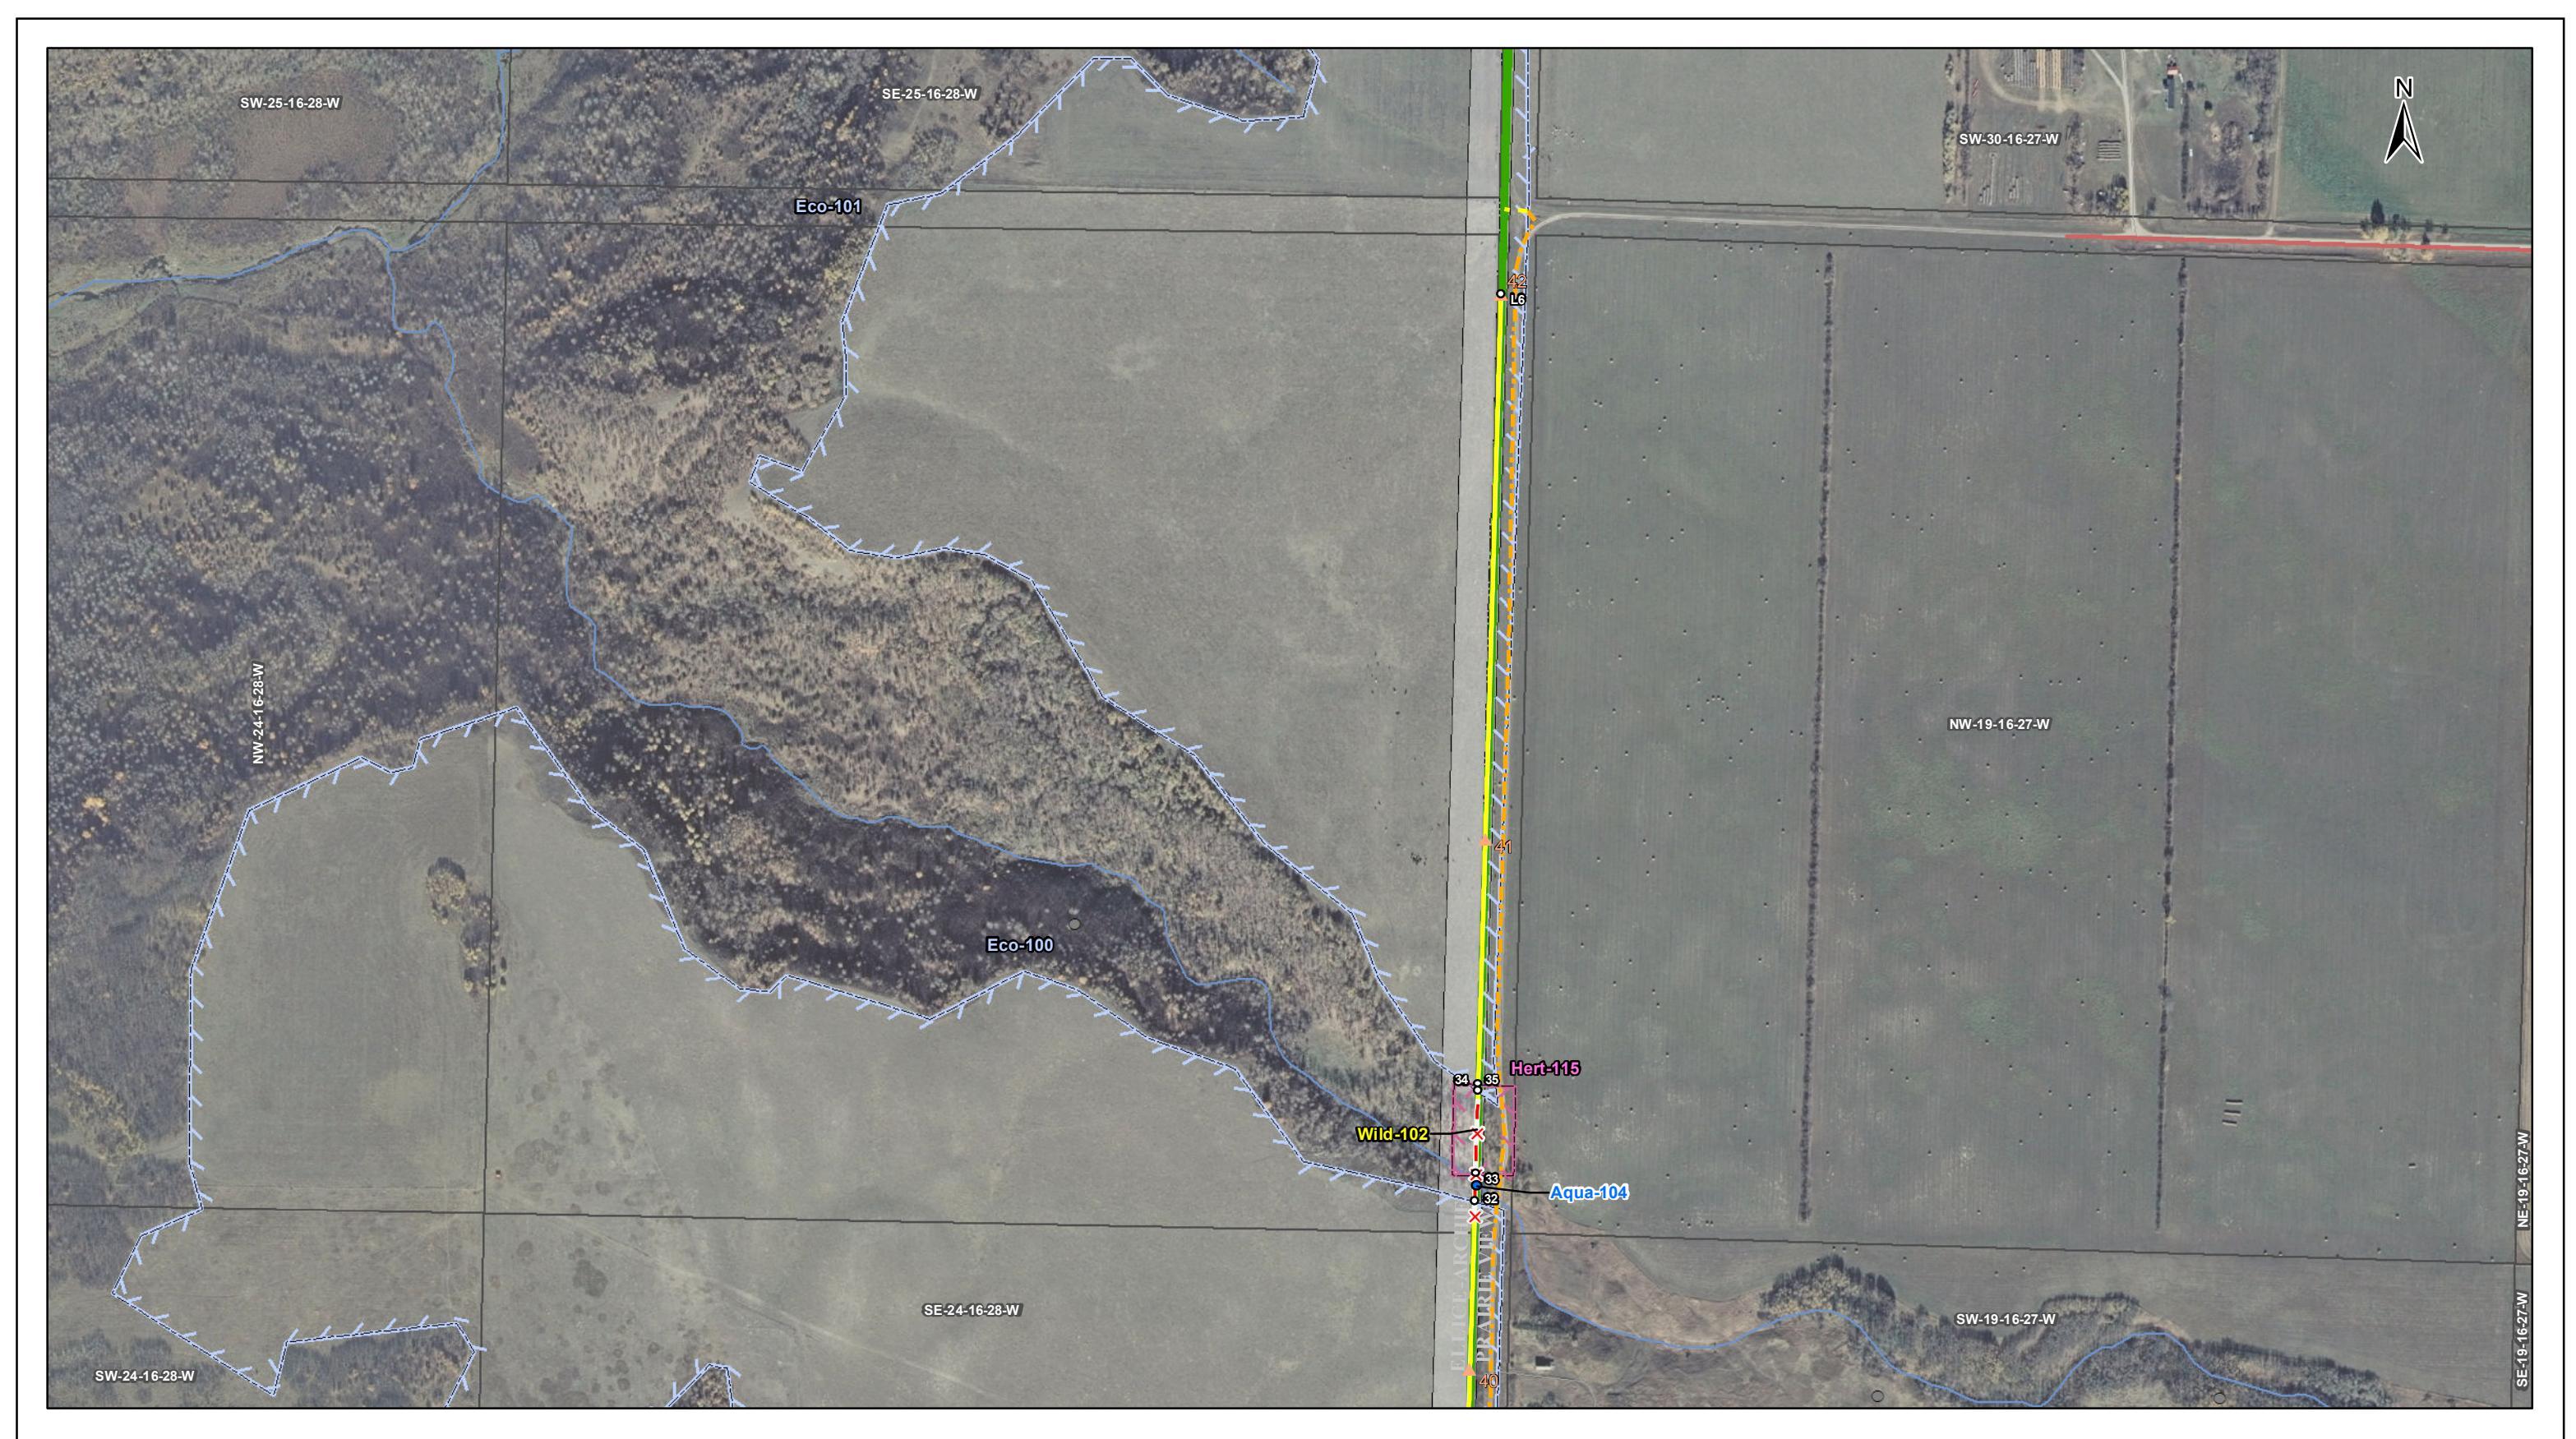
ESS Group: Archaeological

- Carry out construction activities on frozen or dry ground to minimize surface damage, rutting and erosion. Construction matting will be used to protect the area from rutting and exposure to mineral soil during nonfrozen ground conditions
- Confine traffic to established trail
- Hand-clearing or other low disturbance clearing approved by Project Archaeologist within the area Project Archaeologist or designate will be present to monitor excavation/subsurface excavations (including geo-technical drilling) for heritage resources
- Cultural and Heritage Resources Protection Plan will be followed when a suspected cultural or heritage resource is discovered
- Should heritage resources be discovered during a pre-construction survey the project Archaeologist may prescribe construction matting to be used to protect the area from disturbance

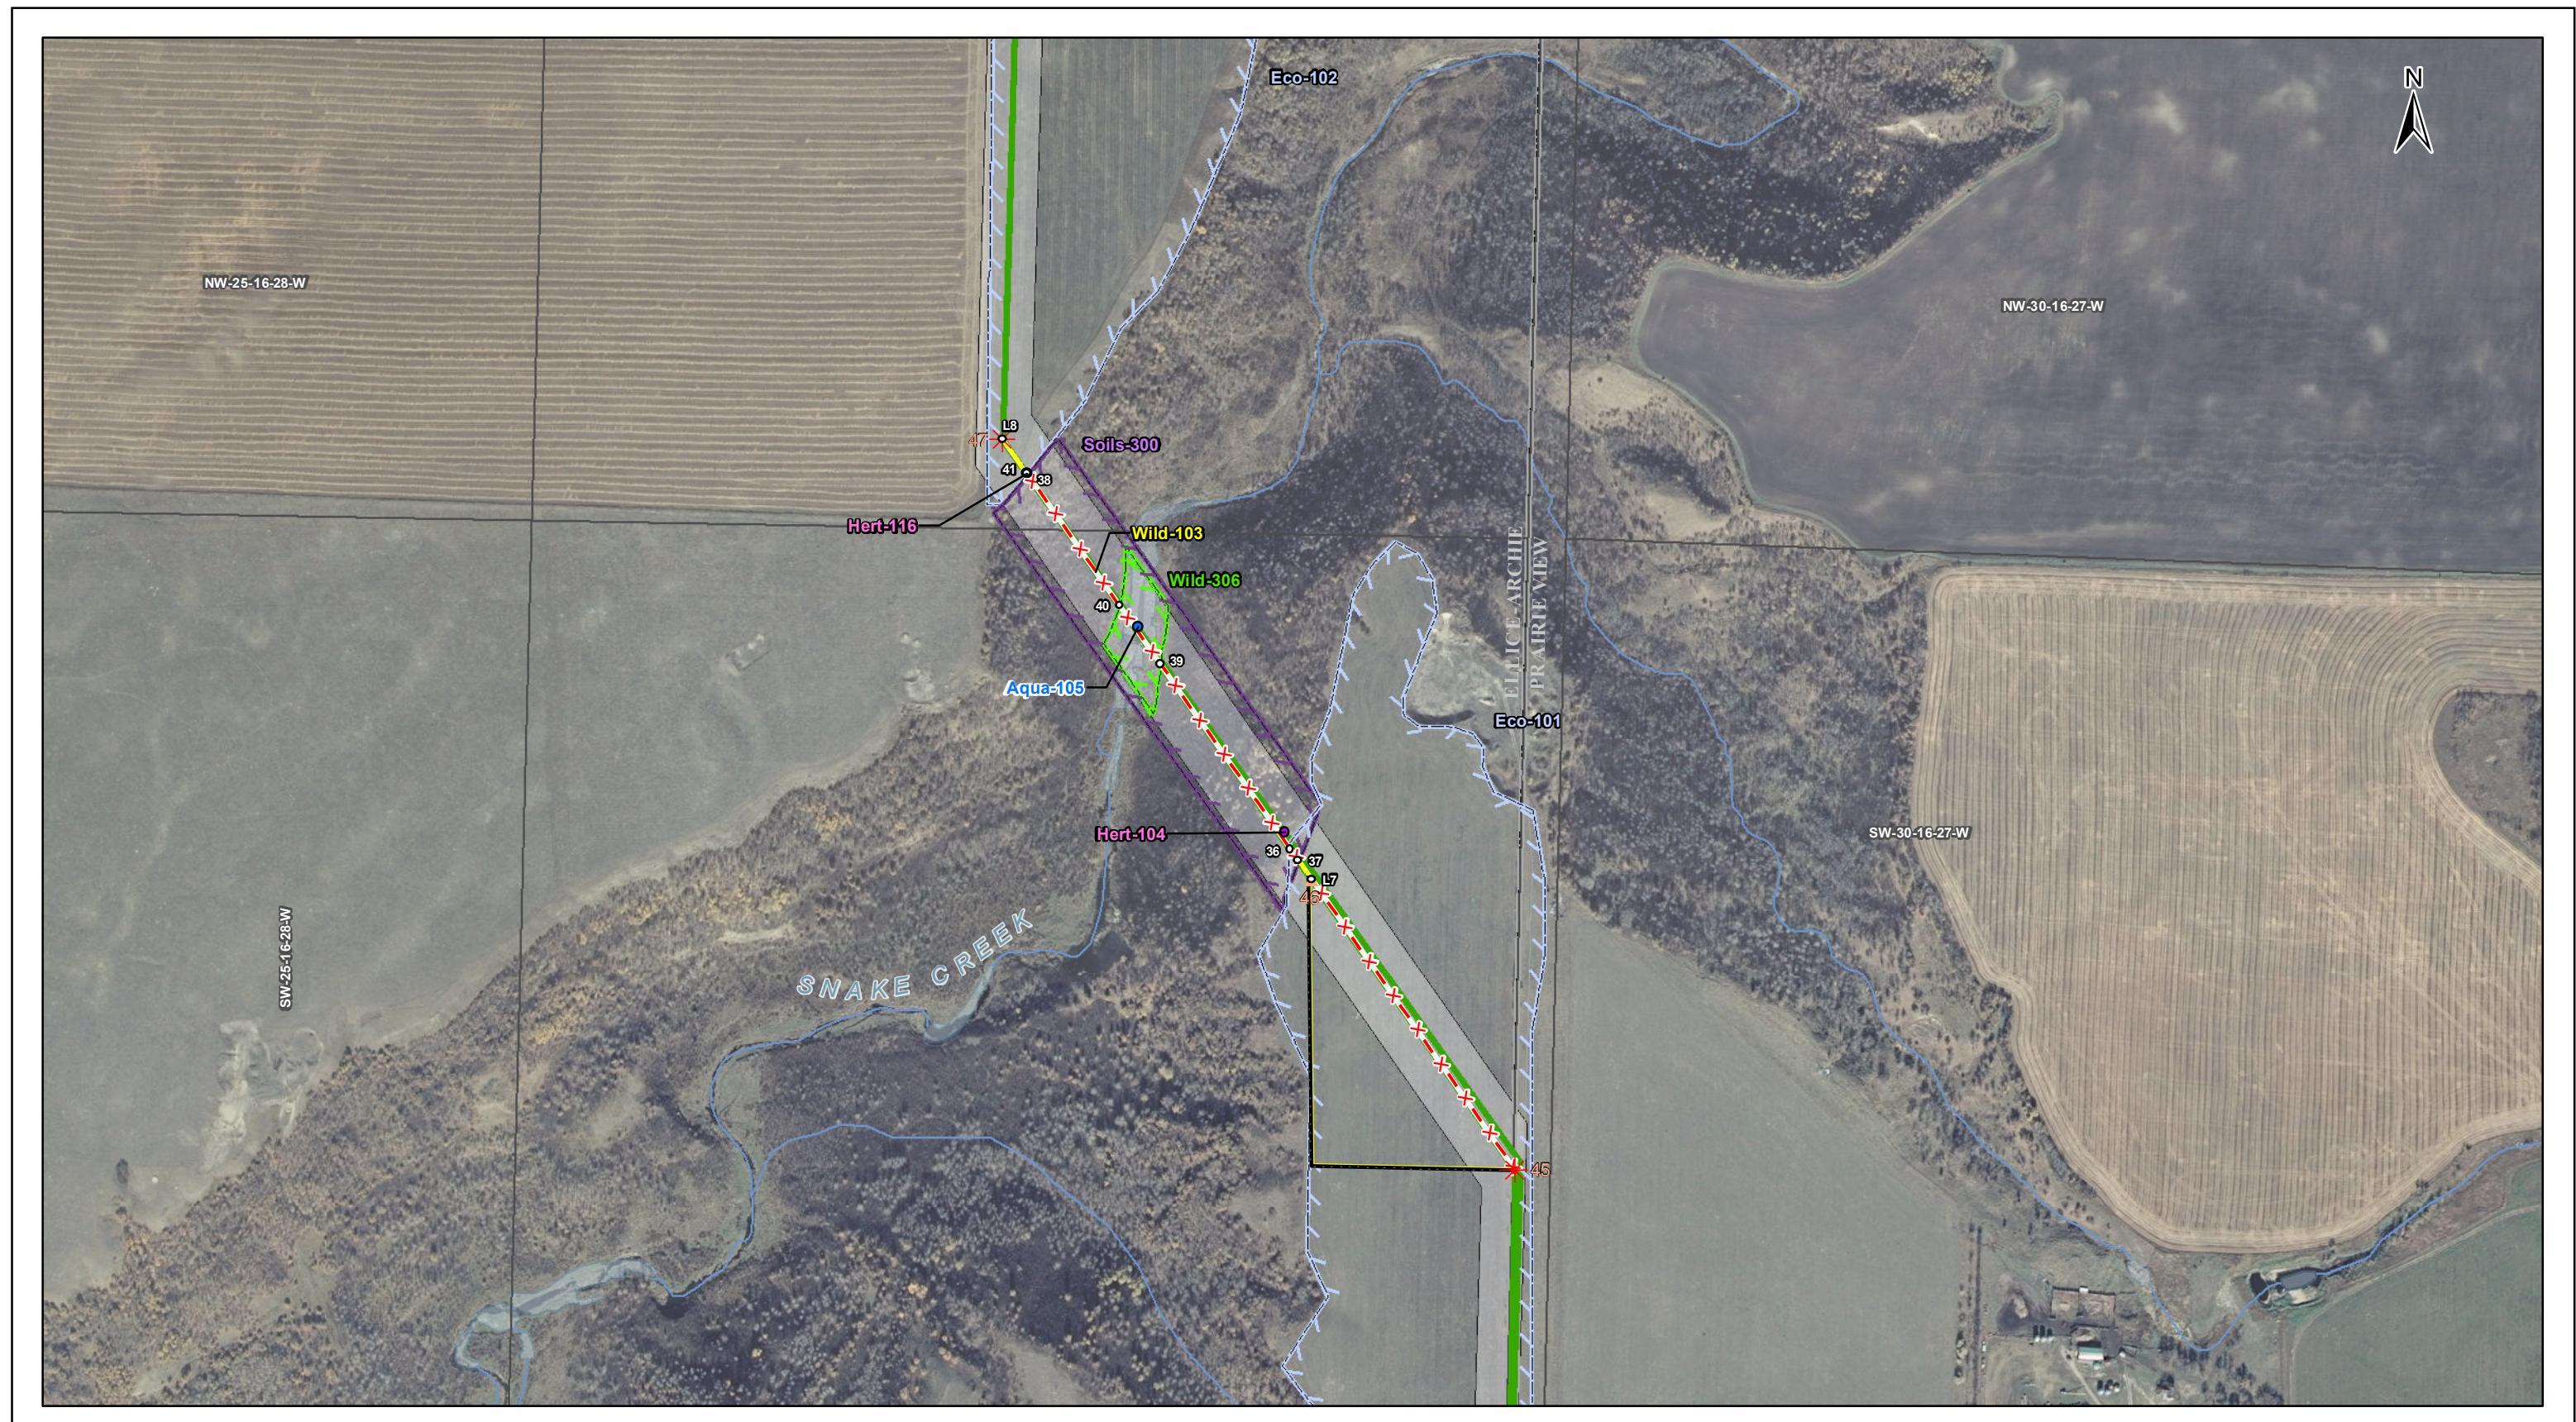
ESS Group: Archaeological

- Carry out construction activities on frozen or dry ground to minimize surface damage, rutting and erosion. Construction matting will be used to protect the area from rutting and exposure to mineral soil during nonfrozen ground conditions
- Confine traffic to established trail
- Hand-clearing or other low disturbance clearing approved by the Project Archaeologist within the area
- ٠ Identify and flag a 30m buffer around site, if not within designated riparian buffer
- In the event of a discovery stop work in area and contact the Project Archaeologist immediately. Refer to Cultural and Heritage Resources Protection Plan for further guidance
- Should heritage resources be discovered during a pre-construction survey the project Archaeologist may prescribe additional mitigation measures

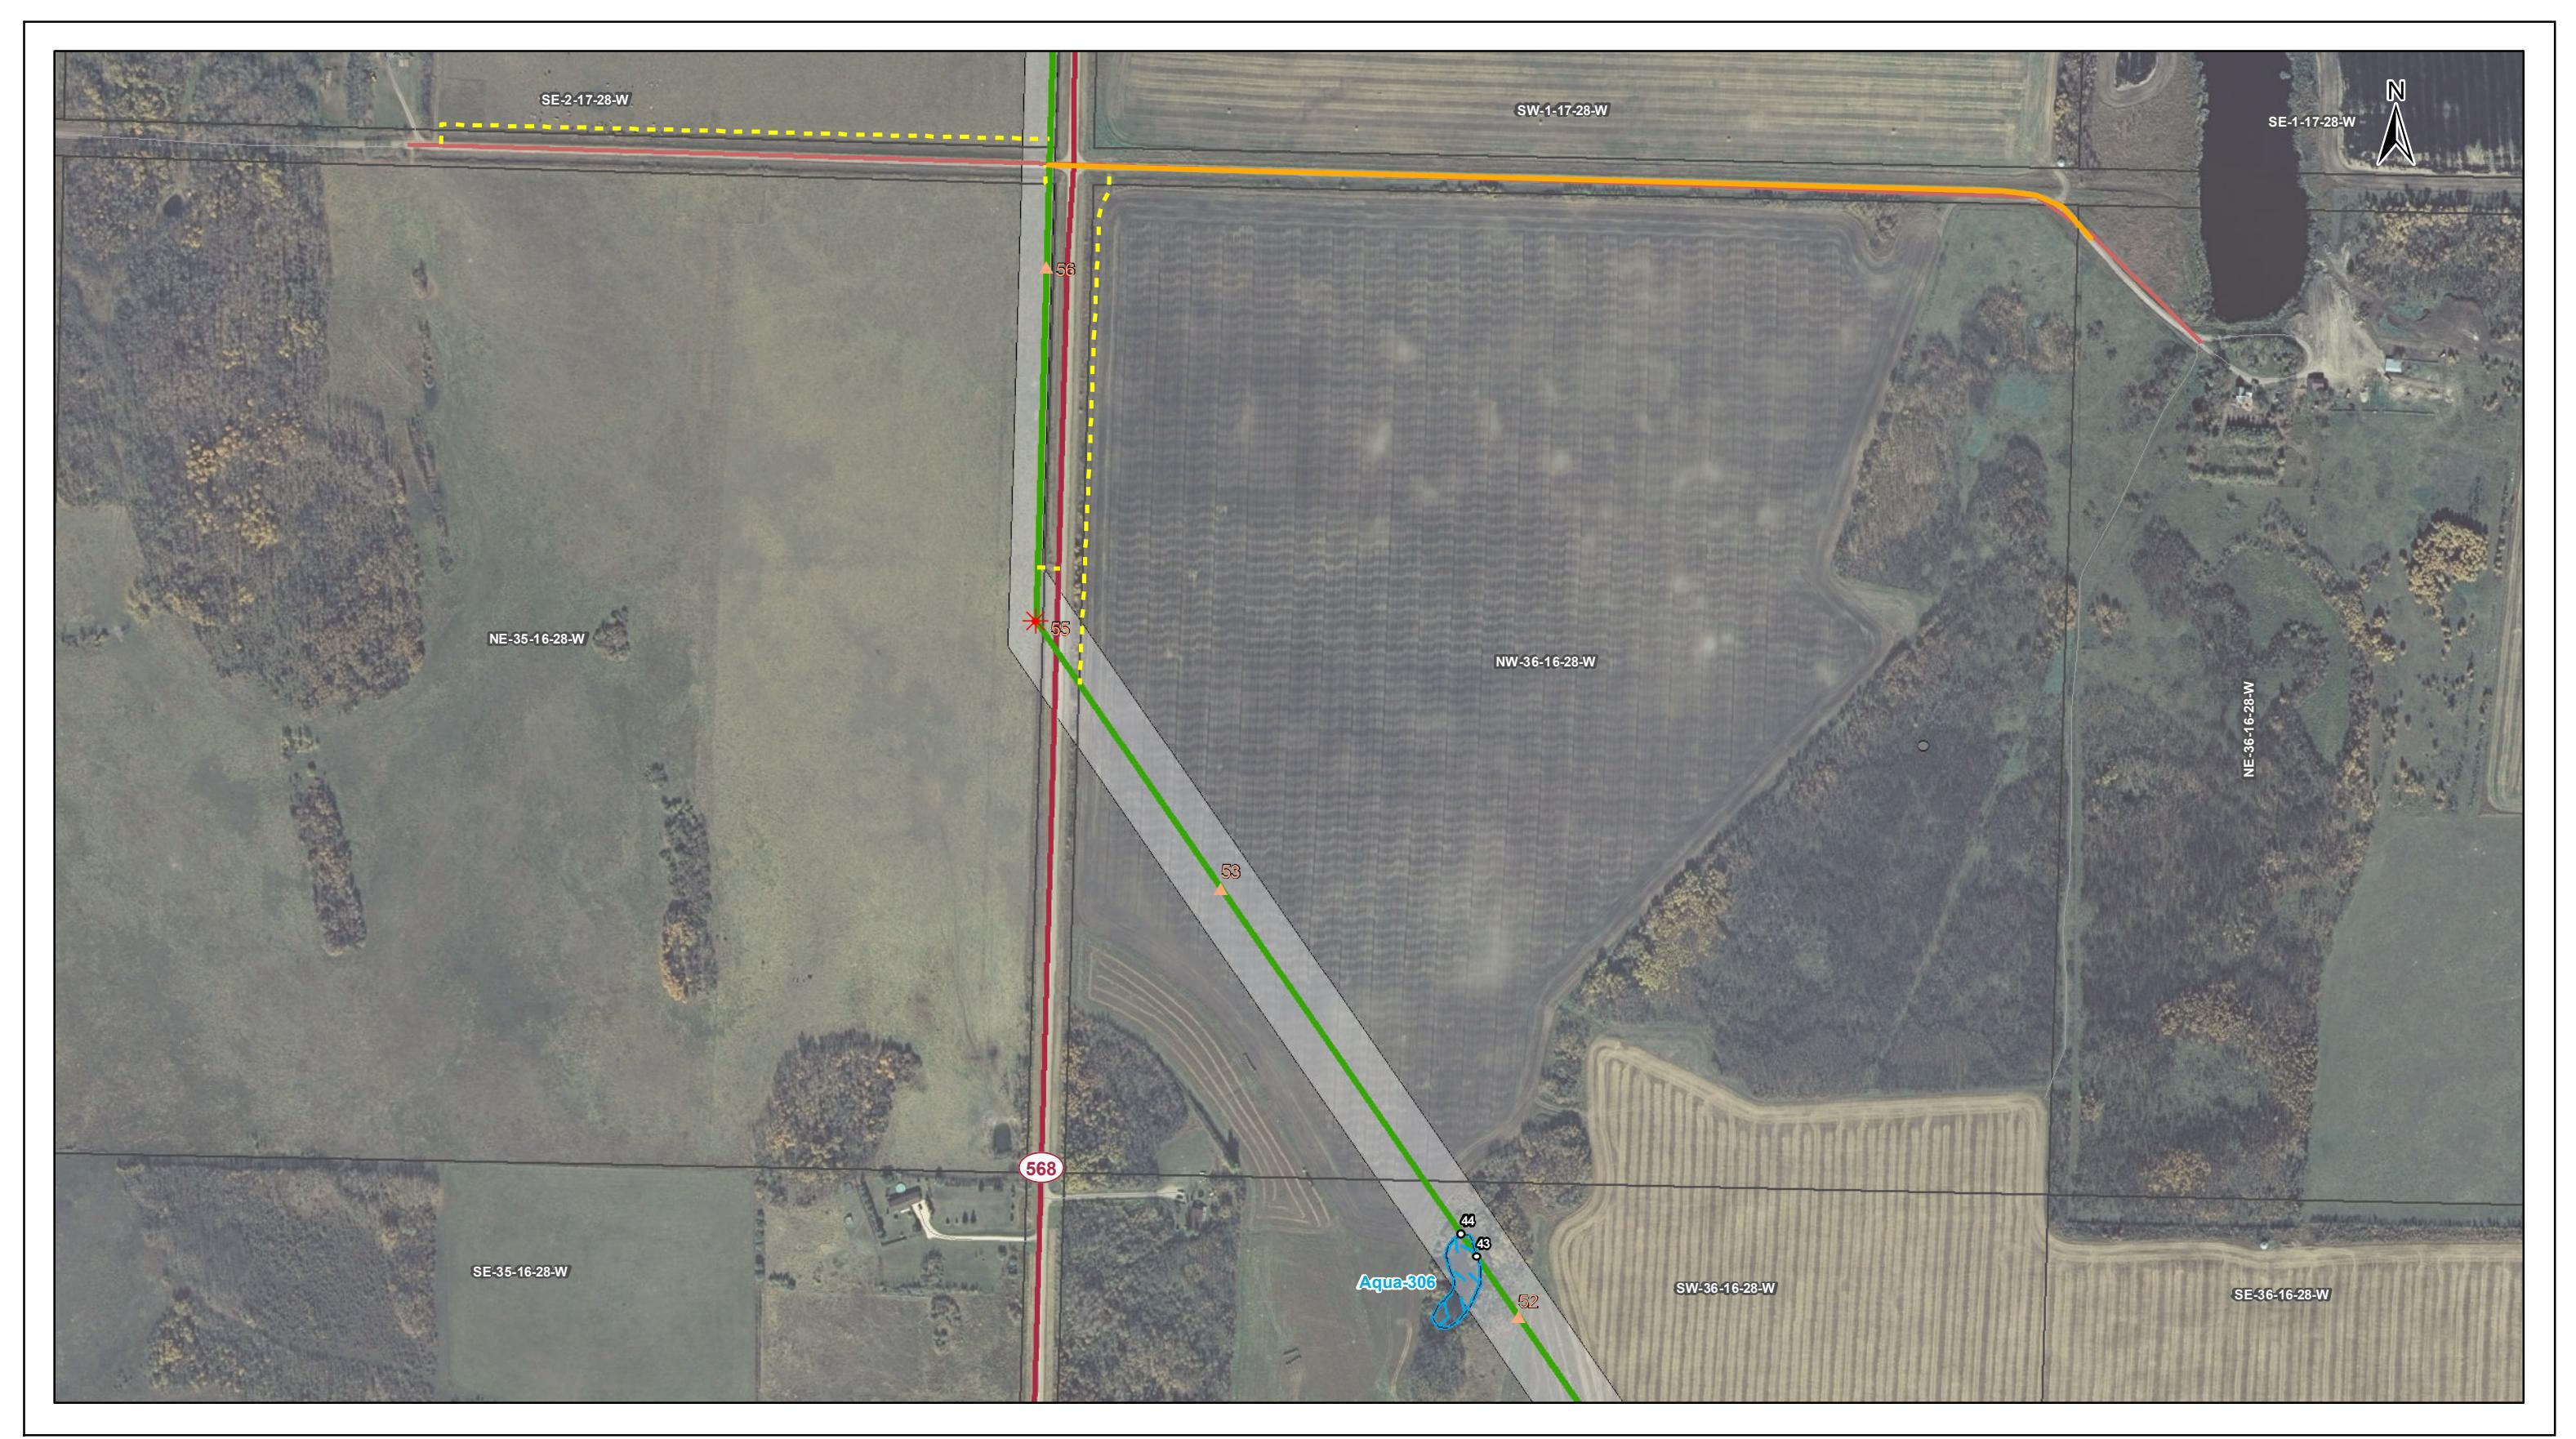
ESS Group: Wetland

- Carry out construction activities on frozen or dry ground to minimize surface damage, rutting and erosion. Construction matting will be used to protect the area from rutting and exposure to mineral soil during nonfrozen ground conditions Identify and flag buffer by following the edge of agricultural crop Remove trees by low ground disturbance methods within buffer The application of herbicides is prohibited within buffer
- ٠
- •
- ٠

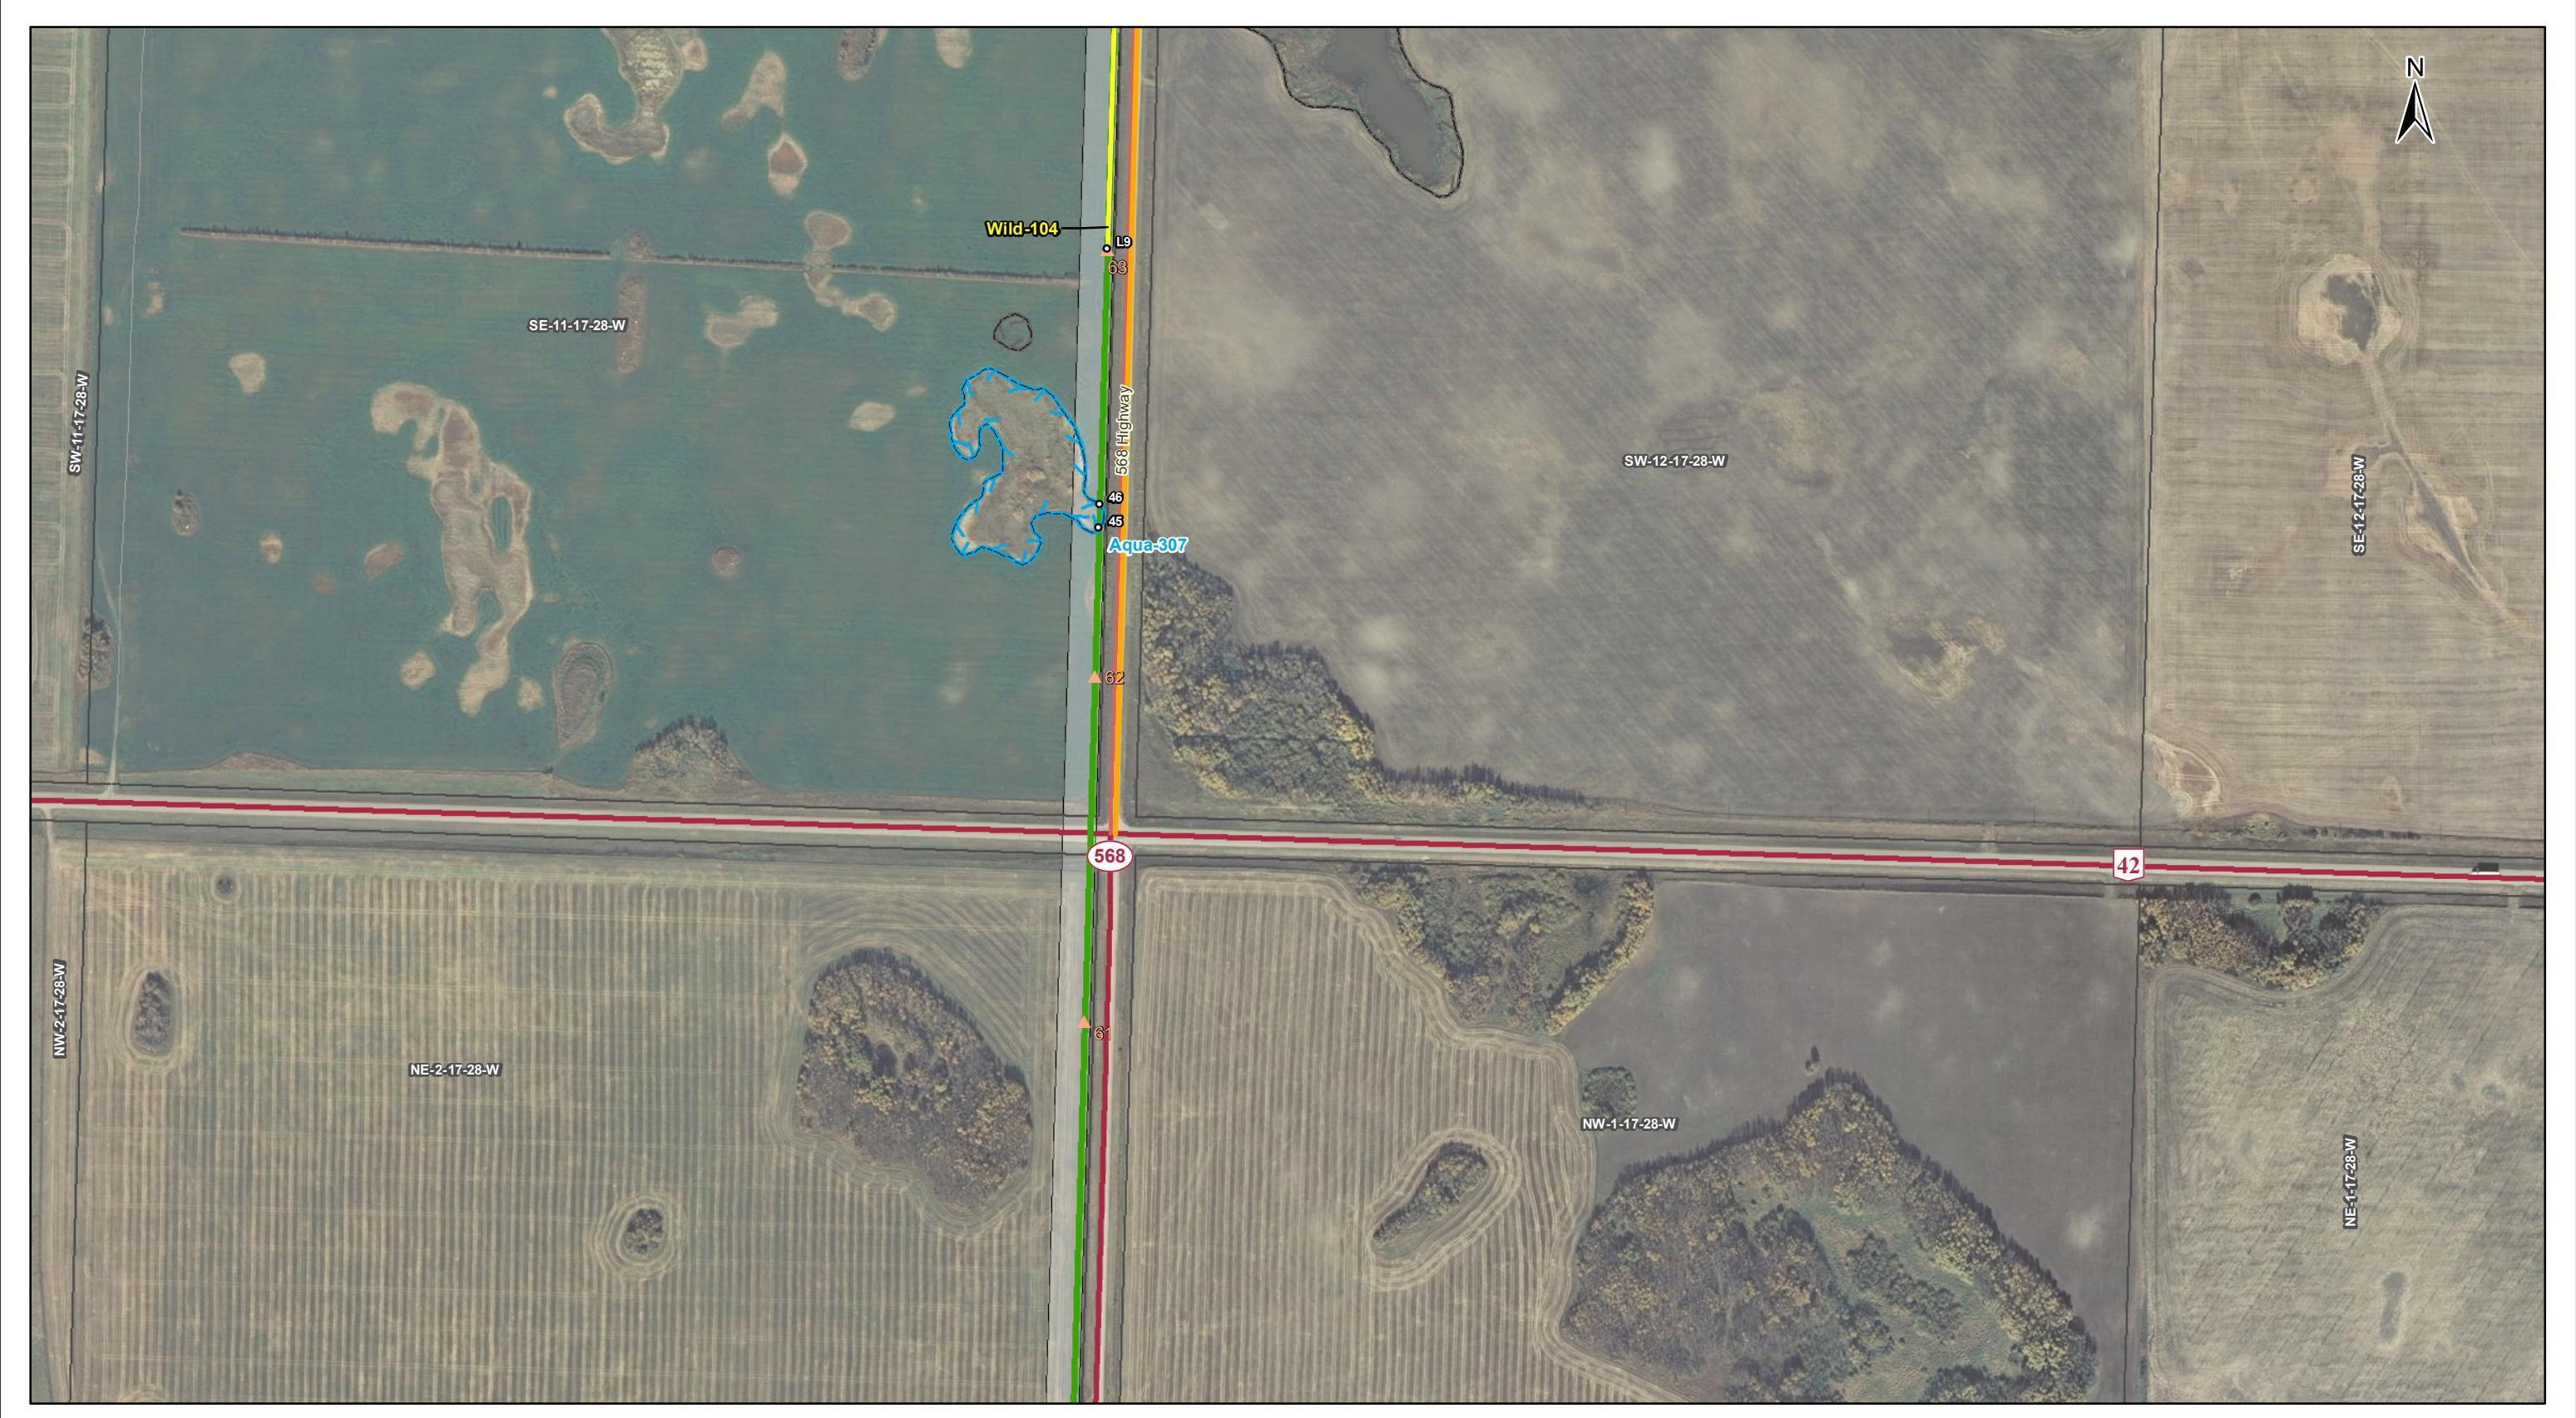
*Features represented as lines

- Carry out construction activities on frozen or dry ground to minimize surface damage, rutting and erosion. Construction matting will be used to protect the area from rutting and exposure to mineral soil during nonfrozen ground conditions
- Identify and flag buffer by following the edge of agricultural crop
 Remove trees by low ground disturbance methods within buffer
 The application of herbicides is prohibited within buffer

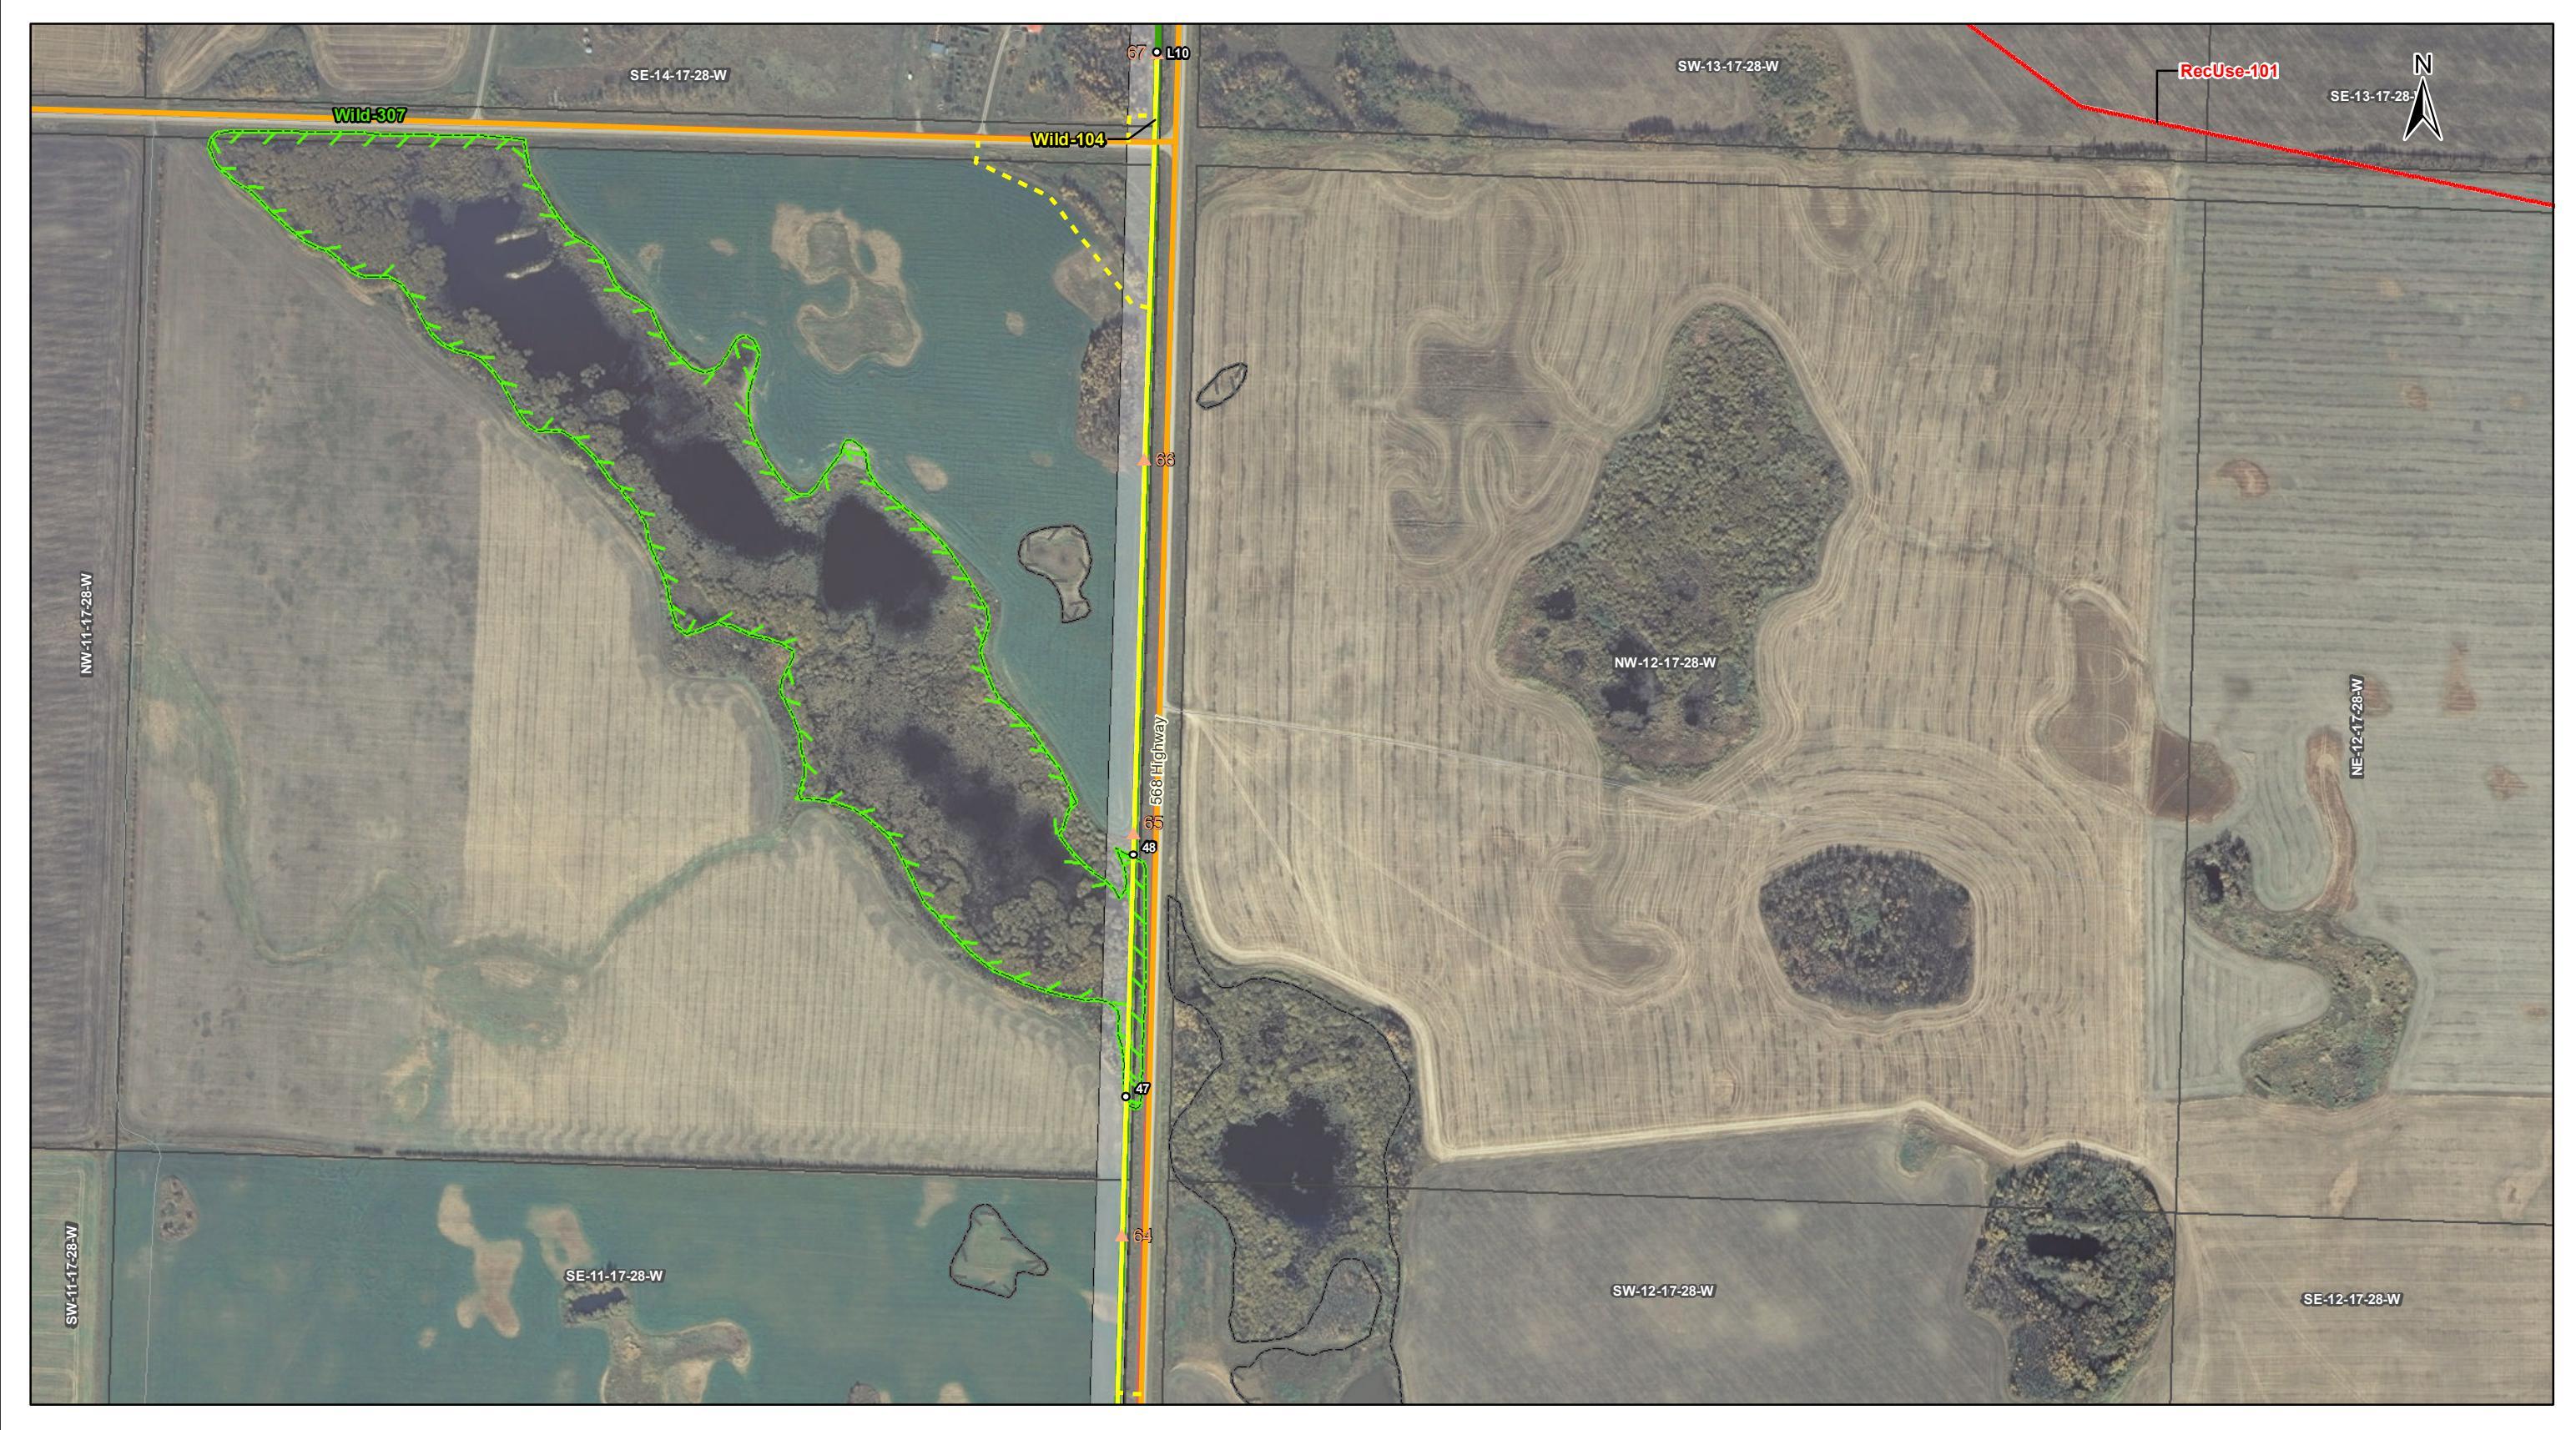
ESS Group: Birds and Habitat

Habitat loss and contamination from structure foundations & installations; wetland contamination and loss of breeding and summering habitat from loss/deterioration of riparian vegetation

- Carry out construction activities on frozen or dry ground to minimize surface damage, rutting and erosion. Construction matting will be used to protect the area from rutting and exposure to mineral soil during nonfrozen ground conditions
- Identify and flag a 30 m vegetated (shrub and herbaceous) buffer around site
- Remove trees by low ground disturbance methods within buffer
- The application of herbicides is prohibited
- Maintain shrub and herbaceous vegetation to the extent possible
- If construction activity is required within this area between April 15 to June 1st all lifestages of amphibian will be captured and removed during a sweep survey
- If construction activity is required within this area between April 15 to June 1st exclusion fencing needs to be installed around the site after a sweep survey and prior to work taking place

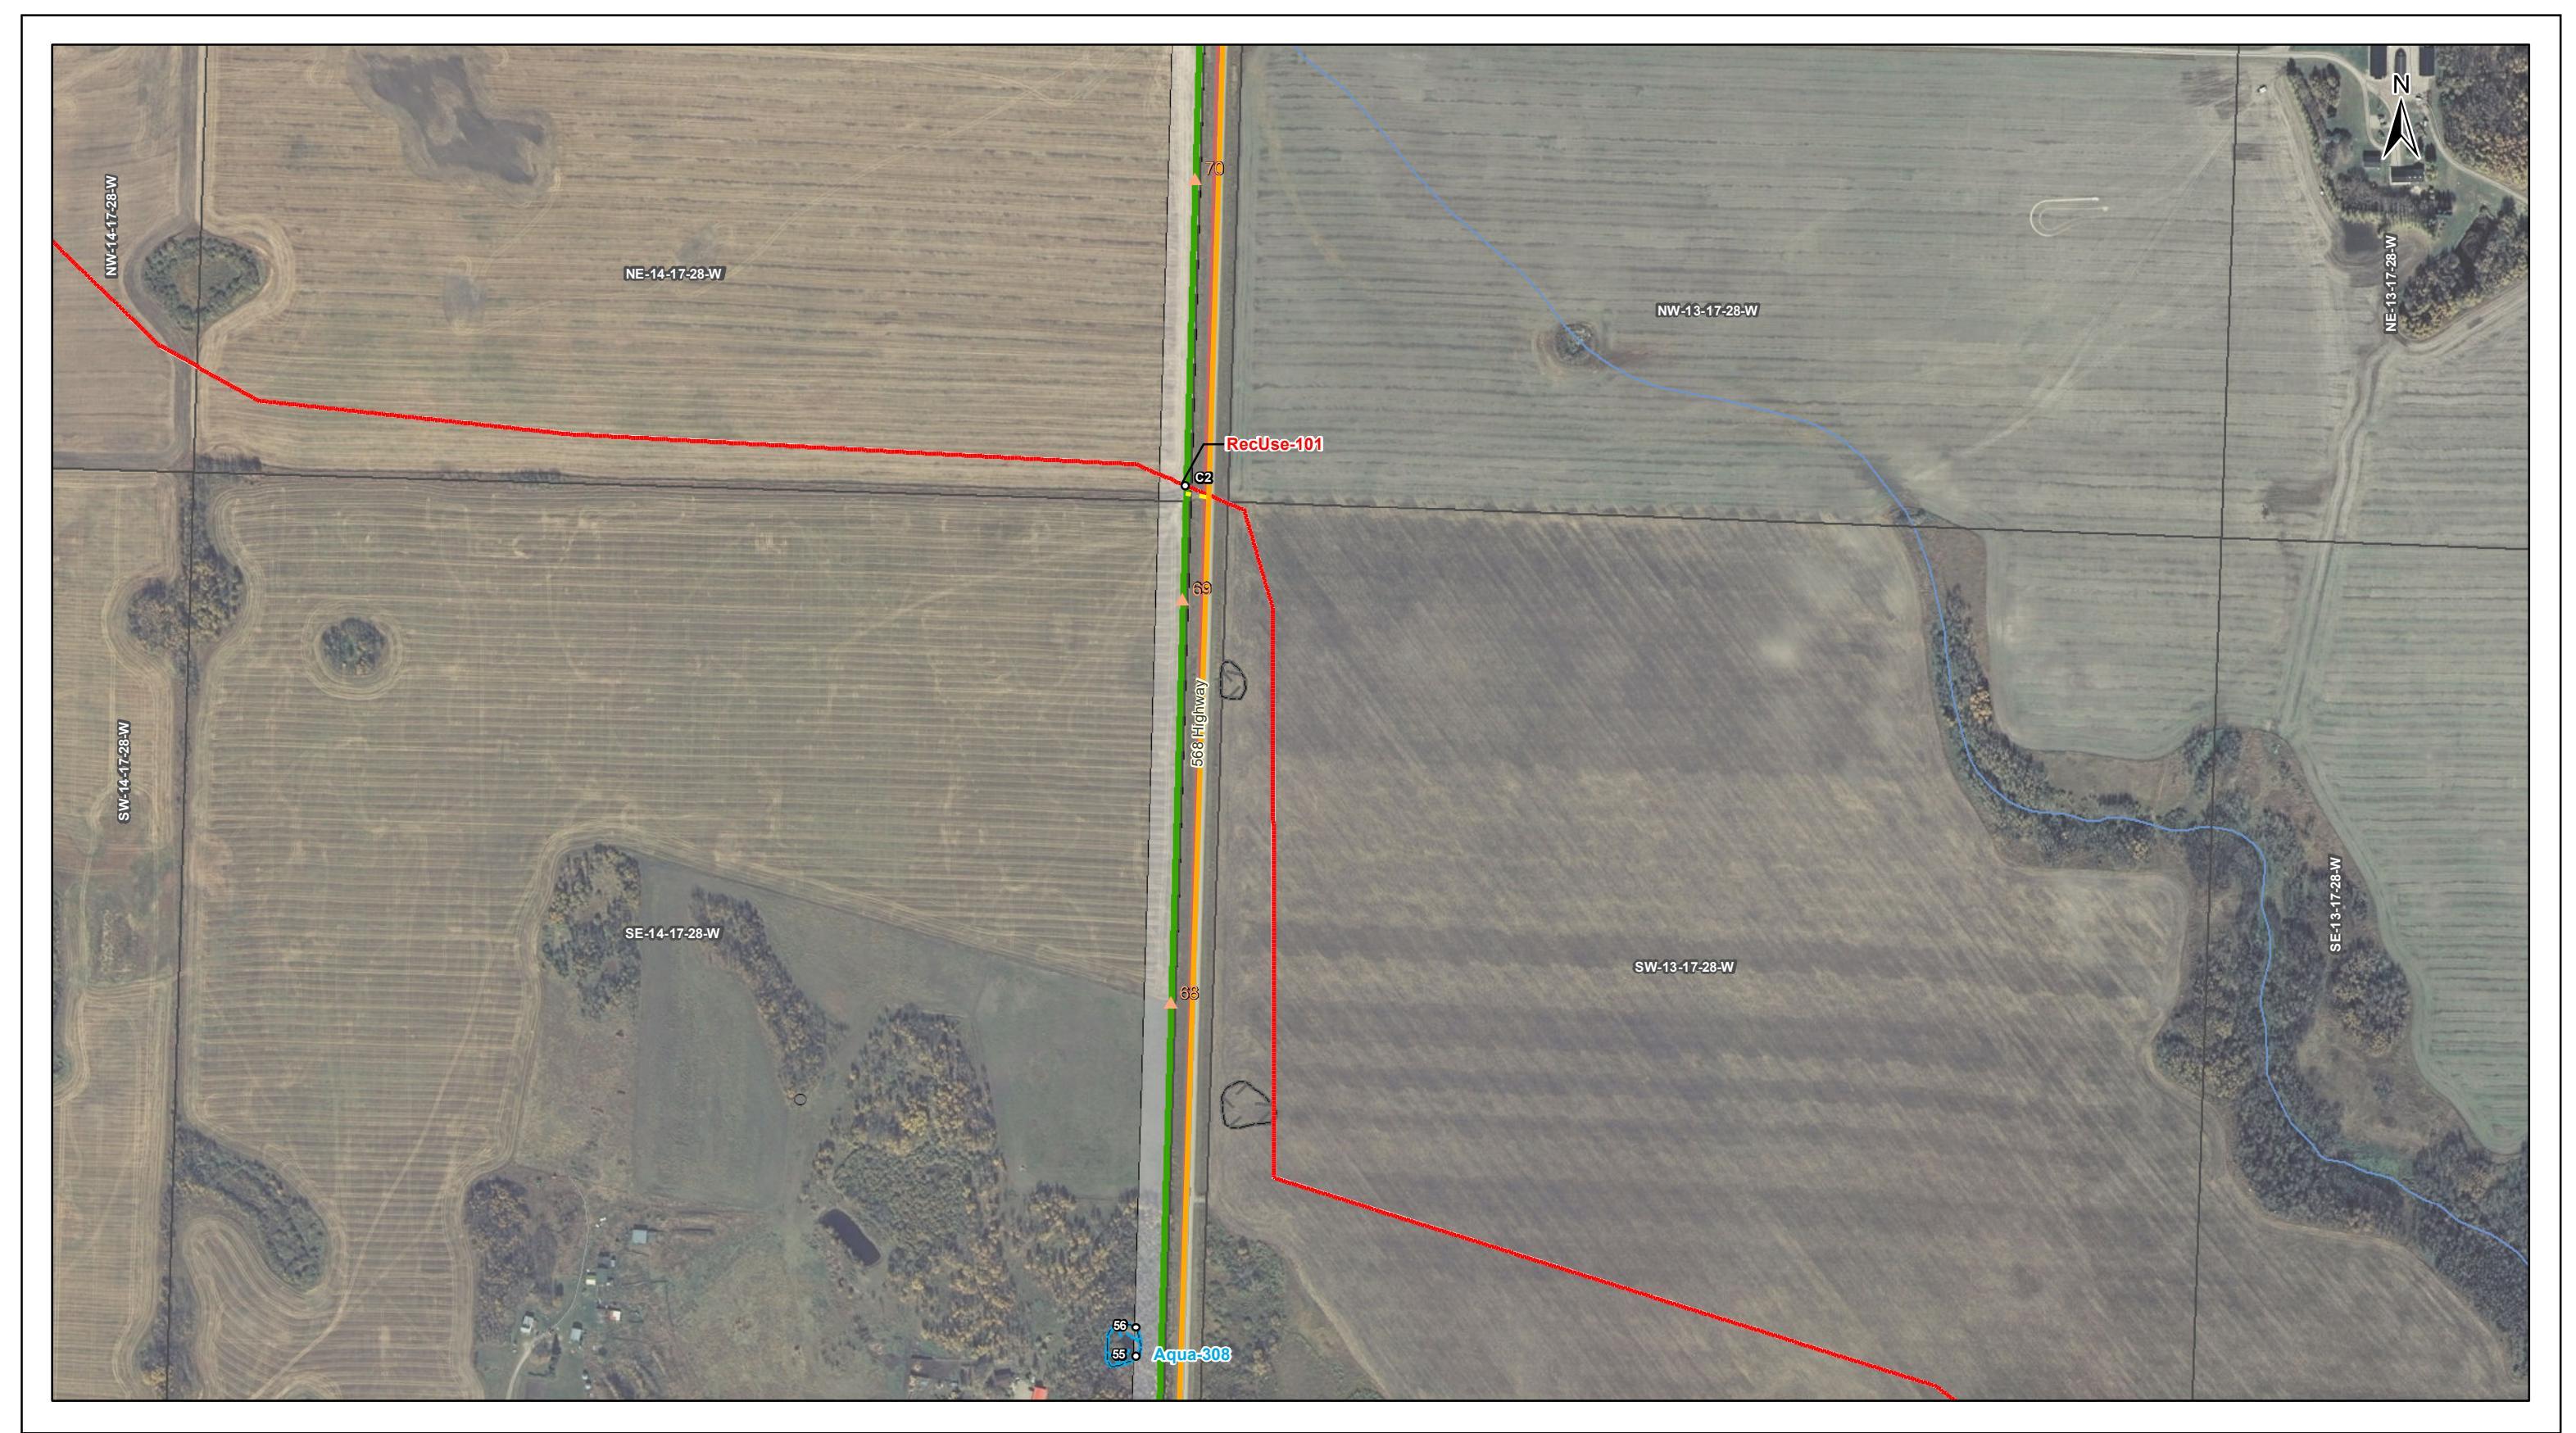
ESS Group: Intersection

- Identify and flag prior to start of work
 Avoid surface damage to and obstruction of access route
 Post warning markers and signs at snowmobile trail location
- ٠ MH to notify snowmobile club/users and local authorities regarding construction activities and schedule, and address concerns prior to construction
