BIRTLE TRANSMISSION PROJECT Construction Environmental Protection Mapbook

Version: Final 1.0

Date: June 08, 2020

Document Owner: Licensing and Environmental Assessment Department Transmission Planning and Design Division Transmission Business Unit Manitoba Hydro

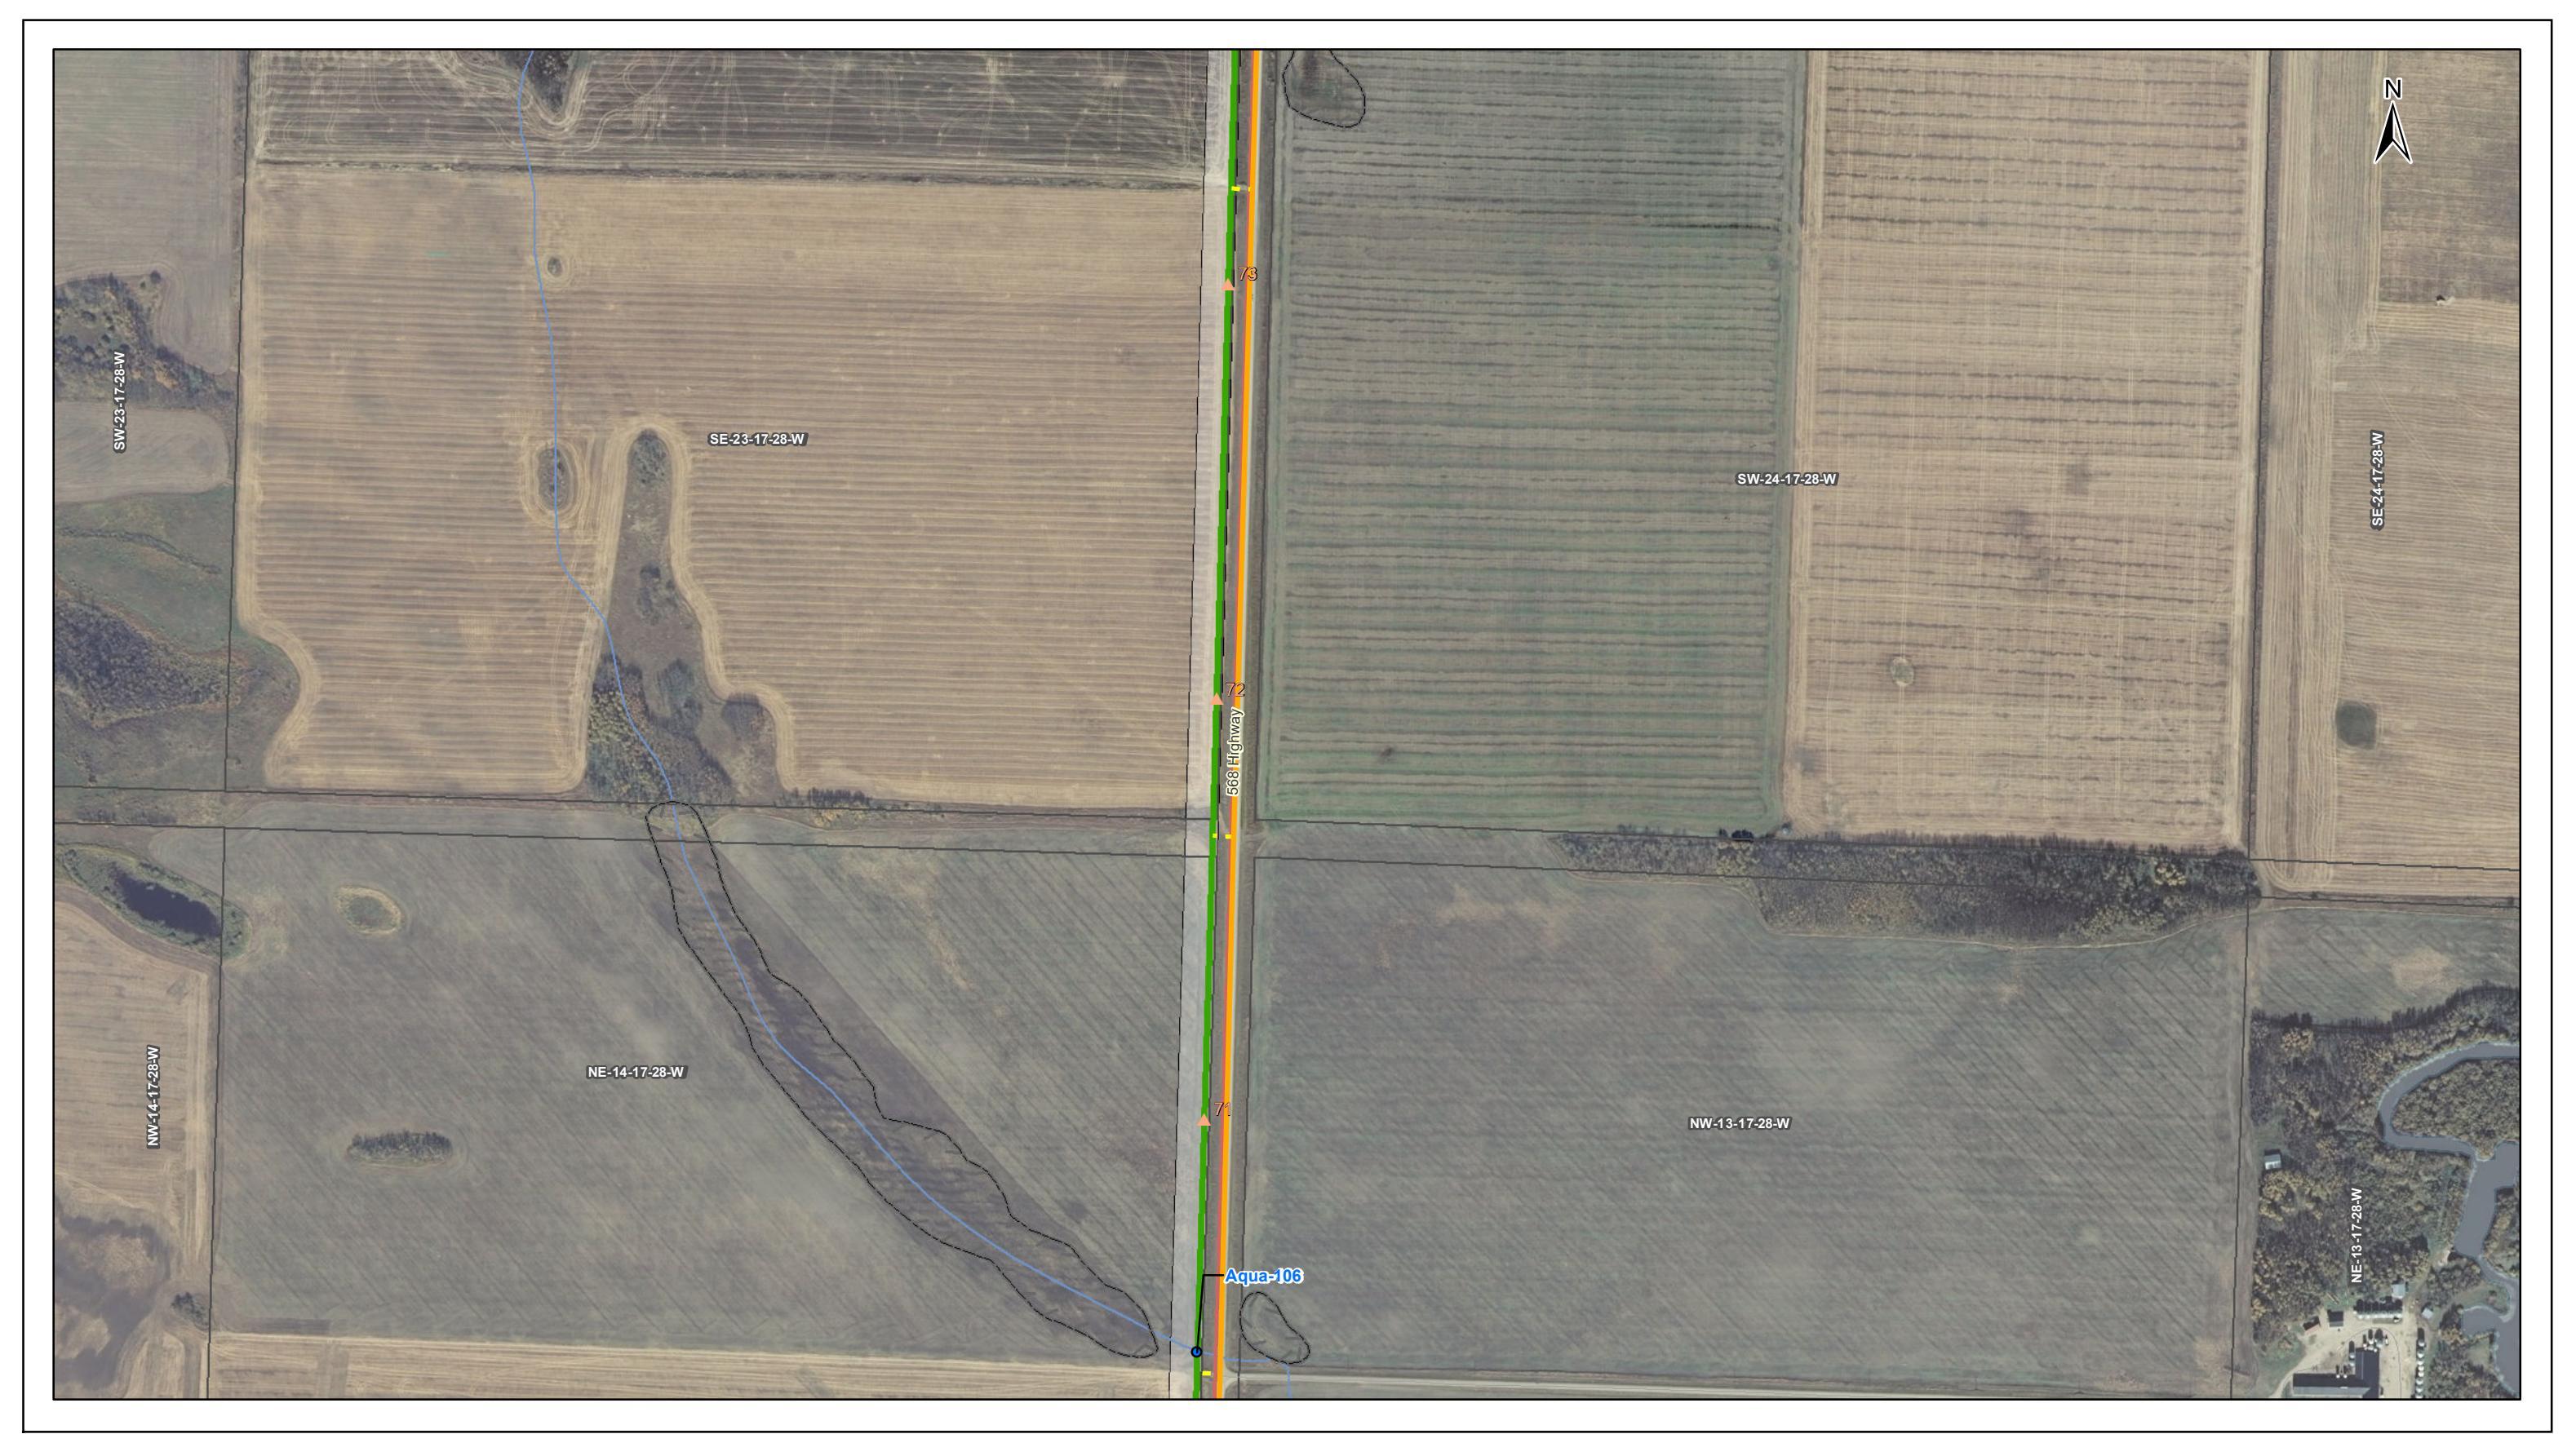
ESS Group: Water Crossing

- ٠
- ٠
- ٠
- Carry out construction activities on frozen or dry ground to minimize surface damage, rutting and erosion Use existing trails, roads or cut lines whenever possible as access routes Identify and flag buffers and no machine zones prior to start of work Riparian Buffers shall be a minimum of 30m and increase in size based on slope of land entering waterway with shrub and herbaceous understory maintained along with trees that do not violate Manitoba ٠ Hydro's vegetation clearance requirements
 7m no machine zone will prohibit equipment in close proximity to the waterbody except at the trail crossing

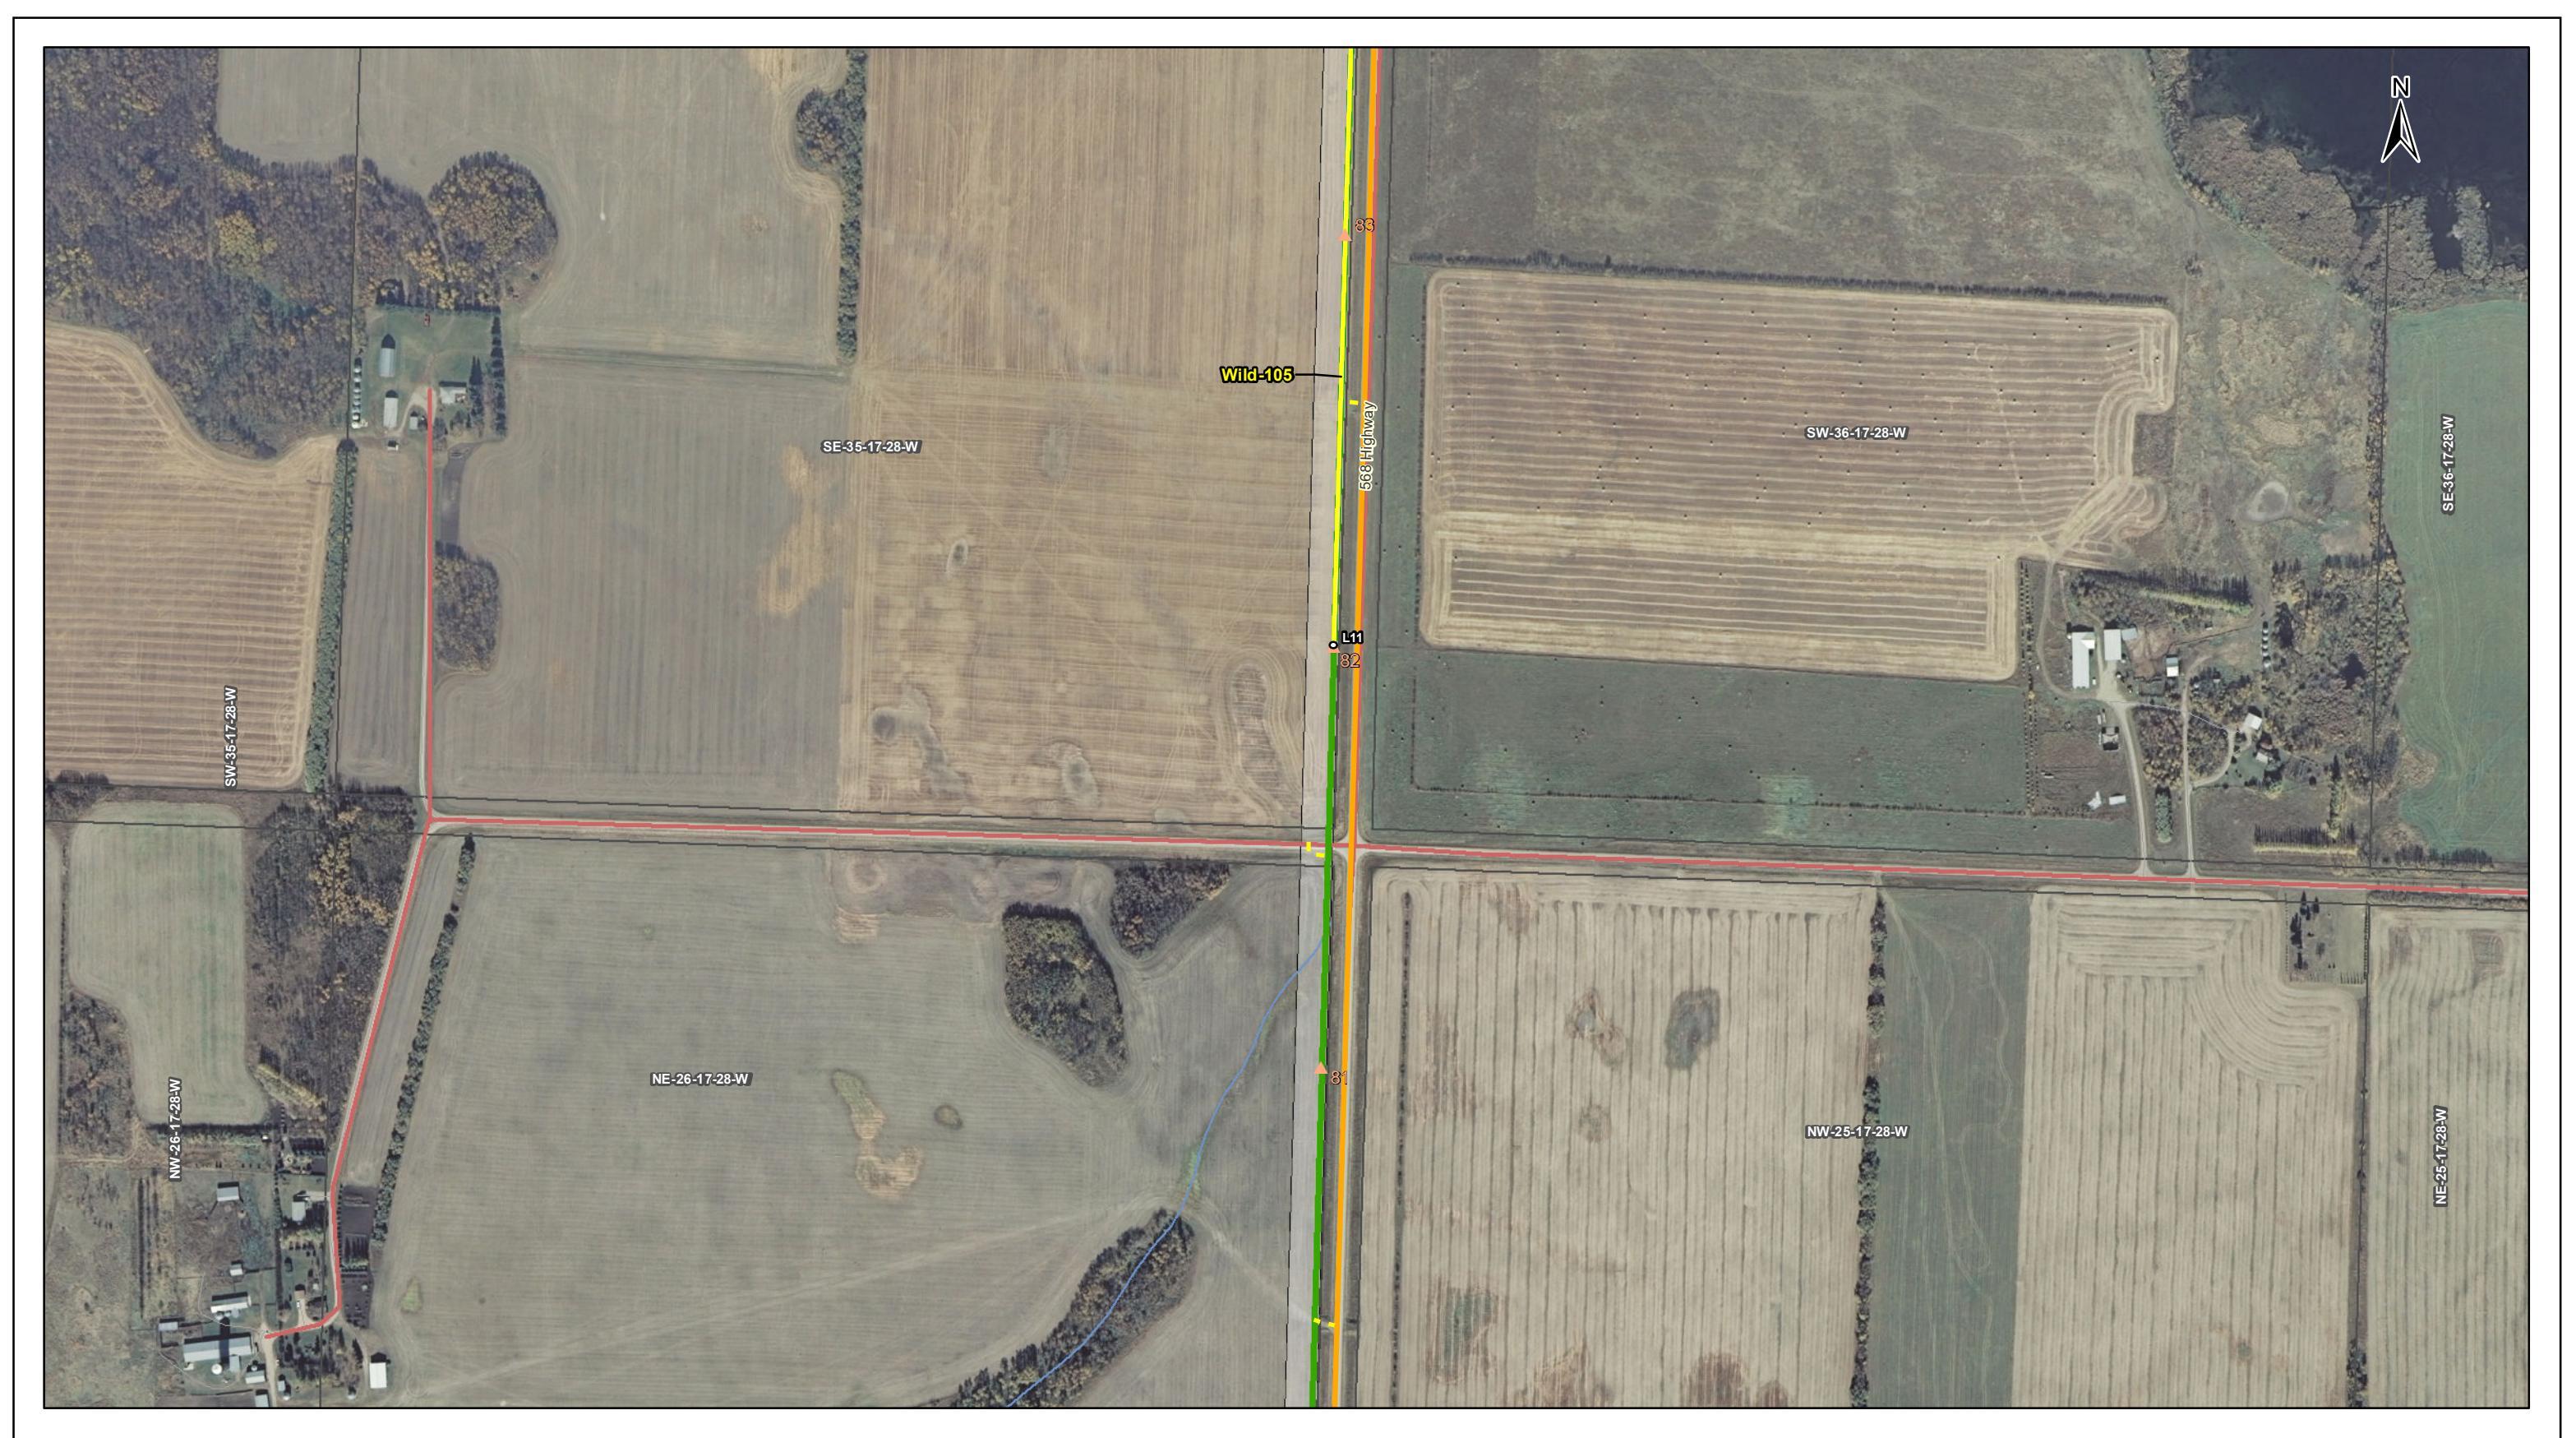
ESS Group: Birds and Habitat

- As per industry standards, bird diverters will be installed in a manner to maximize visibility by alternating between reflective and spiral diverters along the two skywires
 Install bird diverter with spacing as per Transmission Line Design specifications for these spans

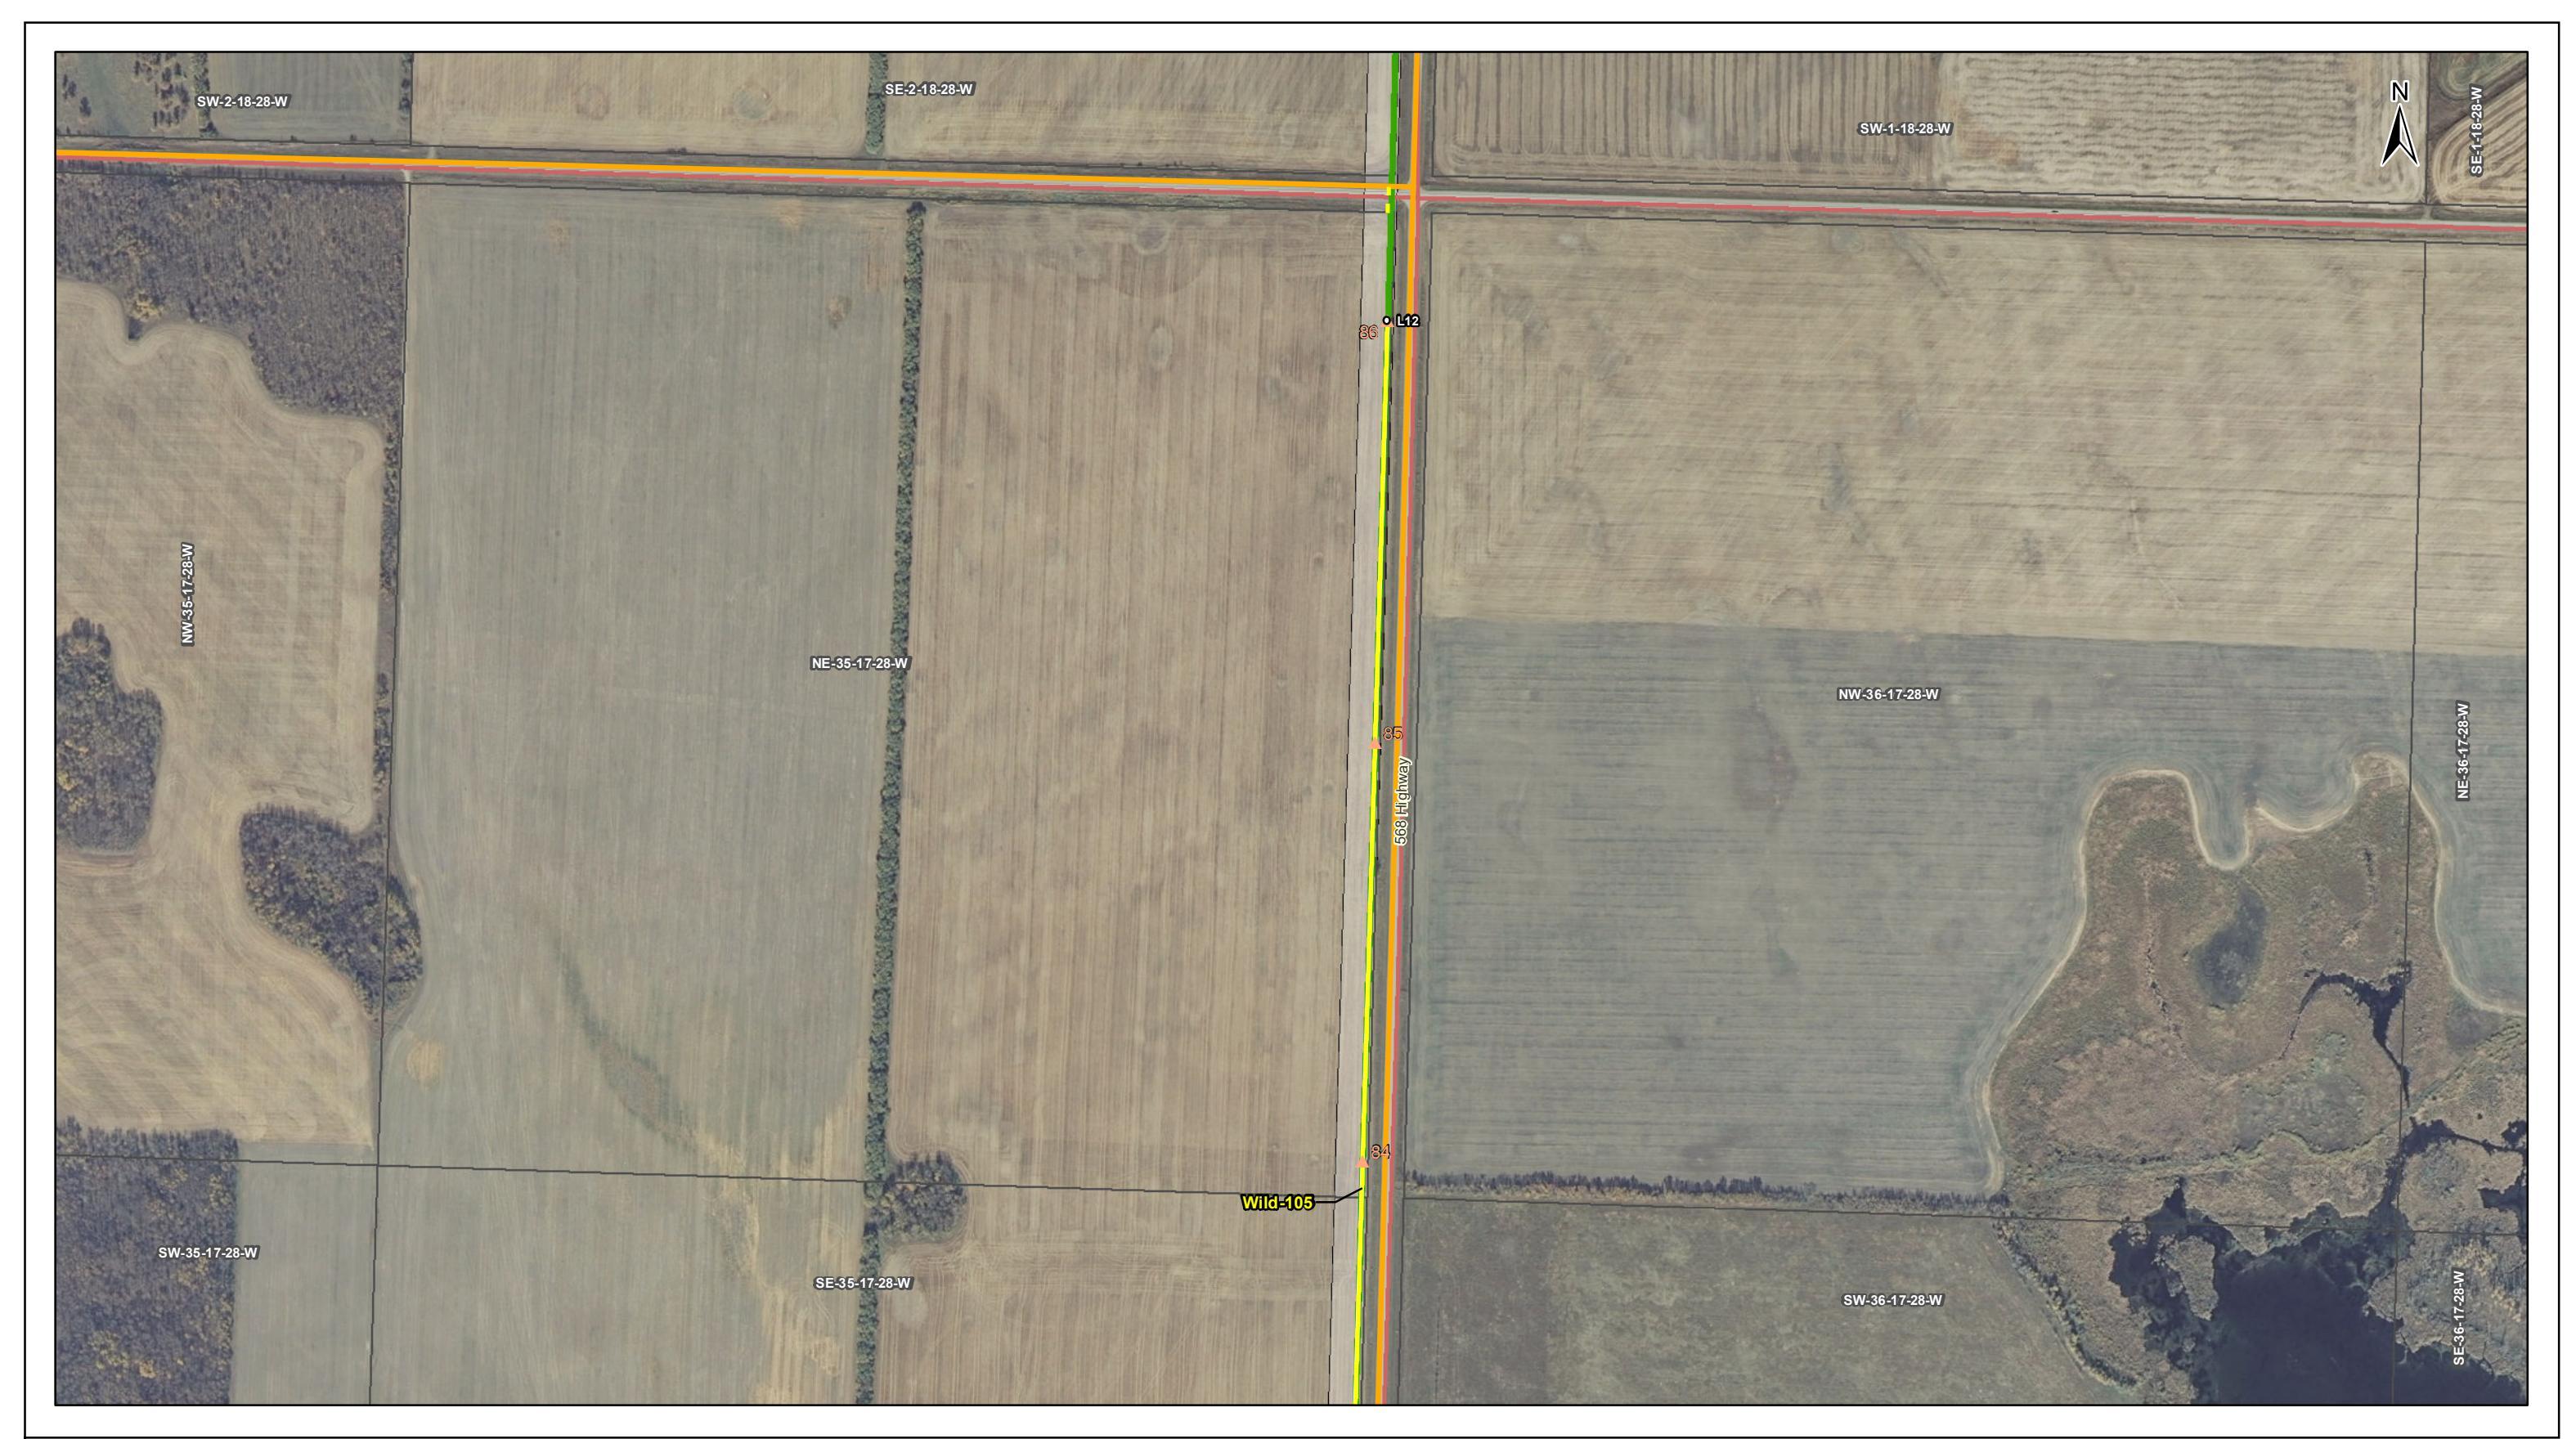
ESS Group: Birds and Habitat

- As per industry standards, bird diverters will be installed in a manner to maximize visibility by alternating between reflective and spiral diverters along the two skywires
 Install bird diverter with spacing as per Transmission Line Design specifications for these spans

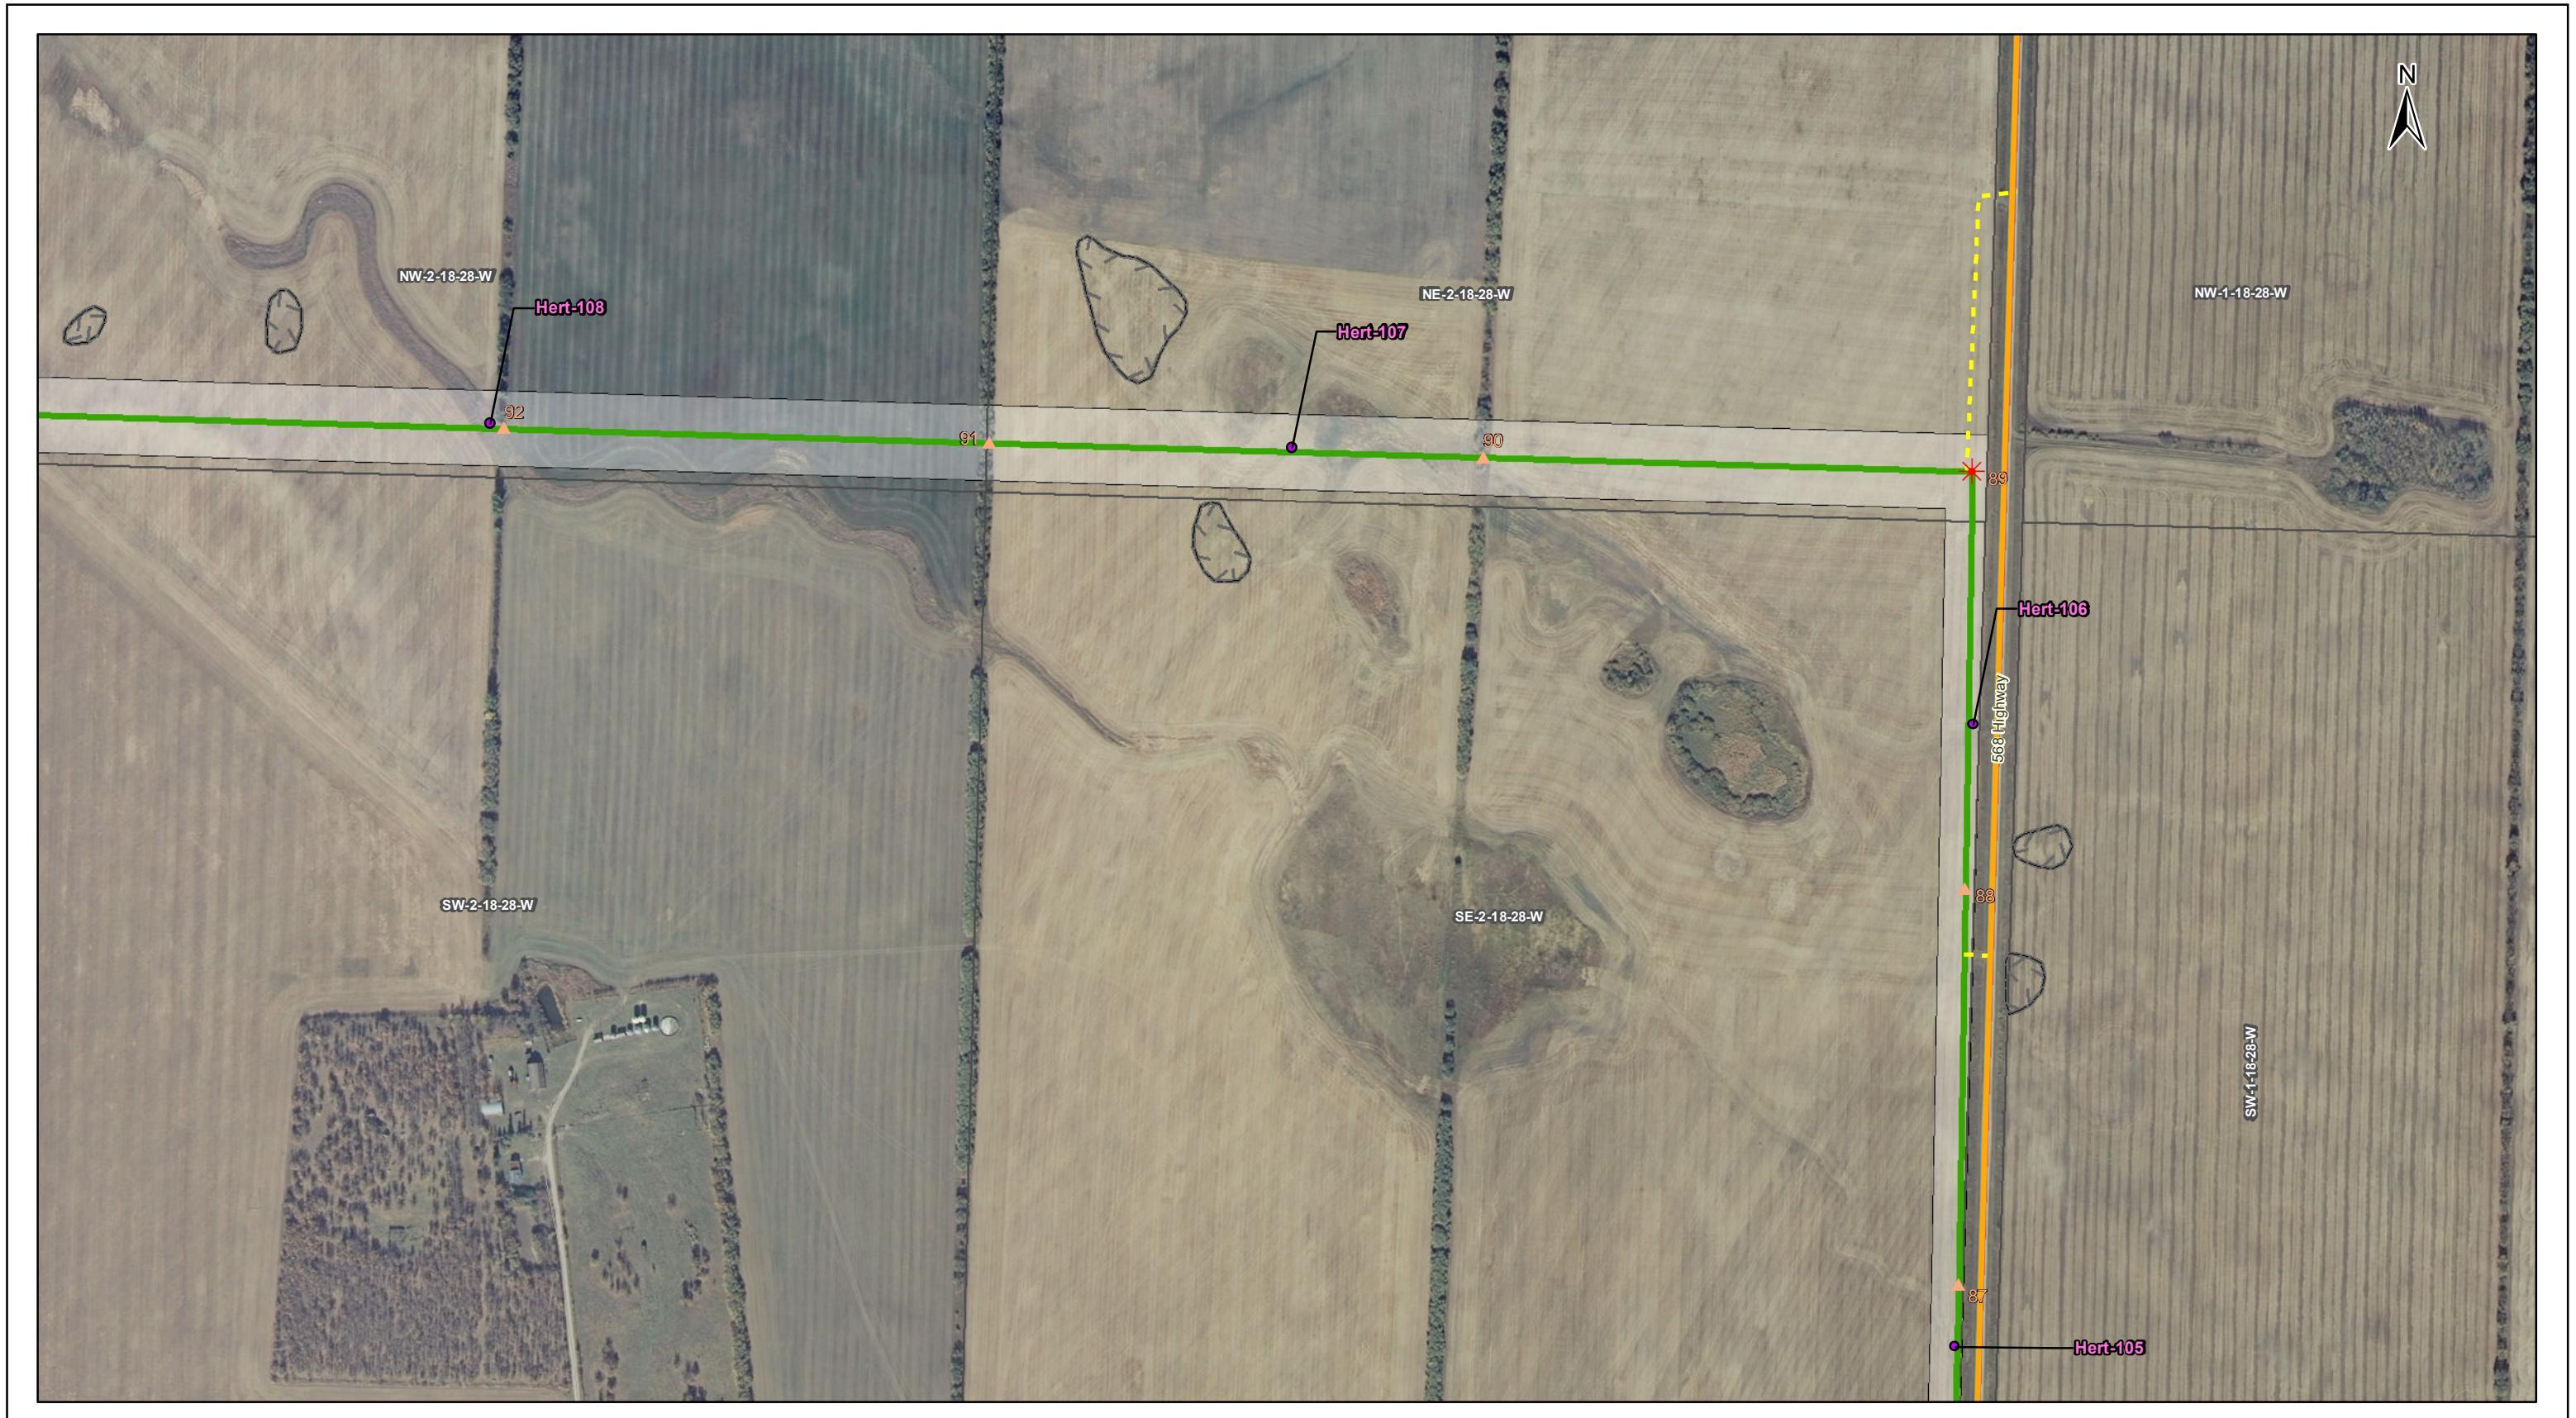
ESS Group: Archaeological

- Carry out construction activities on frozen or dry ground to minimize surface damage, rutting and erosion. Construction matting will be used to protect the area from rutting and exposure to mineral soil during nonfrozen ground conditions
- ٠ Confine traffic to established trail
- ٠
- ٠
- Hand-clearing or other low disturbance clearing approved by the Project Archaeologist within the area Identify and flag a 30m buffer around site, if not within designated riparian buffer In the event of a discovery stop work in area and contact the Project Archaeologist immediately. Refer to ٠ Cultural and Heritage Resources Protection Plan for further guidance
- ٠ Should heritage resources be discovered during a pre-construction survey the project Archaeologist may prescribe additional mitigation measures

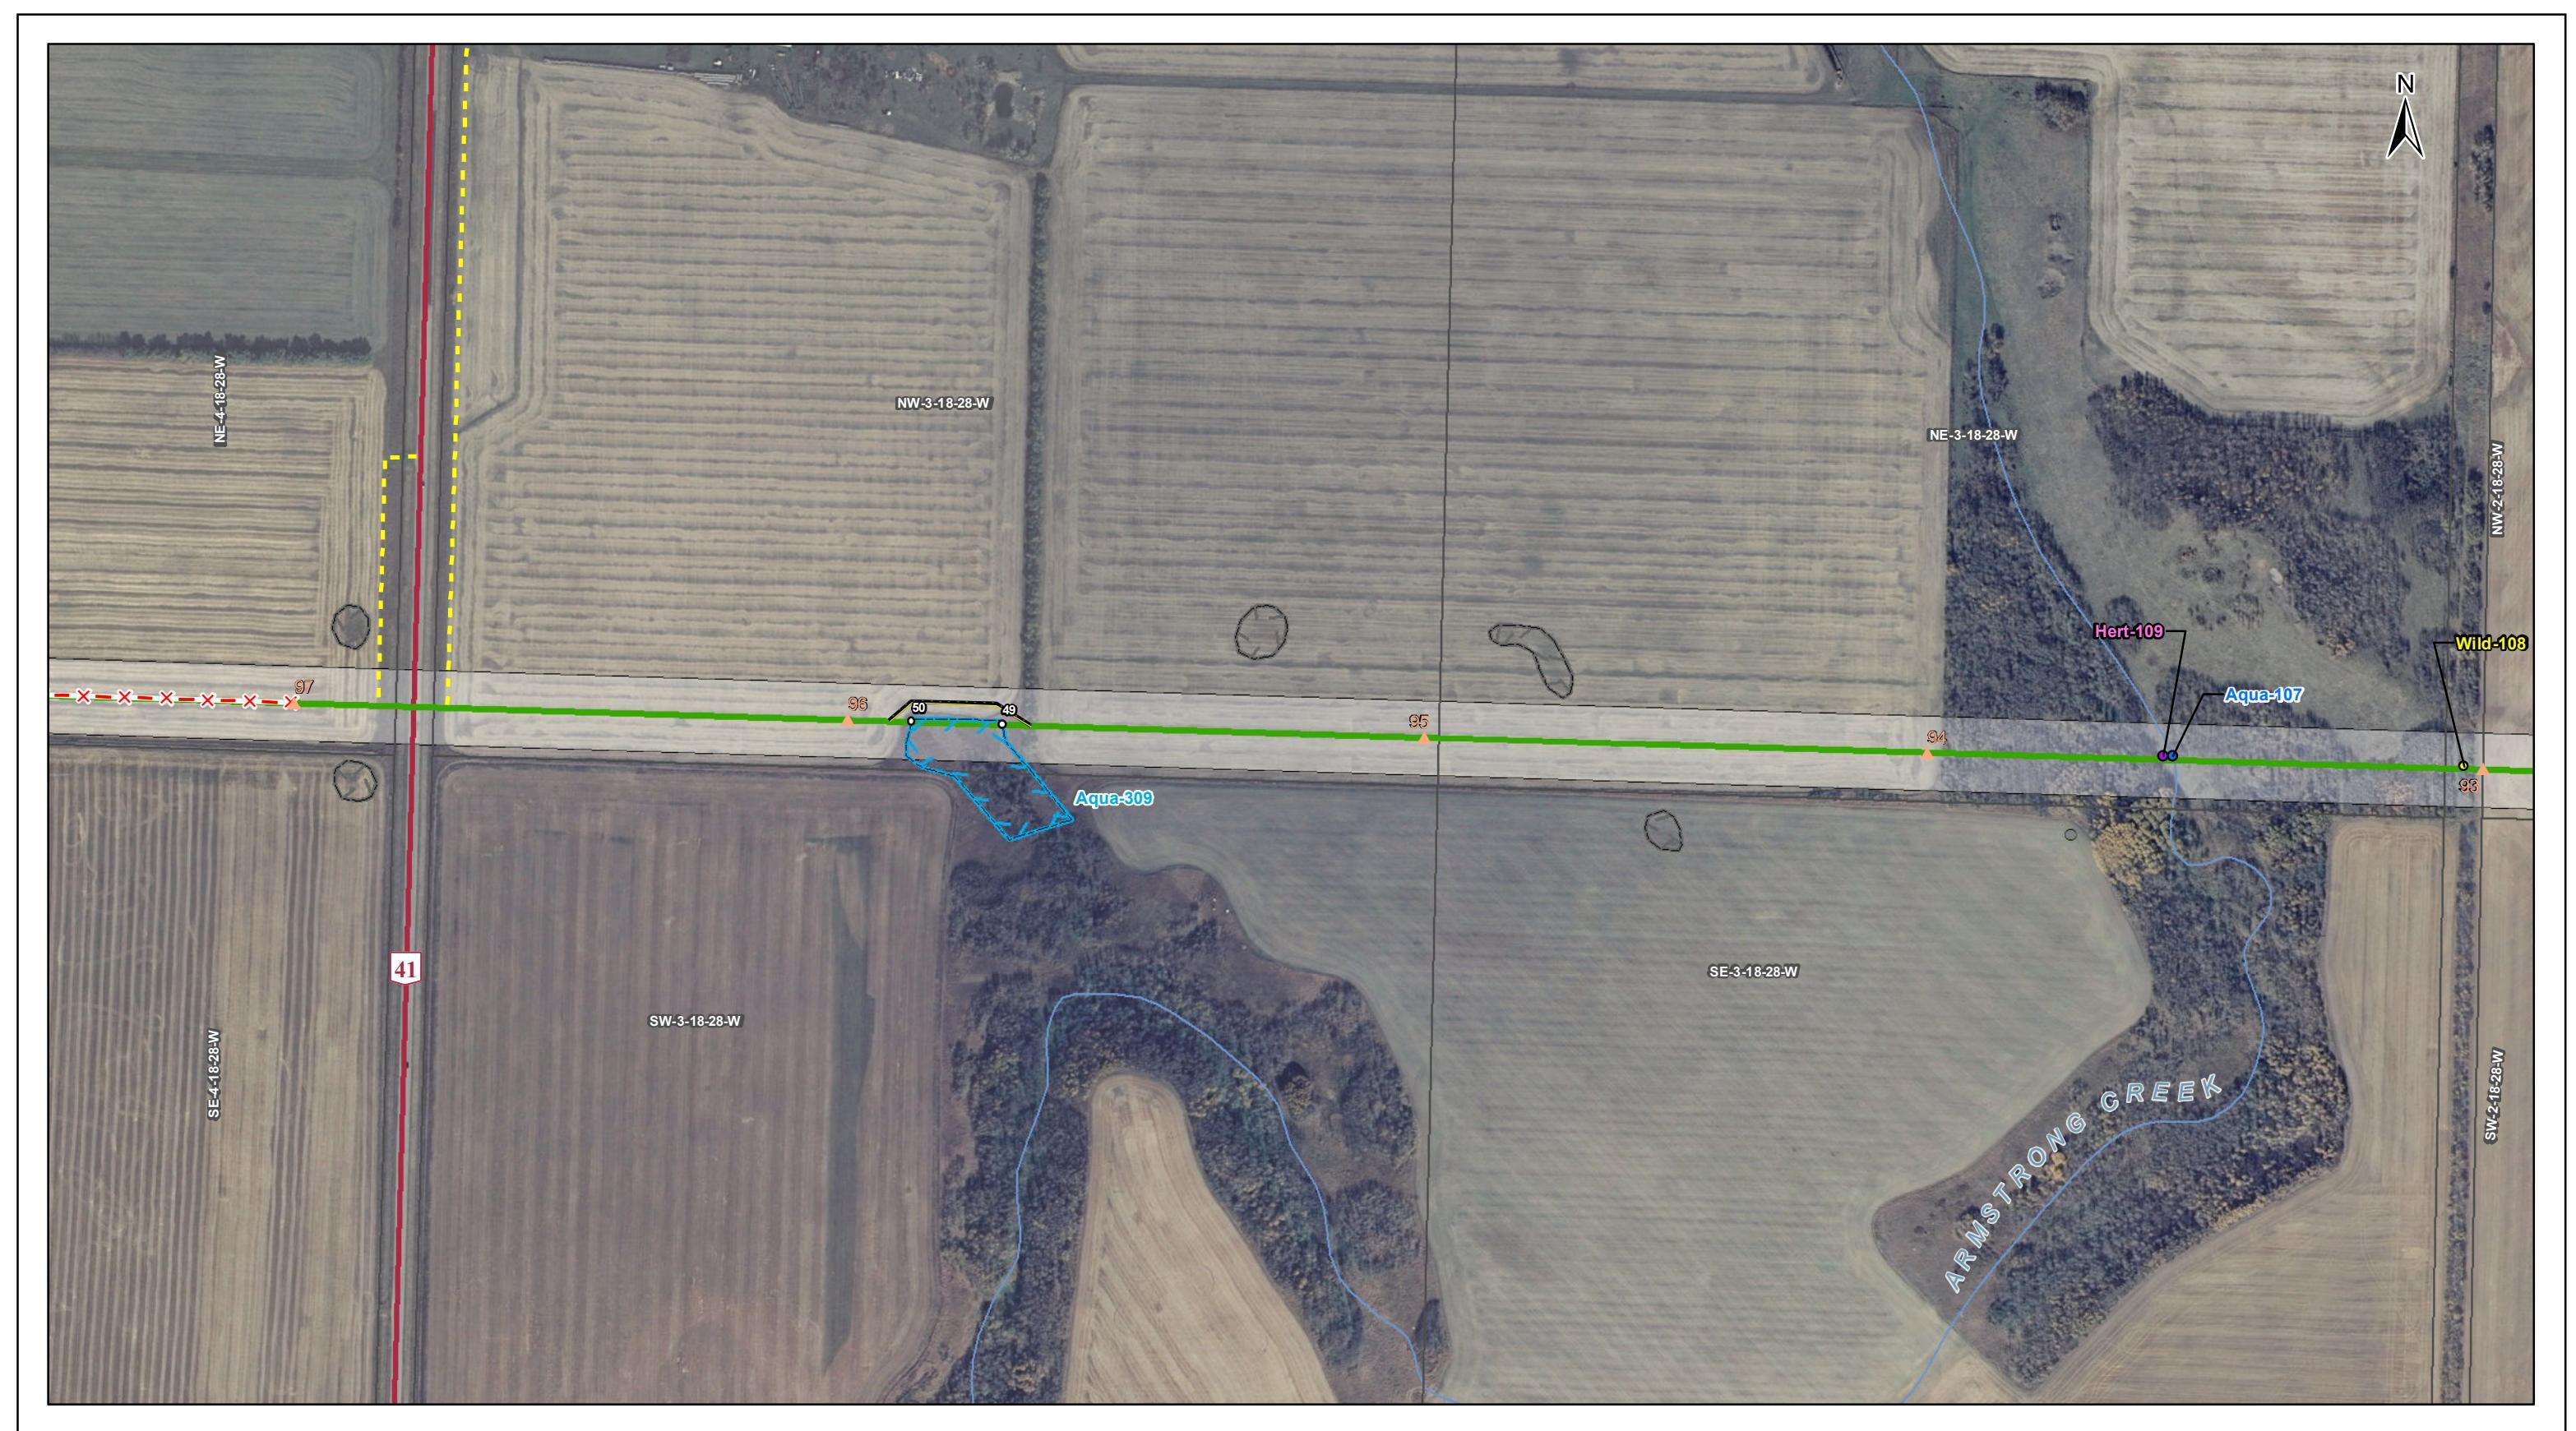
ESS Group: Archaeological

- Carry out construction activities on frozen or dry ground to minimize surface damage, rutting and erosion. Construction matting will be used to protect the area from rutting and exposure to mineral soil during nonfrozen ground conditions
- Confine traffic to established trail
- Hand-clearing or other low disturbance clearing approved by the Project Archaeologist within the area
- Identify and flag a 30m buffer around site, if not within designated riparian buffer
- In the event of a discovery stop work in area and contact the Project Archaeologist immediately. Refer to Cultural and Heritage Resources Protection Plan for further guidance
- Should heritage resources be discovered during a pre-construction survey the project Archaeologist may prescribe additional mitigation measures

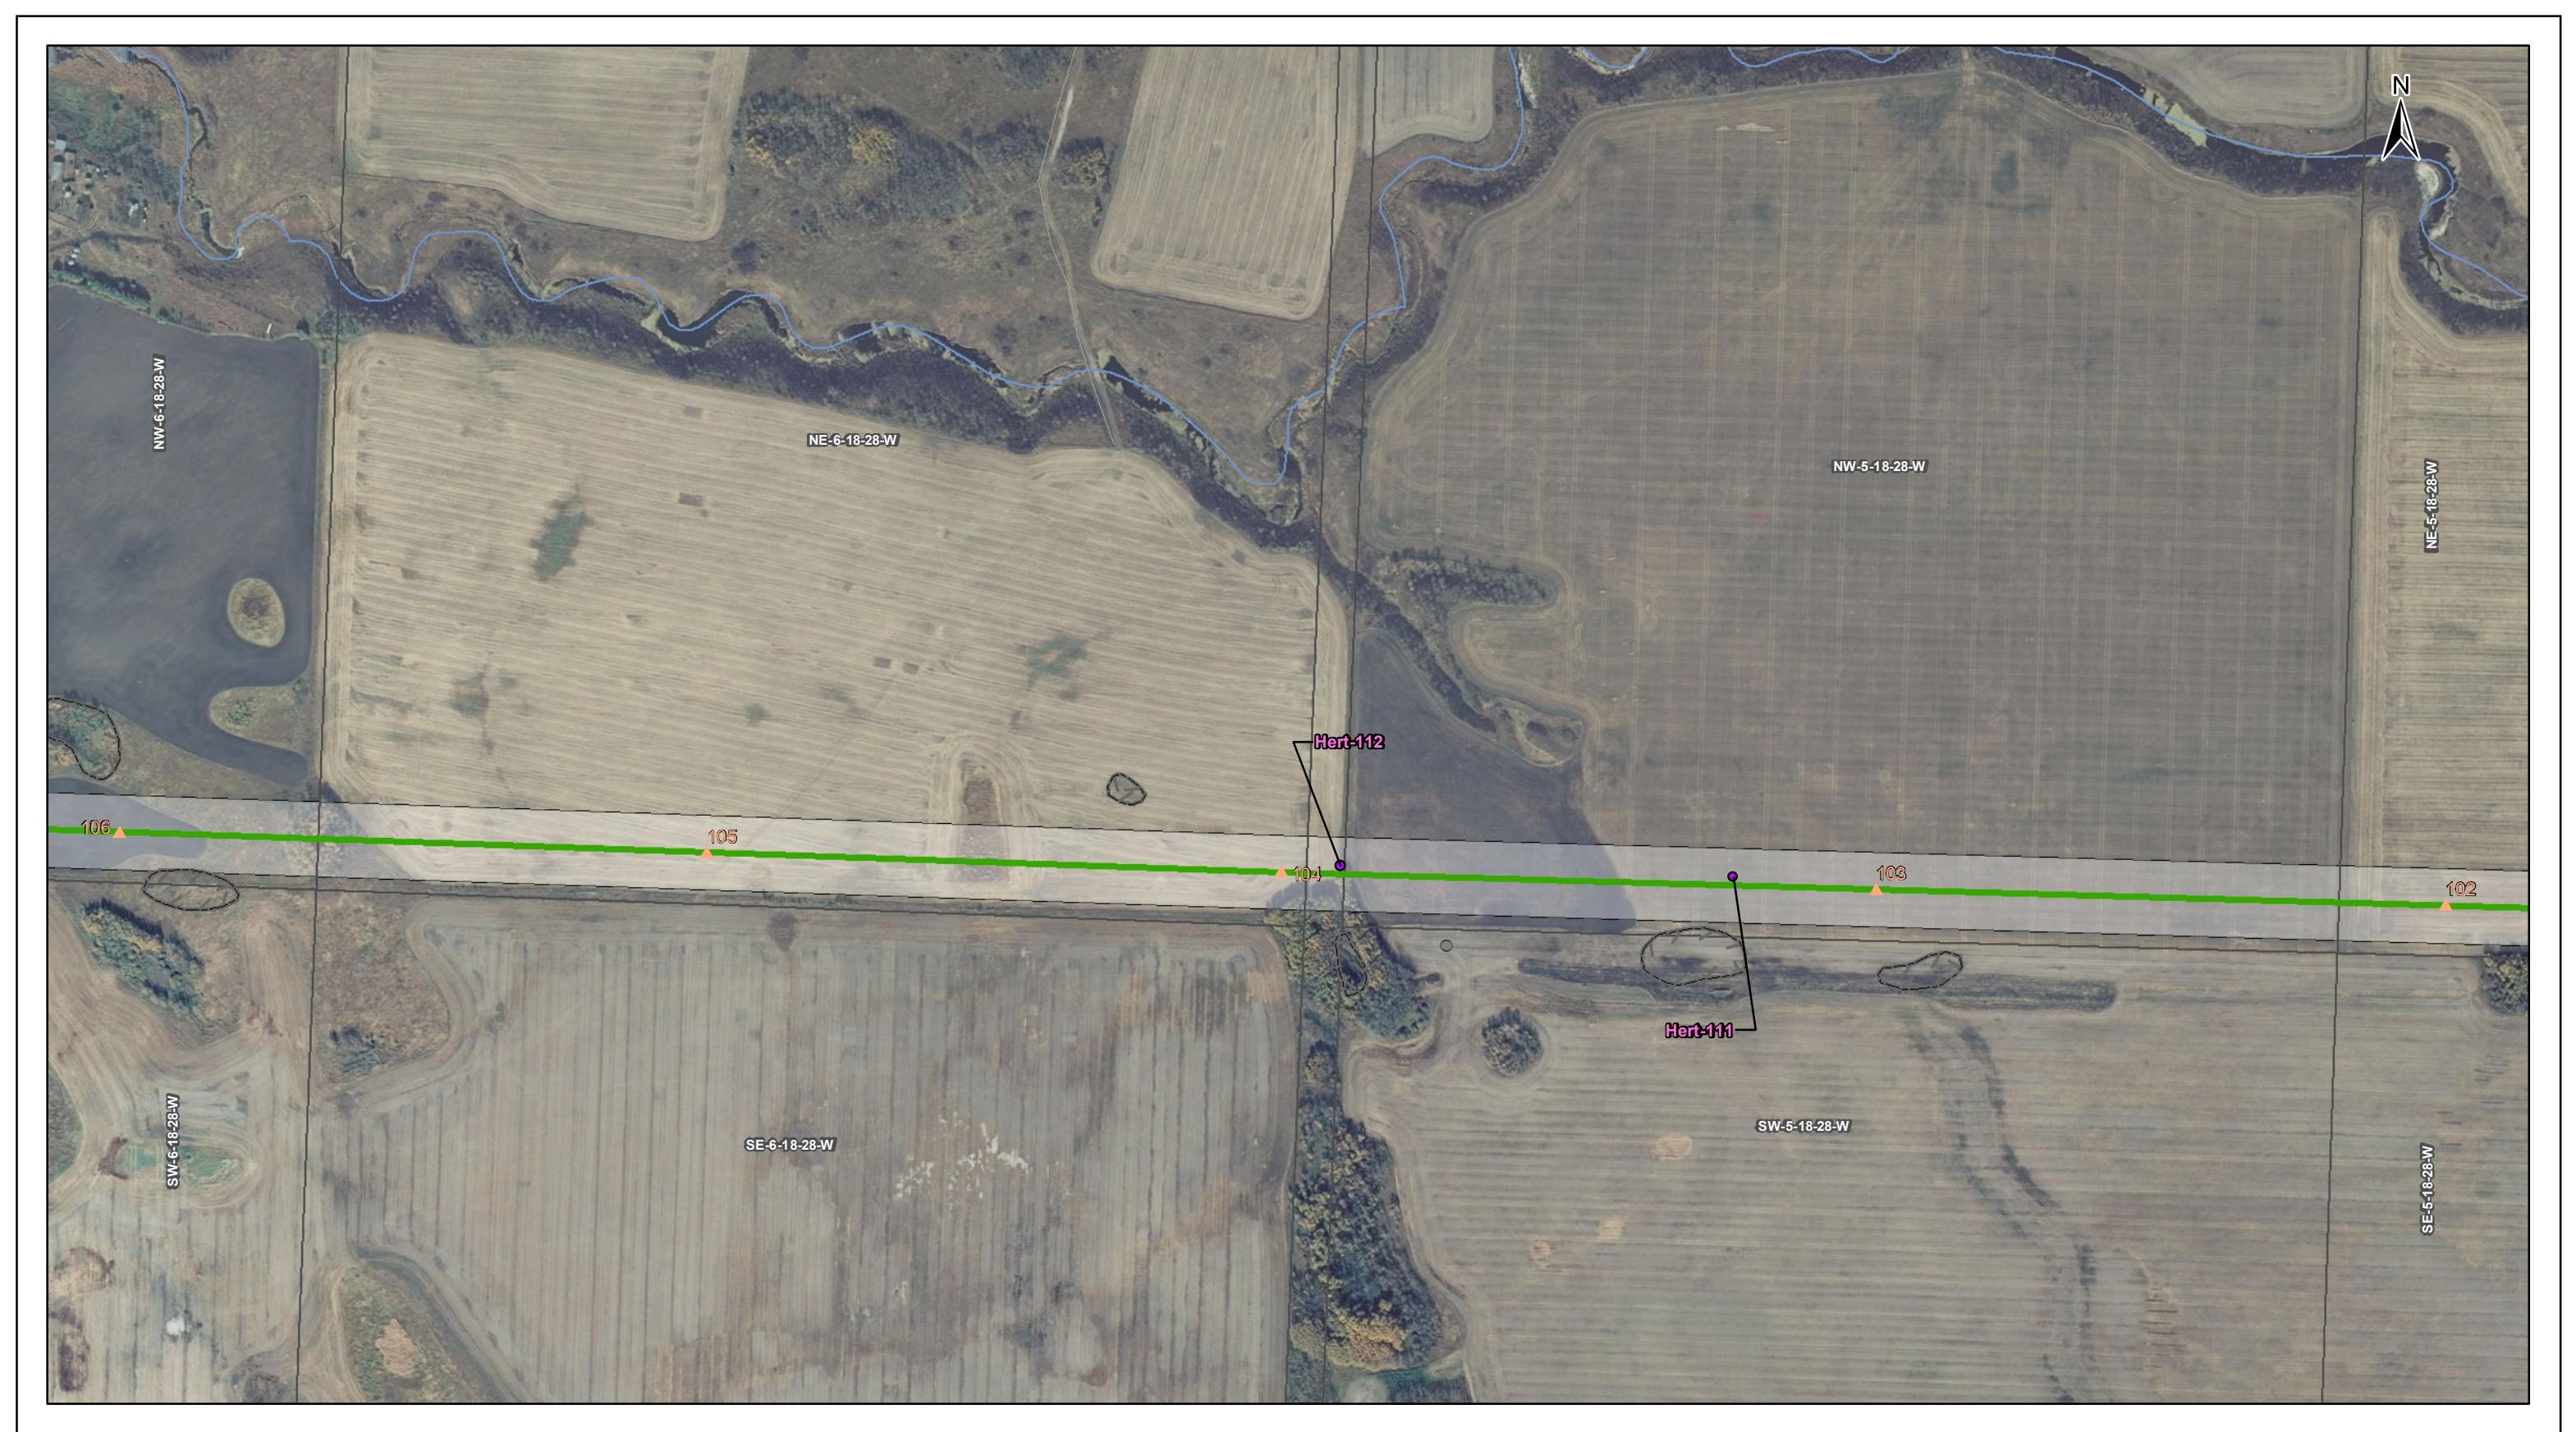
ESS Group: Archaeological

- Hand-clearing or other low disturbance clearing approved by the Project Archaeologist within the area
 Identify and flag a 30m buffer around site, if not within designated riparian buffer
 In the event of a discovery stop work in area and contact the Project Archaeologist immediately. Refer to Cultural and Heritage Resources Protection Plan for further guidance
- ٠ Should heritage resources be discovered during a pre-construction survey the project Archaeologist may prescribe additional mitigation measures
